National Transportation Safety Board

Safety Recommendation

Date: August 12, 1998

In reply refer to: A-98-65 through -66

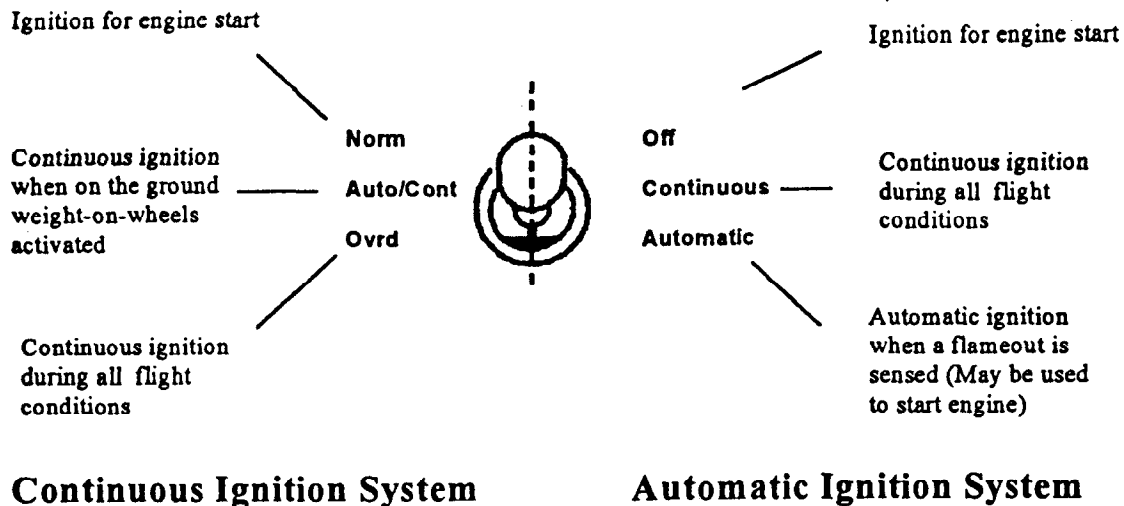
Figure 1. Typical Ignition Switch Position Labeling in TPE331-powered Airplanes

Most TPE331-powered airplanes have a pilot-activated engine anti-ice system to prevent the accumulation of ice in the engine inlet duct. When selected by the pilot, the anti-ice system directs hot engine bleed air to the engine inlet lip to prevent ice formation in the engine inlet. This system is designed to be activated before ice accumulation; it is not intended as a deicing system. Activation of the anti-ice system after ice has accumulated can cause pieces of ice to shed from the inlet lip and cause an engine flameout. As an added flameout protection, some TPE331-powered Fairchild airplanes incorporate an "automatic" ignition system (see right side of figure 1) that can detect a flameout and automatically activate the ignition system. This system is

not truly automatic because the pilot must first select an ignition mode using a manually selectable three-position switch. Flameouts can be detected by the decay in certain engine parameters, such as engine revolutions per minute or torque. The automatic ignition system can relight the engine without pilot action or awareness of any engine or airplane performance changes if the ignition mode switch is in the automatic position.

The Fairchild Aircraft ignition system installed in the Bullhead City and Blountville accident airplanes did not incorporate the automatic ignition system but a "continuous" ignition system (see left side of figure 1), which provides continuous ignition in flight when the pilot selects the "override" mode using a similar three-position switch. The Fairchild SA227-AC and SA227-TT airplane AFMs state that in advance of intentionally flying into icing conditions and heavy rain, the pilot should select engine and propeller heat and override ignition. The procedures for inadvertent flight-into-icing conditions state that after discovering ice accumulation, the pilot should select "override" ignition, then engine and propeller heat for one engine (to ensure that the engine is operating satisfactorily), and then engine and propeller heat for the other engine.

Require that all TPE331-powered airplanes be equipped with an engine ignition system that is activated automatically (without pilot input) following an engine flameout. (A-98-65)
