National Transportation Safety Board

Safety Recommendation

Date: December 21, 2006

In reply refer to: R-06-24 through -27

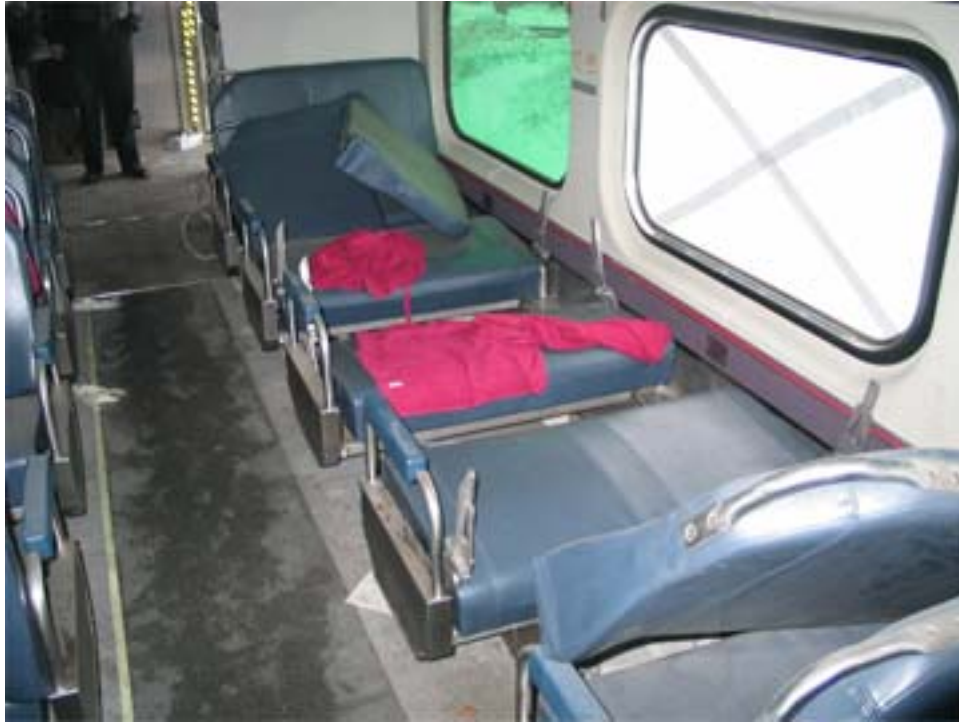
A postaccident inspection of the seats showed that some had sustained extensive damage. For example, car 7488 had 12 seat backs that had separated from their frames (3 of the 12 seat backs had broken frames). Nine seat backs had lifted up and completely separated from the frames, exposing the two vertical posts that held the seat back onto the seat assembly. An inspection of car 7351 showed that 22 seat backs were dislodged, including 1 that had a seat post exposed. In car 8548, four seat backs were dislodged, including one that had completely separated from the seat frame. (See figure 1.)

Figure 1. Exposed seat back supports in car 8548.

Research tests on the walkover seats have shown that the seat backs remain attached during the dynamic test with longitudinal accelerations.¹⁴ However, the vertical and lateral accelerations that occur in a derailment are not adequately represented in the dynamic test. As this accident has shown, the components of the walkover seat can separate from the seat assembly, even in rail cars placed into service after September 2002 (such as car 8548).

The Safety Board concludes that the current design of walkover seats presents an unacceptable risk of injury to passengers during an accident. The FRA regulations already require, and industry standards recommend, that passenger seats be securely fastened to the car body. However, the regulations do not require that other components of the seat assembly, such as seat cushions and seat backs, be securely fastened to the seat. Although some of the passenger cars involved in this accident were put into service prior to the effective date of the current FRA standards, this deficiency should be addressed for all seats, including walkover seats, regardless of the date that they were placed into service. Therefore, to address the cars currently in service, the Safety Board believes that the FRA should immediately require that all passenger car seat backs be secured to the seat assembly. Further, to address cars entering service in the future, the Safety Board believes that the FRA should revise the language in 49 CFR 238.233 to define seat to include all components of the seat assembly, such as seat cushions and seat backs, that could become dislodged when subjected to accelerations specified in that section. The Safety Board also believes the FRA should require all rail passenger car seat assemblies to be dynamically tested to withstand the accelerations specified in 49 CFR 238.233, and require both upward and downward vertical acceleration tests.

Immediately require all rail passenger car seat backs be secured to the seat assembly. (R-06-24)

Revise the language in 49 *Code of Federal Regulations* 238.233 to define seat to include all components of the seat assembly, such as seat cushions and seat backs, that could become dislodged when subjected to accelerations specified in that section. (R-06-25)

Require all rail passenger car seat assemblies to be dynamically tested to withstand the accelerations specified in 49 *Code of Federal Regulations* 238.233, and require both upward and downward vertical acceleration tests. (R-06-26)

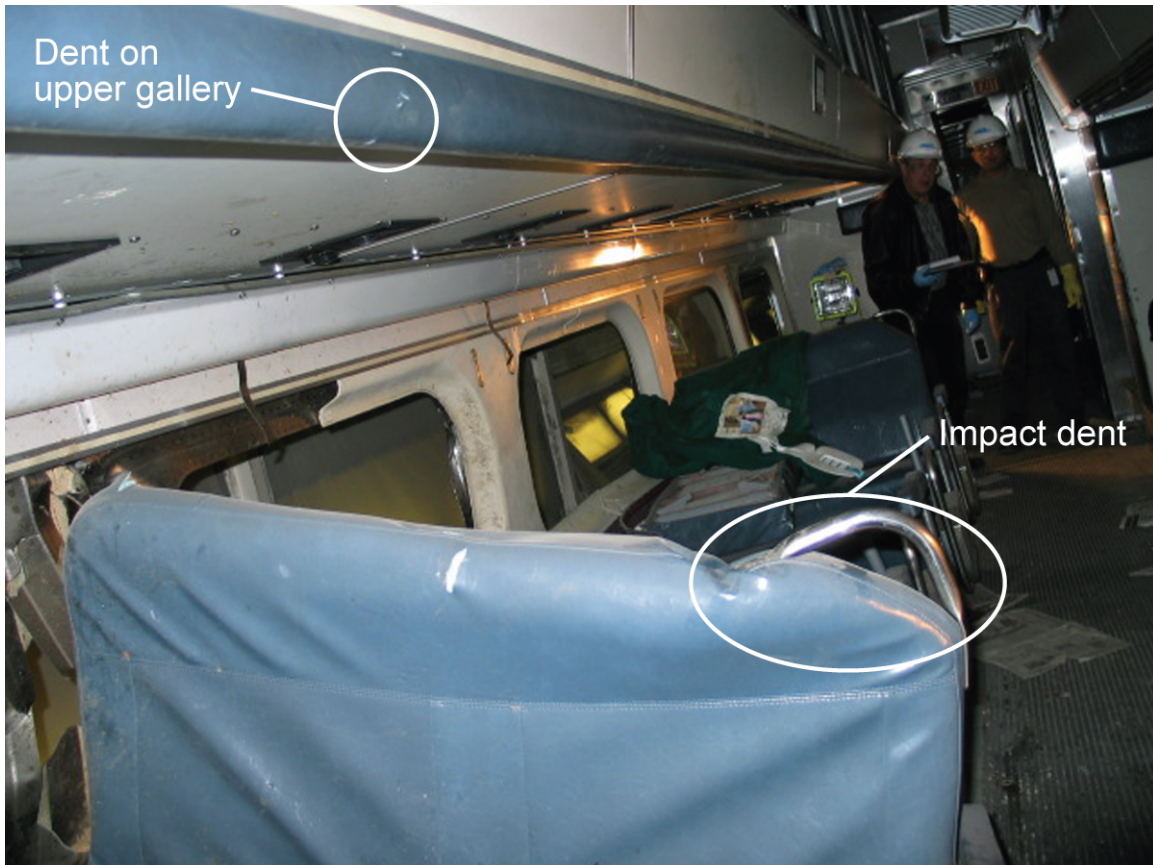
were bowed outward about 2 inches and 15 inches on the left and right sides, respectively. Corresponding segments of car body sidewall, directly above the leading end/lower right side-sill, displayed severe sheet metal crushing and displacement/distortion damage, where a 19-foot segment of car body floor¹⁵ had separated and lifted from its supporting structural members. The separated segment of car body floor, at the right front corner, had lifted at least 24 inches,¹⁶ resulting in seat backs located in that area of the car contacting the underside panel of the upper-gallery level. (See figure 2.)

Figure 2. Seat back in front right of car 7488 showing impact dents, the location of which corresponds with the inboard edge of the underside panel of the upper-gallery level (located directly above the seat).

Both passenger fatalities occurred in car 7488; one passenger was pronounced dead on the scene and the other later at the hospital. Both individuals were found in the area where the maximum amount of car body floor lift (24 inches) had occurred. One was found wedged beneath seats and between the folds of deformed metal of the buckled car body sidewall panel. A

In light of the significant injuries and fatalities that resulted from this accident, some of which were apparently related to lack of car body floor integrity, the Safety Board believes that the FRA should establish crashworthiness standards for passenger car body floor structure systems.

Establish crashworthiness standards for passenger car body floor structure systems. (R-06-27)
