National Transportation Safety Board

Safety Recommendation

In reply refer to: A-11-7 through -11

Protection of the Elevator PCU Input Arm Assembly

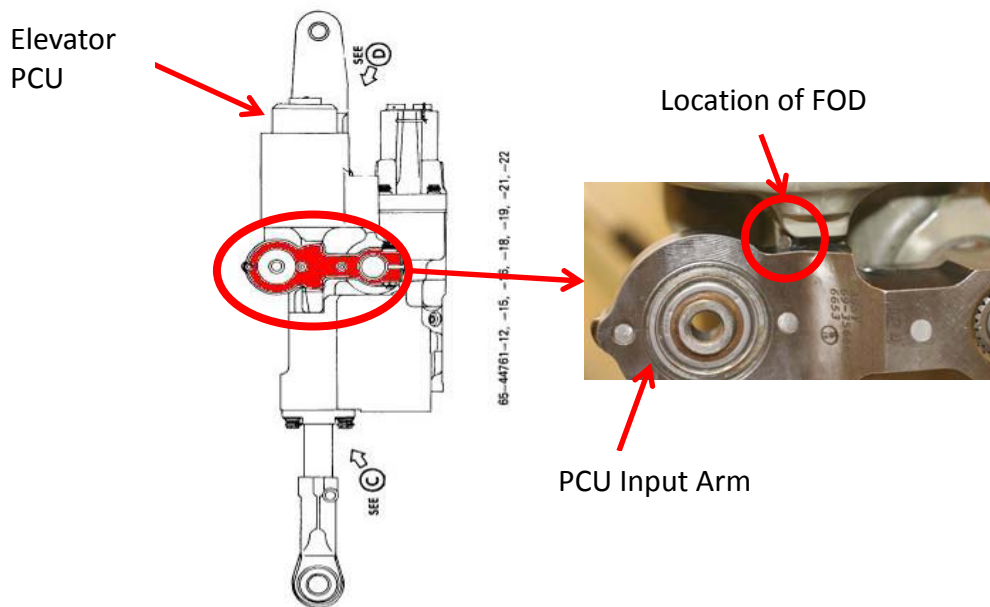
The NTSB's investigation found that the incident was caused by an uncommanded elevator deflection as a result of a left elevator power control unit (PCU) jam due to foreign object debris (FOD). The FOD was a metal roller element (about 0.2 inches long and 0.14 inches in diameter) from an elevator bearing. During its investigation of this incident, the NTSB identified safety issues relating to the protection of the elevator PCU input arm assembly, design of the 737 elevator control system, guidance and training for 737 flight crews on a jammed elevator control system, and upset recovery training.

Figure. Location of FOD.

Tailwind Airlines' postincident inspection of the elevator PCUs revealed that the system "A" elevator PCU input arm assembly was jammed by a piece of FOD (a metal bearing roller) in a position that offset the control arm in a downward direction. With the control arm deflected downward and with hydraulic pressure available, the PCU would be commanded to move the elevator to a position that would pitch the aircraft nose up. The incident airplane's flight data recorder (FDR) recorded an aircraft pitch up during the landing flare just before the commanded go-around maneuver. Because of the way the elevators are linked together, a jam in one PCU will cause both elevator surfaces to deflect in the same direction. (The two sides of the system cannot be disconnected so that the unjammed PCU can control the elevators.)

In January 2009, a scheduled maintenance check ("C" check) was performed on the airplane. Part of the check involved replacement of the upper torque tube output crank bearing. Postincident inspections of the airplane's elevator system components located within the tailcone also revealed that the left elevator upper torque tube output crank bearing/sleeve appeared new, with all bearings present. The NTSB determined that, at some point during maintenance or in-service operation before the January 2009 maintenance check, metal rollers⁷ became dislodged from the bearing and scattered throughout the aft elevator system components.

⁷ In addition to the metal bearing roller that caused the jam, a second metal bearing roller was found resting at the bottom of the tailcone near the drain hole, mostly buried in debris. Boeing's metallurgical analysis revealed that both metal bearing rollers had the same dimensions and material as the rollers that are installed in two locations in the aft elevator control system (the right and left ends of the elevator upper output torque tube crank assembly).

Require Boeing to develop a method to protect the elevator power control unit input arm assembly on 737-300 through -500 series airplanes from foreign object debris. (A-11-7)

Once Boeing has developed a method to protect the elevator power control unit input arm assembly on 737-300 through -500 series airplanes from foreign object debris as requested in Safety Recommendation A-11-7, require operators to modify their airplanes with this method of protection. (A-11-8)
