National Transportation Safety Board

Safety Recommendation

In reply refer to: A-11-12 through -15

On October 19, 2009, about 0605 eastern daylight time,¹ a Boeing 767, N185DN, operating as Delta Air Lines flight 60, landed on taxiway M at Hartsfield-Jackson Atlanta International Airport (ATL), Atlanta, Georgia. The flight was operating as a 14 *Code of Federal Regulations* Part 121 flight from Rio de Janeiro/Galeão-Antônio Carlos Jobim International Airport to ATL with 11 crewmembers and 182 passengers. No injuries to the crew or passengers were reported, and the airplane was not damaged. Night visual meteorological conditions prevailed.²

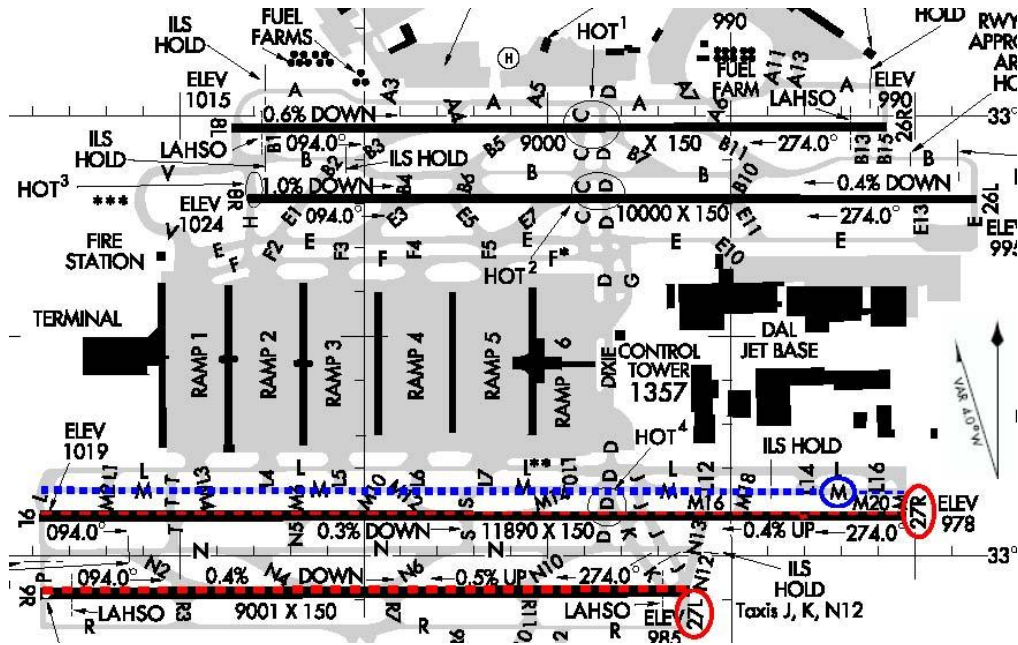
Figure. Diagram Showing ATL Runways 27L, 27R, Taxiway M

During the descent and approach, the flight crew was assigned a number of runway changes; the last of which occurred near the final approach fix for runway 27L. While the flight was on final approach, the crew was offered and accepted a clearance to sidestep to runway 27R³ for landing (see figure for a diagram of ATL runway configurations). Although the flight crew had previously conducted an approach briefing for runways 27L and 26R, they had not briefed the approach for runway 27R and were not aware that the approach light system and the instrument landing system (ILS) were not available to aid in identifying that runway.⁴

According to the captain, who was the flying pilot, he maneuvered for the sidestep from runway 27L to 27R and lined up on “the next brightest set of lights” he saw. He said that he saw “bright edge lights and centerline lights” and thought he had the runway in sight. The first officer was preoccupied during the final approach with attempting to tune and identify the ILS frequency for runway 27R. Just prior to the airplane touching down, the captain realized they were landing on a taxiway. The airplane landed on taxiway M, 200 feet north of, and parallel to, runway 27R. The local controller did not notice the crew’s error until after the airplane had landed. The taxiway was unoccupied, and the flight crew was able to stop the aircraft safely and taxi to the gate.
