# National Transportation Safety Board

## Safety Recommendation

**In reply refer to:** A-11-16

The National Transportation Safety Board (NTSB) is investigating three incidents involving Cessna Aircraft Company (Cessna) 560XL airplanes that experienced loss of rudder control after ice built up inside the tailcone.<sup>1</sup> Preliminary findings indicate that water can collect inside the tailcone and then freeze around and restrict the movement of the rudder boost cables and pulleys. As long as the frozen ice impedes the cables and pulleys, the pilot may be unable to deflect the rudder, which is particularly dangerous when attempting to land in a crosswind or maneuver on the runway. Normally, a pilot would not use the rudder during cruise flight and would not detect that the rudder was frozen until just before or after landing. Although the investigations are ongoing, the information gathered to date has raised serious concerns about the potential loss of rudder control when ice builds up inside the tailcone. We believe this matter warrants action by the Federal Aviation Administration (FAA).

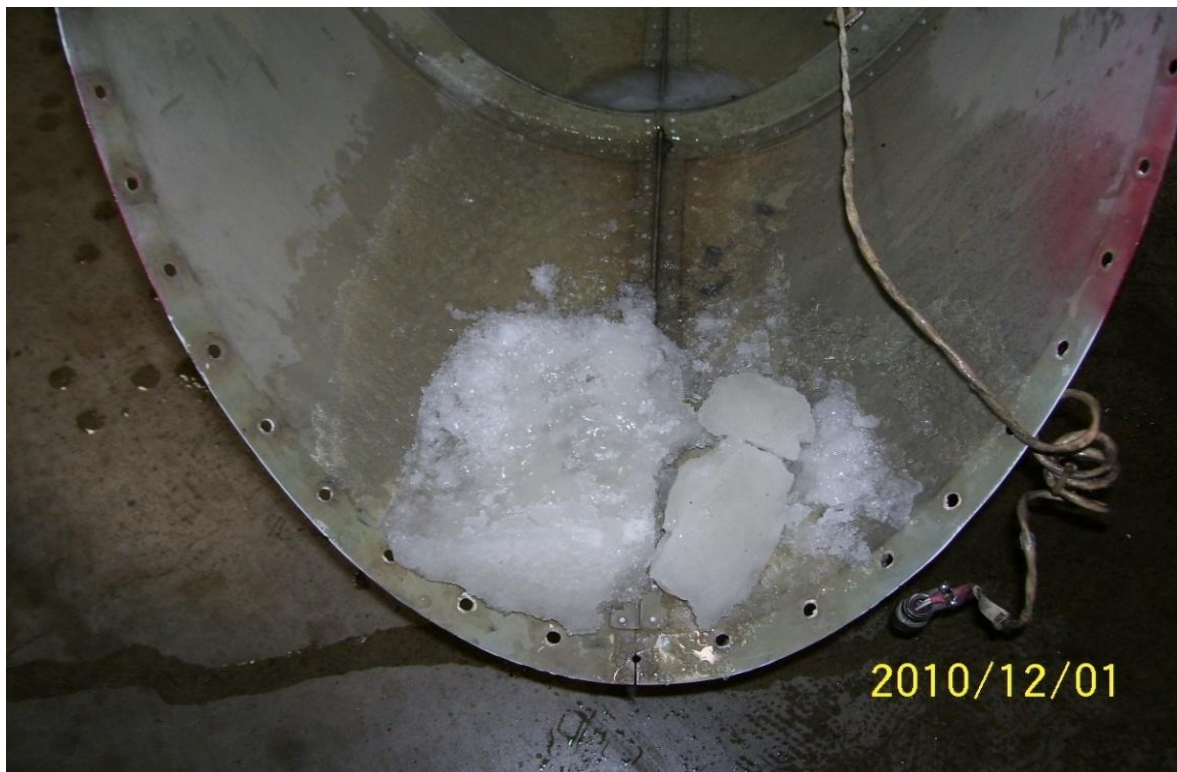
FAA inspectors examined the airplane at a fixed-base operator (FBO) and found that ice had formed at the bottom of the tailcone and around the rudder boost cables and pulleys in the tailcone (see figures 1 and 2).<sup>4</sup>

**Figure 1.** Ice found in the bottom of the tailcone.

According to Cessna, water can enter the Cessna 560XL tailcone through a large opening at the top of the tailcone where the rudder torque tube passes into it. In order to prevent water from accumulating in the tailcone, Cessna, on April 21, 2005, issued service letter (SL) 560XL-53-05, which requested that all operators drill a 0.201-inch-diameter drain hole in the bottom of the tailcone. However, while in flight, low pressure develops across the tailcone; the pressure differential across the drain hole is sufficient to draw water into the tailcone and also prevents water from draining. The water can then collect during flight and can rise to the level of the rudder boost cables and pulleys, potentially freezing around the cables and pulleys, as seen in figure 2. When the water freezes, the motion of the rudder boost cables and pulleys is restricted.

All three Cessna 560XL incident airplanes likely had ice in their tailcones. Because the December 13 and 20, 2010, incident airplanes had the correct 0.201-inch-diameter hole in their tailcones and still collected moisture that froze around the rudder's boost cables, it is evident that a tailcone hole that complies with SL 560XL-53-05 is not sufficient to adequately drain moisture and may allow water to enter the tailcone during flight.

The NTSB understands that Cessna has developed a modification to address the problem of water collecting in the tailcone area. SL 560XL-53-08 asks operators to, within 90 flight hours or 90 days from the date of receipt, drill a 0.75-inch-diameter hole in the bulkhead in the aft fuselage frame, slightly above the lower edge and below the holes for the rudder boost cables. This hole would drain any water from the tailcone into the fuselage before the water level could become high enough to freeze around the rudder boost cables or pulleys. SL 560XL-53-08 also proposes that operators seal the drain hole in the tailcone, if one exists.

Issue an airworthiness directive to require that all Cessna 560XL operators comply with Cessna service letter 560XL-53-08. (A-11-16)

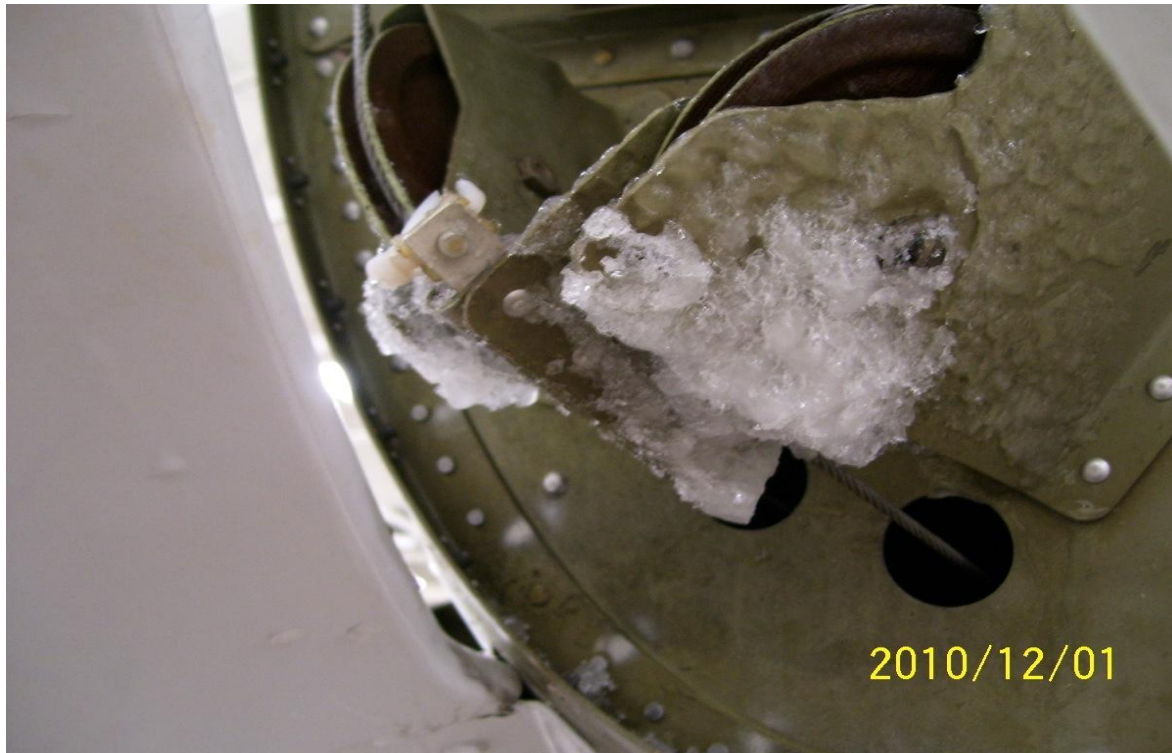
<sup>4</sup> The rudder boost cables and pulleys are near the bottom of the tailcone and are attached directly to the rudder cables. The cables affected by the icing are from the rudder boost system to the rudder bell crank. The main rudder cables are not affected. However, frozen rudder boost system cables effectively prevent the movement of the main rudder cables and rudder.

**Figure 2.** Ice found on the rudder boost cables and pulleys.
