# National Transportation Safety Board

## Safety Recommendation

**In reply refer to:** A-11-32 through A-11-34

On October 25, 2010, about 1352 mountain daylight time,<sup>1</sup> a Mooney M20J airplane, N201HF, collided with mountainous terrain near Lander, Wyoming.<sup>2</sup> The pilot and three passengers were fatally injured, and the airplane sustained substantial damage. The airplane was operated under the provisions of 14 *Code of Federal Regulations* (CFR) Part 91 as a personal flight. Instrument meteorological conditions likely prevailed at the time of the accident,<sup>3</sup> which operated on an instrument flight rules (IFR) flight plan to Pierre Regional Airport (PIR), Pierre, South Dakota. The flight originated from Jackson Hole Airport (JAC), Jackson Hole, Wyoming, at 1305.

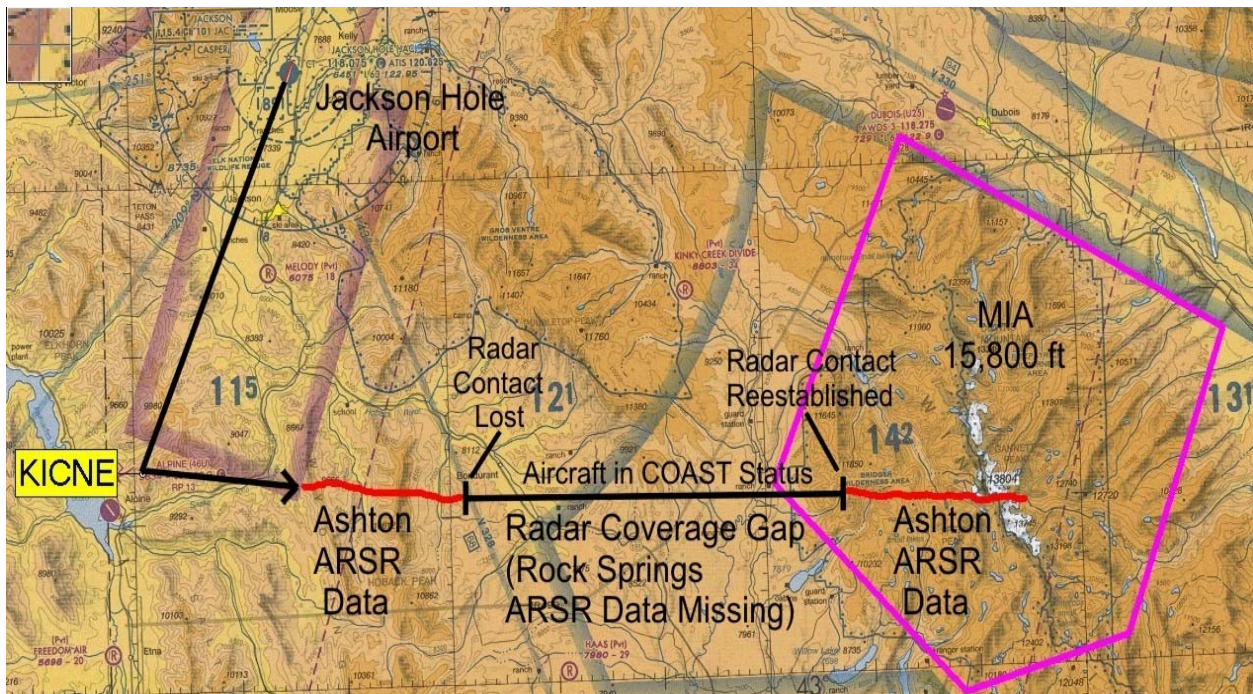
Radar targets for aircraft operating under the control of Salt Lake Center are supplied by multiple radar sites; however, at lower altitudes or in mountainous areas, an aircraft may not be visible or visible to only one radar site. The information displayed to the Salt Lake Center controller indicated a loss of radar contact with the Mooney from 1335:44 until 1346:13 (see figure). Although the Rock Springs Air Route Surveillance Radar (ARSR) covered this area, Salt Lake Center had declared it not usable for technical issues,<sup>7</sup> and no other radar site could fill in the missing coverage; thus, ATC radar contact with the Mooney was lost for the segment of its flight where it was only visible to the Rock Springs radar.

**Figure.** Airplane flight path with MIA polygon and radar coverage depicted. (Riverton is east of the MIA polygon.)

During the period that the Mooney was in coast track status and progressing along its route at 14,000 feet, the airplane entered an area where the MIA is 15,800 feet. However, E-MSAW alerts that affect aircraft in coast status are suppressed. The NTSB is concerned that this suppression function may not be appropriate and, in some circumstances, such as those demonstrated by this accident, could prevent controllers from receiving a valid and timely alert about an aircraft approaching hazardous terrain.

According to ERAM documentation, ERAM is designed to provide an E-MSAW alert to the controller about 2 minutes before an aircraft is predicted to enter an area where it will be below the MIA. The ERAM-predicted position for the coast track data block crossed the 15,800 foot MIA boundary at 1342:52; the Rock Springs radar data for the Mooney shows that it actually crossed the MIA boundary less than a minute later. Given the accuracy of the position estimates (provided by the ERAM coast tracking function) and the reported altitude (provided to the controller by the pilot of the Mooney), there appears to be little justification for the suppression of E-MSAW alerts based solely on the aircraft's coast track status. If E-MSAW alerts had not been suppressed based on the coast track, the controller would have received an alert at approximately 1340:52 (based on the ERAM-predicted position of the airplane), more than 5 minutes before the alert actually occurred at 1346:13. With the additional time, the controller could have instructed the pilot to attempt to climb earlier or to choose other options, such as a controller-directed radar vector around the high terrain. The NTSB concludes that providing controllers with an E-MSAW alert when an aircraft is in coast mode and is predicted to enter restricted airspace or another area, such as an MIA polygon, could provide additional time for the pilot to take alternative action. Therefore, the NTSB recommends that the FAA modify ERAM software such that E-MSAW alerts are provided for aircraft in coast track status that are receiving automatic position updates.

Modify en route automation modernization software such that en route minimum safe altitude warning alerts are provided for aircraft in coast track status that are receiving automatic position updates. (A-11-33)

Modify en route automation modernization software such that cautionary warnings are provided to controllers when an aircraft is predicted to enter a minimum instrument flight rules altitude (MIA) polygon below the MIA. (A-11-34)
