National Transportation Safety Board

Safety Recommendation

In reply refer to: A-11-35 and -36

On July 7, 2007, about 1651 eastern daylight time, a Eurocopter EC-130-B4 helicopter, N453AE, operated by Liberty Helicopters, Inc., experienced an in-flight separation of a section of one of the main rotor blades during flight and sustained substantial damage during an emergency descent and subsequent autorotation into the Hudson River, New York, New York.¹ The commercial pilot and seven passengers were uninjured. No flight plan was filed with the Federal Aviation Administration (FAA) for the 14 *Code of Federal Regulations* Part 135 and 136 sightseeing flight, nor was one required.² Visual meteorological conditions prevailed at the time of the accident.

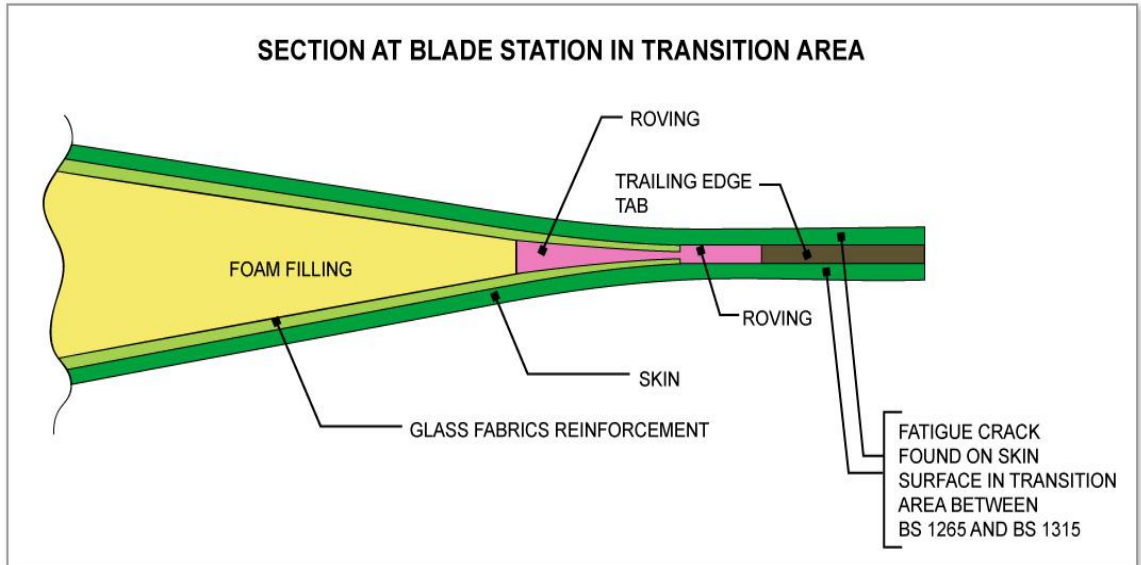
The main rotor blades on certain Eurocopter helicopters⁴ are manufactured from glass fiber-reinforced composite material skin and skin reinforcement layers that overlap a spar, foam core, trailing-edge roving, and trailing-edge tab (see figure). The trailing-edge roving is comprised of unidirectional fibers aligned parallel to each other in a spanwise direction. A transition area (of about 2 inches long) exists at the trailing edge of the blade between blade station (BS) 1265 and BS 1315 where the trailing-edge roving narrows toward the trailing-edge tab.

Figure. Trailing edge of blade.

The NTSB determined that the main rotor blade part number (P/N) 355A11-0030, serial number (S/N) 22312,⁵ of the accident helicopter fractured due to fatigue cracks in the trailing-edge skin that initiated within the transition area due to the misalignment of the unidirectional fibers in the trailing-edge roving.⁶ The NTSB's materials laboratory examined fragments of the trailing-edge roving and found that the fibers of the roving fractured at a stress lower than what would typically cause them to fracture. Thus, the strength of the roving was less than what was expected. Eurocopter also found that the trailing-edge skin adjacent to the misaligned trailing-edge roving fibers in the transition area showed evidence of fatigue cracking, and the trailing-edge roving showed evidence of a compression fracture. Further, erosion was found locally along the crack, indicating that the crack traversed through the trailing-edge skin and was visible on the outside of the blade.

The NTSB notes that the misalignment of the trailing-edge roving fibers⁷ occurred during manufacturing, when the fibers likely shifted during the curing process. Because the unidirectional fibers of the roving were not properly aligned (were not parallel) in the spanwise direction of the blade, a localized stiffness change occurred at the trailing edge. The misalignment of the fibers reduced the local load-carrying capacity of the roving, and the loads were transferred to the skin,

Require Eurocopter to revise its aircraft maintenance manual for all helicopters equipped with part number 355A11-0020 and/or 355A11-0030 main rotor blades to include, as part of the daily flight-related check, specific visual inspections of the trailing edge of the blades' upper and lower skin surfaces for cracks and surface deterioration/disfiguration. (A-11-35)

Once the Eurocopter aircraft maintenance manual is revised as described in Safety Recommendation A-11-35, require operators of all Eurocopter helicopters equipped with part number 355A11-0020 and/or 355A11-0030 main rotor blades to revise their maintenance manuals to include specific daily visual inspections of the trailing edge of the blades' upper and lower skin surfaces for cracks and surface deterioration/disfiguration. (A-11-36)
