PIPELINE ACCIDENT REPORT

WILLIAMS PIPE LINE COMPANY
LIQUID PIPELINE RUPTURE AND FIRE
MOUNDS VIEW, MINNESOTA
JULY 8, 1986

NTSB/PAR-87/02

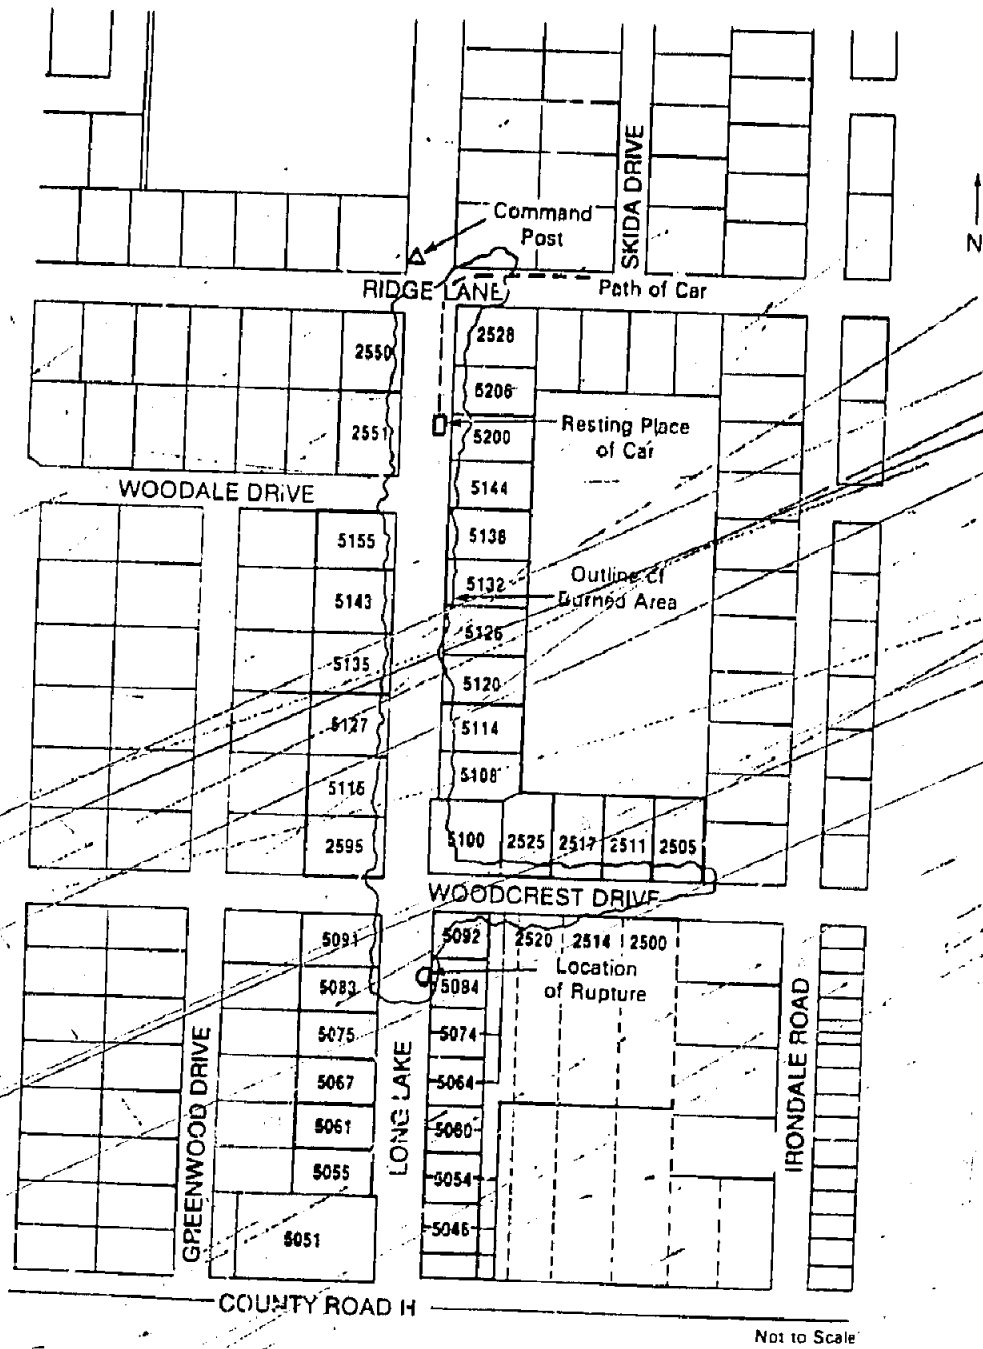
Figure 3.—Accident area.

The first fire department unit arrived onscene about 4:50 a.m. At that time, flames covered two blocks of Long Lake Road and one block of Woodcrest Drive. Shortly afterward, a fire department district fire chief set up a command post marked with a flashing blue light at the intersection of Ridge Lane and Long Lake Road, just north of the burning area. The district fire chief surveyed the scene and instructed firefighters to lay hose lines to extinguish any structural or related fires and to protect all exposures. Due to the characteristics of the fire, fire department officers believed gasoline was involved; however, they did not know whether a tank truck or a pipeline was the source of the gasoline. Firefighters at the south end of the fire informed the officers at the command post that a tank truck was not involved. After finding a pipeline marker, which contained local and out-of-state numbers for WPL, onscene firefighters requested the fire department dispatcher to notify WPL that its line probably was involved and to shut down the pipeline. The request was transferred to the RCSO dispatchers. About 5 a.m., the RCSO notified the Minneapolis terminal of the fire and injuries on Long Lake Road. The RCSO then reported the accident to the WPL dispatch center in Tulsa, Oklahoma, by dialing the out-of-state telephone number listed on the pipeline marker. While WPL had the general information provided by the dispatch shift supervisor that the rupture was within 10 miles of the Minneapolis Terminal, this information was the first notification that WPL had concerning the exact location of the leak.
