THE SECRETARY OF TRANSPORTATION
WASHINGTON, D.C. 20590

Subject: Whistleblower Investigation – Allegations of Mold and Moisture Problems at Detroit Metropolitan Airport

**INVESTIGATION OF MOLD AND MOISTURE AT THE
FEDERAL AVIATION ADMINISTRATION
DETROIT METROPOLITAN AIR TRAFFIC CONTROL TOWER FACILITY**

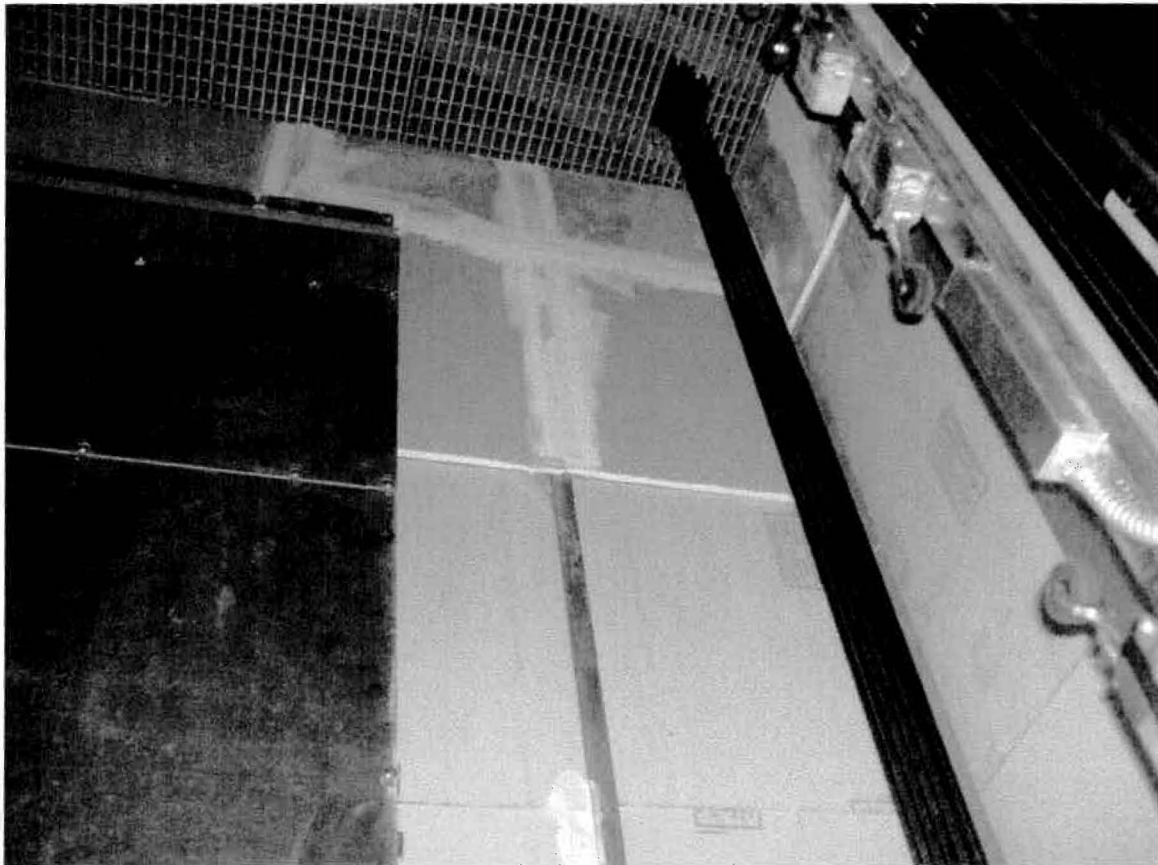
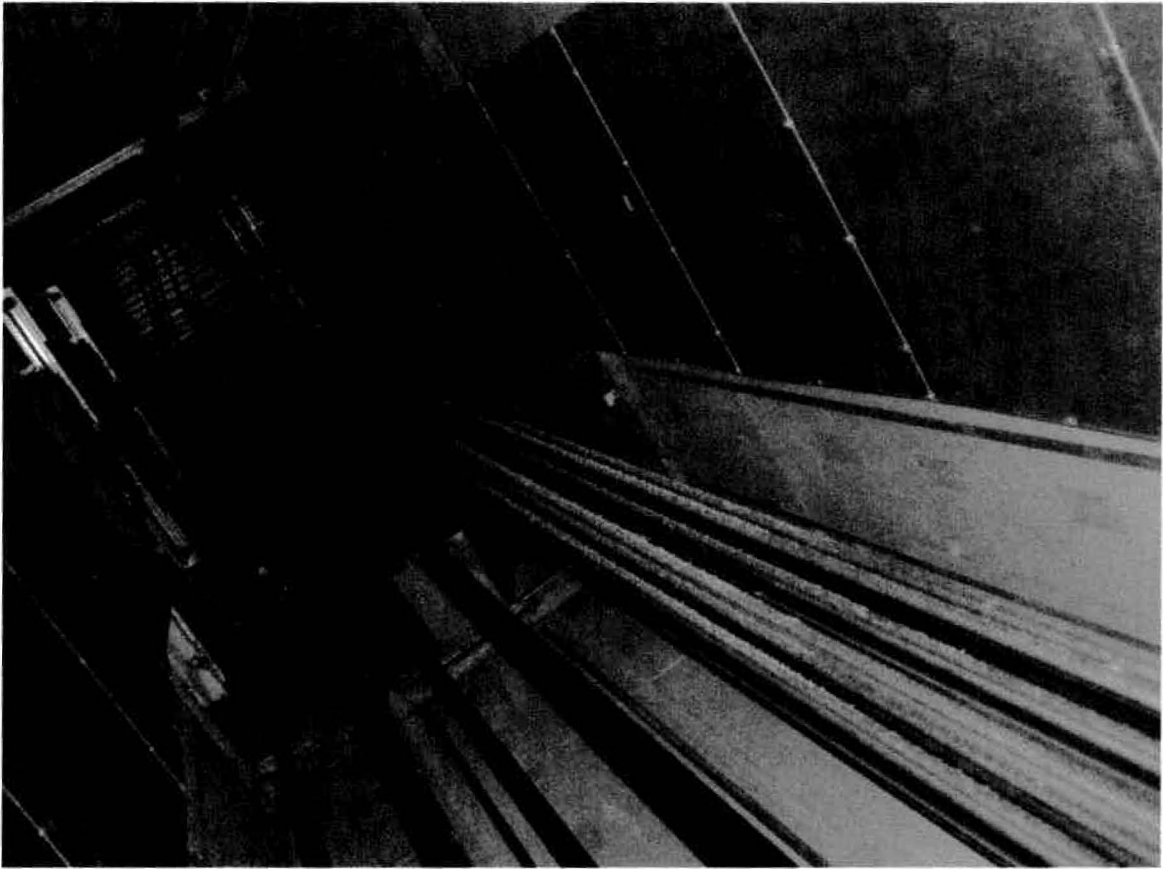
- The shaft was observed to have visual evidence of having been cleaned. Some past tracking of water stains was observed. Areas where mold had been cleaned away from the wall board liner were lighter in color than areas where past mold growth was present.

- The elevator shaft had air supply and return vents.
- The elevator shaft had devices installed to measure temperature and relative humidity. FAA had not been using the sensors, but decided to activate them during the investigation. There are 9 moisture monitors in total; some are outside the elevator shaft in unoccupied tower space.

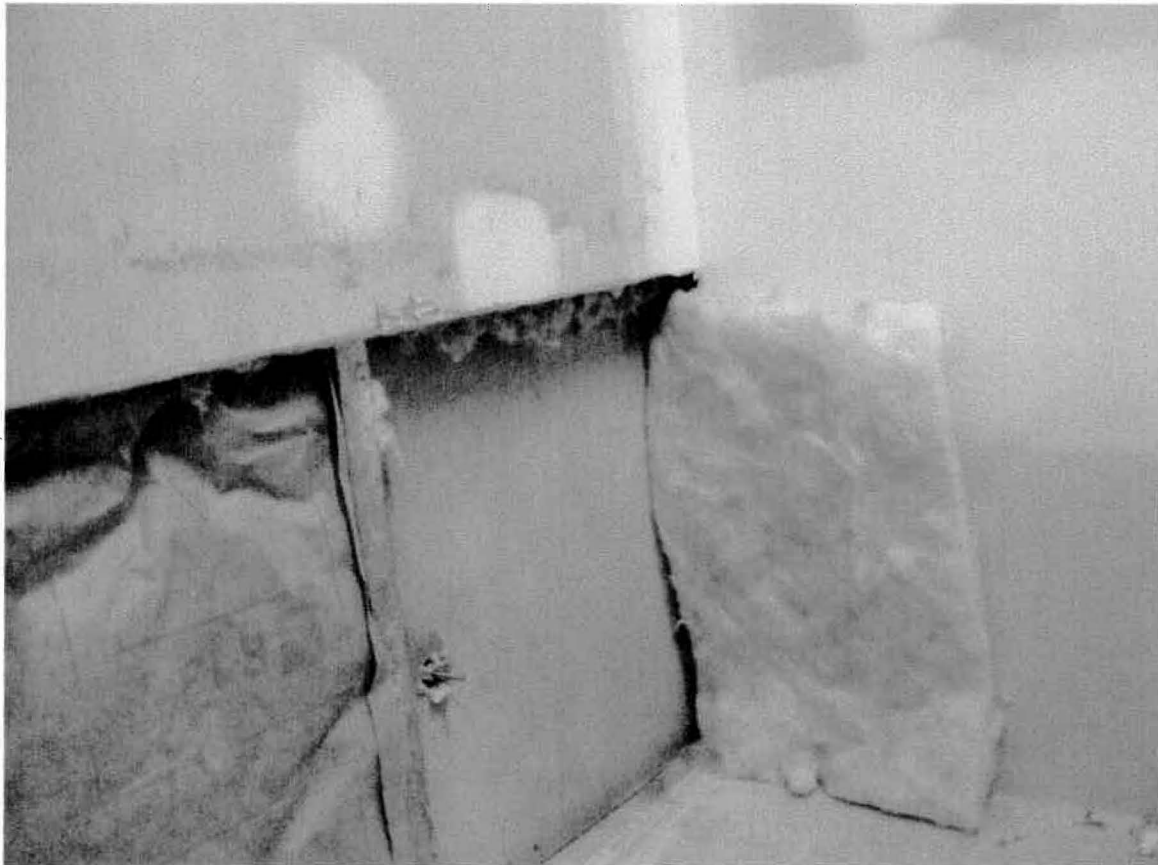
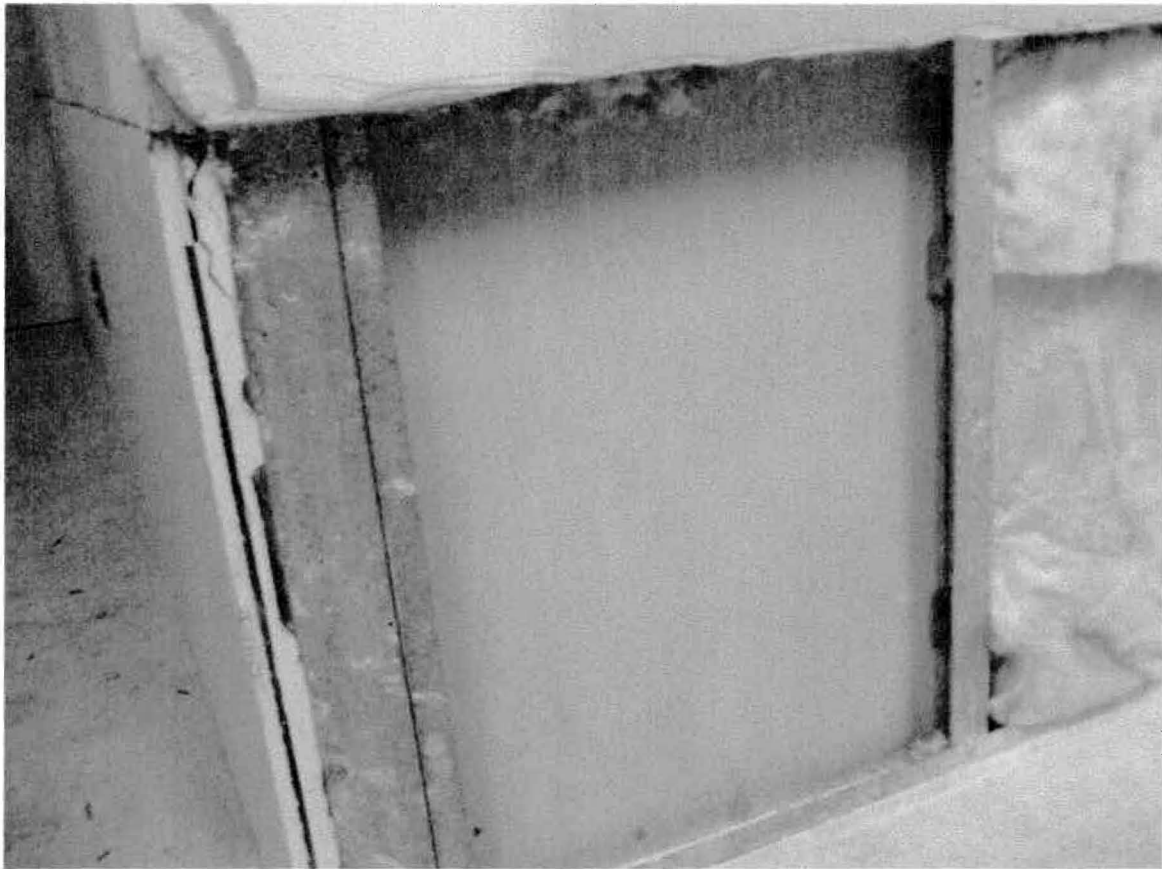
Room 428 (unoccupied space)

- A very small amount of visible mold was also observed in room 428 on the green wallboard elevator shaft inside the wall cavity. No visible mold was observed in the new drywall that was installed in the remediation area in room 428. The amount of visible mold was small, less than 10 square feet.

- Room 428 was observed to have had portions of wall board removed in a past remediation effort. The wall board was screwed into place, but the seams not taped. Wall board was in direct contact with the concrete slab deck.
- Two layers of wall board were unscrewed and removed from the back side of the elevator shaft.
- No visible mold was observed on the front or back sides of the first and second layers of wall board.
- A small strip of mold growth was observed on the back side of the elevator shaft liner.
- No moisture was observed.
- Visible mold area was less than 10 square feet and to be considered a Level I, small isolated area according to the NY City and EPA Mold Guidelines.
- Two stained ceiling tiles were observed in the stairway leading up to the 2nd Floor of the Base Building.

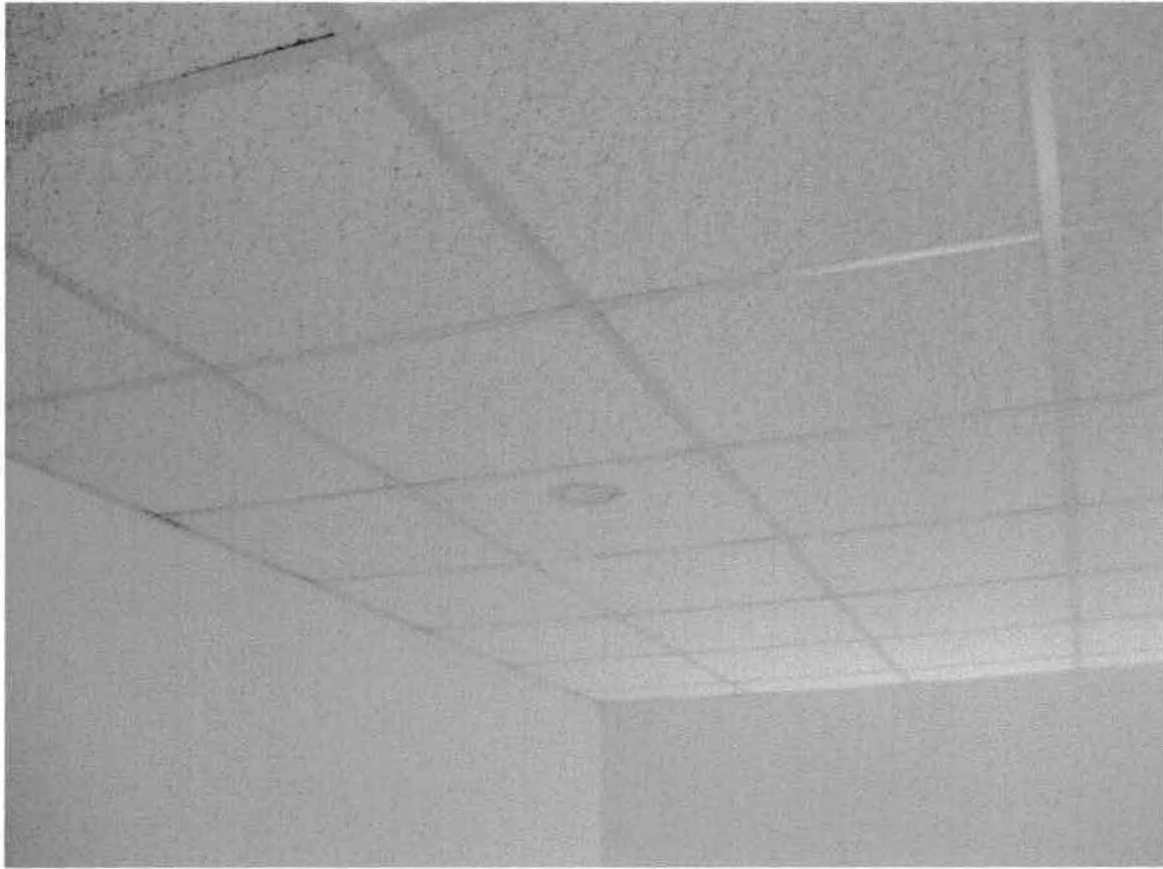
Base Building Observations

- In many areas of the tower, drywall is in direct contact with the concrete floor surface.
- The base building roof is leaking badly in several areas. Catch pans and a funnel were observed above the drop ceiling in an attempt to catch rain water and snow melt that is entering the building.

- An active roof leak was observed on the 2nd Floor of the Base Building, outside of room 222 and the employee locker area.
- Plastic trays were located above the drop ceiling to collect water.
- The trays had absorbent socks in them to absorb the water.
- A funnel was in the ceiling and a hose connected to it to collect rain water and divert it to a janitor's closet sink in Room 222.
- No mold growth was visible on the under-side of the steel roof deck or above the ceiling.
- 3 to 4 ceiling tiles had been removed in this area and looked new. One tile was beginning to show a new stain.
- Water was intruding into the building around a roof drain penetration.

J. OST Recommendation (Base Building): Replace the leaking base building roof.

FAA Response: **Action:** Prior to the Department's investigation, the FAA had plans to replace the roof. At the Department's request, those plans were placed on hold pending the conclusion of the investigation. A new roofing membrane will be installed by March 30, 2009.

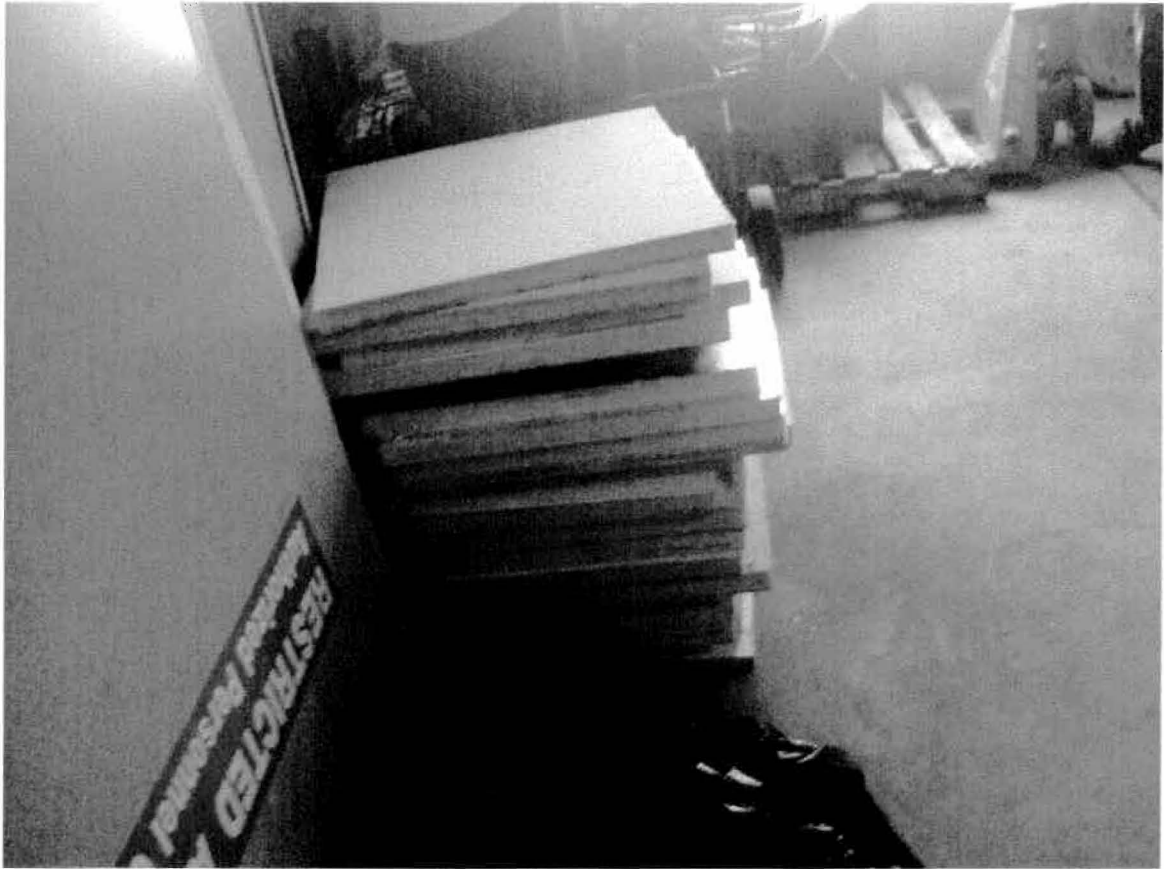
Base Building Ceiling Tiles

- Approximately 20 stained ceiling tiles were observed to have been recently removed from the base building. These tiles had become wet from base building roof leaks. FAA management indicated that stained/wet ceiling tiles are removed and replaced as a part of routine maintenance.

- Approximately 20 ceiling tiles were observed to be stacked in the ESU Building. FAA Management indicated the tiles had been removed over the weekend of 5/17/08 and 5/18/08 as a normal operational practice. As facility maintenance technicians observe stained ceiling tiles after periods of rain, the ceiling tiles are removed and disposed of. The ceiling tiles were discarded into a dumpster, but removed from the dumpster after Mr. Sugent's objection and placed into the ESU Building. The ceiling tiles are fiberglass insulated, foil backed, and vinyl faced tiles that do not offer a good food source for mold growth. The tiles were observed to have some staining.

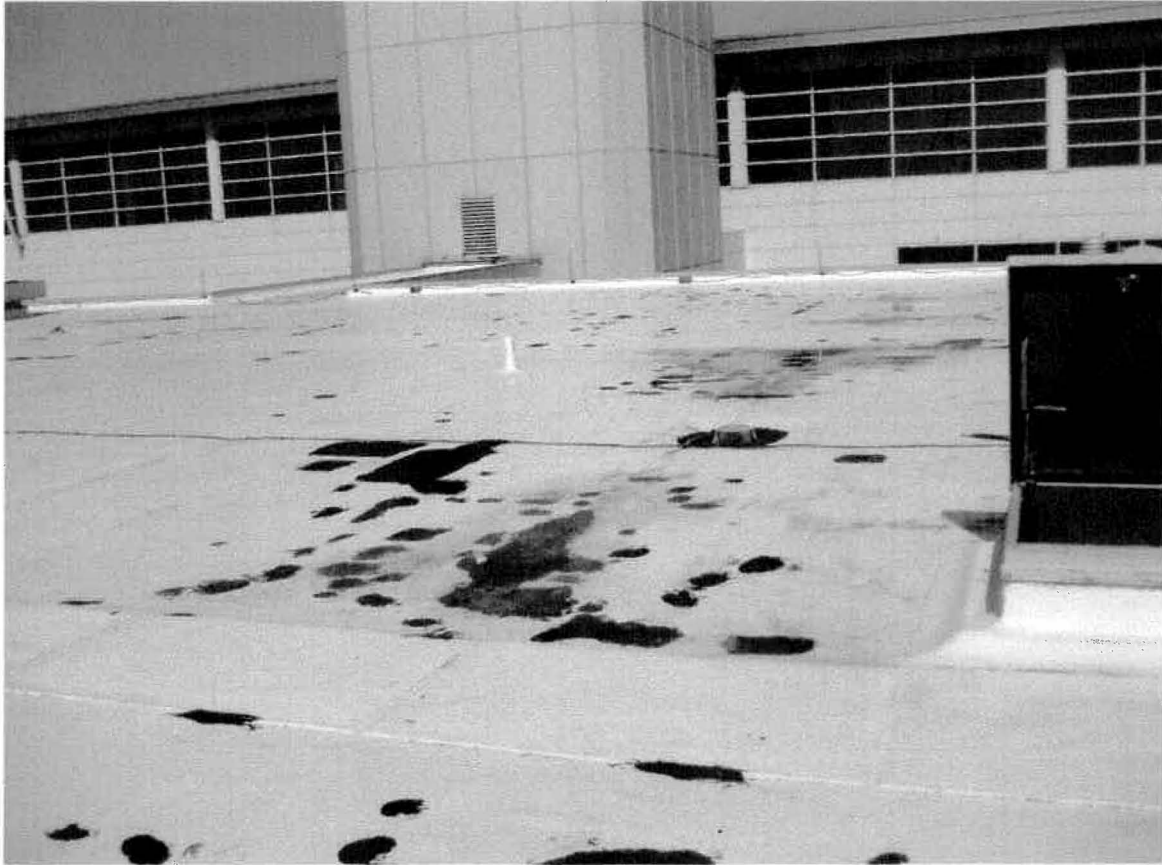
Base Building Roof

- The roof of the Base Building was inspected. Attempts to repair and patch the roof have been made in the past and a portion of the roof membrane is torn. A very small area of the roof had some standing water. The roof needs to be replaced as is evidenced by the stained ceiling tiles on the 2nd floor of the Base Building. It is a built-up roof with fiberglass insulation over top of the steel deck and does not offer a good food source for mold growth.
