MCI ATCT MOLD REMEDIATION PROJECT CLEARANCE PROTOCOL

Kansas City Airport Traffic Control Tower (MCI ATCT)

FEDERAL AVIATION ADMINISTRATION
CENTRAL REGION
901 LOCUST
KANSAS CITY, MISSOURI 64106

March 28, 2007

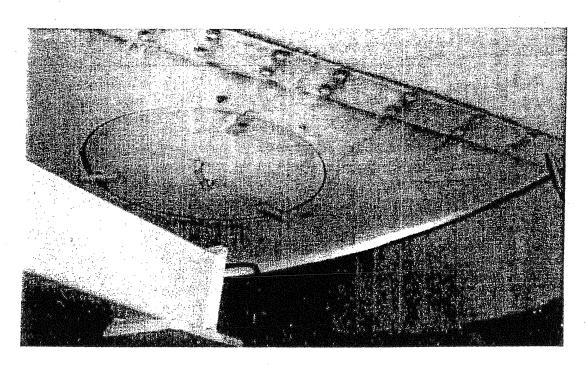
This photo shows the structural steel ring or curb beneath the ASDE antenna. The application of spray-on insulation (Contract Option 5) begins at the top of the ring and covers all structural steel below as well as the ¼" steel plate roof. A ground cable is seen at the base of the ring.

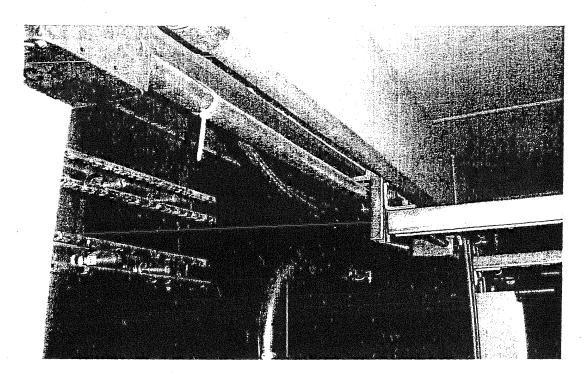
This photograph shows a typical beam at the perimeter wall insulated on one side. Junction box covers shall remain accessible after application of the insulation. Typical beam clamps and hangers can be seen.

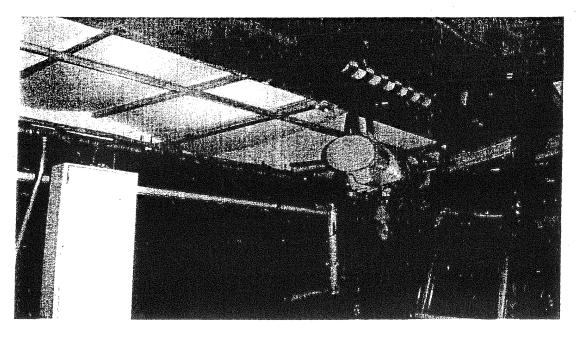
This photo shows the insulated roof deck with the fiberglass panels (thermal barrier) coming loose at many locations. Items to be protected from overspray such as a light fixture, conduit body cover, and heater can be seen in the background.

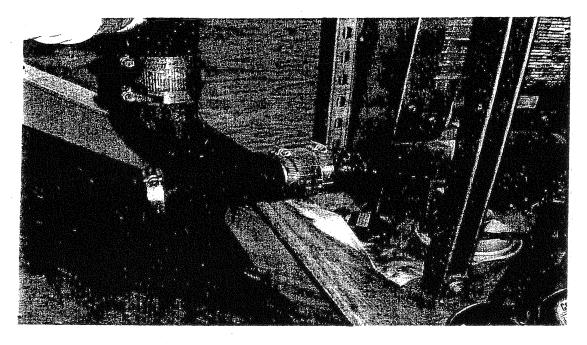
This photo shows the drain line under the Cab sink. The cast iron drain line section shall be removed and cut shorter allowing the cleanout to move to the right creating more space beneath it for a drip pan. The horizontal section of the drain line may also be moved up. A new drain line will be installed from this point to the sink.

- 7. Modify the existing drain line and clean out under the Control Cab sink and install a drip pan to prevent water damage to the gypsum board below when the clean out must be opened for maintenance.

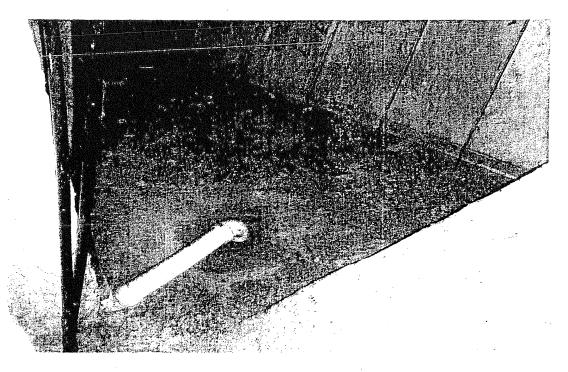
This photo shows the pigeon droppings and fire proofing to be HEPA vacuumed in one of the Subjunction Level air shafts. An angle will be installed behind the drain as a water stop to prevent water entry into the building at the column. The vertical drain line may have to be cut shorter in order to install the angle.

- 8. Perform work listed to prevent water infiltration into the building such as sealing openings in the handrail posts on the Junction Level and installing water-stops (angles) at drains in Subjunction Level air shafts.

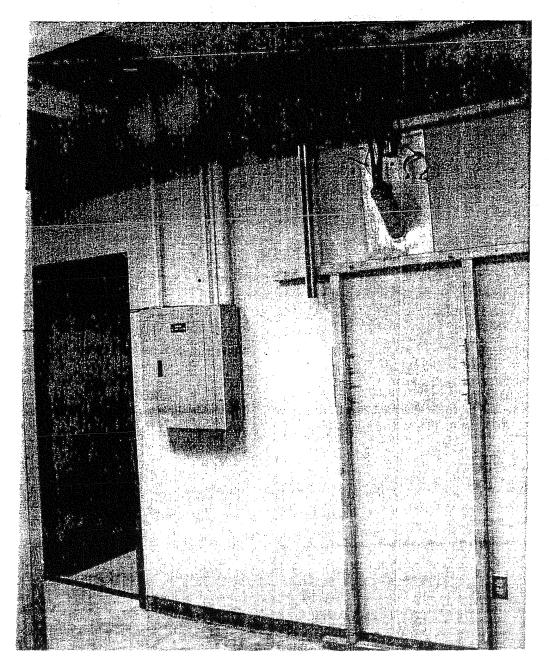
This photo shows the east wall of room 11TS5. The strut support will be temporarily removed to remove and replace gypsum board. The door and a section of wall will be removed and a header installed to support the wall above since an electric panel in the corner of room 11TS5A will prevent replacing the wall. The new gypsum board will terminate at the NW corner of the elevator shaft. A strut rack shall be installed between the floor and header where the wall is being removed.

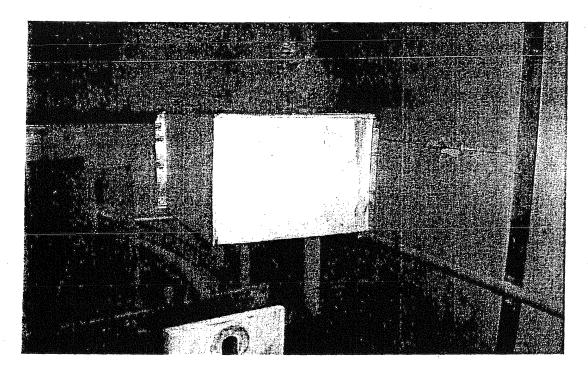
This photo shows the duct for smoke relief at the top of the elevator shaft. This duct shall be used to exhaust air to the building exterior and create a negative pressure containment during cleaning procedures in the elevator shaft.

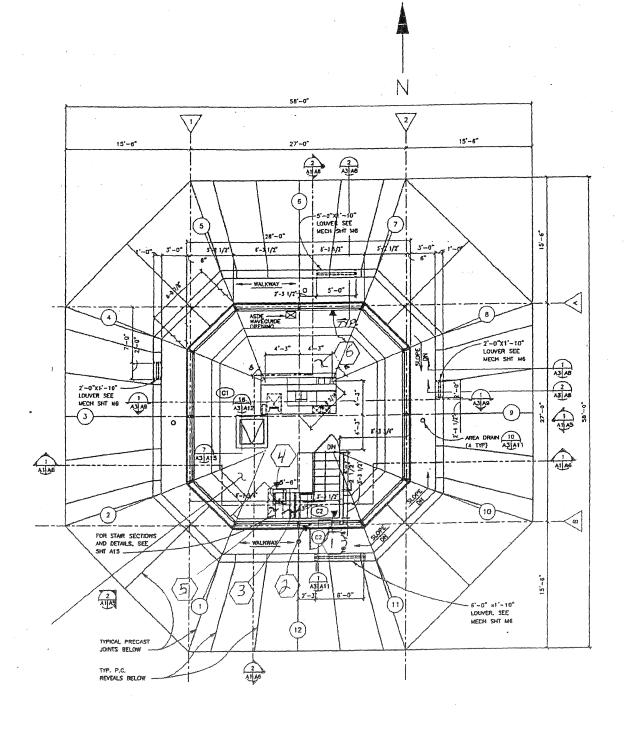
CAB LEVEL

- The location shown for door C2 is incorrect. It is located on the landing and the east edge of the frame aligns with the east wall of the cab stairs. Remove vinyl cove base to the first joint beyond the remediation limits shown. Starting at the east side of the door frame, remove a minimum of 2 linear feet (LF) of gypsum board to a height of 18" above floor finish (AFF). Remove any water damaged or contaminated insulation. Complete remediation work as specified. Replace any insulation removed and install new gypsum board. Prime new gypsum board. Paint entire wall. Install Government furnished cove base where removed.

6 HEPA vacuum and wet wipe all supply and return air grilles, registers, diffusers, etc. See the Statement of Work. Locate the HEPA vacuum remotely from the Control Cab and utilize longer hoses to reach work areas or insulate the vacuum to reduce noise to an acceptable level for facility operations.
