BUILDING ENCLOSURE INVESTIGATION: DETROIT AIR TRAFFIC CONTROL TOWER

2009.10.26

Prepared For:
Parsons – Technical Center
Michael J Rapuano

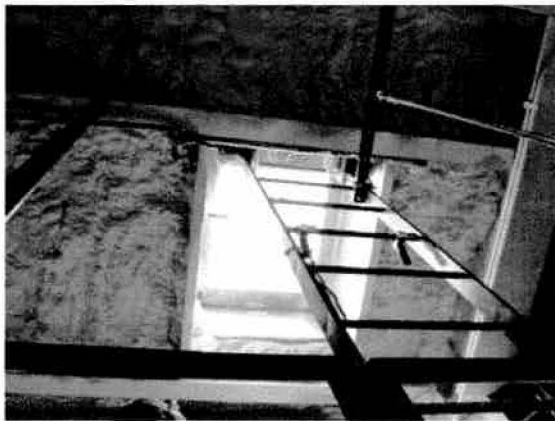
Reports from staff indicated problems of condensation on the radar access hatch.

Figure 2: Radar access hatch

Condensation is occurring on the radar access hatch due to the highly conductive nature of the metal and glass hatch coupled with cold outside air temperatures. This condition lowers the interior surface temperature of the hatch. If the surface temperature is lower than the interior dewpoint temperature, then condensation will occur. The concern with condensation at this location is minimal due to the non-moisture sensitive materials.

It is recommended to replace the access hatch with a thermally broken and insulated hatch. The exterior curb of the access hatch should be insulated.

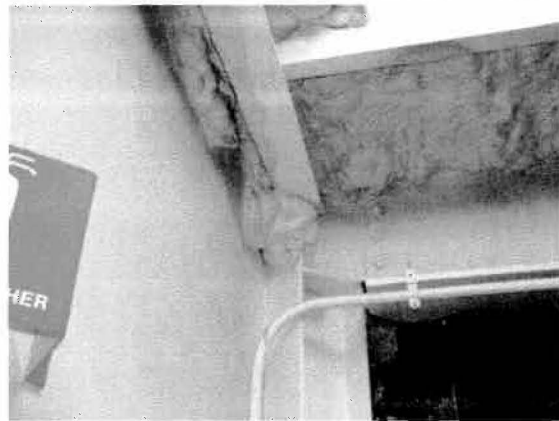
The ceiling of the penthouse has been retrofit with a layer of closed cell spray foam installed to the underside of the metal deck. It was reported to BSC that this retrofit was completed in order to address problems of condensation that had been noted on the underside of the roof assembly. The closed cell spray foam extends out to the interior face of the exterior drywall installed on the interior side of the metal stud wall at the perimeter of the penthouse.

Figure 3: closed cell spray foam on underside of penthouse roof

The retrofit work conducted to manage the condensation problems below the roof deck of the penthouse level was appropriate. However, the closed cell spray foam only extended to the front face of the gypsum board on the exterior steel stud framed wall. This creates a gap in the continuity of the thermal insulation between the retrofit roof insulation and the insulated metal wall panels. This gap in the thermal insulation and air barrier is at risk for condensation due to cold surfaces. This area should be addressed due to the moisture sensitive nature of the gypsum wall board.

It is recommended to remove the top 6” of gypsum in order to expose the stud cavity and top track of the exterior wall. The top track should be sprayed with a closed cell spray polyurethane foam in order to complete the thermal insulation and vapor control layer out to the exterior insulated metal panel.

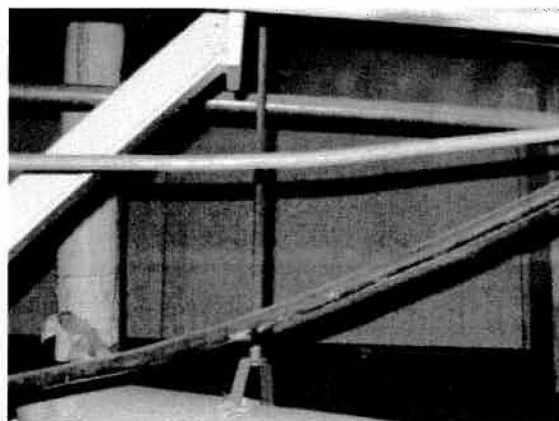
Water stains and drips were noted on the interior face of the exterior metal cladding panel in drop ceiling area of the CAB. The water stains appear to be originating in the parapet construction of the exterior penthouse catwalk above the CAB.

Figure 5: Water staining on exterior insulated metal panels (visible at the dropped ceiling)

The staining that was noted on the interior face of the insulated metal panels in the dropped ceiling area of the CAB was a function of condensation within the parapet construction of the penthouse catwalk.

It is recommended to cut a 12” tall section of the parapet facing (on the catwalk side) around the entire perimeter of the catwalk to expose the air infiltration location at the roof deck level. The area should be blocked at the top of the roof deck in order to provide a backing for a closed cell spray foam insulation and air seal to be installed. The blocking material can be a range of products from plywood to sections rigid insulation board (such as XPS), the intent for the product is to prevent overspray of the closed cell foam into the conditioned space below. After the area is sealed, the inner face of the parapet should be covered with a sheet metal backing and a new compatible roof membrane installed to seal the opening. The roof should be properly flashed with the parapet cap flashing.

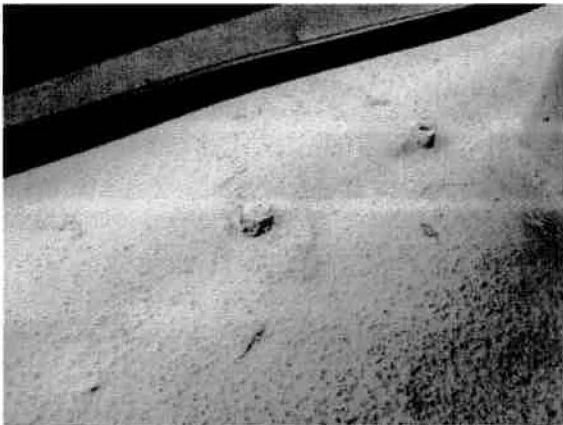
Some minor concerns were identified regarding the condition of the roof traffic coating installed on the catwalk areas. A few discontinuities were noted where anchor bolts penetrate through the concrete slab and where holes are drilled into the railing posts that are cast into the concrete slab.

Figure 11: Discontinuity of deck traffic coating

It is recommended to repair any other distressed areas identified in the waterproof traffic coating on the exposed catwalk at the same time as the retrofit work for the metal panel interface.

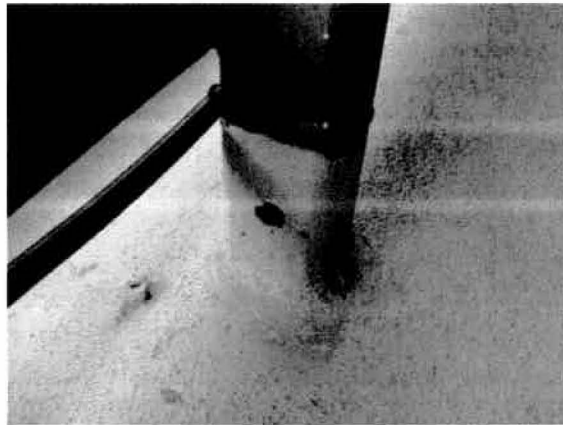
Figure 12: Hole in post railing

The hole drilled in the post holes should be covered with a membrane and the liquid applied traffic coating installed over top of the membrane patch.

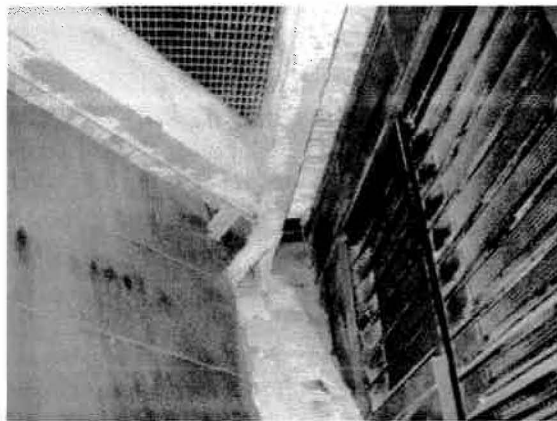
Water staining was noted on the metal structure in the air intake plenums.

Figure 14: Water staining on sloped metal panels and structural steel at air intake plenum

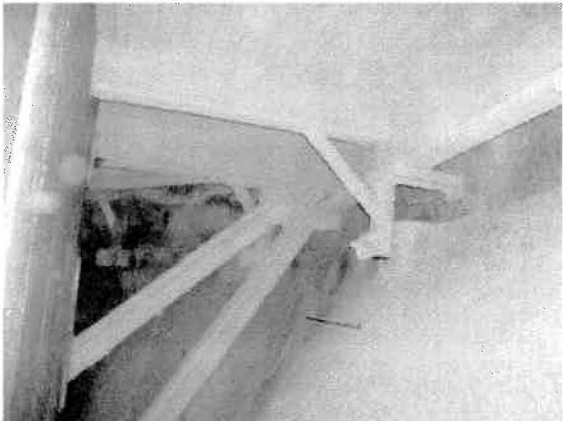
In the interstitial space between the gypsum exterior wall and the precast concrete panels, significant water staining was identified on the cementitious fireproofing (covering the steel structure) and on the interior surface of the exterior precast panel. The highest concentration of staining appeared at the 45 degree bends in the precast panels. Some minor staining was noted at roof drain collars and on a few miscellaneous areas of the structural steel.

Figure 15: Staining noted in interstitial space at 45 degree bend in precast

Figure 16: Staining noted in interstitial space at 45 degree bend in precast

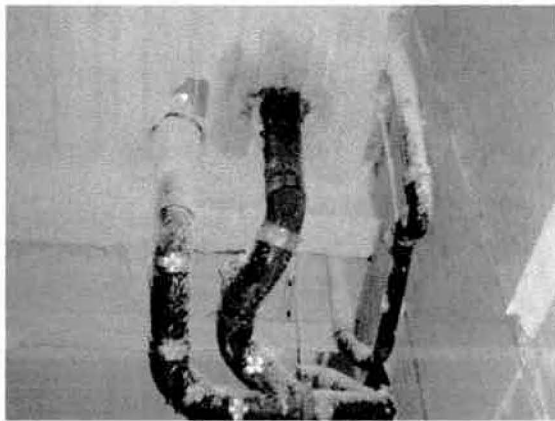
Additional water staining below the bathroom plumbing on Junction level was also noted. It could not be identified at the time of the review if the water staining was from an active leak or from a past leak.

Figure 17: Staining below bathroom plumbing

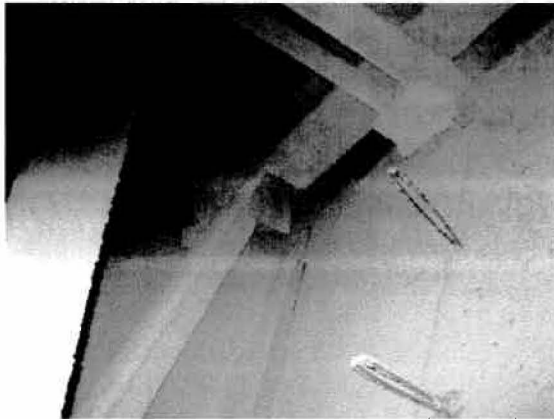
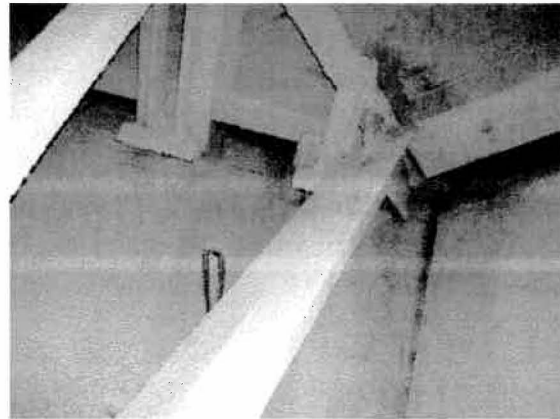
In the interstitial space between the gypsum exterior wall and the precast concrete panels, significant water staining was identified on the cementitious fireproofing (covering the steel structure) and on the interior surface of the exterior precast panel. The highest concentration of staining appeared at the 45 degree bends in the precast panels. Some minor staining was noted on a few miscellaneous areas of the structural steel.

Figure 18: Water staining in interstitial space at 45 bend in precast

Figure 19: Water staining in interstitial space at 45 bend in precast

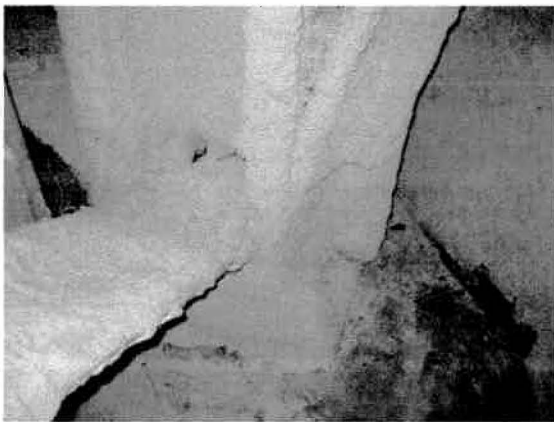
In the interstitial space between the gypsum exterior wall and the precast concrete panels, water staining was identified on the cementitious fireproofing (covering the steel structure), on the interior surface of the exterior precast panel, and on the concrete floor slab where the steel terminates into the concrete structure. The highest concentration of staining appeared at the 45 degree bends in the precast panels. Some minor staining was noted on a few miscellaneous areas of the structural steel.

Figure 20: Staining at base of steel structure (reduced compared to floors above)

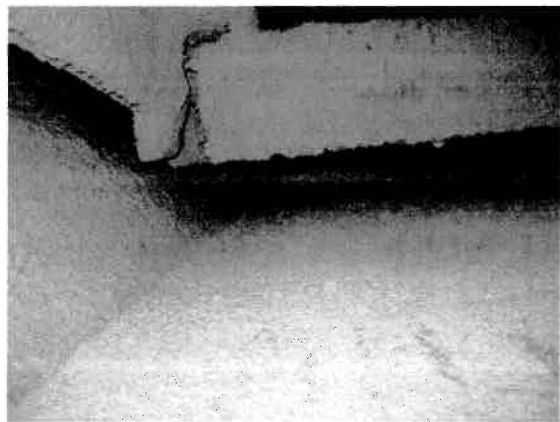
Figure 21: Staining at 45 bend in precast

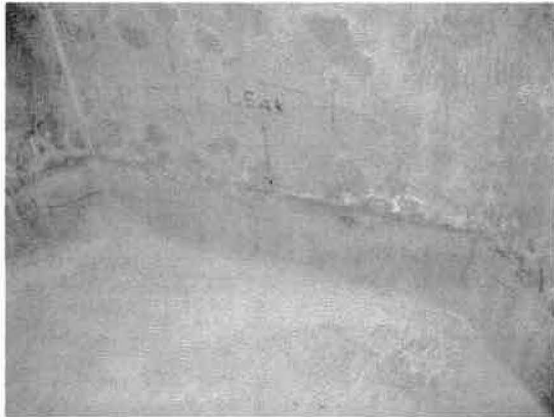
Level 8 and below all had similar issues. Water stains were noted at cold joint locations between the precast concrete panels and the cast in place concrete.

Figure 22: Water staining at cold joint in precast panel

Water intrusion events occurring on Level 8 and below are related to water infiltration at exterior precast joints of the concrete structure. The building was constructed by using precast concrete

panels joined together with formed and cast-in-place concrete. The exterior joints are filled with a non-shrink grout. This joint is not waterproof and allows for water infiltration into the small gap behind the grout at the precast panels. Once the water penetrates past the exterior grout, it gets drawn into the cold joints of the concrete due to capillary forces. With enough water, the hydrostatic pressure created by gravity overcomes the capillary forces holding the water in the cold joint, and liquid water will flow to the interior (and exterior) resulting in water leakage through the concrete structure.

The installation of the elastomeric coating on the exterior of the building has addressed the immediate concern relating to water infiltration for Level 8 and below. The elastomeric coating creates a flexible and waterproof film (or barrier) over the exterior concrete and associated mortar joints. This barrier prevents water penetration into the joints between the precast panels, and prevents leakage to the interior of the building. However, as with any paint or waterproof coatings, elastomeric paints are subject to temperature changes and UV radiation which will deteriorate the coating over time. Due to this, the coating must routinely inspected (once per year), and re-applied as necessary in order to maintain long term performance.

An alternate approach is to allow the joints to drain to the exterior, thereby reducing the reliance on the continuity of the elastomeric to maintain a complete barrier. To accomplish this, it is recommended to provide weep holes in the vertical joints at each horizontal joint in the exterior precast panels to relieve any water that is able to penetrate past the exterior seal.

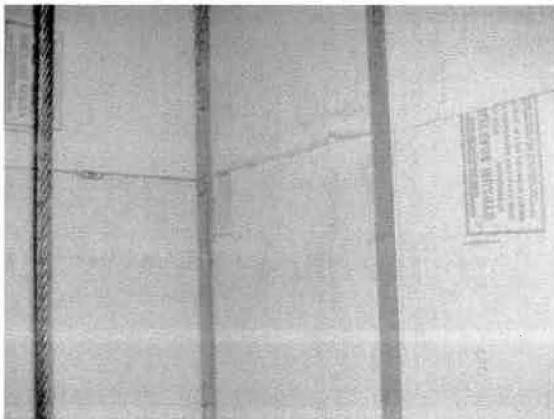
The interior of the elevator shaft was reviewed for signs of water staining and damage. The interior shaft liner showed signs of water staining occurring at the floor slab to wall interface. The levels of most significant staining were level 9, and level 3.

Figure 23: Stained elevator shaft liner at level 3

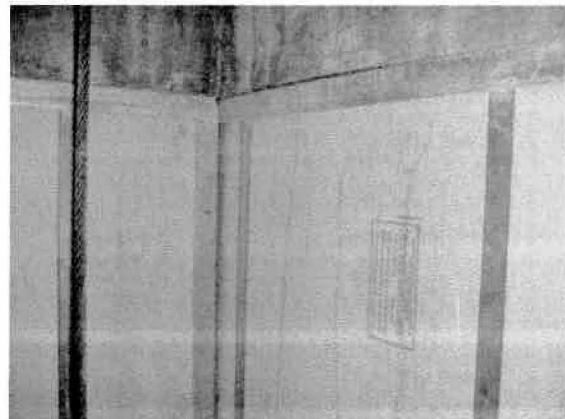
Figure 24: Stained elevator shaft liner at slab edge of level 9

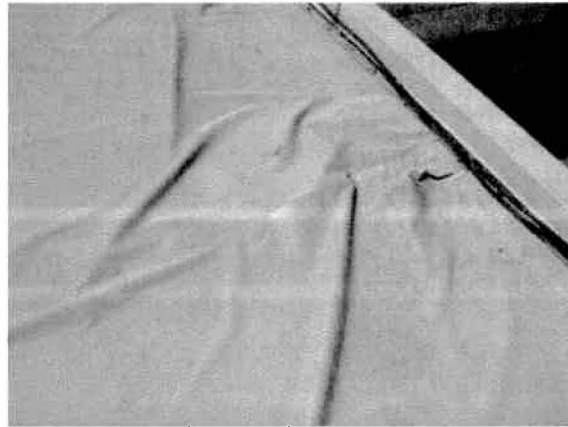
The base building roof system appears to be a light weight vinyl type roof membrane that is mechanically attached at the membrane seams. The connection of the roof membrane to the parapet and other roof curbs appeared to be done by returning the membrane up the curb and clamping the top of the membrane with a retaining bar. Many of the connection details appear to be poorly done.

Figure 26: Roof parapet connection

The roof installation on the base building is recommended to be replaced with a new fully adhered compact roof assembly. The recommended assembly for this project would be:

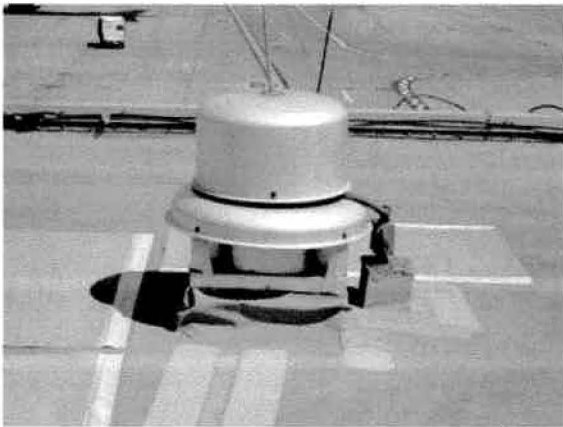
Figure 27: mechanical curb

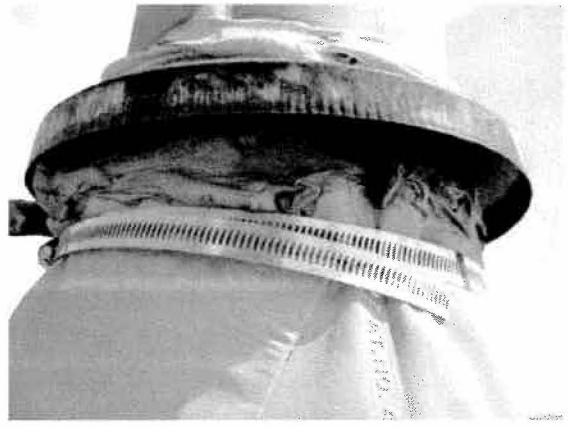
Figure 28: Plumbing vent connection

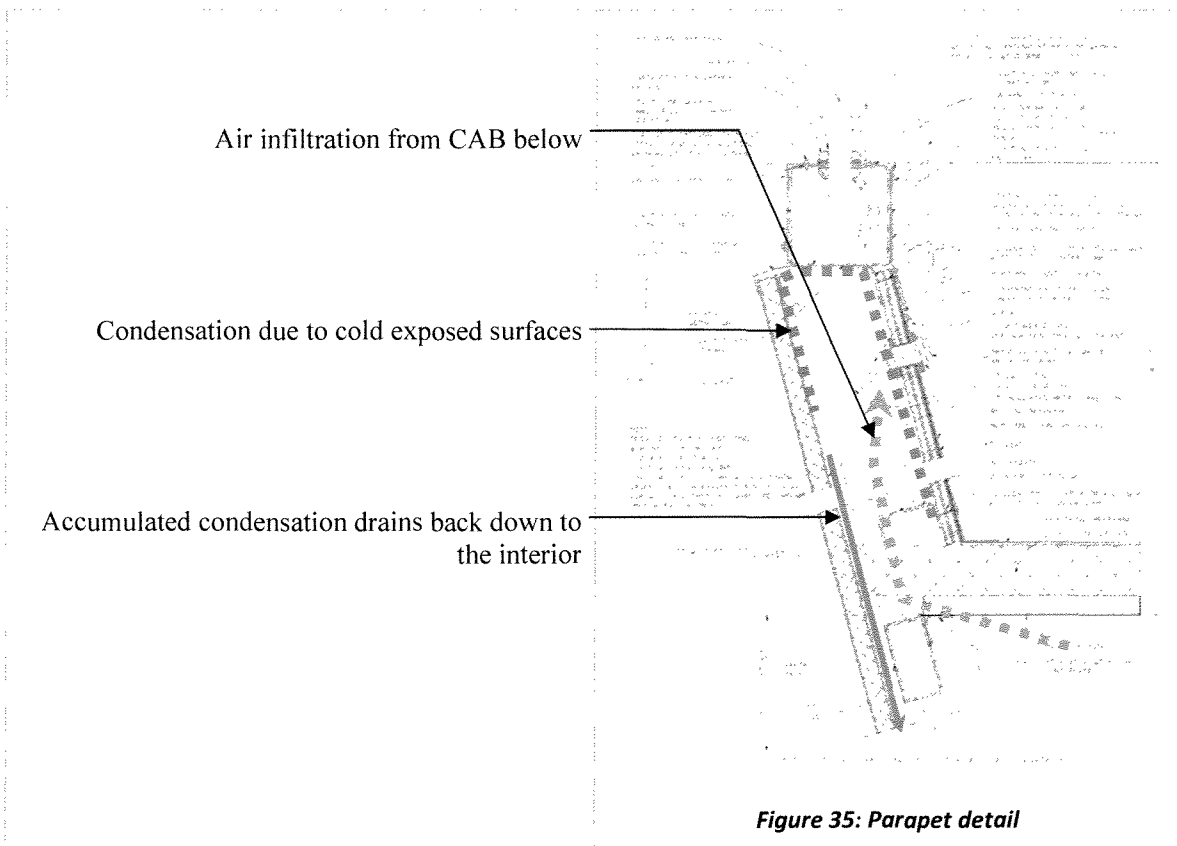
Figure 35: Parapet detail

It was suspected that no provision for air sealing had been made during the initial construction to prevent warm interior air from leaking up into the parapet construction. Air infiltration into the parapet from the space below will result in condensation accumulation due to the exposed cold surfaces of the parapet construction. If sufficient condensation builds up, it will drain back down to the interior in liquid form often being mistaken for a roof leak.

To confirm this hypothesis, an investigation opening was cut in the parapet to examine the construction and confirm the existence of an air flow pathway. The investigation opening confirmed the presence of an air flow pathway from the CAB below into the parapet construction as well as revealed signs of past condensation accumulation.
