Office of the Naval Inspector General

OSC Case Control Number DI-09-1294
NAVINGEN Case Control Number 200900425
NAVSEA Case Control Number 090015L

Report of Investigation

Subj: ALLEGED FAILURE TO REPORT CRANE MISHAP AT NSWC CARDEROCK
BAYVIEW DETACHMENT, BAYVIEW IDAHO

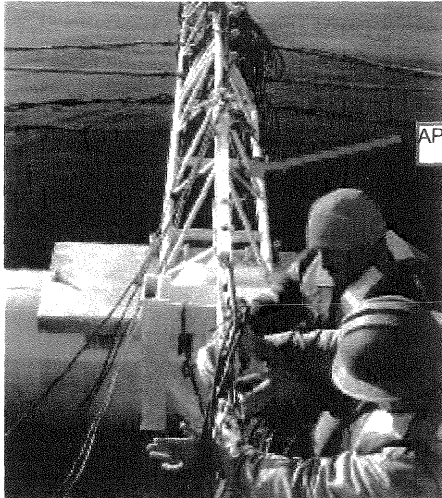
Picture 4:
AP Mounting/Alignment Bar mounted to HRA truss structure with AP perpendicular to HRA (typical mounting configuration)

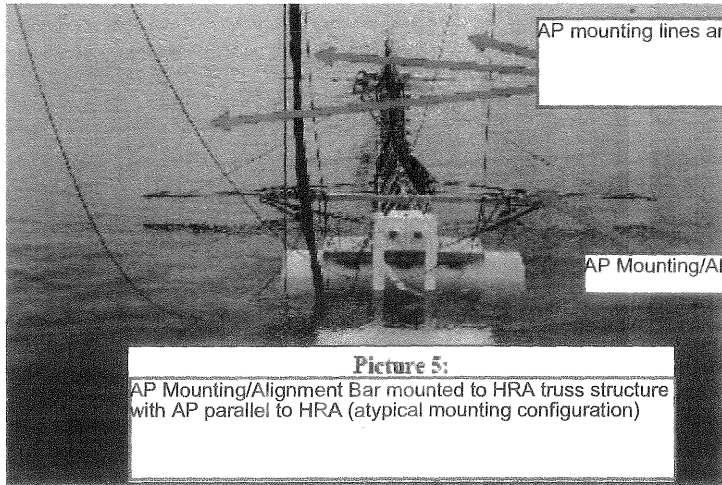
63. The evidence developed during this investigation revealed damage did occur to the AP mounting/alignment bar and two Group One sensor cables. During the deployment of the AP on 15 January 2009, the AP was required to be oriented 90 degrees from the typical configuration so that it is parallel. In order to install the AP in this atypical orientation, the AP mounting/alignment bar had to be installed so that it is perpendicular to the HRA truss structure (Appendix C, Picture 5).

Picture 5:
AP Mounting/Alignment Bar mounted to HRA truss structure with AP parallel to HRA (atypical mounting configuration)

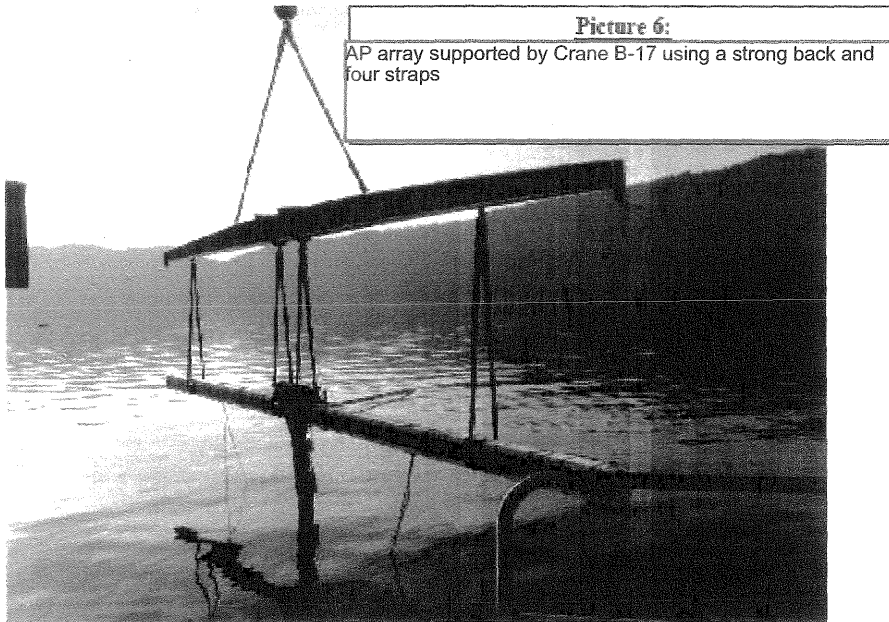
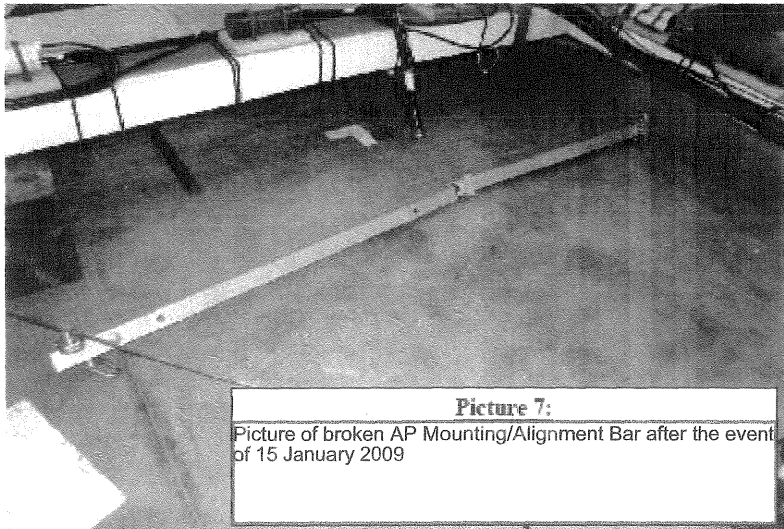
6. While the assembly was being lowered, it became evident, by the AP support lines going slack, that the aluminum mounting/alignment bar could have broken. The AP and HRA were subsequently raised to the surface and it was confirmed that the mounting/alignment bar had broken (Appendix C: Picture 7).

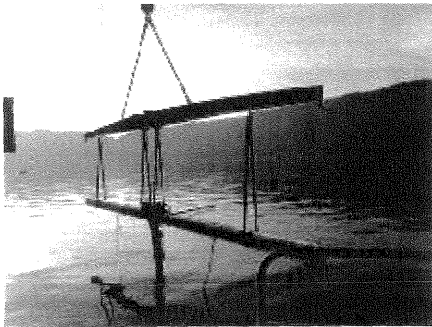
Picture 1:
AP array supported by Crane B-17 using a lifting beam and four slings

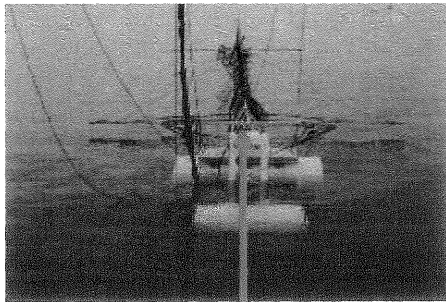
Picture 2:
HRA Array & AP Mounting/Alignment Bar
