| <b>Title:</b> | <b>National Highway Traffic Safety Administration<br/>Toyota Unintended Acceleration Investigation –<br/>Appendix B</b> | <b>Page #:</b><br>1 of 47 |

**Appendix B – Fishbone Diagrams**  
(Note that tables and fishbone diagrams are 11x17 layout size)

**Technical Support to the National Highway Traffic Safety  
Administration (NHTSA) on the Reported Toyota Motor  
Corporation (TMC) Unintended Acceleration (UA)  
Investigation**

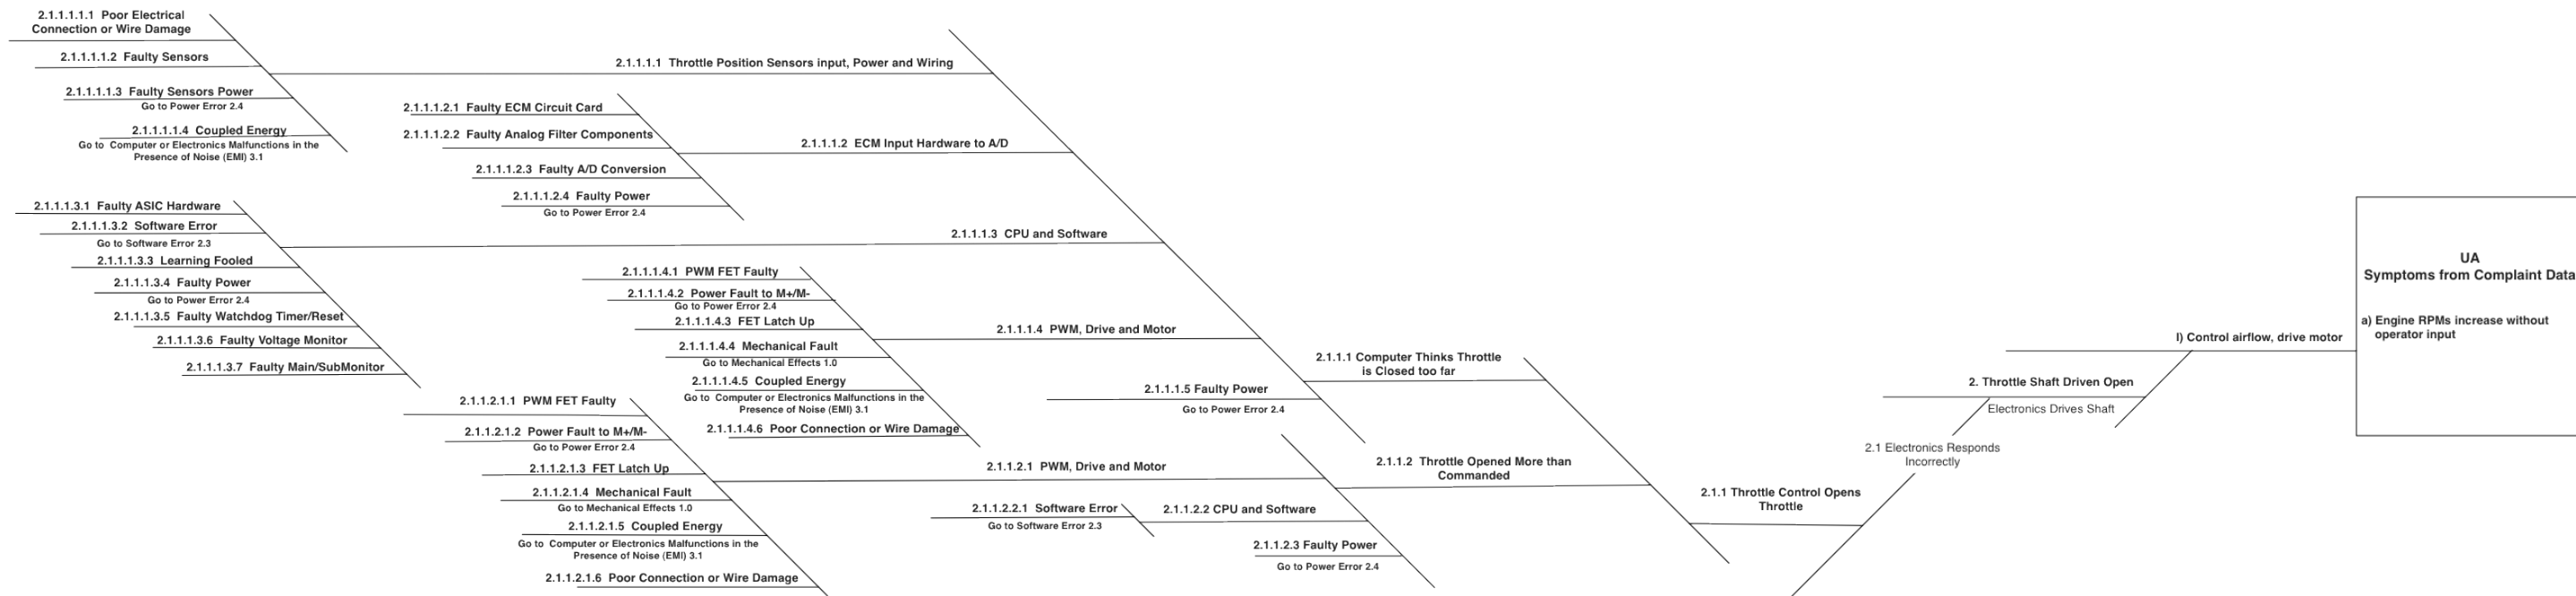
**Figure B1-1. ThrottleFishbone Diagram**

| Throttle Function Fishbone Disposition | | Description and Disposition | Detection & System Level Mitigations | |
|--|---|--|---|--|
| 2.1.1.1 Computer Thinks Throttle is Closed too far | 2.1.1.1.1 Throttle Position Sensors input, Power and Wiring | 2.1.1.1.1.1 Poor Electrical Connection or Wire Damage | <p>VC: A failure mode that causes an increase in resistance to the sensor power, VC, is self-limiting to 3 degrees. This failure mode would cause a drop in VC and, when combined with the learning algorithm, a drop in the sensor output causing the control system to open the throttle to compensate and increase the engine rpm. It is self-limiting as the supply voltage is dropping and the compensating signal cannot be larger than the supply voltage. Some types of Hall Effect sensors' outputs will go to the supply voltage if the supply voltage drops below ~3.7 volts. With resistance above approximately 40 ohms, the failure will be detected and the system will go to a fail-safe mode. Resistive shorts between +5v and Ground is disposition in the Power Element (B-6) and are found to stall the vehicle. Shorting to random signals in the vehicle wiring was not investigated. In the study in the field of connectors within aerospace, conductive contamination causing additional electrical connections in a connector and mechanical wire damage where wires are resistive shorting to chassis or other signals have been observed.</p> | <p>DTC for sensors not within the valid range.<br/>DTC when commanded versus measured position do not agree, DTC when PID controlled increases motor duty cycle up to current limit threshold</p> <p>Disable Throttle #3 Slightly above Idle Mode<br/>Power Off Throttle motor,<br/>Valve returns to spring detent 6.5° off closed.<br/>Engine Power Management through Fuel Cut based on Accelerator Pedal</p> <p>Idle Mode Fuel Cut, #4<br/>Fuel Cut at 2500 rpm when accelerator pedal released</p> |
| | | | <p>Return: An increase in resistance on the sensor power return line can result in a throttle increase of approximately 1 degree. The learning algorithm will learn the increased input signal caused by the resistance and, when the resistance is removed, the control loop will compensate by increasing the throttle opening. Shorting to random signals in the vehicle wiring was not investigated. In the study in the field of connectors within aerospace, conductive contamination causing additional electrical connections in a connector and mechanical wire damage where wires are resistive shorting to chassis or other signals have been observed.</p> | <p>DTC for sensors not within the valid range.<br/>DTC when commanded versus measured position do not agree, DTC when PID controlled increases motor duty cycle up to current limit threshold</p> <p>Disable Throttle #3 Slightly above Idle Mode<br/>Power off Throttle motor, Valve returns to spring detent 6.5° off closed.<br/>Engine Power Management through Fuel Cut based on Accelerator Pedal</p> <p>Idle Mode Fuel Cut, #4<br/>Fuel Cut at 2500 rpm when accelerator pedal released</p> |
| | | | <p>Hall Effect: A high resistive connection downstream of the Hall sensor output would result in a voltage increase and the throttle closing. Resistive shorts of VTA1 to power result in closing the throttle; resistive shorts to ground on VTA1 might result in opening of the throttle up to 3 degrees. No DC magnetic source was identified near the throttle, which could cause a faulty sensor signal that would last for several seconds or minutes and then disappear. The Earth's magnetic field is orders of magnitude too weak to perturb the sensor signal. Failure of Hall sensor internal circuitry is mitigated by comparison to the second sensor. Maximum throttle opening due to perturbation from magnetic field internal faults of the sensor would be limited to 3 degrees before setting a DTC.</p> | <p>DTC for sensors not within the valid range.</p> <p>Disable Throttle #3 Slightly above Idle Mode<br/>Power off Throttle motor, Valve returns to spring detent 6.5° off closed.<br/>Engine Power Management through Fuel Cut based on Accelerator Pedal</p> <p>Idle Mode Fuel Cut, #4<br/>Fuel Cut at 2500 rpm when accelerator pedal released</p> |
| | 2.1.1.1.1.3 Faulty Sensors Power | <p>VC: A failure mode that causes an increase in resistance to the sensor power, VC, is self-limiting to 3 degrees. This failure mode would cause a drop in VC and, consequently, a drop in the sensor output causing the control system to open the throttle to compensate and increase</p> | <p>DTC for sensors not within the valid range. DTC Position does not match commanded</p> <p>Disable Throttle #3 Slightly above Idle Mode</p> | |

| Throttle Function Fishbone Disposition | | Description and Disposition | Detection & System Level Mitigations |
|--|---|--|---|
| | 2.1.1.1.4 Coupled Energy | <p>Throttle sensor component level testing with current injection in both VTA signals noted an engine rpm increase at various frequencies from 125Hz to 10KHz. At a 500Hz sine wave aliasing was observed between the input signal and the throttle output.<br/>There are two Technical Field Reports (TQCN/TOY-RQ-00074023_FTR-7QR101241 and TQCN/TOY-RQ-00074046_FTR-7QK101441A) documenting unknown coupling to VTA traced to the E8 ground splice. One field report (TQCN/TOY-RQ-00074514) documented an unknown spike coupling to VTA resulting in a 100 rpm engine surging.<br/>See EMI branch 3.1 Coupling of the M+ into the VTA signal was not indicated by a comparison of six complaint vehicles with two non-complaint vehicles. Measurements of the 6 complaint vehicles did not indicate a higher coupling of M+ into the VTA signals than the 2 non-complaint vehicles.</p> | <p>DTC for sensors not within the valid range.<br/>DTC Position does not match commanded</p> <p>Disable Throttle #3 Slightly above Idle Mode<br/>Power off Throttle motor, Valve returns to spring detent 6.5° off closed.<br/>Engine Power Management through Fuel Cut based on Accelerator Pedal</p> <p>Idle Mode Fuel Cut, #4<br/>Fuel Cut at 2500 rpm when accelerator pedal released</p> |
| 2.1.1.1.2 ECM Input Hardware to A/D | 2.1.1.1.2.1 Faulty ECM Circuit Card | <p>Poor solder joints or cracked traces could result in an increased resistance that would decrease both VTA's resulting in an increase in throttle opening, as covered in 2.1.1.1.1.1 Poor Electrical Connection or Wire Damage.<br/>The failure would be self-limiting as the supply voltage is dropping and the compensating signal cannot be larger than the supply voltage or result in a throttle increase of approximately 3 degrees.</p> | <p>DTC for sensors not within the valid range.<br/>DTC Position does not match commanded</p> <p>Disable Throttle #3 Slightly above Idle Mode<br/>Power off Throttle motor, Valve returns to spring detent 6.5° off closed.<br/>Engine Power Management through Fuel Cut based on Accelerator Pedal</p> <p>Idle Mode Fuel Cut, #4<br/>Fuel Cut at 2500 rpm when accelerator pedal released</p> |
| | 2.1.1.1.2.2 Faulty Analog Filter Components | <p>Cracked or damaged passive components could result in an increased series resistance that would increase both VTA's resulting in a decrease in throttle opening, as covered in 2.1.1.1.1.1 Poor Electrical Connection or Wire Damage. Changes in the cutoff frequency of the filtering does not change the gain therefore is unlikely to cause an opening of the throttle.</p> | <p>DTC for sensors not within the valid range. DTC Position does not match commanded</p> <p>Disable Throttle #3 Slightly above Idle Mode<br/>Power off Throttle motor, Valve returns to spring detent 6.5° off closed.<br/>Engine Power Management through Fuel Cut based on Accelerator Pedal</p> <p>Idle Mode Fuel Cut, #4<br/>Fuel Cut at 2500 rpm when accelerator pedal released</p> |

| Throttle Function Fishbone Disposition | | Description and Disposition | | Detection & System Level Mitigations | |
|--|--|---|--|---|--|
| | | 2.1.1.1.3.2 Software Error | With the tools utilized during the course of this study, software defects that unilaterally open the throttle or defeat defenses were not found. Extensive software testing and analysis was performed on Toyota 2005 Camry L4 source code using static analysis, logic model testing, recursion testing, and worse case execution timing. | Disable Throttle #3 Slightly above Idle Mode<br>Power off Throttle motor, Valve returns to spring detent 6.5° off closed.<br>Engine Power Management through Fuel Cut based on Accelerator Pedal<br><br>Idle Mode Fuel Cut, #4<br>Fuel Cut at 2500 rpm when accelerator pedal released<br>Engine Turned Off | |

| Throttle Function Fishbone Disposition | | Description and Disposition | Detection & System Level Mitigations |
|--|---|---|--|
| | 2.1.1.1.4.1 PWM FET Faulty | Open, shorted, latchup, or resistive failures of any single H-Bridge FET or shorted failure of the on/off FET would be detected by the high current check which would prevent a persistent increase of the throttle. A resistive increase of M+/M- signals would be compensated by an increased duty cycle. Additionally, a shorted failure of the external power on/off FET would also be mitigated by a drive cutoff function and a power cutoff for sensed failures. Latchup is obviated by use of Silicon on Insulator ASICs. | Hardware power disable and DTC for PWM High current, or temperature, DTC when commanded versus measured position do not agree, DTC when PID controlled increases motor duty cycle up to current limit threshold.<br><br>Disable Throttle #3 Slightly above Idle Mode<br>Power off Throttle motor, Valve returns to spring detent 6.5° off closed.<br>Engine Power Management through Fuel Cut based on Accelerator Pedal<br><br>Idle Mode Fuel Cut, #4<br>Fuel Cut at 2500 rpm when accelerator pedal released |

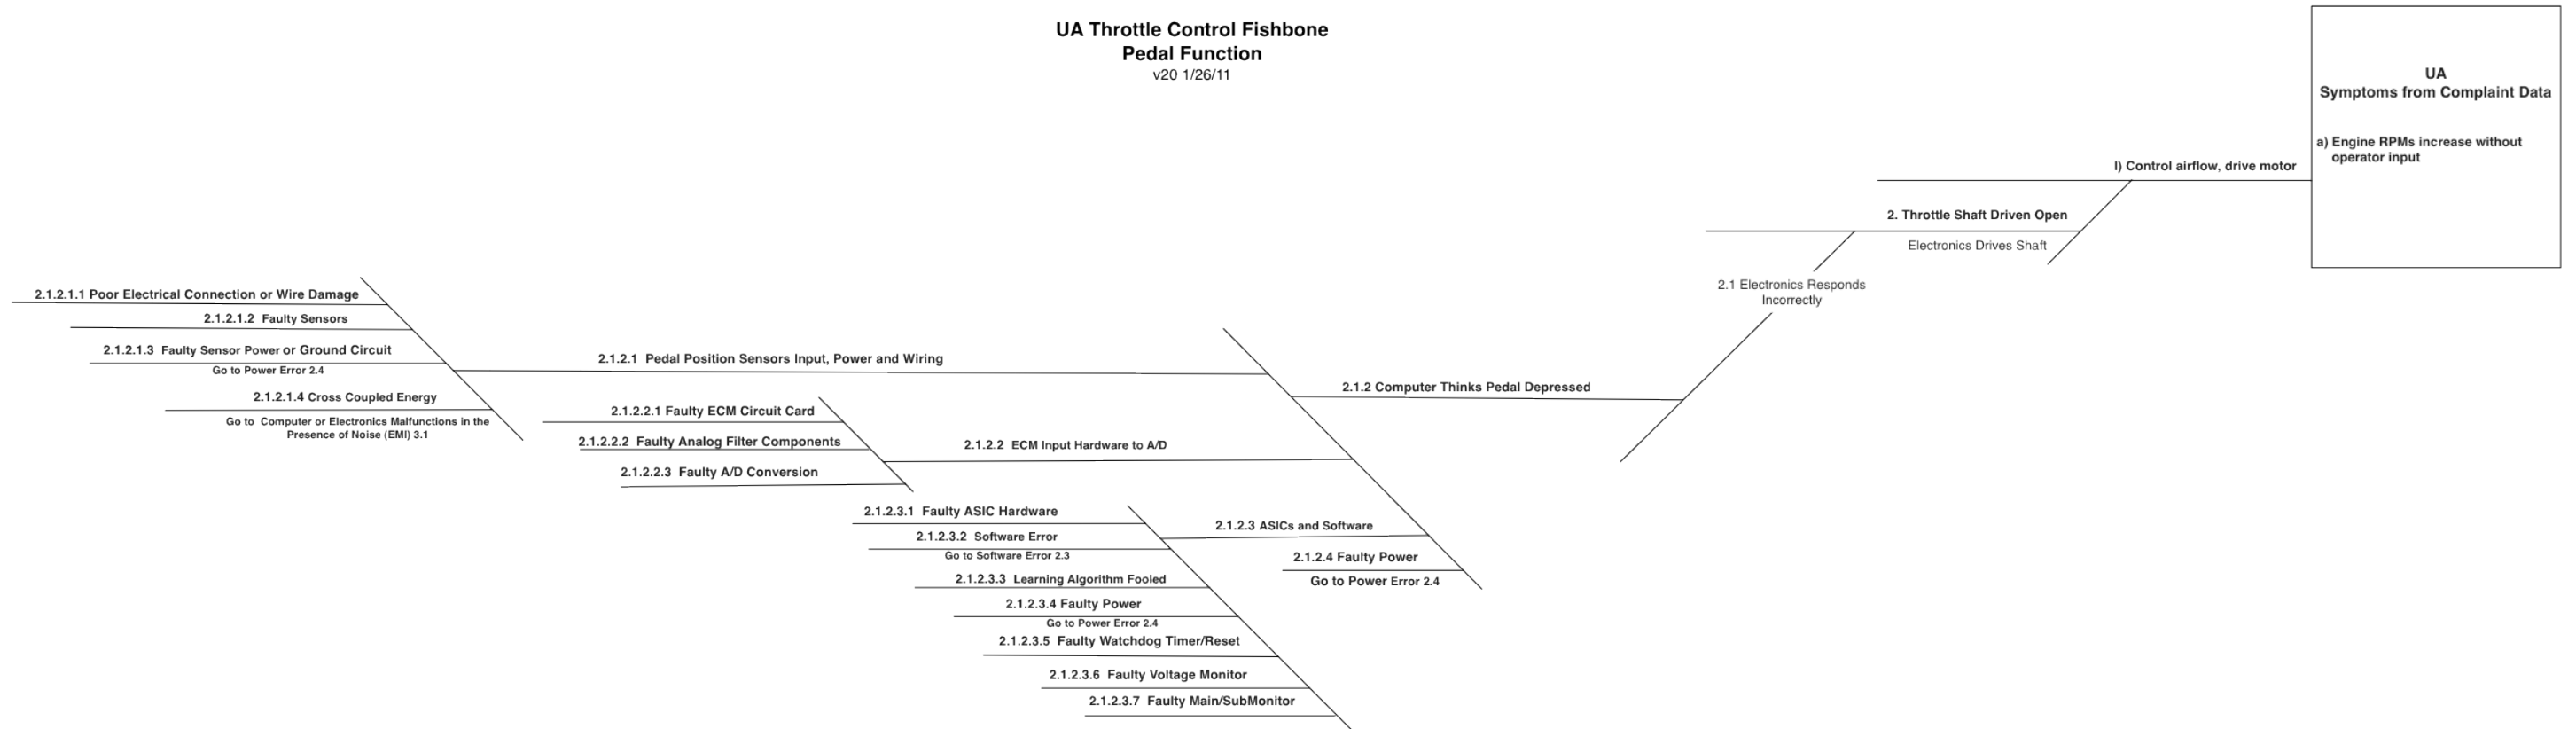
**Figure B2-1. Pedal Fishbone Diagram**

| Pedal Function Fishbone Disposition | | Description and Disposition | | Detection & System Level Mitigations | |
|---|--|---|---|---|--|
| 2.1.2 Computer Thinks Pedal Depressed | 2.1.2.1 Pedal Position Sensors Input, Power and Wiring | 2.1.2.1.1 Poor Electrical Connection or Wire Damage | An increased resistance fault of pedal voltage supply, VCP1 and VCP2 can result in a throttle increase limited to 10 degrees in throttle command. The increased resistance will result in a drop in VPA signals that will be compensated for by the learning algorithm. Removal of the fault will then result in an increase in throttle opening. This sensitivity requires postulated faults in two signals and the condition to be learned then removed. The cause of such a failure would be a poor electrical connection, which would most likely manifest as an increased resistance in the electrical circuit. | DTC for high, low and outside lane. None, if Pedal sensors fail within operational lane<br>DTC<br>Limp Home Mode #1, Throttle control limited to 15 degrees relative opening above idle, by remaining sensor. If neither Pedal Sensor operable then Idle only | |
| | | | A double series or parallel resistance fault between pedal sensors or sensor to the supply voltage placing VPA1 and VPA2 in their operational lane cannot be detected as a fault and may result in increased throttle opening. This postulated fault requires two independent set of conditions to create UAs in two pedal types. This sensitivity requires postulated faults in two signals which may results in any throttle command even up to full throttle and the condition would be present as long as the fault is present. Either two simultaneous or latent and second faults are required. Series resistance will result in a lower voltage and closing of the throttle or lowering of the learned release position. | Dual Failures within Operational Lane:<br>Engineered Fault in operational lane Valid pedal signal escapes detection, no DTC<br><br>No mitigation possible for multiple failures that look like a valid pedal signal | |
| | | 2.1.2.1.2 Faulty Sensors | Potentiometer type:<br>There were no single failure causes found which manifests as a valid command and concurrently (< 0.5sec) impacts both VPA1 & VPA2. High series resistive connections or shorts to +5 volts or ground of VPA1 to VPA2 do not result in an increase in throttle opening. There are dual failures that can open the throttle caused by resistive shorts of VPA1 to VPA2 and a second short between VPA2 and +5 volts or an open on VPA2's return. A second resistive short to ground on VPA1 might result in closing of the throttle or lowering the learned value when the accelerator pedal is released. The dual failures results in opening the throttle as long as resulting voltages remain in the operational lane. A resistive fault between VPA1 & VPA2 (due to tin whiskers) was discovered on a defective pedal with a potentiometer sensor. | DTC for high, low and outside lane. None, if Pedal sensors fail within operational lane<br>DTC<br><br>Limp Home Mode #1, Throttle control limited to 15 degrees relative opening above idle, by remaining sensor. If neither Pedal Sensor operable then Idle only. (There are particular ignition key cycles and pedal application conditions where the throttle opening may not be limited to 15 degrees after DTC 2121 is detected. These are captured in the "Pedal Resistive Fault Event Sequence Diagram (Figure 6.6.2.3-2). | |
| | | 2.1.2.1.2 Faulty Sensors | Hall Effect:<br>There were no Single failure causes found which manifests as a valid command and concurrently (< 0.5sec) impacts both VPA1 & VPA2. High series resistive connections or shorts to +5 volts or ground of VPA1 to VPA2 do not result in an increase in throttle opening. There are dual failures that can open the throttle caused by resistive shorts of VPA1 to VPA2 and a second short between VPA2 and +5 volts or an open on VPA2's return. A second resistive short to ground on VPA1 might result in closing of the throttle or lowering the learned value when the accelerator pedal is released. The dual failures results in opening the throttle as long as resulting voltages remain in the operational lane. No DC magnetic source was identified near the pedal, which could cause a faulty sensor signals that would last for several seconds or minutes and then disappear. The Earth's magnetic field is orders of magnitude too weak to perturb the sensor signal. Failure of Hall sensor internal circuitry is mitigated be comparison to second sensor. | DTC for high, low and outside lane. None, if Pedal sensors fail within operational lane<br>DTC<br><br>Limp Home Mode #1, Throttle control limited to 15 degrees relative opening above idle, by remaining sensor. If neither Pedal Sensor operable then Idle only | |

| Pedal Function Fishbone Disposition | | Description and Disposition | Detection & System Level Mitigations |
|---|---|---|--|
| | 2.1.2.1.4 Cross Coupled Energy | Coupling on a single signal sensor lead or the total wire bundle did not result in a throttle opening. Vehicle level EMC testing with current injection in both VPA signals noted an engine rpm increase at various frequencies from 200Hz to 150KHz. At a 500Hz sine wave audio signal aliasing was observed between the pedal input signal and the throttle output. Similarly, component level noise rejection testing noted aliasing at 500Hz on both the VPA signals. See EMI branch 3.1. | DTC for high, low and outside lane. None, if Pedal sensors fail within operational lane DTC<br><br>Limp Home Mode #1, Throttle control limited to 15 degrees relative opening above idle, by remaining sensor. If neither Pedal Sensor operable then Idle only |
| 2.1.2.2 ECM Input Hardware to A/D | 2.1.2.2.1 Faulty ECM Circuit Card | A double series or parallel resistance fault between pedal sensors or sensor to the supply voltage placing VPA1 and VPA2 in their operational lane cannot be detected as a fault and may result in increased throttle opening, as described in 2.1.2.1.1 Poor Electrical Connection or Wire Damage. | Dual Failures within Operational Lane:<br>Engineered Fault in operational lane Valid pedal signal escapes detection, no DTC<br><br>No mitigation possible for multiple failures that look like a valid pedal signal |

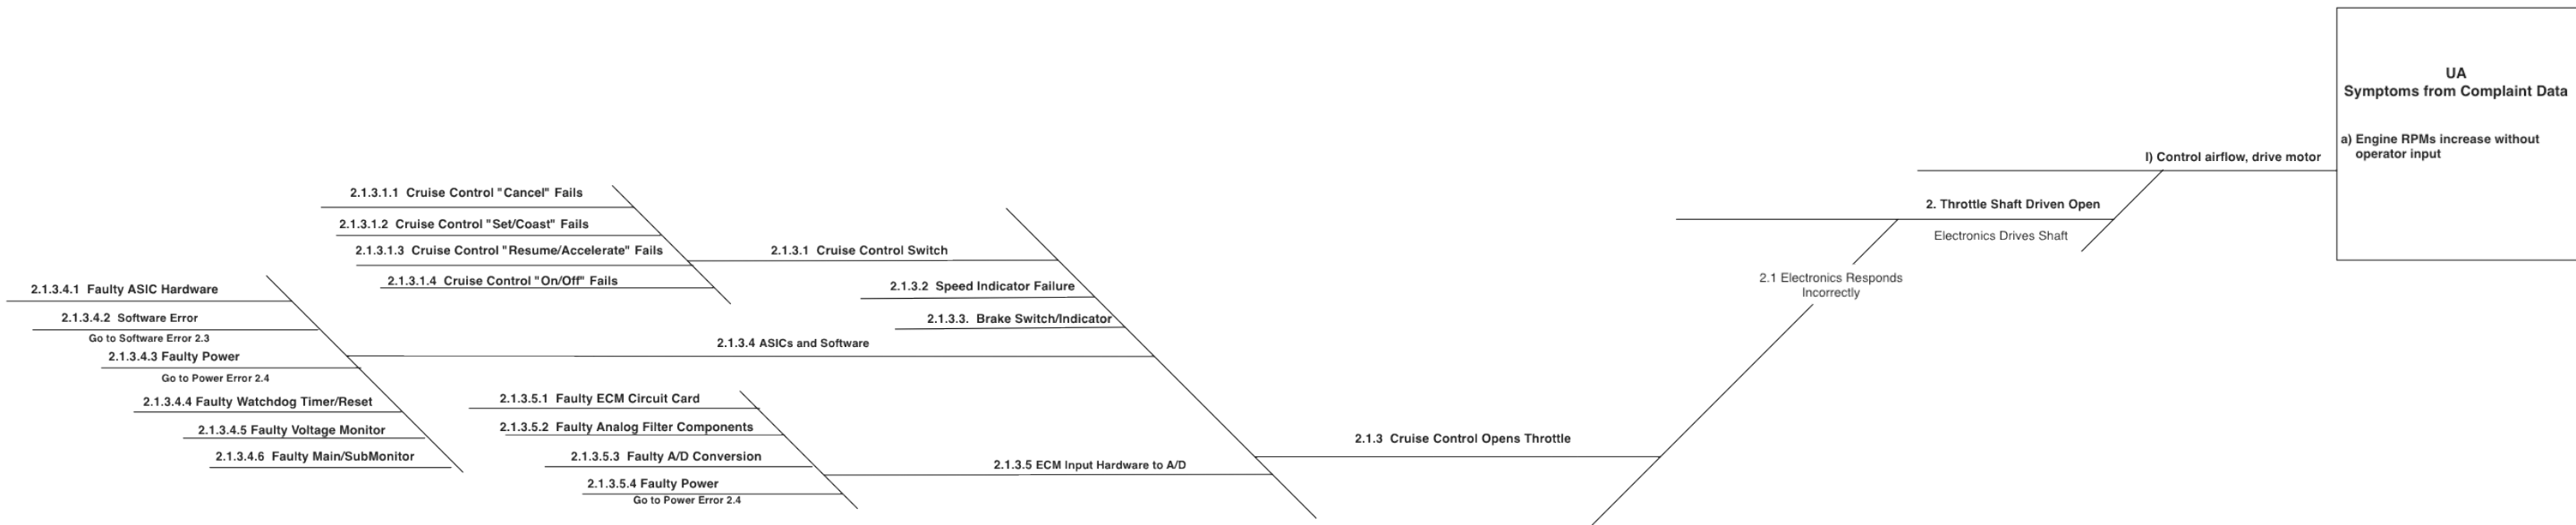
*Figure B3-1. Cruise Control Fishbone Diagram*

| Cruise Control Function Fishbone Disposition | | Description and Disposition | | Detection & System Level Mitigations |
|--|---|---|---|--|
| 2.1.3 Cruise Control Opens Throttle | 2.1.3.1 Cruise Control Switch | 2.1.3.1.1 Cruise Control "Cancel" Fails | There are multiple mitigations and protections in place to protect against a failed Cruise Control "Cancel" failures. Normal switch position is "OFF". | Specific ordering for activation, Short to ground is "OFF"<br>Driver can cancel, Brake Switch, or 9 MPH slow down cancels Cruise, or shift to neutral |
| | | 2.1.3.1.2 Cruise Control "Set/Coast" Fails | There are multiple mitigations and protections in place to protect against a failed Cruise Control "Set/Cancel" failures. Normal switch position is "OFF". Engaging the set switch for longer than 0.6 seconds results in coast and a decrease the vehicle speed of the vehicle. | Specific ordering for activation, Short to ground is "OFF"<br>Driver can activate, Brake Switch, or 9 MPH slow down cancels Cruise, or cancel cruise, or shift to neutral |
| | | 2.1.3.1.3 Cruise Control "Resume/Accelerate" Fails | A resistive short of the cruise control signal wire to ground of the Cruise Control "Resume/Accelerate" with the cruise control engaged, will result in the vehicle accelerating to the maximum speed threshold of the system. Application of the brake pedal will cancel cruise control. | Specific ordering for activation, Short to ground is "OFF"<br>Driver can cancel, Brake Switch, or 9 MPH slow down cancels Cruise, or shift to neutral |
| | | 2.1.3.1.4 Cruise Control "On/Off" Fails | There are multiple mitigations and protections in place to protect against a failed Cruise Control "Cancel" failures. Normal switch position is "OFF". | Specific ordering for activation, Short to ground is "OFF"<br>Driver can cancel, Brake Switch, or 9 MPH slow down cancels Cruise, or shift to neutral |
| | 2.1.3.2 Speed Indicator Failure | There are multiple mitigations and protections in place If a faulty wheel speed signal indicates a slower speed than the actual vehicle speed causing an increase in throttle to maintain set speed. Acceleration is limited to 0.6 g. The operator has 5 methods to cancel cruise. | | Sensor ignored, Cruise Control Cancel at 9 MPH reduction<br>Driver can cancel, Brake Switch, or 9 MPH slow down cancels Cruise or shift to neutral |

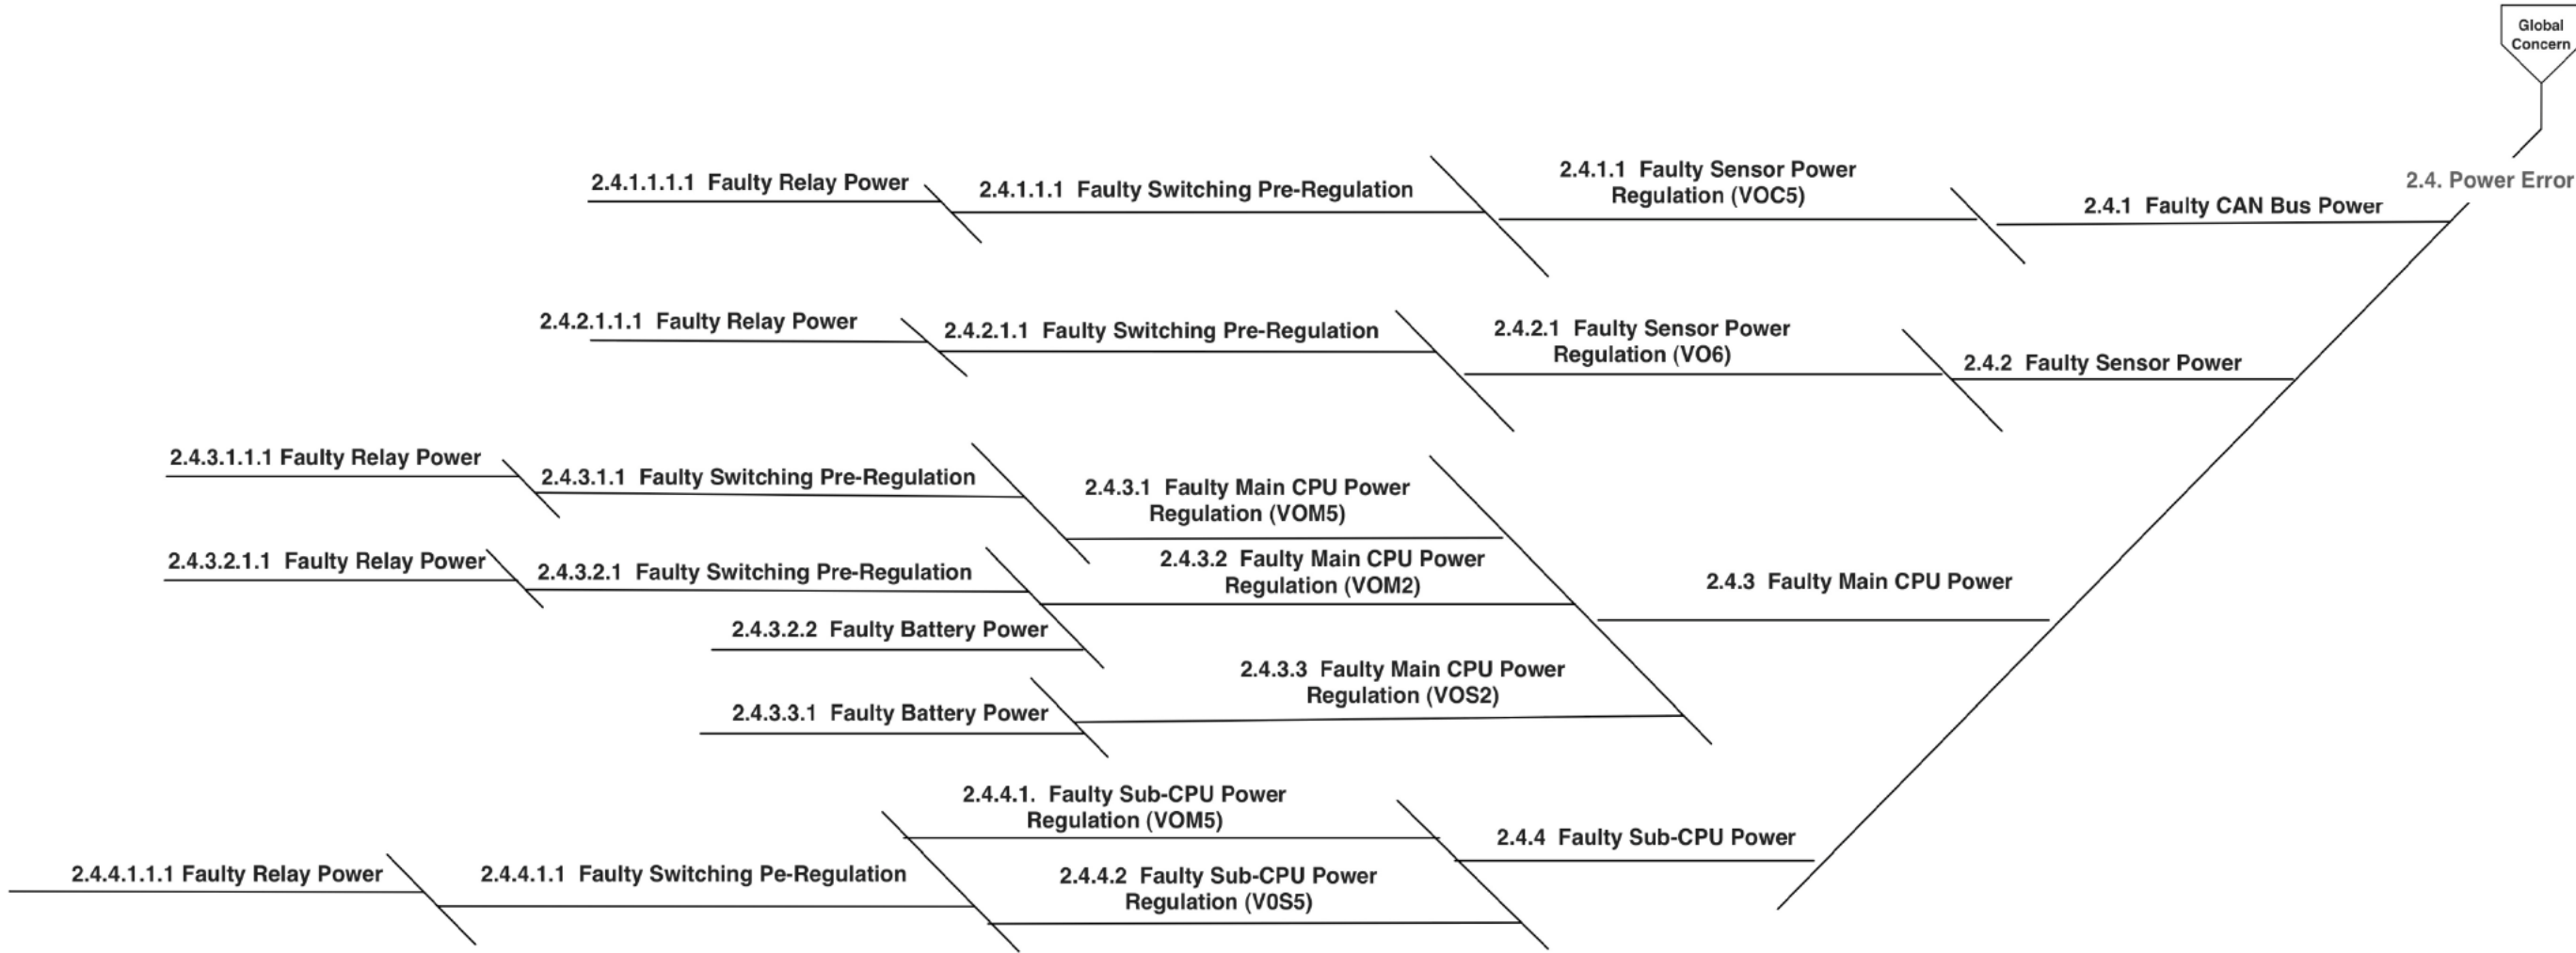
*Figure B6-1. Power Fishbone Diagram*

The power supply ASIC configuration includes [REDACTED] [REDACTED] associated with this ASIC, and the [REDACTED] to the Main CPU. The Sub-CPU operates from [REDACTED]. Figure B6-1 is the fishbone for the Power only with those elements that have been identified as design sensitivities with postulated faults denoted by a red square. Table B6-1 lists the dispositions for each element in the fishbone and those design sensitivities with postulated faults are highlighted in yellow.

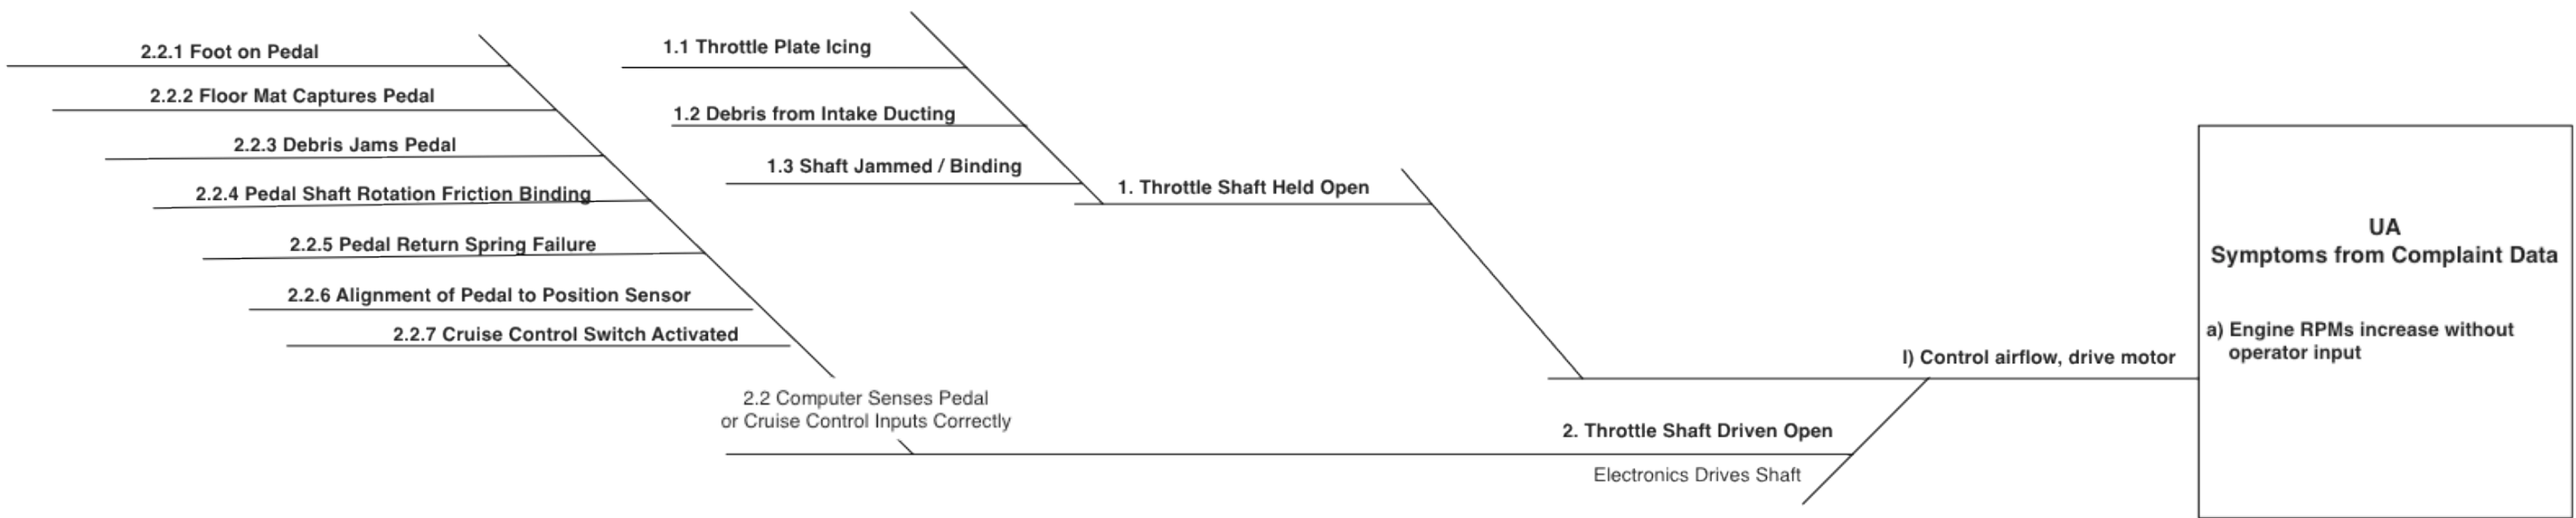
*Figure B9-1. Mechanical Effects Fishbone Diagram*

Mechanical Effects were included for completeness, but were not part of this study. Table B9-1 lists the dispositions for each element in the.
