United States-  
Environmental Protection  
Agency

# CHEMICAL ACCIDENT INVESTIGATION REPORT

## TERRA INDUSTRIES, INC. NITROGEN FERTILIZER FACILITY PORT NEAL, IOWA

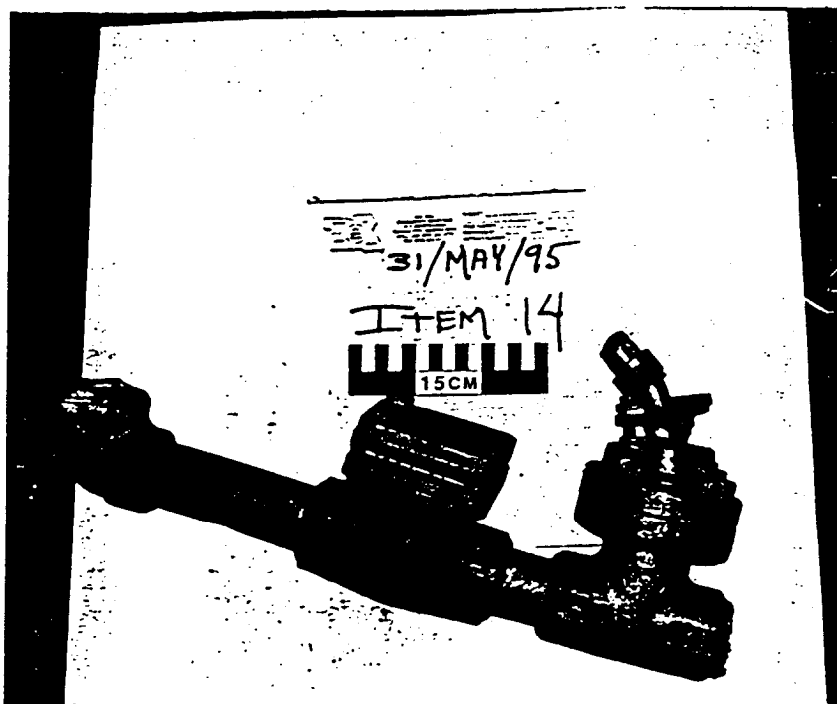
**Photo 7 - 1**  
**EPA Item # 14, Unknown Fragment**

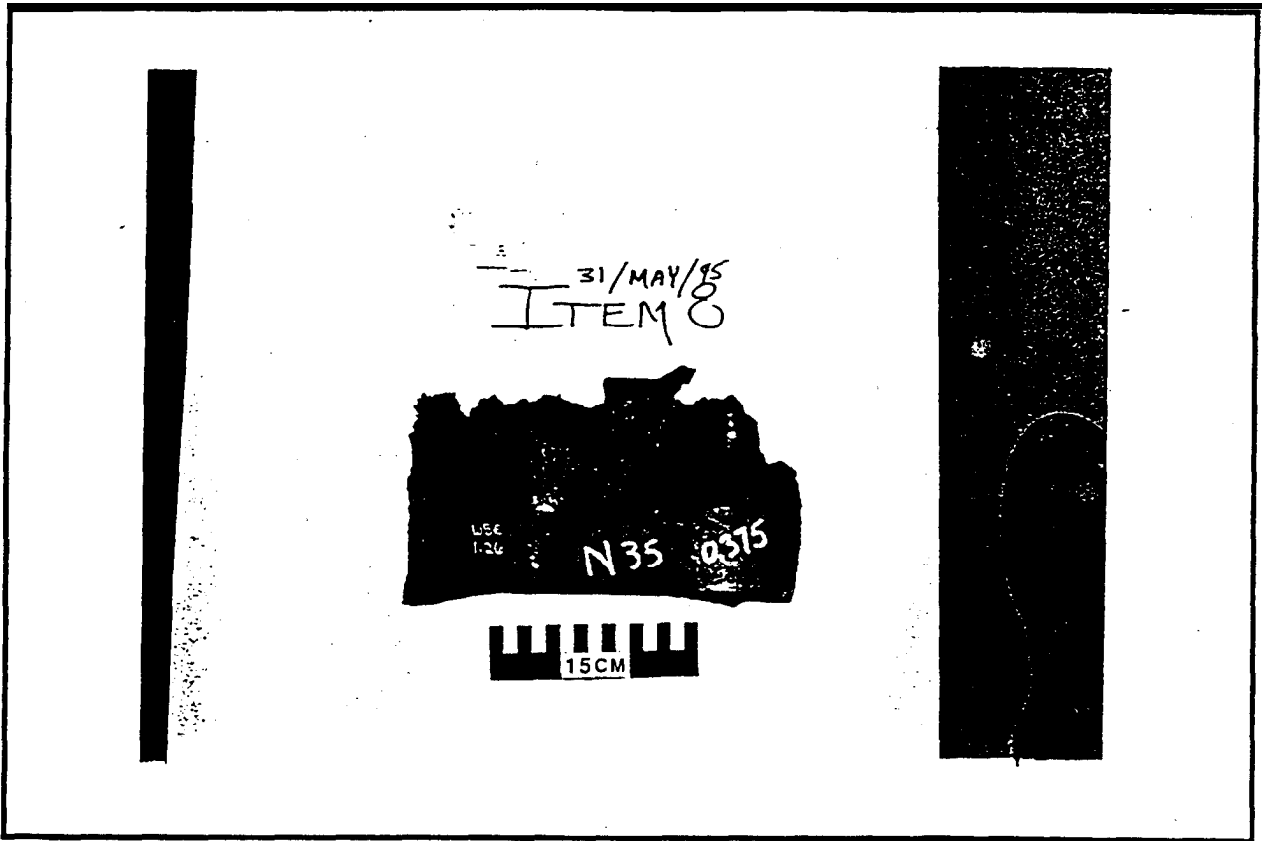
Photo 7 - 2  
Neutralizer Fragment

Metallurgical analytical results indicated that the fragment displayed a high-temperature discolored surface and severe erosion in one direction (*Photo 7-2*). The adjacent area showed little discoloration. The opposite surface exhibited severe tearing and fracturing with evidence of high-temperature discoloration (*Photo 7-3*). Unetched cross sections exhibited high-temperature oxidation on the inside diameter with severe surface tearing/seams or laps. The etched cross-sections displayed evidence of severe surface movement and cold working with a one-directional heavy force. Of the fragments analyzed, metalographic analysis suggests that the highest temperature, internal pressure and velocity was located in the area of Item #8. This sample exhibited the most severe surface distortion and high-temperature grain structure change.

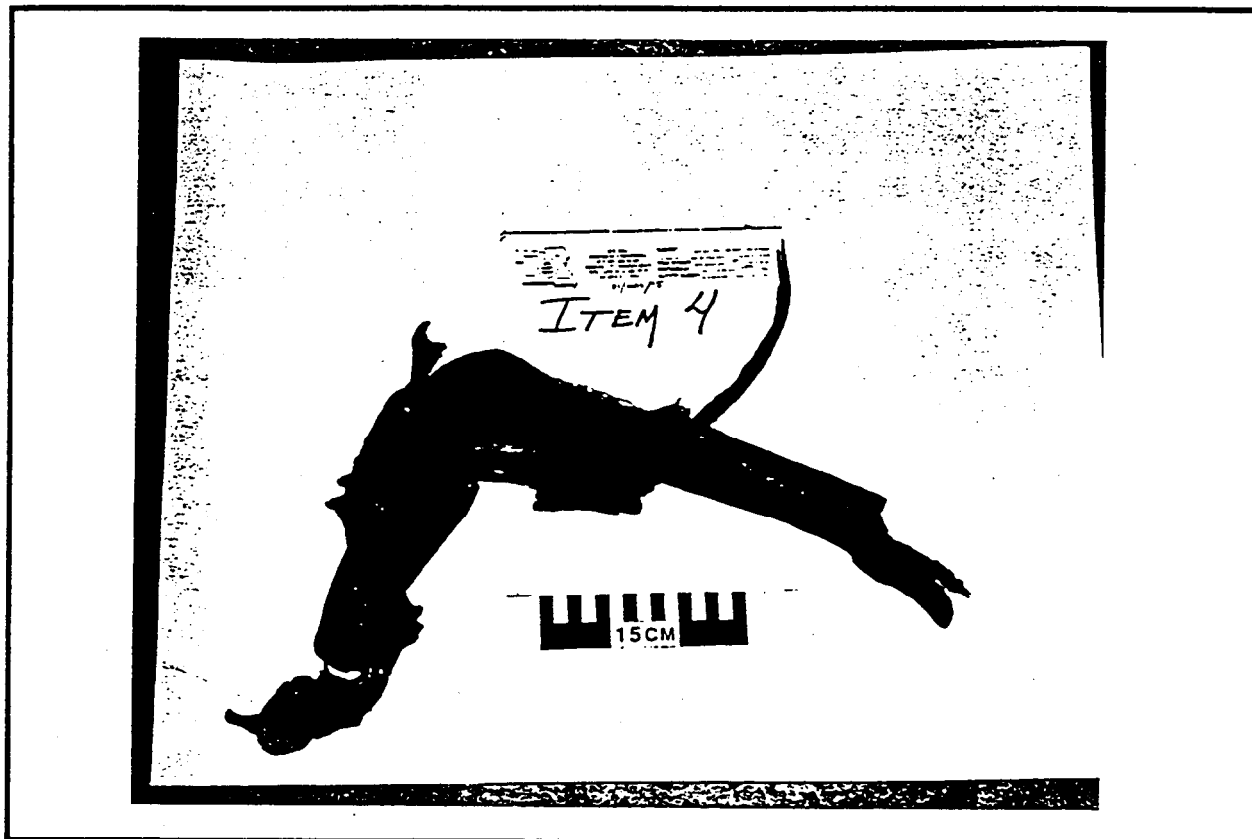
**Photo 7 - 4**  
**Sparger Fragment**

2. EPA Item #4. This fragment was described as originating from, the titanium sparger, and had been severely twisted (*Photo 7-4*). The titanium fragment exhibited a dark-colored surface with numerous areas indicating high-temperature oxidation. The interior and exterior surfaces displayed numerous mechanical damaged areas and no excessive thinning.
3. EPA Item #17. This fragment was described as originating from the titanium sparger, and displayed the same characteristics as all titanium fragments examined. The fragment was severely distorted and exhibited a dark interior and exterior surface.

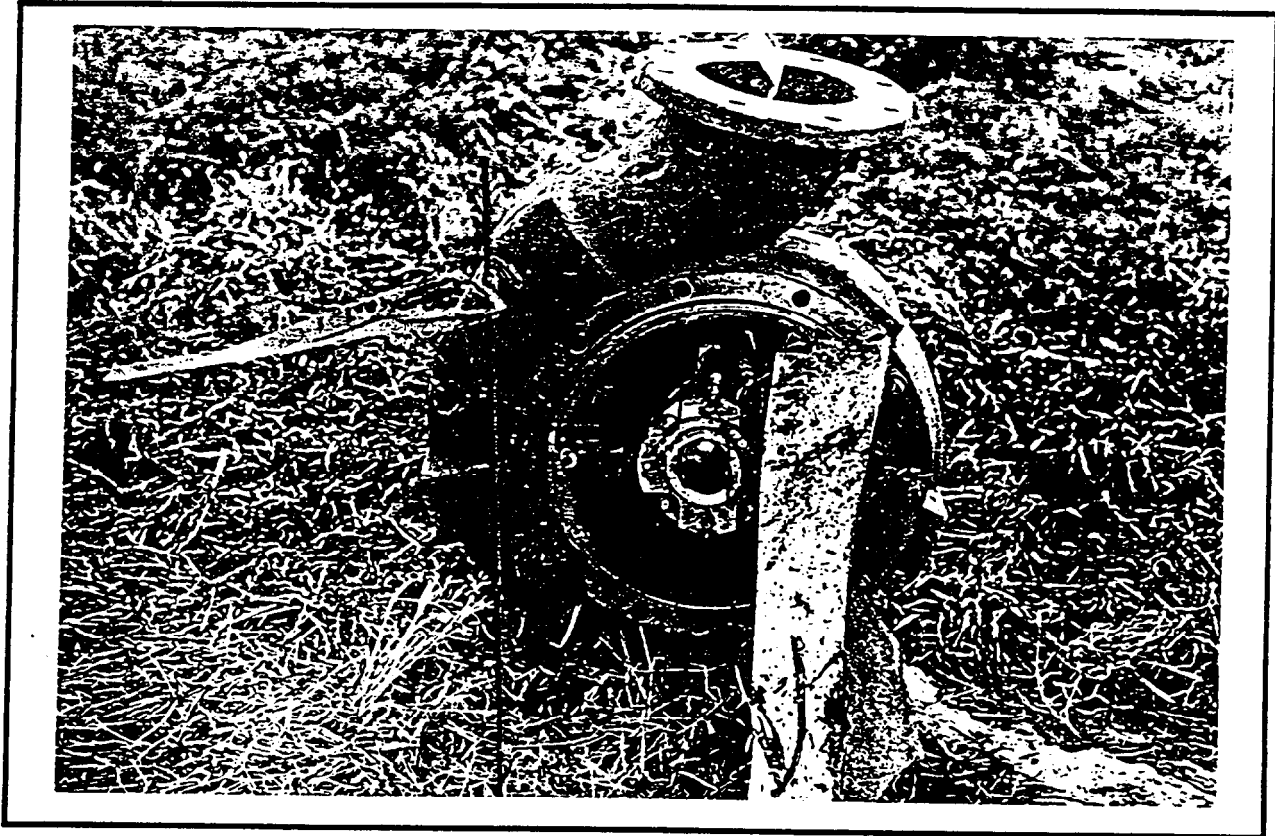
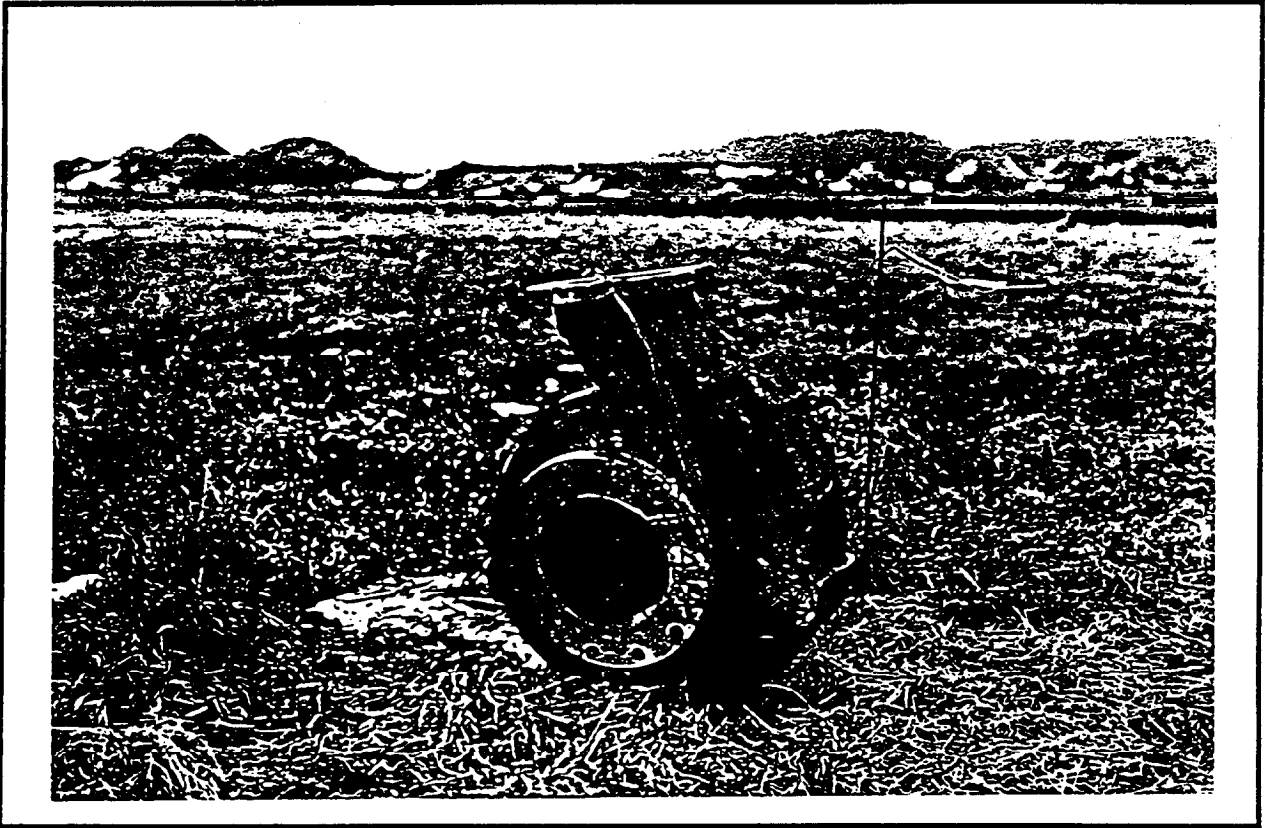
1. The pump casing was intact and located approximately 800 feet northwest of the AN plant as a result of the explosion (*Photos 8-4 A and 8-4B*).

**Photo 8 - 4A**  
**4165 Shaft View**

**Photo 8 - 4B**  
**4165 Suction View**

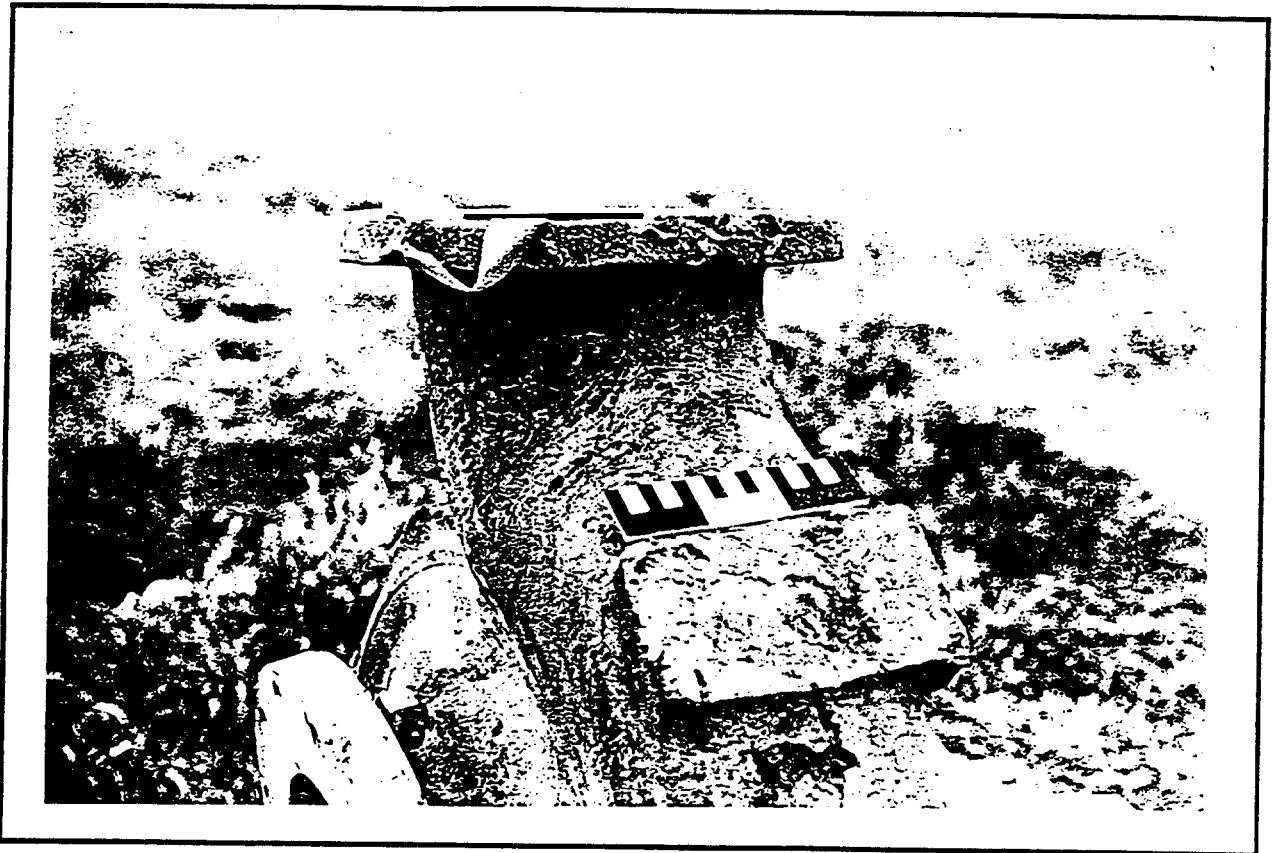
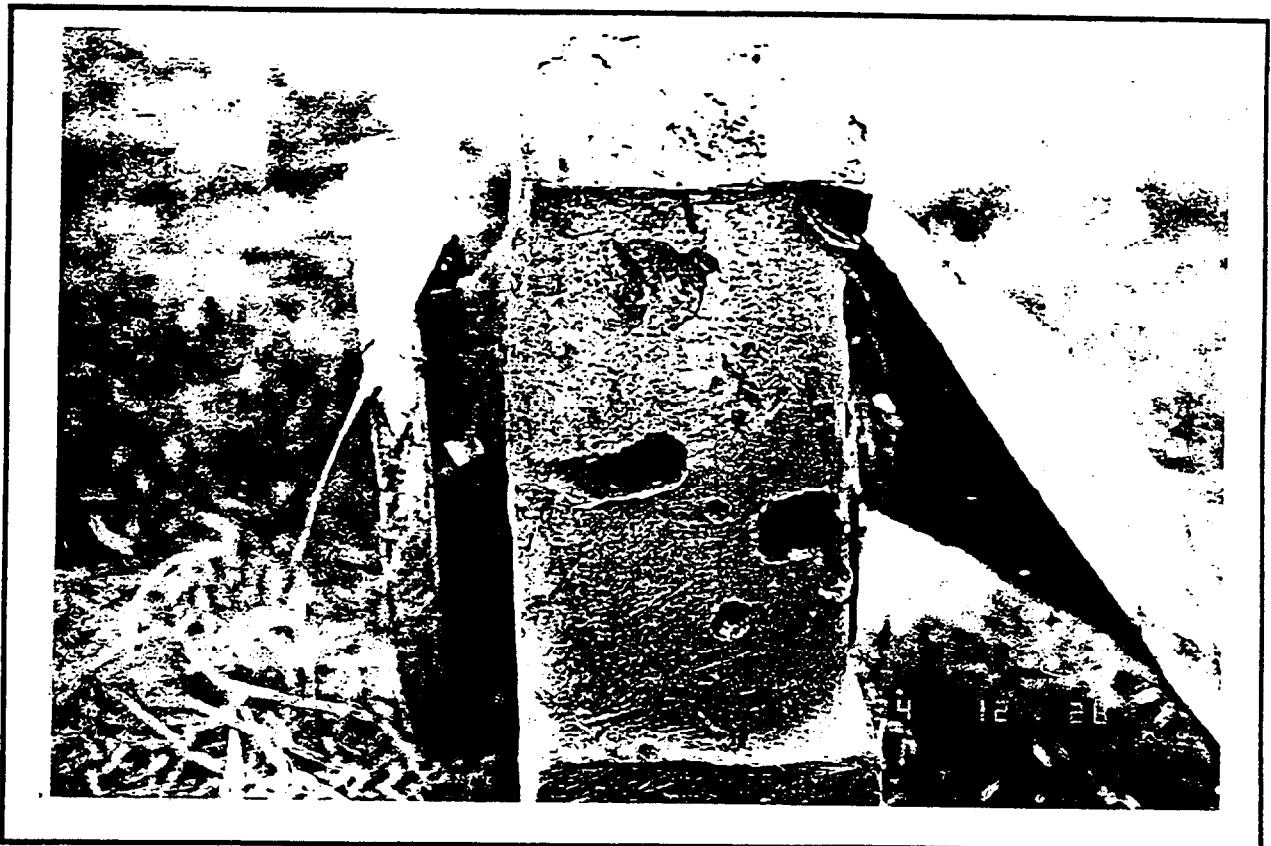
2. Damage to the pump casing included perforations caused by high-energy missiles from outside the pump from the direction of the neutralizer (*Photo 8-5 and 8-6*).
3. Damage to the pump impeller and impeller shaft were consistent with an external force from the direction of the neutralizer.
4. Metallurgist's inspection of the pump failed to reveal any evidence of heating or deformation from internal pressures (*Photo 8-7 and 8-8*).

**Photo 8 - 5**  
**416J External Damage**

**Photo 8 - 6**  
**416J External Damage**

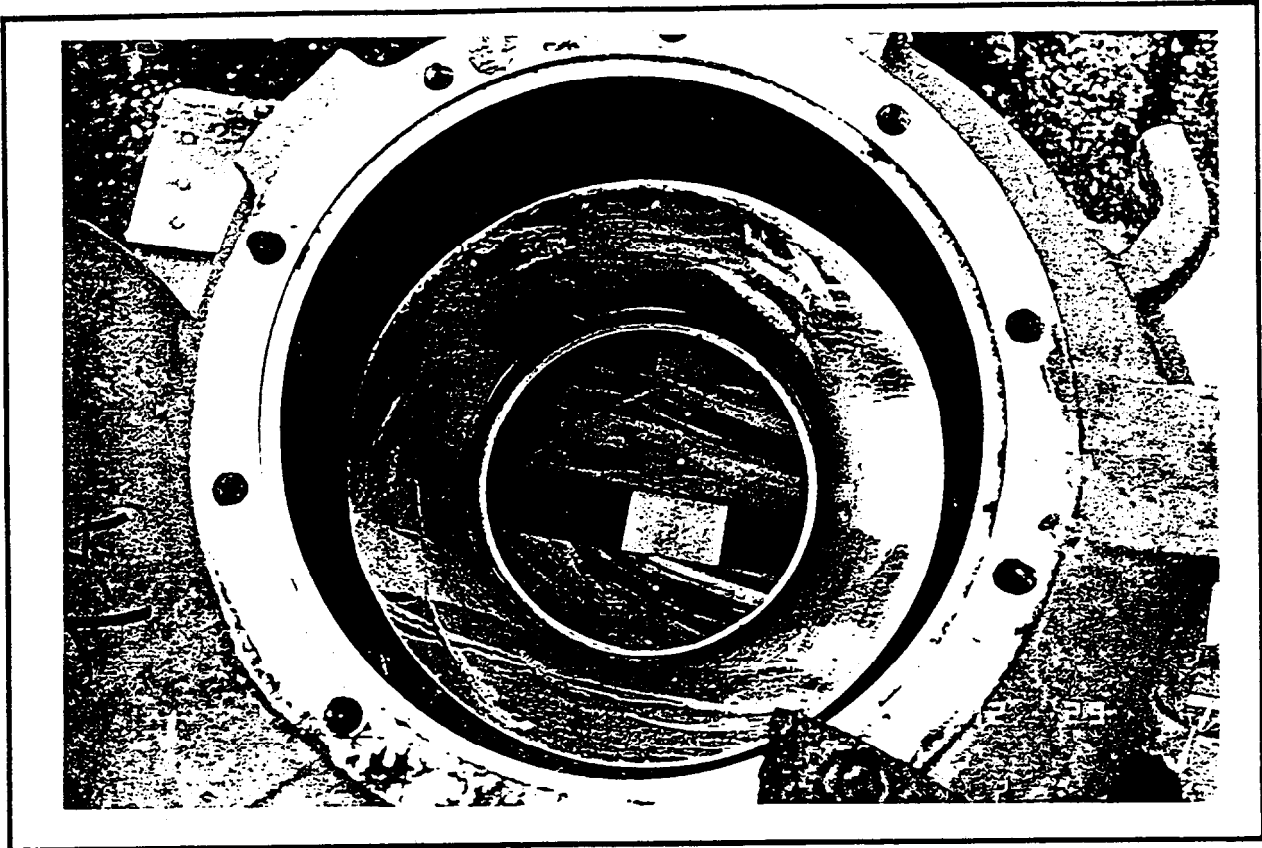
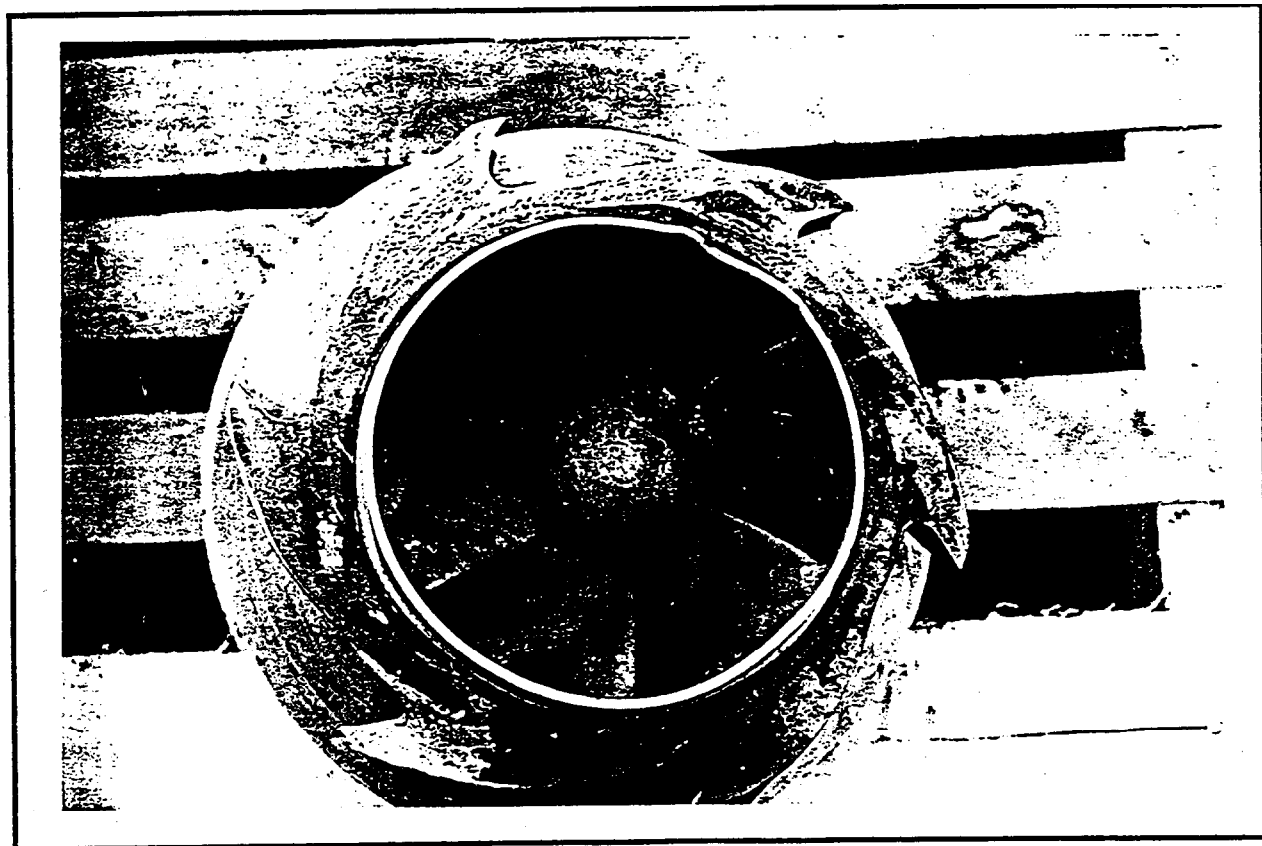
**Photo 8 - 7**  
**416J Casing**

**Photo 8 - 8**  
**1165 Impeller**

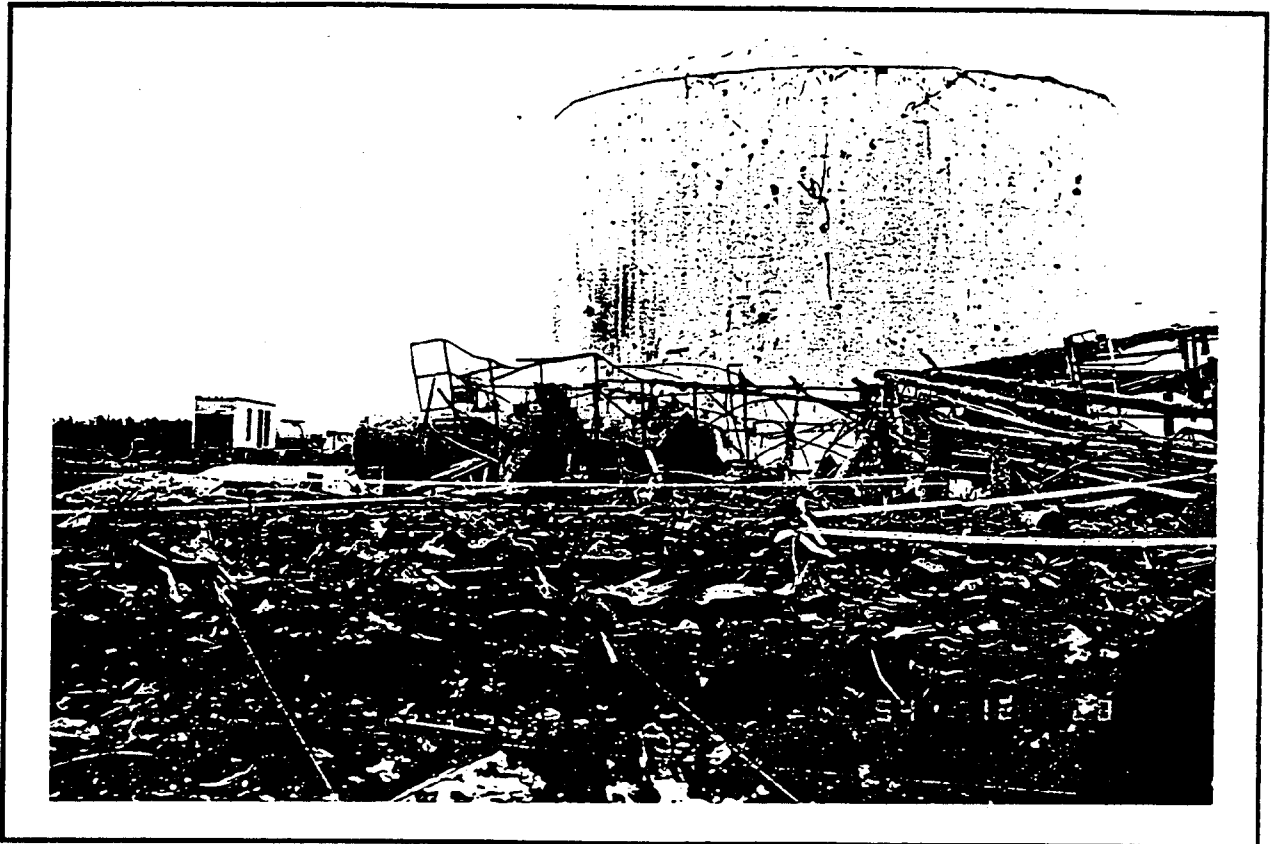
1. Reverse trajectory sighting of damage to a nearby water tank (*Photo 8-12*) and the ends of two pressure ammonia vessels (*Photo 8-13*) indicated that the neutralizer was the source of the penetrating fragments.
2. Reverse trajectory sighting of reinforcing bar angles, anchor bolt directions, and prill tower footing bolts and pads converged on the original neutralizer site.
3. Reverse trajectory sighting of a chemical stripper originally located near the AN plant indicated the explosion origin to be along a line that intersected with the original neutralizer site (*Photo 8-14*).
4. Reverse trajectory sighting of scrubber sections and the ammonia vaporizer indicated the explosion origin to be along a line that intersected the original neutralizer site.

Photo 8 - 12  
Water Tank Damage (Ammonia Tank Background)

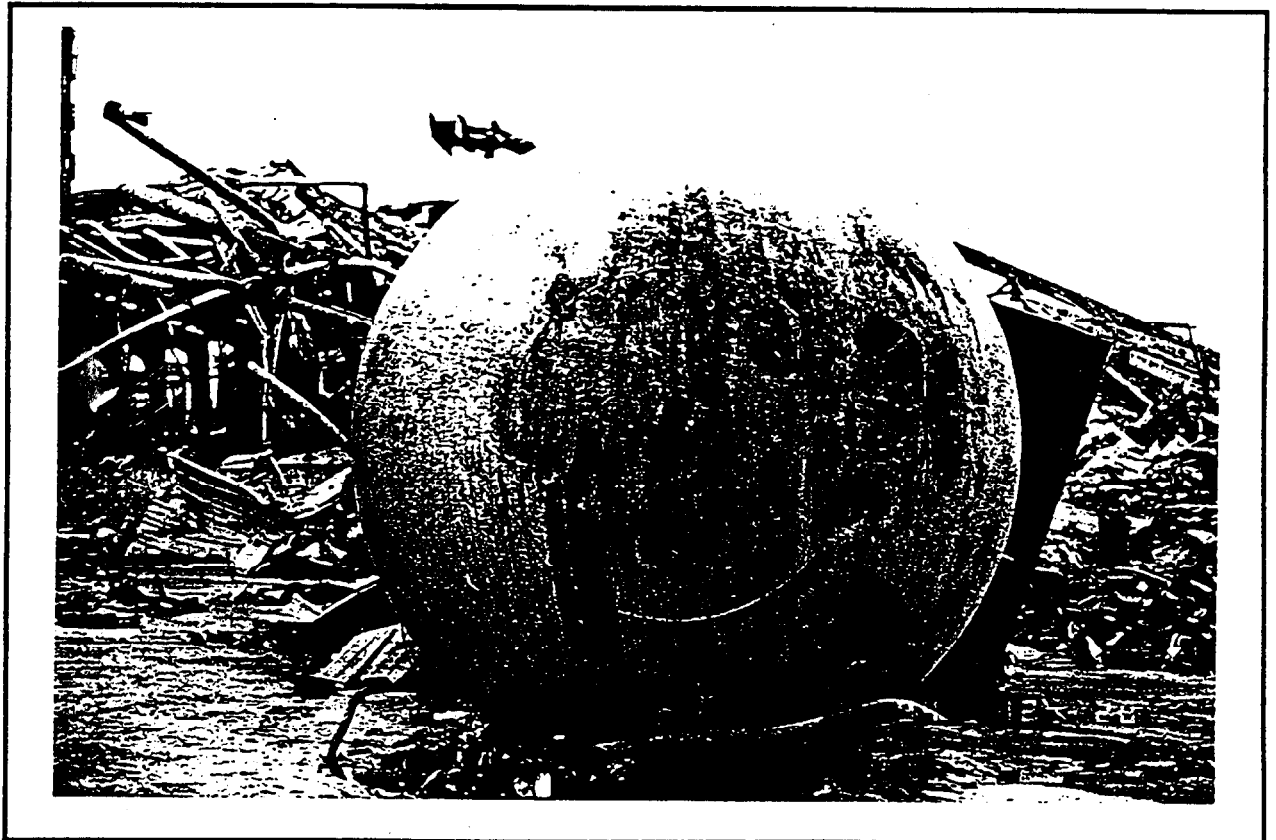
Photo 8 - 13  
Ammonia Bullet Tank Damage
