United States  
Environmental Protection  
Agency

# CHEMICAL ACCIDENT INVESTIGATION REPORT

## TERRA INDUSTRIES, INC. NITROGEN FERTILIZER FACILITY PORT NEAL, IOWA

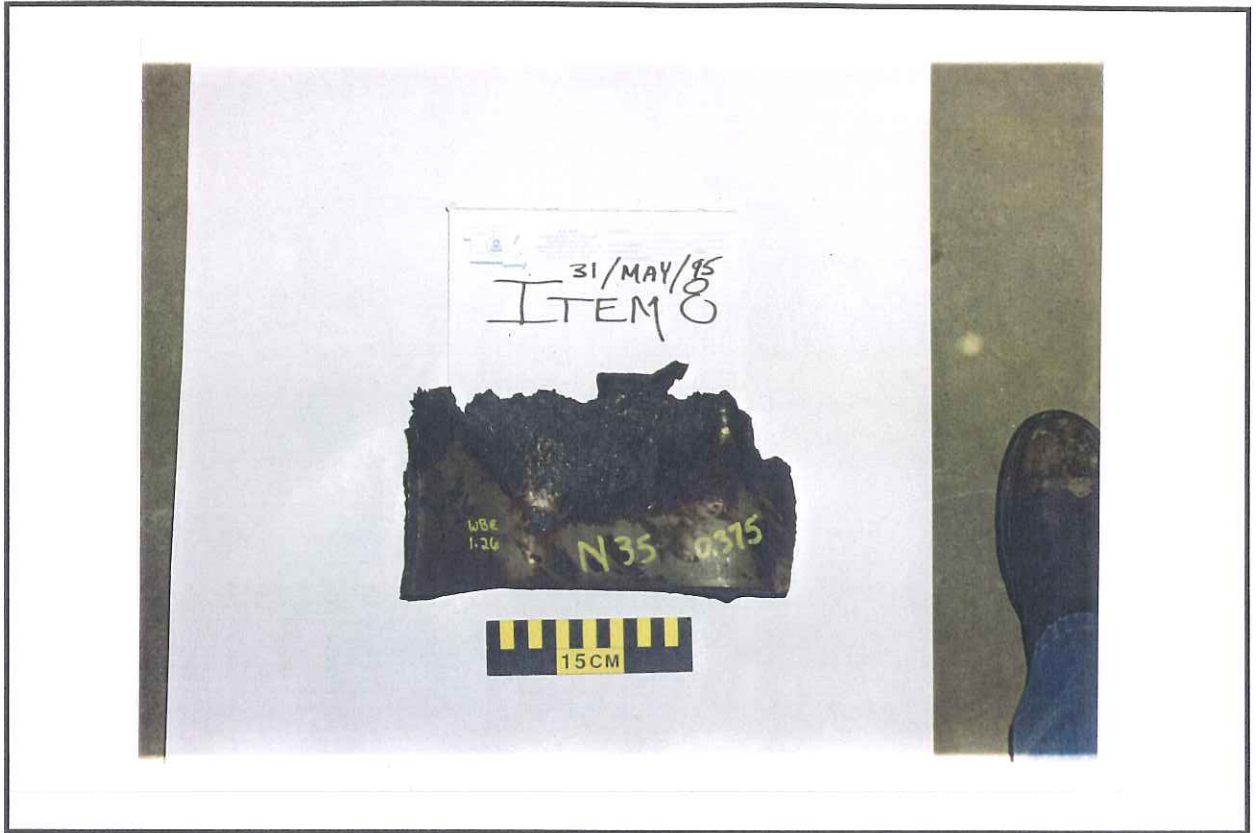
Photo 7 - 2  
Neutralizer Fragment

Metallurgical analytical results indicated that the fragment displayed a high-temperature discolored surface and severe erosion in one direction (*Photo 7-2*). The adjacent area showed little discoloration. The opposite surface exhibited severe tearing and fracturing with evidence of high-temperature discoloration (*Photo 7-3*). Unetched cross sections exhibited high-temperature oxidation on the inside diameter with severe surface tearing/seams or laps. The etched cross-sections displayed evidence of severe surface movement and cold working with a one-directional heavy force. Of the fragments analyzed, metalographic analysis suggests that the highest temperature, internal pressure and velocity was located in the area of Item #8. This sample exhibited the most severe surface distortion and high-temperature grain structure change.

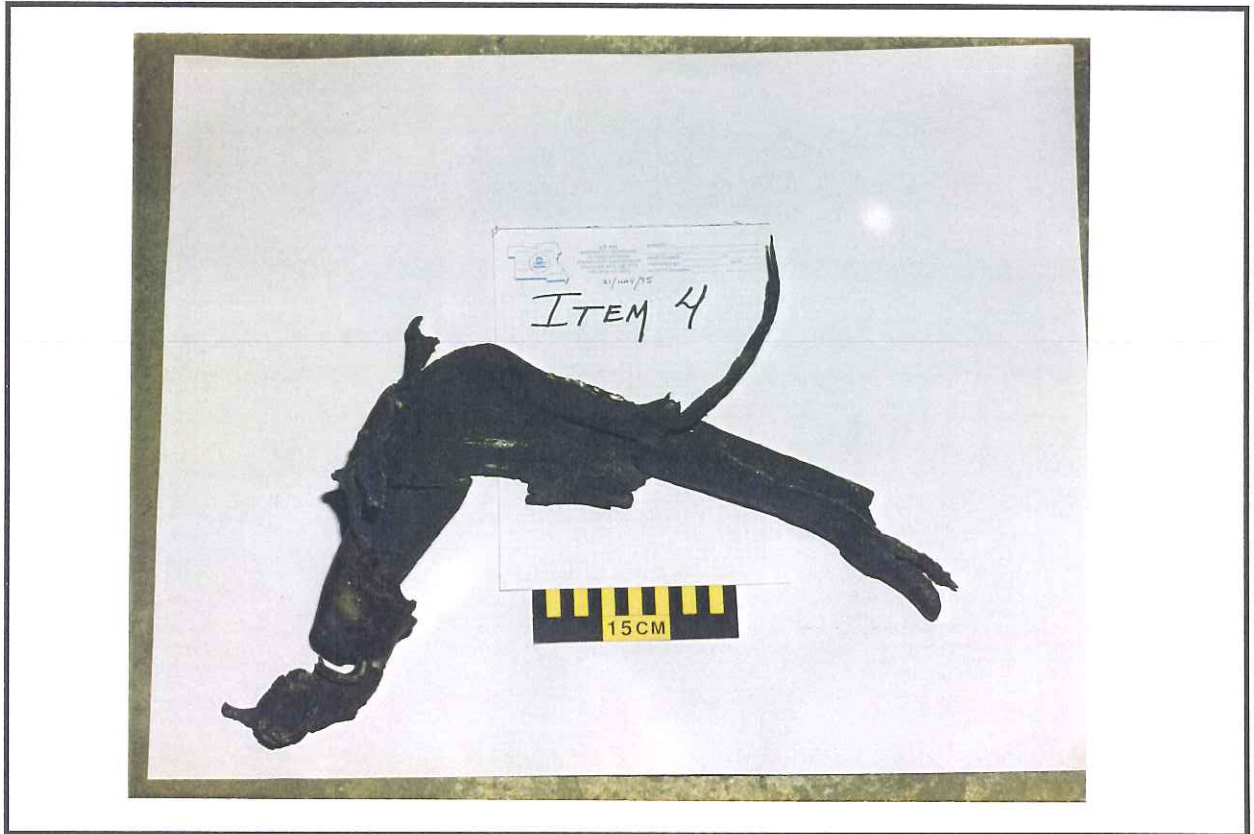
**Photo 7 - 4**  
**Sparger Fragment**

2. EPA Item #4. This fragment was described as originating from the titanium sparger, and had been severely twisted (*Photo 7-4*). The titanium fragment exhibited a dark-colored surface with numerous areas indicating high-temperature oxidation. The interior and exterior surfaces displayed numerous mechanical damaged areas and no excessive thinning.
3. EPA Item #17. This fragment was described as originating from the titanium sparger, and displayed the same characteristics as all titanium fragments examined. The fragment was severely distorted and exhibited a dark interior and exterior surface.

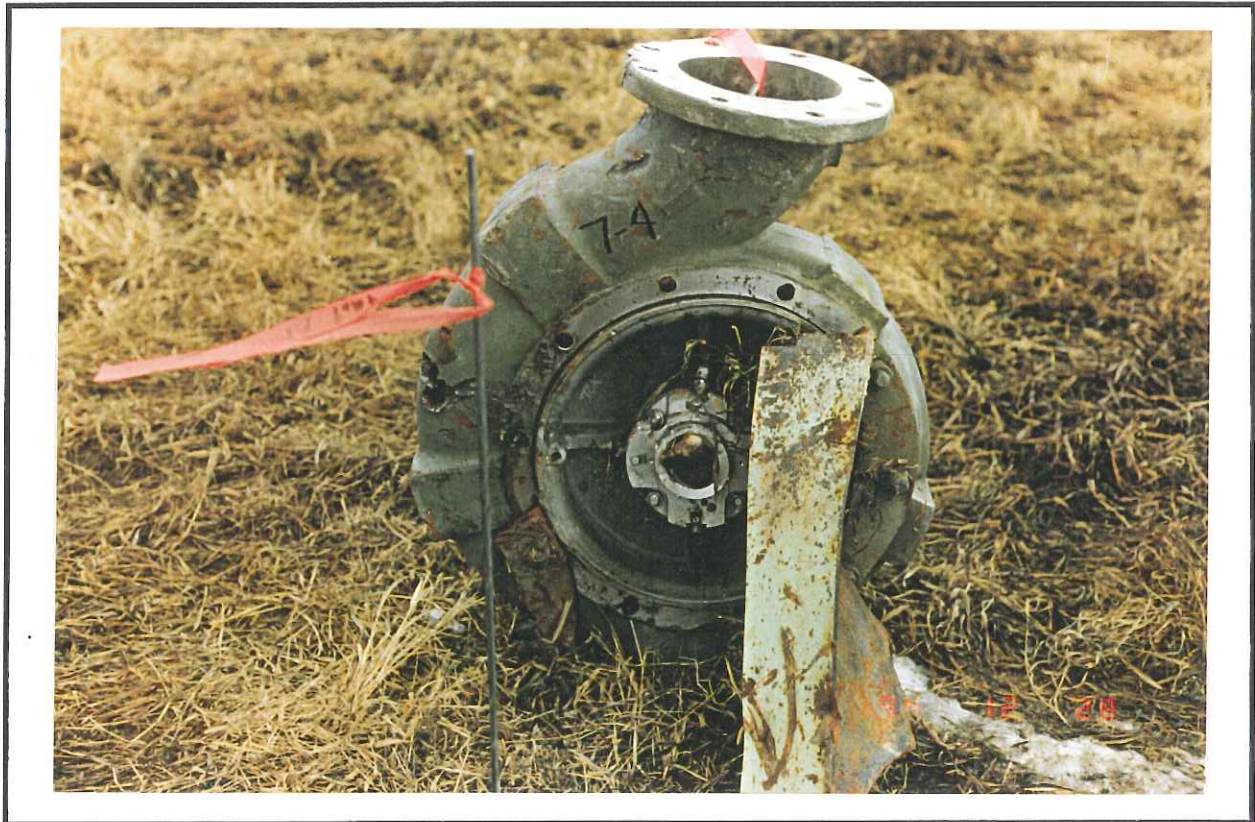
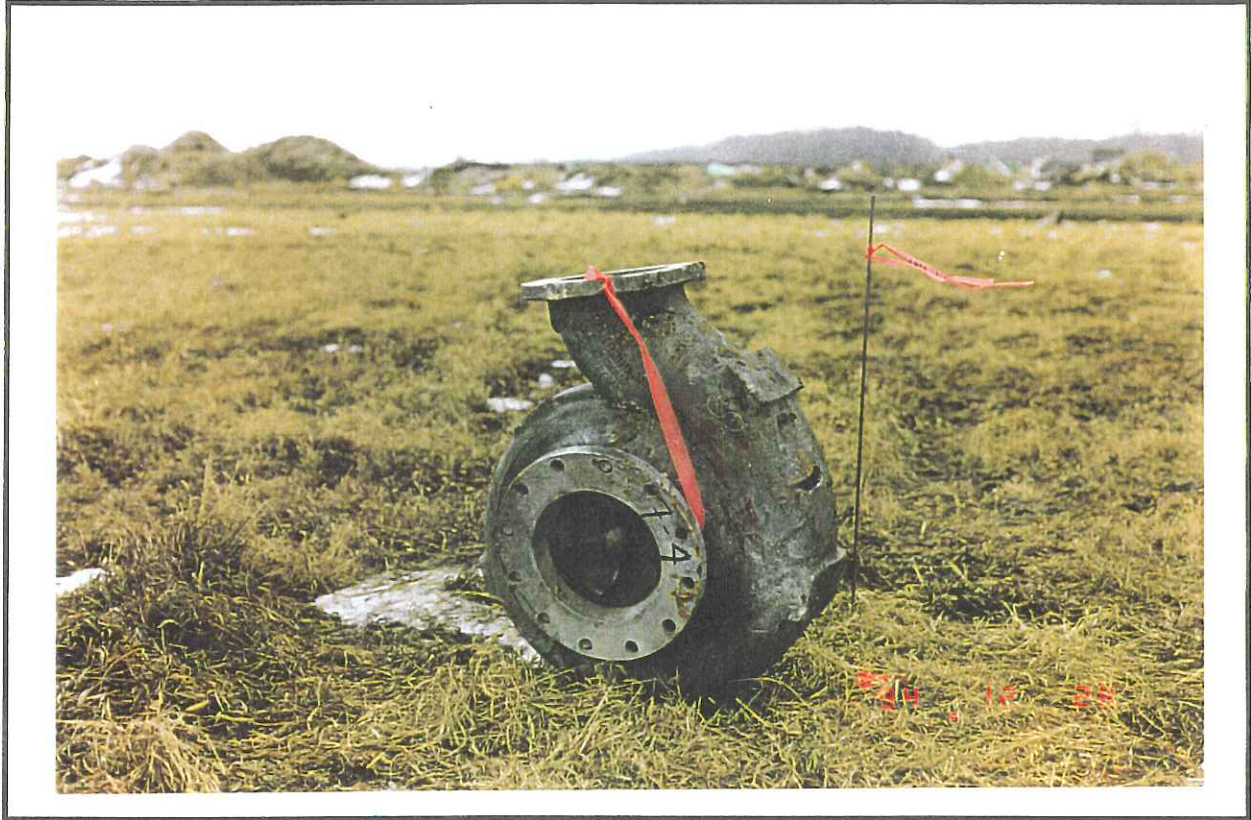
1. The pump casing was intact and located approximately 800 feet northwest of the AN plant as a result of the explosion (*Photos 8-4A and 8-4B*).

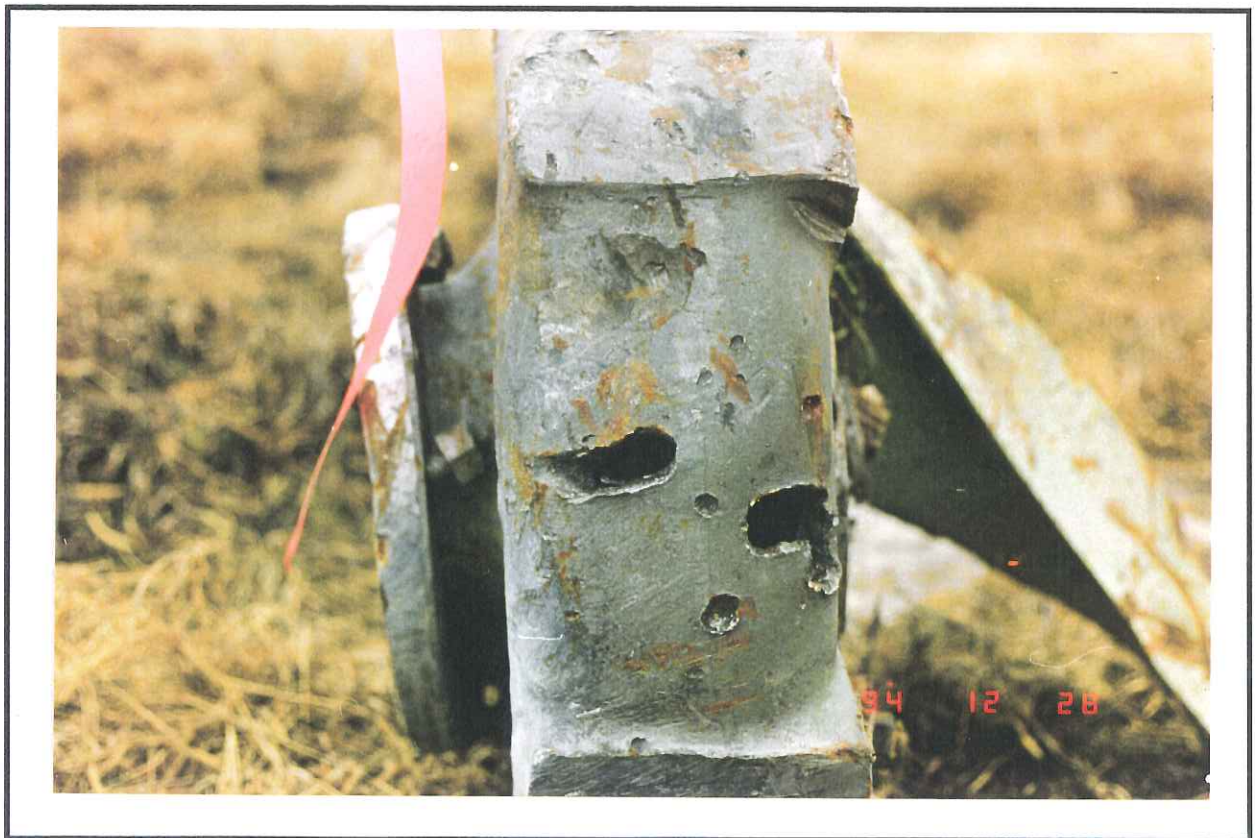
2. Damage to the pump casing included perforations caused by high-energy missiles from outside the pump from the direction of the neutralizer (*Photo 8-5 and 8-6*).
3. Damage to the pump impeller and impeller shaft were consistent with an external force from the direction of the neutralizer.
4. Metallurgist's inspection of the pump failed to reveal any evidence of heating or deformation from internal pressures (*Photo 8-7 and 8-8*).

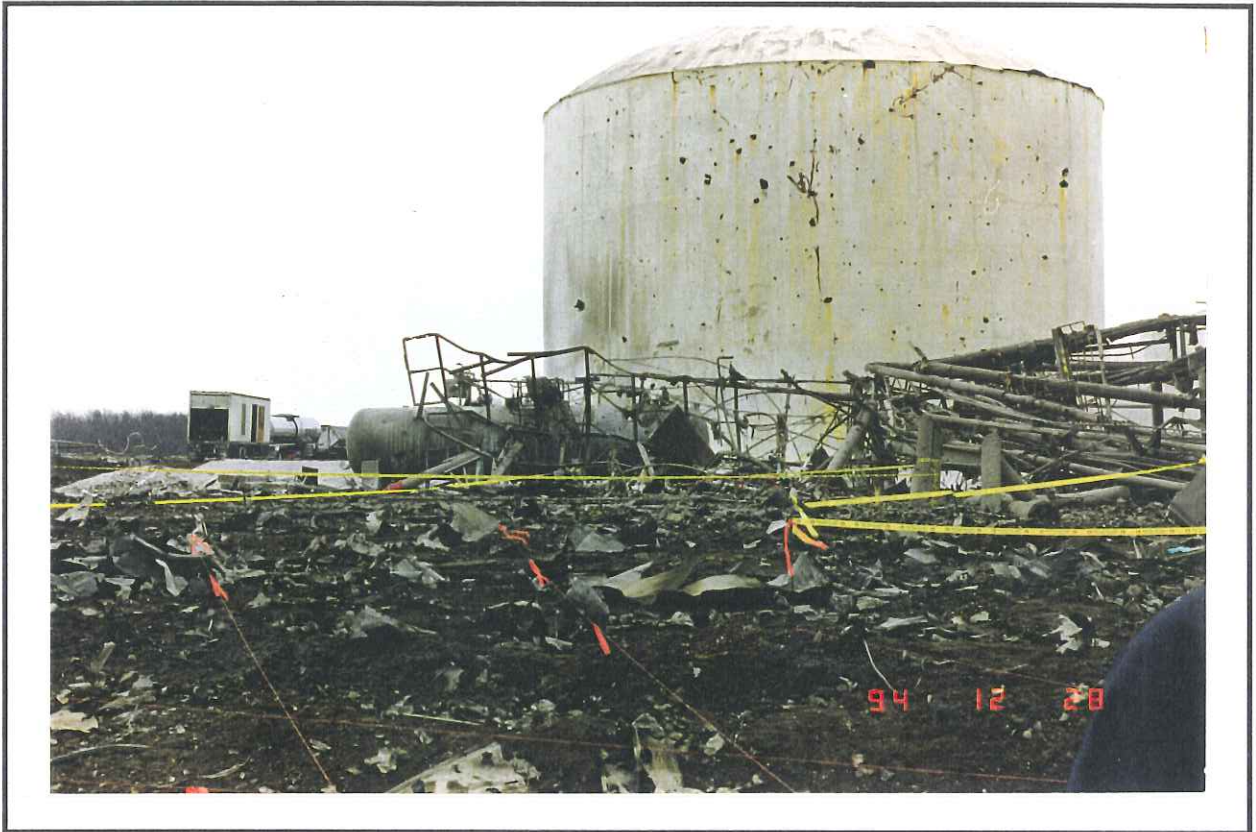
**Photo 8 - 12**  
**Water Tank Damage (Ammonia Tank Background)**

1. Reverse trajectory sighting of damage to a nearby water tank (*Photo 8-12*) and the ends of two pressure ammonia vessels (*Photo 8-13*) indicated that the neutralizer was the source of the penetrating fragments.
2. Reverse trajectory sighting of reinforcing bar angles, anchor bolt directions, and prill tower footing bolts and pads converged on the original neutralizer site.
3. Reverse trajectory sighting of a chemical stripper originally located near the AN plant indicated the explosion origin to be along a line that intersected with the original neutralizer site (*Photo 8-14*).
4. Reverse trajectory sighting of scrubber sections and the ammonia vaporizer indicated the explosion origin to be along a line that intersected the original neutralizer site.

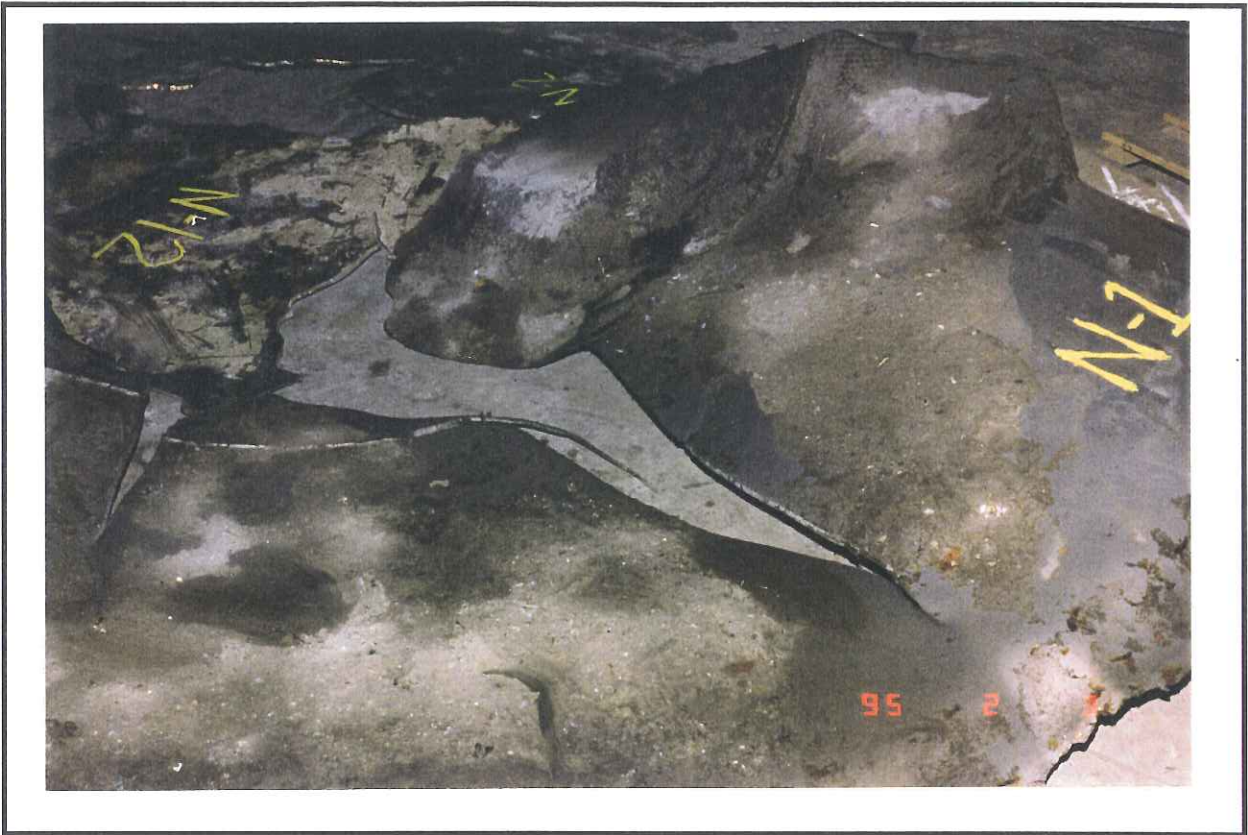
**Photo 8 - 15**  
**Neutralizer Base Fragments**

5. Visual analysis of recovered neutralizer pieces indicated that a deflagration had originated inside the vessel, and none of the pieces examined exhibited impacts from external missiles (*Photo 8-15*).
