EPA/OSHA JOINT CHEMICAL ACCIDENT INVESTIGATION REPORT

Napp Technologies, Inc.
Lodi, New Jersey

Executive Summary/Overview

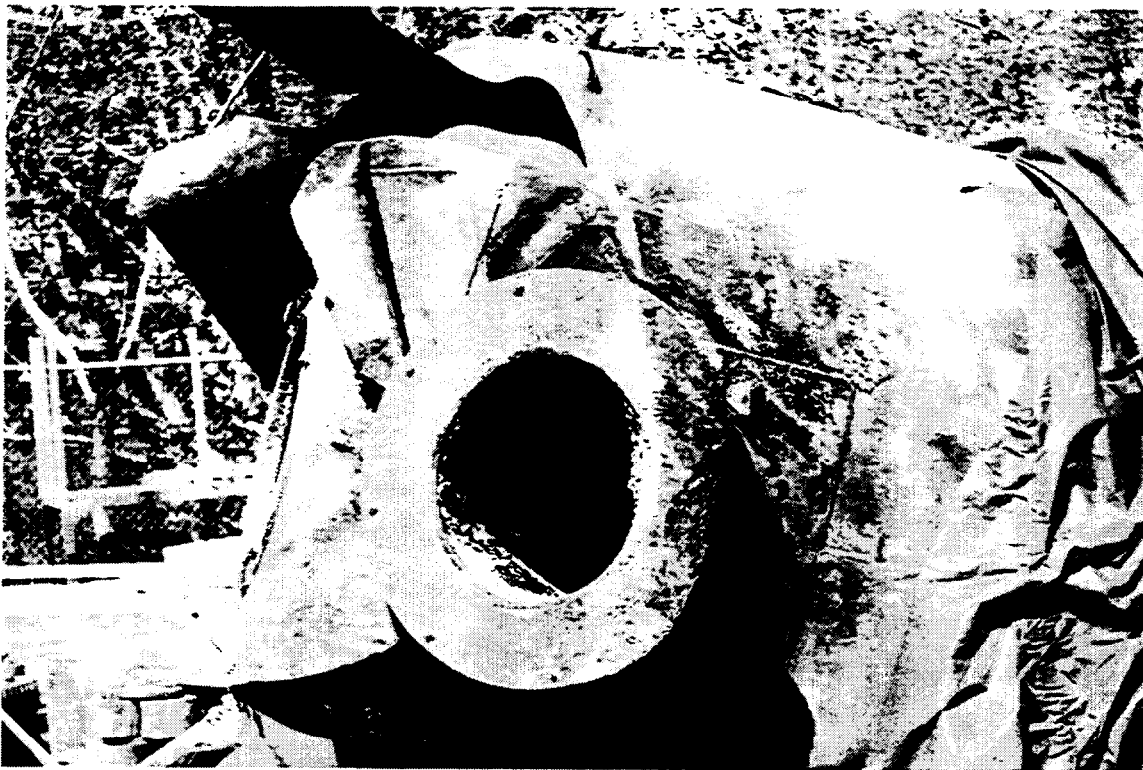
Figure 9: The general condition of the 125 cubic foot blender: a) the top access ports and damaged insulation jacket, and b) the flange to which the belt drive attaches.

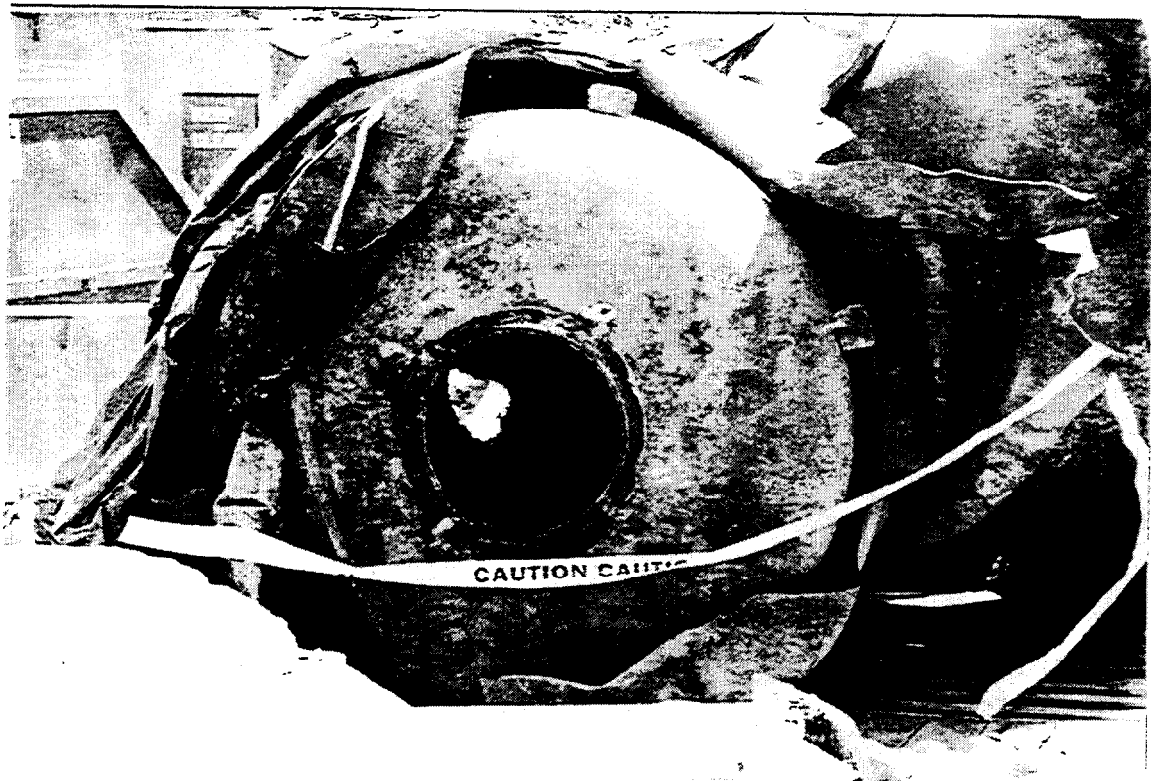
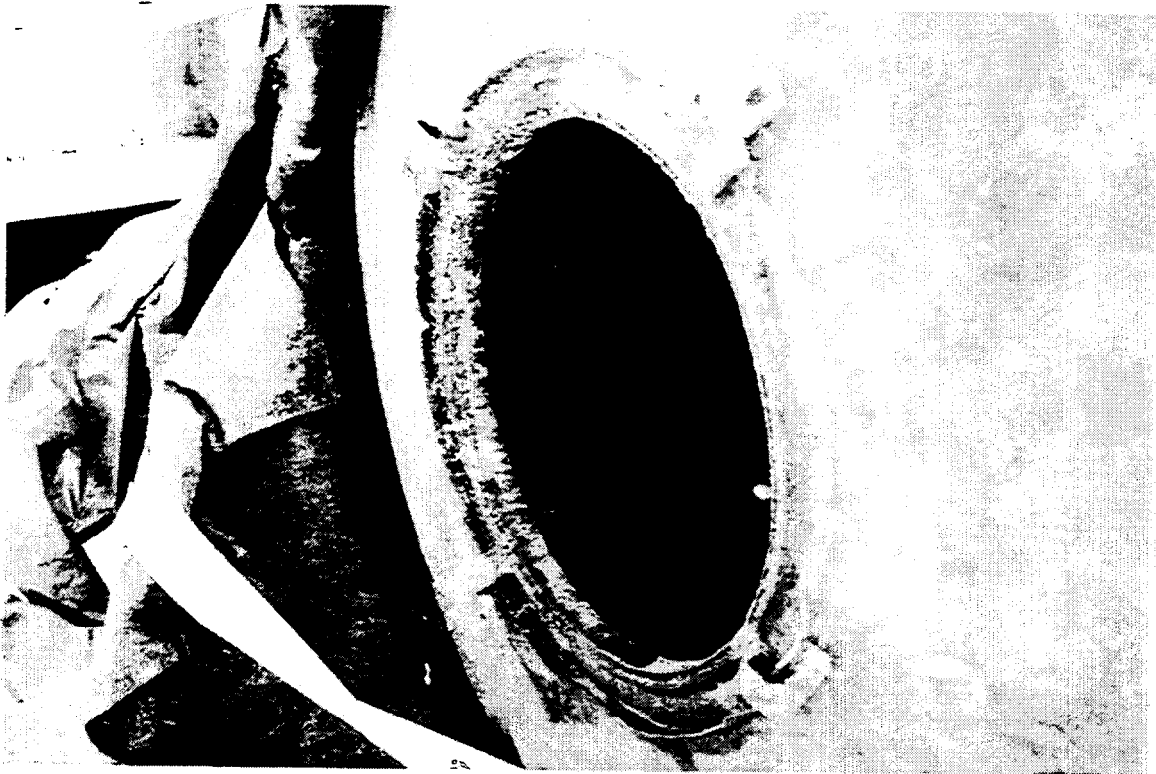
Figure 10: Top access port: a) looking through a top port and out the bottom off-load port, and b) close-up view of a top port.

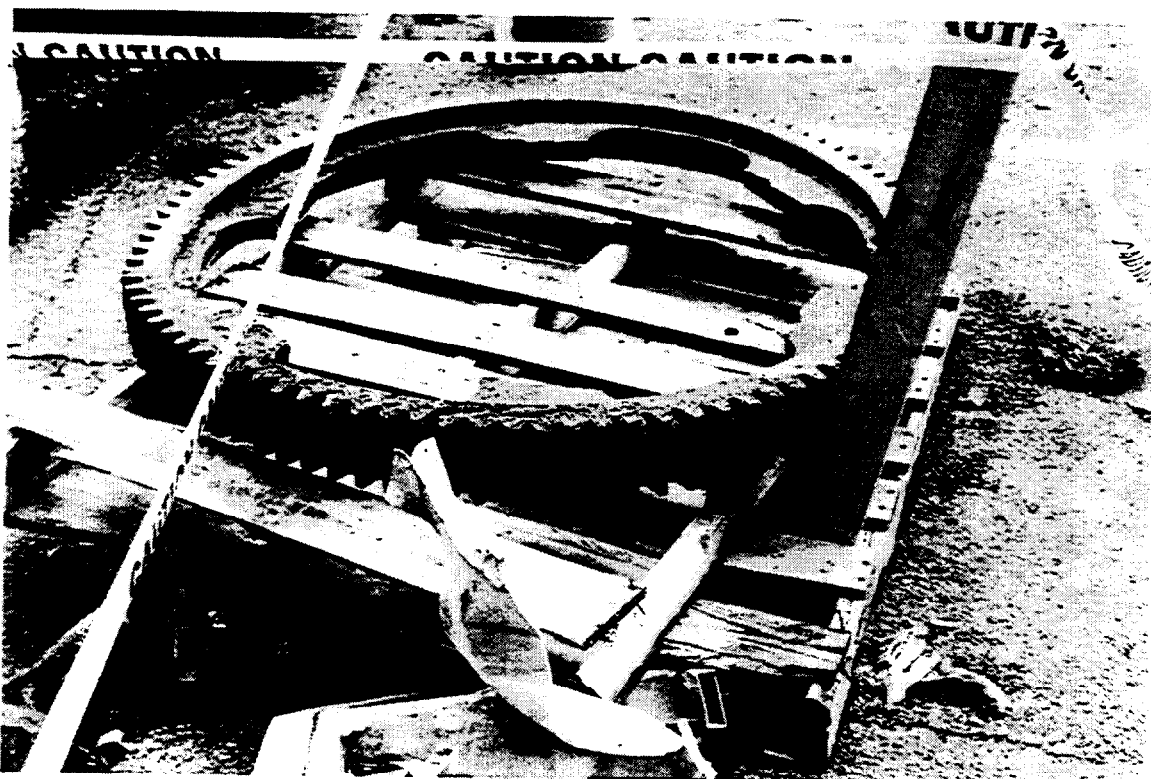
Figure 16: The gear drive side of the blender: a) the shaft (drive side) and b) the portion of the gear that fractured and separated from the blender in the accident.

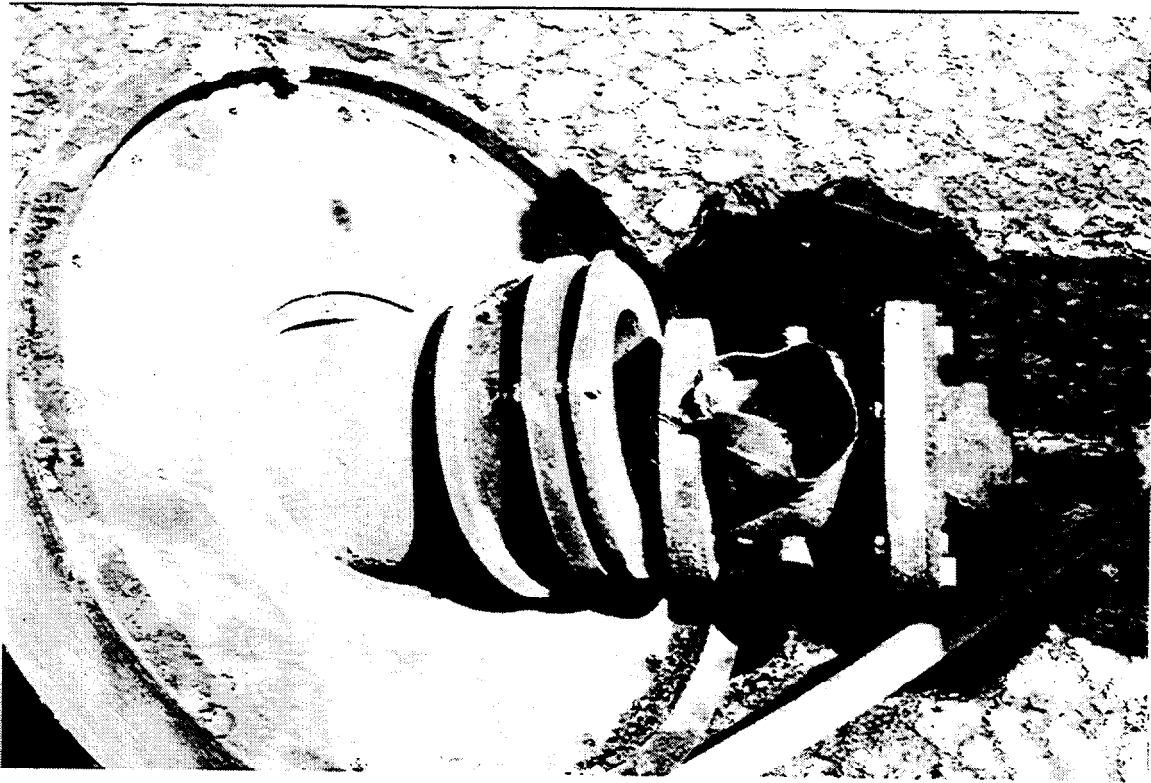
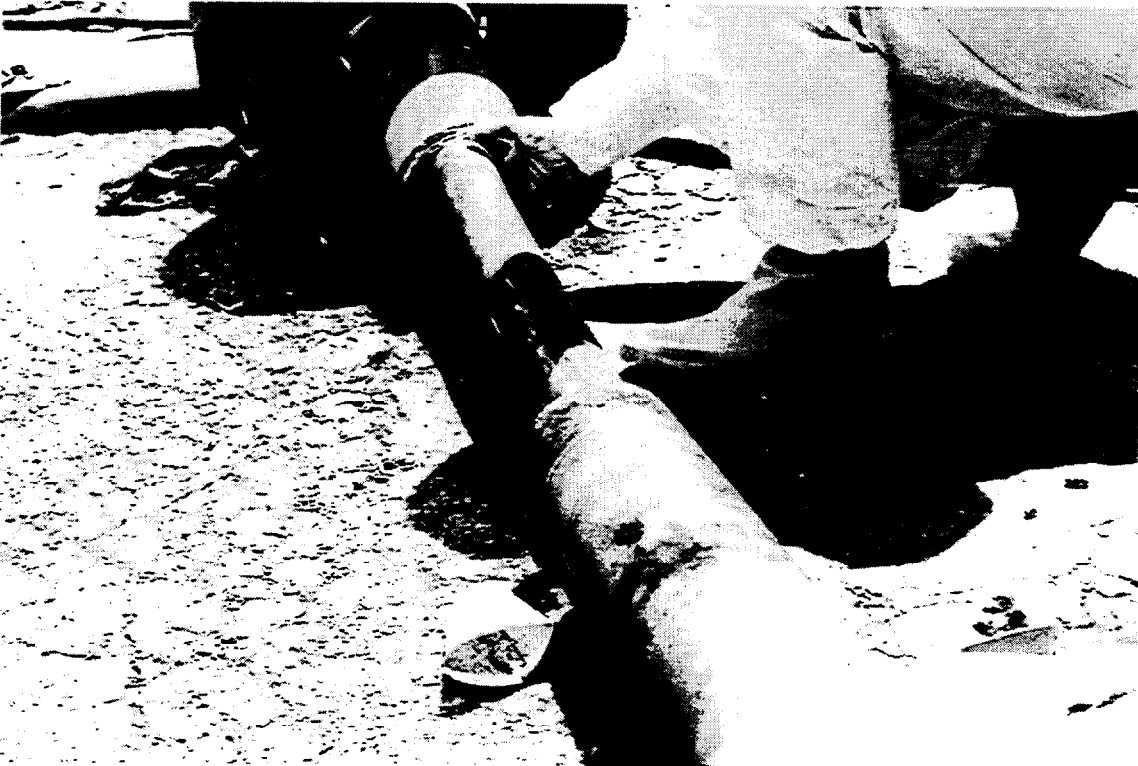
Figure 20: The wheel that supported the blender on the belt drive side and the shaft components: a) the wheel and shaft, b) the concentric shafts and tube that went into the interior of the blender.

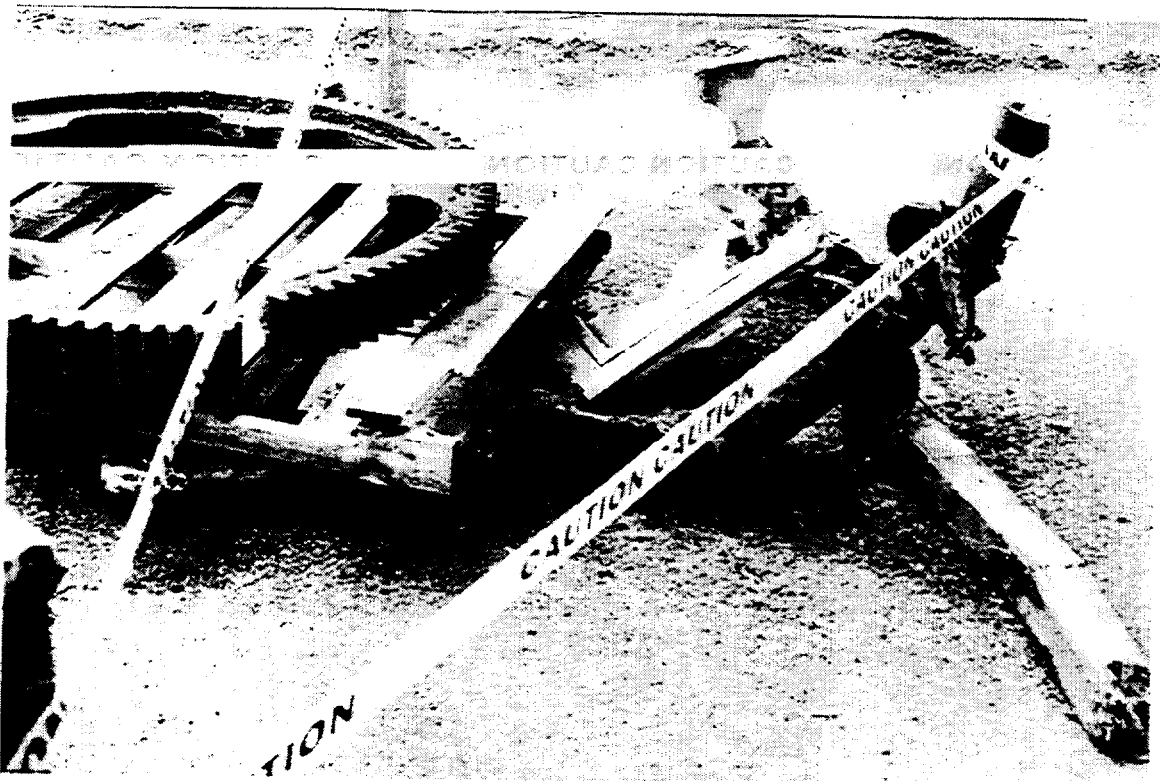
Figure 23: The intensifier bar: a) the shaft of the bar is severely deformed, b) two of the mixing plates are left, both are broken away from the shaft.

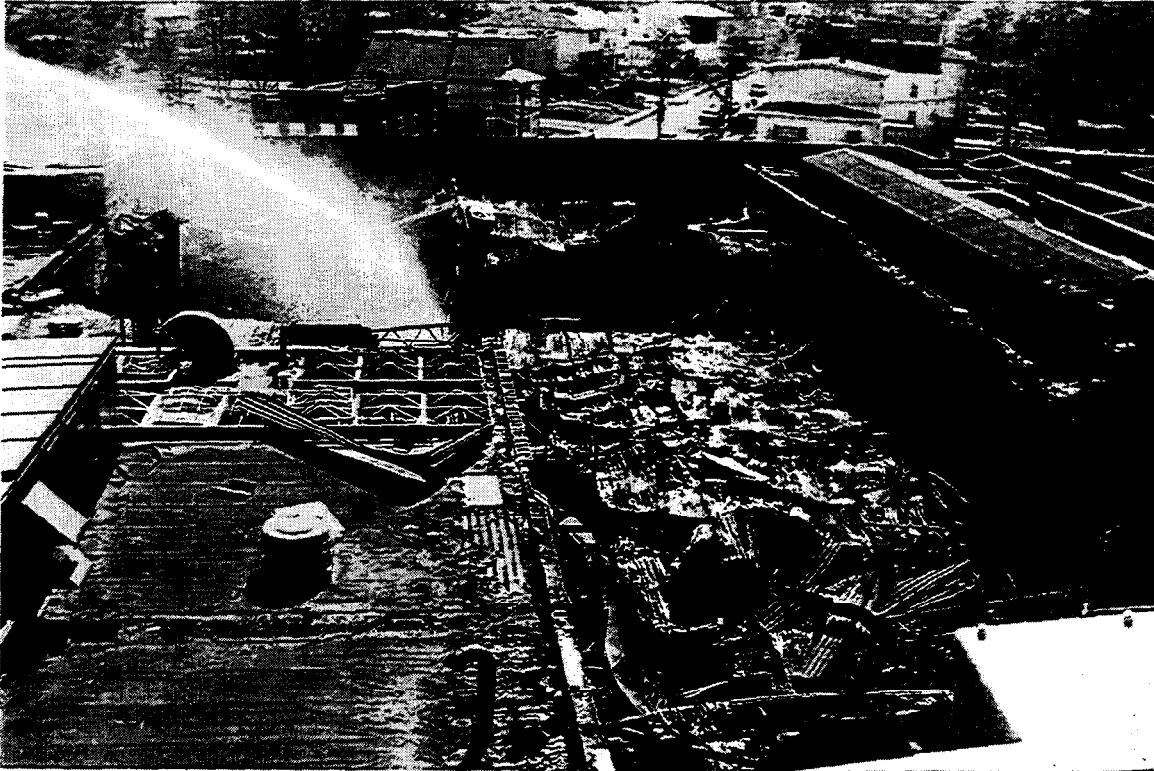
Figure 24: The Napp facility after the explosion and fire showing location in the plant where the processing took place and the location of the facility with respect to residential area in background.
