EPA CHEMICAL ACCIDENT INVESTIGATION REPORT

**Powell Duffryn
Terminals, Inc.
Savannah, Georgia**

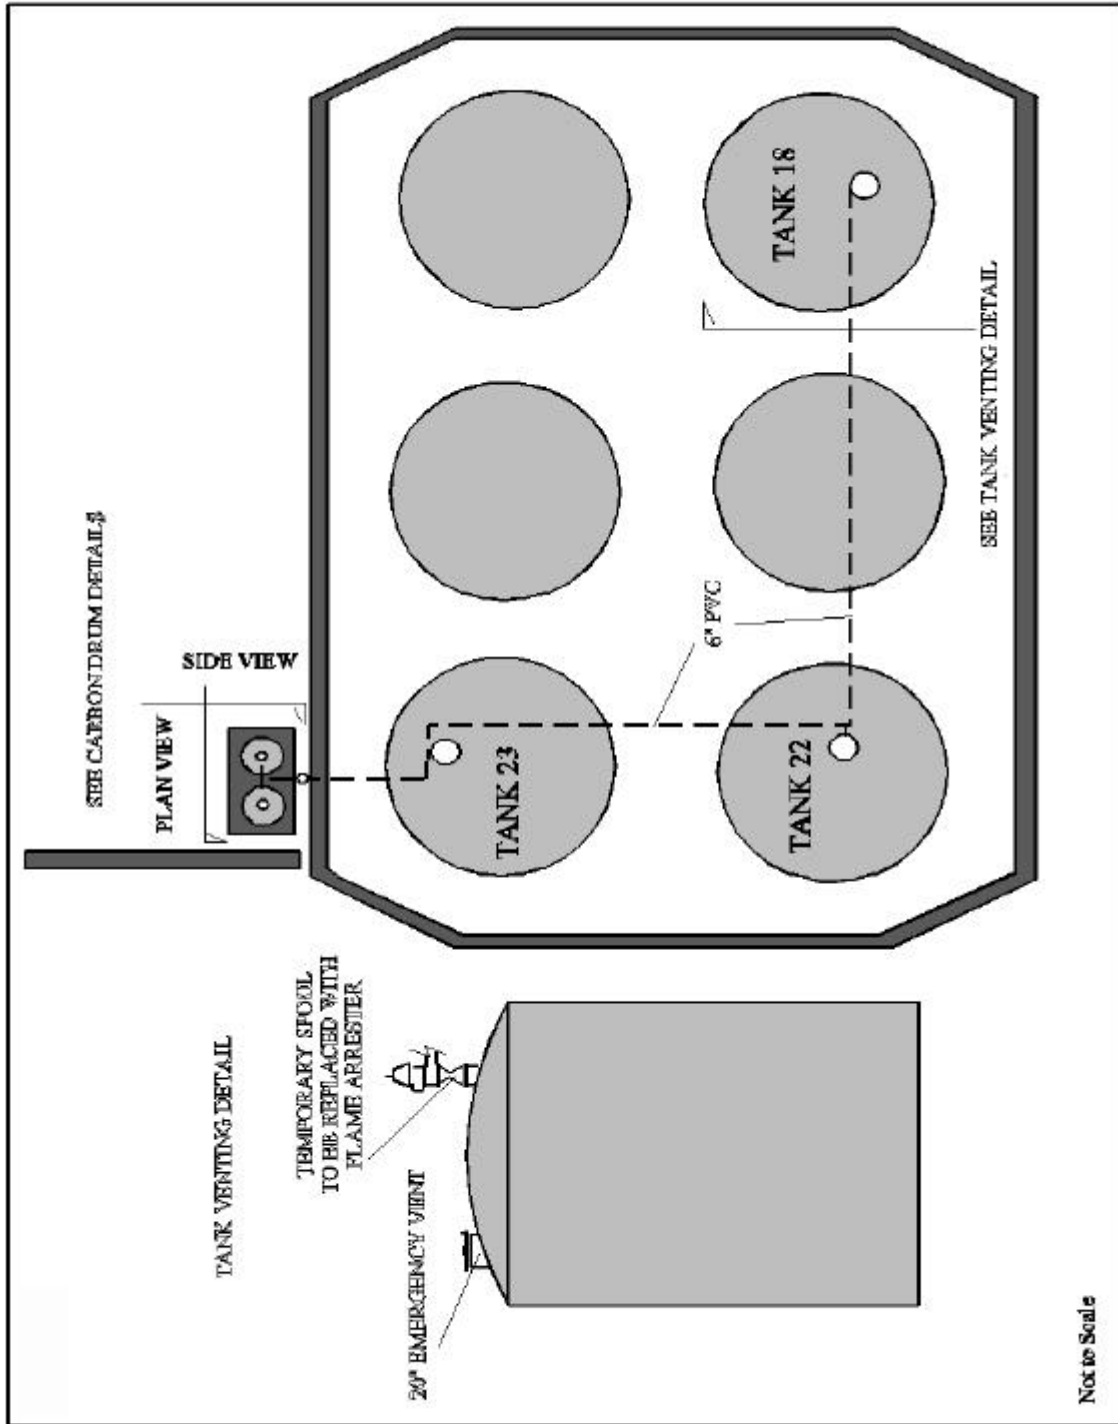
Exhibit 3. Vapor Control System

The system consisted of two metal drums (50-gallon size) containing activated carbon used for absorbing CST vapor, polyvinyl chloride (PVC) piping connecting the drums to the three flame arresters, and three pressure release vents located on the storage tanks.²⁵ It was intended that vapor from the tanks would travel through the flame arresters to the PVC piping that was mounted to existing cat walks and enter two drums of activated carbon located at ground level just outside of the enclosure area. Each tank was supposed to be equipped with a

flame arrester at its connection to the PVC pipe; however, at the time of the accident, the flame arresters were not installed. The VC system was in place, with the exception of the flame arresters, for more than a month before the accident. Piping “spools” (small fixed sections) were installed in place of the flame arresters. (However, the system was not completely closed to the atmosphere until the last foamer was installed and sealed at 2 p.m. on the afternoon of the accident - see below.)

Although the temperature of the activated carbon may have become hot when CST vapor was vented from the storage tanks to the carbon drums, the low level of oxygen present in the drums probably averted a fire. However, the VC system did not have a bypass for preventing outside air from being drawn into the drums when cool outside temperatures caused vapor in the storage tanks to contract. The introduction of air provided the needed oxygen to trigger a fire.

The VC system was designed without electrical grounding for the drums containing activated carbon. The metal drums were connected to the storage tanks by non-conducting PVC pipes. This permitted possible development of differences in electric potential between the drums containing activated carbon and the CST storage tanks. A spark in the PVC pipe resulting from static discharge could possibly ignite the CST vapor and trigger a vapor explosion and fire. However, the weather conditions at the time of the fire, low wind speed and high humidity, make this an unlikely possibility.

- Facilities using activated carbon systems, in conjunction with vendors or recognized experts, should conduct tests to determine the potential for formation of hot spots, runaway reactions, or other consequences associated with adsorption of vapors on activated carbon and ensure that the hazards associated with the heat of adsorption are identified, well understood, and addressed through safeguards, procedures, or other controls. An evaluation of the potential for, and the consequences associated with, air being drawn into a carbon adsorption system (for example, associated with normal tank breathing) must also be addressed as necessary through safeguards or other controls.

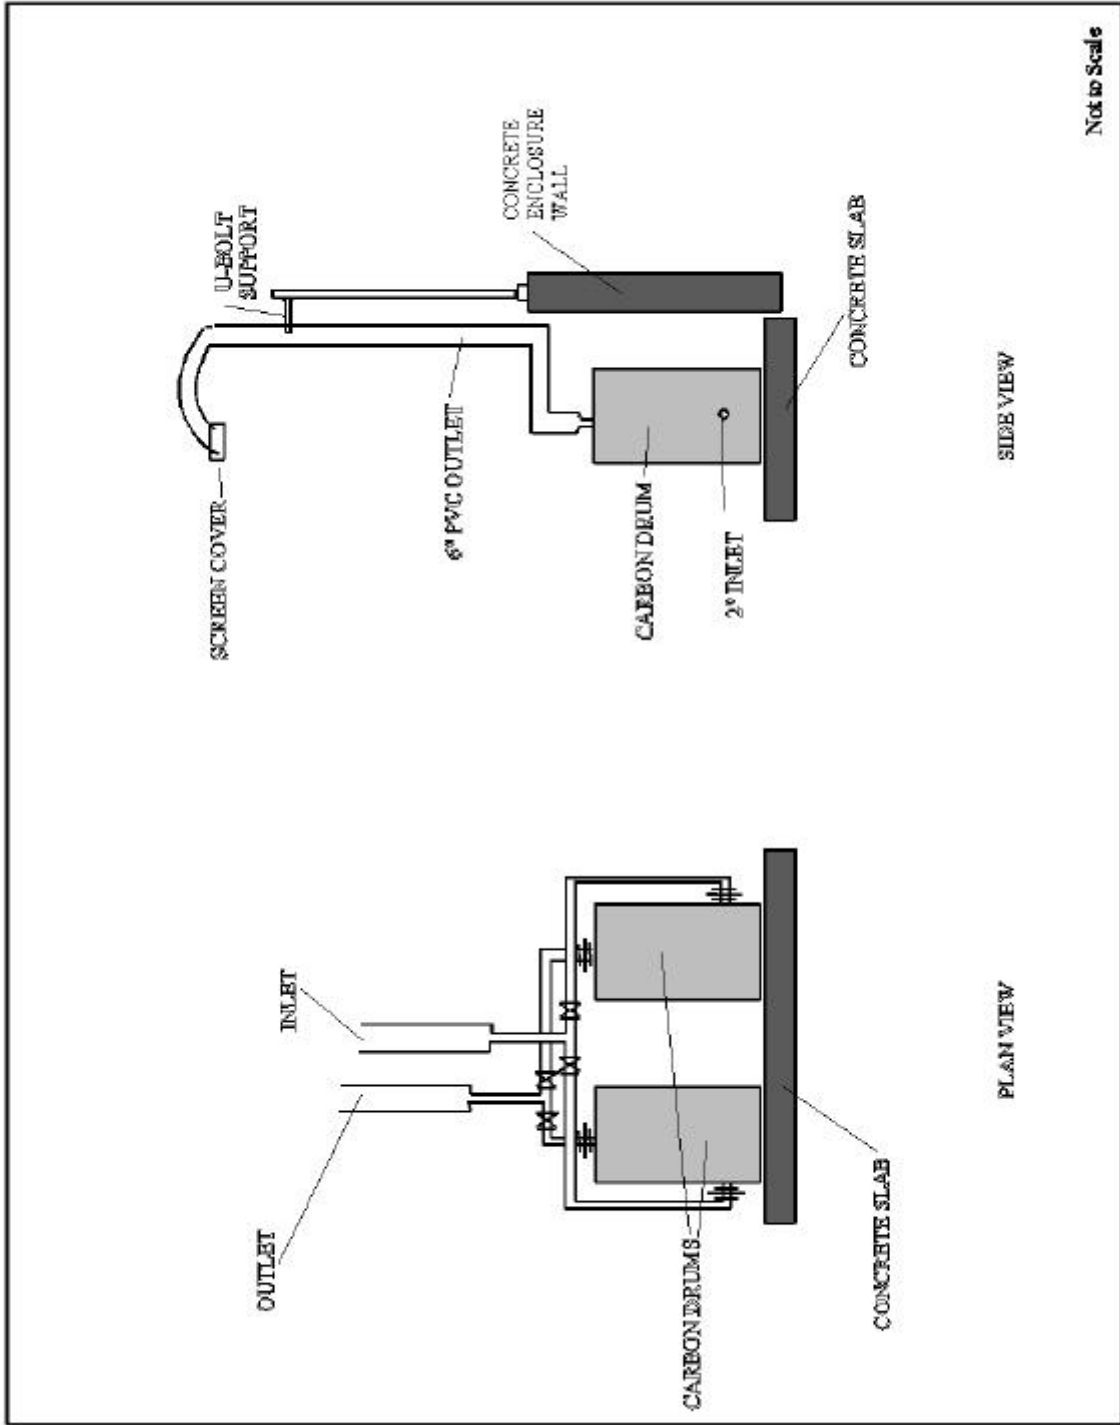
Exhibit 4. Carbon Drums

Product literature from Calgon, the manufacturer of the activated carbon, highlighted the hazards of exotherms (high temperatures) caused by adsorption of organic sulfur compounds, present in CST, onto activated carbon. Heat generated from the adsorption of CST vapor on the activated carbon can raise the temperature in the drums above the autoignition temperature of the CST vapor.

Calgon Carbon Corporation, the manufacturer of the activated carbon, recommended a procedure of wetting the carbon in the drums with water and of re-wetting it periodically thereafter. The evaporation of the water in the drums would prevent the activated carbon from becoming too hot. PDTI reportedly followed this procedure during initial installation. The VC system had been in place for over a month before the accident. However, it was not functioning as designed during this time, since part of the system was open to the atmosphere. During this time, the carbon in the drums could have dried out, even if it had been wetted initially. It is not known if the carbon was rewetted at anytime after initial installation.

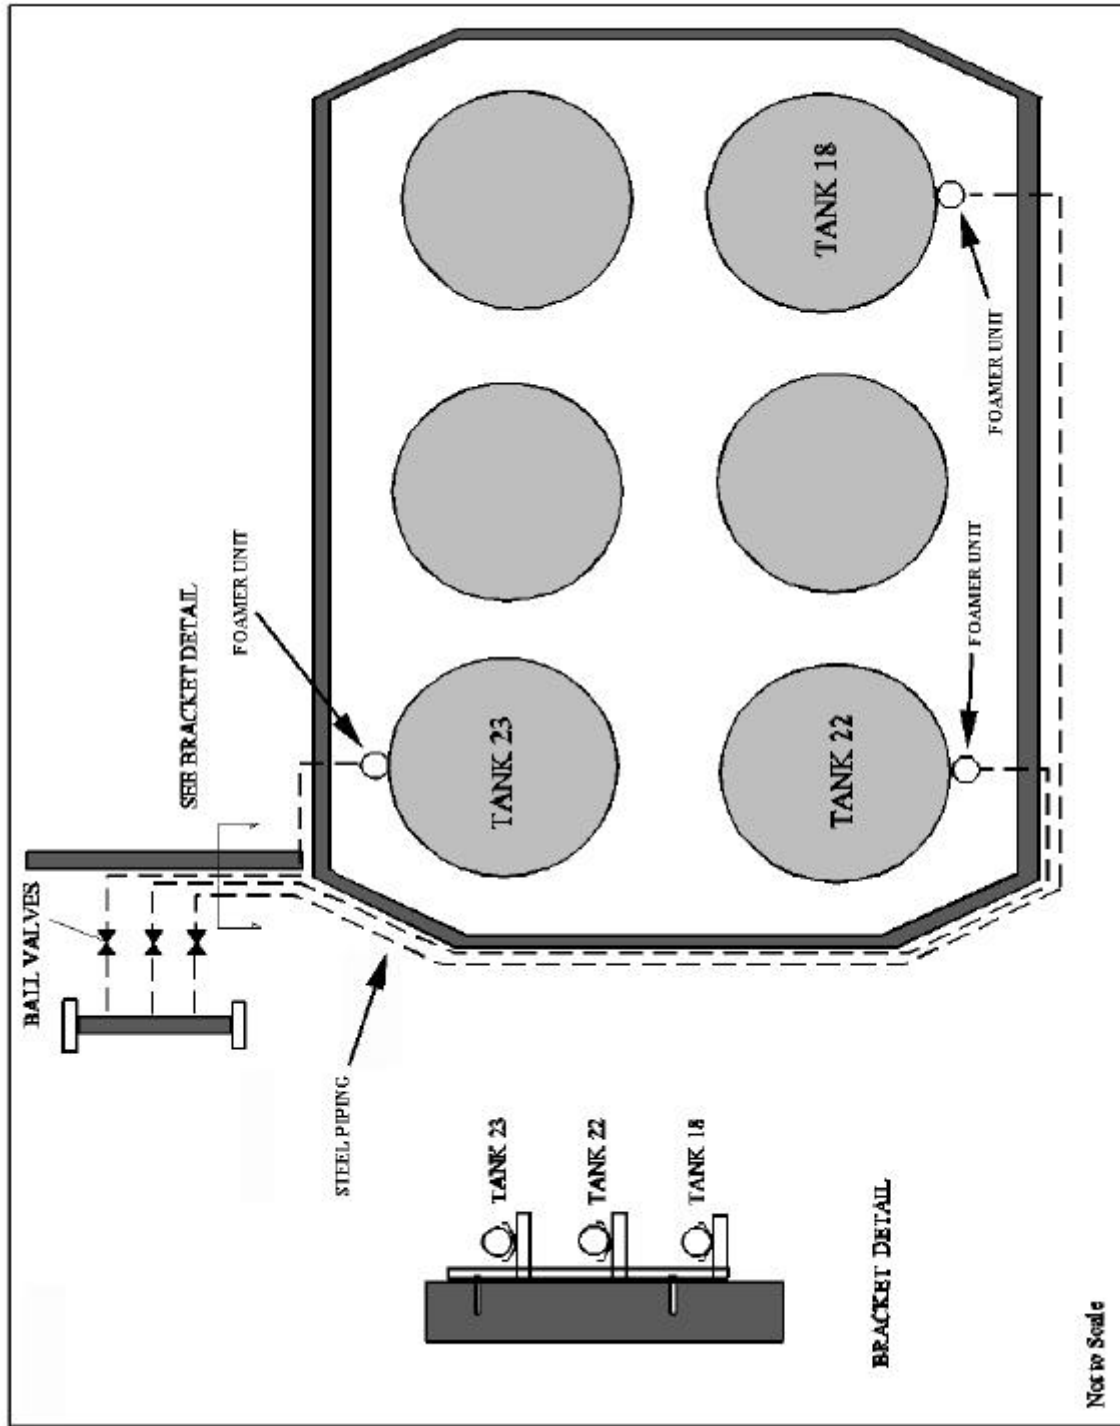
Exhibit 5. Fixed Piping Foam Fire Protection System

- The facility had been broken into and vandalized on two occasions -- two months prior to the fire and two weeks prior to the fire.⁴
- On March 3, 1995, PDTI's contractor began installing the foam fire protection system. The installation of the foam fire protection system had not been completed, and the system was not operational at the time of the fire.^{41, 44}

- The foam fire suppression system was not completed on the tanks containing CST. Foam fire suppression system was included as part of changes to be made for storing flammables. CST storage had begun before modifications were completed. Fire fighters were not able to use the foam pumper connection outside the enclosure area. Fire fighters used water to fight the fire until a connection to the foam pumper could be rigged within the enclosure area. An operational foam fire suppression system could have reduced the amount of time required to suppress the fire and reduce the amount of heat damage to the adjacent storage tanks and limited the amount of runoff from fire water which contaminated sensitive wetland area along the Savannah River.

- Facilities must ensure that equipment for use in handling hazardous substances is equipped with the proper safety devices, and in compliance with national, state, and local fire and hazardous material safety codes and standards before hazardous materials are handled in such equipment. The safeguards, safety devices, or emergency systems designed to prevent or protect the equipment must be in place and fully operational as intended prior to startup of the equipment.

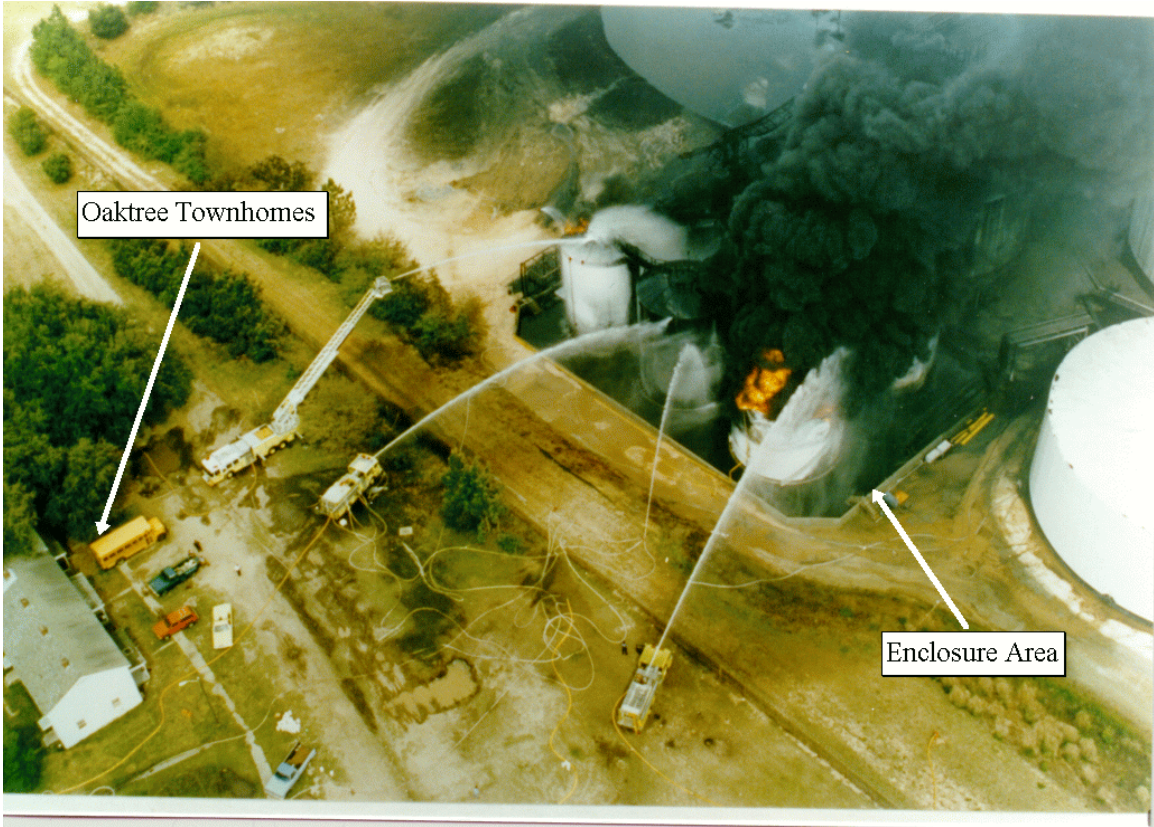
Exhibit 6
Area of Fire and Firefighting Efforts ²⁹

Eventually, firefighters were able enter the enclosure area and connect the foam system to apply foam to the tanks. The fire appeared to be extinguished several times only to reignite because the CST tanks had become extremely hot as a result of the fire. Water was used to cool the CST tanks to prevent re-ignition and protect the adjacent tanks within the enclosure area. However, due to concerns over contamination of marshland and the Savannah River from the overflow of fire water, the use of cooling water had to be limited until the Coast Guard constructed a berm to prevent contaminated water from reaching the river. The Savannah

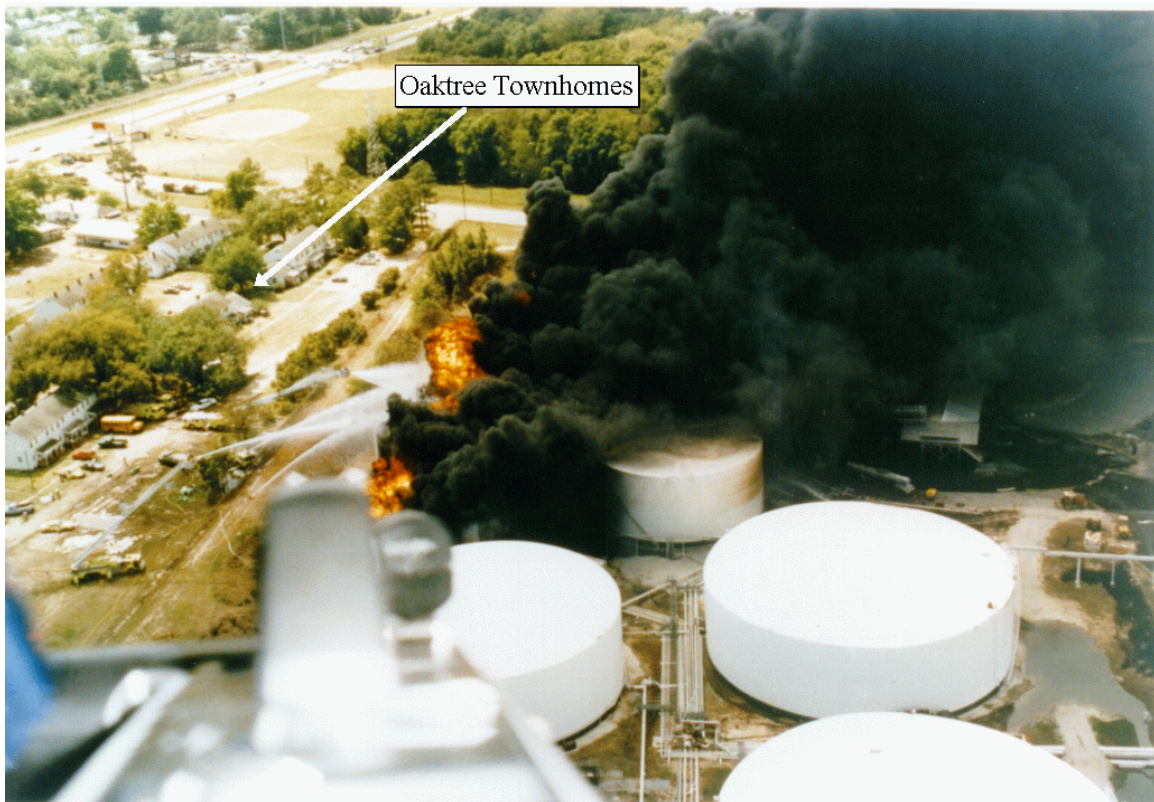
Exhibit 7
Area of Fire and Oaktree Townhomes ²⁹

The intense fire forced the nearby residents of the Oaktree Townhomes complex to immediately evacuate. The fire was sufficiently intense to cause damage to some trees and buildings in the Oaktree complex. The location of the Oaktree Townhomes in relation to the fire can be seen in the photograph in Exhibit 6.^{3, 7, 30, 31}

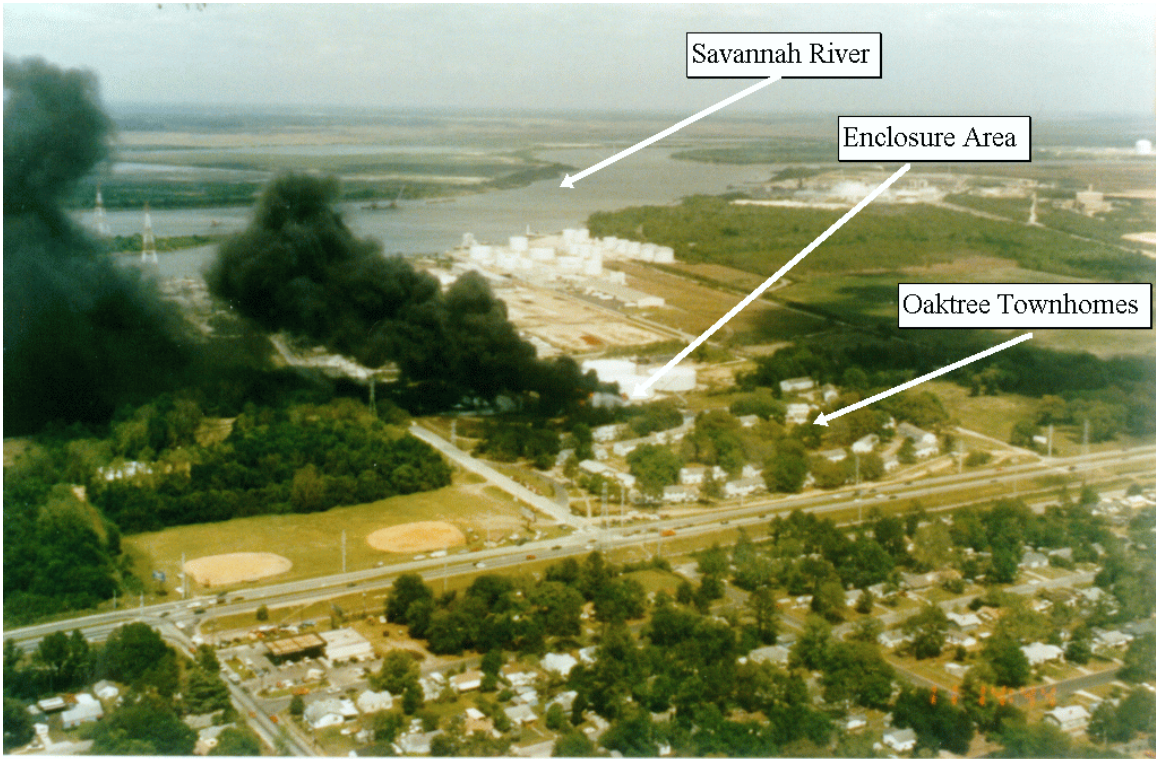
Exhibit 8
Area of Fire and Savannah River ²⁹

River in relation to the fire in the six-tank enclosure area can be seen in the photograph in Exhibit 8. The fire burned on and off for approximately three days before being extinguished late on April 12, 1995.^{3, 30, 31, 32} The three tanks containing CST (18, 22, and 23) were destroyed, and the other three tanks in the six-tank enclosure were damaged. The company's office building, located about 100 yards north of the enclosure, was also destroyed in the fire. Some of the large tanks to the north and east of the enclosure area suffered some degree of radiant heat and smoke damage, but none of them leaked as a result of the damage.⁷ Some of these large tanks are shown in Exhibit 9.

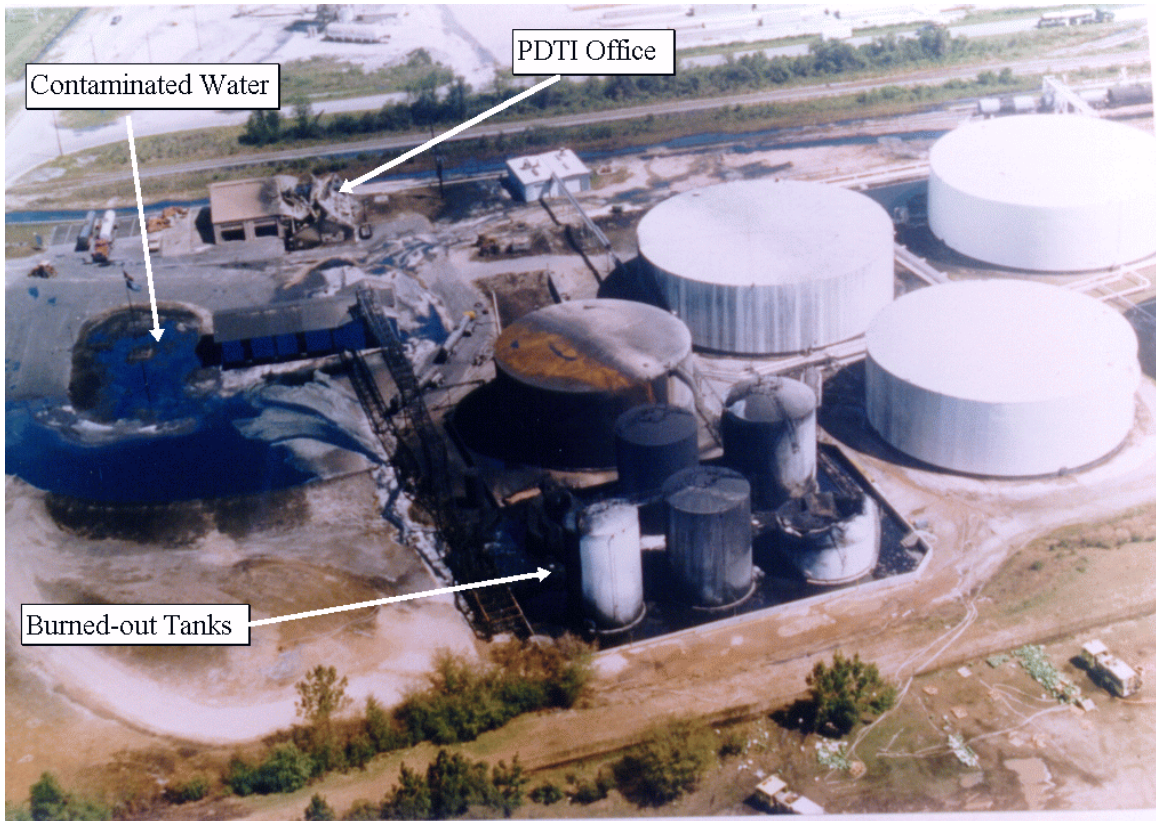
Exhibit 9
Burned-out Tanks and Pool of Contaminated Water ²⁹

The damaged tanks and firefighting effort left approximately 12 million gallons of contaminated water covering an area of about 25 to 40 acres of marsh. The photograph in Exhibit 9 shows the area after the fire was extinguished. A large pool of water that overflowed from the enclosure area can be seen. The contaminated water was determined to be hazardous

because of the high pH and the presence of reactive sulfides that produced hydrogen sulfide. Hydrogen sulfide is toxic, with an Immediately Dangerous to Life and Health (IDLH) level of 100 parts per million (ppm). (IDLH levels are developed for worker protection by the National Institute for Occupational Safety and Health (NIOSH).) Hydrogen sulfide is also flammable, with a flammability range between 4.0 and 44.0 percent. An extensive cleanup of the area was required.⁹

- The concrete wall of the enclosure area failed during the fire, resulting in the release of contaminated water from the firefighting efforts. This contributed to damage to the environment and slowed the fire fighting effort.

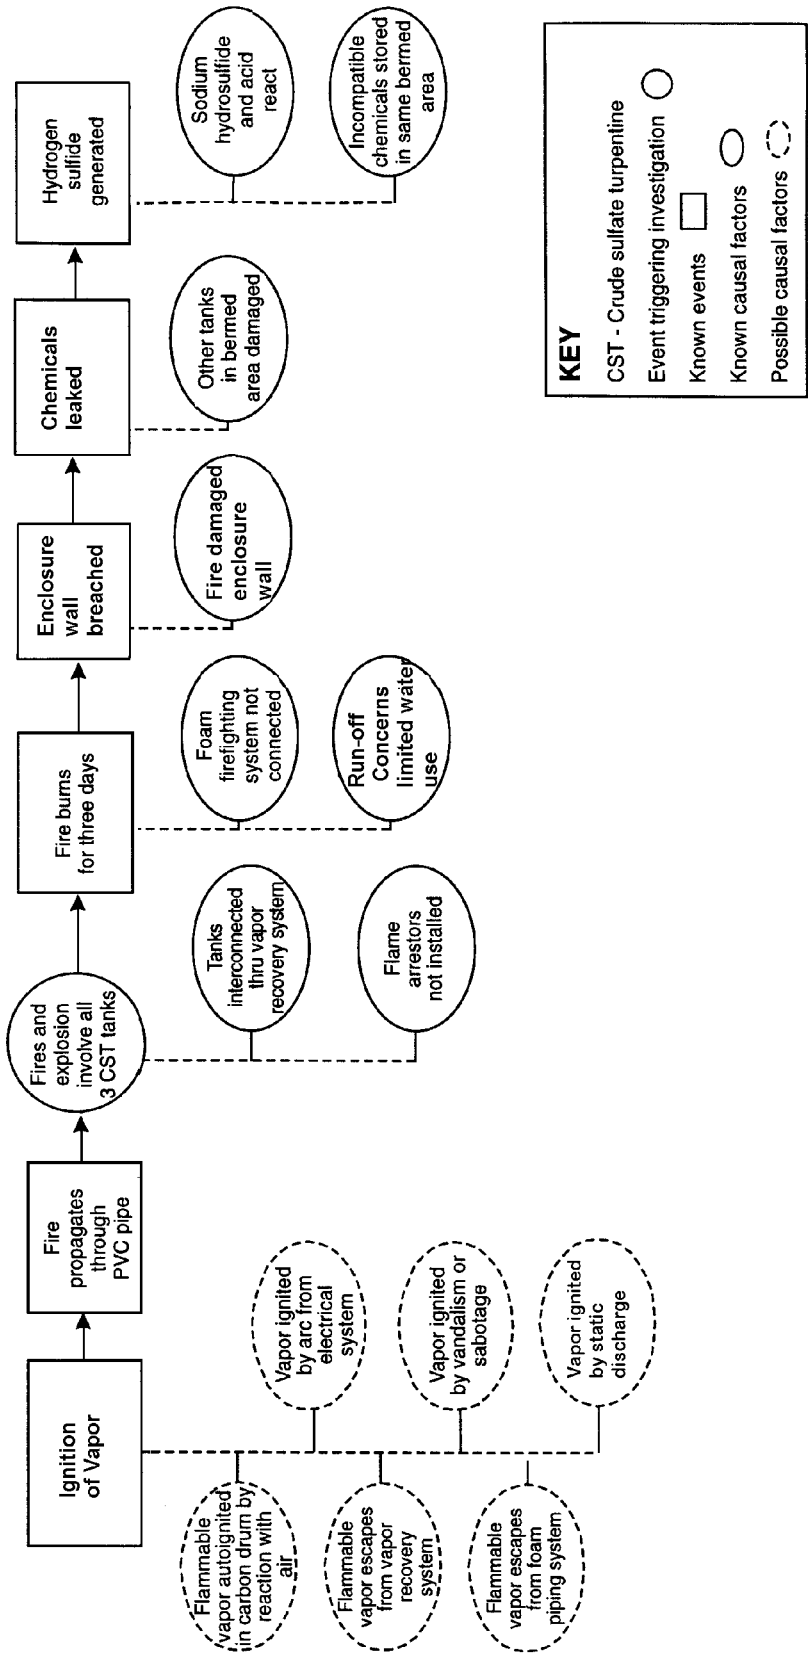
An Event and Causal Factors Diagram for the PDTI accident is presented in Exhibit 10. This diagram presents the sequence of events and causal factors that may have contributed to the occurrence of each of the events. Possible scenarios for immediate cause of the accident, and contributing factors are discussed below. They are included in the Events and Causal Factors Diagram.

Prior to accident:

- CST stored for three months.
- Vapor recovery system, including drums of activated carbon, in place for one month.
- Fixed foam fire protection system partially installed on day of accident.
- Seals installed on foamers on day of accident.
