EPA/OSHA JOINT CHEMICAL ACCIDENT INVESTIGATION REPORT

**Surpass Chemical Co., Inc.
Albany, NY**

Accident Investigation Report
Surpass Chemical Company, Inc., Albany, New York, April 8, 1997

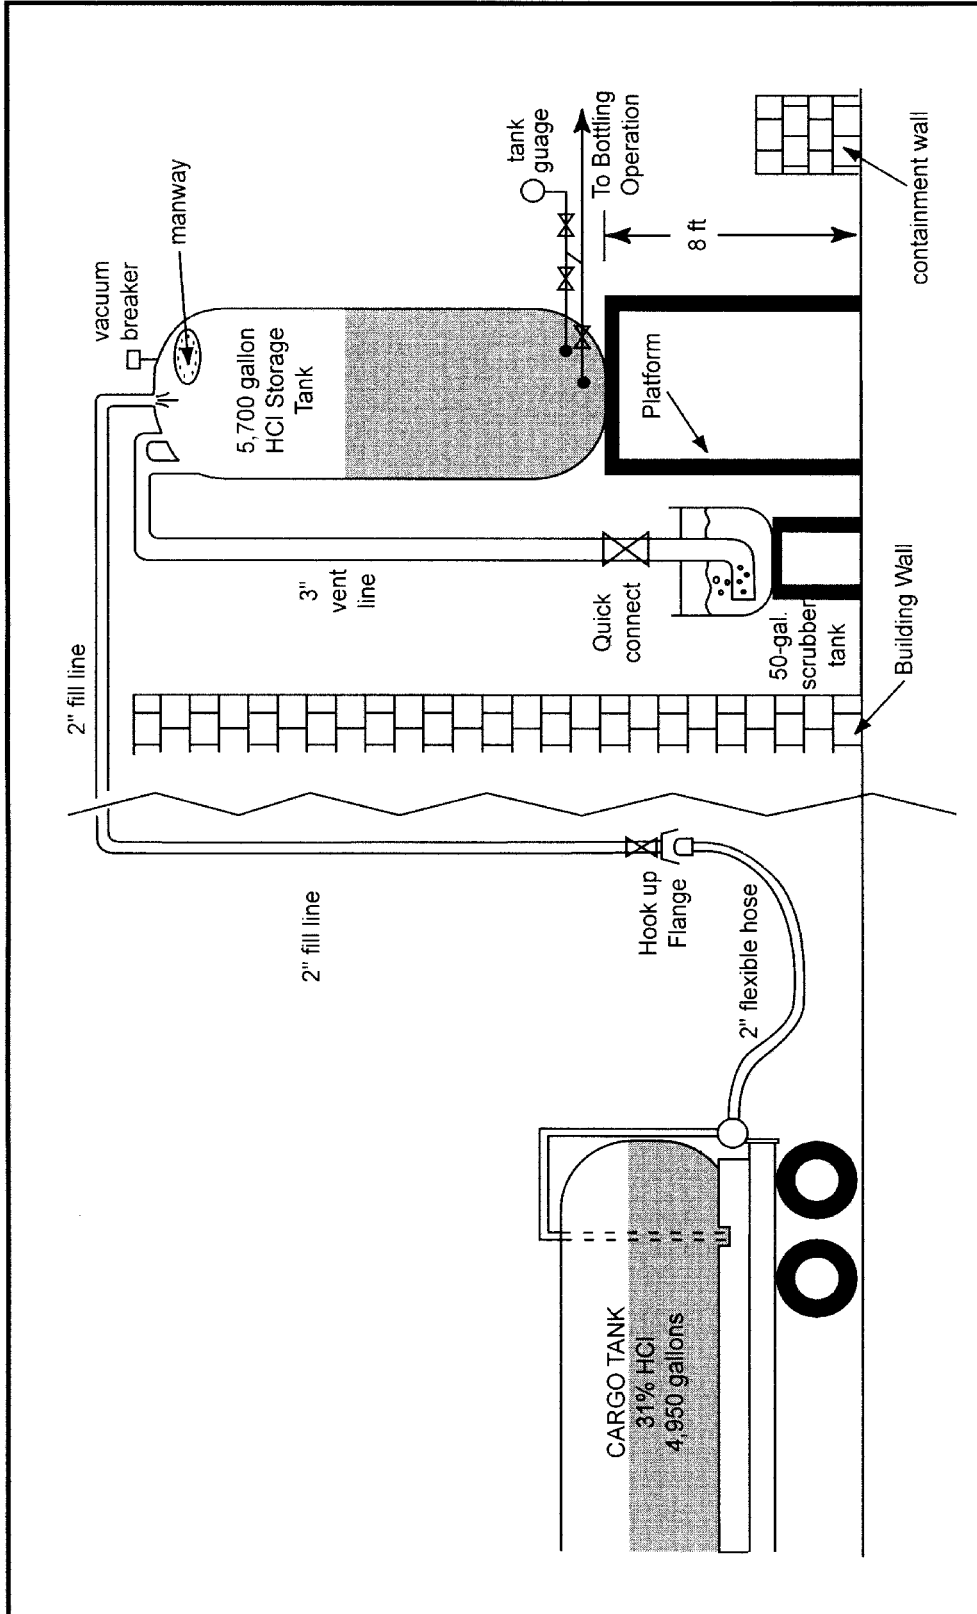
Figure 2: Representation of Offloading Operation
(not to scale)

The diffuser sat in a 50-gallon, loosely-covered plastic drum referred to as the scrubber tank. (The scrubber system is shown in **Figure 2**.) Initially, the tank was filled with sodium

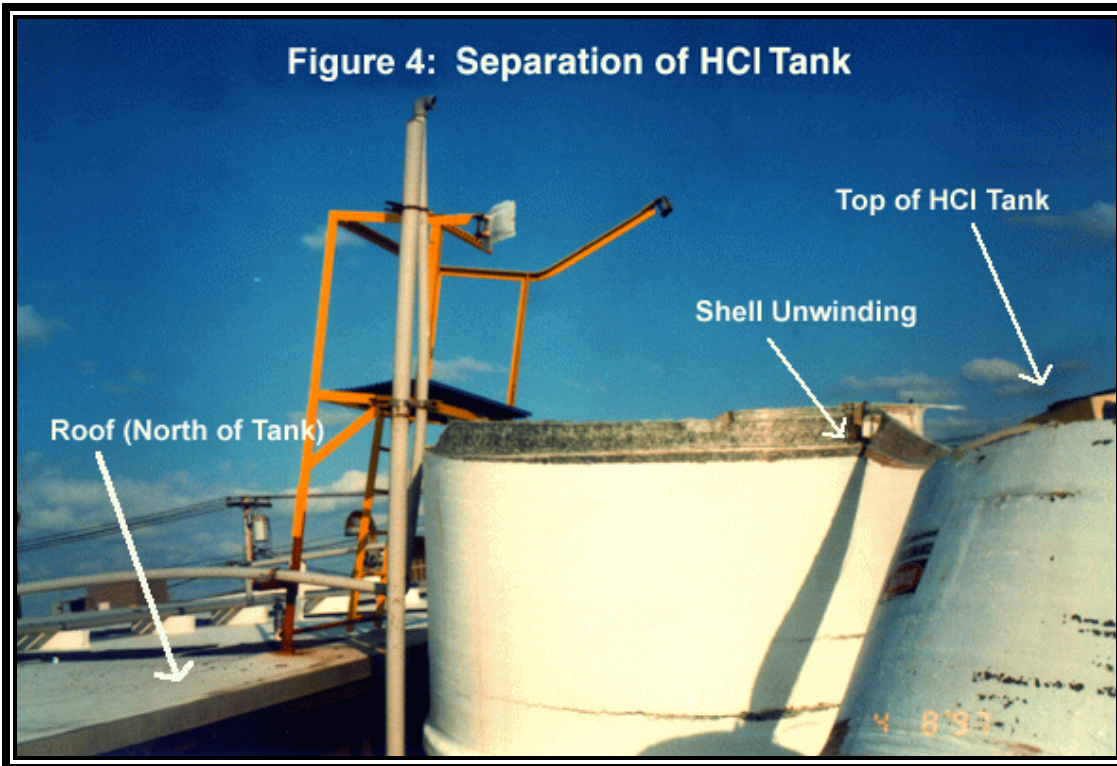
Figure 4: Separation of HCl Tank

The HCl tank head separated at a point about 5 feet from the top of the tank and flew about 15 feet west to the roof of an adjacent building. **Figure 4** shows the separated tank after the incident, and **Figure 5** shows the top of the tank. The bottom of tank failed in the knuckle area where the cylindrical part of the HCl tank meets the flat bottom, as shown in **Figure 6**. The tank bottom remained on the platform. The cylindrical part of the fiberglass shell began to unwind itself at the top edge (see **Figures 4 and 5**). The shell also remained on the platform but collapsed, leaning toward the west building wall (see **Figure 6**). The scrubber tank was not affected by the tank failure; it was found intact in its original position after the incident, as shown in **Figure 7**.

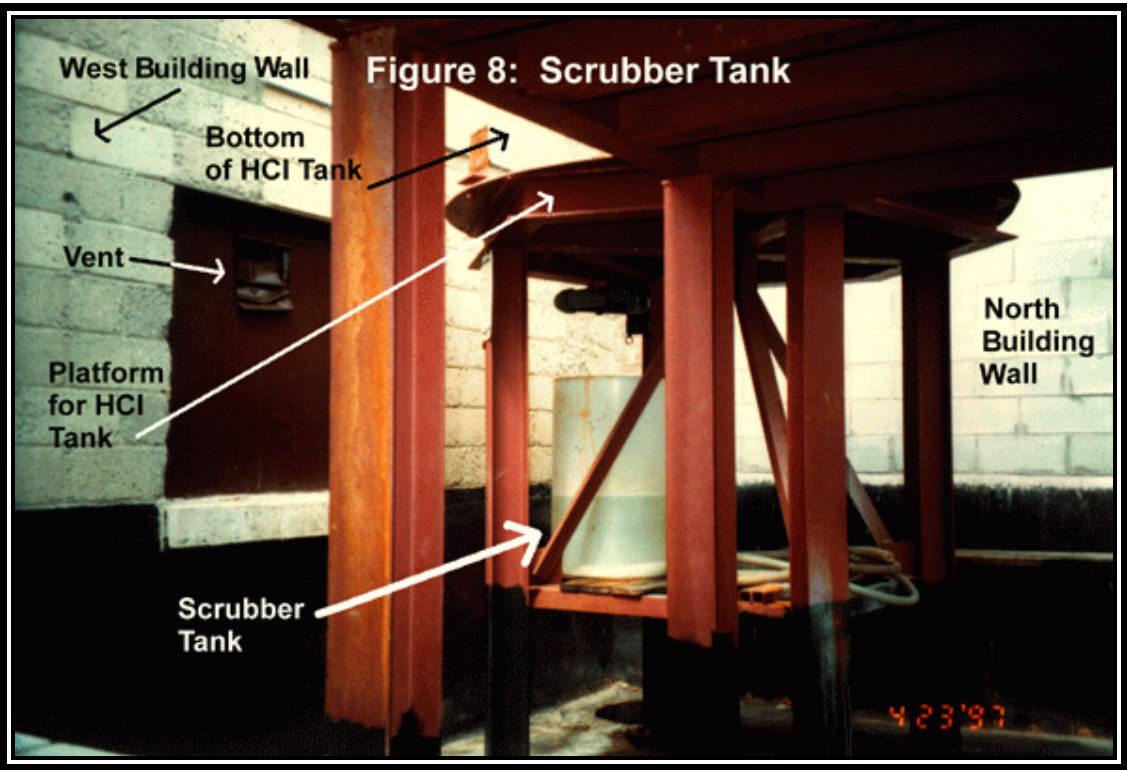
- The HCl tank ruptured into three pieces, as described in Section 3.2.
- The manway on the tank top was sealed shut, and the only way for vapor to escape from the tank was through the vent line. (See **Figure 7**.)

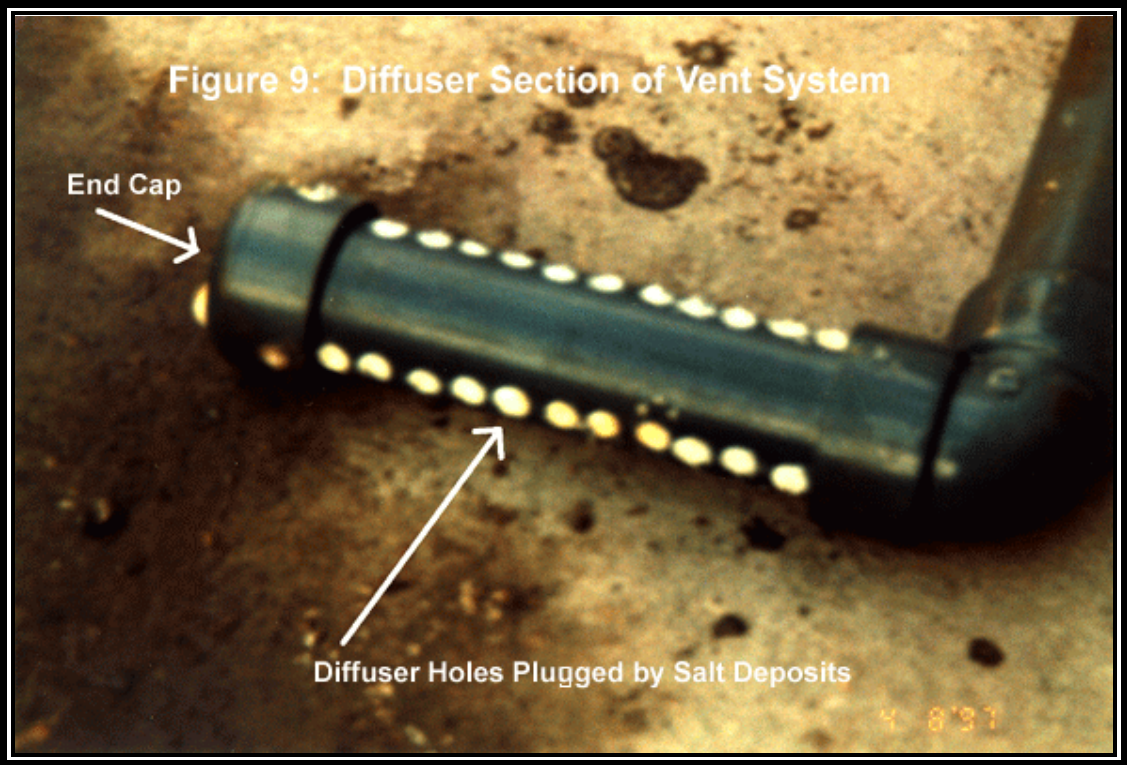
- The scrubber tank was not affected by the tank failure; it was found intact in its original position after the incident. (See **Figure 8**.)
- After the incident, the diffuser in the scrubbing tank was removed by disconnecting the vent line quick connect and removing the lid from the scrubber tank. The holes in the diffuser were found to be clogged with a white crystalline substance, as shown in **Figure 9**. This substance was sodium chloride, according to laboratory analysis.

- A layer of white crystalline material was also found in the bottom of the scrubber tank. This substance also was sodium chloride, according to laboratory analysis.
