Report No. FHWA-RD-78-163

Hydraulics Branch  
Library

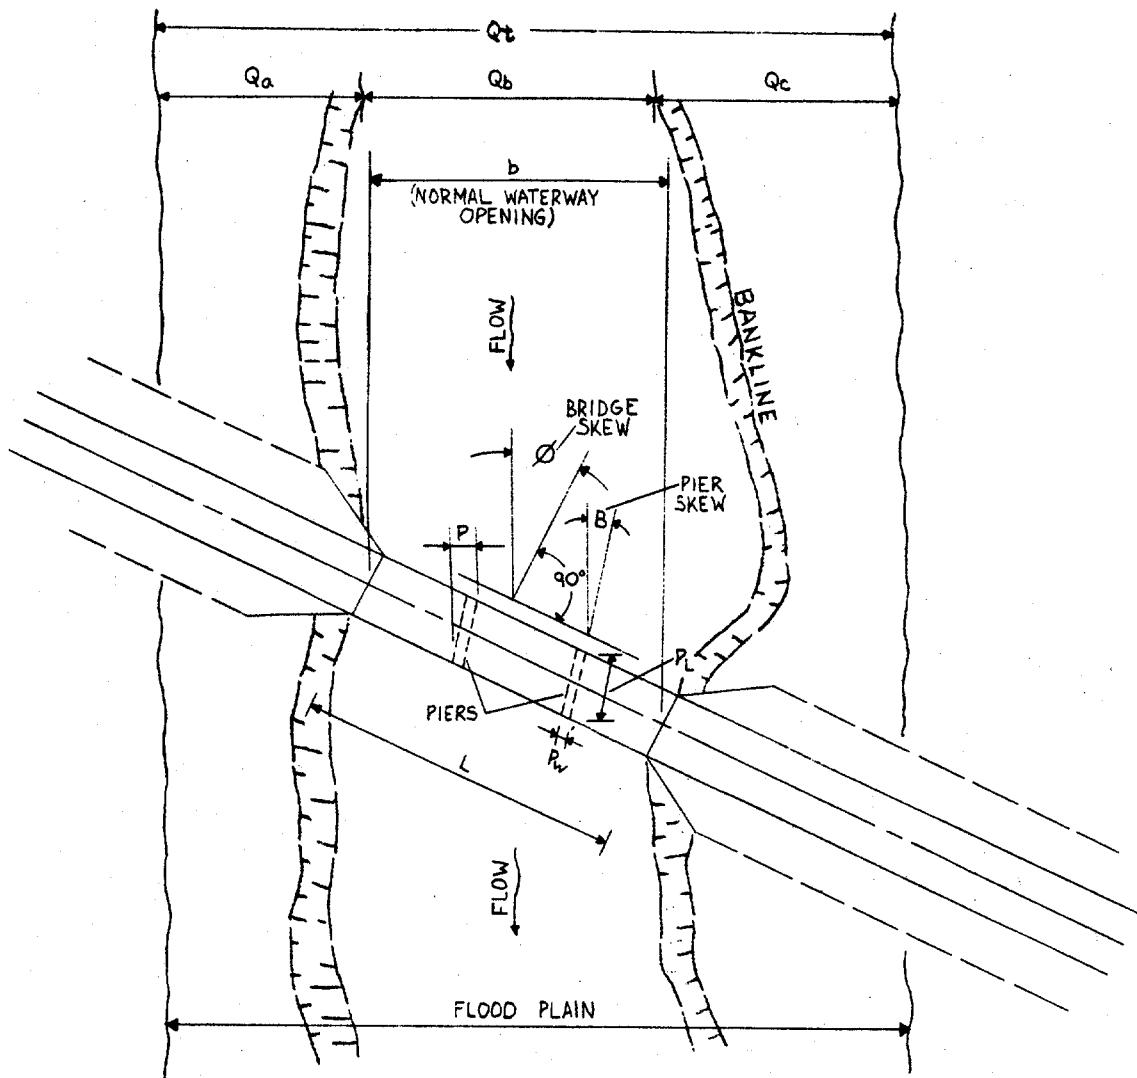
Figure 1. Definition sketch of a skewed crossing and overbank flow.

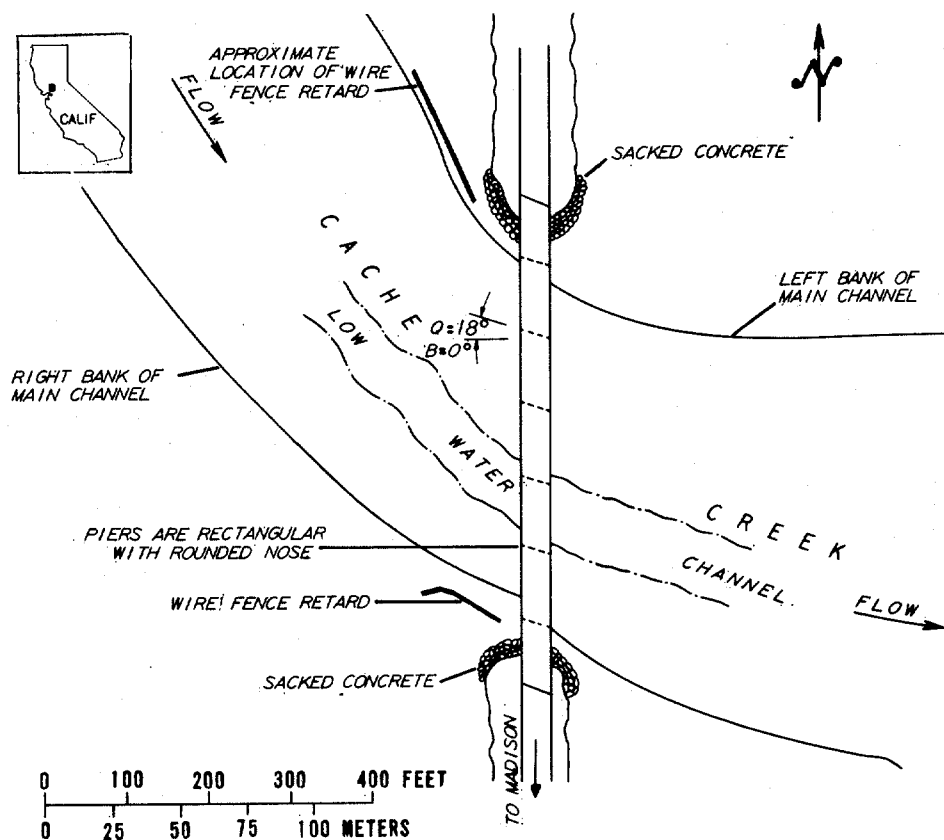
Figure 5. Plan of Cache Creek at I-505 bridge, 1959.

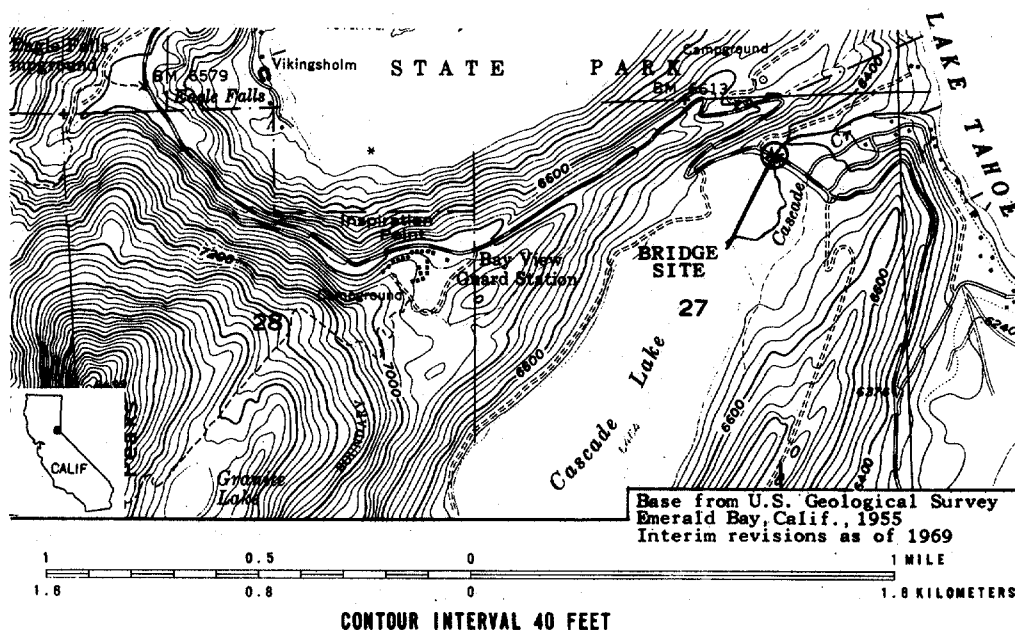
Figure 12. Location of Cascade Creek bridge site.

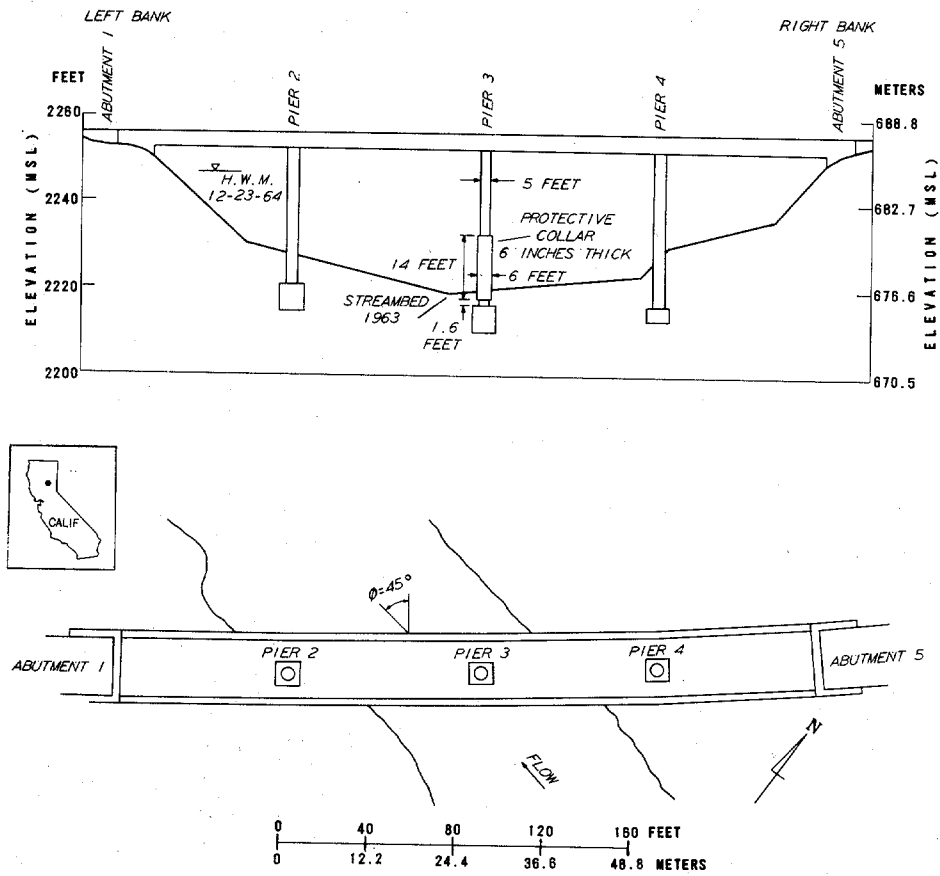
Figure 16. Plan and cross section of North Yuba River at SR-49 bridge near Goodyears Bar, California.

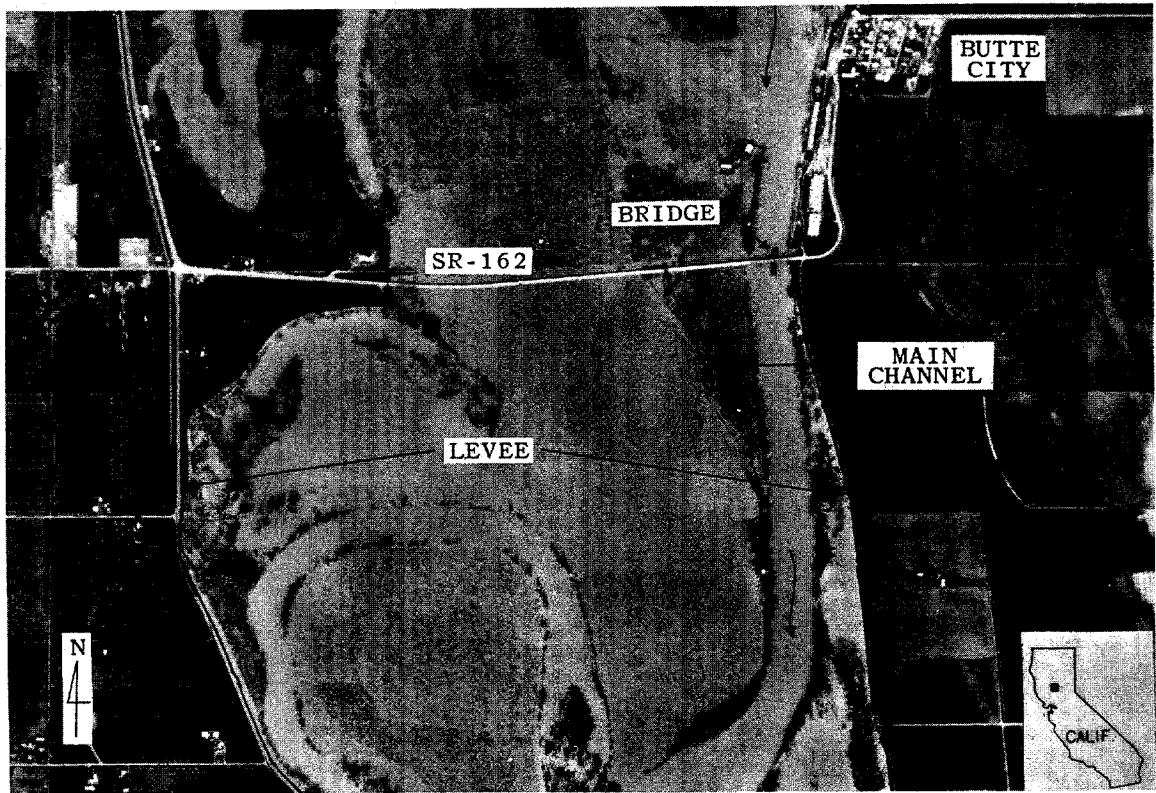
Figure 19. Aerial photograph of Sacramento River at SR-162 bridge during flood of January 19, 1974. (From Calif. Dept. of Water Resources.)

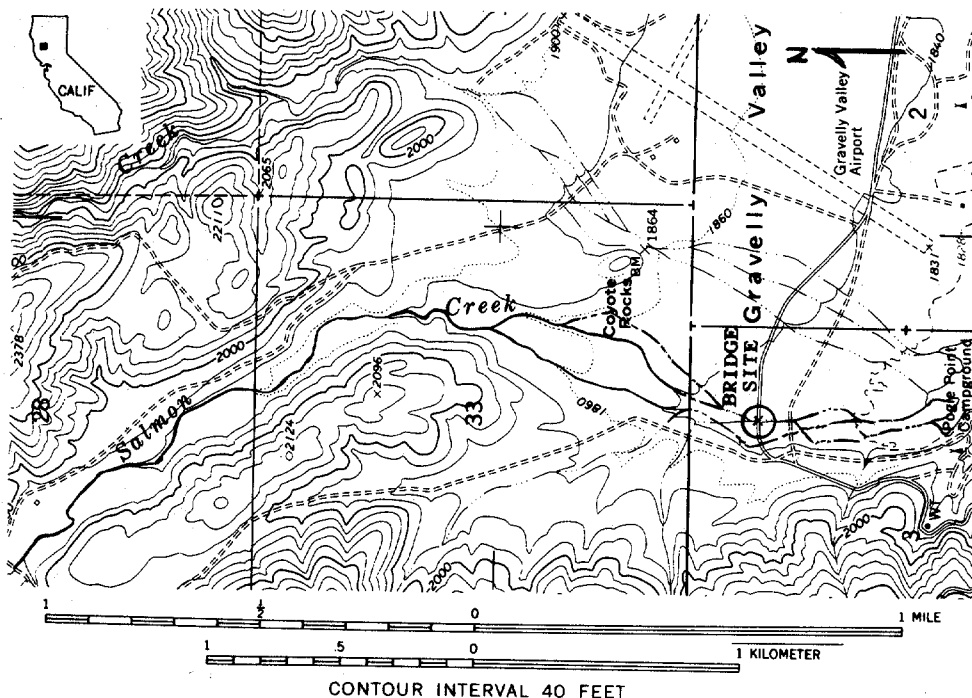
Figure 24. Map showing Salmon Creek at Forest Service road 20N01.6. (Base from U.S. Geol. Survey Lake Pillsbury, Calif., 7.5' quadrangle, contour interval 40 ft, 1967.)

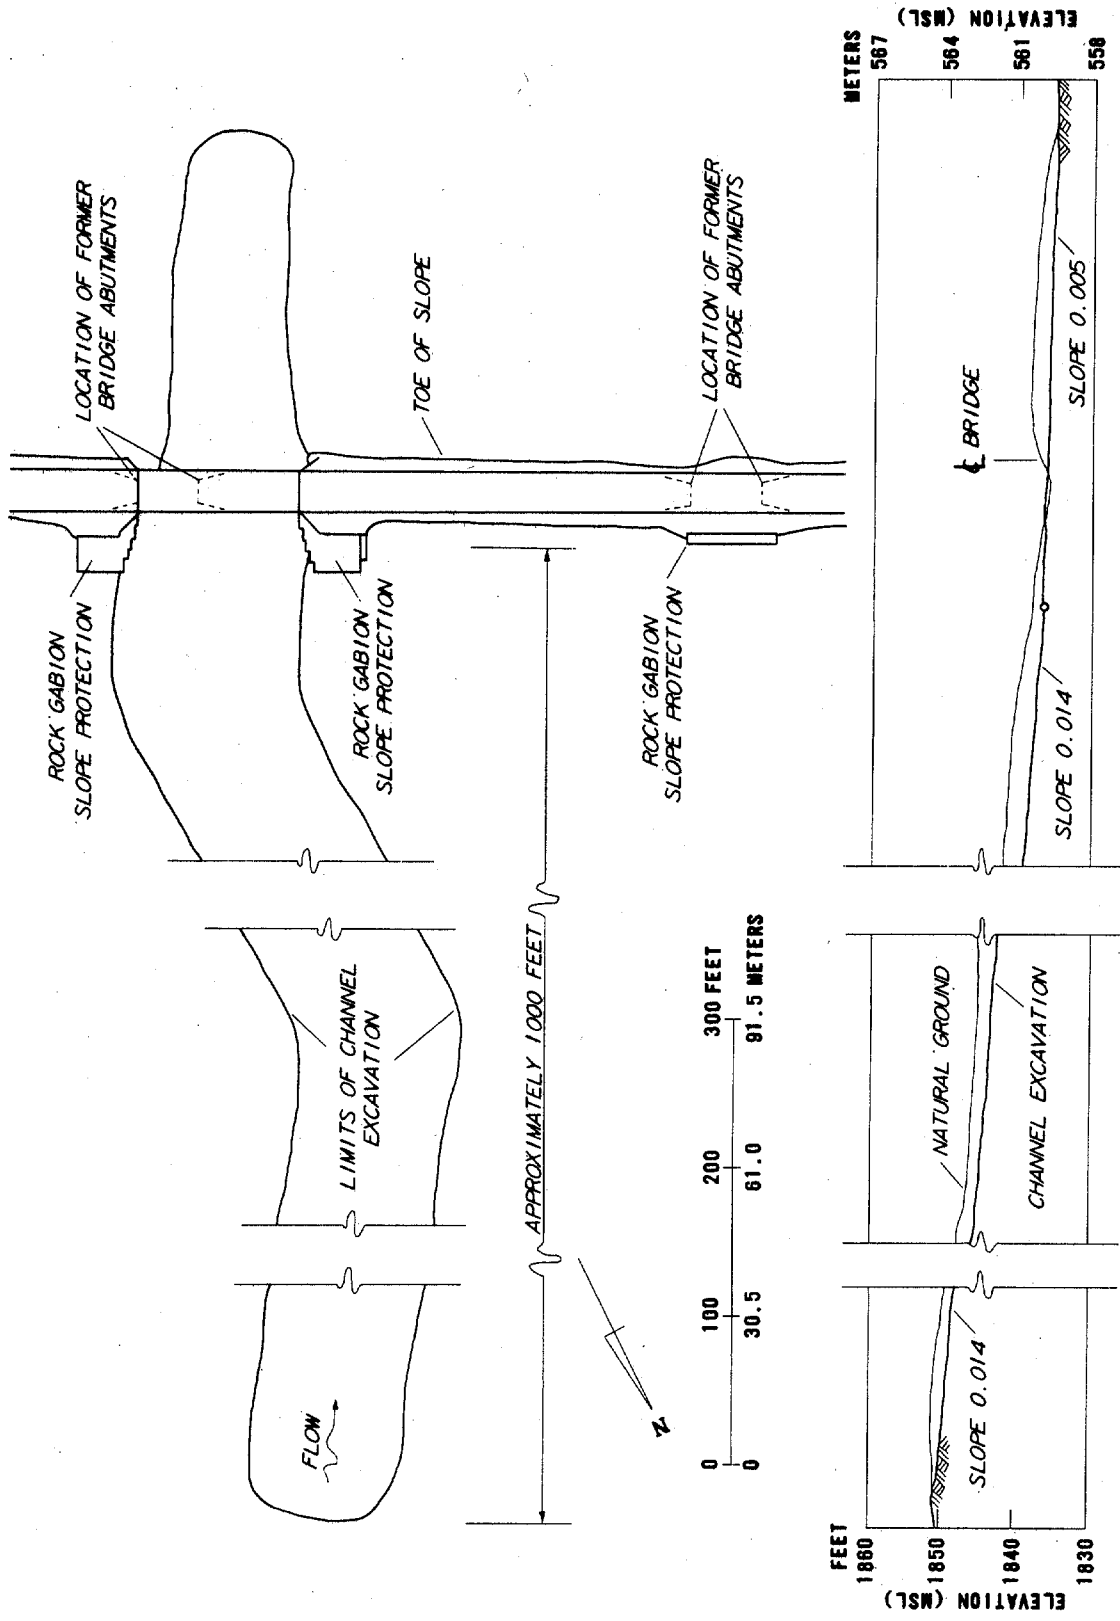
Figure 30. Plan and profile of Smokehouse Creek at Forest Service road 20N01.6.

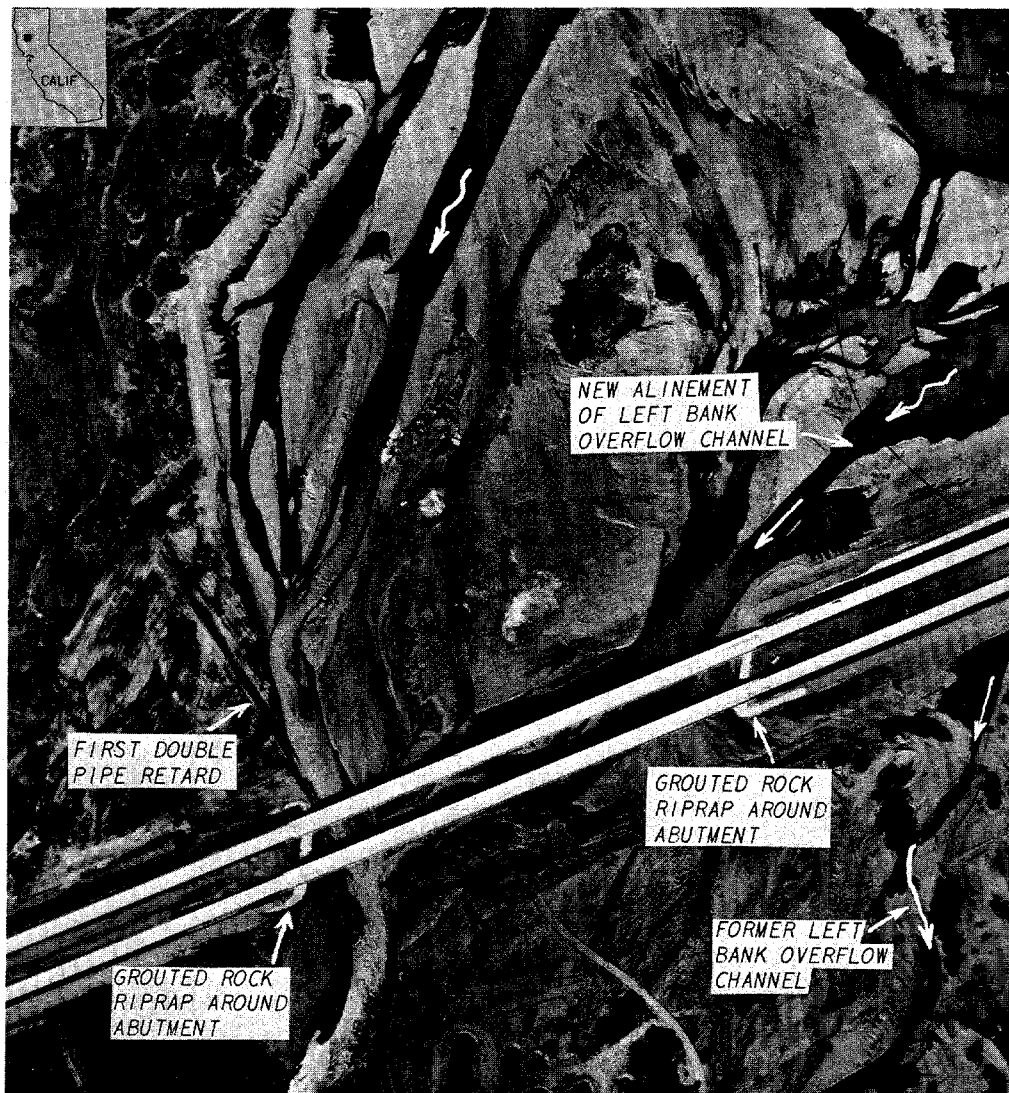
Figure 33. Aerial view of Stony Creek bridge after flood of January 1967. (From Calif. Dept. of Transportation.)

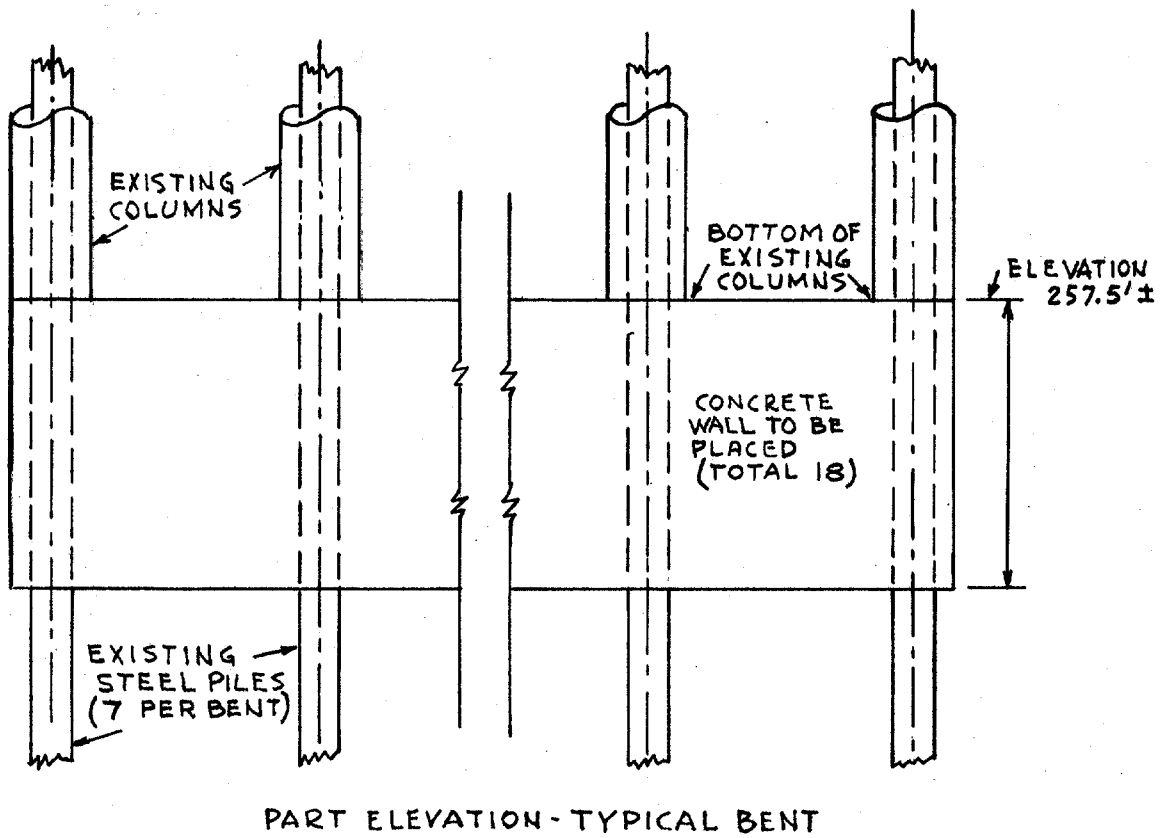
Figure 37. Repairs made in 1967 to exposed parts of steel H-piles.

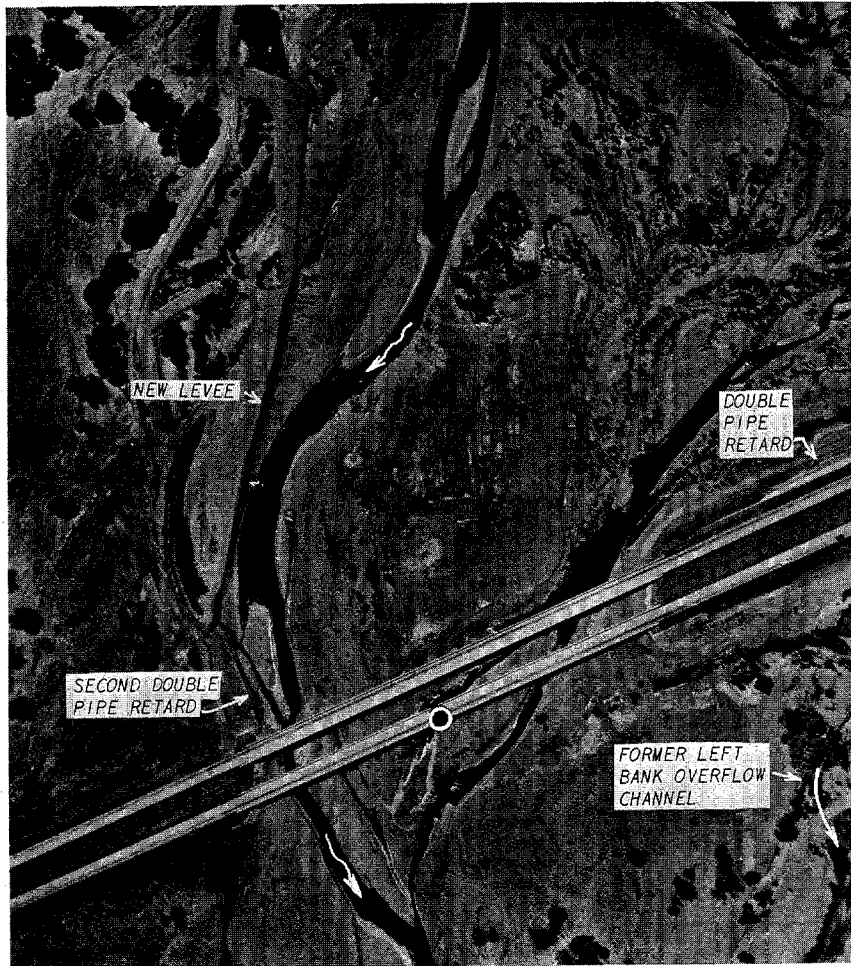
Figure 38. Aerial view of Stony Creek bridge showing extension of right-bank levee in 1970. (From Calif. Dept. of Transportation.)

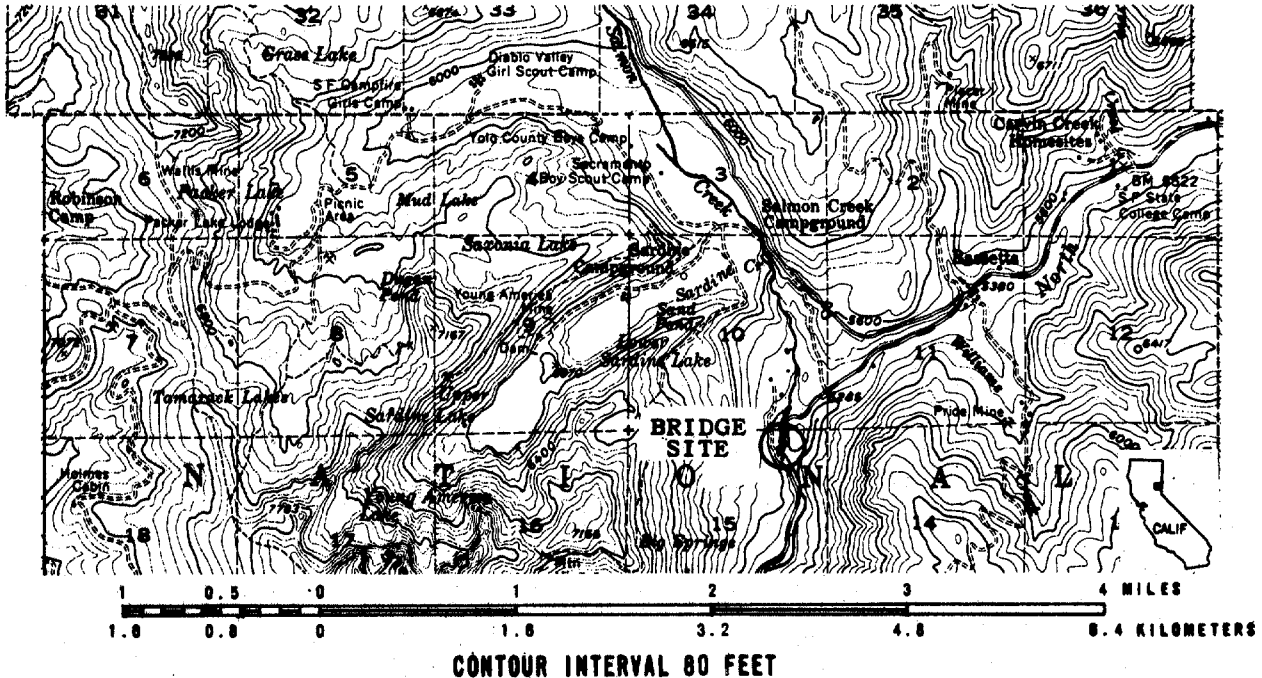
Figure 40. Location of Salmon Creek at SR-49 crossing. (From U.S. Geol. Survey Sierra City, Calif., 15' quadrangle, 1955.)

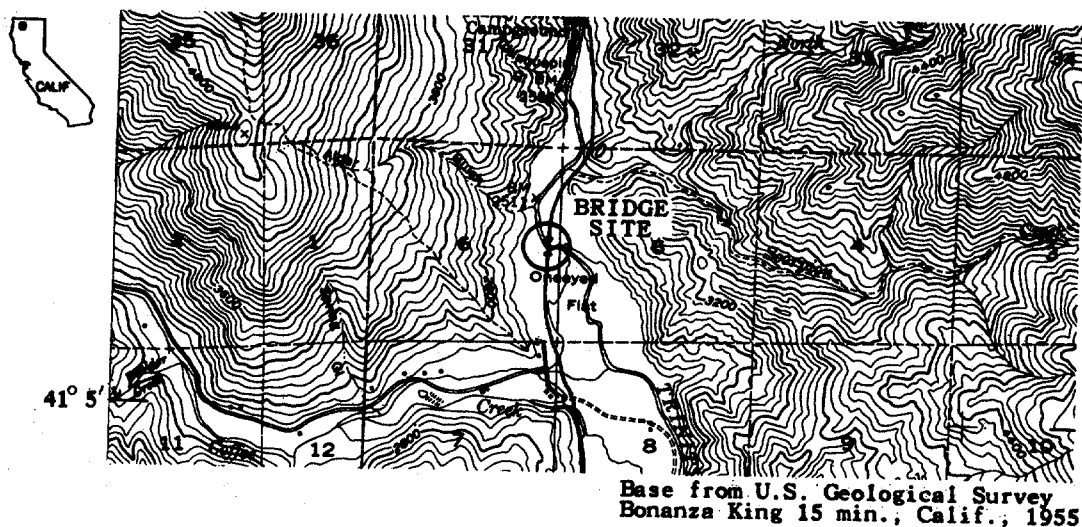
Figure 48. Location of Trinity River at SR-3 crossing.

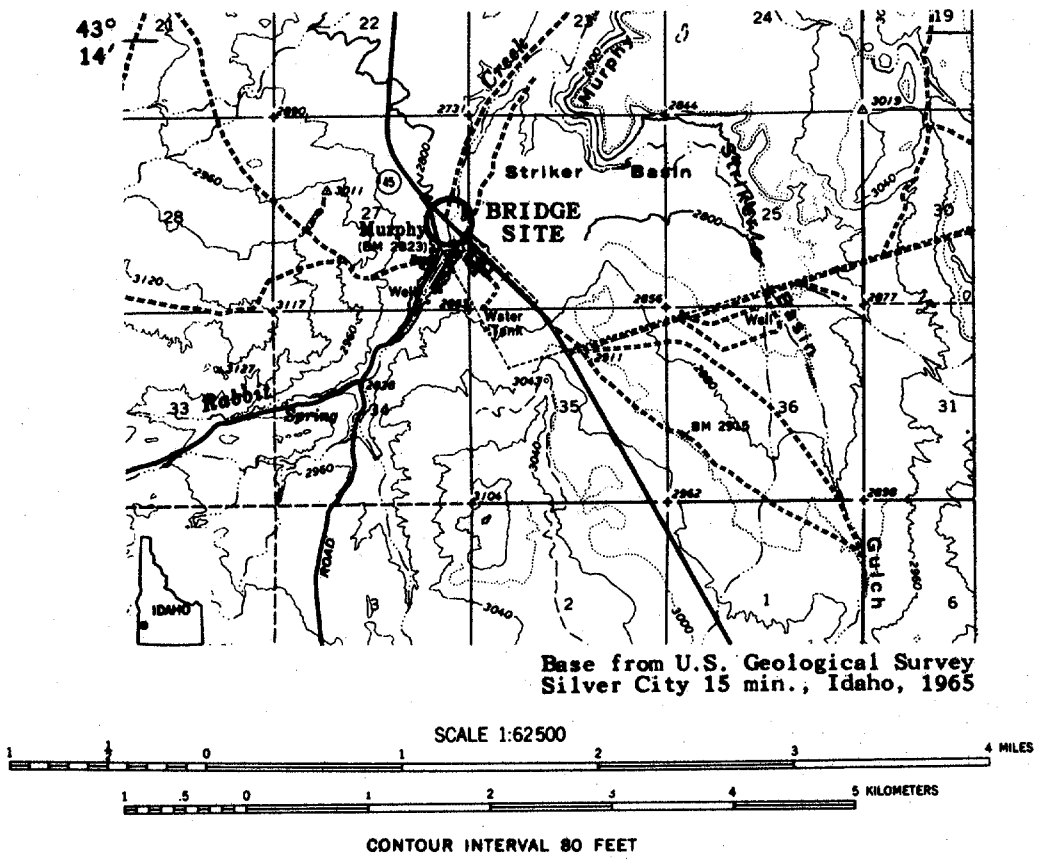
Figure 52. Location of Rabbit Creek at SR-45 at Murphy, Idaho.

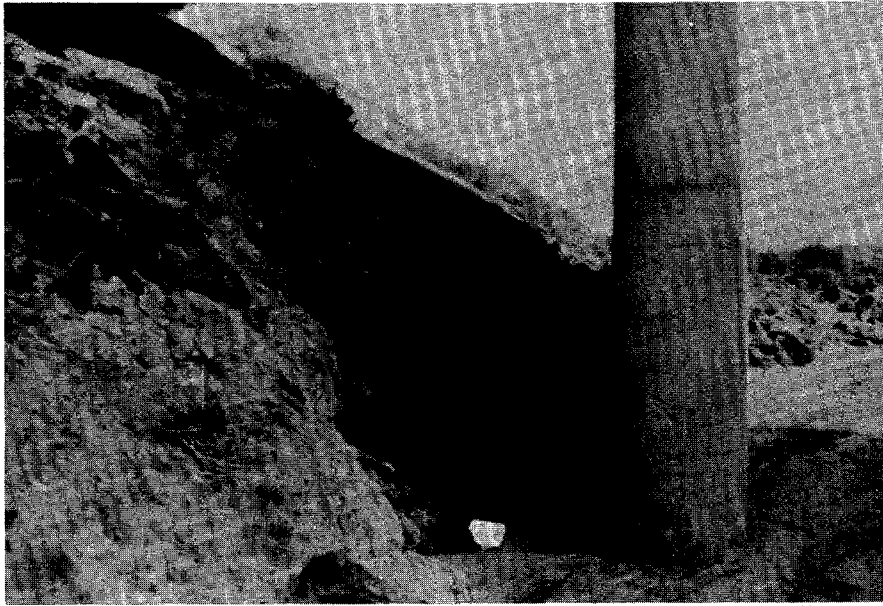
Figure 56. Local scour at upstream side of left bank pier, as observed in 1976.

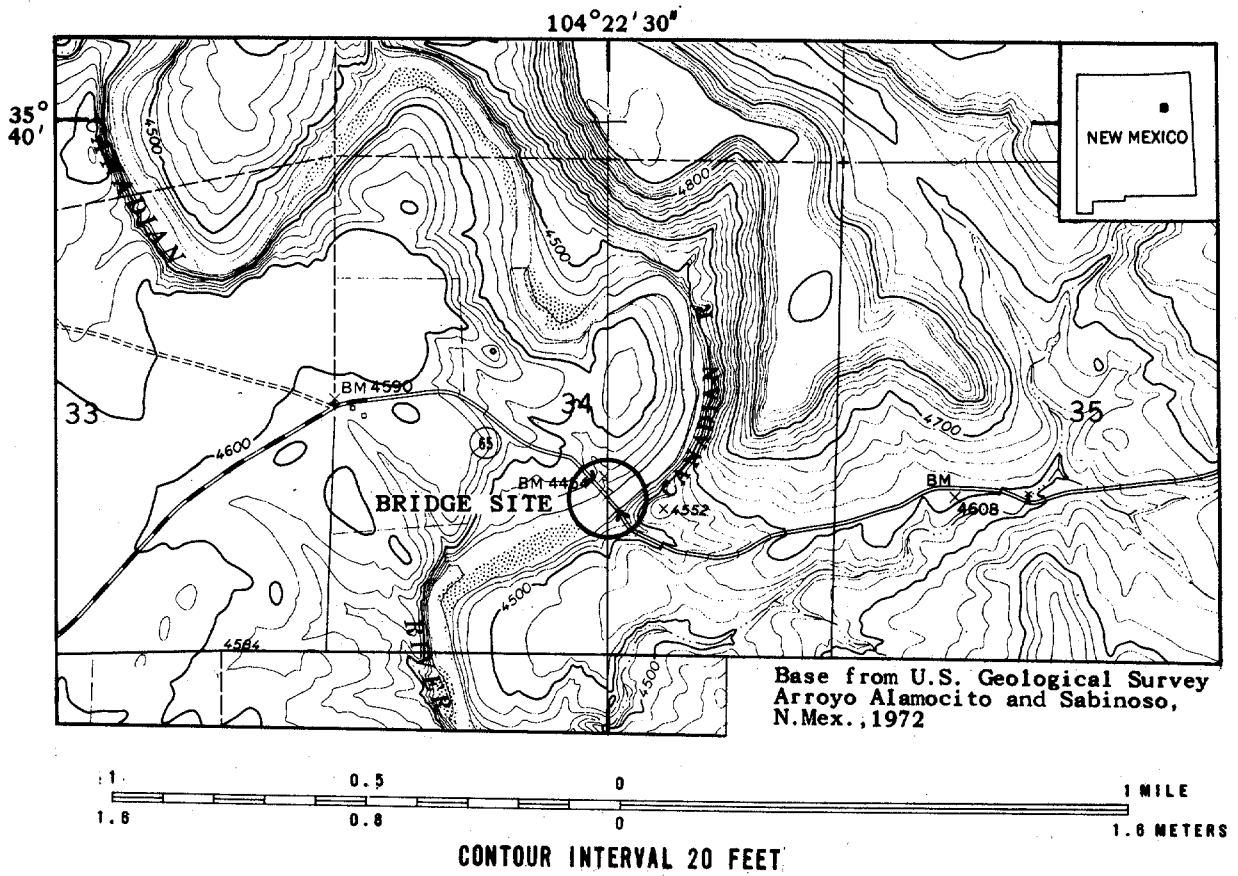
Figure 57. Location of Canadian River at SR-65 near Sanchez, New Mexico.

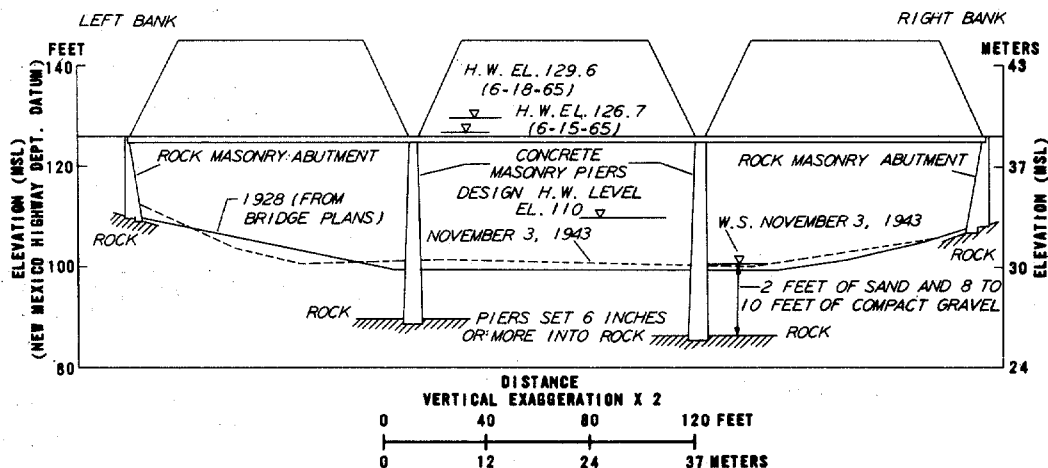
Figure 58. Cross section of Canadian River at SR-65 near Sanchez, New Mexico in 1928 and 1943.

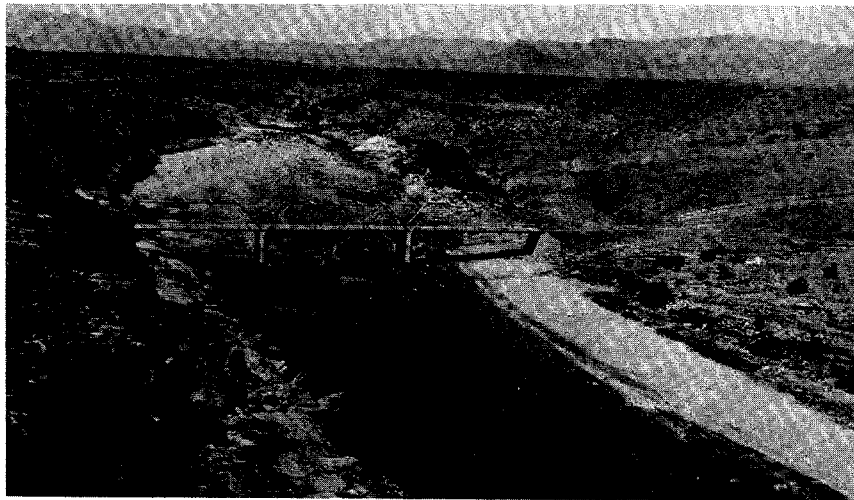
Figure 59. View downstream at bridge site prior to June, 1965. (From New Mexico Dept. of Highways.)

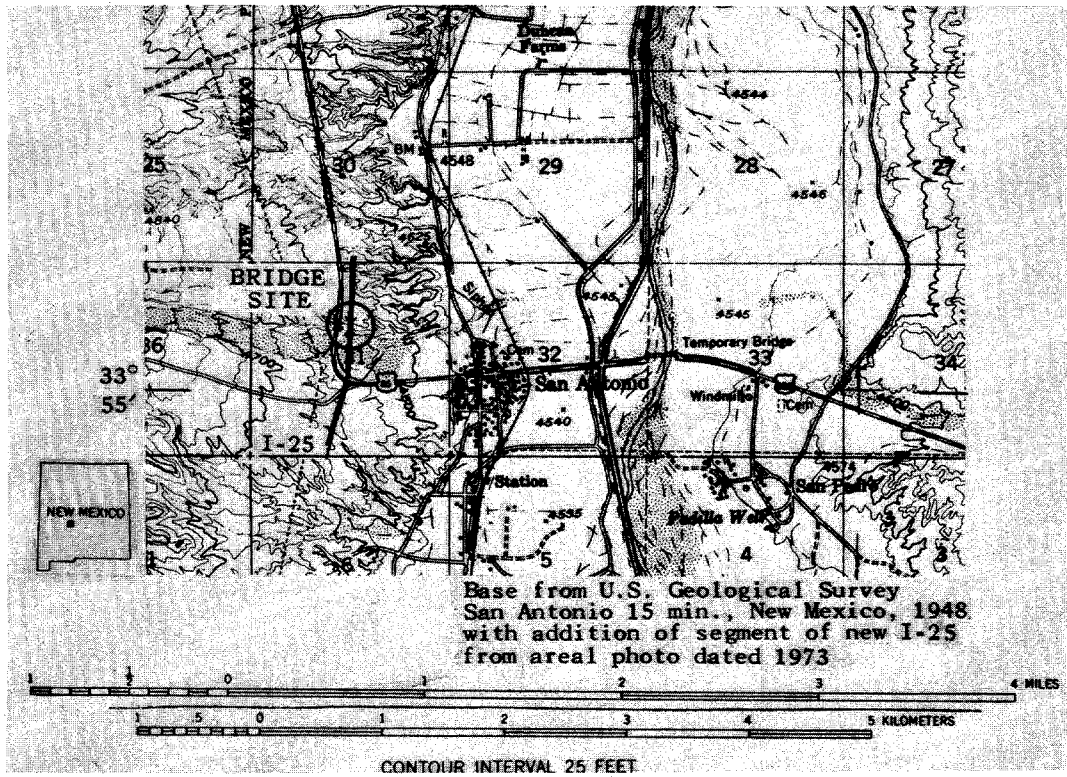
Figure 64. Location of Walnut Creek at I-25 near San Antonio, New Mexico.

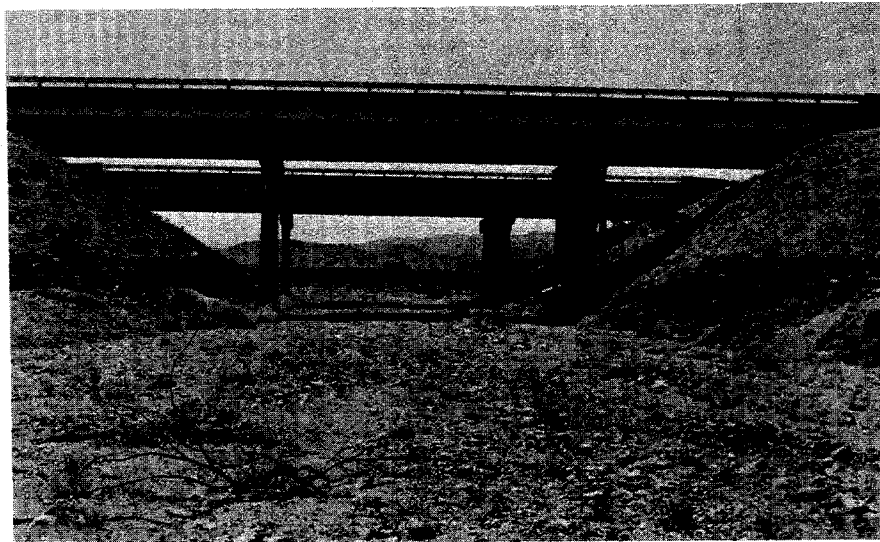
Figure 68. View upstream in 1976 of wire-enclosed riprap as repaired after the 1972 flood.

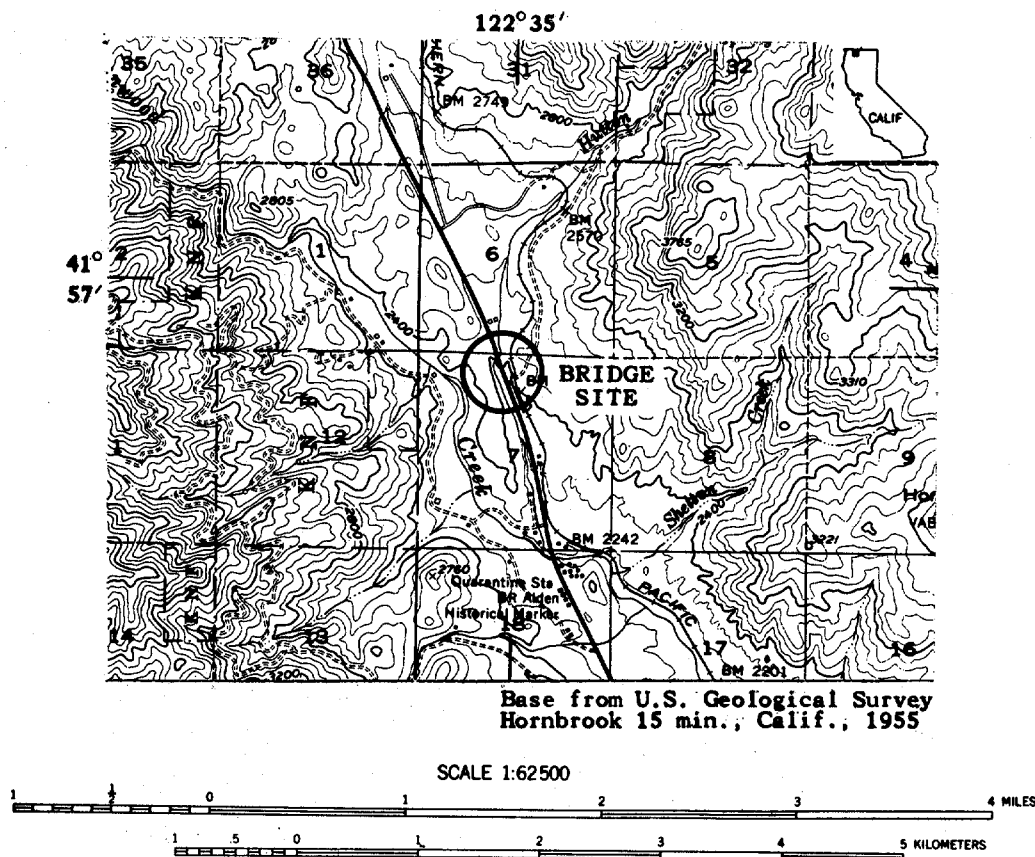
Figure 69. Location of Hutton Creek at I-5 near Hilt, California.

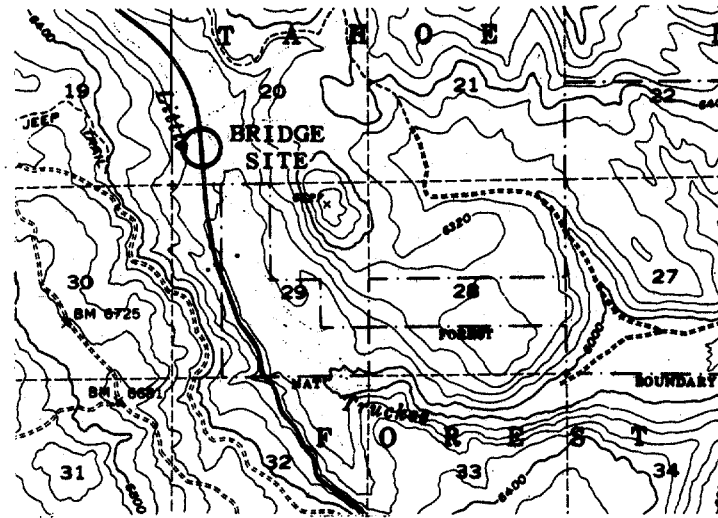
Base from U.S. Geological Survey  
Truckee 15 min., Calif., 1955

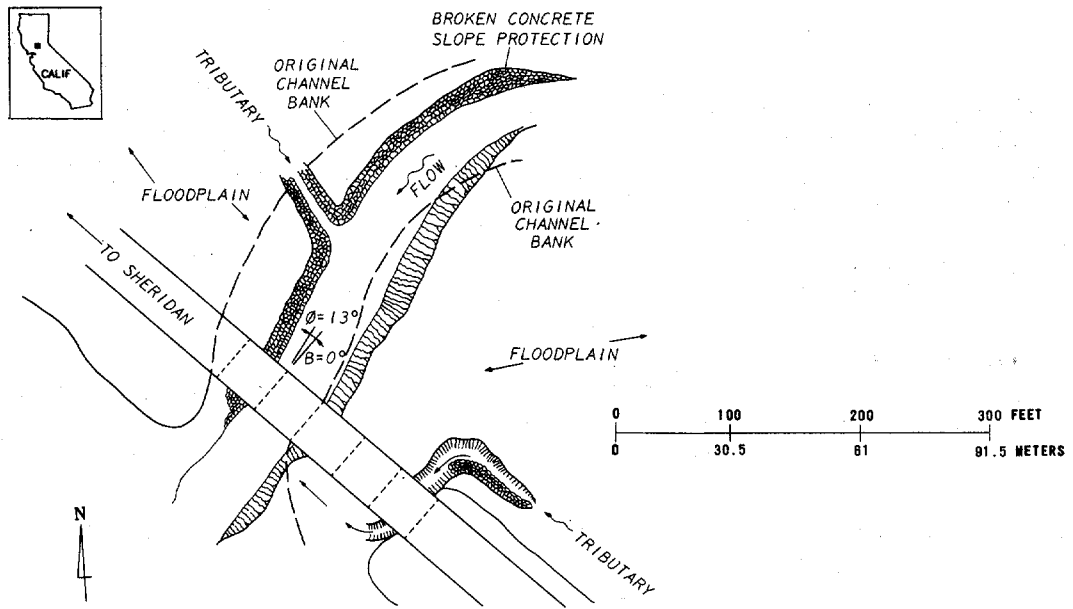
Figure 78. Plan of Coon Creek at SR-65 crossing.

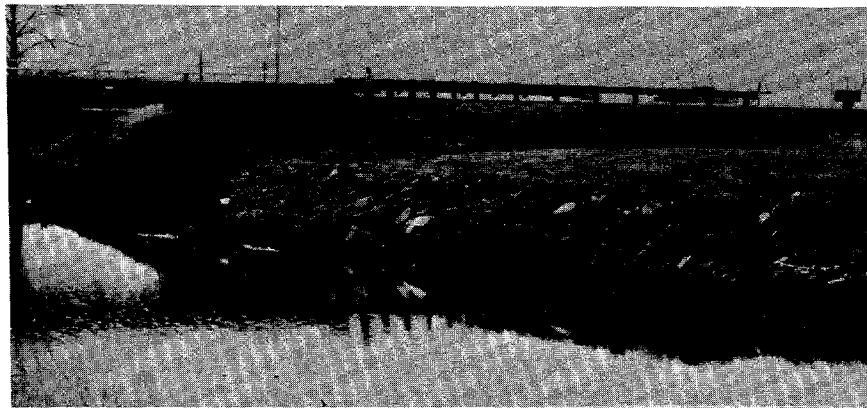
Figure 80. View in 1977 of broken concrete used to protect right bank of channel.

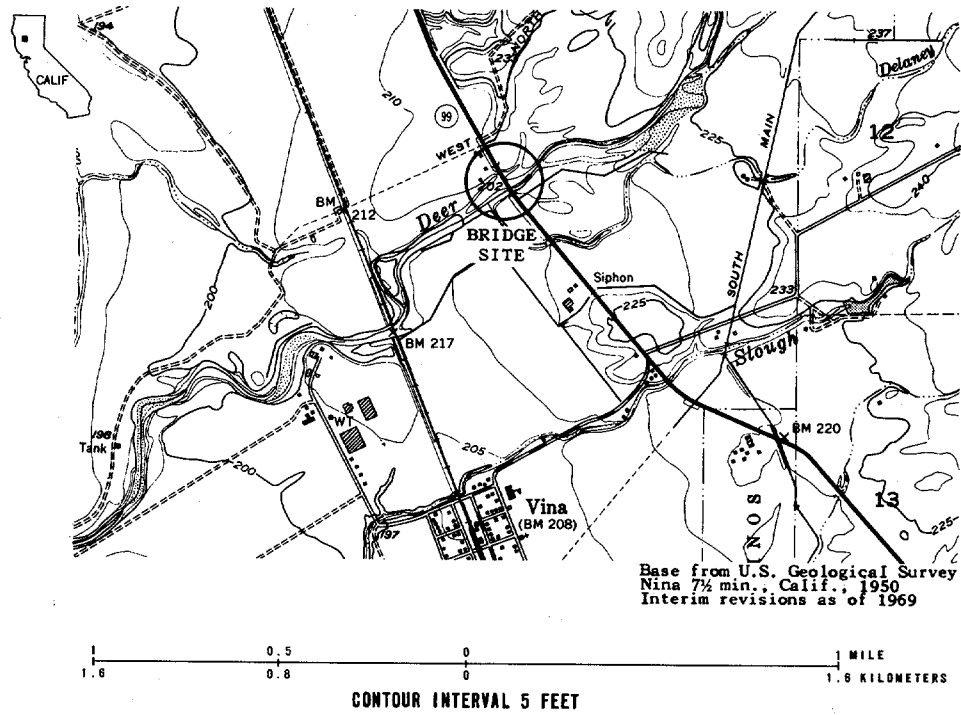
Figure 81. Location map of Deer Creek at SR-99 near Vina, California.

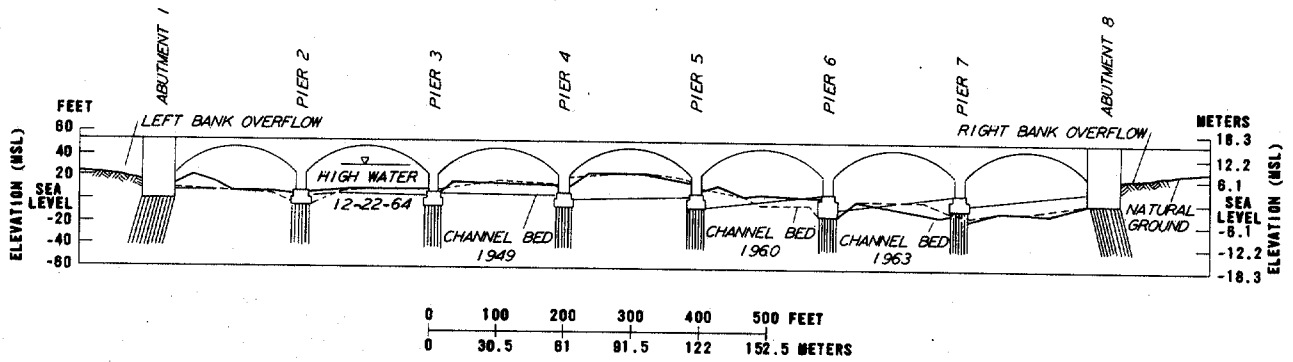
Figure 87. Cross section of main channel of Bel River in 1949, 1960, and 1963.

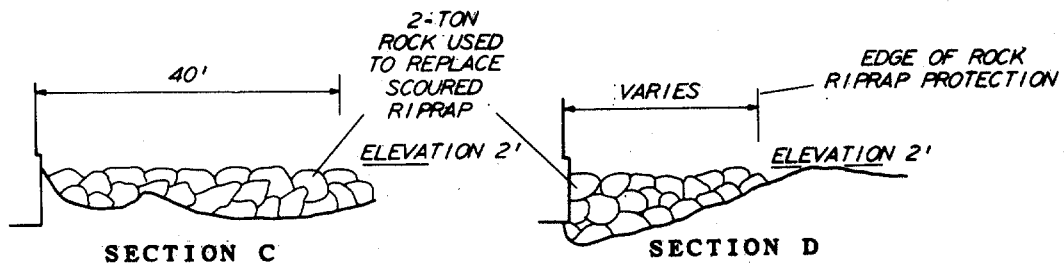
Figure 90. Plan of scour hole at pier 7 as surveyed in 1965; and details of rock riprap replacement.

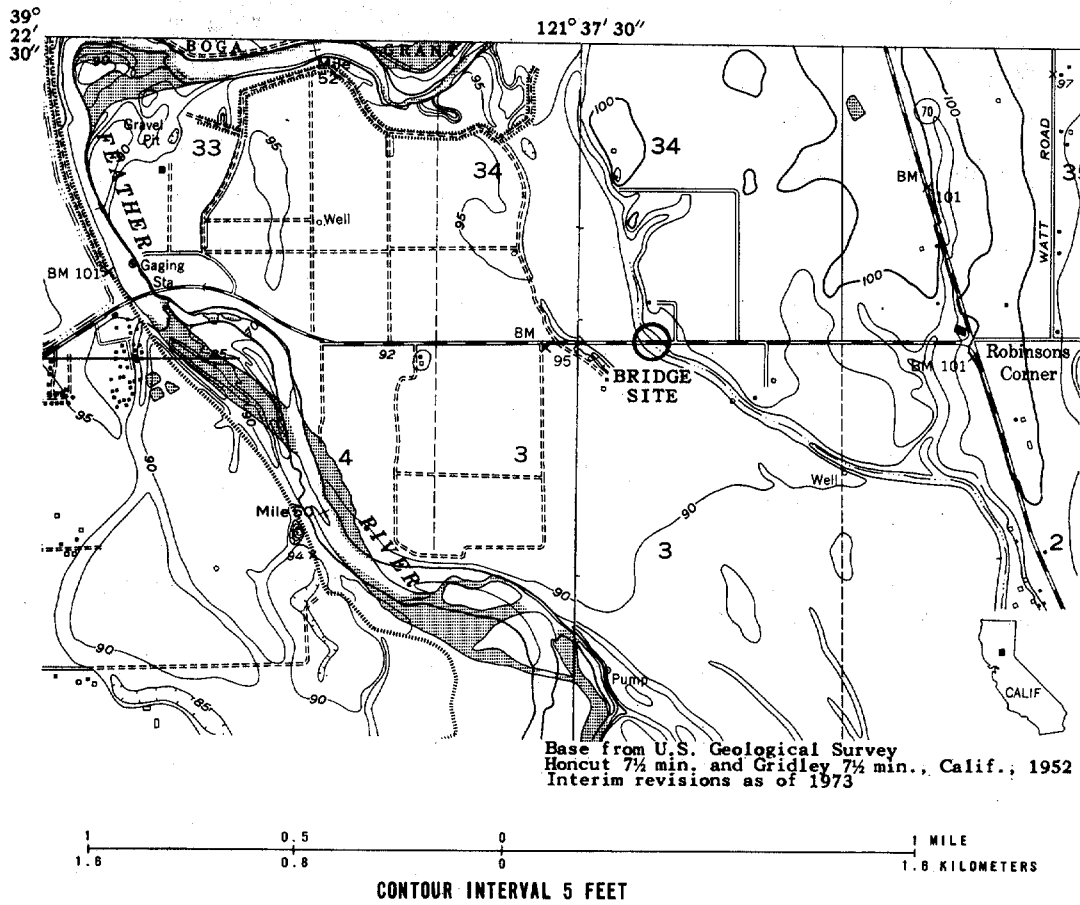
Figure 91. Location of Feather River overflow at Gridley-Oroville road near Gridley, California.

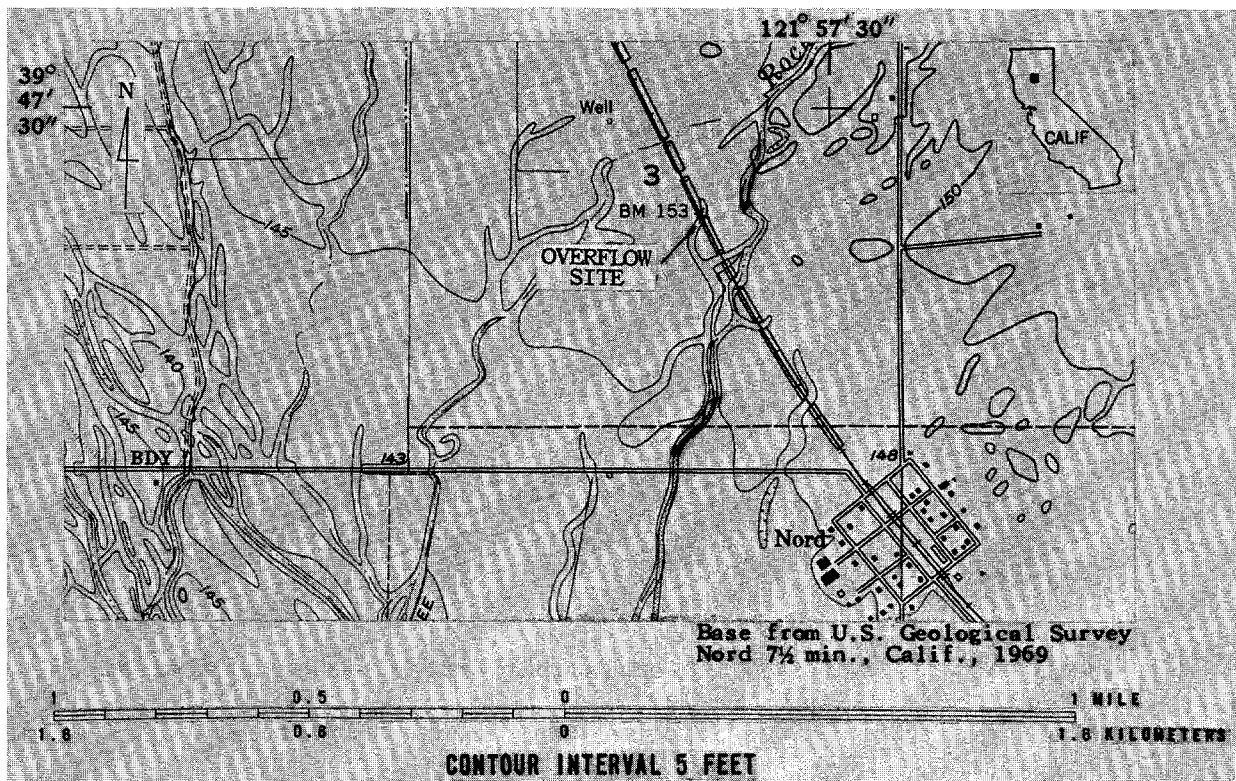
Figure 94. Location of Rock Creek at county road near Nord, California.

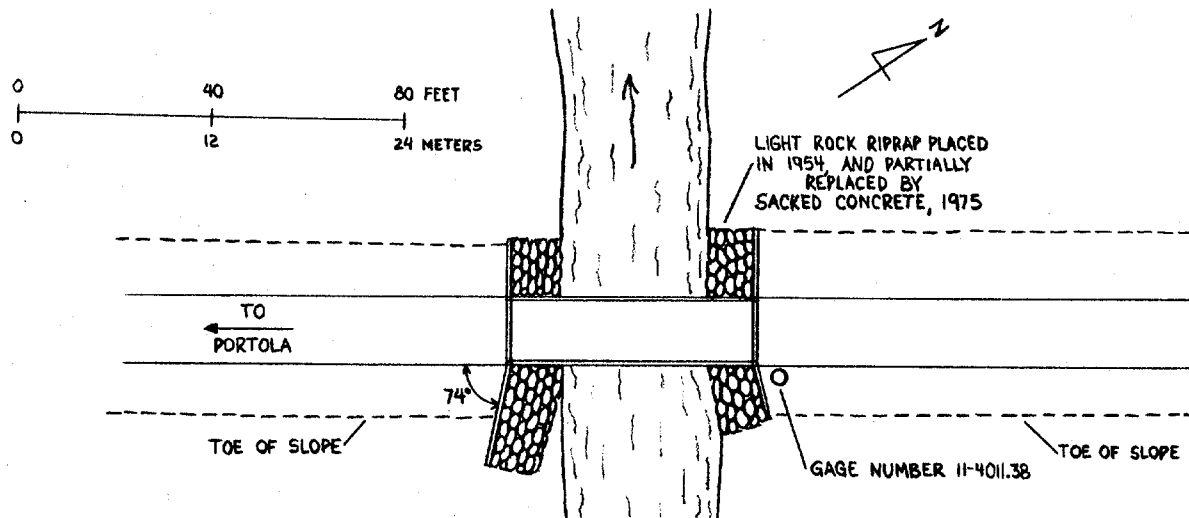
Figure 99. Plan of Red Clover Creek bridge.

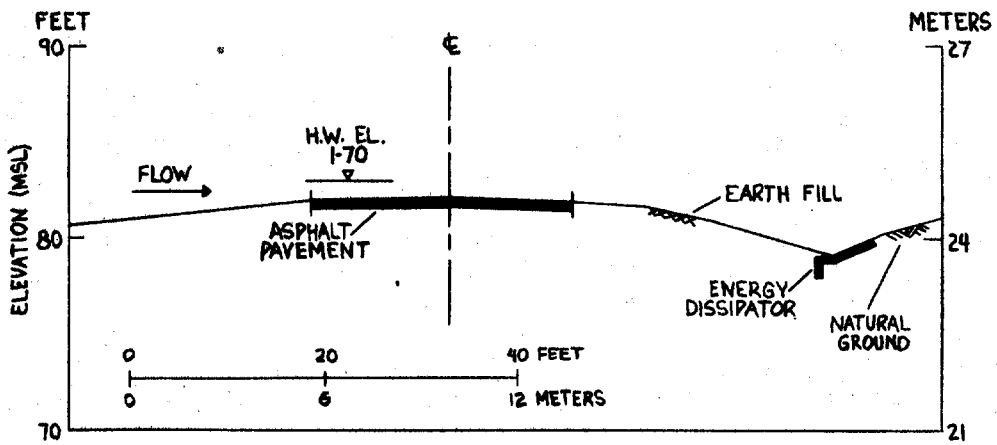
Figure 109. Cross section of road embankment.
