Report No. FHWA-RD-78-163

Hydraulics Branch  
Library

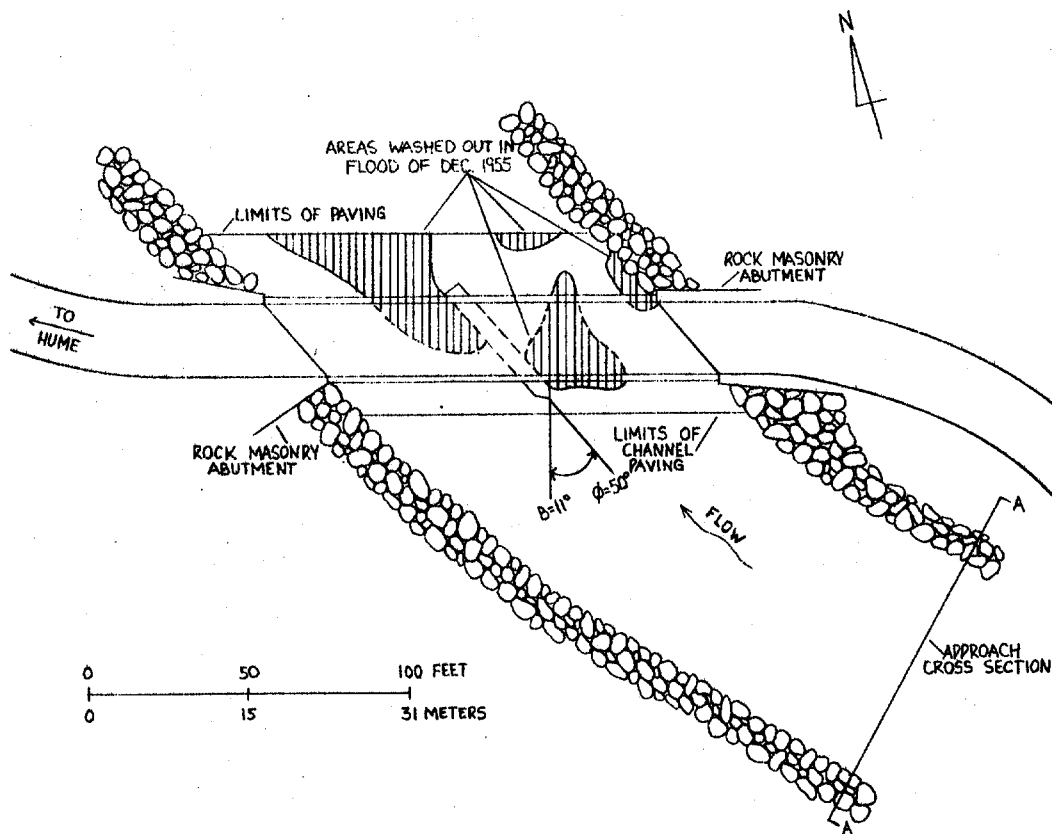
Figure 112. Plan of S.F. Kings River at SR-180 crossing.

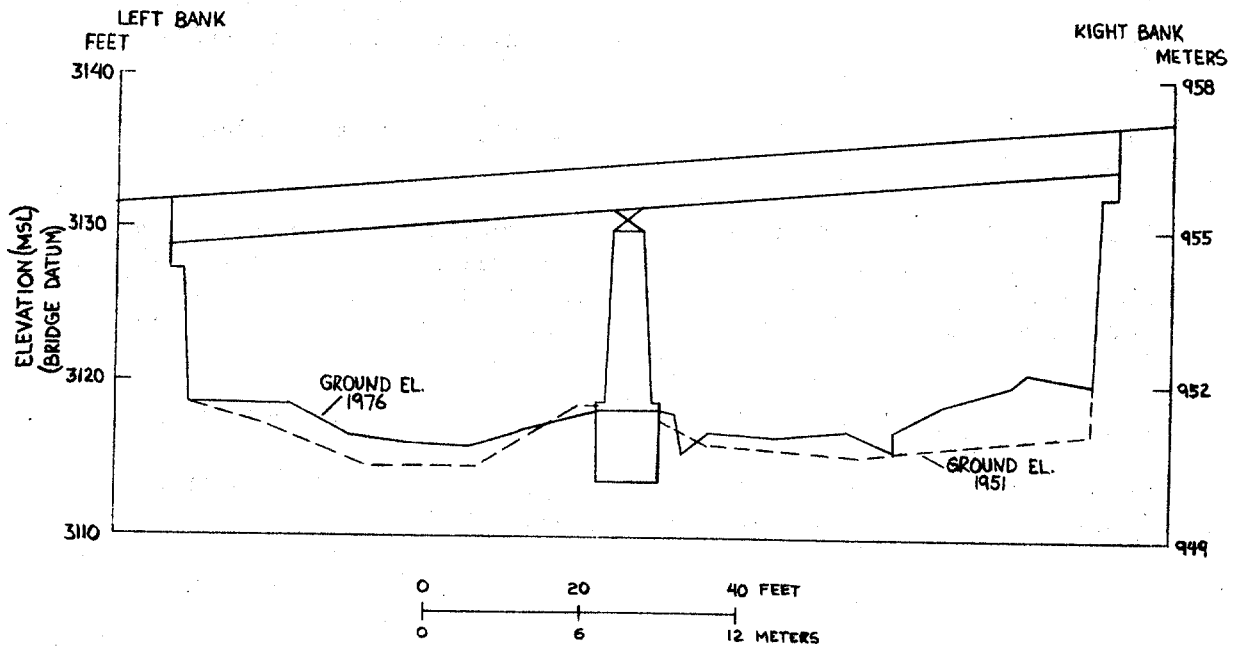
Figure 113. Cross sections of S.F. Kings River at SR-180 crossing, 1951 and 1976.

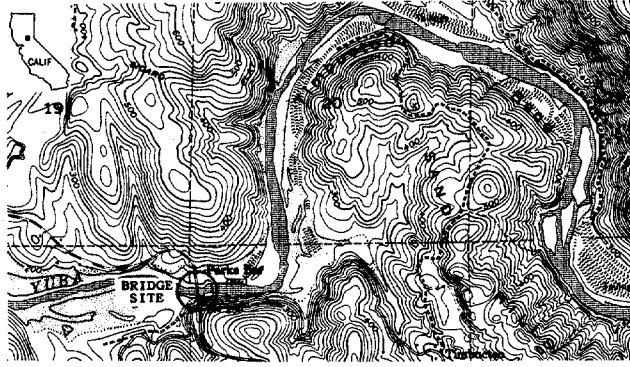
Figure 115. Location of Yuba River at SR-20 near Smartville. (Base from U.S. Geol. Survey Smartville, Calif., 7.5' quadrangle, contour interval 20 feet, 1951 revised 1973.)

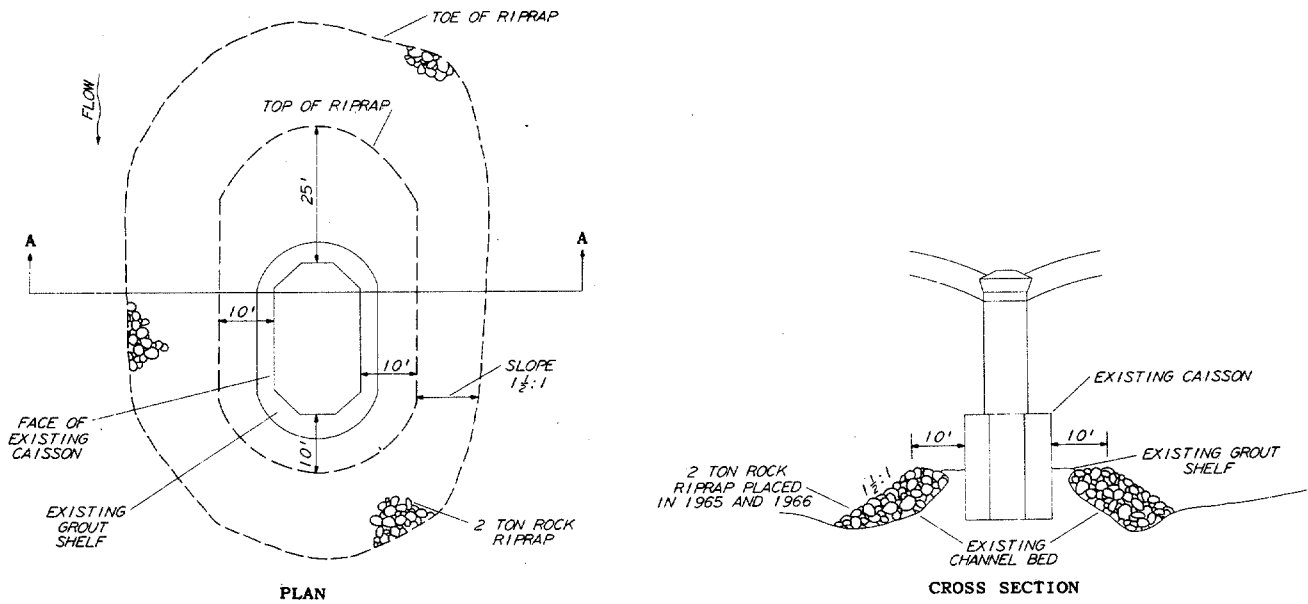
Figure 119. Details of repairs at piers in 1965 and 1966.

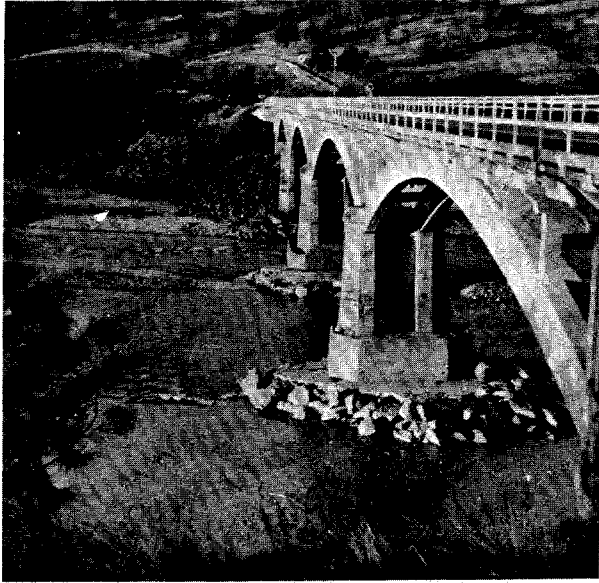
Figure 120. View from left bank of rock riprap around pier, about 1965. (From Calif. Dept. of Transportation.)

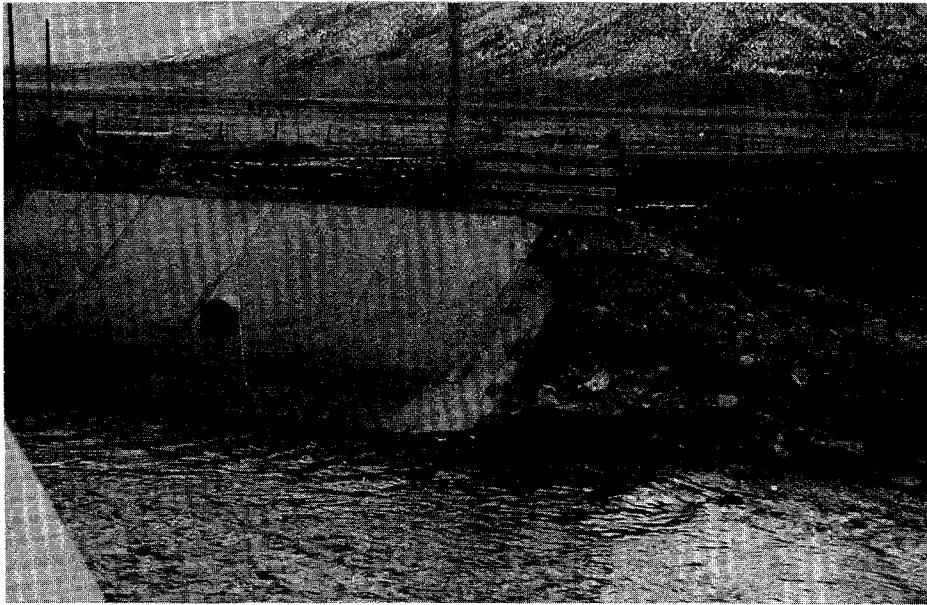
Figure 123. Slope paving left bank at downstream side of bridge on Dec. 27, 1955. Note lateral erosion of bank downstream from end of slope paving. (From Nevada Dept. of Highways.)

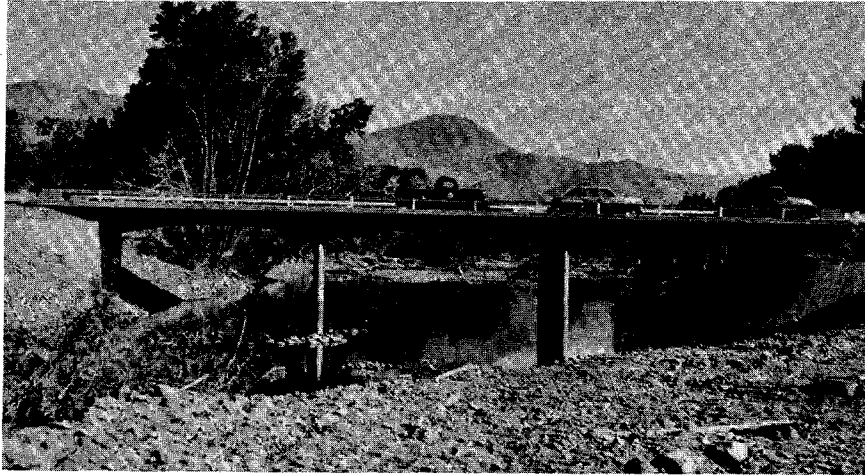
Figure 125. Abutment protection at bridge built in 1951. (From Nevada Dept. of Highways.)

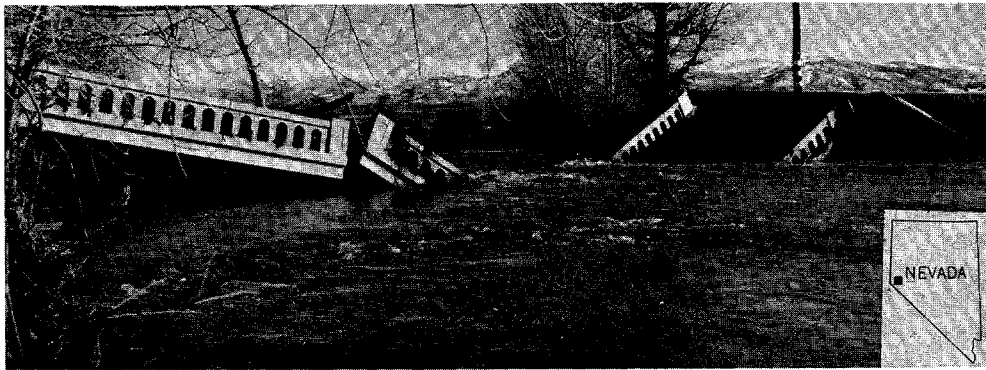
Figure 128. Failure of piers founded on spread footings, during Dec. 1955 flood. (From Nevada Dept. of Highways.)

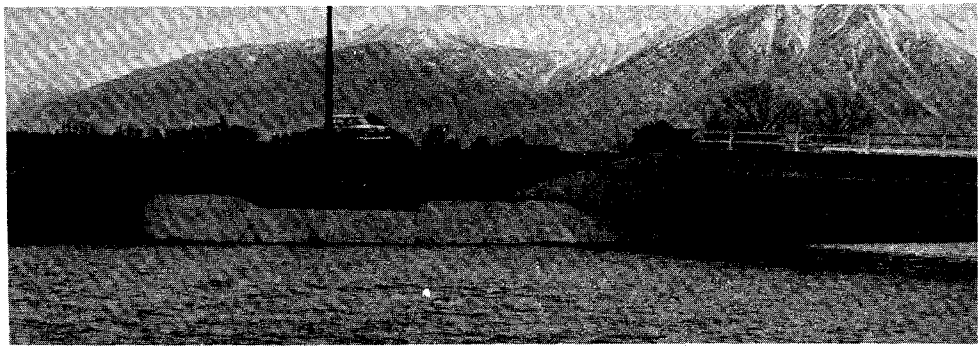
Figure 129. Slope paving on left bank at upstream side of bridge on May 8, 1957. (From Nevada Dept. of Highways.)

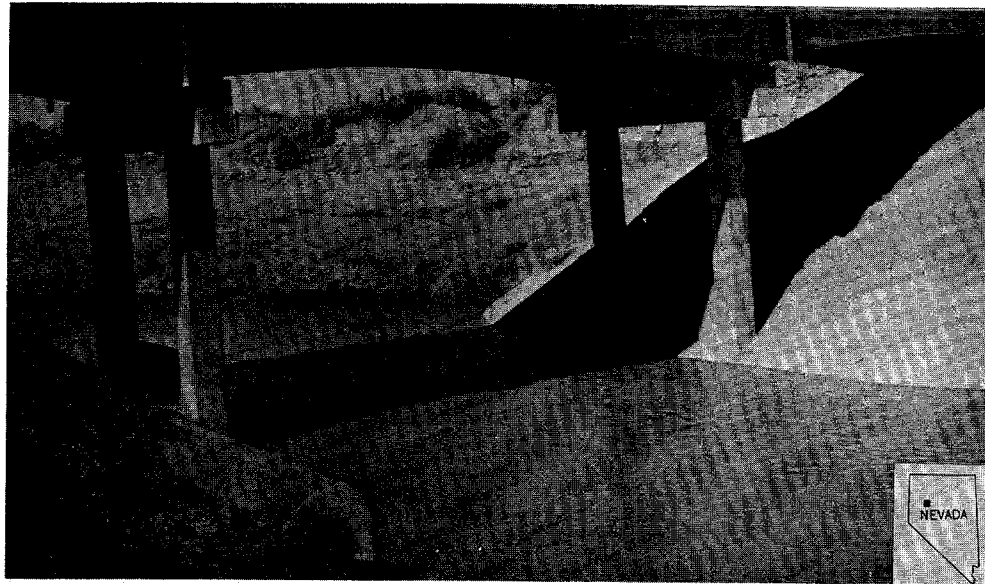
Figure 130. Pavement on abutment slopes on April 17, 1952. (From Nevada Dept. of Highways.)

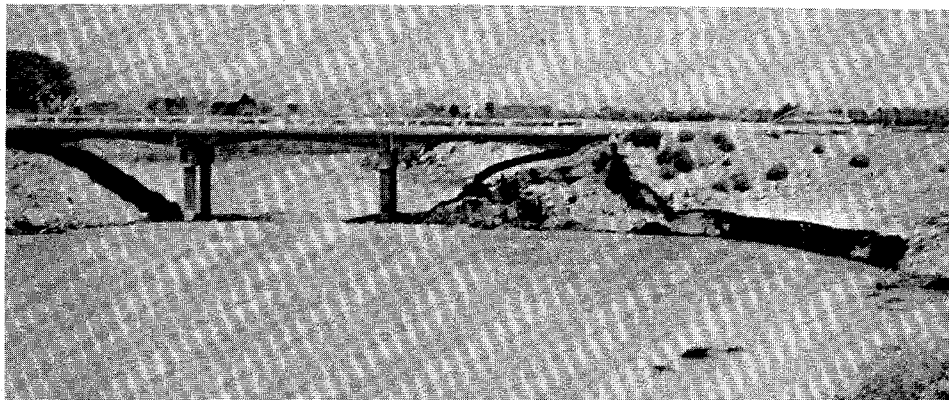
Figure 132. View upstream at bridge during flood of May 2-16, 1952. Note flow constriction caused by abutments and lateral erosion of left bank downstream from bridge. (From Nevada Dept. of Highways.)

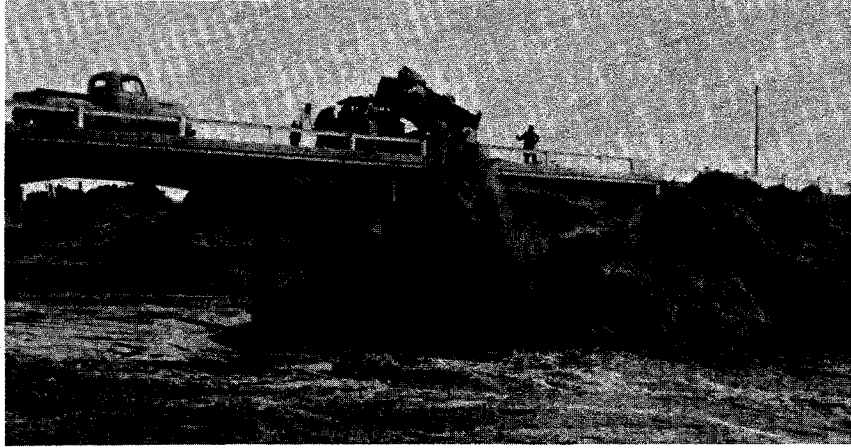
Figure 133. Erosion of sacked concrete from left bank on downstream side of bridge. Note fall in water surface beneath bridge and eddy near left bank causing lateral erosion of approach embankment. (From Nevada Dept. of Highways.)

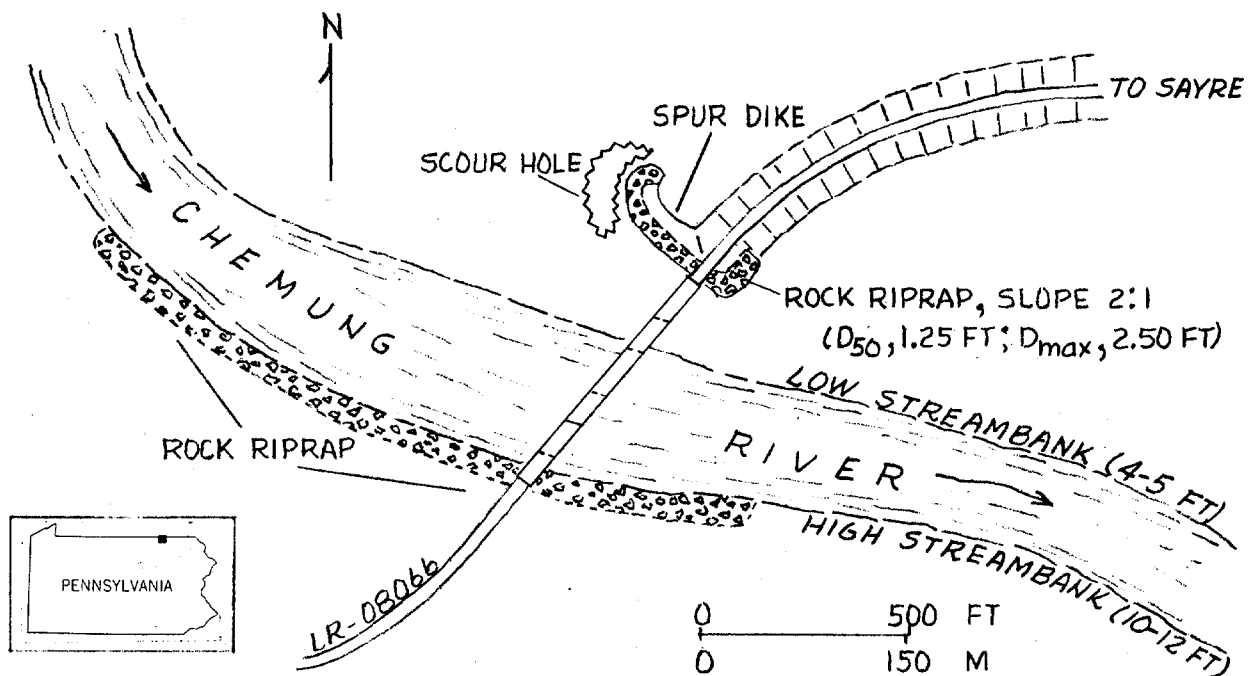
Figure 135. Plan sketch of Chemung River at LR-08066 crossing.

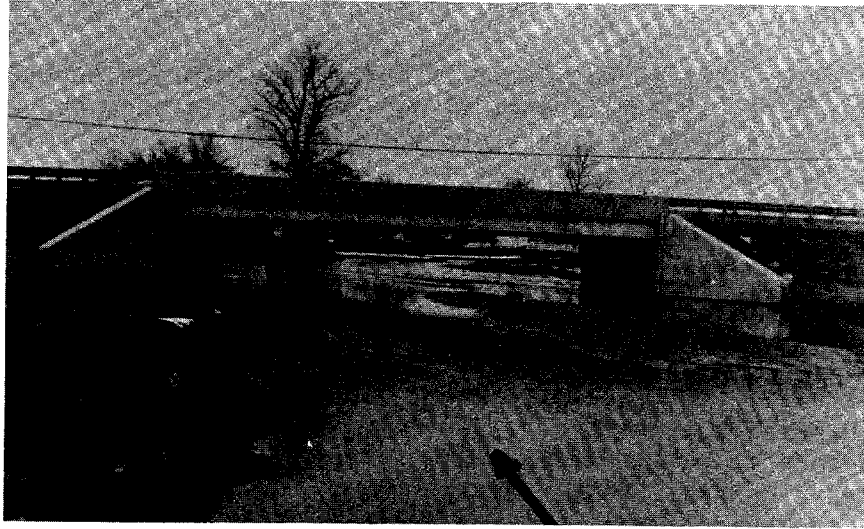
Figure 138. View in 1976 of full-height abutments. Mid-channel bar upstream from bridge is attributed to turbulence near abutments.

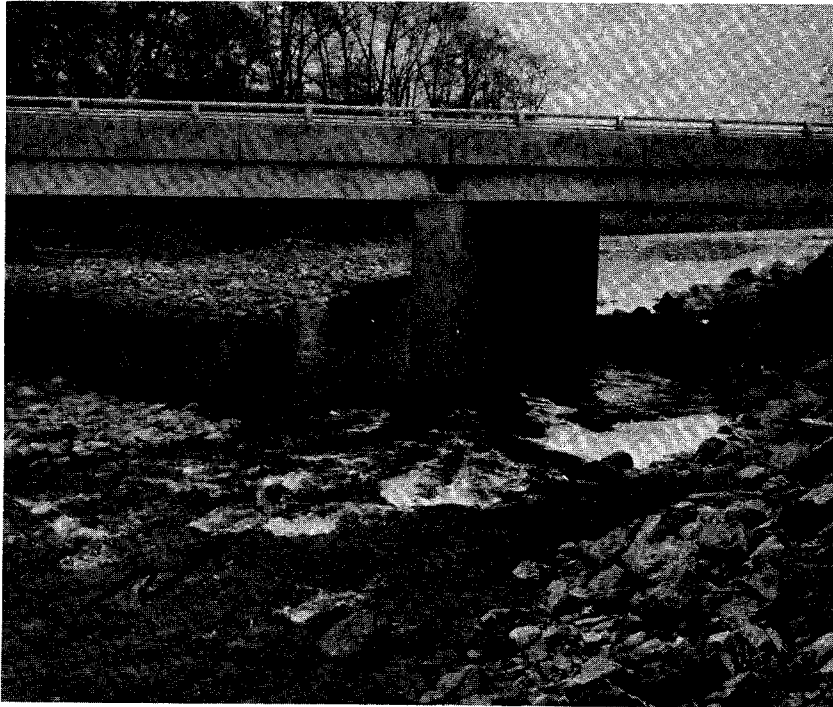
*Figure 140. Flow alinement associated with scour at pier 1, as photographed in 1976.*

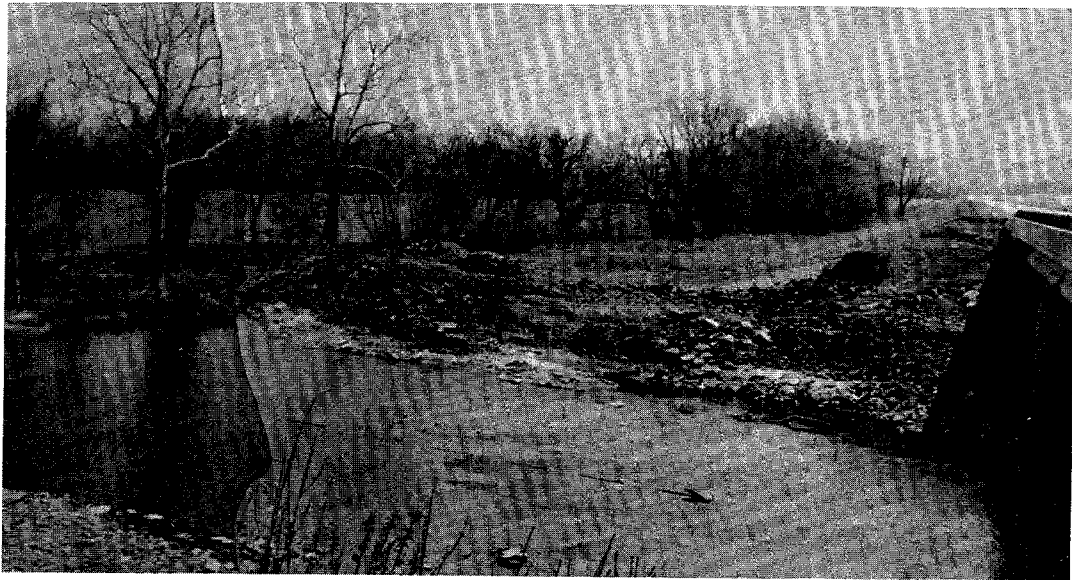
Figure 142. View of damaged spur dike along left bank, in 1976.

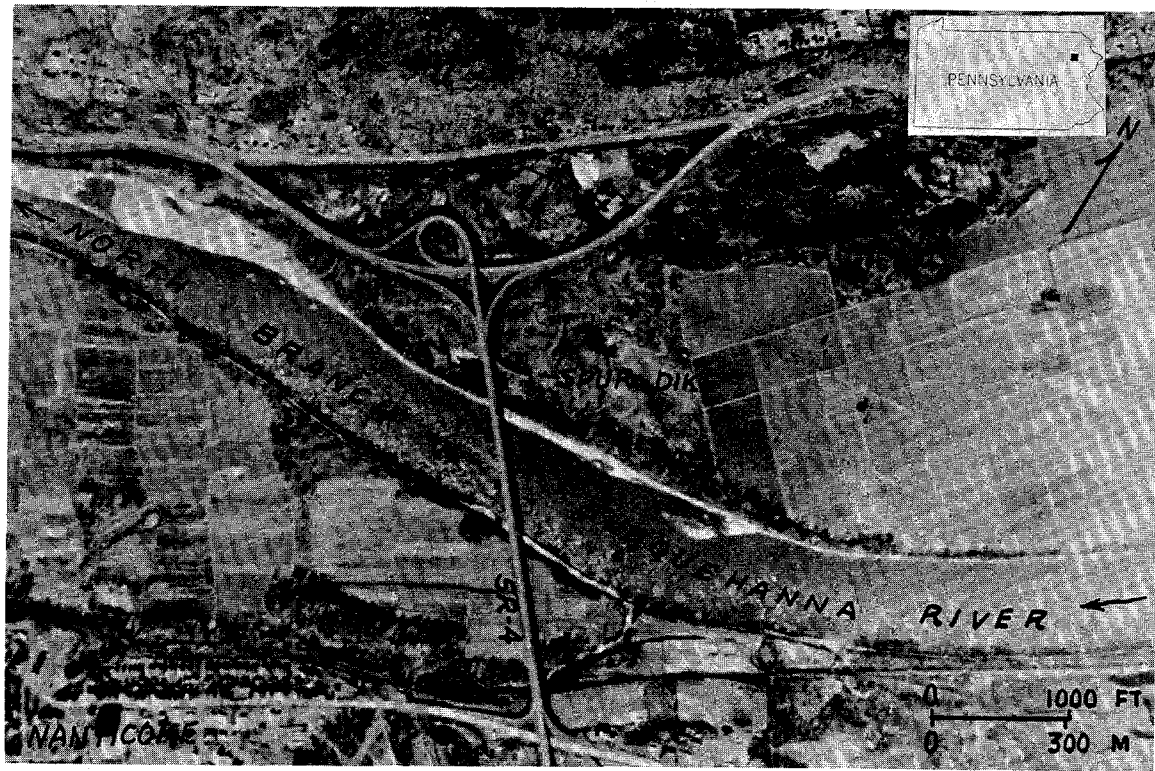
Figure 143. Aerial photograph of SR-4 crossing, North Branch Susquehanna River, January 28, 1969. (From U.S. Geological Survey.)

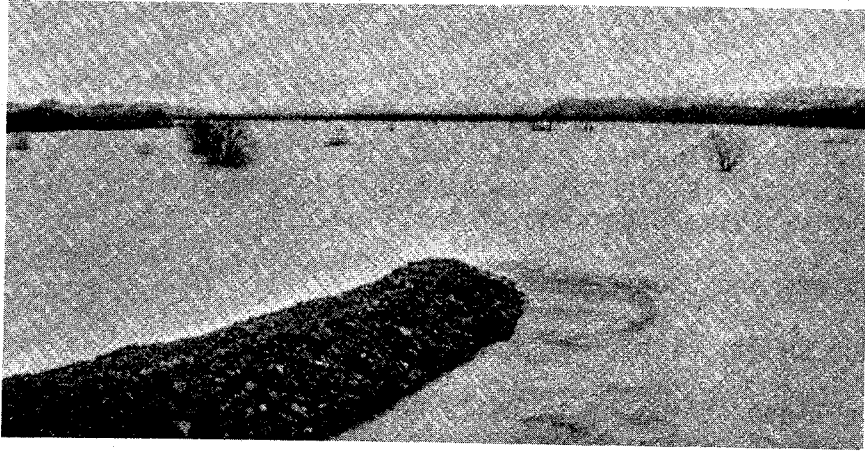
Figure 144. Upstream view of spur dike at SR-4 crossing, during flood of March 1964.

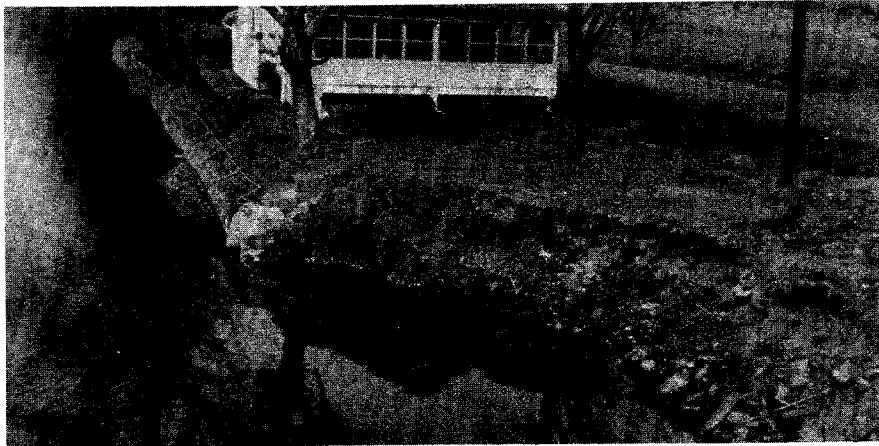
*Figure 146. Erosion of left bank between retaining wall and bridge, as photographed in 1976.*

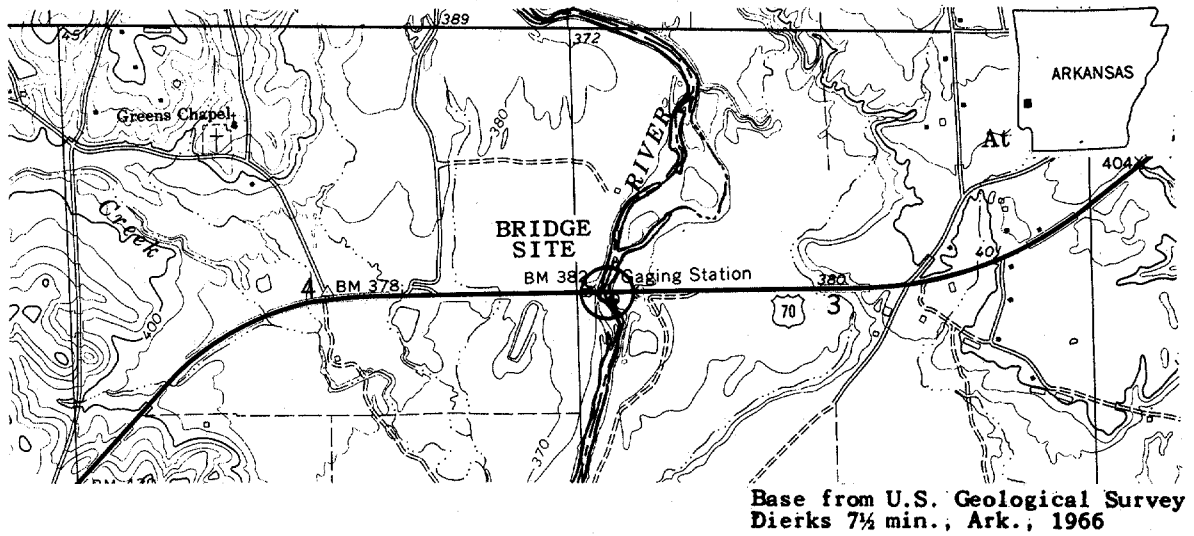
Figure 148. Location of Saline River at US-70 near Dierks, Arkansas.

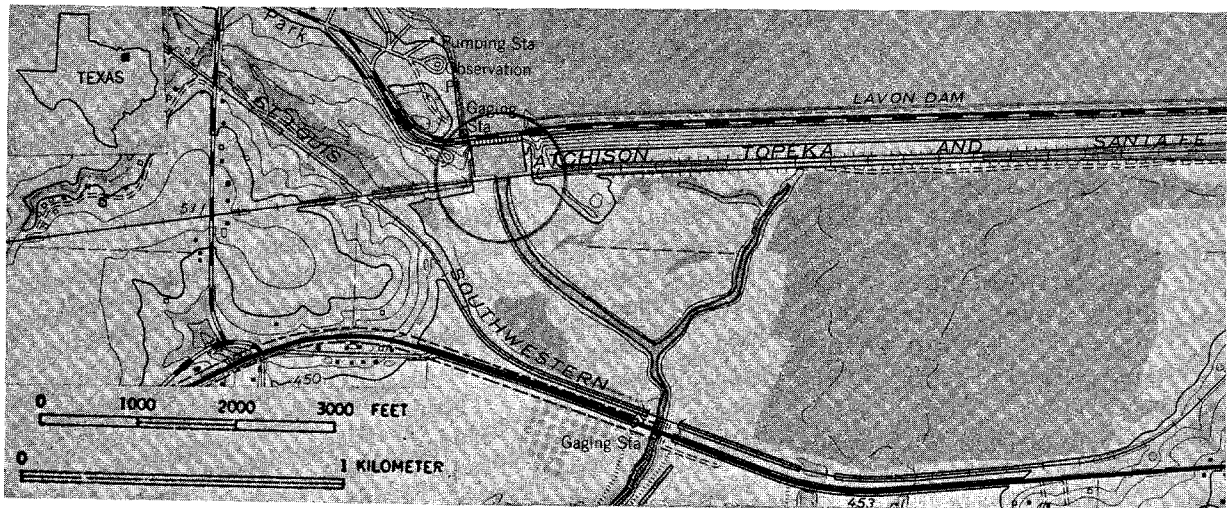
Figure 153. Location of bridge (circled) on Atchison, Topeka, and Santa Fe Railroad, downstream from Lavon Dam. (Base from U.S. Geol. Survey Lavon 7.5' quadrangle, Texas, contour interval 10 ft, 1963.)

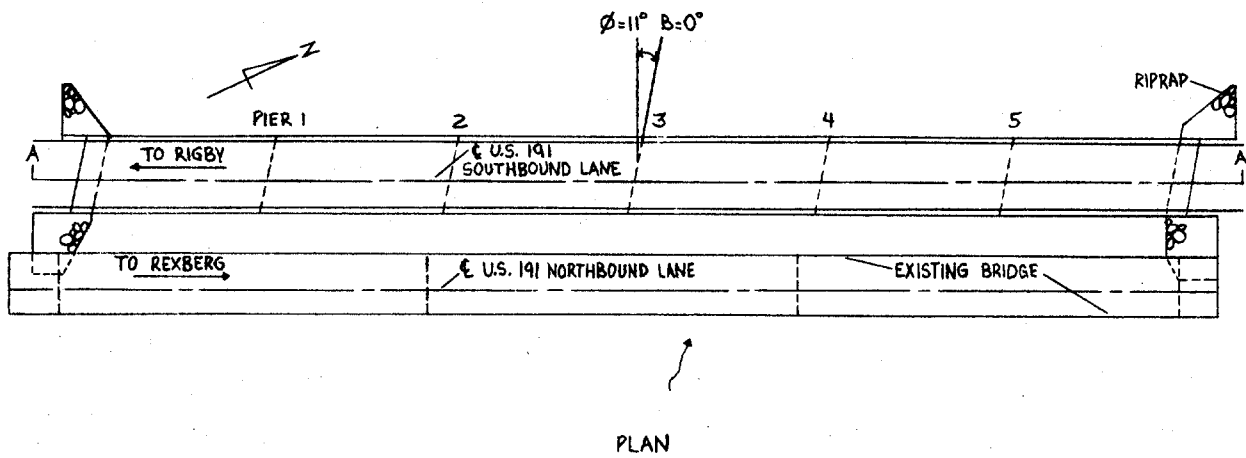
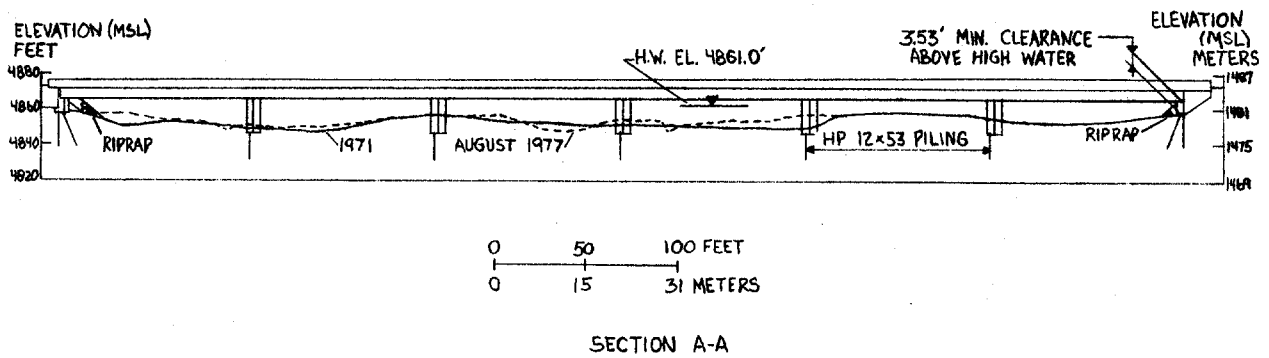
Figure 155. Plan and cross section at bridge site.

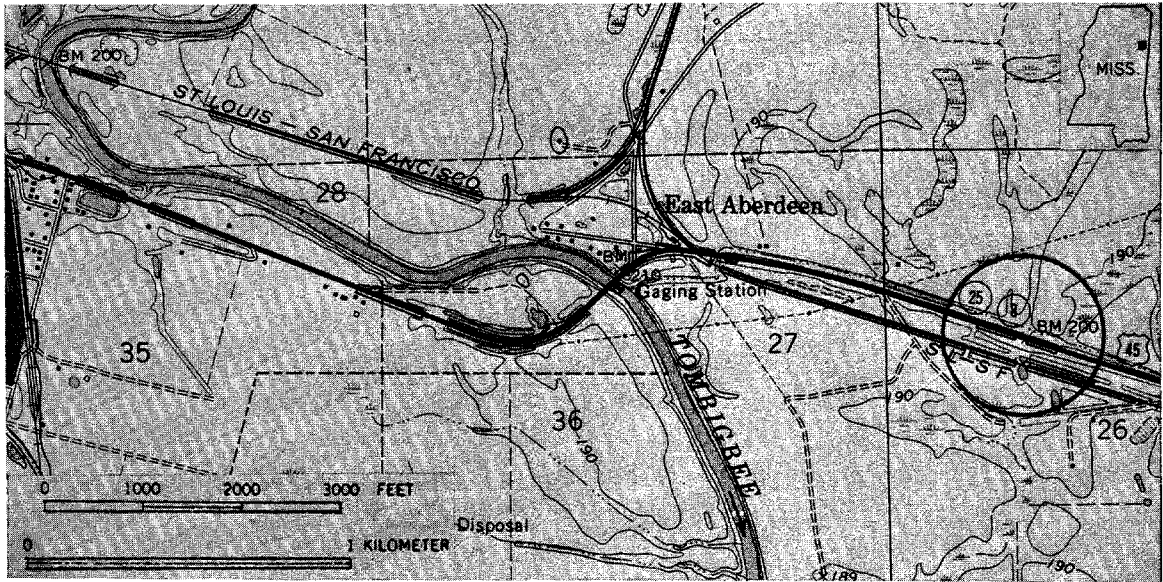
Figure 157. Location of Tombigbee River relief bridge 2 (circled). (Base from U.S. Geol. Survey Aberdeen, Miss., 7.5' quadrangle, contour interval 10 feet, 1966.)

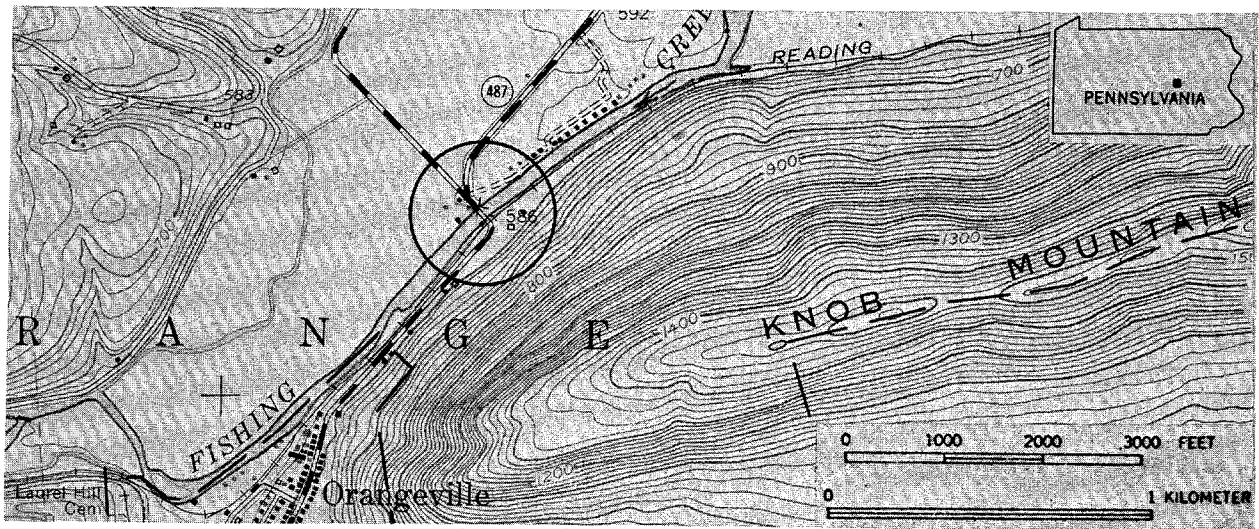
Figure 163. Location of SR-487 crossing, Fishing Creek. (Base from U.S. Geol. Survey Bloomsburg, Pa., 7.5' quadrangle, contour interval 20 feet, 1953 photorevised 1969.)

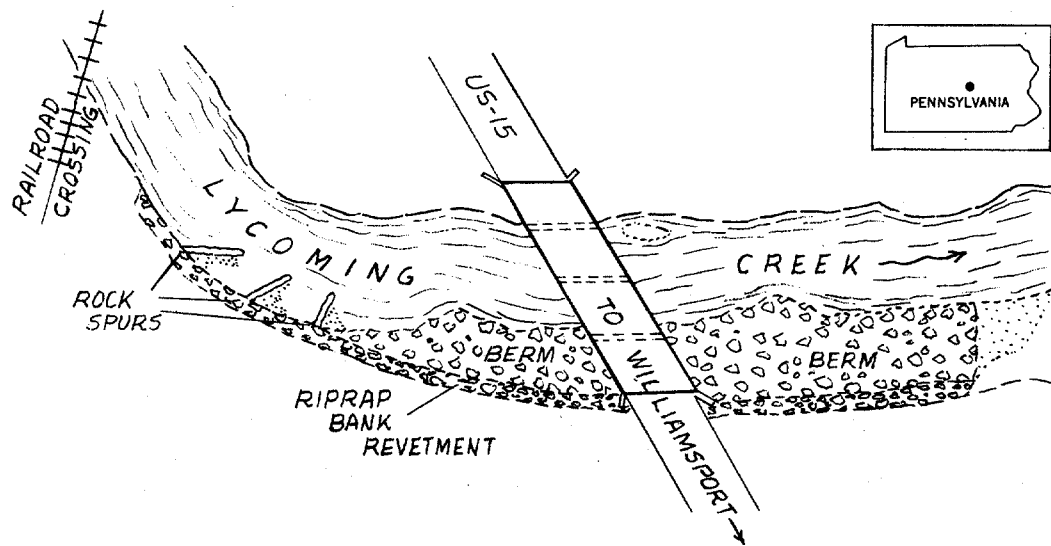
Figure 165. Plan sketch of countermeasures at US-15 crossing, Lycoming Creek.

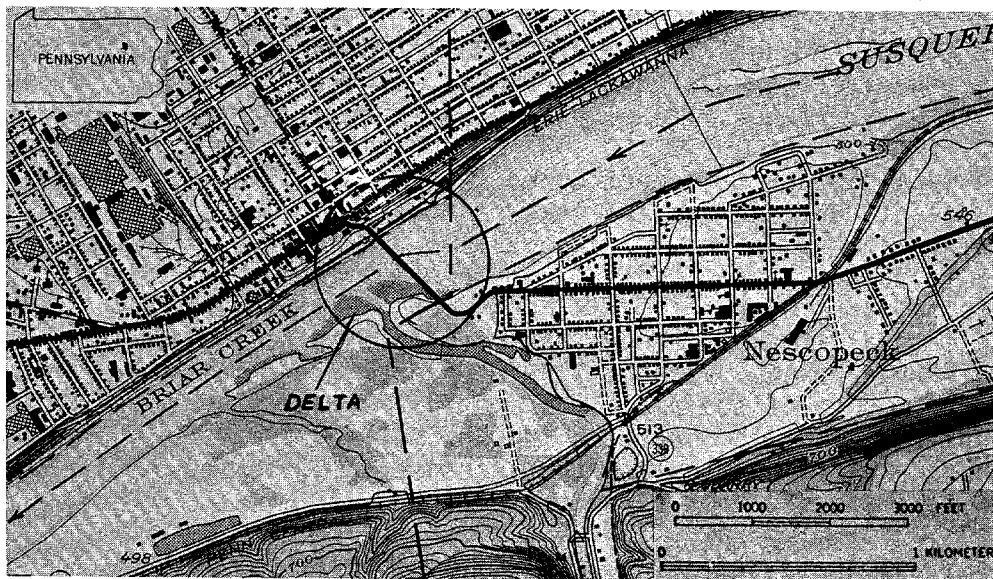
Figure 167. Location of North Branch Susquehanna River at SR-93 (circled). (Base from U.S. Geol. Survey Berwick, Pa., 7.5' quadrangle, contour interval 20 feet, 1955 photorevised 1969.)

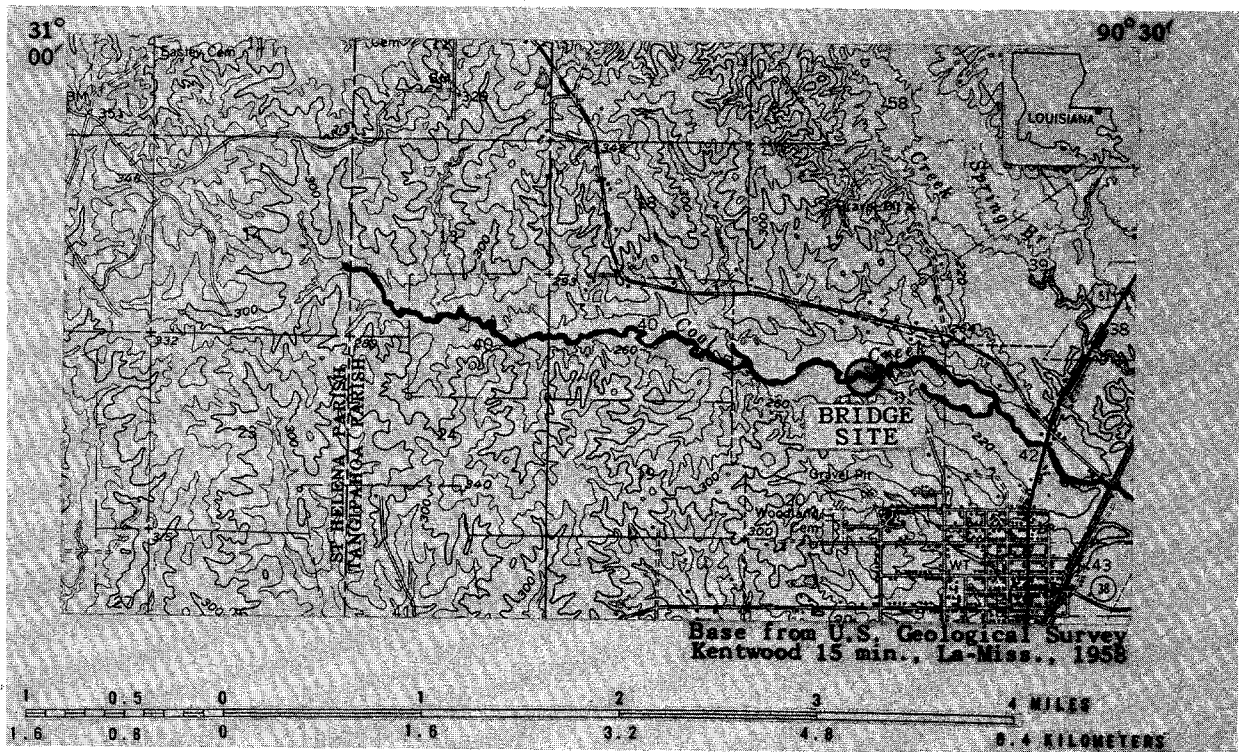
Figure 169. Location of Cool Creek at I-55 near Kentwood, Louisiana.

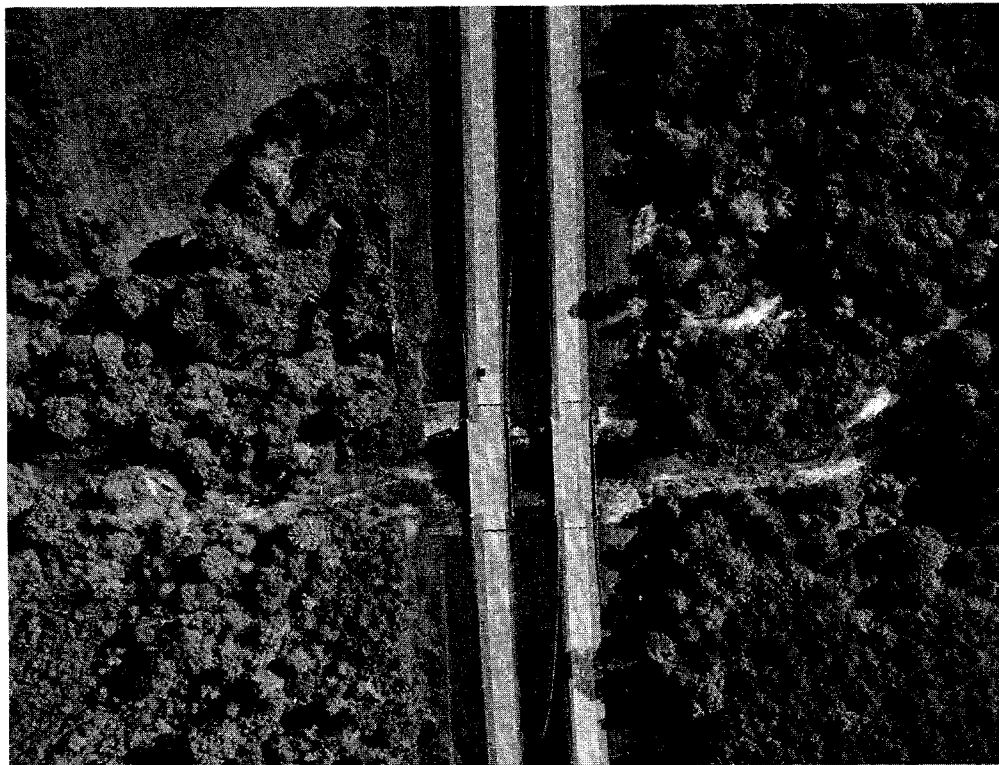
Figure 172. Aerial view of bridge site in 1975 showing failure of abutment protection and location of former creek channel. (From Louisiana Dept. of Highways.)

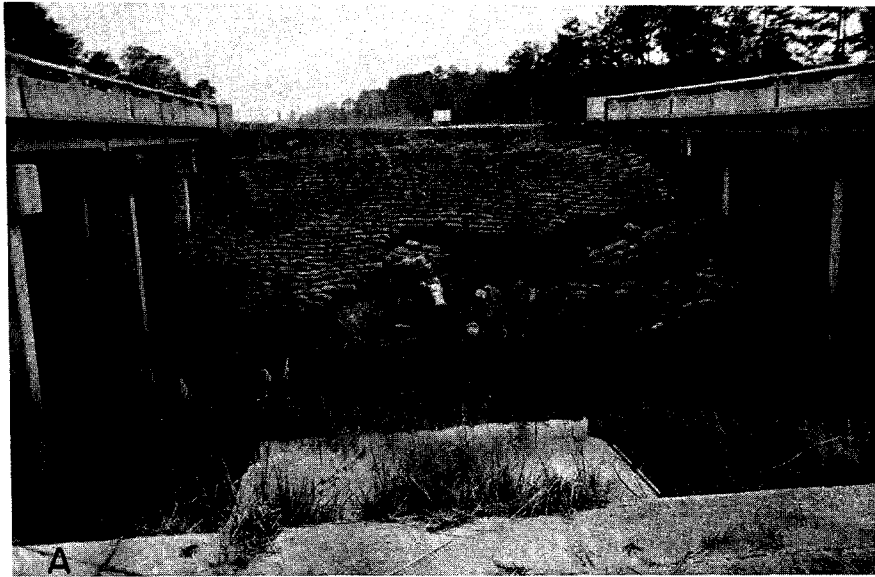
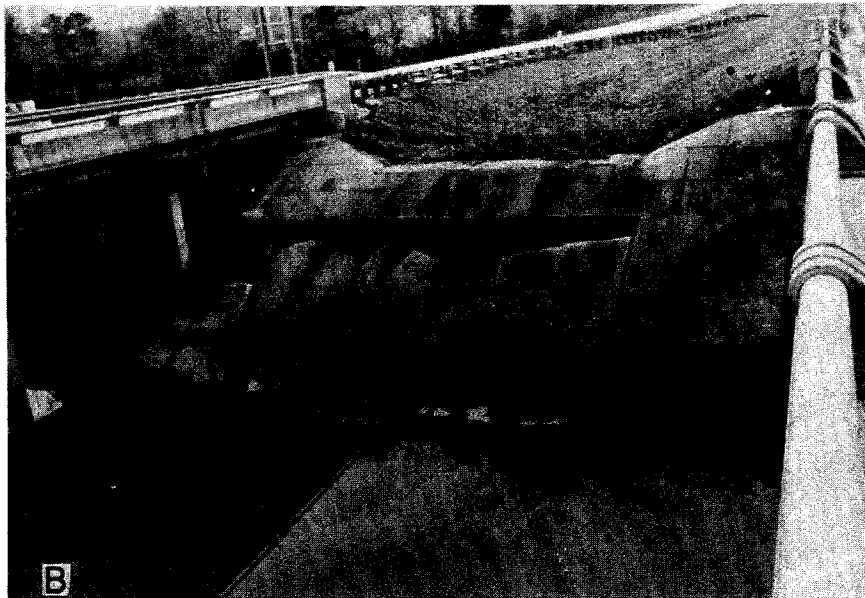
*Figure 173. A, sacked concrete revetment and B, concrete pavement damaged in 1974 flood, as photographed in 1976.*

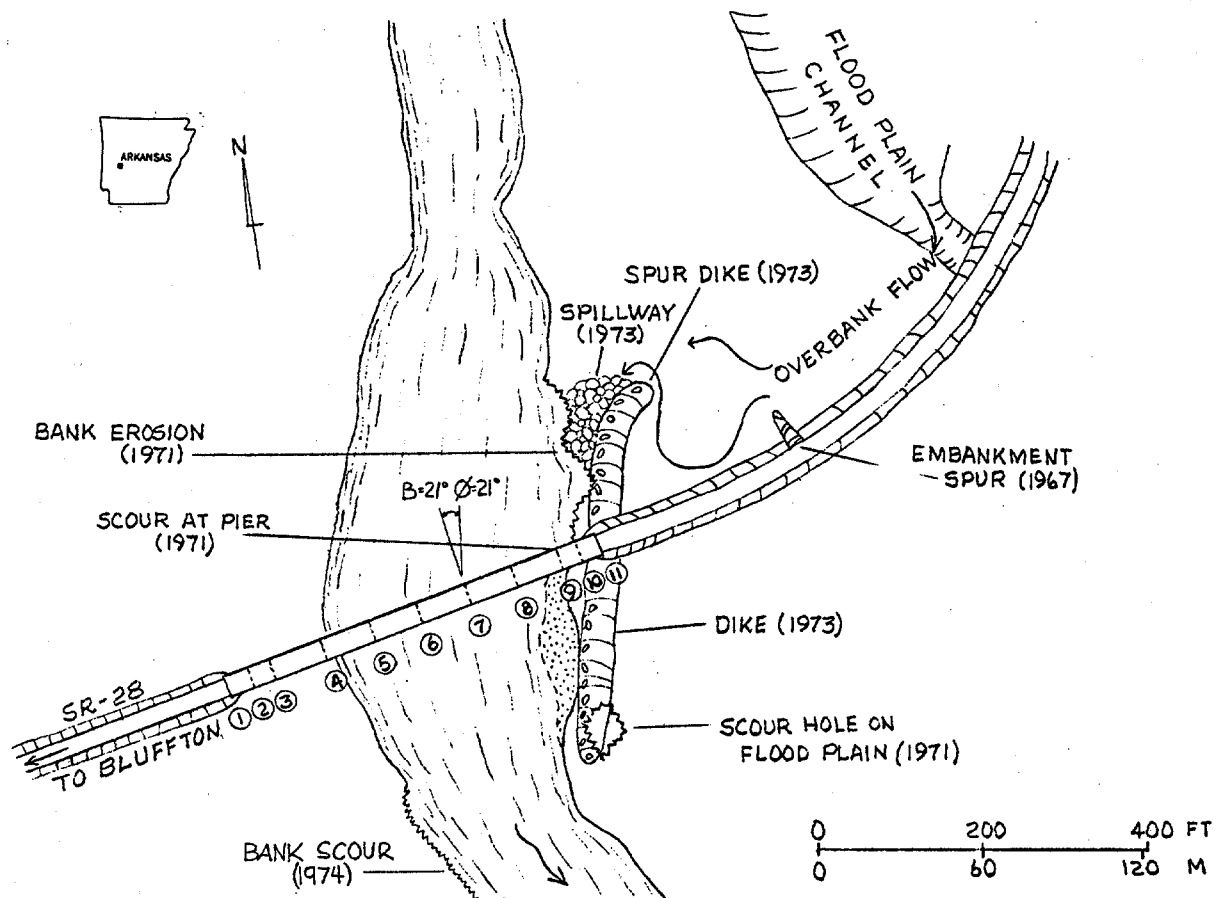
Figure 174. Plan of Fourche La Fave River at SR-28. (Based on aerial photograph dated 12-27-72.)

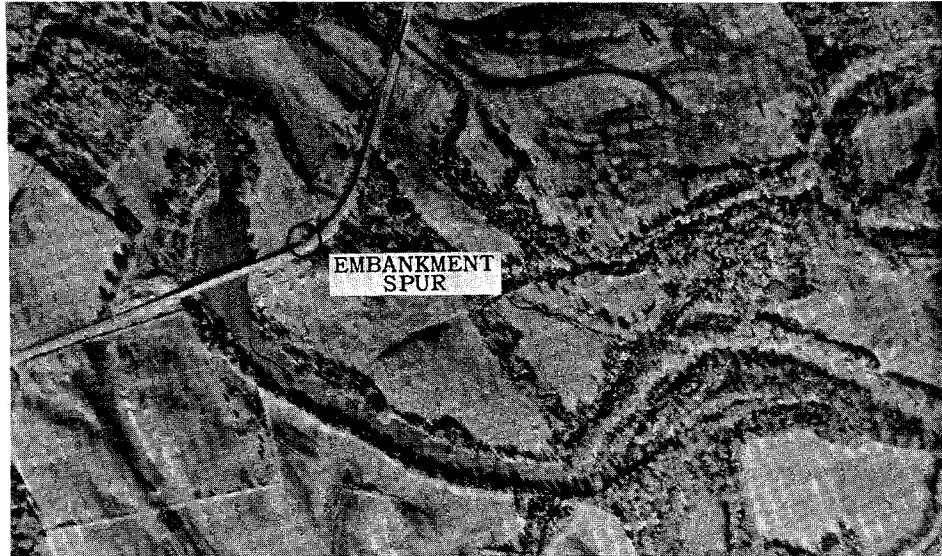
Figure 175. Aerial photograph of Fourche La Fave River at SR-28, taken in 1972 prior to installation of countermeasures. (From Arkansas Dept. of Highways.)

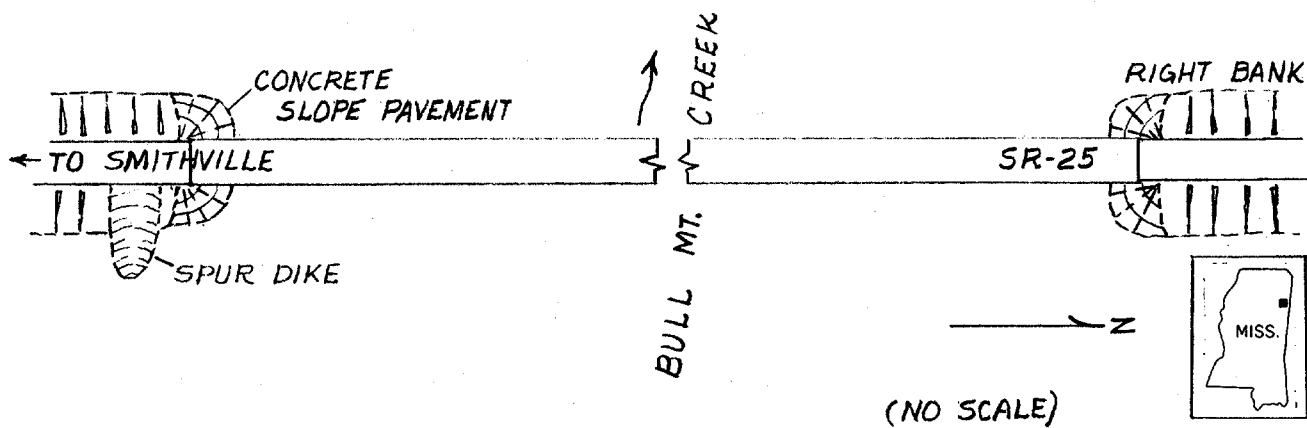
Figure 177. Plan sketch of SR-25 crossing at Bull Mountain Creek.

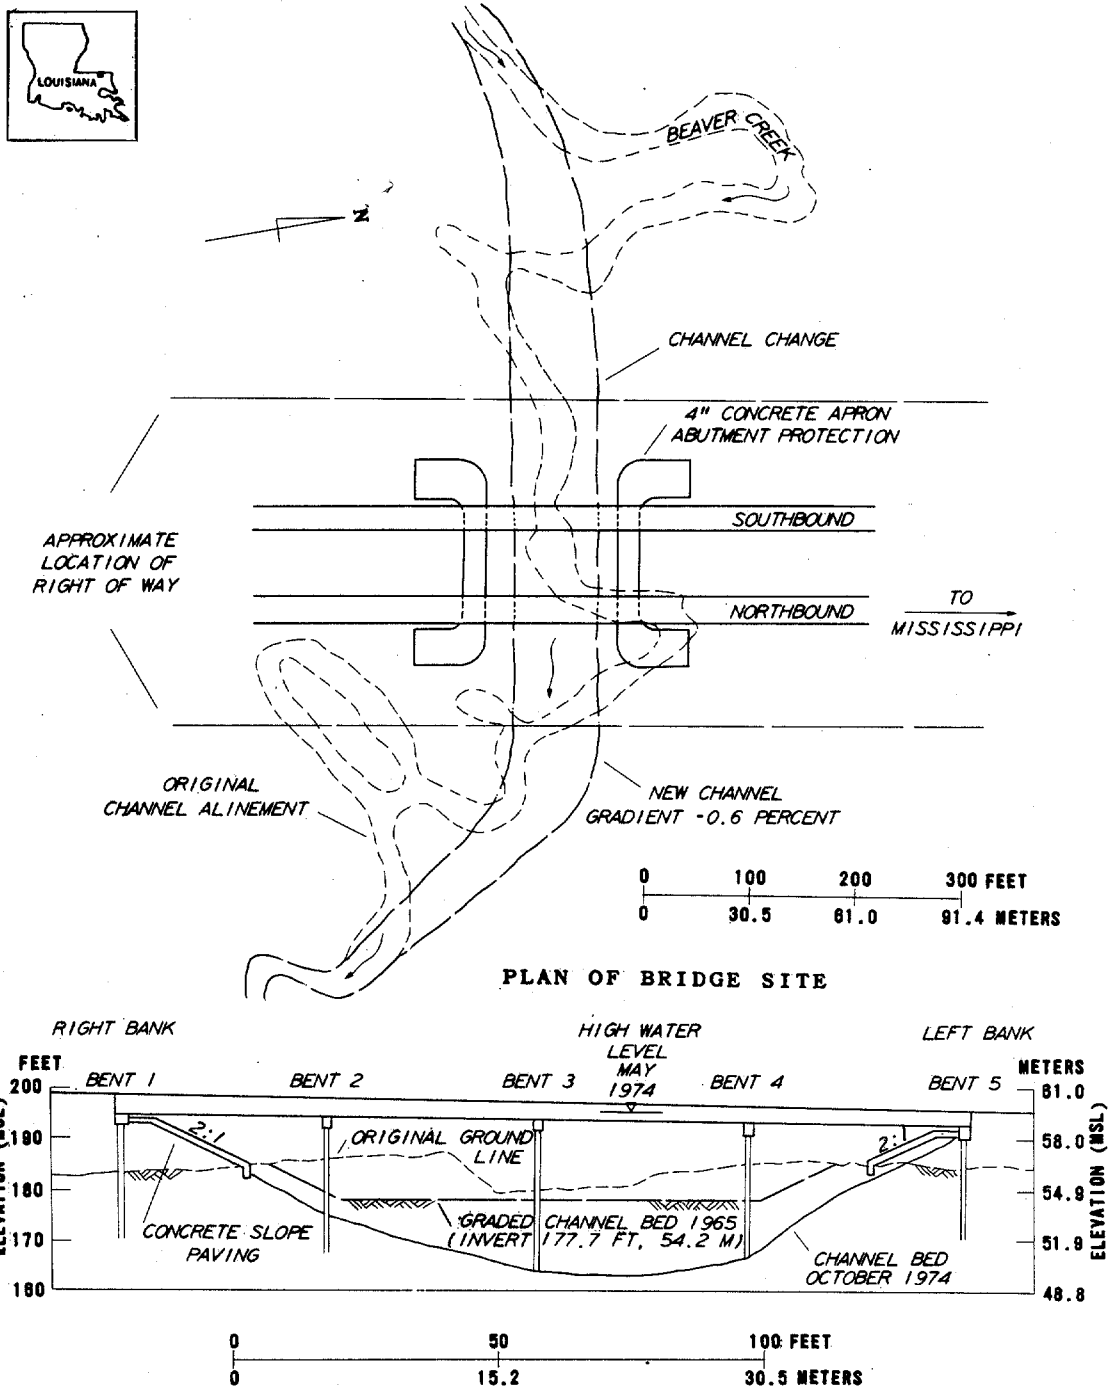
Figure 179. Plan and cross section of Beaver Creek at I-55 bridge.
