Report No. FHWA-RD-78-163

Hydraulics Branch  
Library

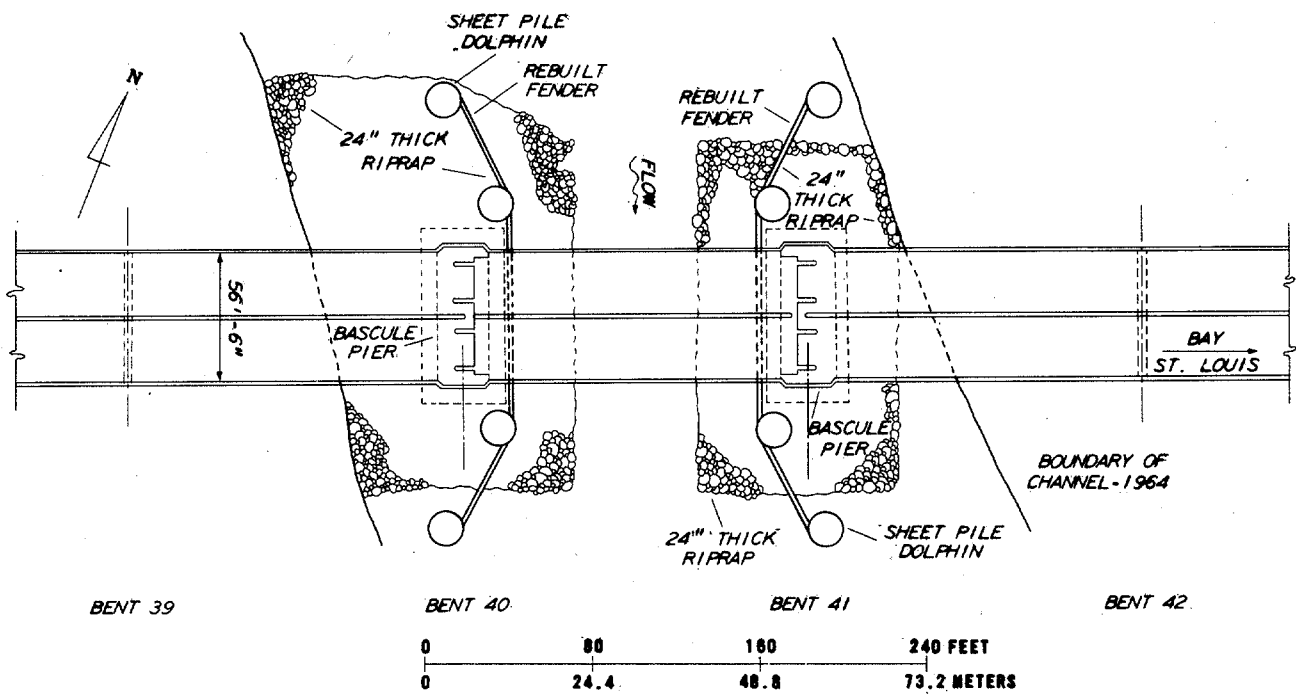
Figure 188. Plan of main channel and bridge footing repairs.

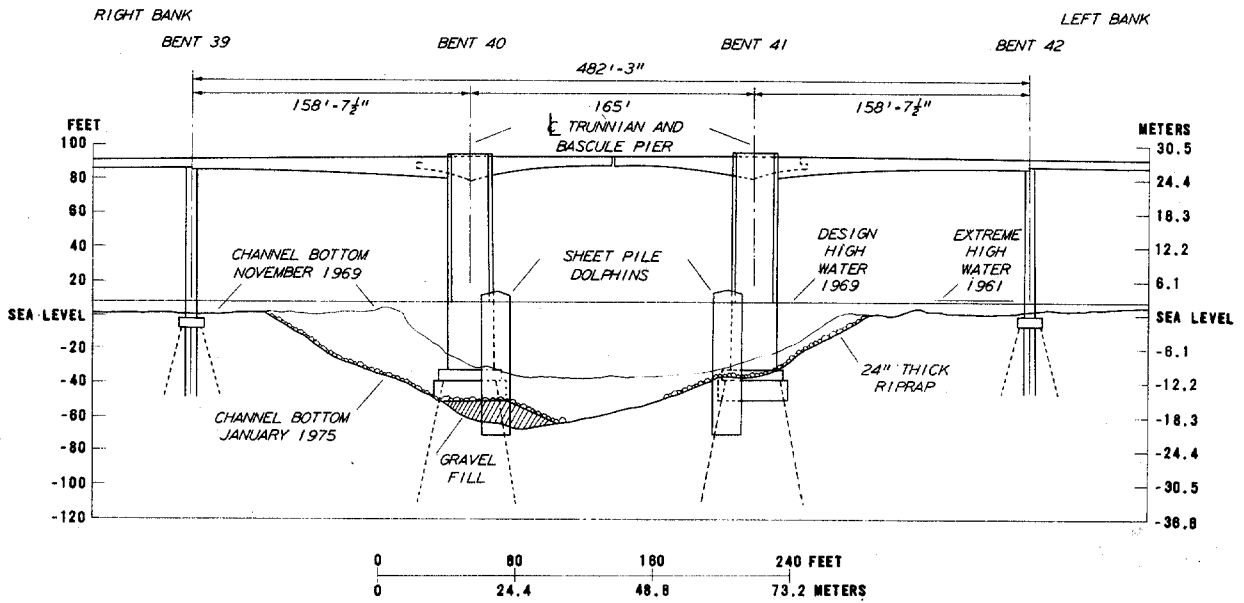
Figure 189. Cross section of main channel showing bridge footing repairs.

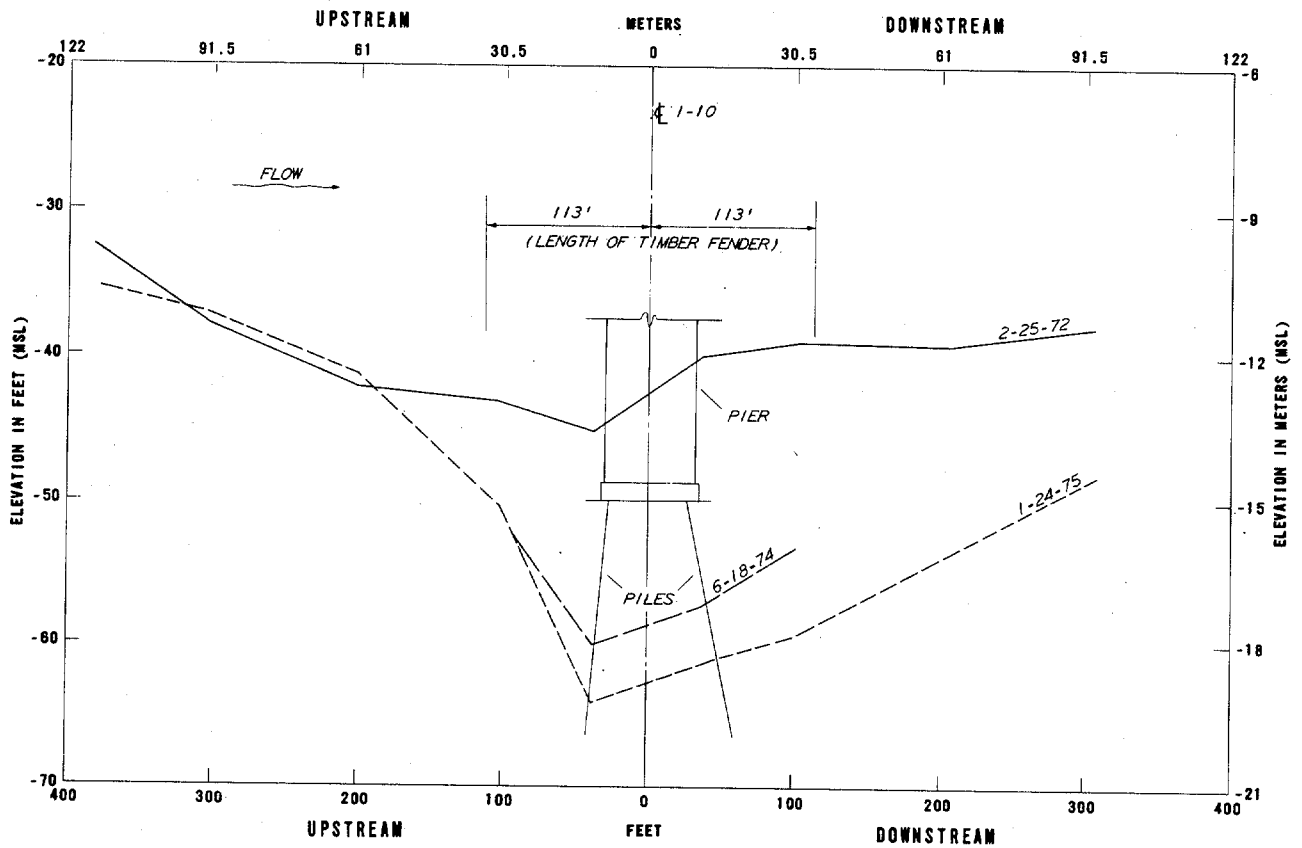
Figure 190. Changes in channel bed profile at bridge between 1972 and 1975.

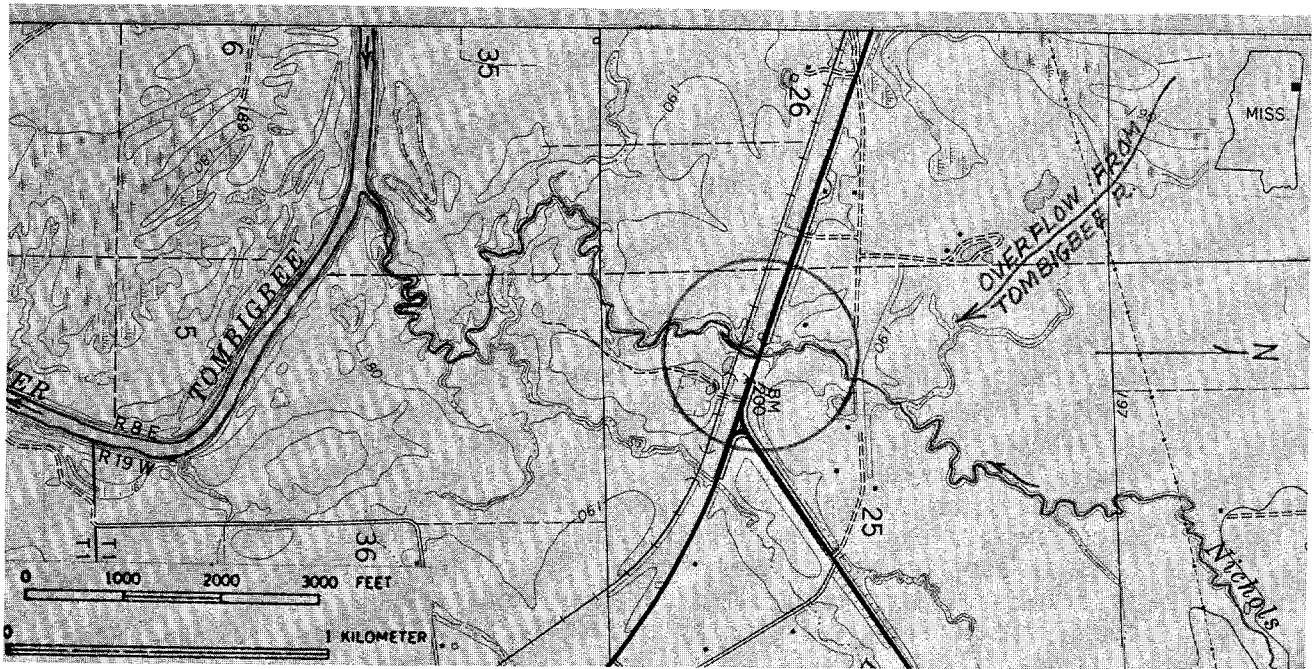
Figure 191. Location of US-45 crossing, Nichols Creek. (Base from U.S. Geol. Survey Amory SW, Miss., 7.5' map, contour interval 10 feet, 1966.).

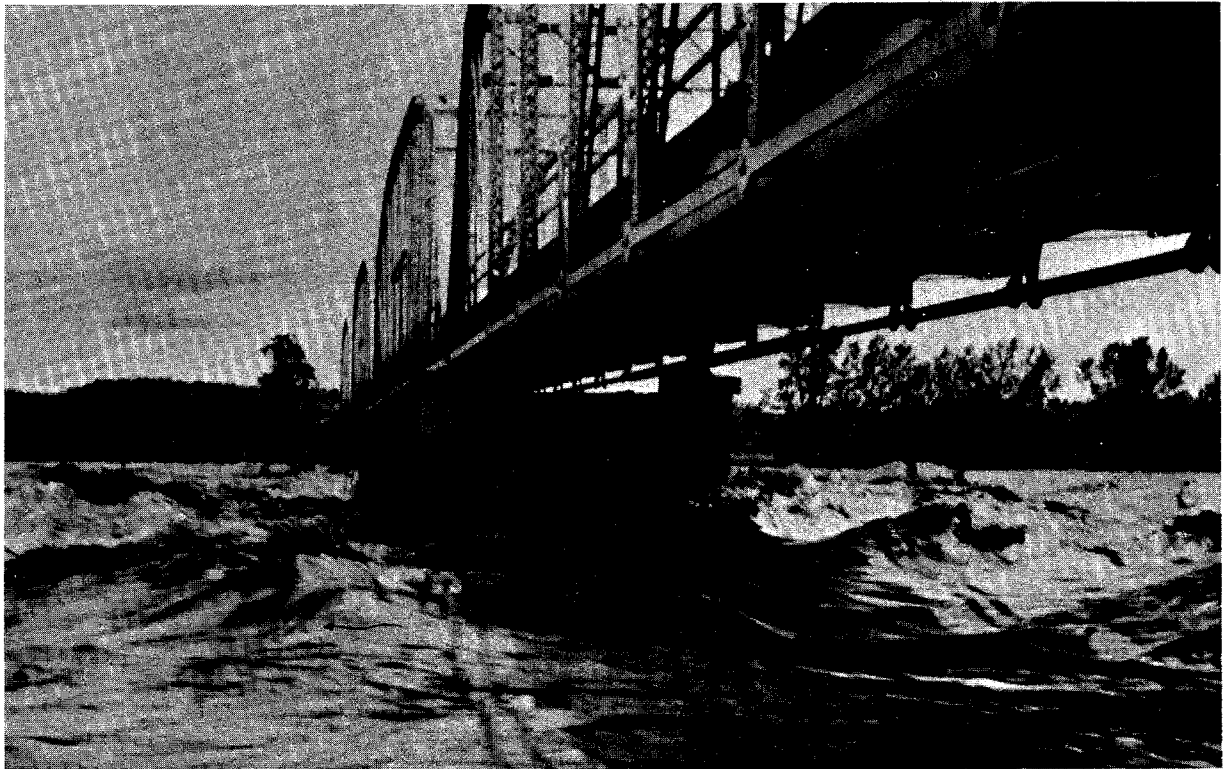
Figure 196. Flood of May 5, 1941 at US-75 truss bridge, built in 1919. Note pileup of water at upstream face of pier.

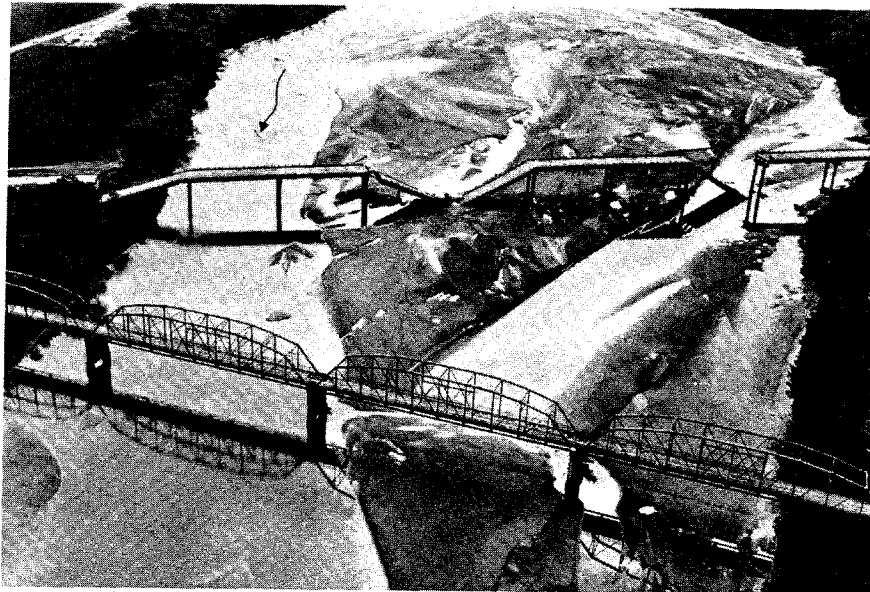
Figure 198. Failure in May, 1976 of US-75 and 270 concrete-beam bridge built in 1966. Older truss bridge in foreground. (Photograph from the Oklahoma Journal.)

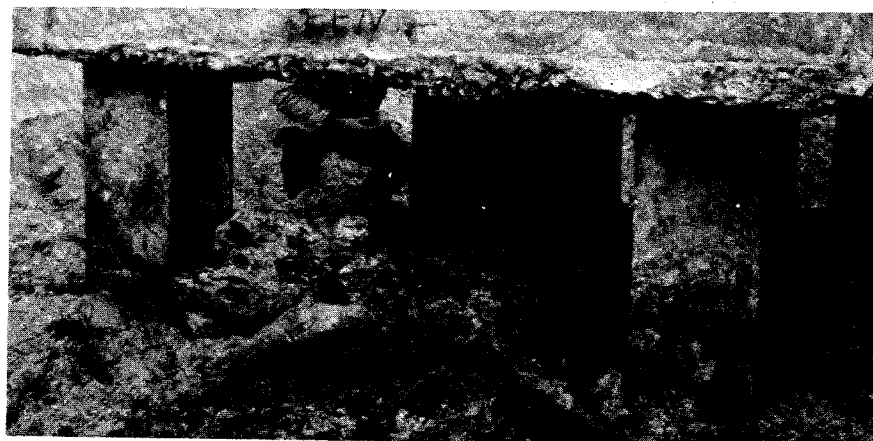
Figure 199. Wood debris lodged under pier 9 during a flood event prior to 1976. (From Federal Highway Administration.)

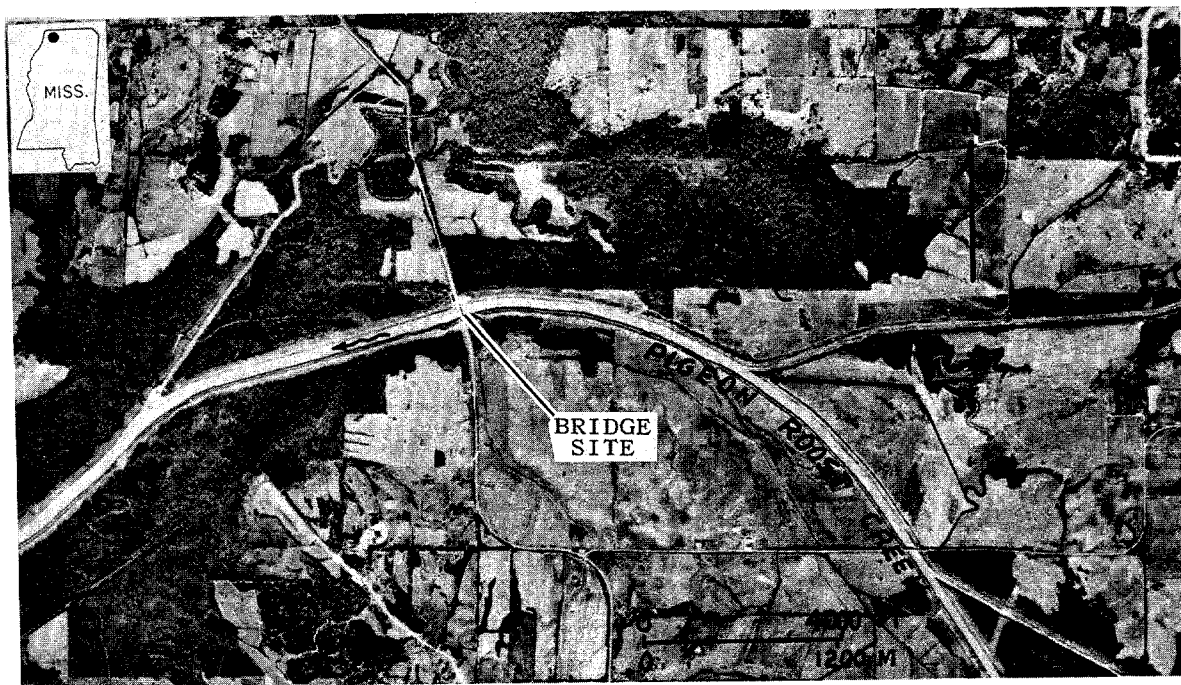
Figure 202. Aerial photograph of Pigeon Roost Creek at SR-305. (From Mississippi Dept. of Highways, 1974.)

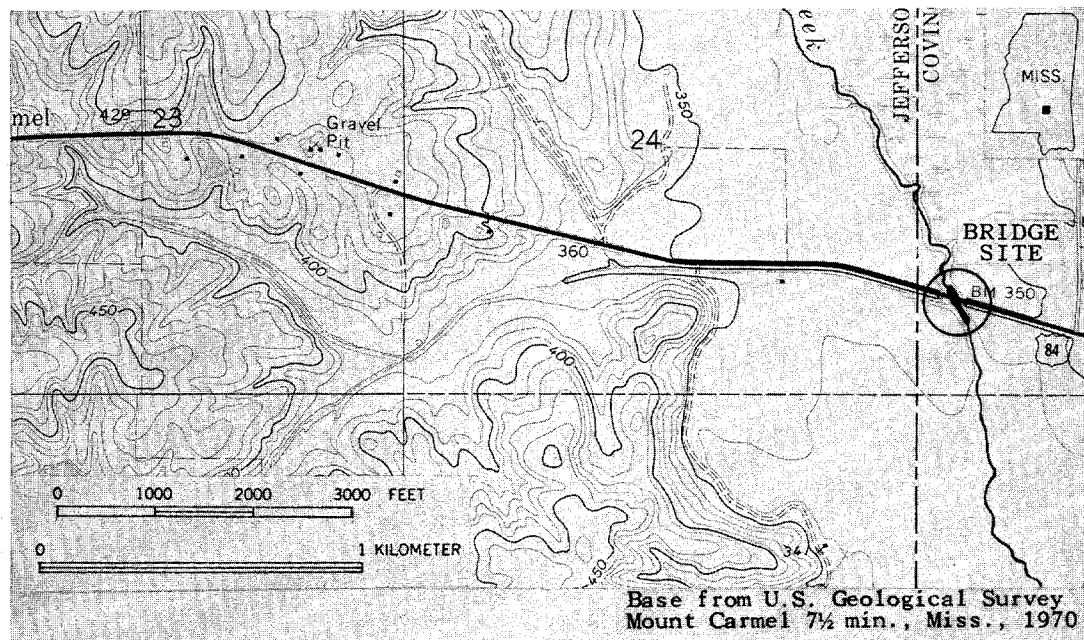
Figure 203. Location of Bowie Creek at US-84 near Collins, Mississippi.

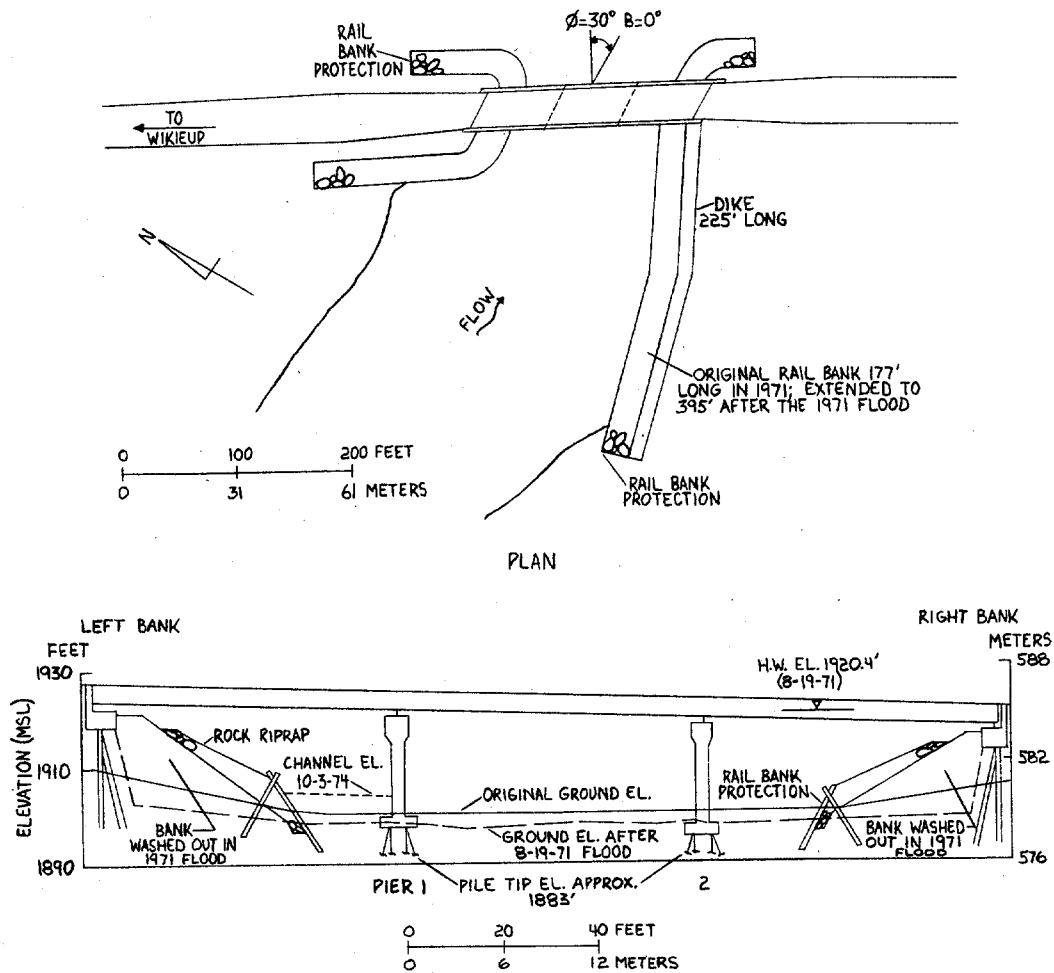
Figure 207. Details of Bronco Creek bridge.

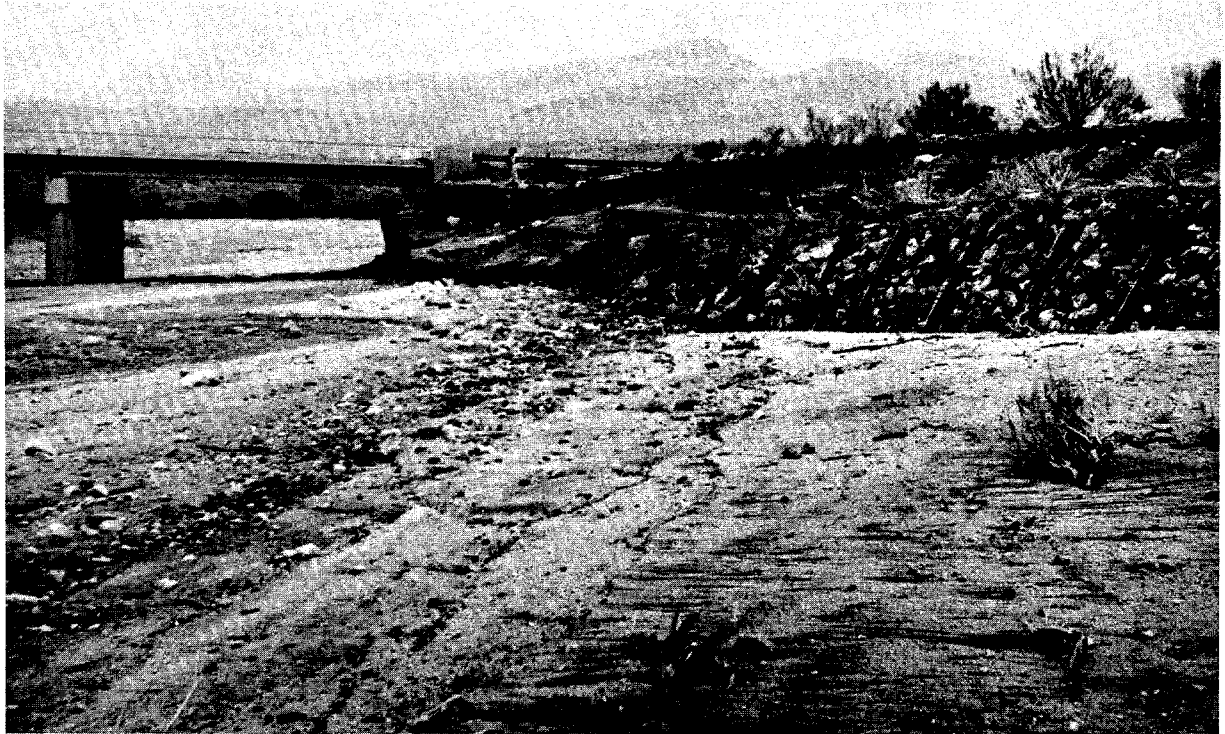
Figure 209. Damaged railbank protection on right bank upstream from bridge after August 1971 flood. (From Arizona Dept. of Highways.)

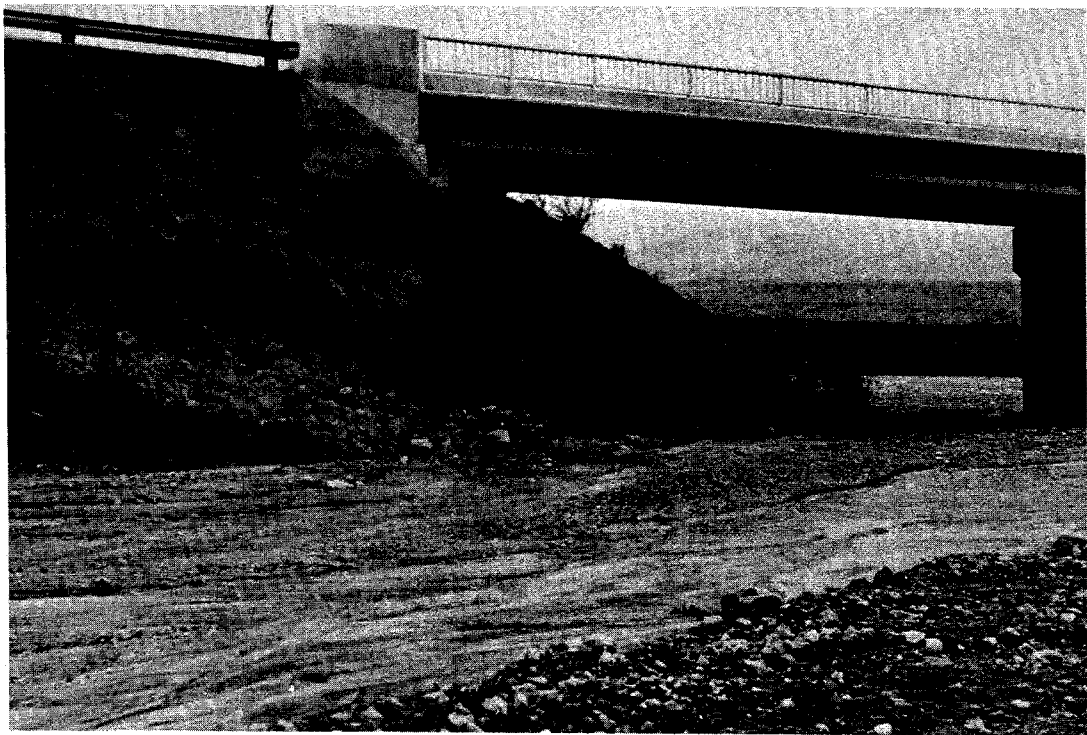
Figure 210. View of eroded left bank abutment after the 1971 flood. (From Arizona Dept. of Highways.)

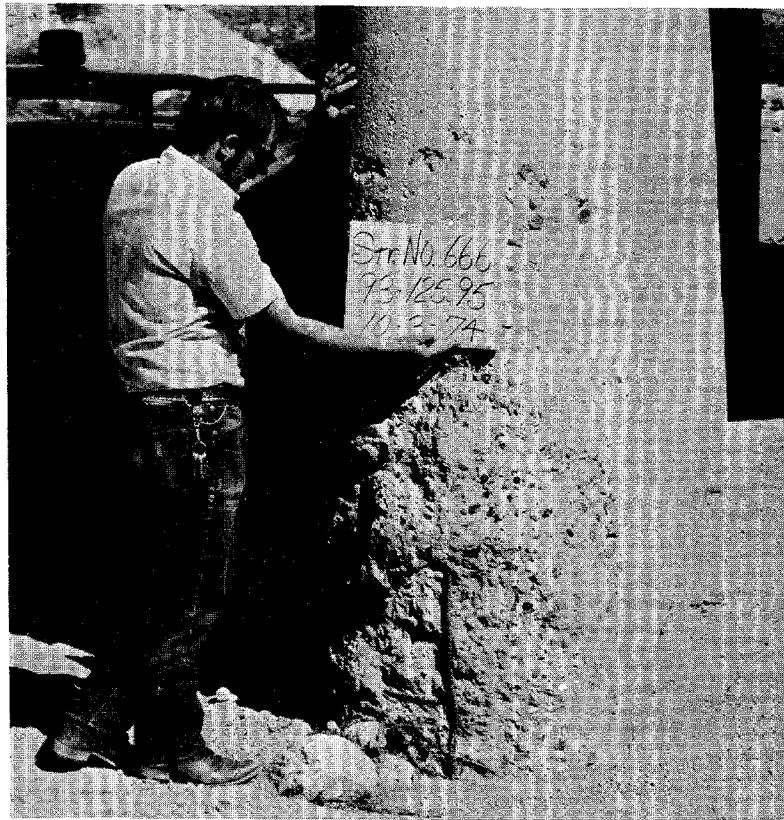
Figure 211. Abrasion damage on upstream side of pier, in 1974. (From Arizona Dept. of Highways.)

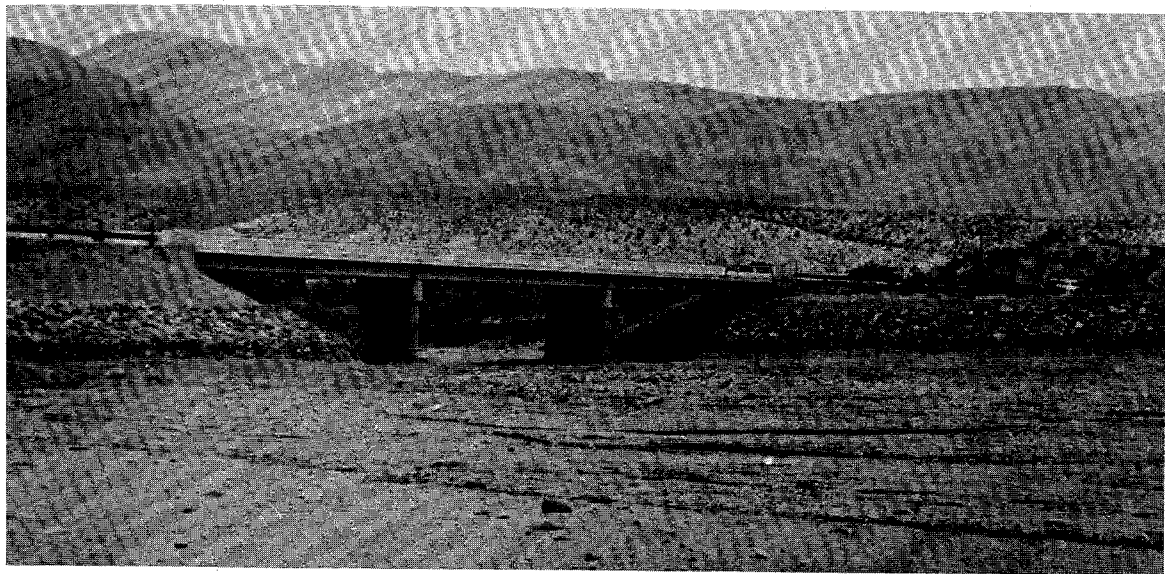
Figure 212. Downstream view of bridge and railbank protection after repairs following 1971 flood. (From Arizona Dept. of Highways.)

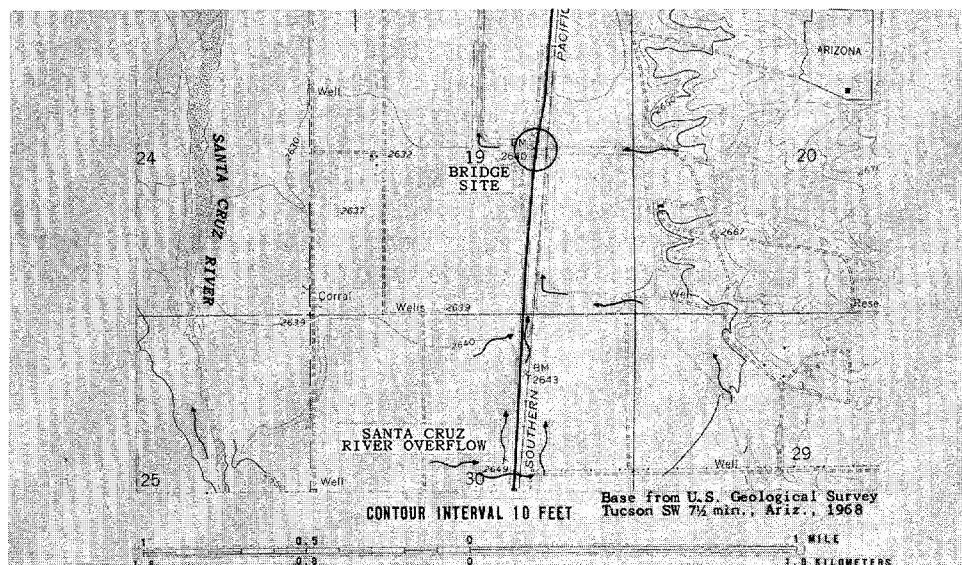
Figure 213. Location of Lee Moore wash at SR-89 near Sahuarita, Arizona.

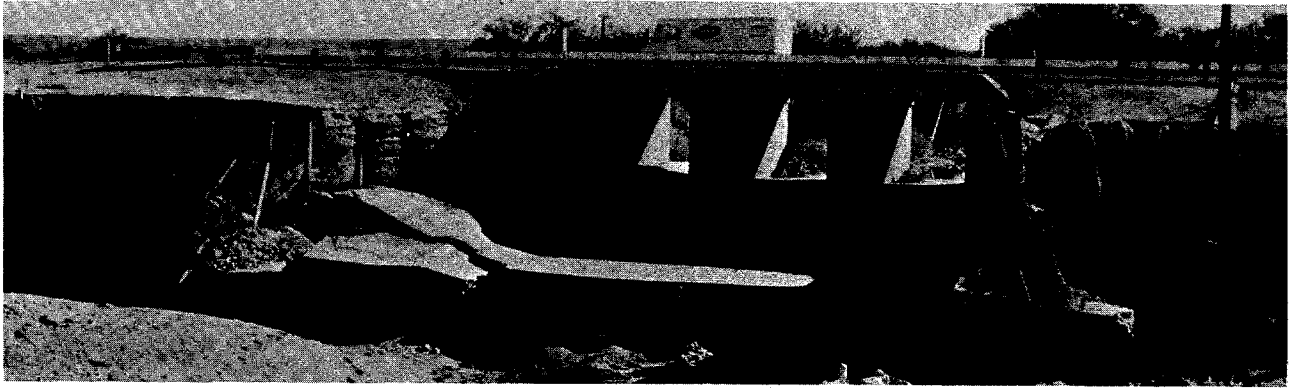
Figure 214. Channel degradation and concrete apron damage at downstream side of bridge in 1971. The concrete apron was added in 1969. (From Arizona Dept. of Highways.)

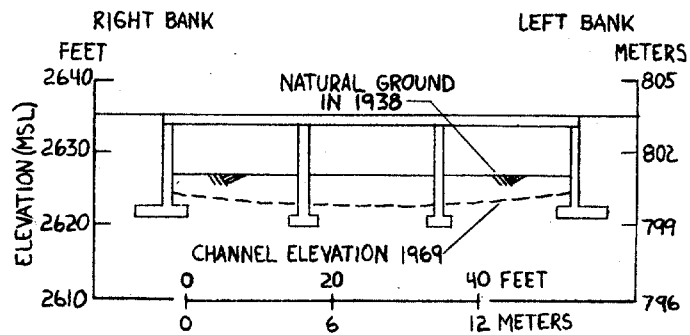
Figure 215. Changes in channel bed elevation between 1938 and 1969.

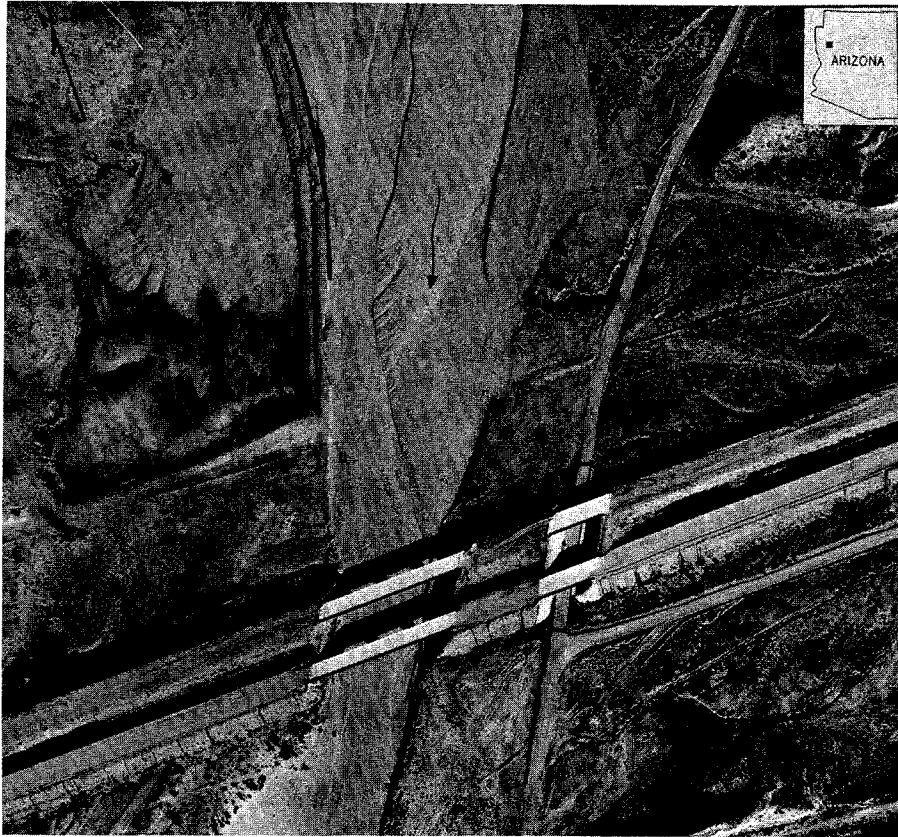
Figure 221. Aerial view of Big Sandy Wash at I-40 showing location of borrow pit on right bank upstream from bridge. Note lateral erosion of levee separating borrow pit from the channel and deposition of sediment at the upstream end of the borrow pit. (From Arizona Dept. of Highways, 1971.)

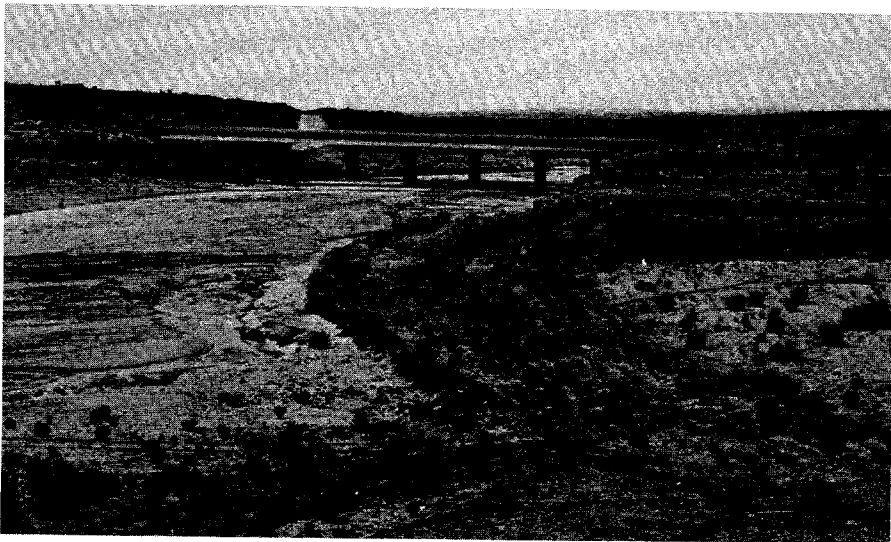
Figure 222. View of borrow pit on right-bank flood plain and damaged rock riprap protection of levee separating channel from borrow pit. (From Arizona Dept. of Highways.)

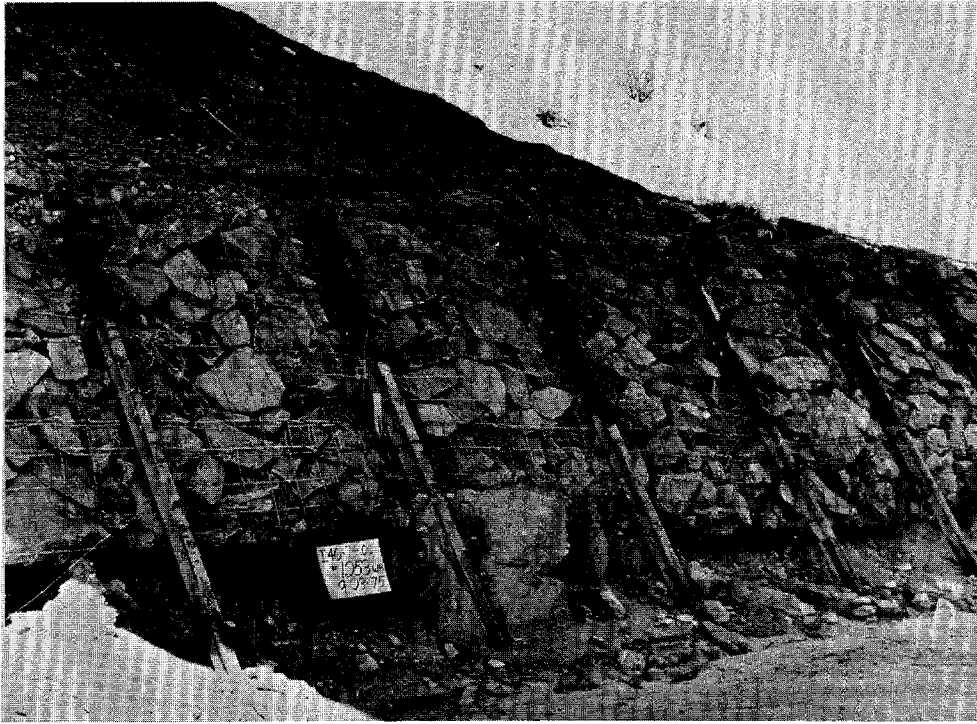
Figure 223. Lateral erosion of railbank (rock-and-wire) protection near upstream left-bank abutment in 1975. (From Arizona Dept. of Highways.)

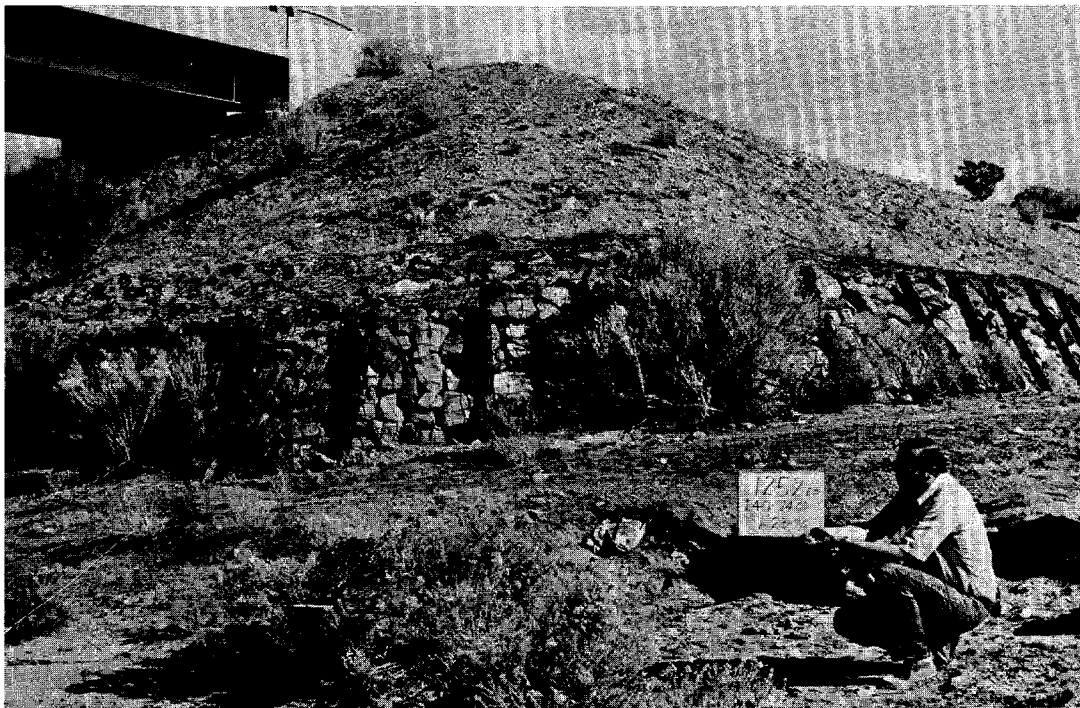
Figure 224. View of downstream left-bank abutment and railbank (rock-and-wire) protection after repairs in 1976. (From Arizona Dept. of Highways.)

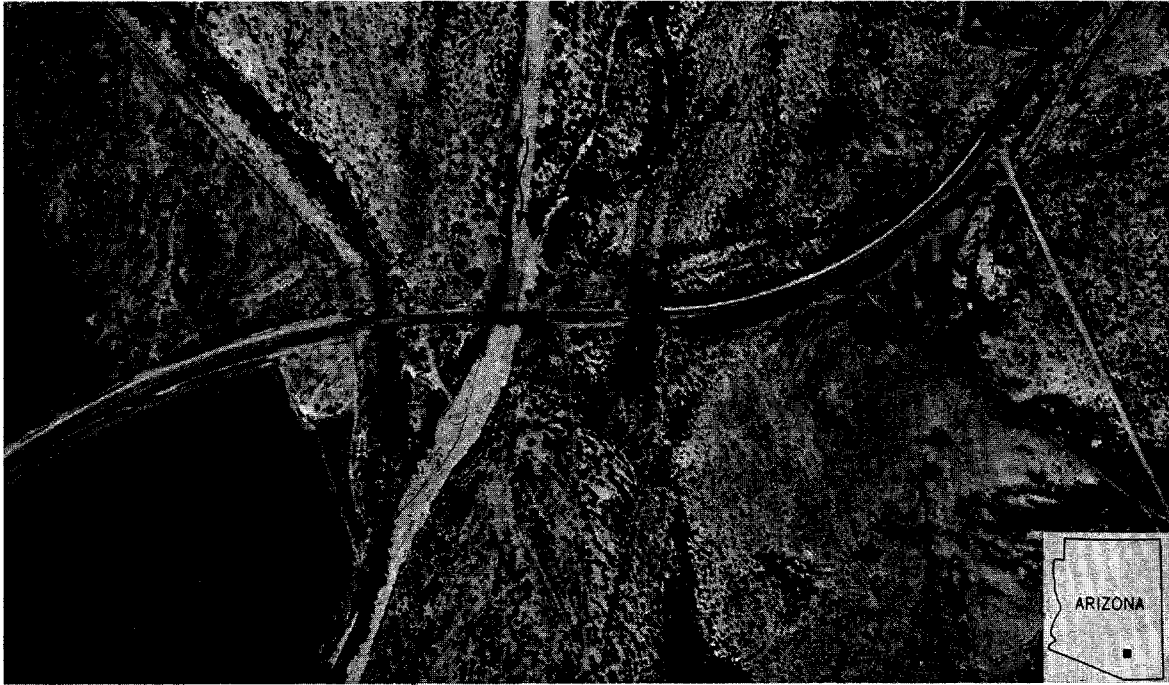
*Figure 225. Aerial photograph in 1973 showing location of main channel and left-bank overflow prior to construction of new bridge. (From Arizona Dept. of Highways.)*

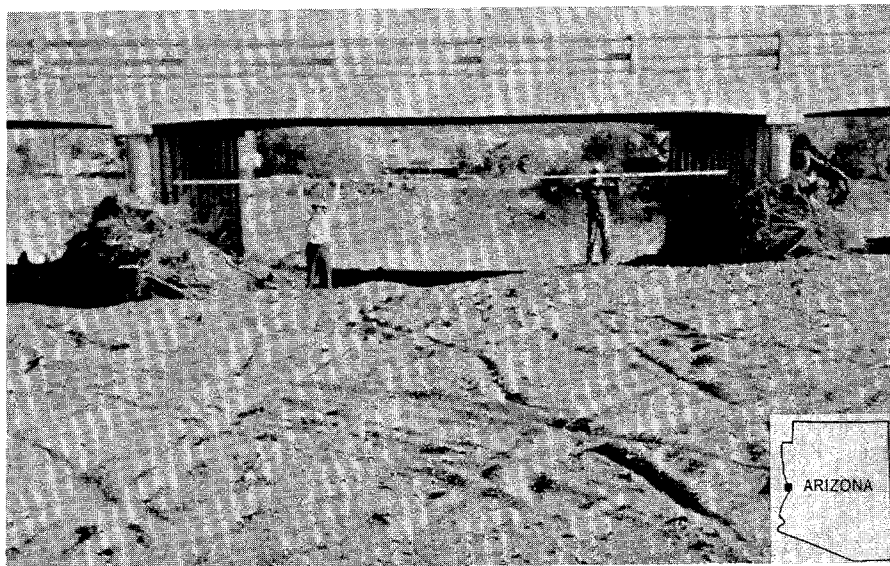
Figure 226. Upstream view of pile bents at piers 2 and 3 showing debris at bridge. Level rods are held at approximate water-surface elevation of 1976 flood. (From Arizona Dept. of Highways.)

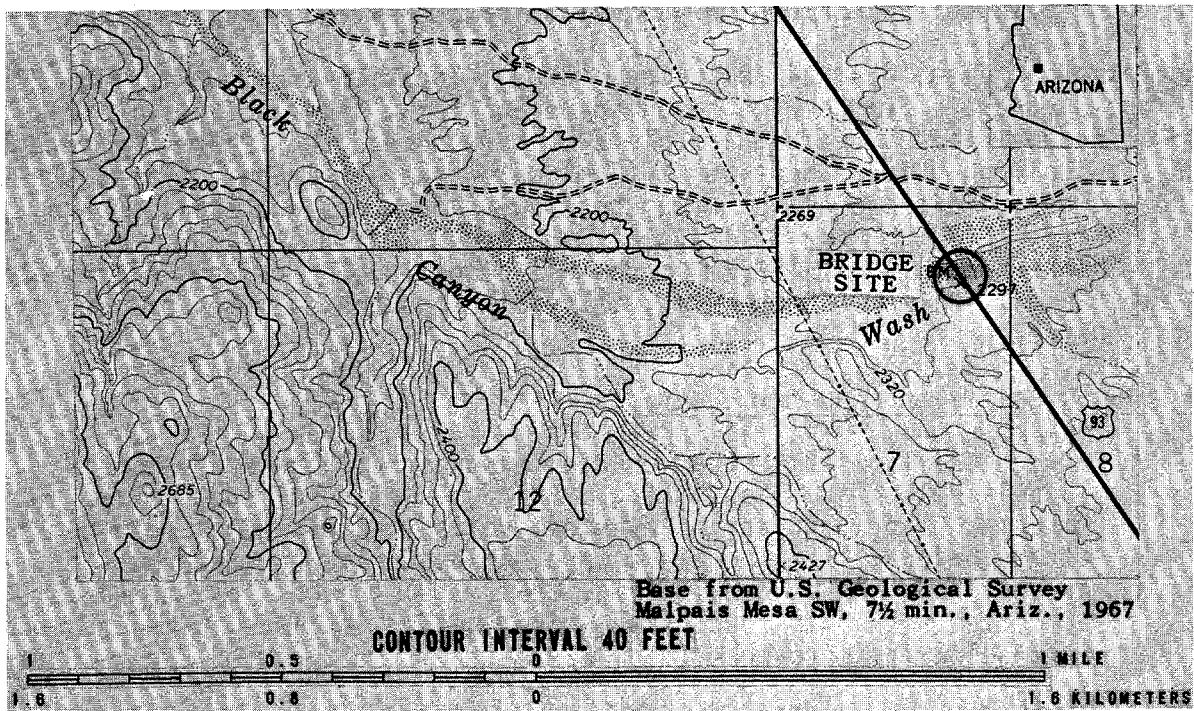
Figure 227. Location of Black Canyon wash at US-93 near Wickenburg, Arizona.

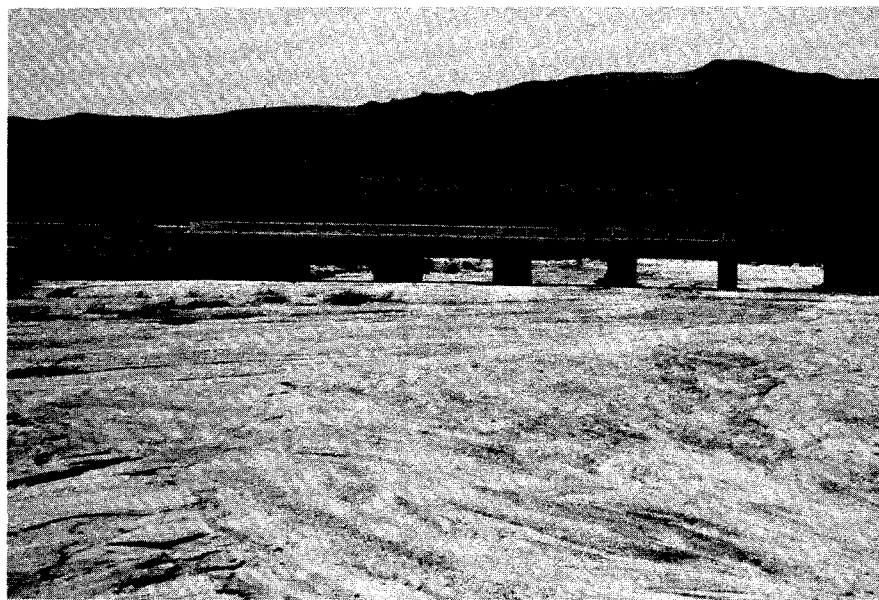
Figure 230. View downstream of bridge and damaged right-bank abutment in September 1964. (From Arizona Dept. of Highways.)

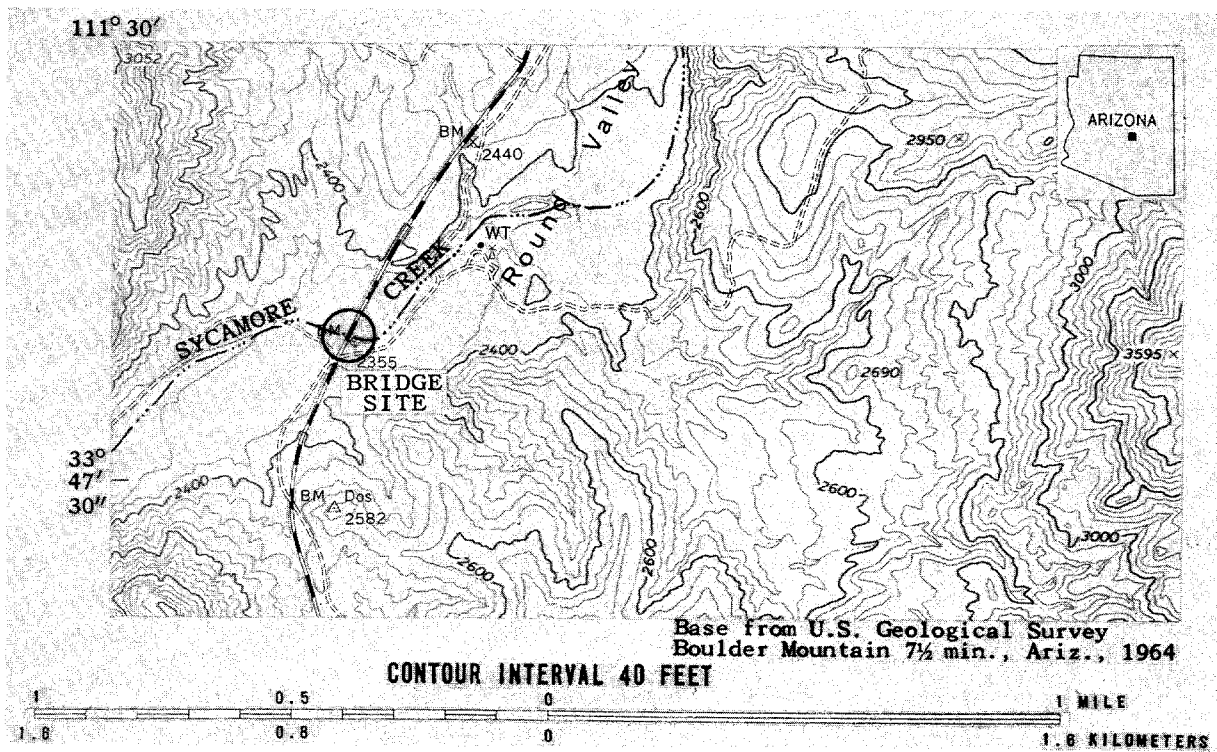
Figure 231. Location of Sycamore Creek at SR-87 near Sunflower, Arizona.

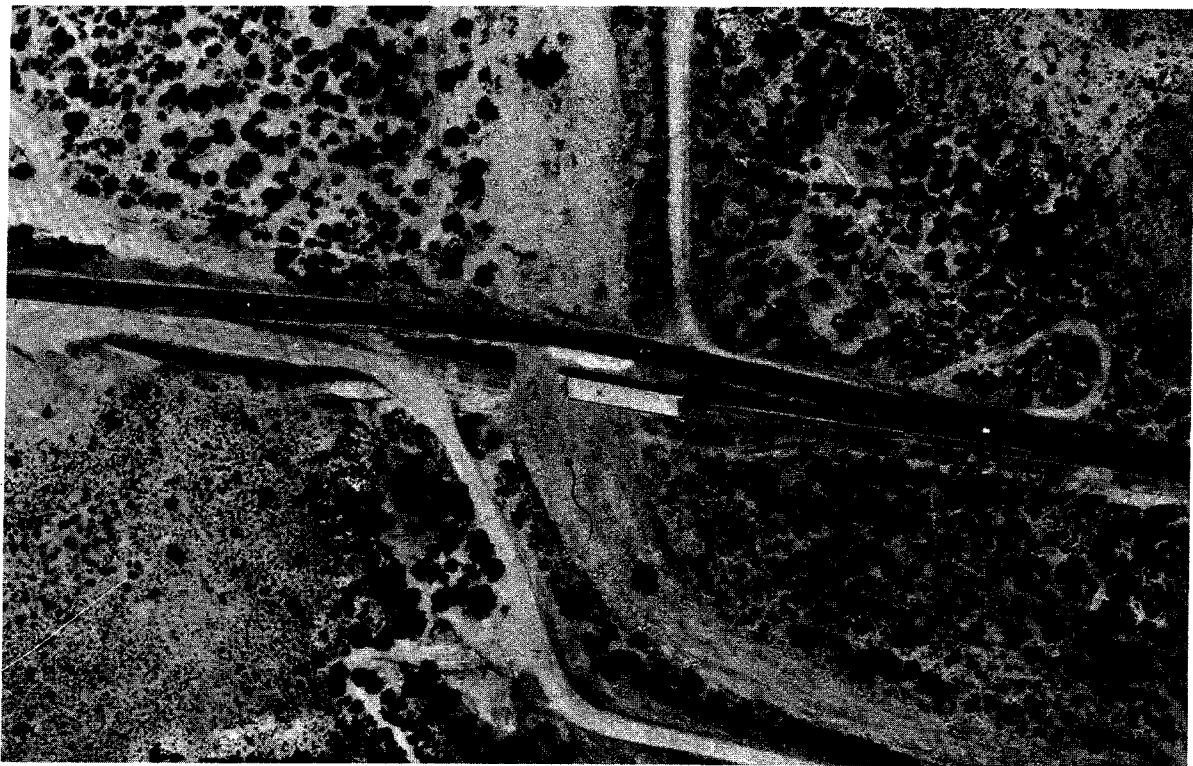
Figure 232. Aerial view in 1971 of bridge damaged by flood of September 1970. (From Arizona Dept. of Highways.)

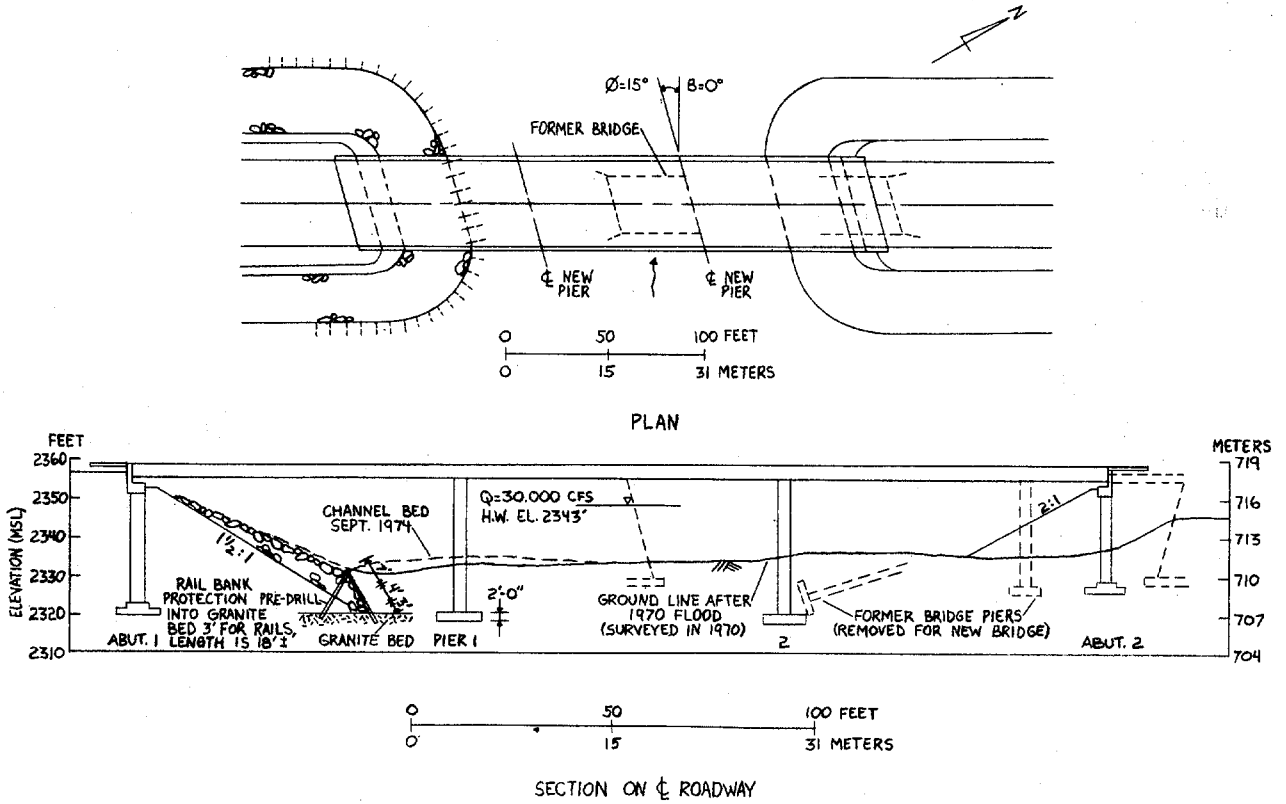
Figure 233. Plan and cross section of bridge built in 1973.

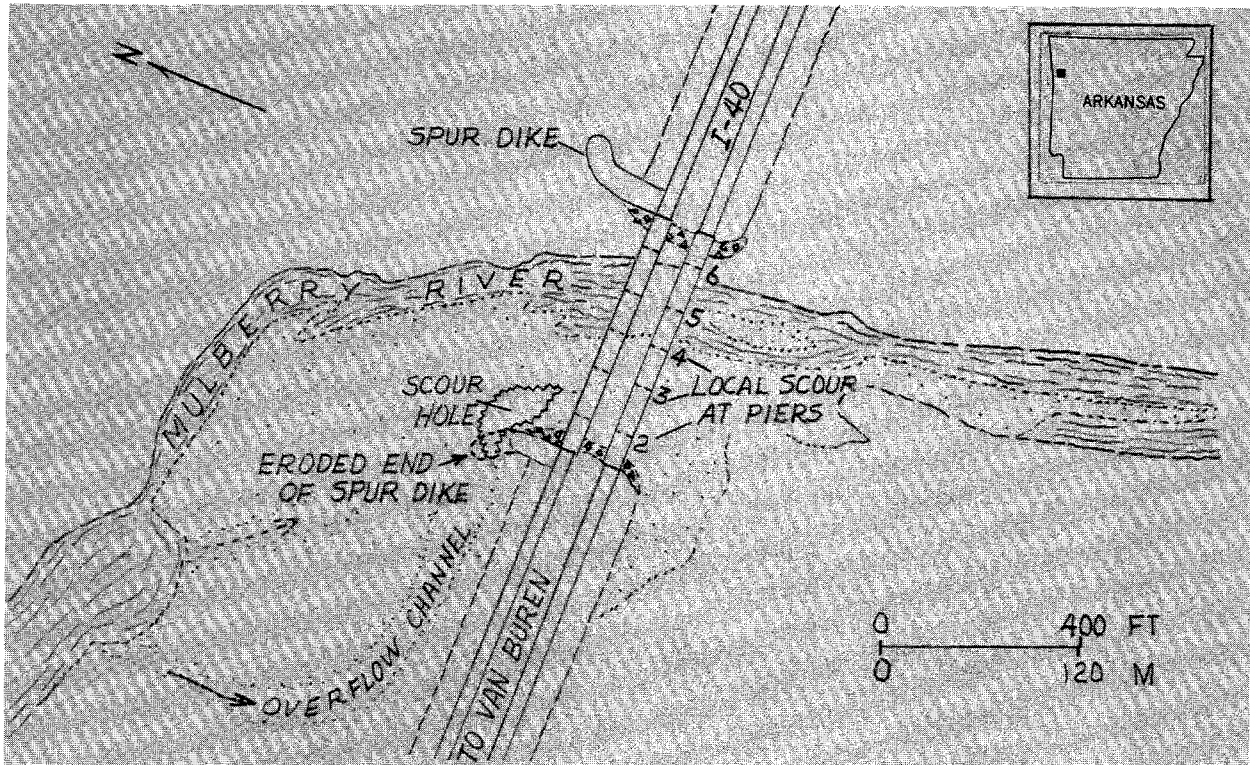
Figure 235. Plan sketch of I-40 crossing, Mulberry River, from aerial photograph taken in 1975.

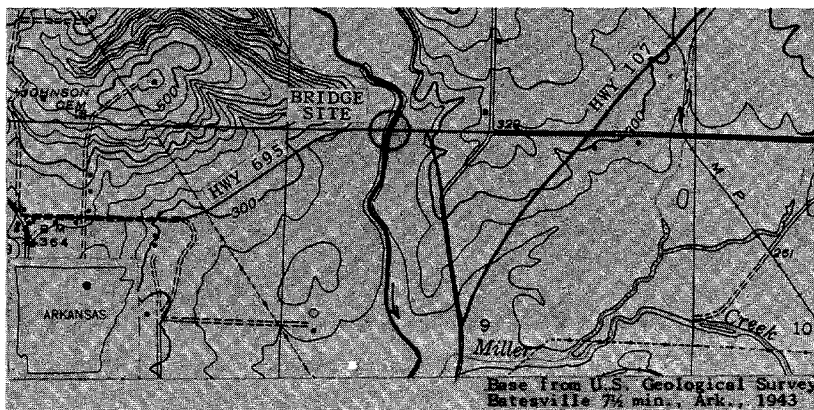
Figure 237. Location of Polk Bayou at SR-69 at Batesville, Arkansas.
