Report No. FHWA-RD-78-163

Hydraulics Branch  
Library

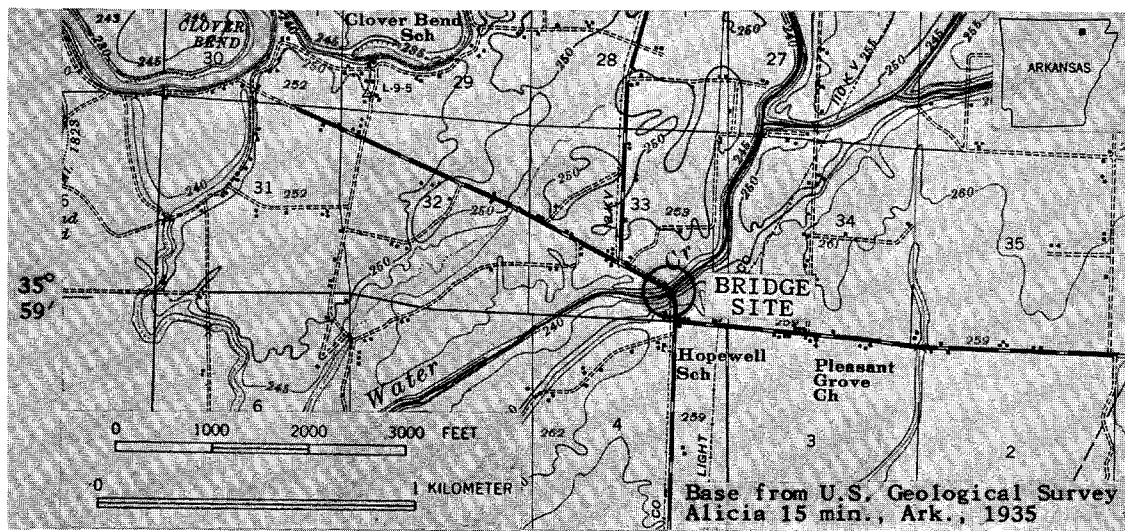
Figure 240. Location of Big Running Water Creek at SR-228 near Clover Bend, Arkansas.

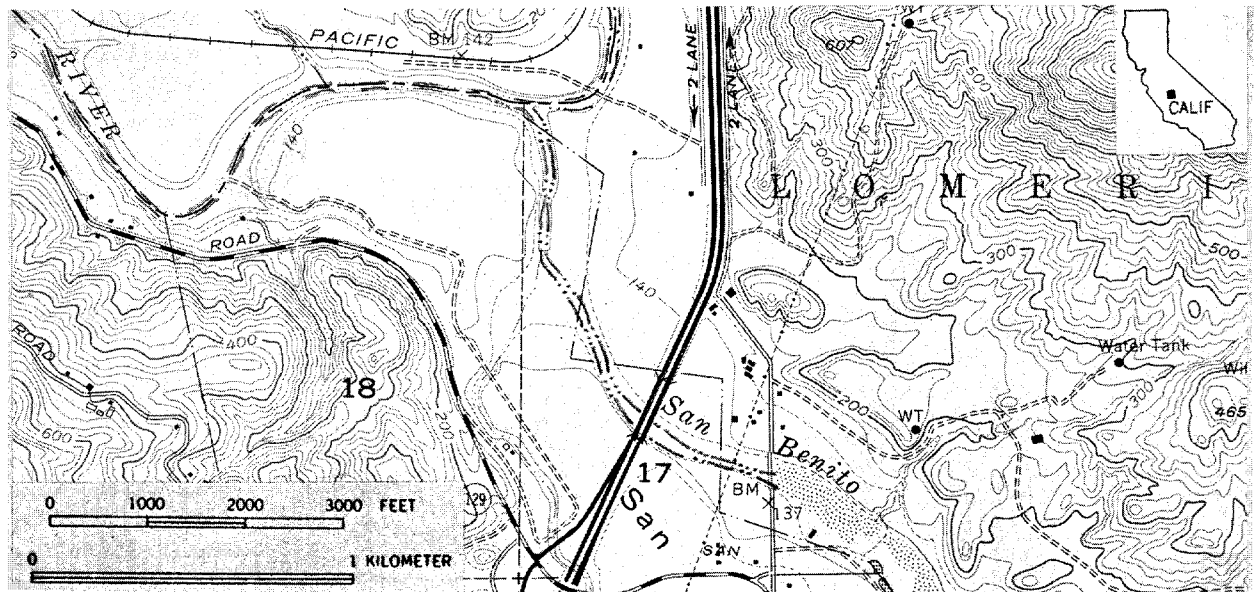
Figure 242. Location of San Benito River at US-101. (Base from U.S. Geol. Survey Chittenden, Calif., 7.5' map, contour interval 20 feet, 1955 photorevised 1973.)

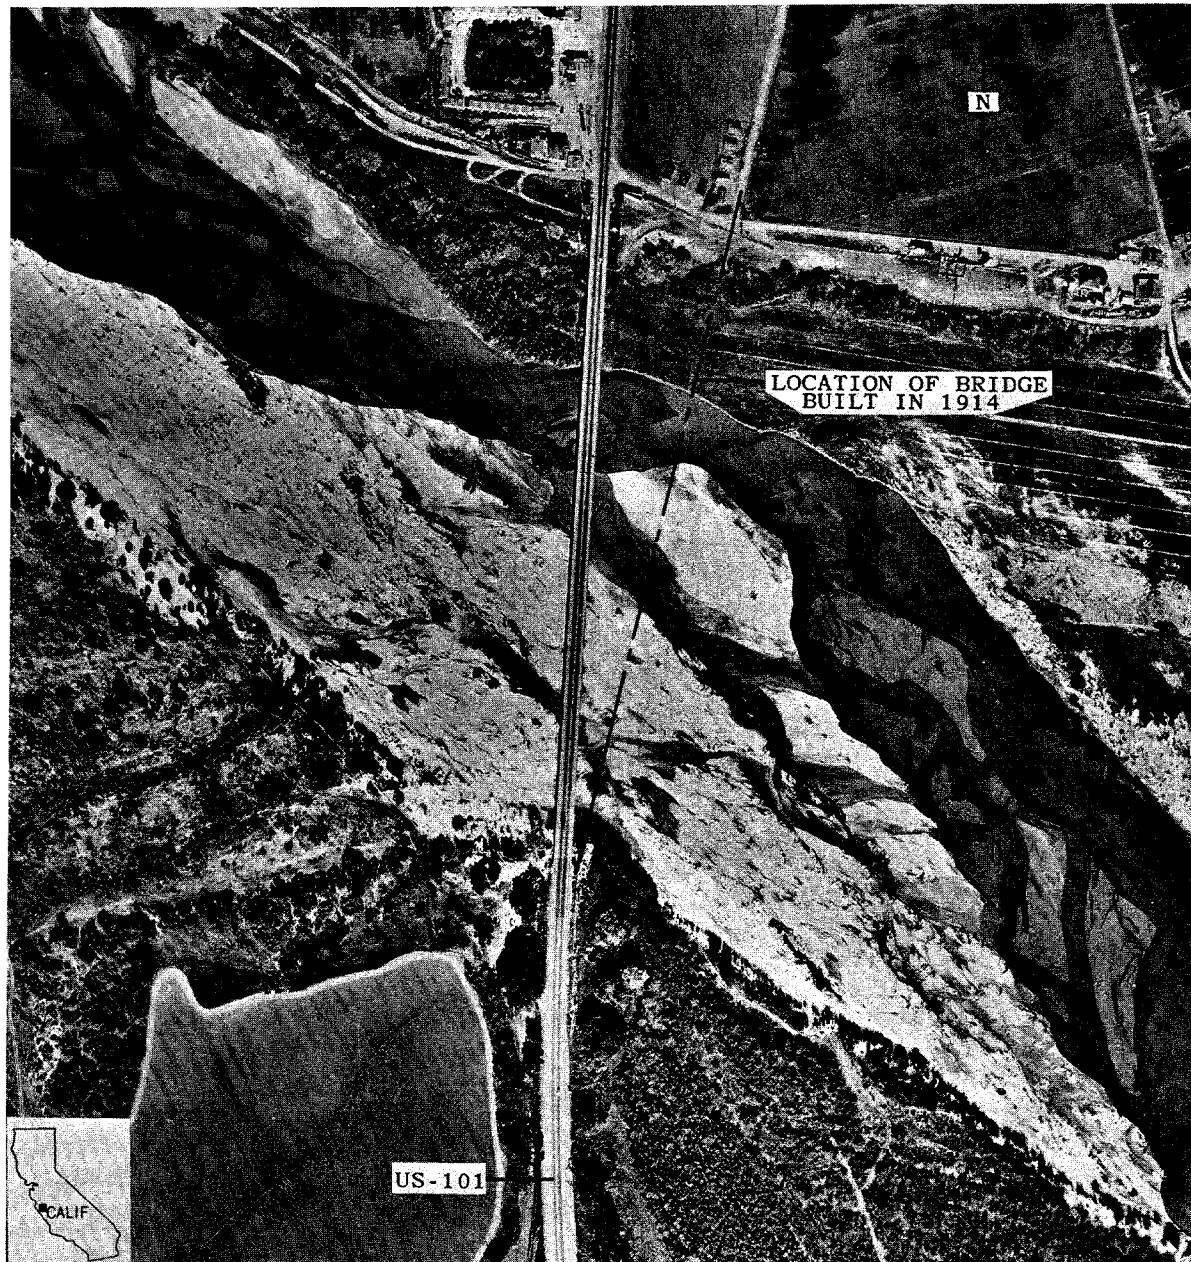
Figure 243. Aerial photograph of Salinas River at US-101, in 1953. (From Calif. Dept. of Transportation.)

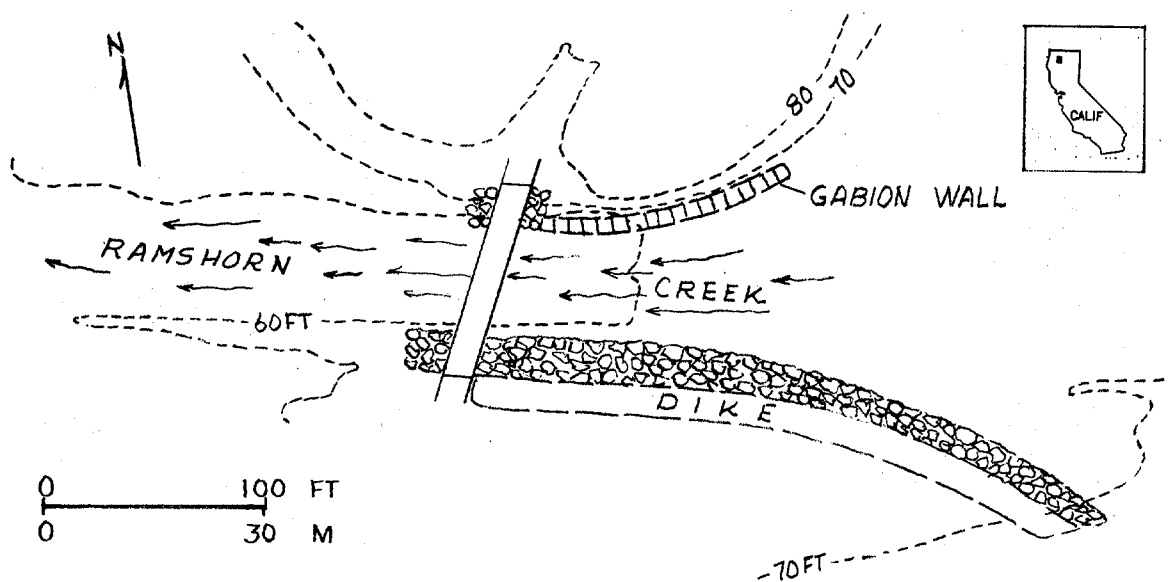
Figure 244. Plan showing countermeasures at Ramshorn Creek.

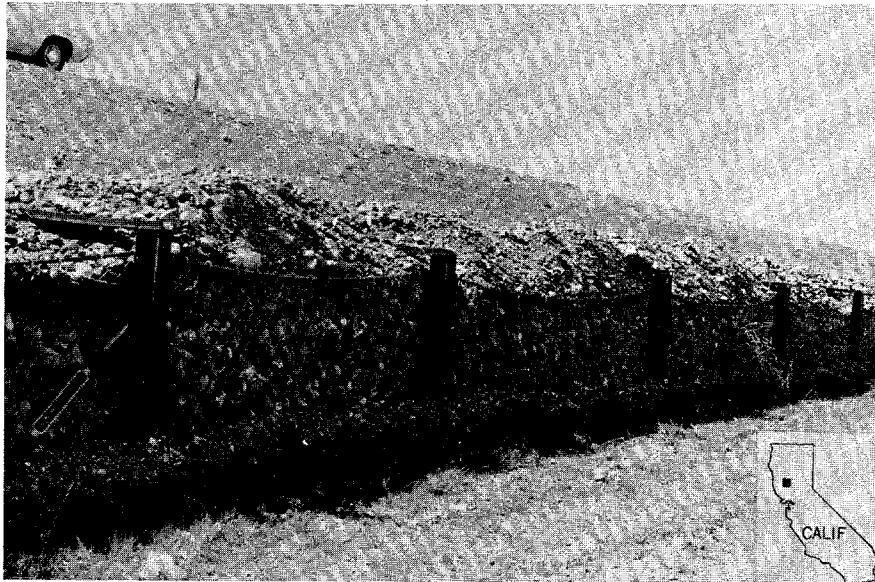
*Figure 246. View of double-post rock-and-wire retard constructed along upstream side of right-bank approach embankment. Photographed in 1977.*

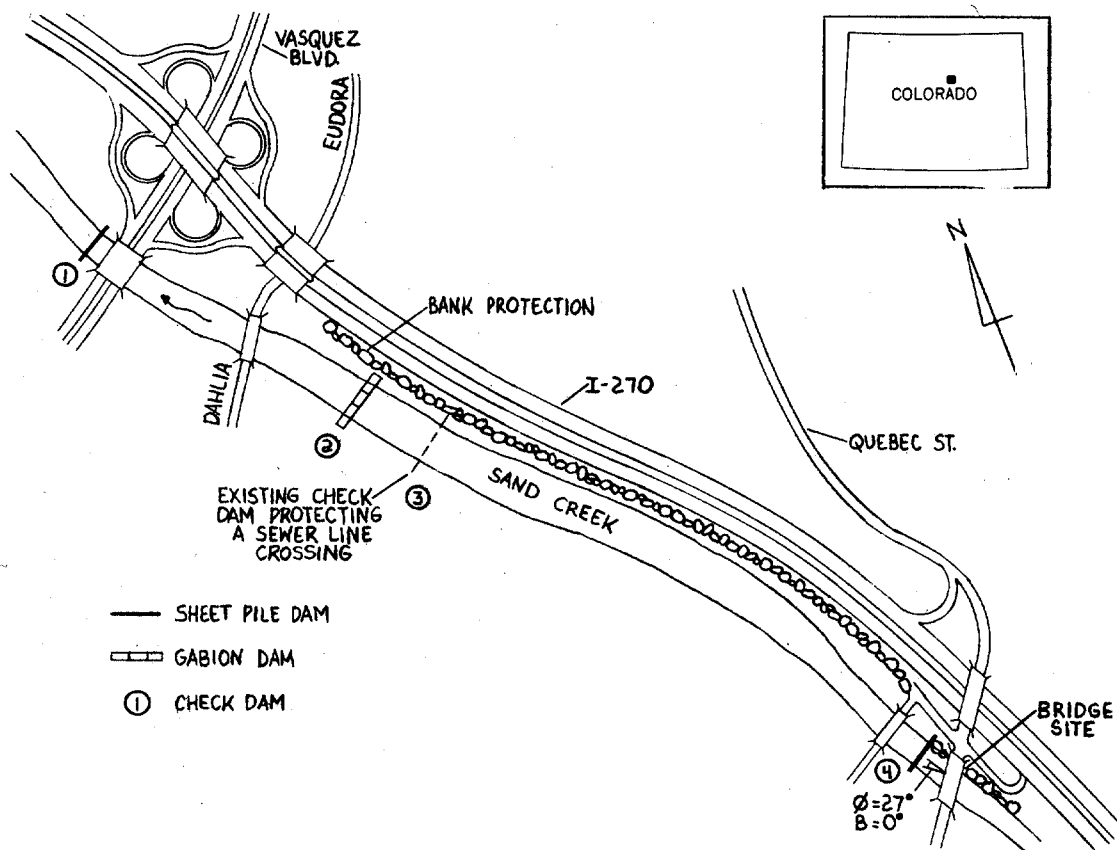
Figure 248. Location of check dams and bank stabilization works on Sand Creek in the vicinity of Quebec Street bridge, Denver, Colo.

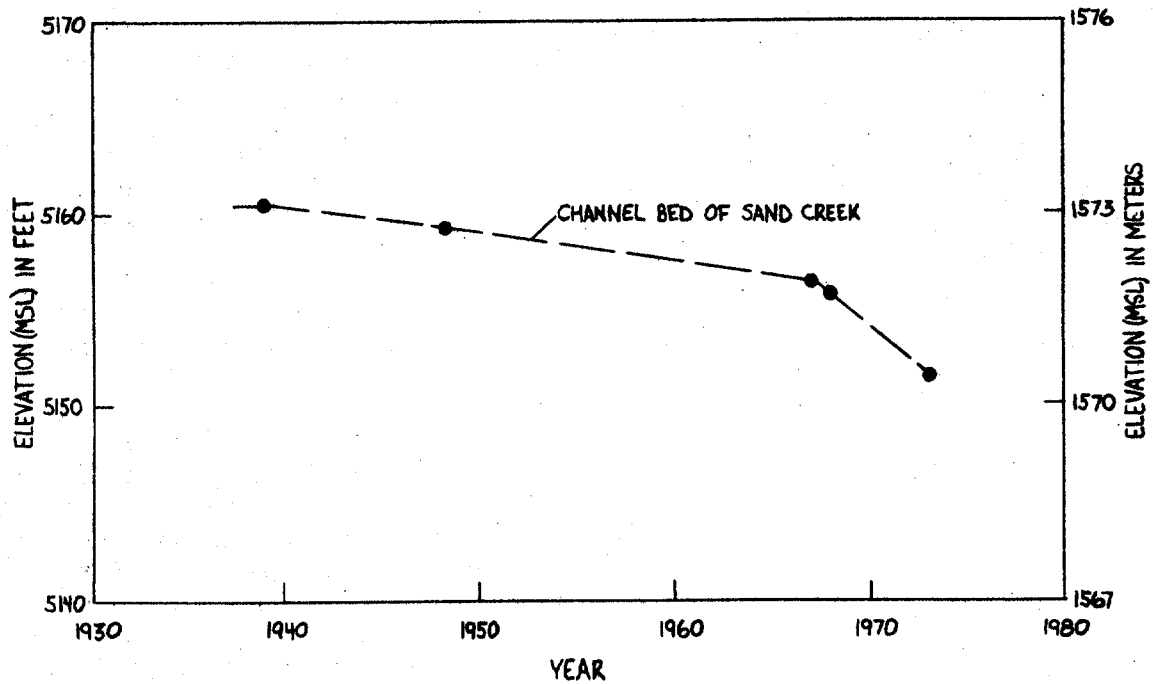
Figure 249. Rate of channel degradation of Sand Creek at Vasquez bridge between 1940 and 1973.

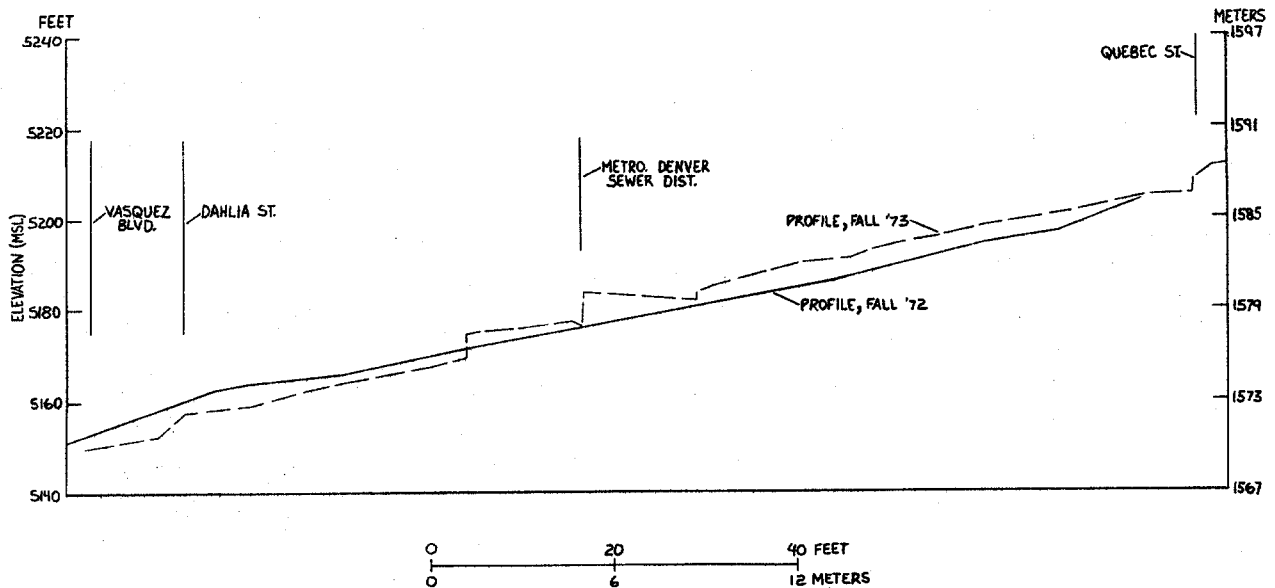
Figure 250. Streambed profile of Sand Creek in vicinity of Quebec Street bridge in 1972 and 1973.

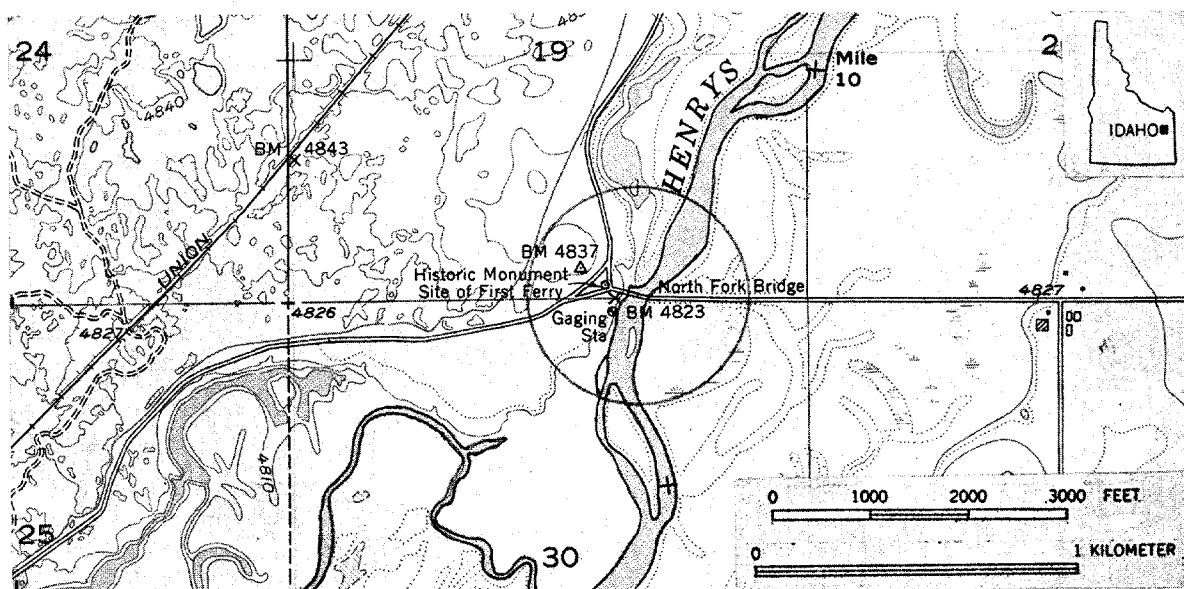
Figure 255. Location of SR-88 crossing (circled) at Henrys Fork. (From U.S. Geol. Survey Menan Buttes, Idaho, 7.5' quadrangle, contour interval 10 ft, 1951.)

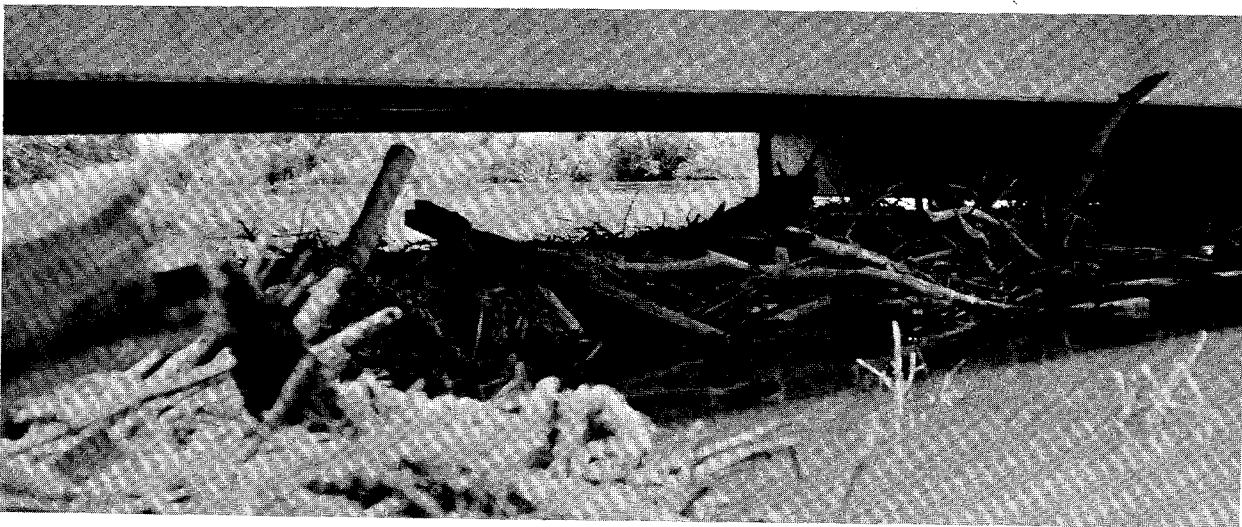
*Figure 256. View of debris lodged under upstream side of SR-88 bridge following flood caused by failure of Teton Dam.*

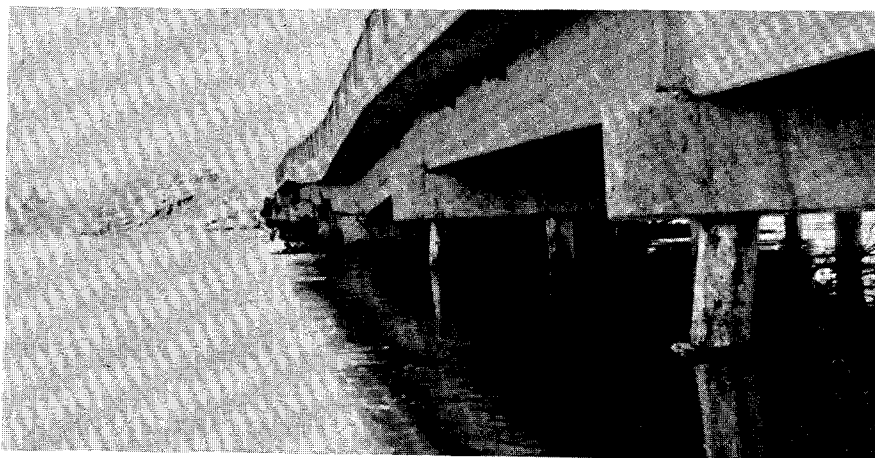
*Figure 257. View of upstream side of bridge showing subsidence at bents 3, 4, and 5.*

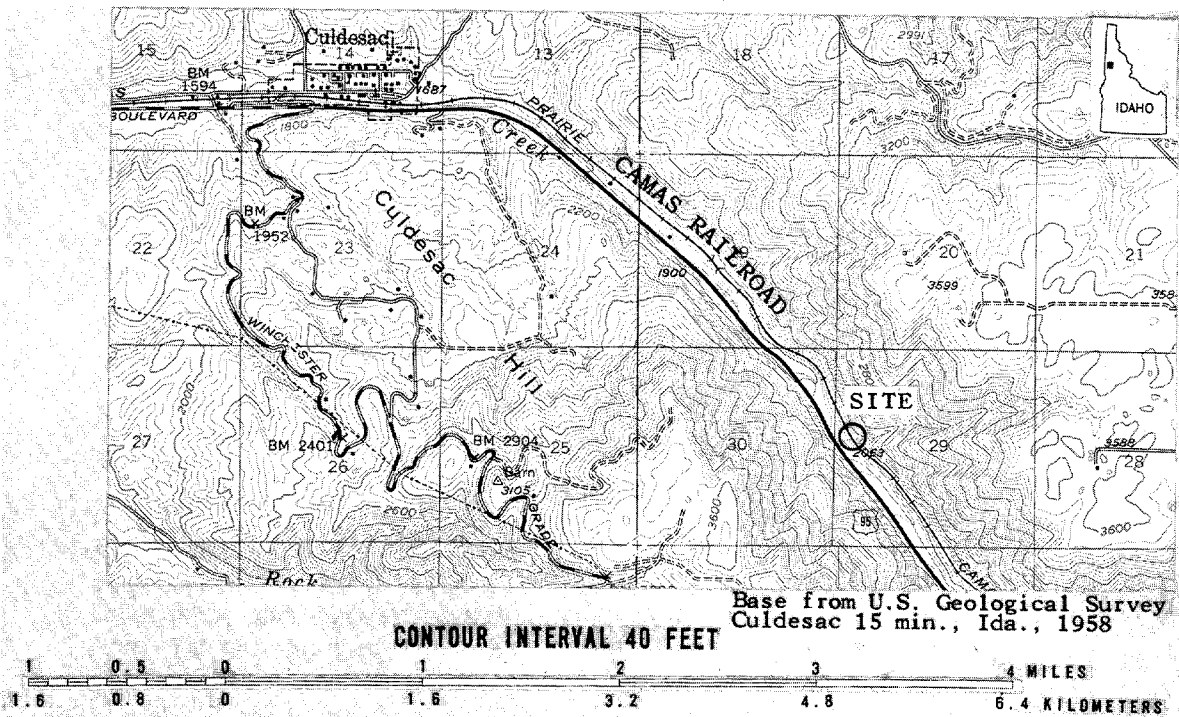
Figure 258. Location of Lapwai Creek tributary at Camas Prairie railroad crossing.

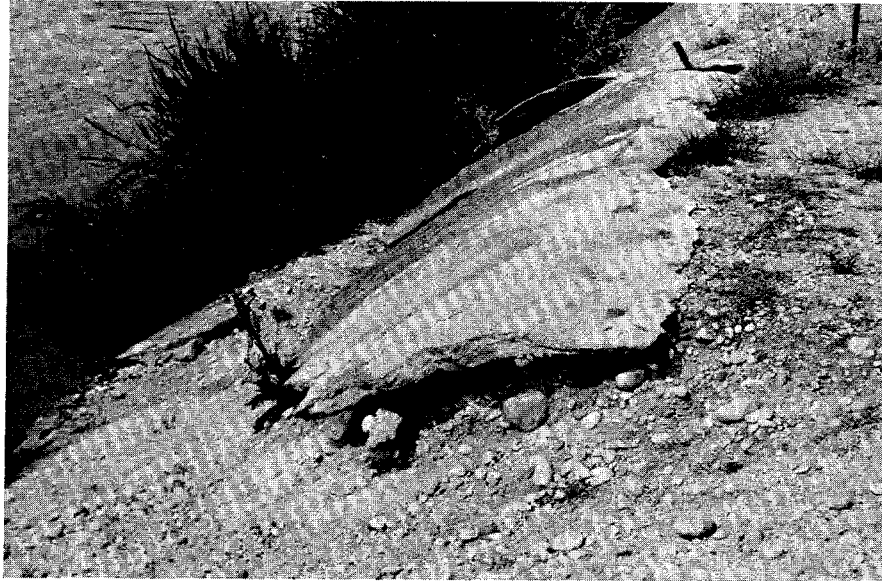
Figure 262. Damaged right-bank revetment, about 40 ft (1 m) downstream from bridge, in 1976.

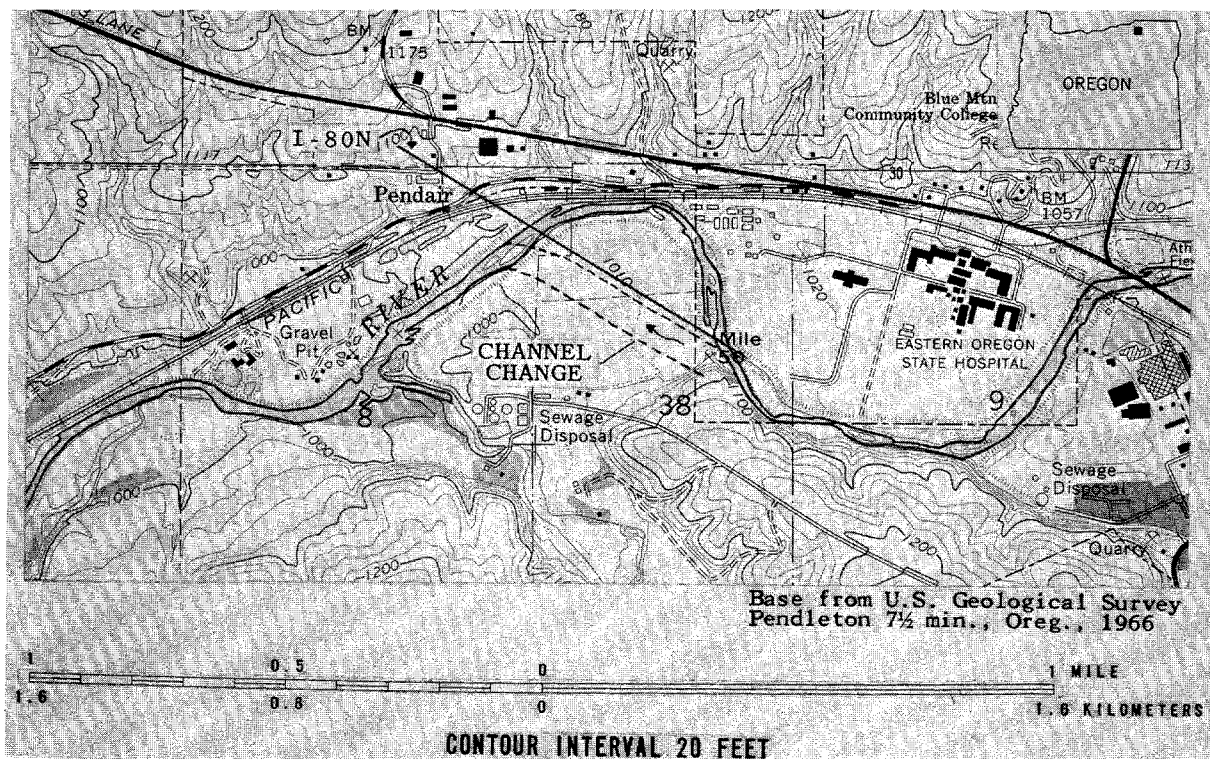
Figure 263. Location of Umatilla River channel relocation at I-80N.

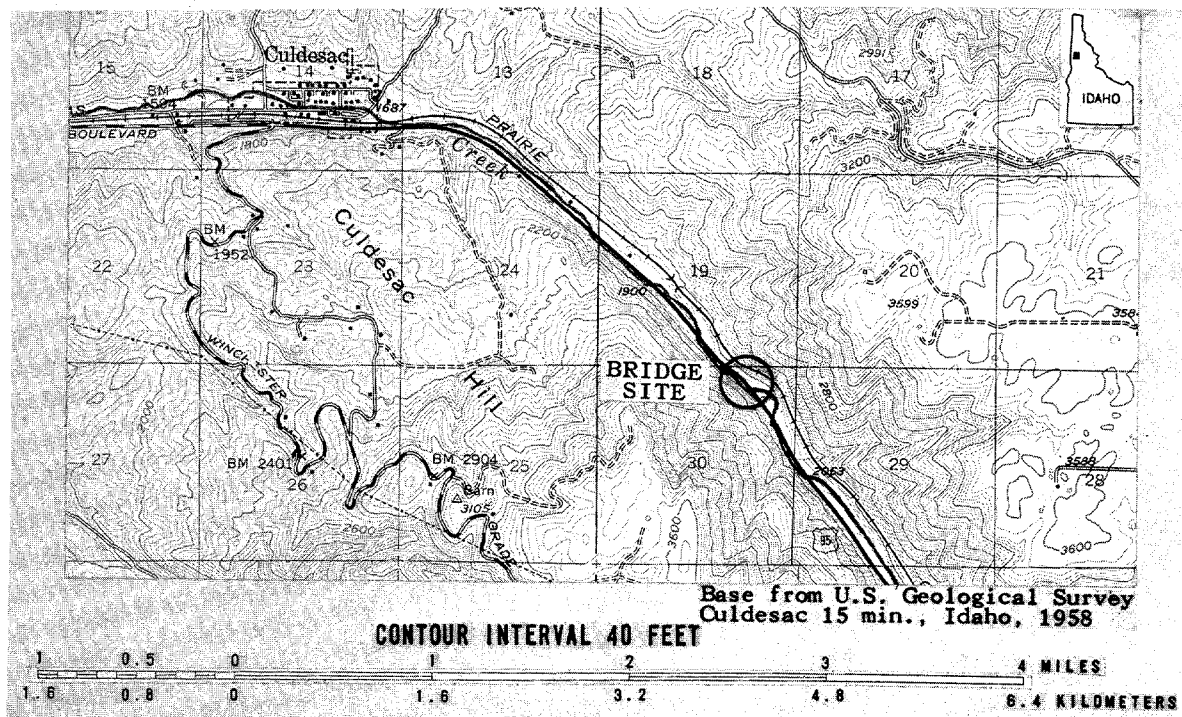
Figure 266. Location of Lapwai Creek at US-95 near Culdesac, Idaho.

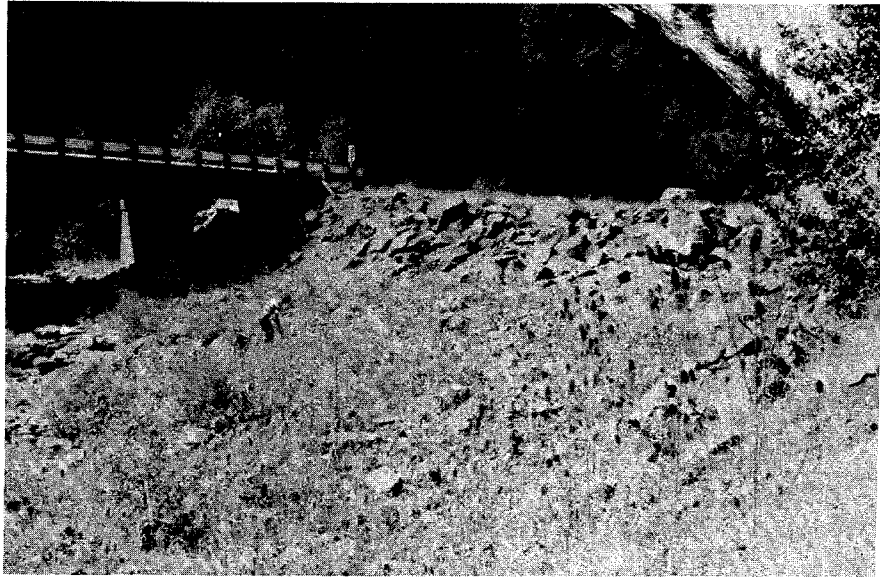
*Figure 268. Condition of rock riprap placed in 1965 on right bank upstream from Lapwai Creek bridge, as photographed in 1977.*

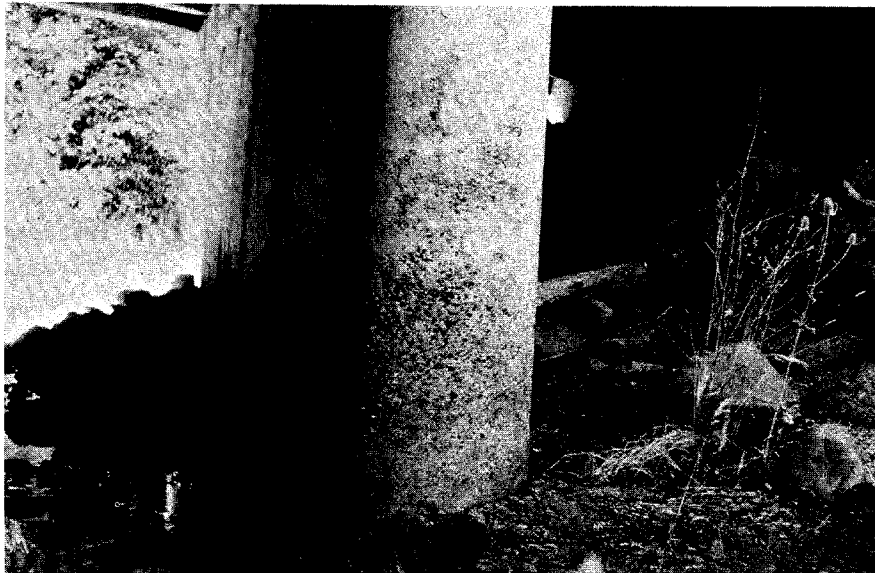
*Figure 269. Abrasion damage on upstream nose of pier at right bank, Lapwai Creek, 1977.*

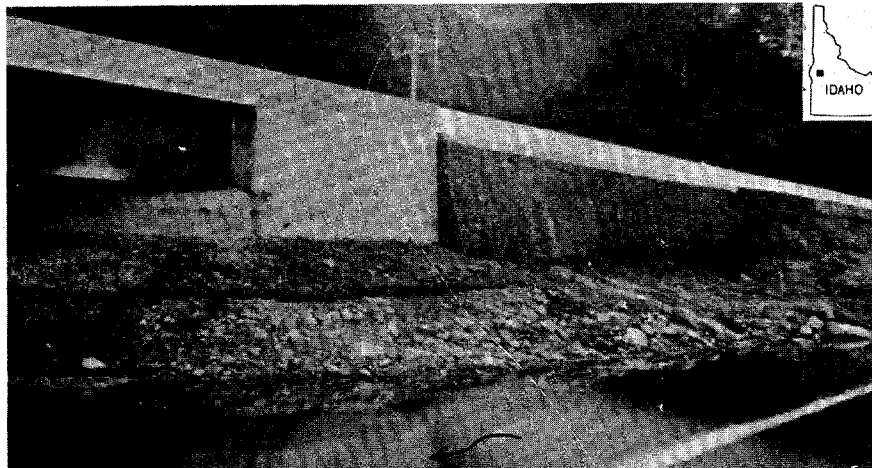
Figure 270. View of upstream right bridge abutment and embankment showing gabion revetment. (From Idaho Dept. of Transportation, 1975.)

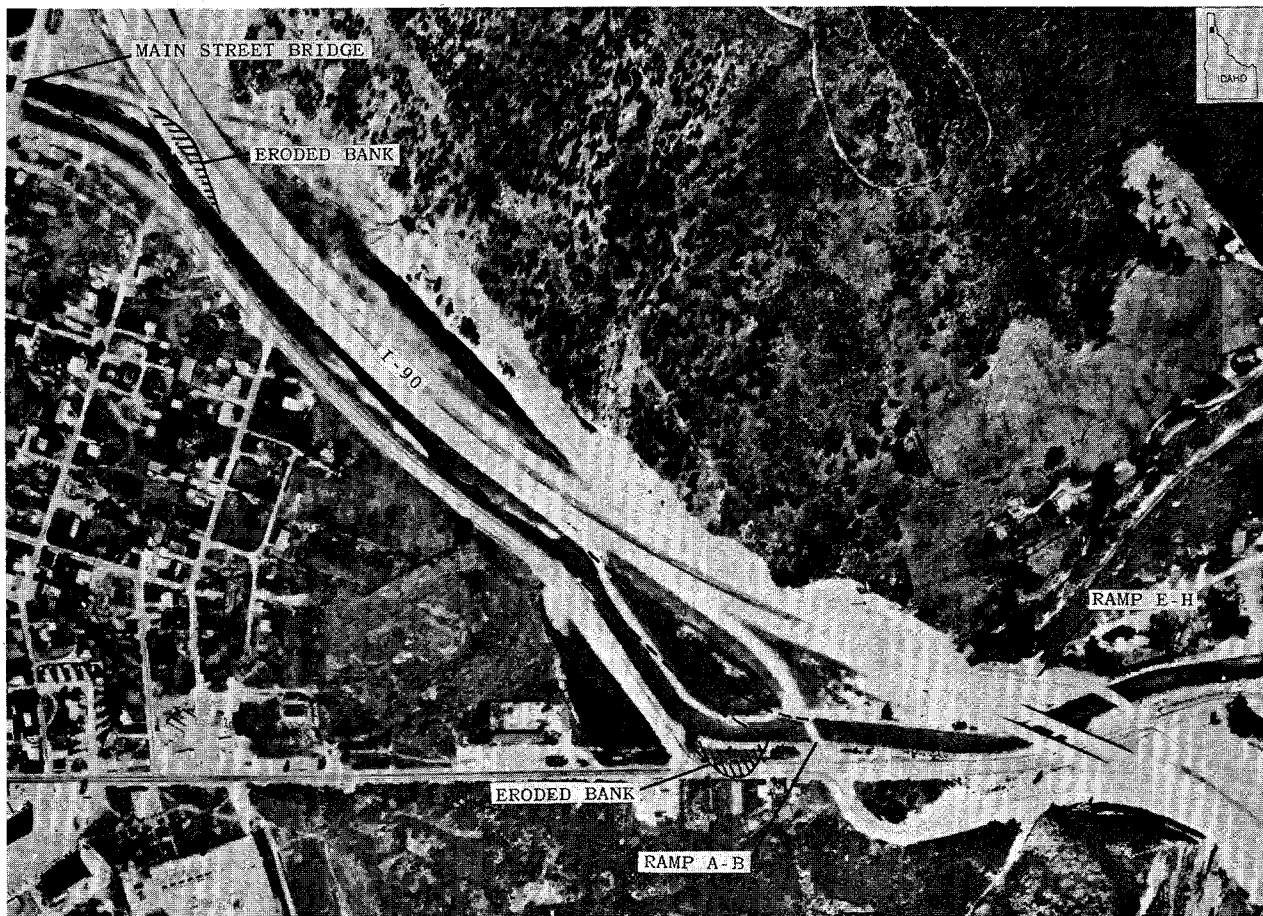
Figure 271. Aerial view of Pine Creek channel in 1971, and proposed relocations. (From Idaho Dept. of Transportation.)

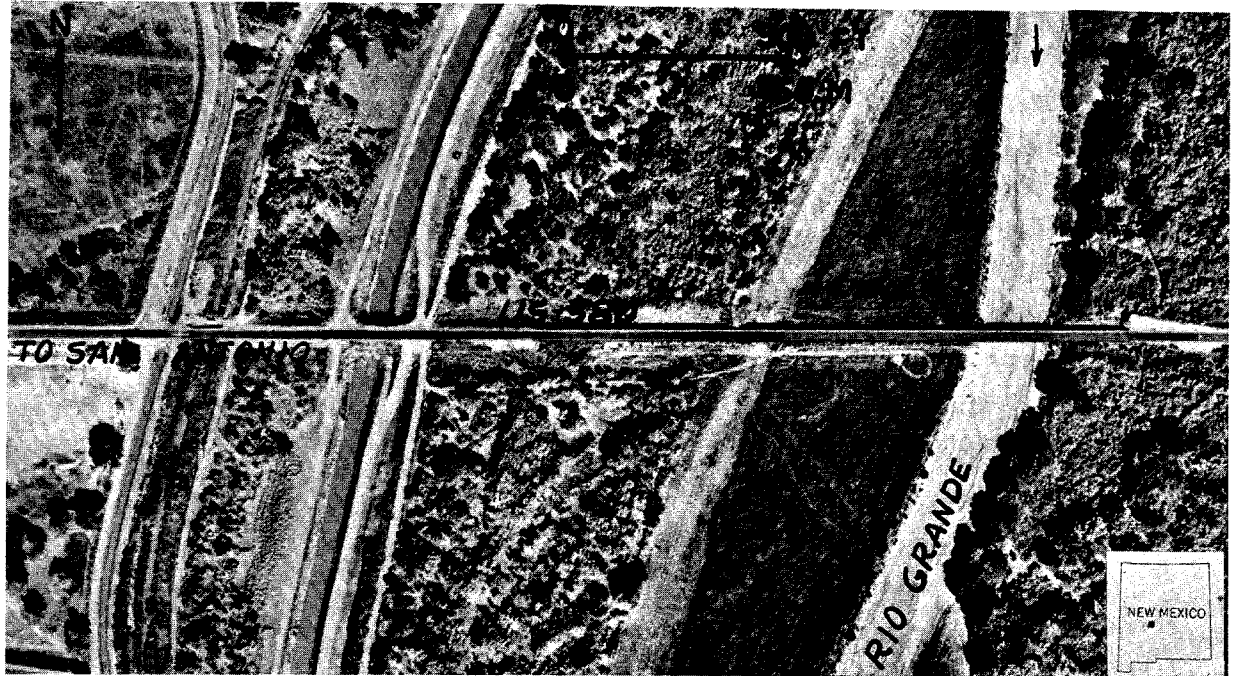
Figure 277. Aerial photograph of US-380 crossing, Rio Grande River, in 1973. (From New Mexico Dept. of Highways.)

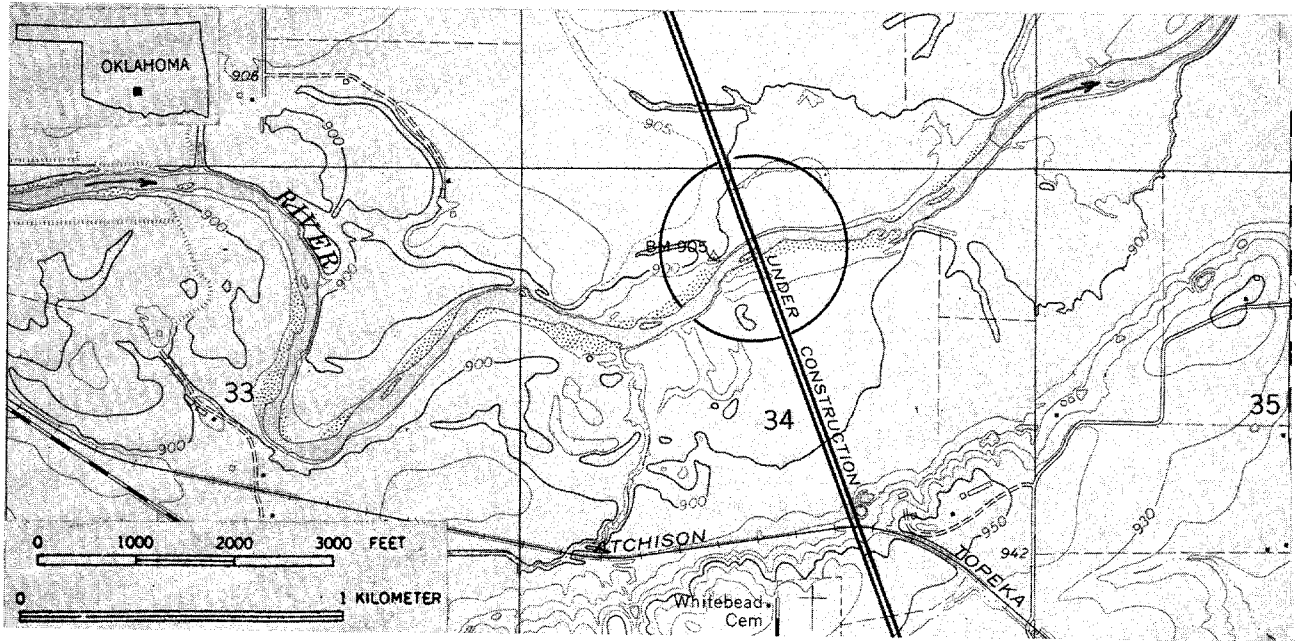
Figure 278. Location of Washita River at I-35 near Whitebead. (From U.S. Geological Survey Paoli, Okla., 7.5' quadrangle, contour interval 10 feet, 1965.)

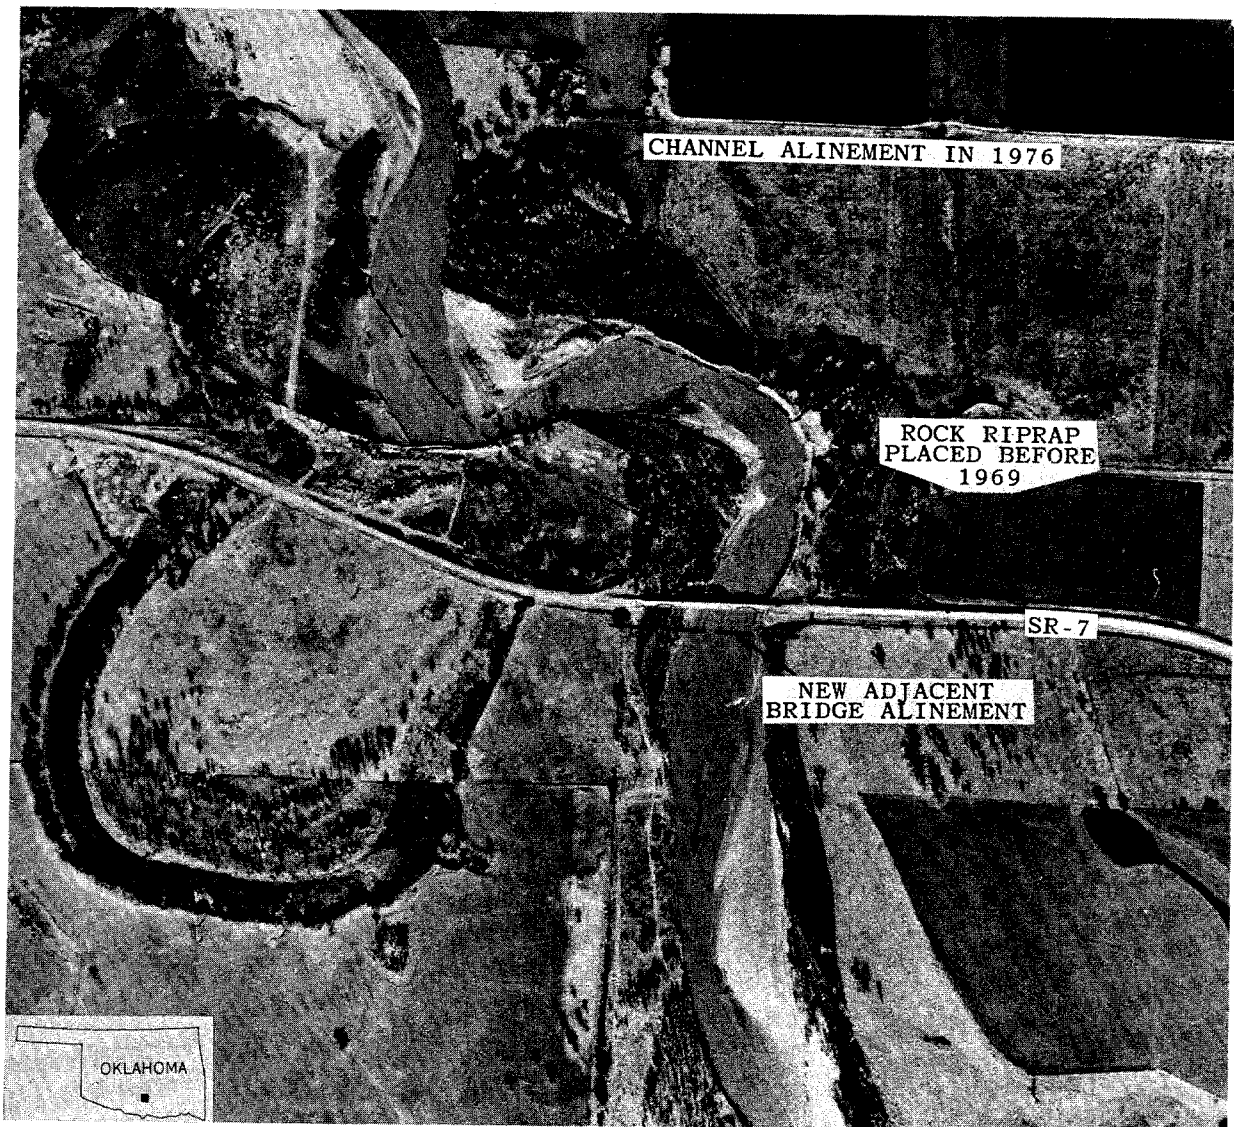
Figure 282. Aerial photograph of Washita River at SR-7 in 1962. Channel alignment at time of new bridge construction in 1976 is indicated in dashed lines. (From Oklahoma Dept. of Transportation.)

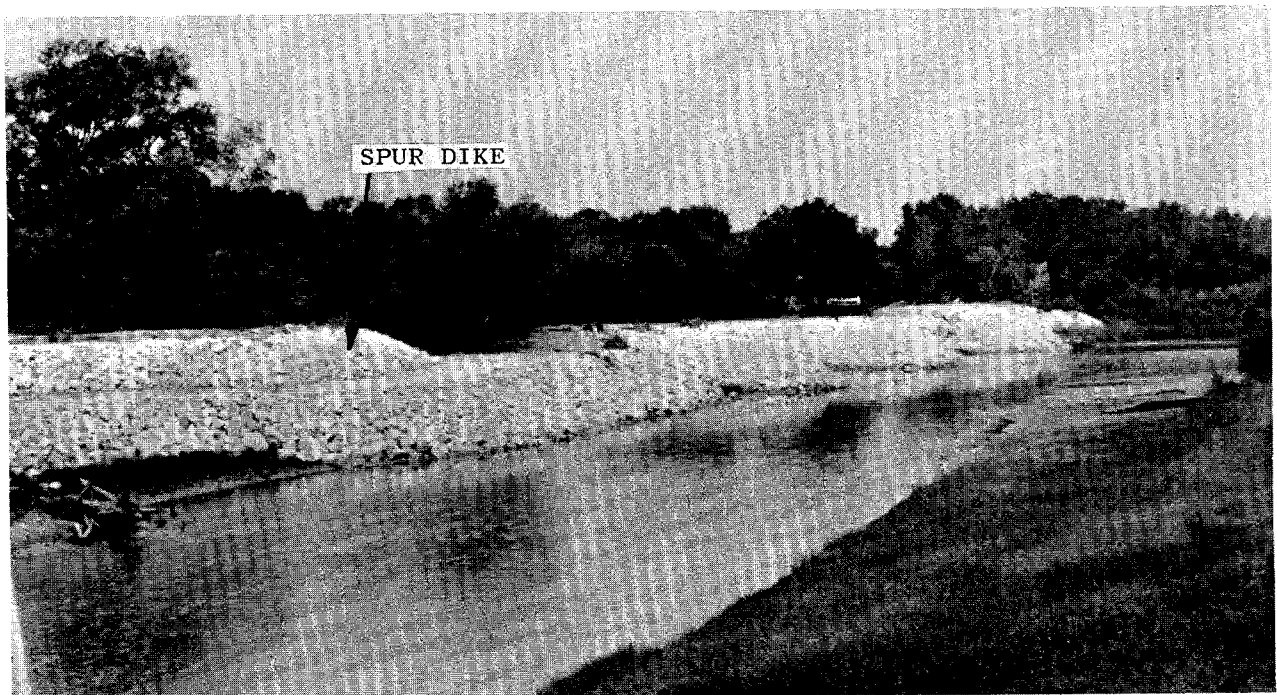
Figure 283. View upstream, in 1976, from old SR-7 bridge toward right bank, showing spur dike, three spurs, and riprapped bank.

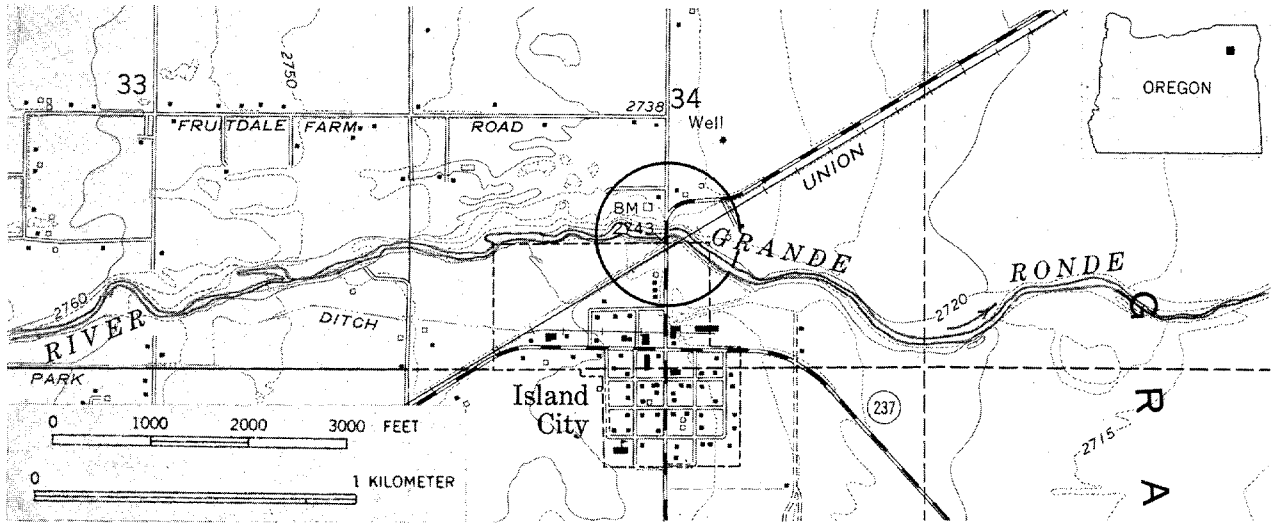
Figure 288. Location of SR-82 crossing, Grande Ronde River.  
 (From U.S. Geological Survey La Grande SE, Oreg., 7.5'  
 quadrangle, contour interval 20 ft, 1963.)

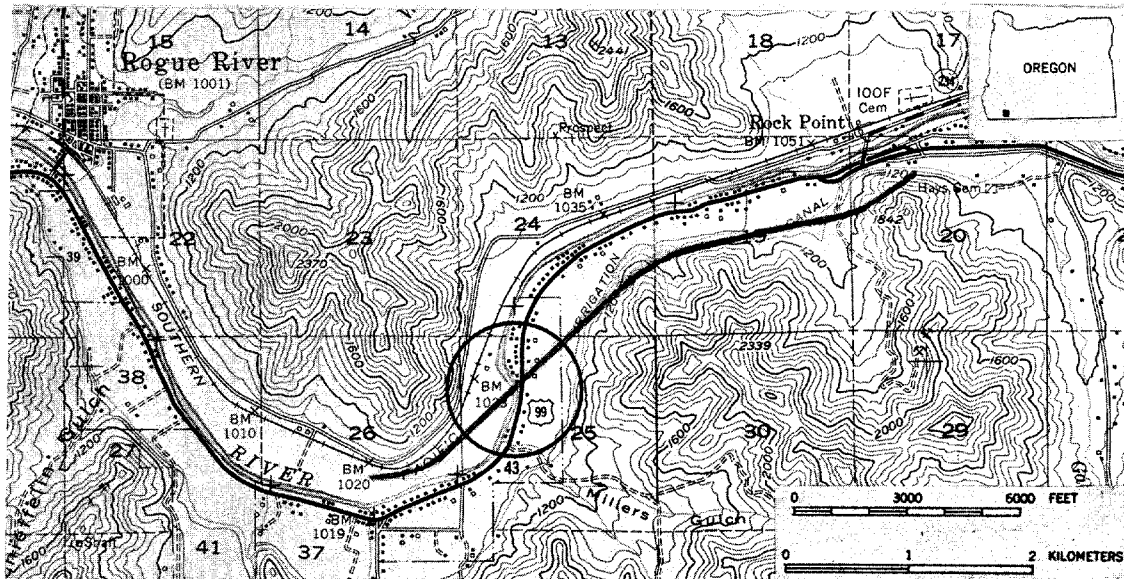
Figure 290. Map showing I-5 crossing of Rogue River (circled). (From U.S. Geological Survey Gold Hill, Oreg., 15' quadrangle, contour interval 100 ft, 1954.)

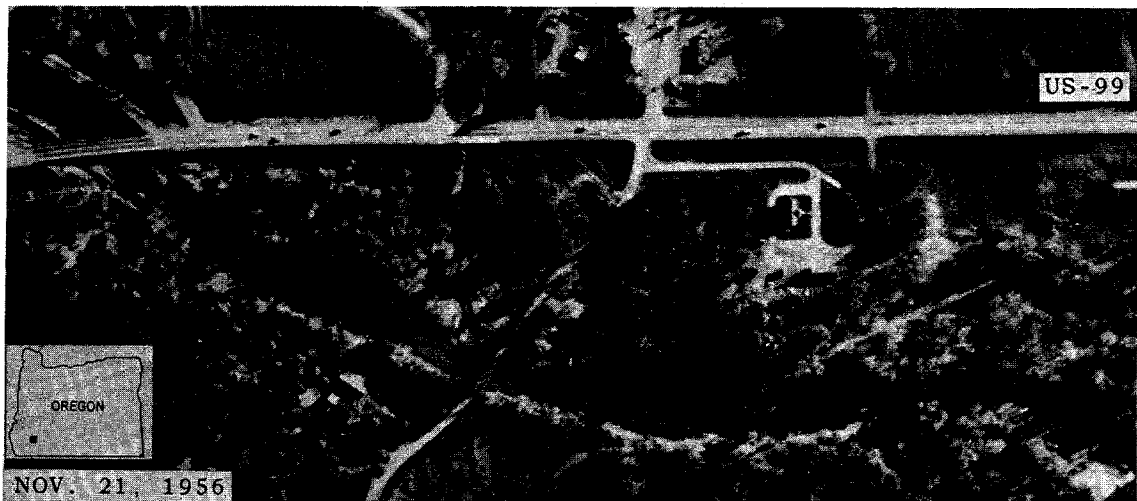
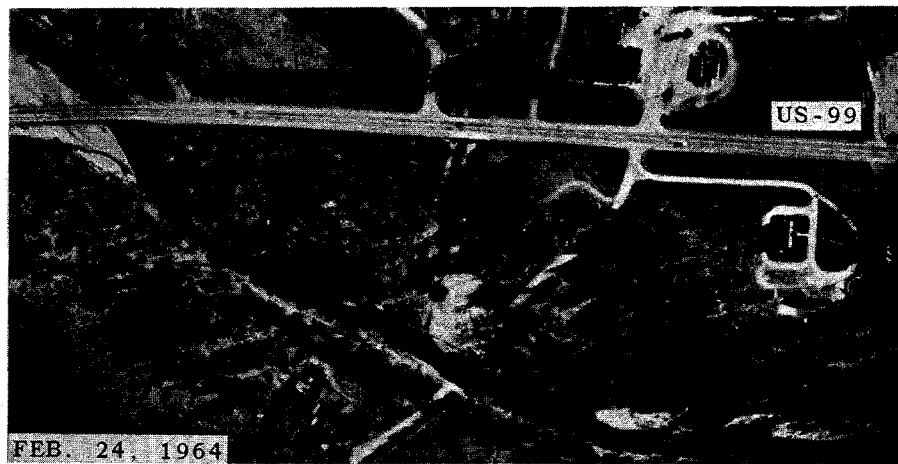
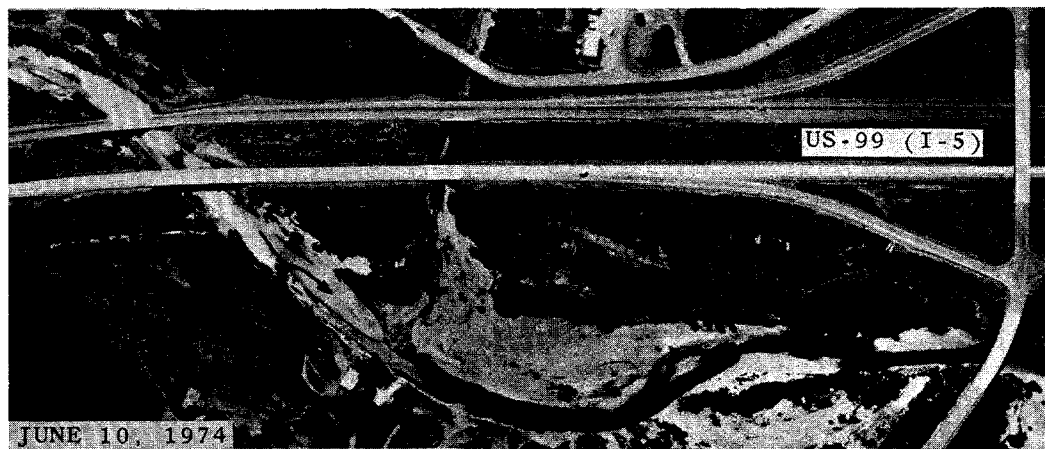
Figure 291. Sequential aerial photographs showing changes in natural channel of Cow Creek, 1956-74. (From Oregon Dept. of Highways.)

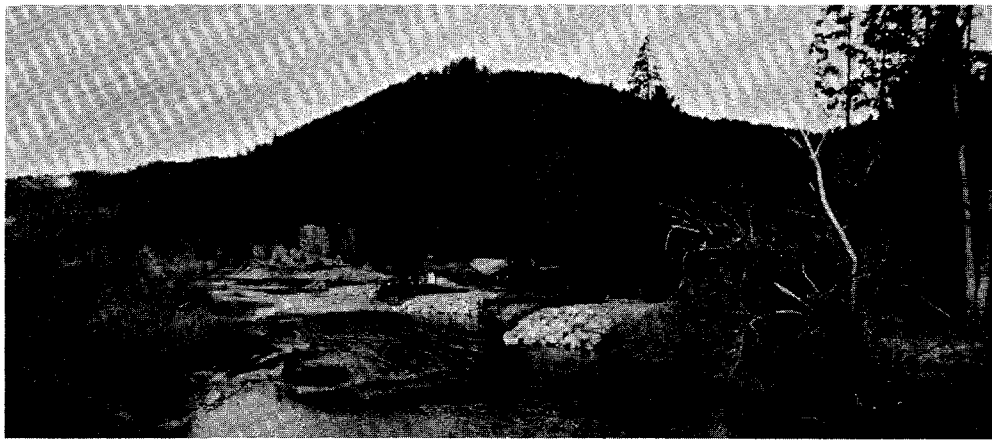
*Figure 292. View downstream from bridge, in 1976, of rock spurs built along right bank. (From Oregon Dept. of Highways.)*

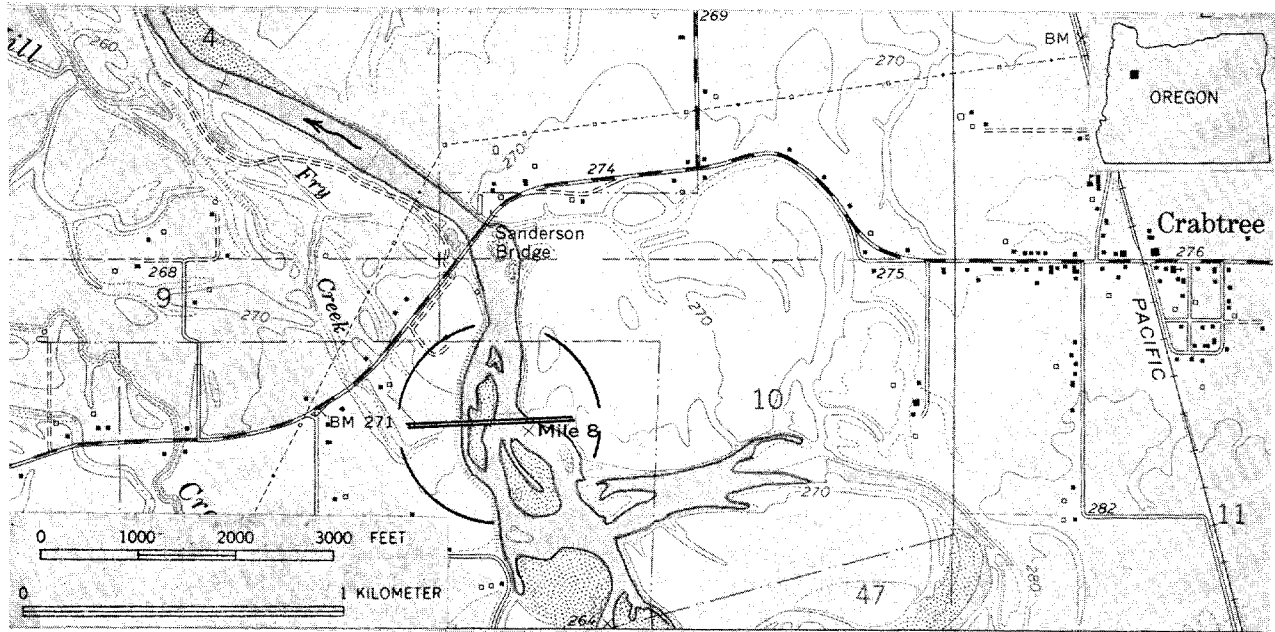
Figure 293. Location of new crossing of SR-226 (circled), South Santiam River. (From U.S. Geological Survey Crabtree, Oreg., 7.5' quadrangle contour interval 10 feet, 1970.)
