Report No. FHWA-RD-78-163

Hydraulics Branch  
Library

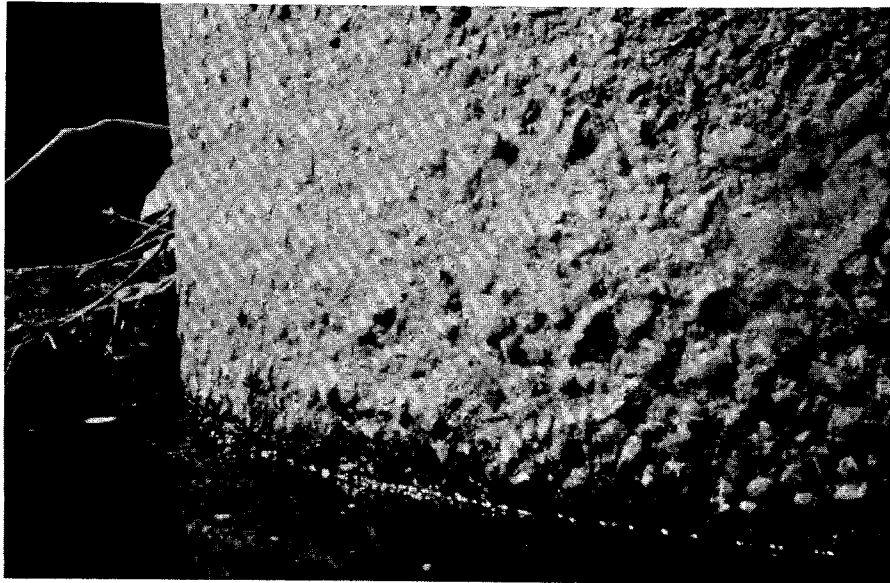
Figure 297. View of downstream face of cylindrical pier showing abrasion damage as photographed about 1971, 13 years after bridge construction. (From Oregon Dept. of Highways.)

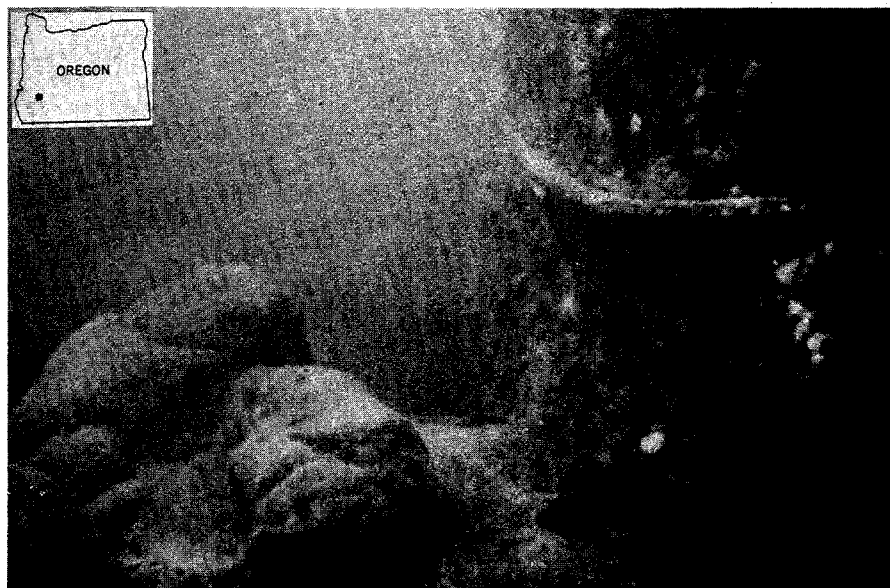
Figure 298. Underwater view of cylindrical pier showing exposed reinforcing steel. Abrasion damage extends to the streambed of cobbles and boulders. (From Oregon Dept. of Highways.)

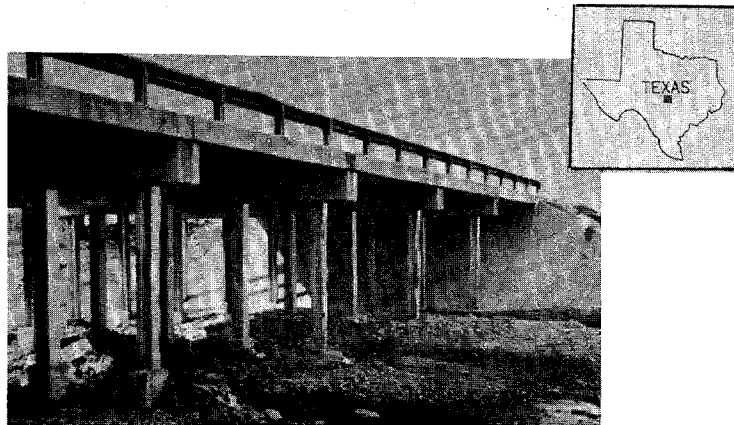
Figure 306. Upstream side of Cold Creek bridge, showing abrasion and impact damage to pile bents.

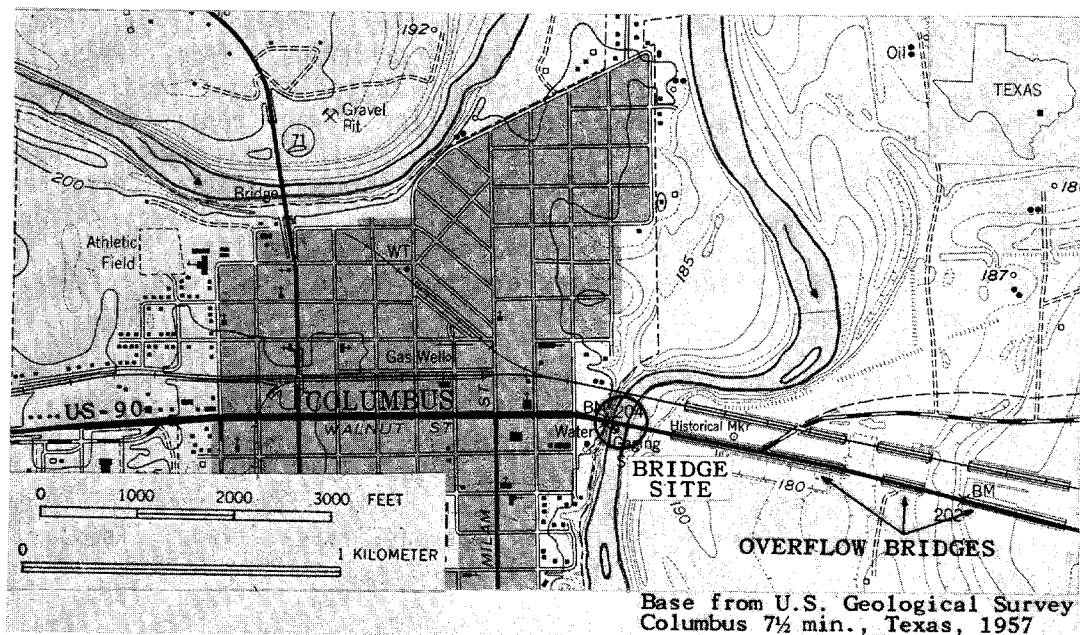
Figure 306a. Location of Colorado River at US-90 at Columbus, Texas.

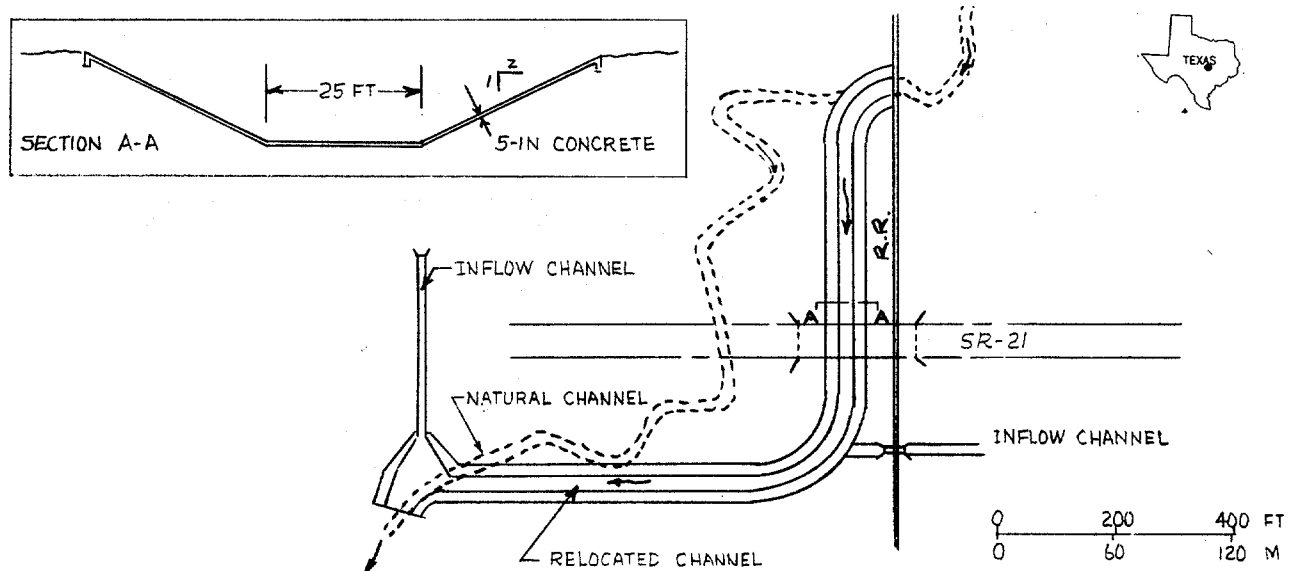
Figure 310. Plan and cross section of relocated channel at SR-21 crossing, Gills Branch.

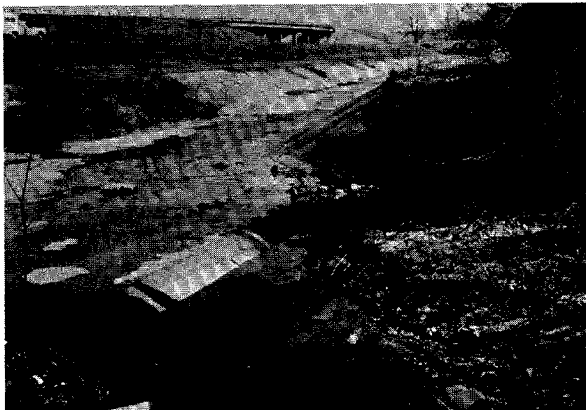
*Figure 311. Upstream view of concrete-lined channel, in 1976. Concrete baffles in channel (foreground) are intended to retard flow velocity.*

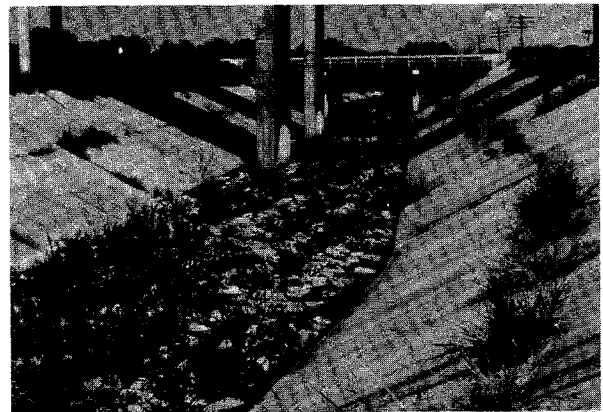
*Figure 312. View in 1976 of concrete-lined channel and broken concrete rubble left in place after damage caused by uplift during flood.*

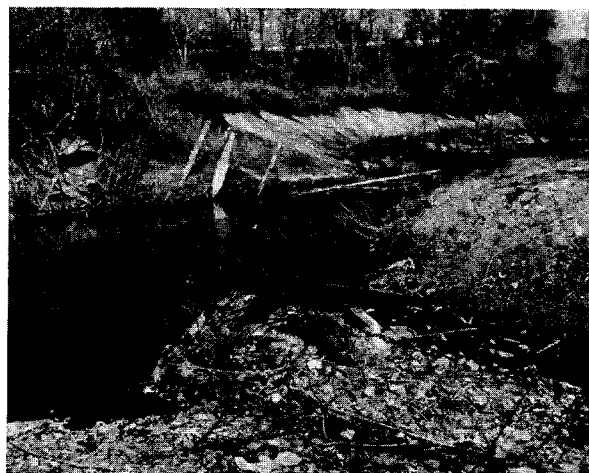
*Figure 313. View in 1976 of scour hole at downstream end of concrete-lined channel*

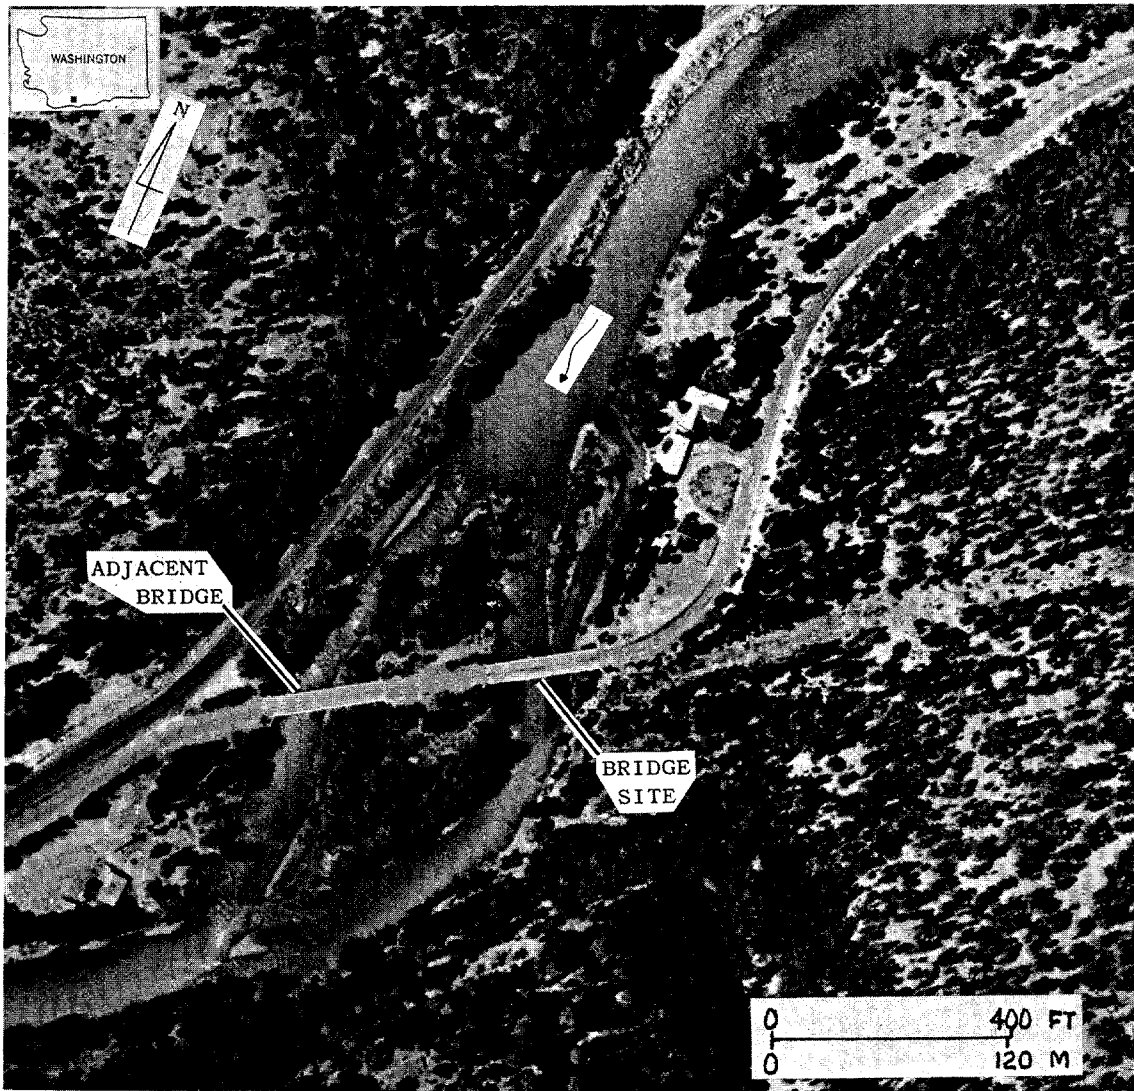
Figure 314. Aerial photograph in 1966 of bridges over Klickitat River at SR-142. (From Washington Dept. of Highways.)

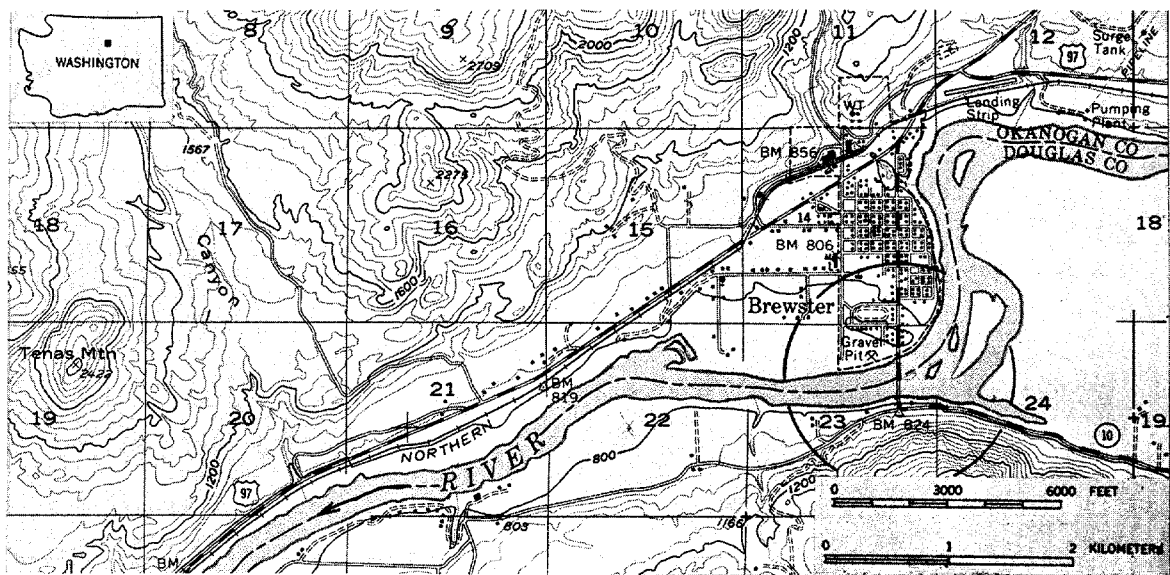
Figure 316. Location of SR-173 crossing (circled), Columbia River. (From U.S. Geological Survey Brewster, Wash., 15' quadrangle, contour interval 80 feet, 1957.)

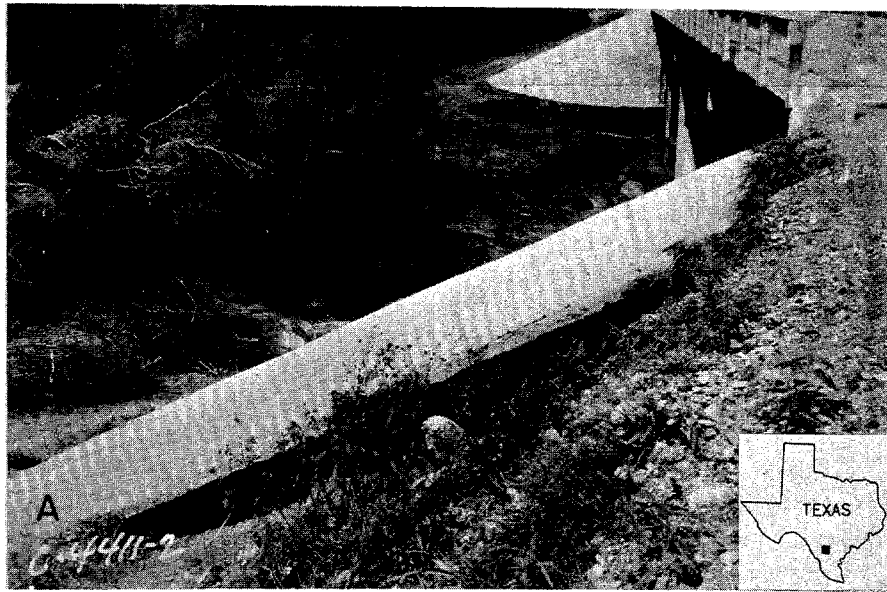
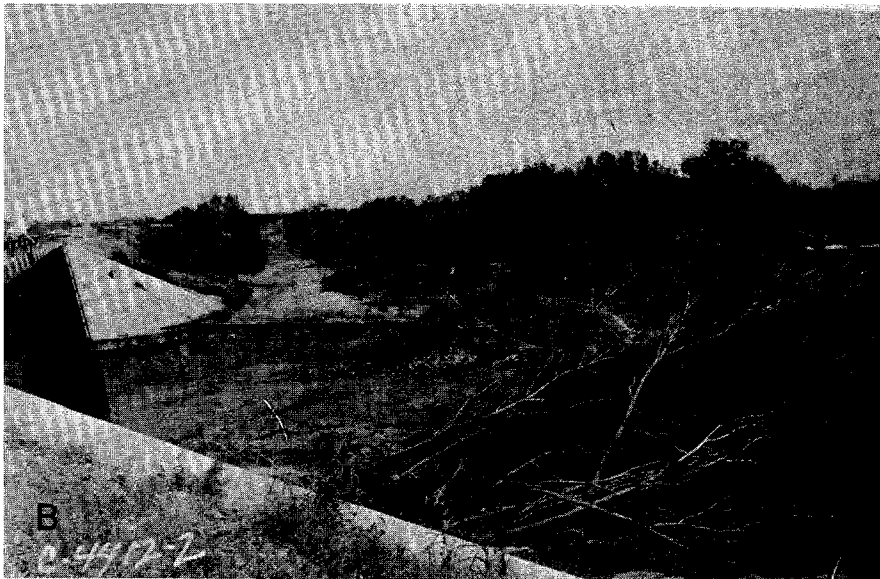
Figure 319. Undermining of concrete slope pavement during flood from Hurricane Beulah, 1967. A, upstream side of bridge; B, downstream side of bridge. (From Texas Dept. of Highways).

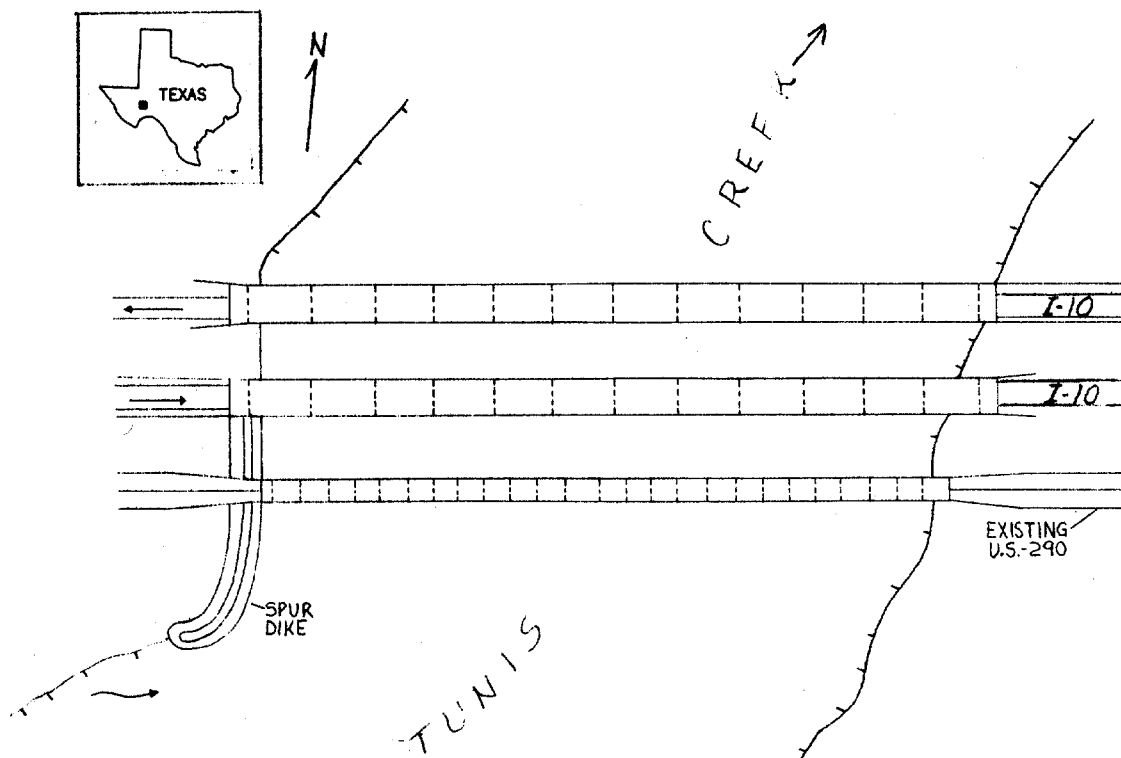
Figure 320. Plan of I-40 crossing at Tunis Creek.

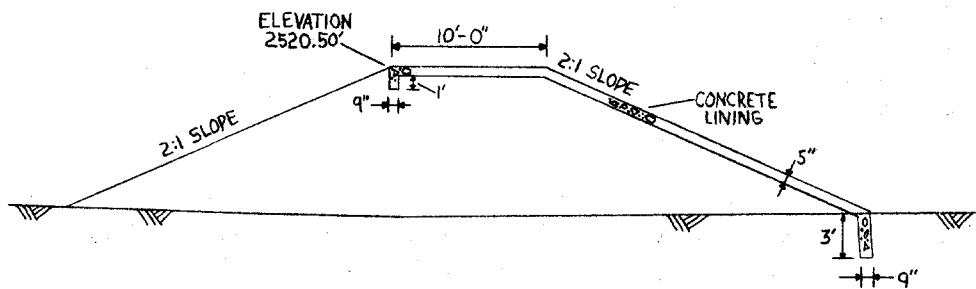
Figure 321. Details of spur dike construction, Tunis Creek.

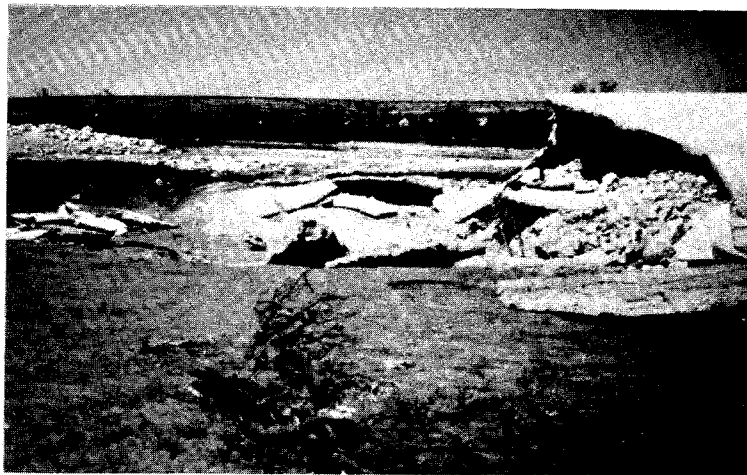
Figure 322. View of damaged upstream end of spur dike after flood of September, 1974. (From Texas Dept of Highways.)

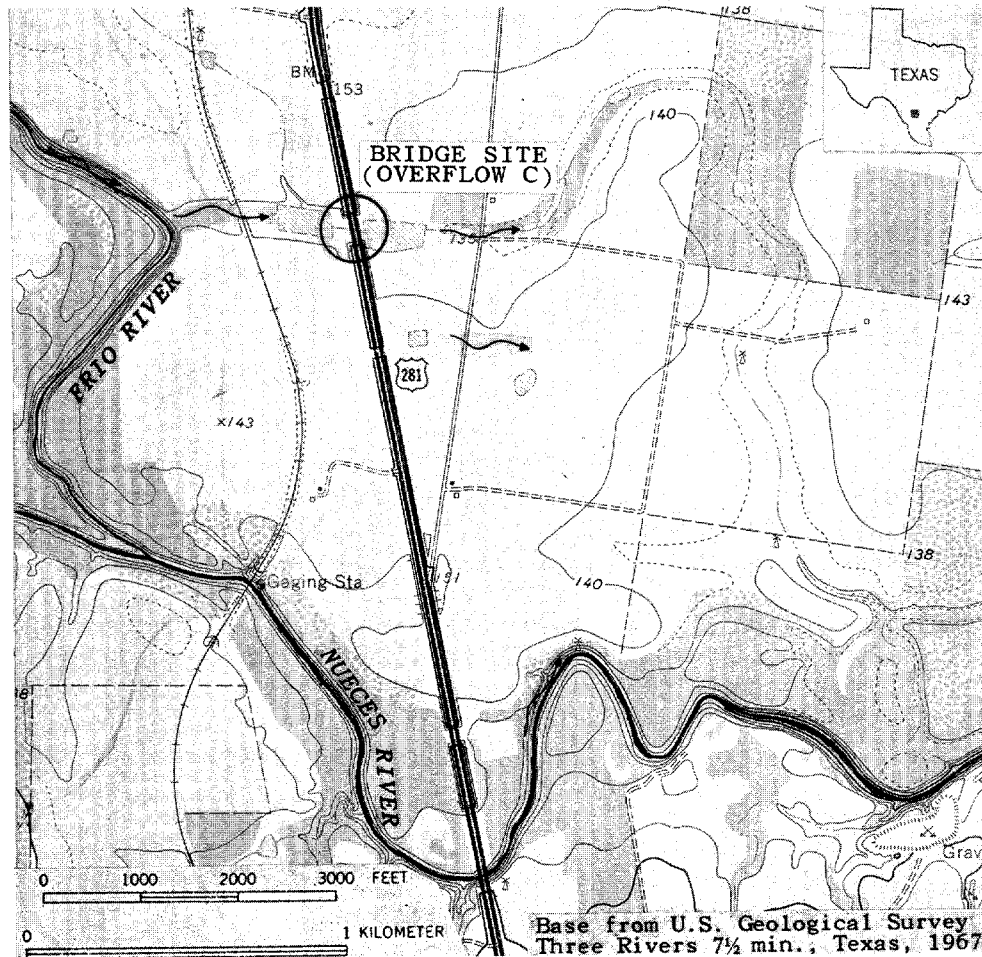
Figure 324. Location of overflow channel at Nueces and Frio Rivers.

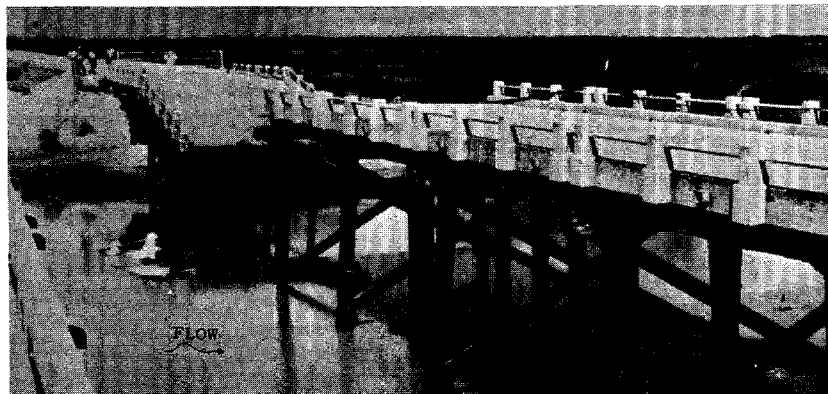
Figure 325. View of damaged bridge, looking north, after flooding by Hurricane Beulah in September 1967. (From Texas Dept of Highways.)

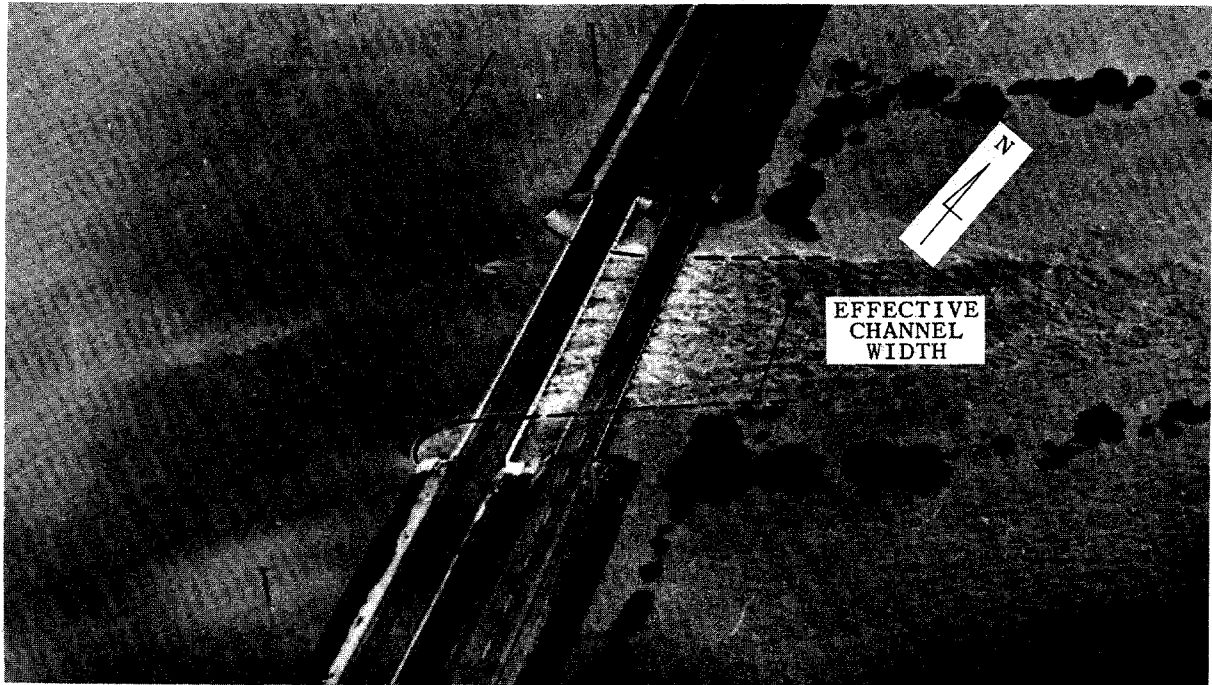
Figure 326. Aerial photograph, on which flow constriction at overflow bridge "C" is indicated, taken before collapse of spans of downstream bridge. (From Texas Dept. of Highways.)

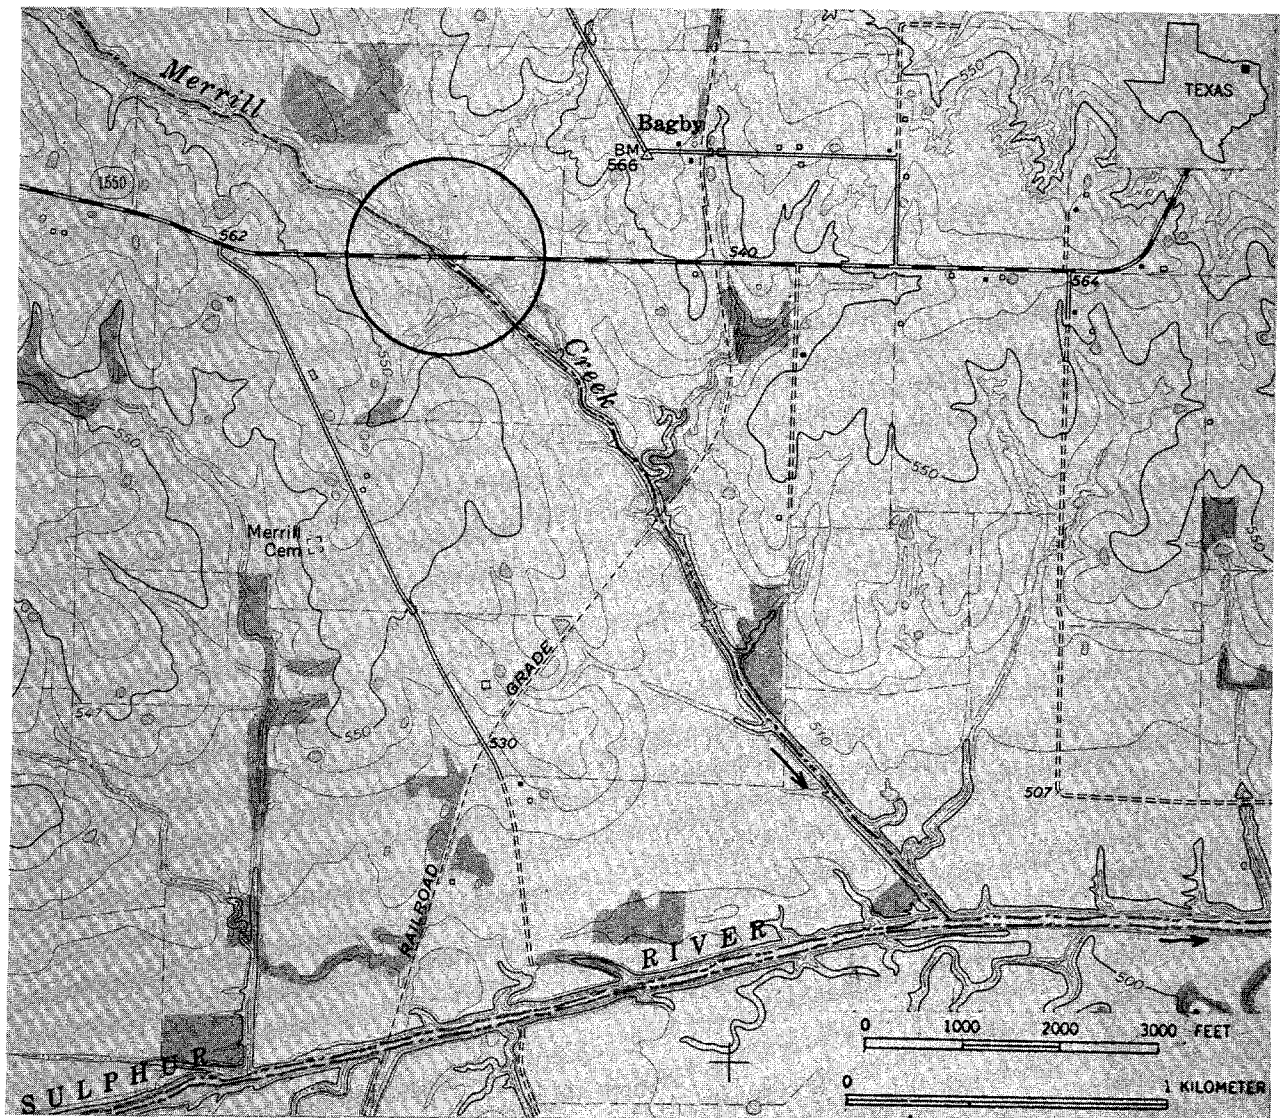
Figure 328. Location of FM-1550 crossing (circled), Merrill Creek, and confluence of Merrill Creek with North Sulphur River. (From U.S. Geological Survey Ladonia, Tex., 7.5' quadrangle, contour interval 10 feet, 1964.)

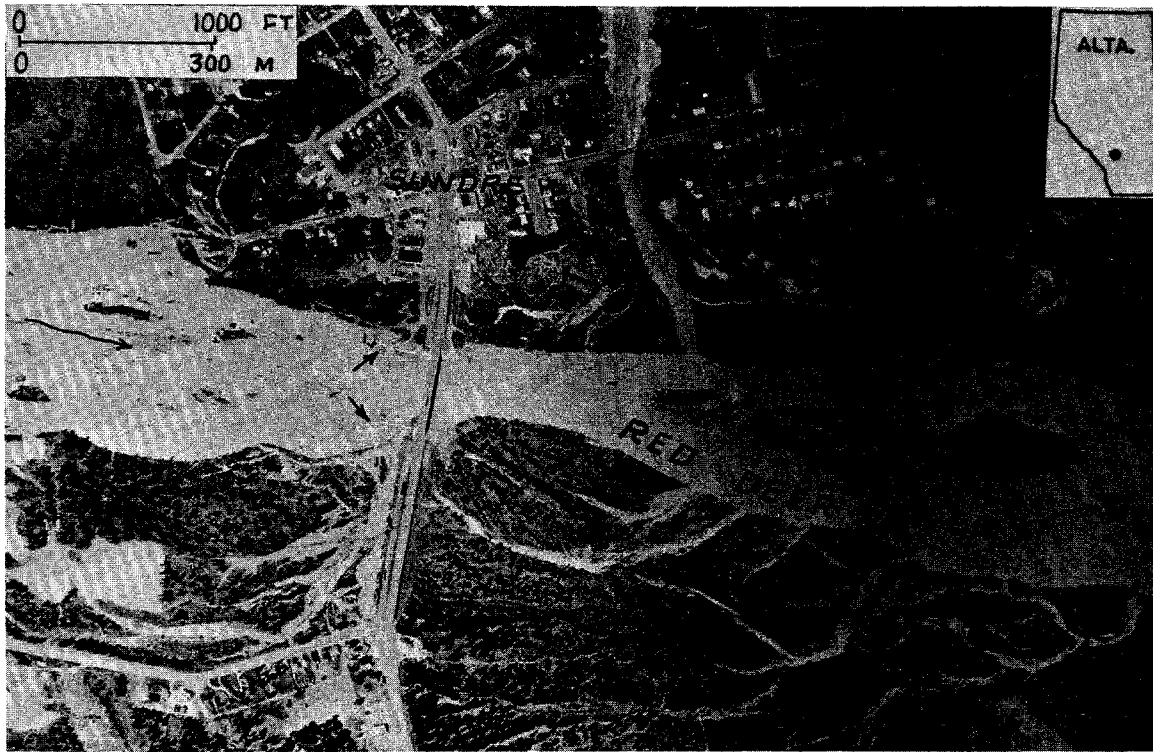
Figure 1. Aerial photograph of Ph-27 crossing, Red Deer River at Sundre, at flood stage on June 19, 1965. Guide banks are indicated by arrows. (From Alberta Highways and Transport).

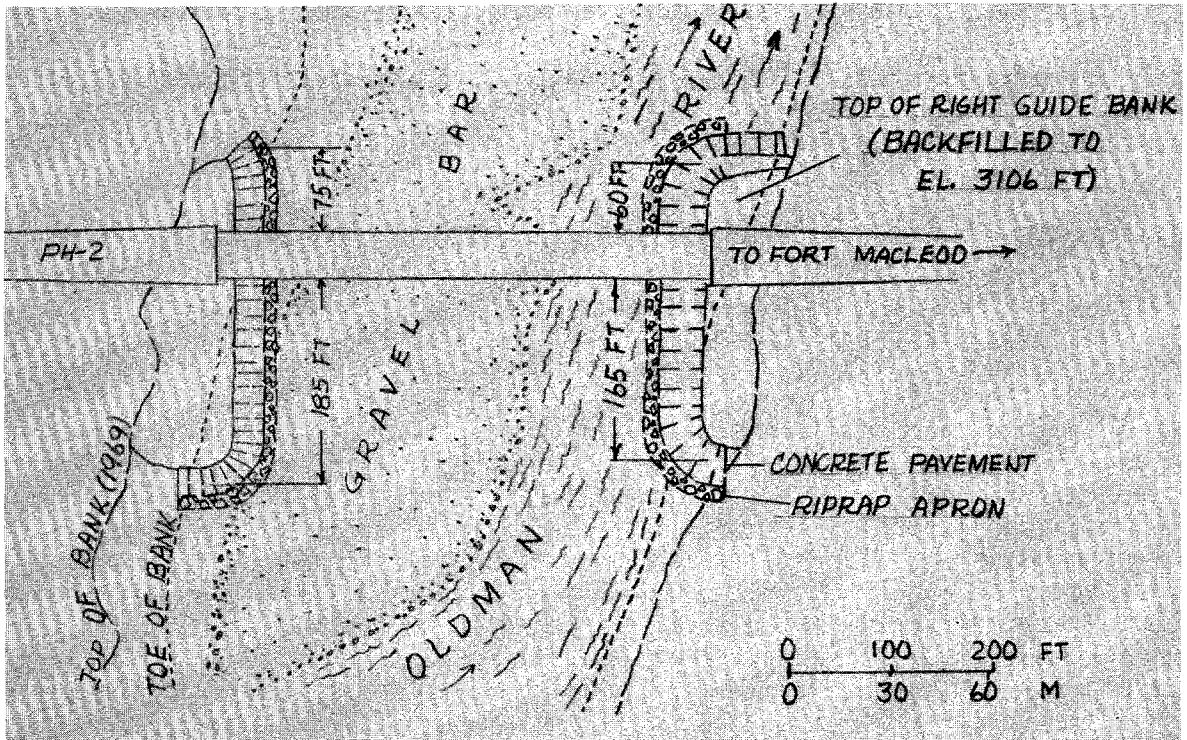
Figure 9. Plan sketch of PH-2 bridge and guide banks, Oldman River near Fort Macleod.

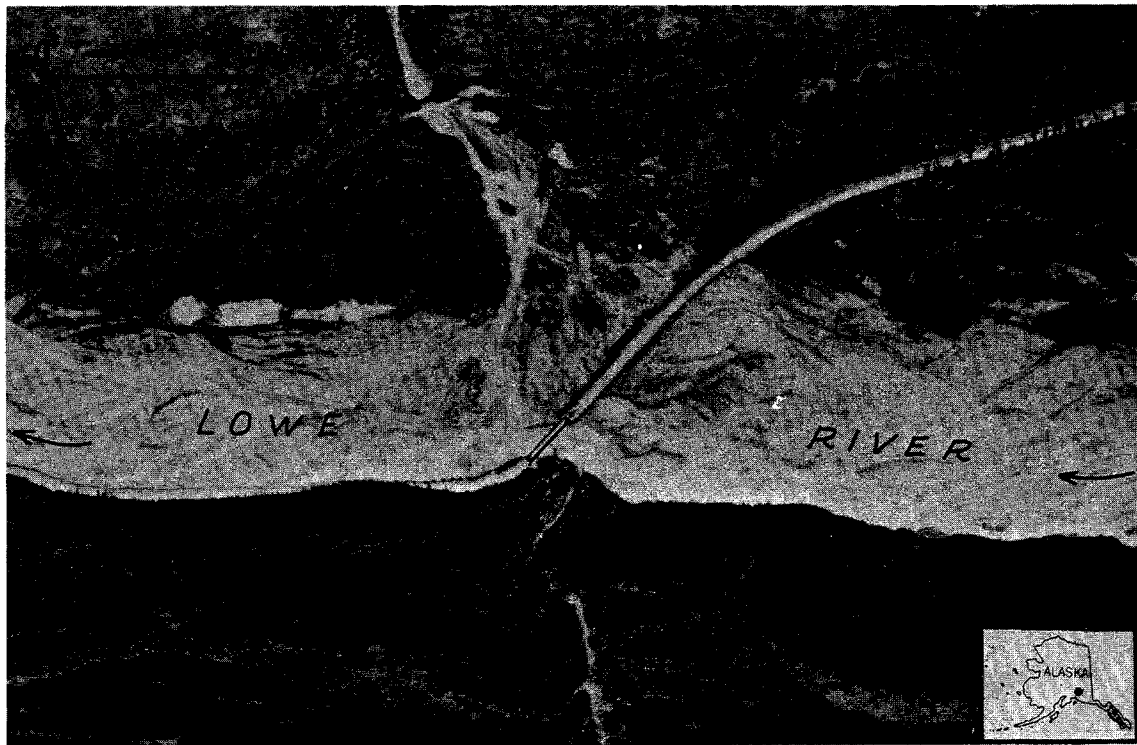
Figure 13. Aerial photograph of Lowe River at SR-4 crossing near Valdez, Alaska. (From Alyeska Pipeline Service Co.)

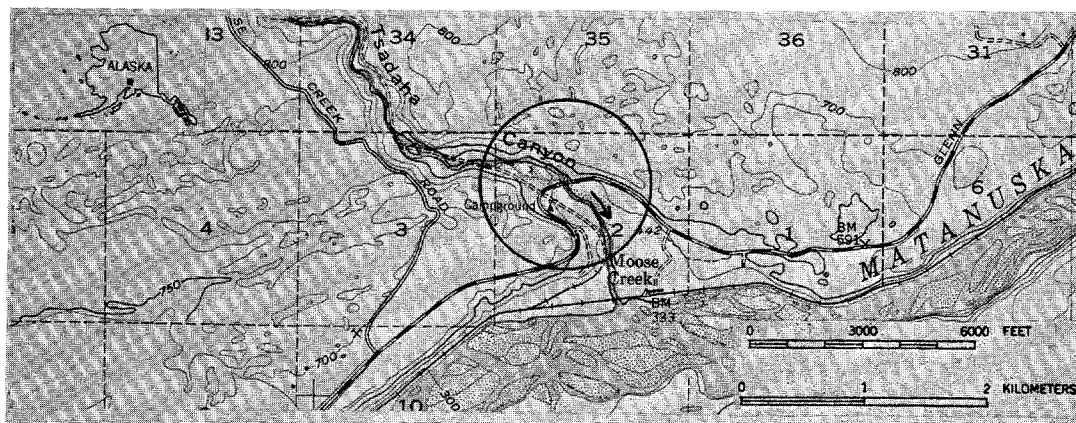
Figure 15. Map showing Moose Creek at SR-1 crossing (circled).  
(From U.S. Geol. Survey Anchorage (C-6), Alaska, 15' quadrangle, contour interval 50 feet, 1951).

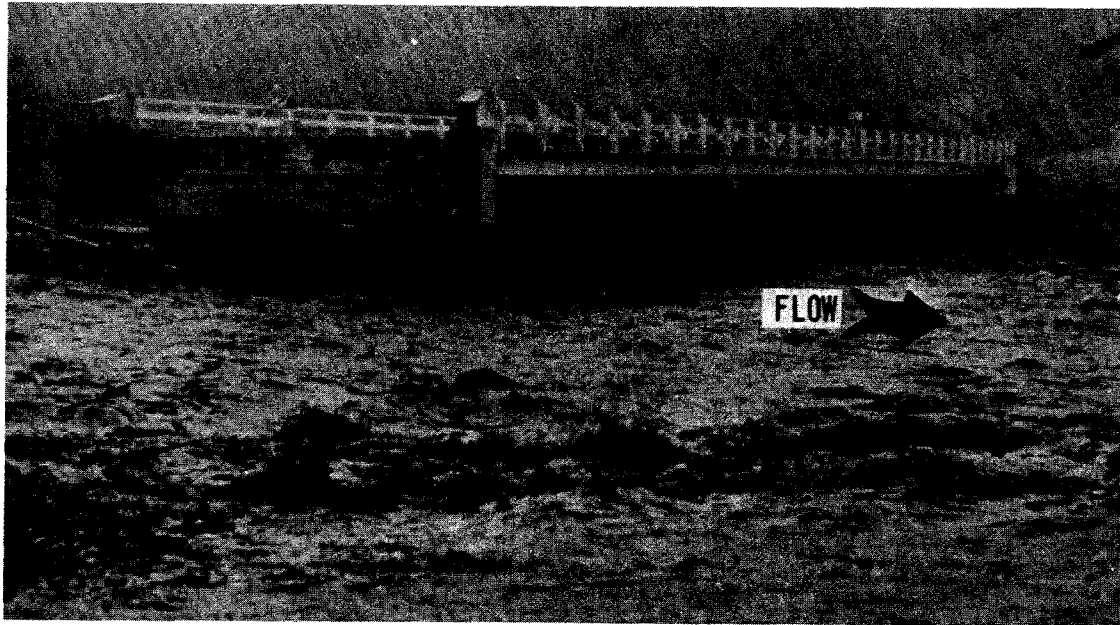
Figure 17. View of SR-1 bridge at Moose Creek after failure of right approach embankment. (From Norman, 1975.)

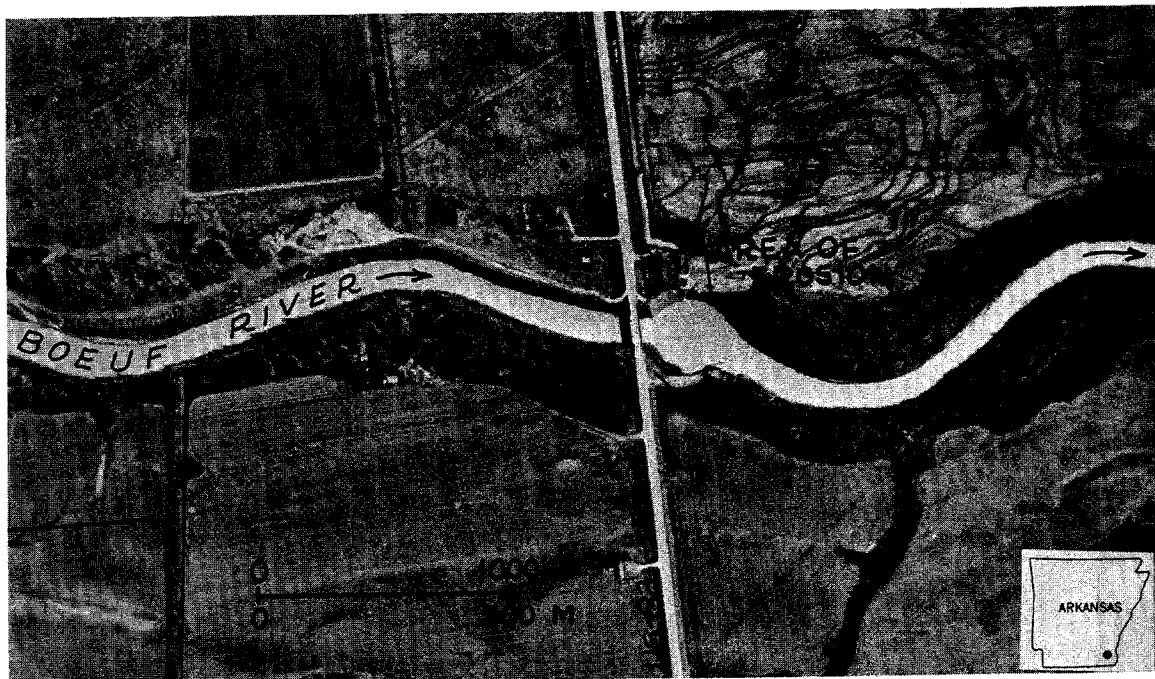
Figure 25. Aerial photograph of Boeuf River at US-82 crossing, on November 27, 1974. (From Arkansas State Highway Department.)

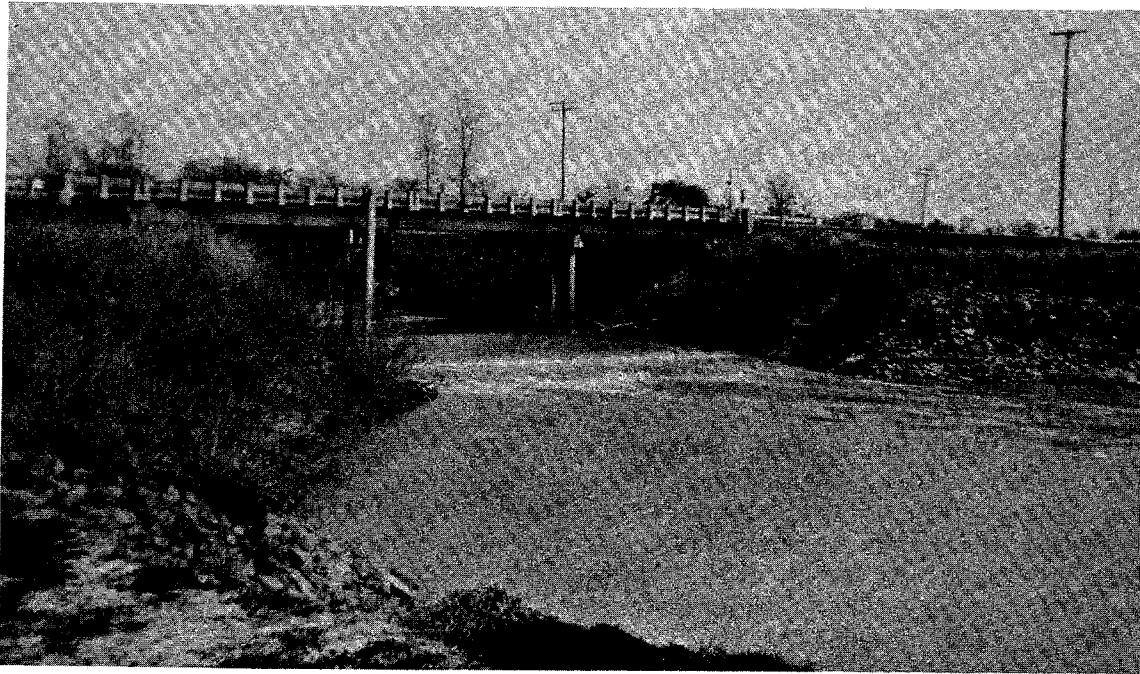
*Figure 26. Upstream view of overfall at check dam and riprap on eroded banks below dam, on March 18, 1976.*

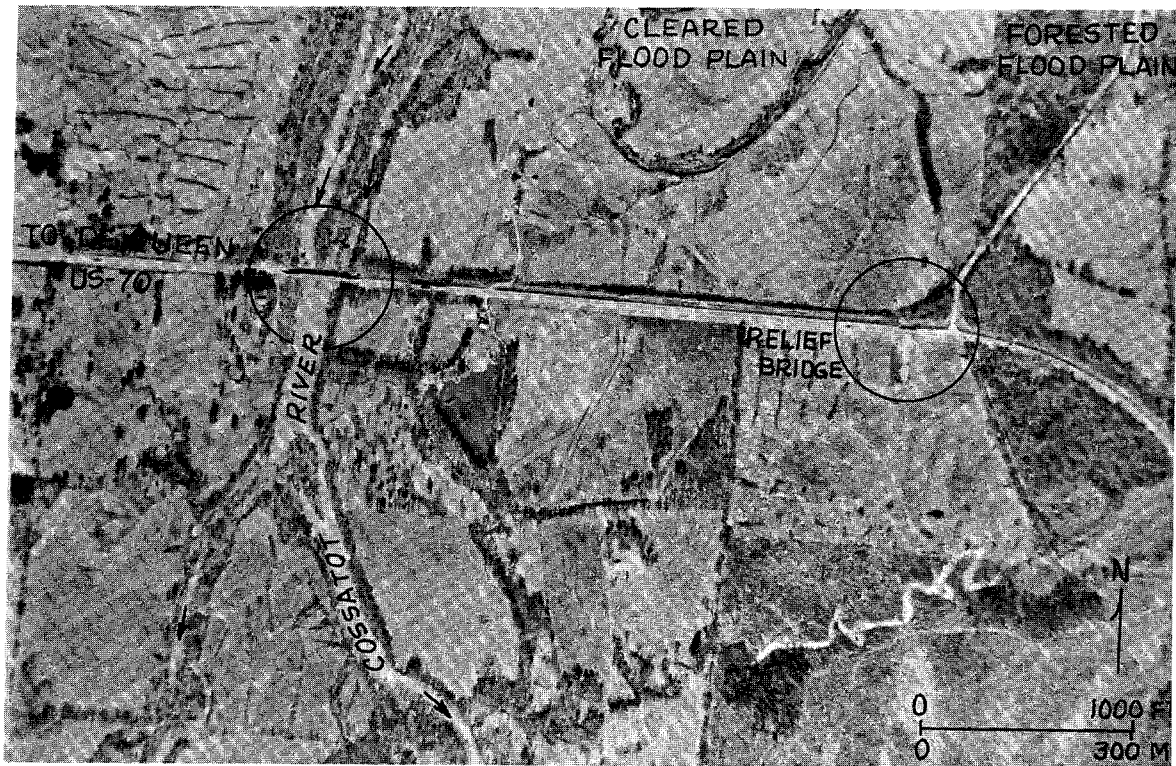
Figure 29. Aerial photograph of Cossatot River and flood plain at US-70 crossing, on February 18, 1976. (From Arkansas Dept. of Highways.)

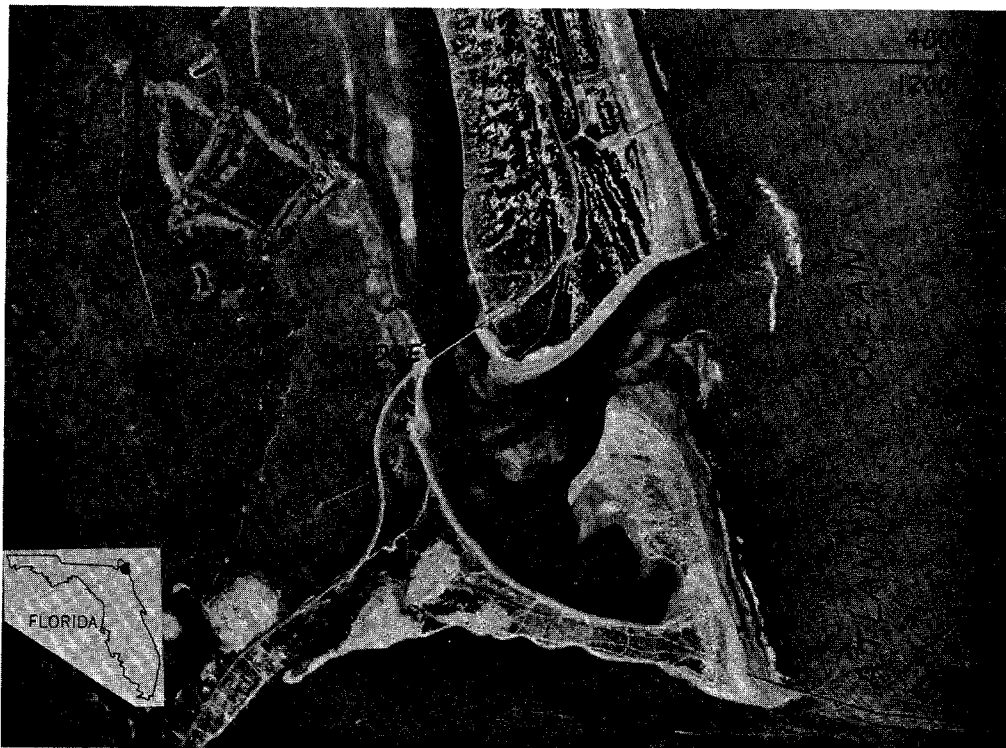
Figure 31. Aerial photograph showing general location of SR-105 crossing, Fort George River, November 8, 1969. (From Florida Dept. of Transportation.)

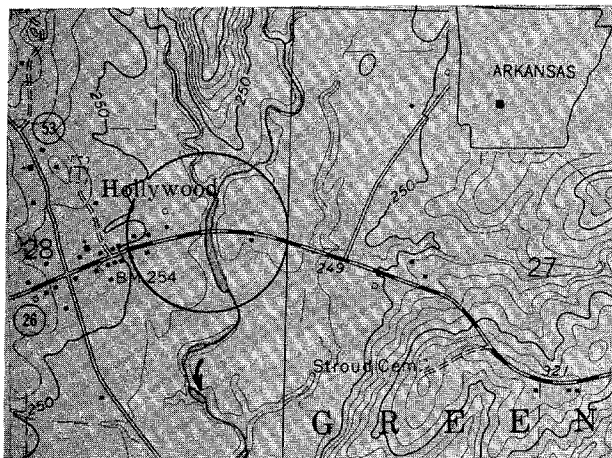
Figure 34. Map showing Hollywood Creek at SR-26 crossing (circled). (Base from U.S. Geol. Survey Hollywood, Ark., 7.5' quadrangle, contour interval 10 feet, scale 1:24,000, 1970.)

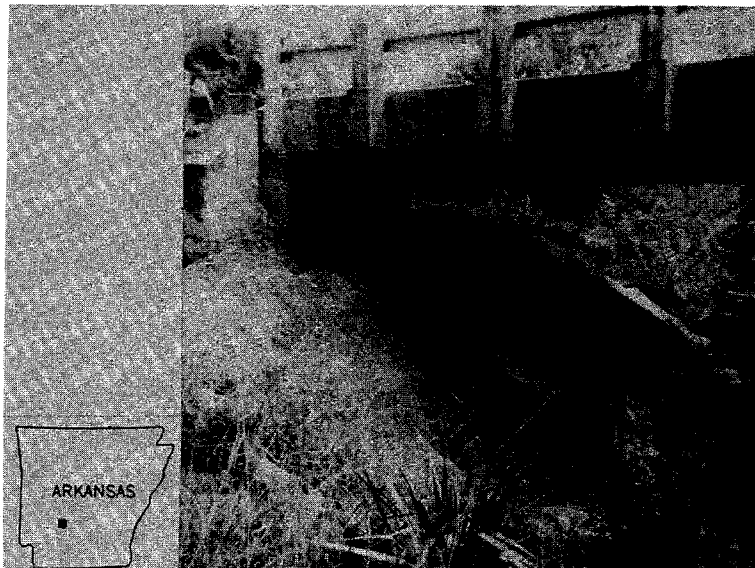
*Figure 36. View of failed concrete pavement at left abutment of SR-9 bridge, April 28, 1976.*

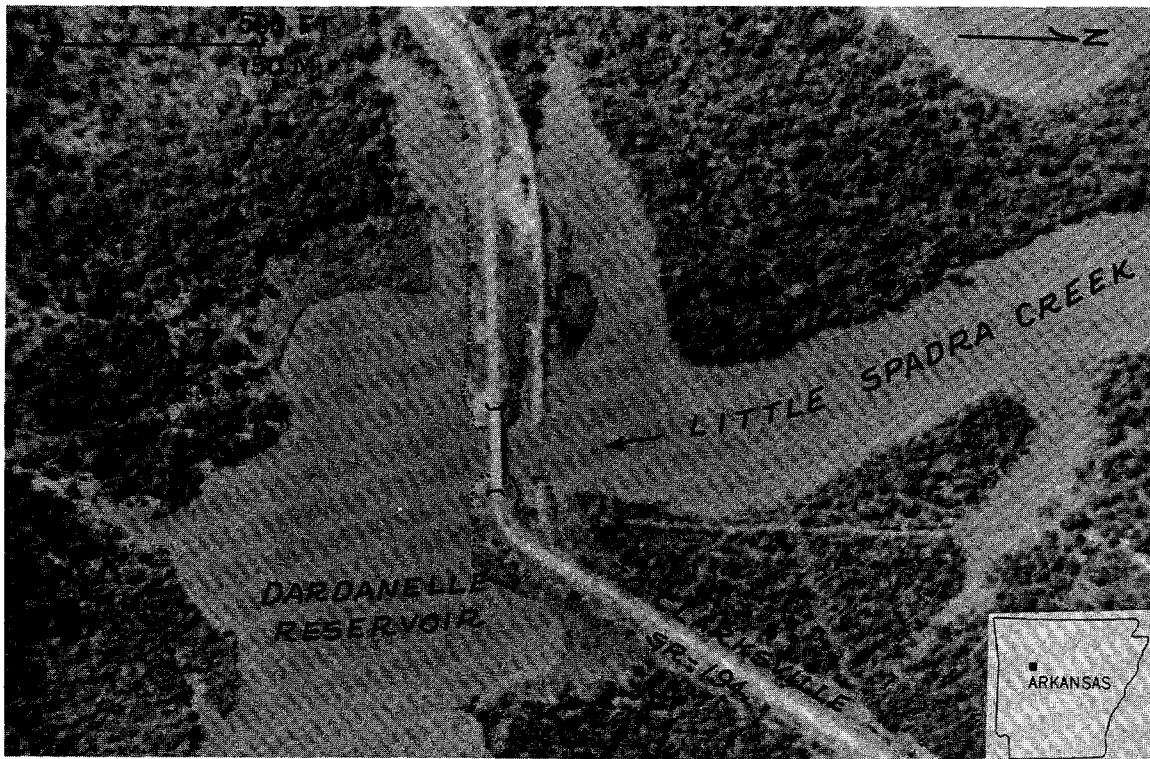
Figure 37. Aerial photograph of Little Spadra Creek at SR-194 crossing, on September 13, 1971. (From Arkansas Dept. of Highways.)

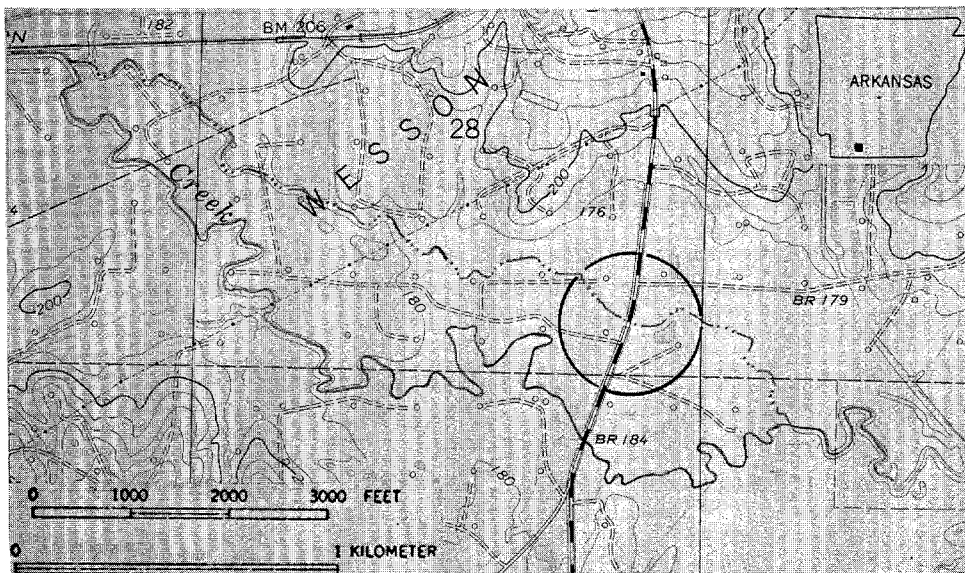
Figure 50. Map showing Smackover Creek at SR-57 relief bridge (circled). (Base from U.S. Geol. Survey Stephens, Ark., 7.5' quadrangle, contour interval 10 feet, 1969.)

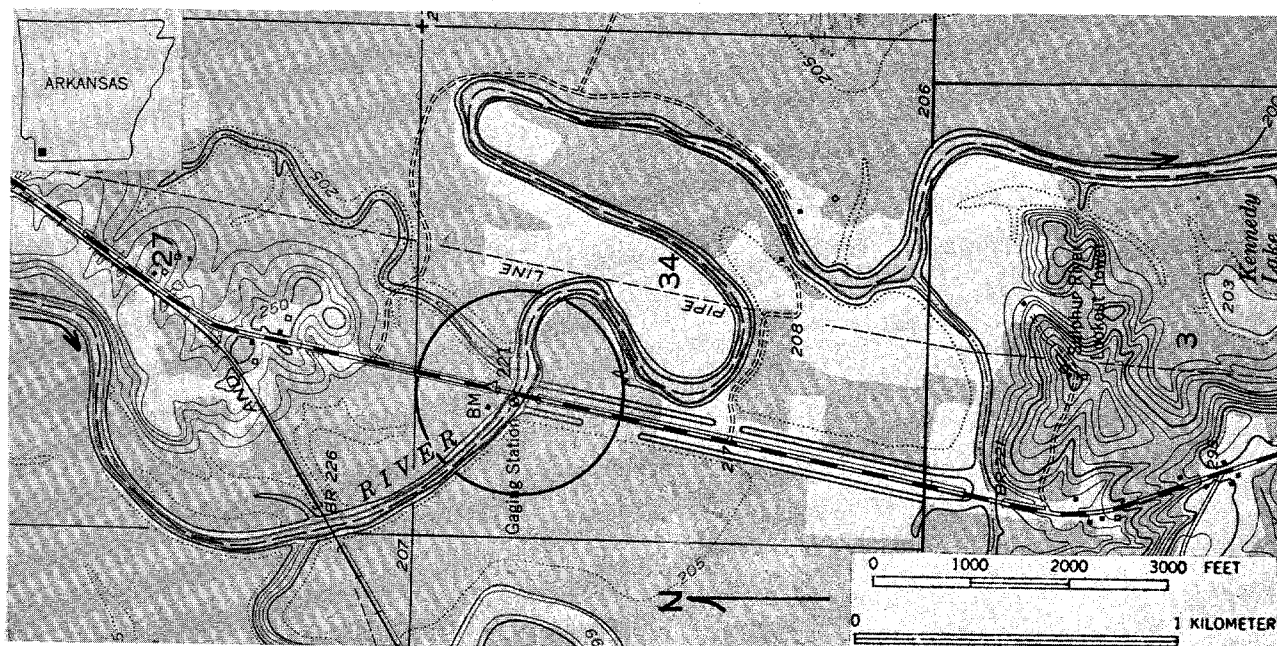
Figure 52. Map showing Sulphur River at US-71 crossing (circled).  
 (Base from U.S. Geol. Survey Doddridge NW, Ark., 7.5' quadrangle,  
 contour interval 20 feet, 1952.)
