Report No. FHWA-RD-78-163

Hydraulics Branch  
Library

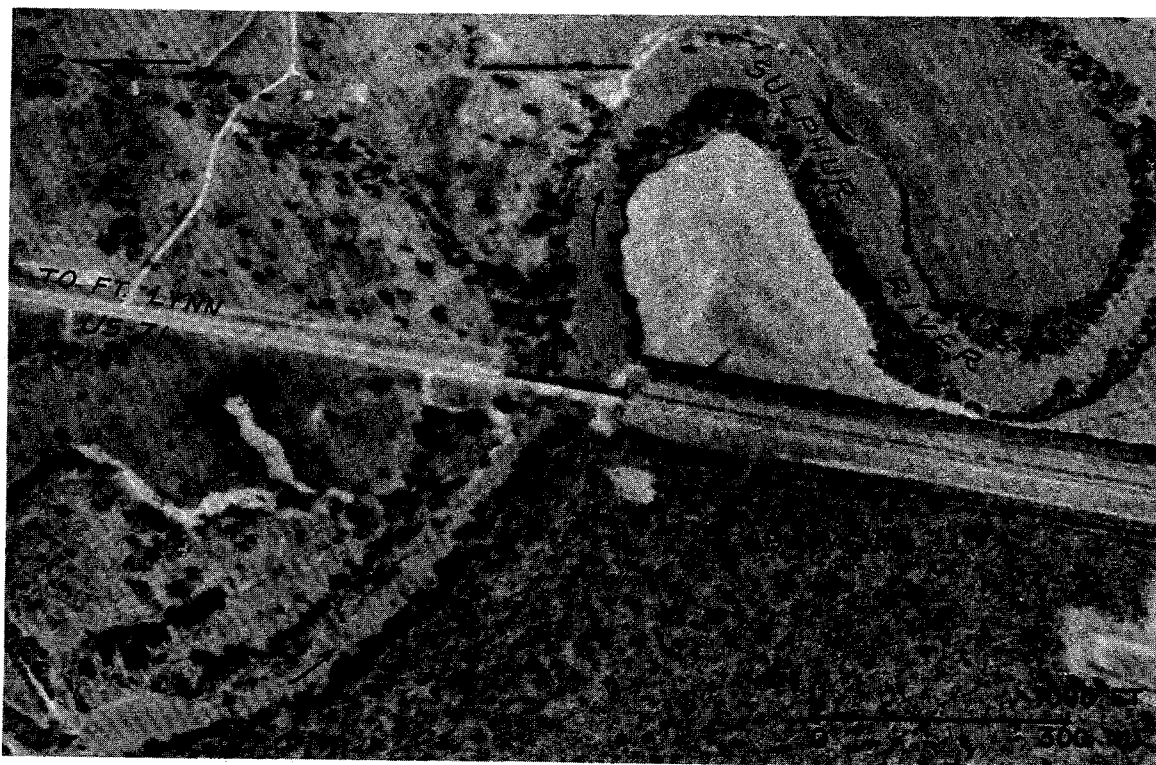
Figure 53. Aerial photograph of Sulphur River at US-71 crossing,  
 on October 16, 1974. (From Arkansas Dept. of Highways.)

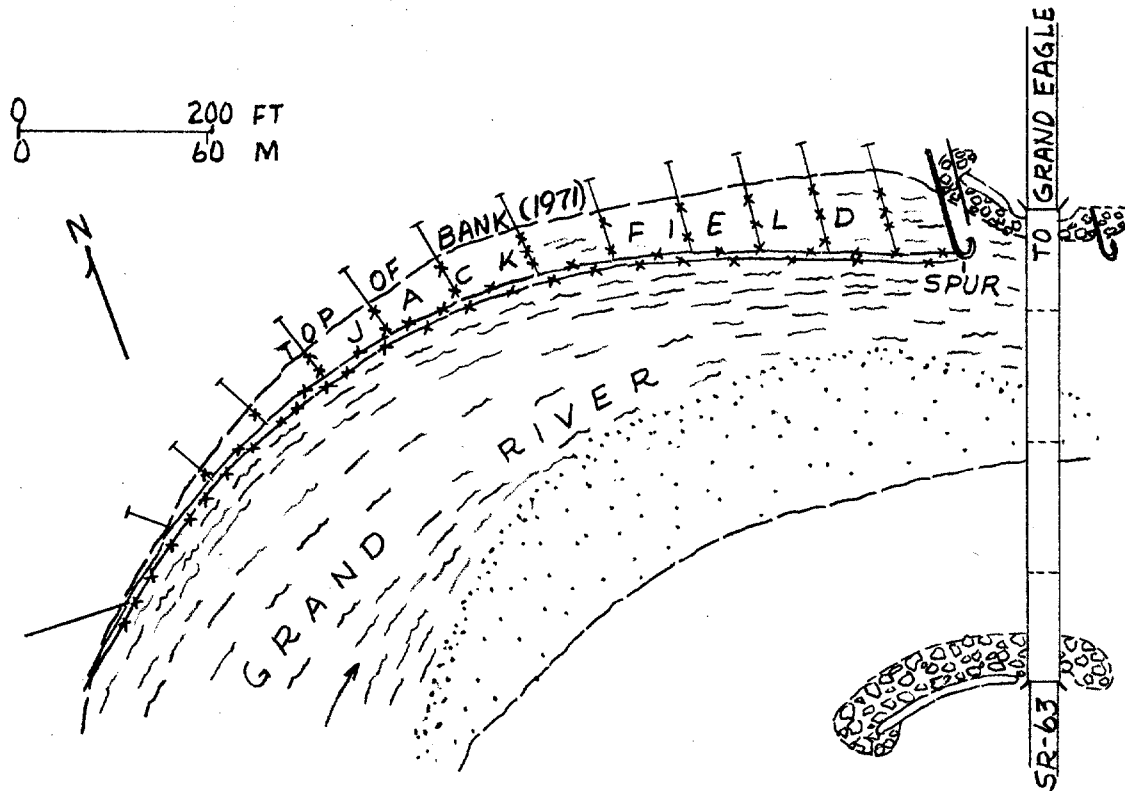
Figure 63. Plan sketch showing countermeasures installed at SR-63 crossing in 1971.

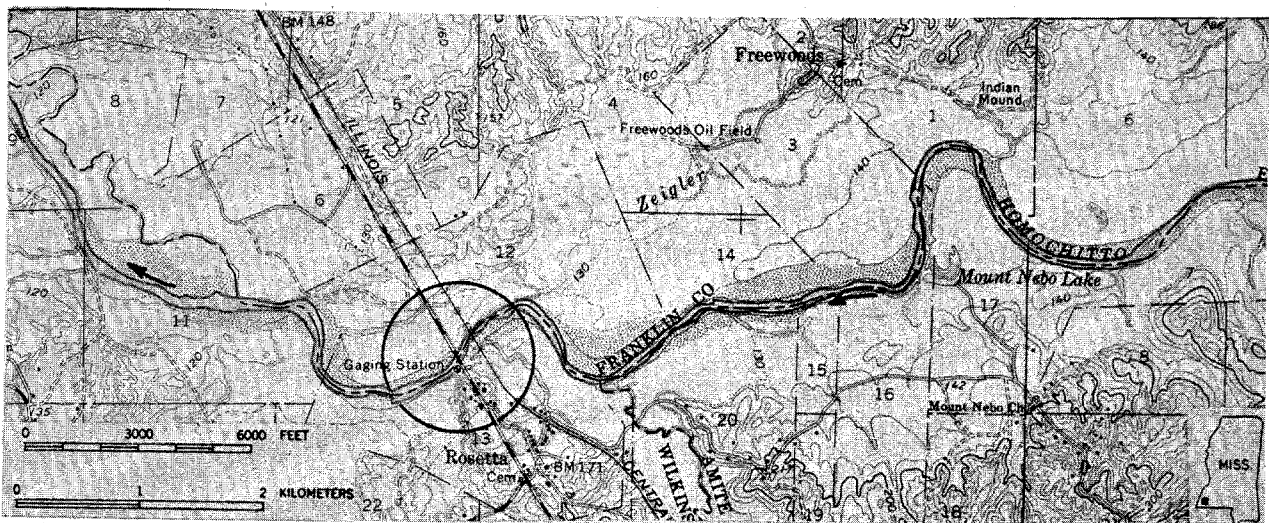
Figure 56. Map showing Homochitto River, SR-33 crossing at Rosetta, Miss. (Base from U.S. Geol. Survey Crosby, Miss., 15' quadrangle, contour interval 20 feet, 1961.)

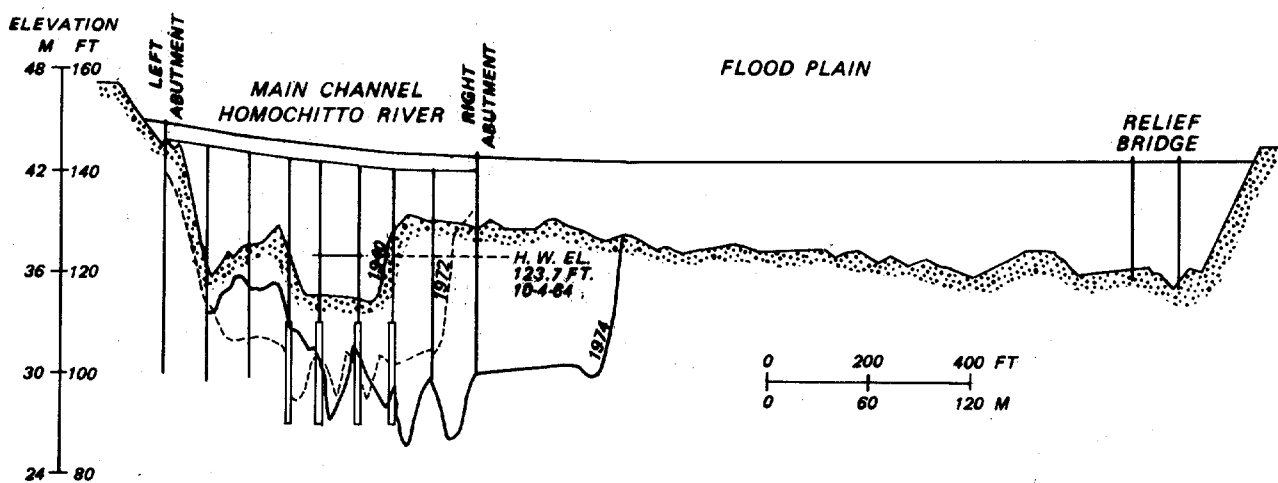
Figure 58. Cross section of Homochitto River, SR-33 crossing at Rosetta, showing degradation and lateral erosion during the period 1940-1974.

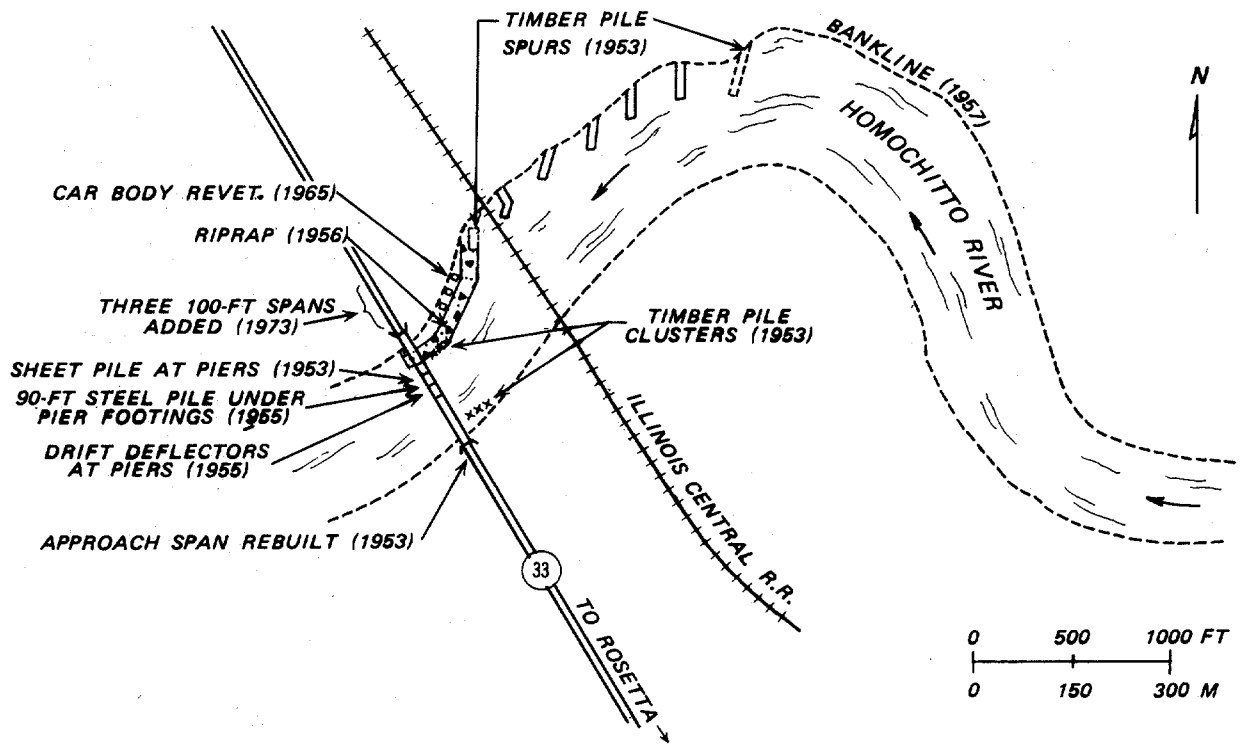
Figure 59. Plan sketch of Homochitto River, SR-33 crossing at Rosetta, showing placement of countermeasures.

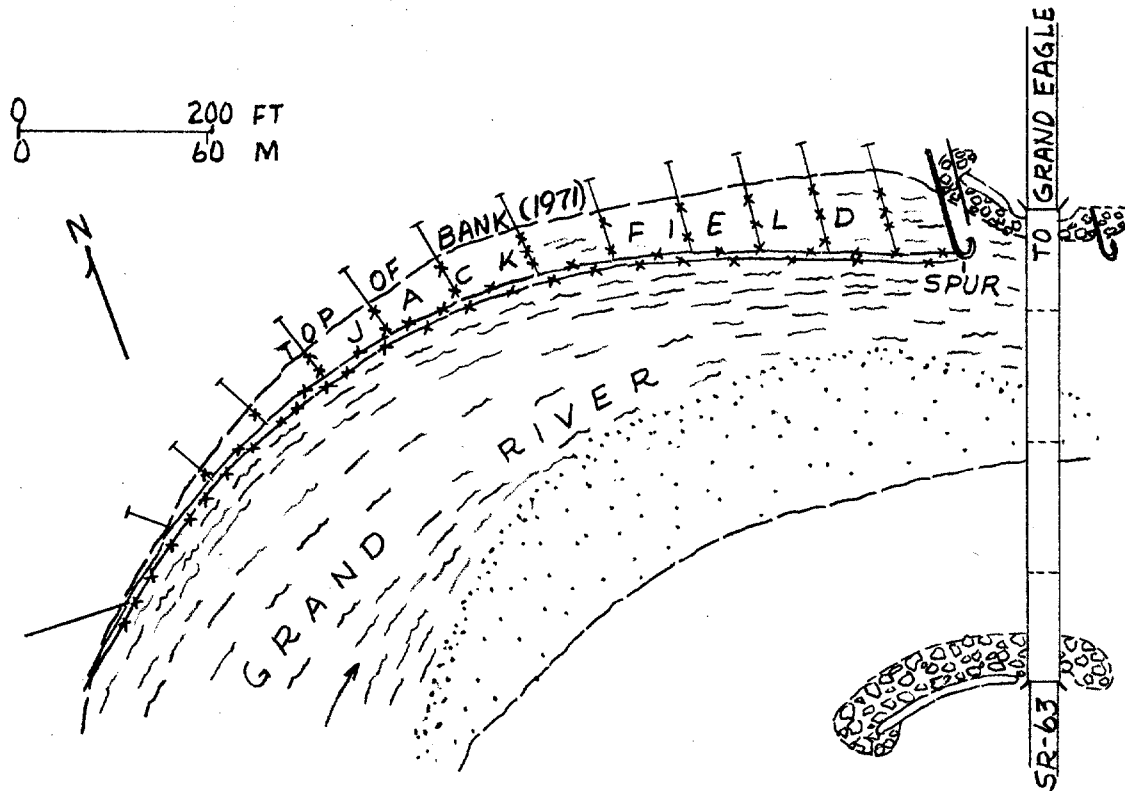
Figure 63. Plan sketch showing countermeasures installed at SR-63 crossing in 1971.

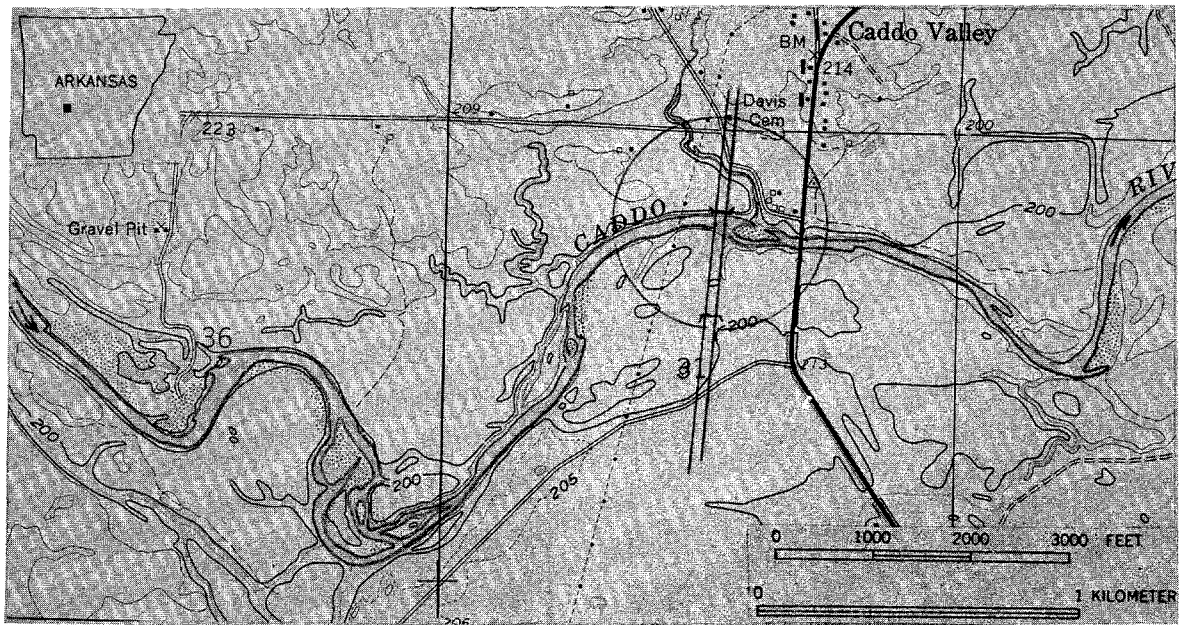
Figure 68. Map showing Caddo River at I-30 crossing (circled). (Base from U.S. Geol. Survey Caddo Valley, Ark., 7.5' quadrangle, contour interval 10 feet, 1959.)

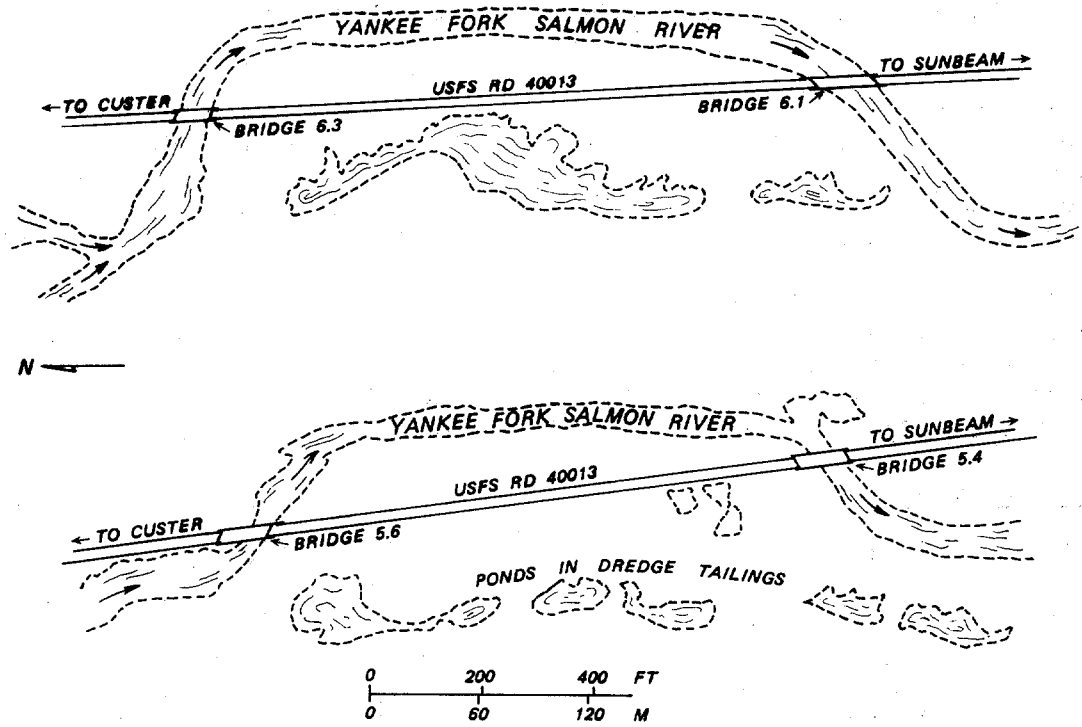
Figure 83. Plan sketch of two reaches of Yankee Fork Salmon River, each crossed by two Forest Service bridges.

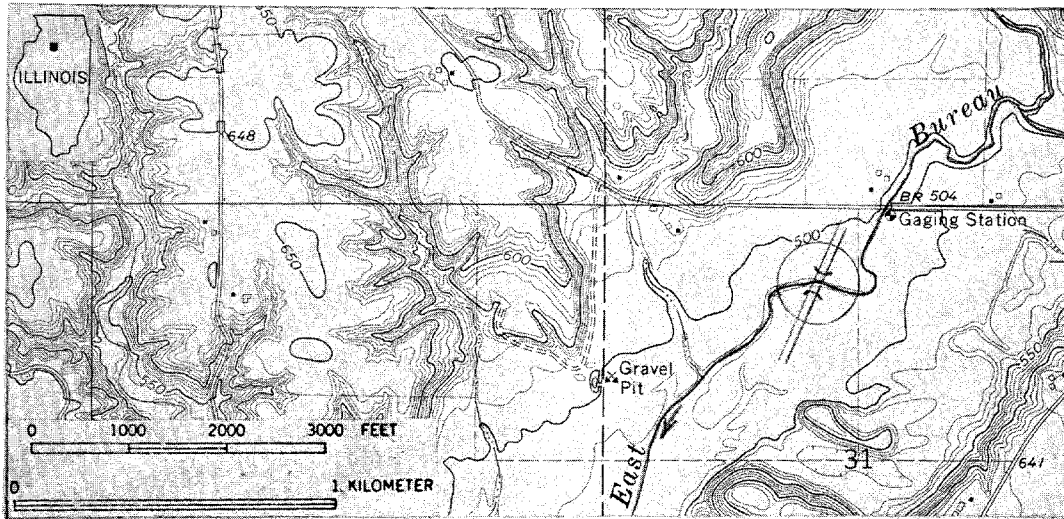
Figure 85. Map showing East Bureau Creek at I-180 (circled). (Base from U.S. Geol. Survey Princeton South, Ill., 7.5' quadrangle, contour interval 10 feet, 1966.)

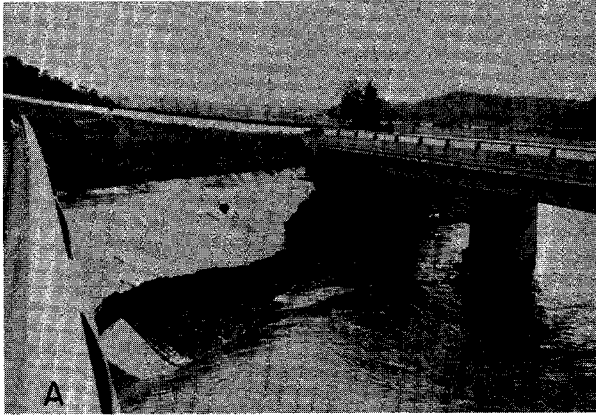
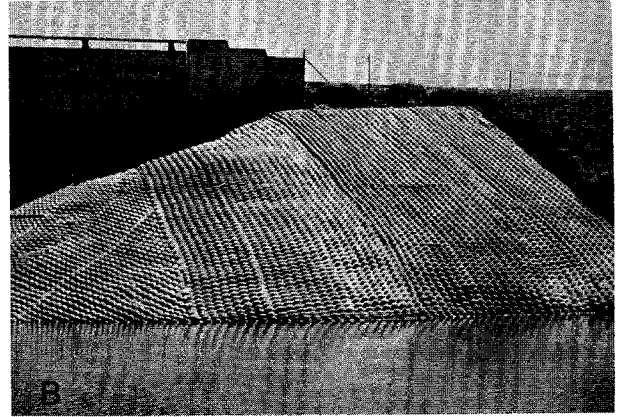
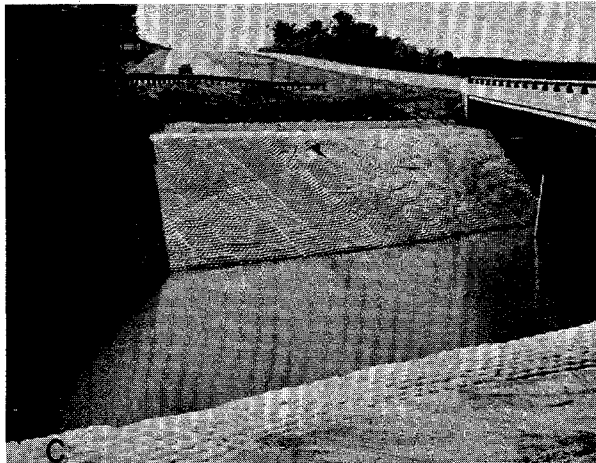
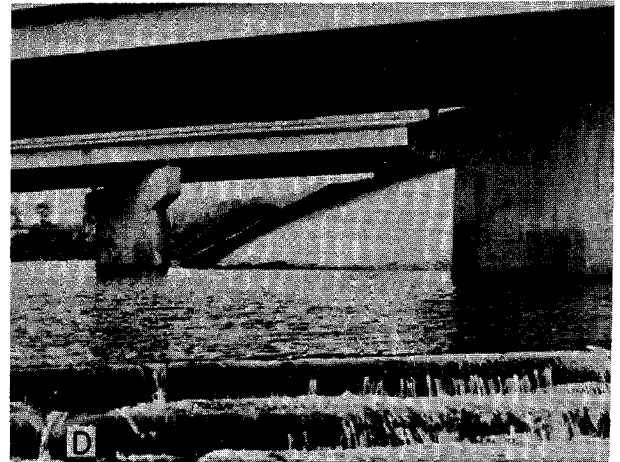
Figure 87. A, view of right (north) abutment fill-slope showing failure of concrete slope pavement at I-180 bridges, in 1974. B, view of "fabriform" revetment on upstream side of south abutment, northbound bridge. C, view of right (north) abutment fill-slope, showing placement of "Fabriform" revetment. D, upstream view of "Fabricast" check dam. (Photographs from Intrusion-Prepakt, Inc.)

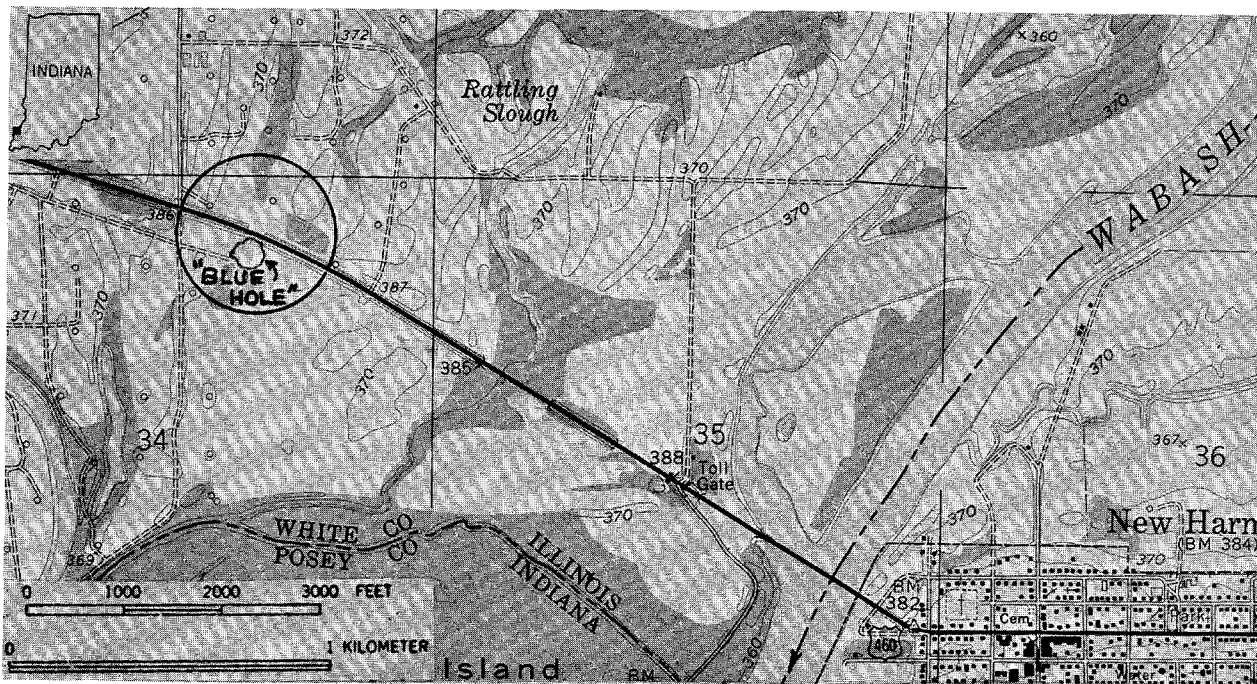
Figure 88. Map showing US-460 crossing of Wabash River and location of relief bridge 3 (circled). (Base from U.S. Geol. Survey New Harmony, Ind.-Ill., 7.5' quadrangle, contour interval 10 feet, 1959.)

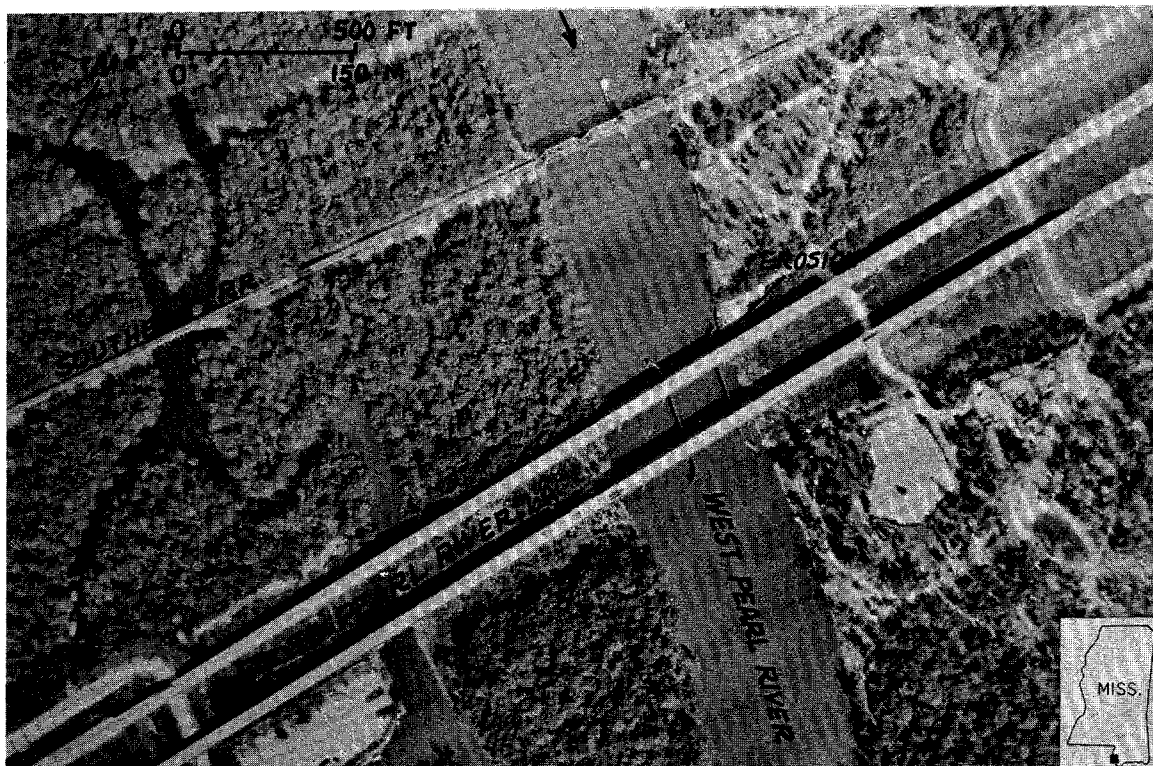
Figure 90. Aerial photograph of West Pearl River at I-59 bridge on September 20, 1974, before countermeasures were installed. (From Louisiana Dept. of Transportation.)

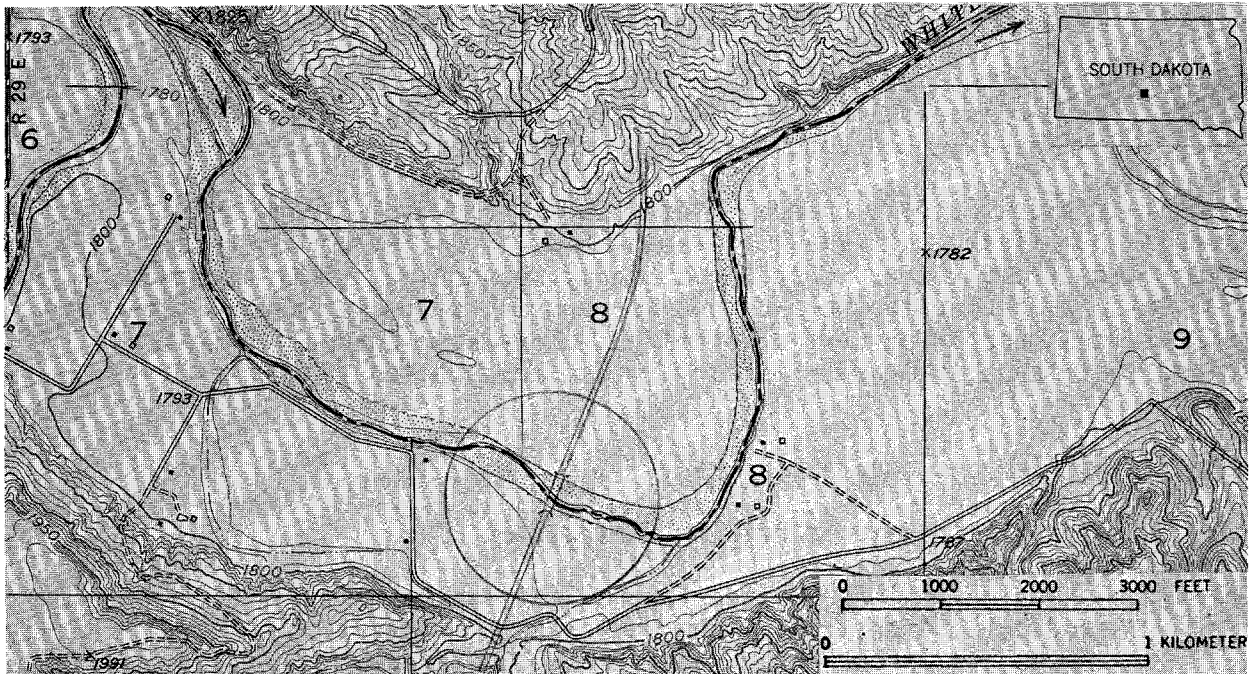
Figure 92. Map showing White River at US-83 crossing (circled). (Base from U.S. Geol. Survey Westover, S. Dak., 7.5' quadrangle, contour interval 10 feet, 1951.)

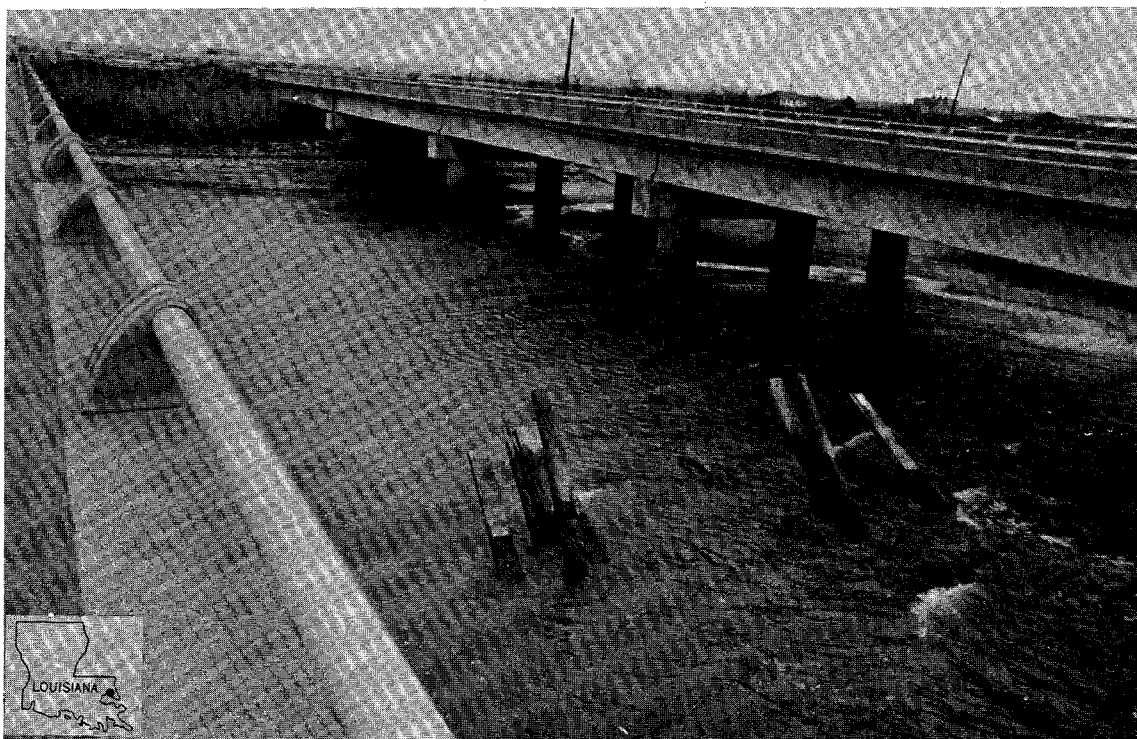
Figure 97. View looking northeast toward abutment of I-10 and shore of Lake Ponchartrain, on March 2, 1977. Remnants of timber-pile wall, foreground, and damaged sacked concrete revetment at abutment, background.

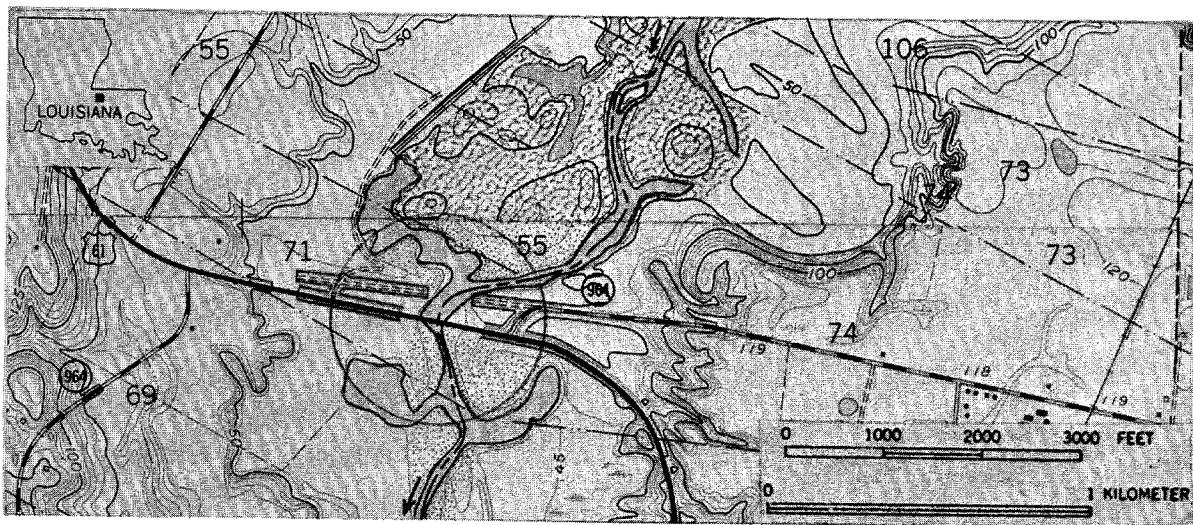
Figure 101. Map showing Thompson Creek at US-61 crossing (circled). (Base from U.S. Geol. Survey Elm Park, La., 7.5' quadrangle, contour interval 10 feet, 1965; and Port Hudson, La., 7.5' quadrangle, contour interval 5 feet, 1963.)

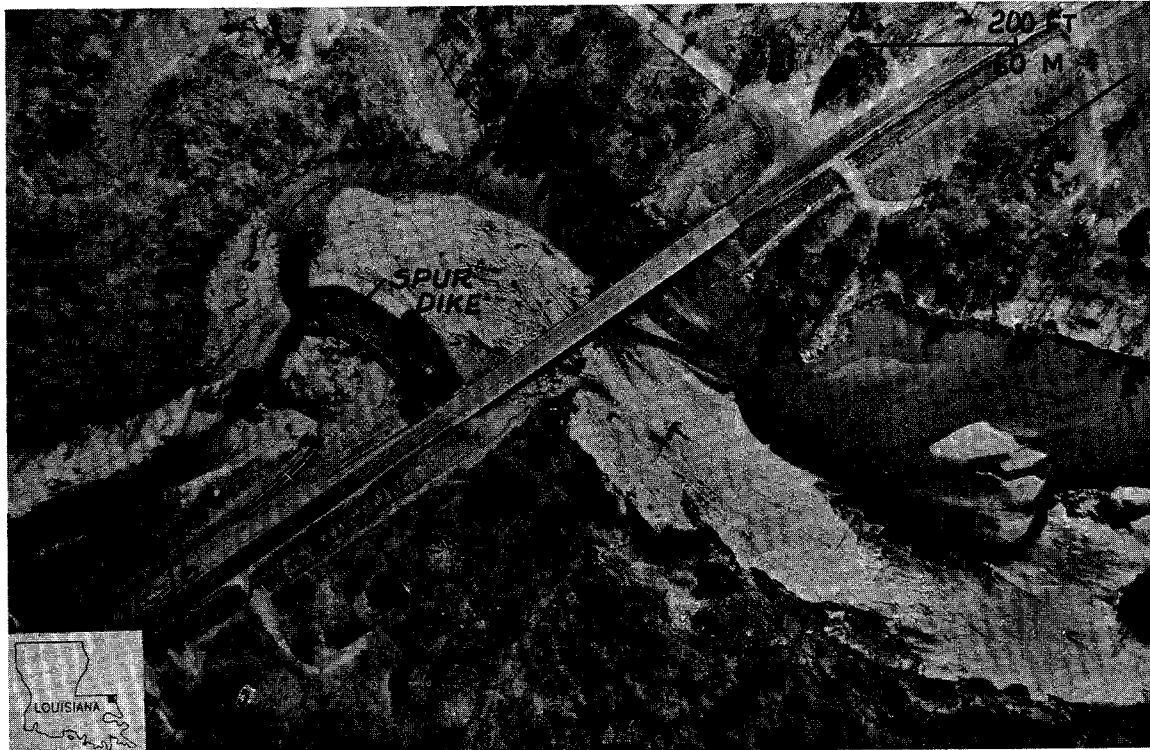
Figure 104. Aerial photograph of Lawrence Creek at SR-16, taken January 21, 1974, during repair of damage to spur dike. (From Louisiana Dept. of Transportation.)

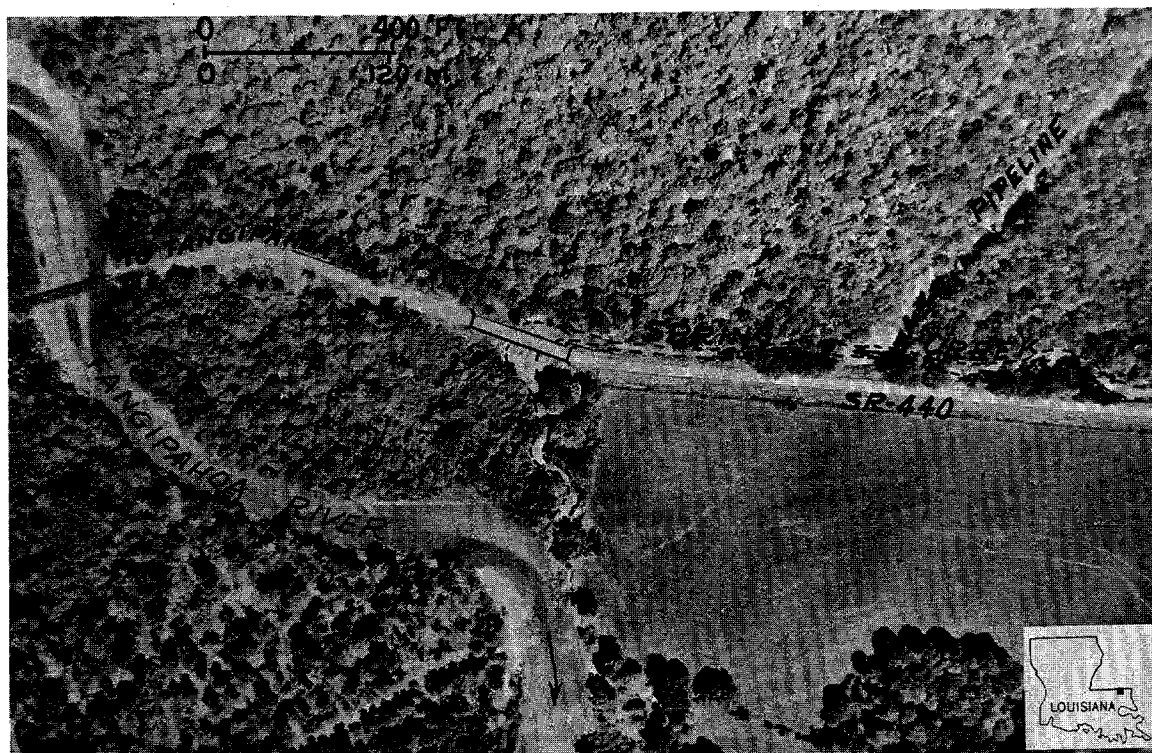
Figure 105. Aerial photograph of Spring Creek at SR-440, on April 5, 1974. (From Louisiana Dept. of Transportation.)

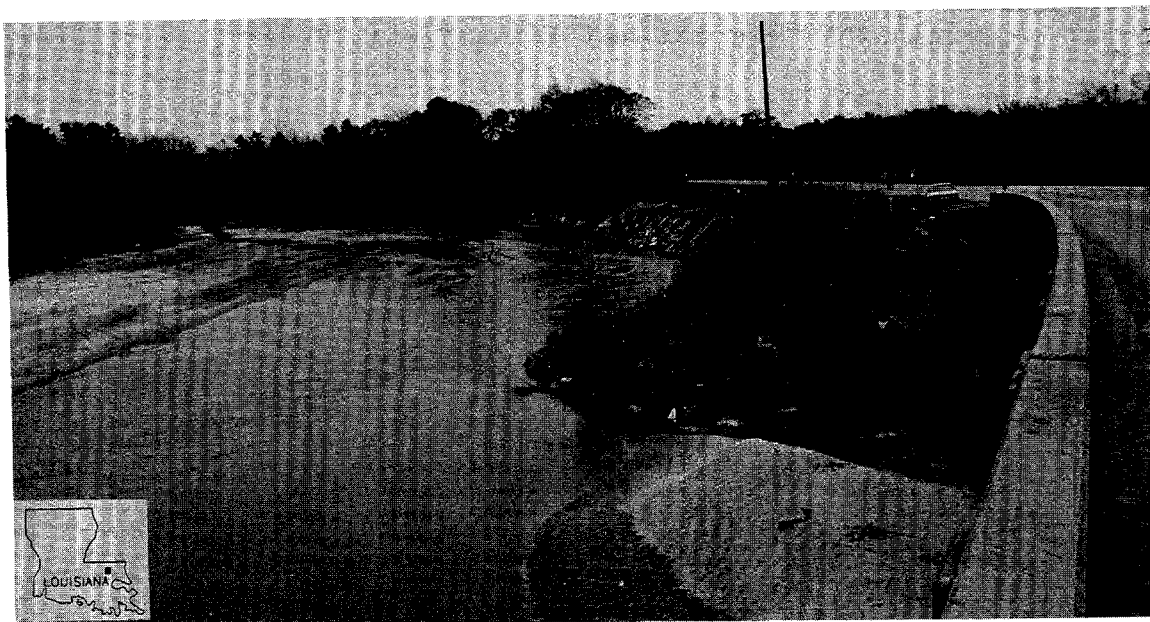
Figure 107. View on March 2, 1977, looking upstream from SR-40 bridge, where stream flows along approach embankment before turning to enter bridge waterway.

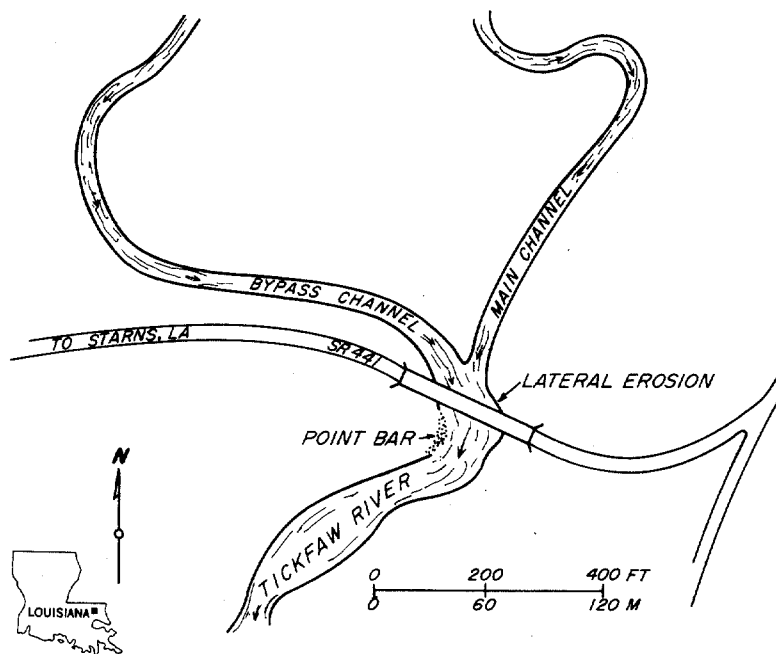
Figure 108. Plan sketch of Tickfaw River at SR-441. (From aerial photograph taken February 13, 1975.)

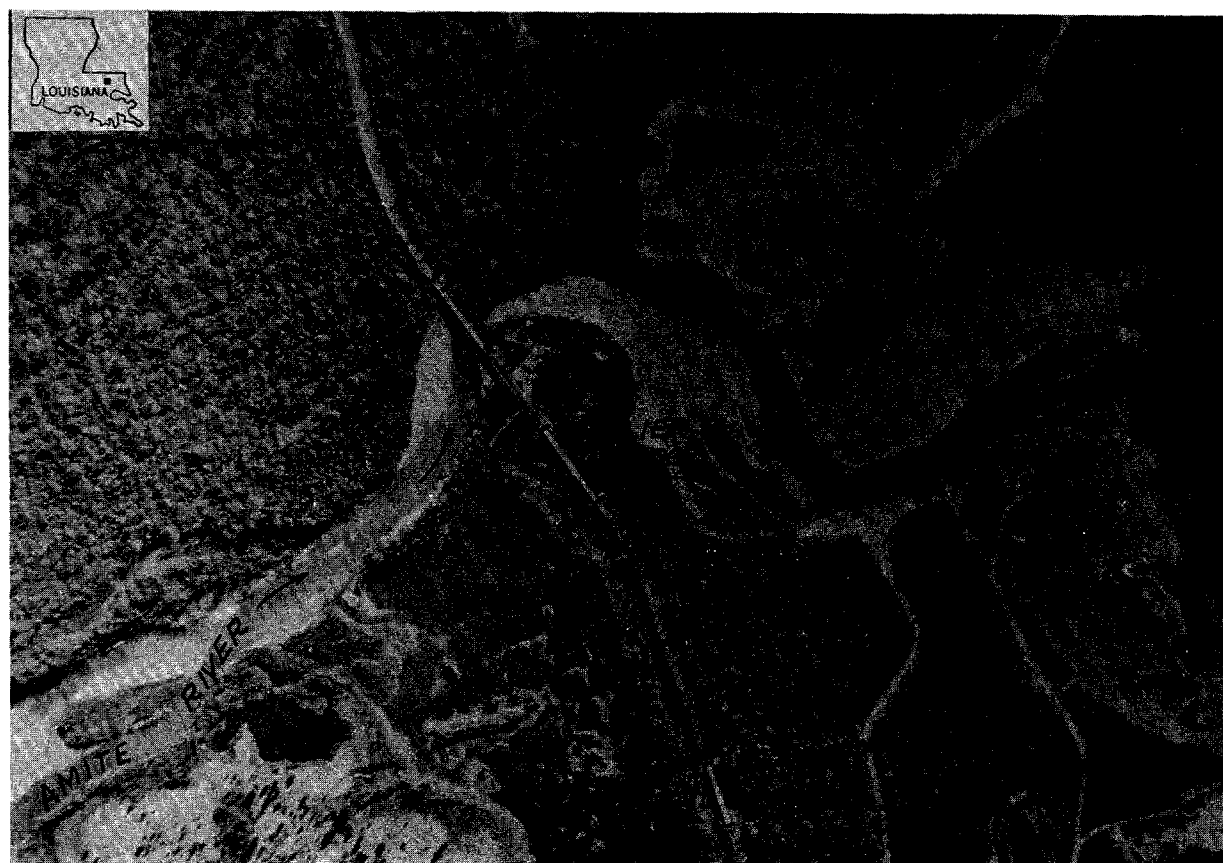
Figure 110. Aerial photograph of Amite River at SR-37, on February 27, 1976. (From Louisiana Dept. of Transportation.)

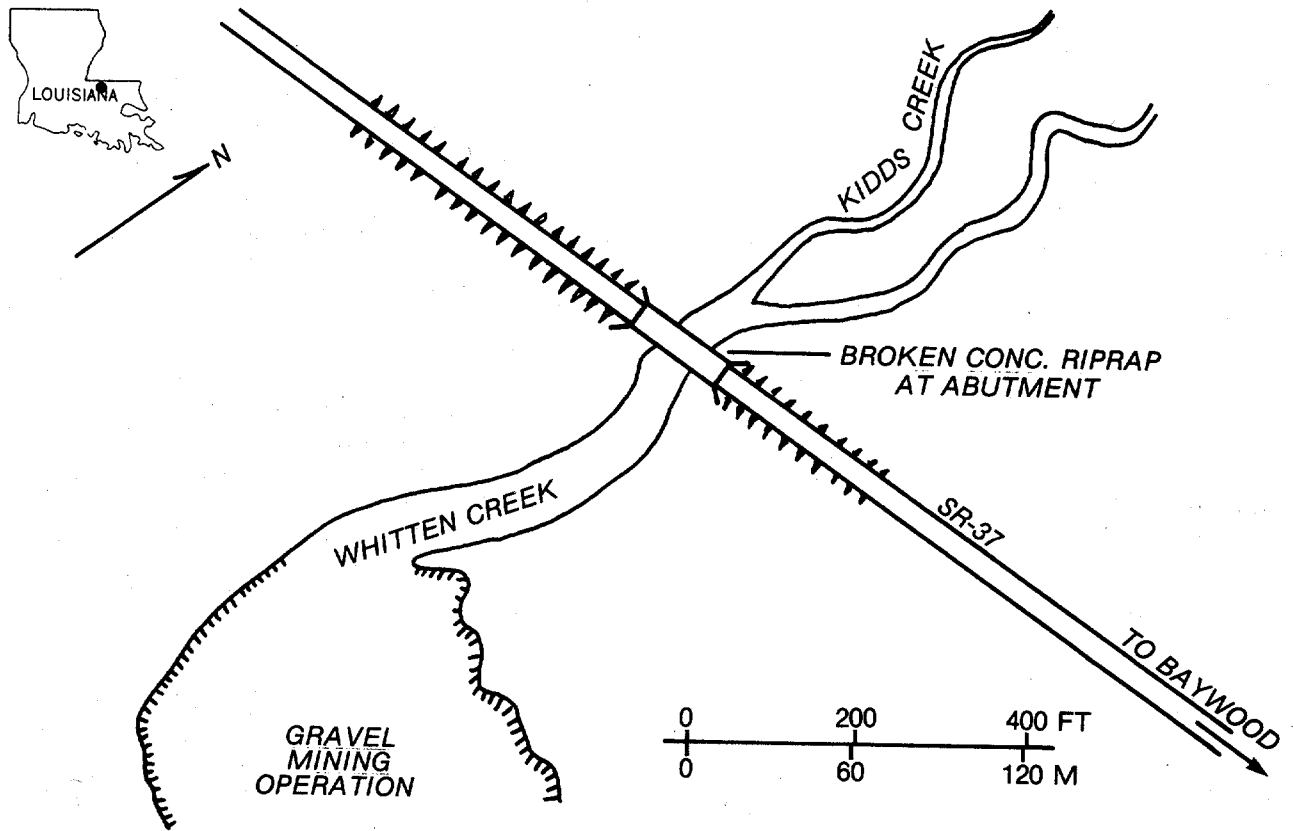
Figure 111. Plan sketch of Whitten Creek at SR-37. (From aerial photograph taken August 31, 1973.)

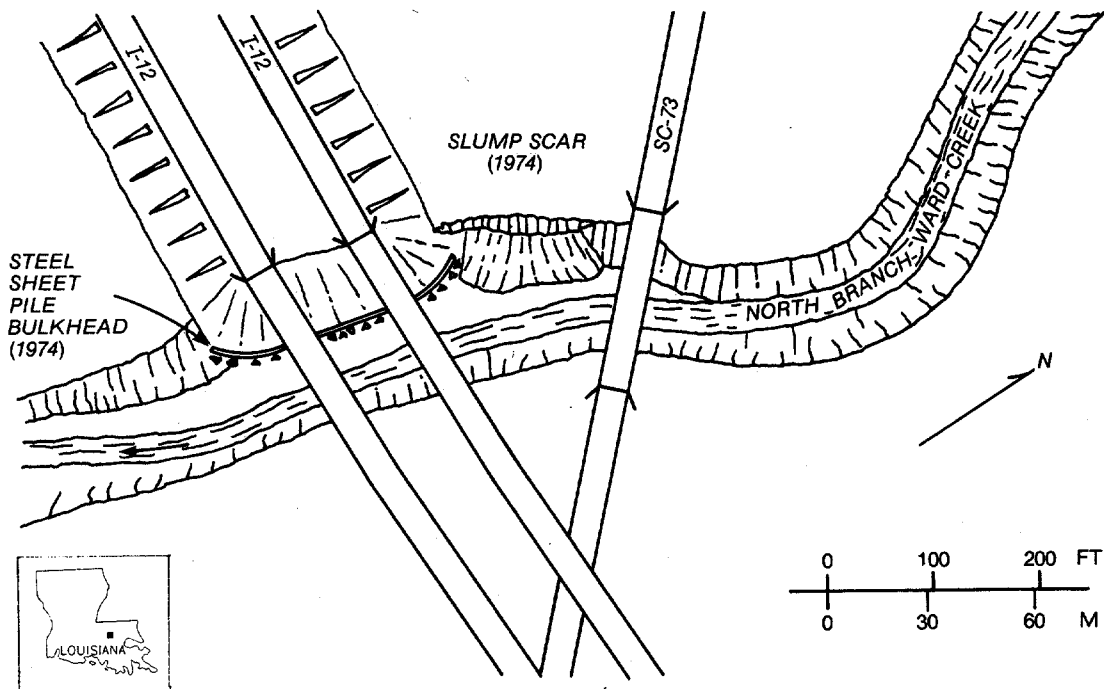
Figure 113. Plan sketch of North Branch Ward Creek at I-12. (From aerial photograph taken February 1974.)

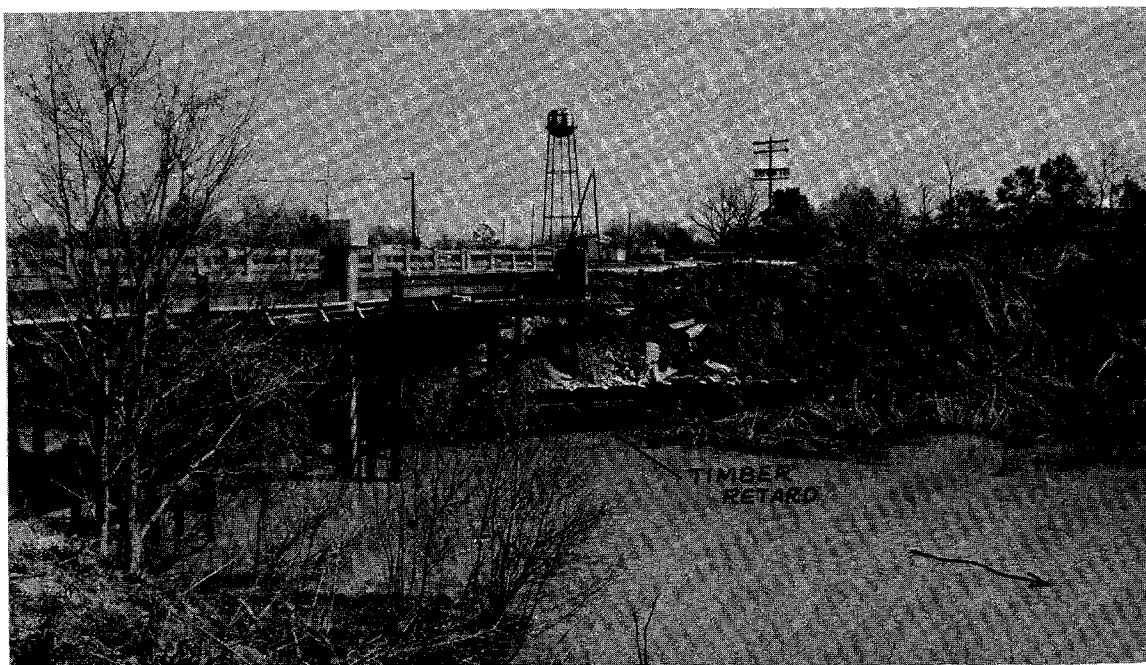
Figure 116. Upstream view of left abutment of SR-114 bridge on March 7, 1977, showing timber retard.

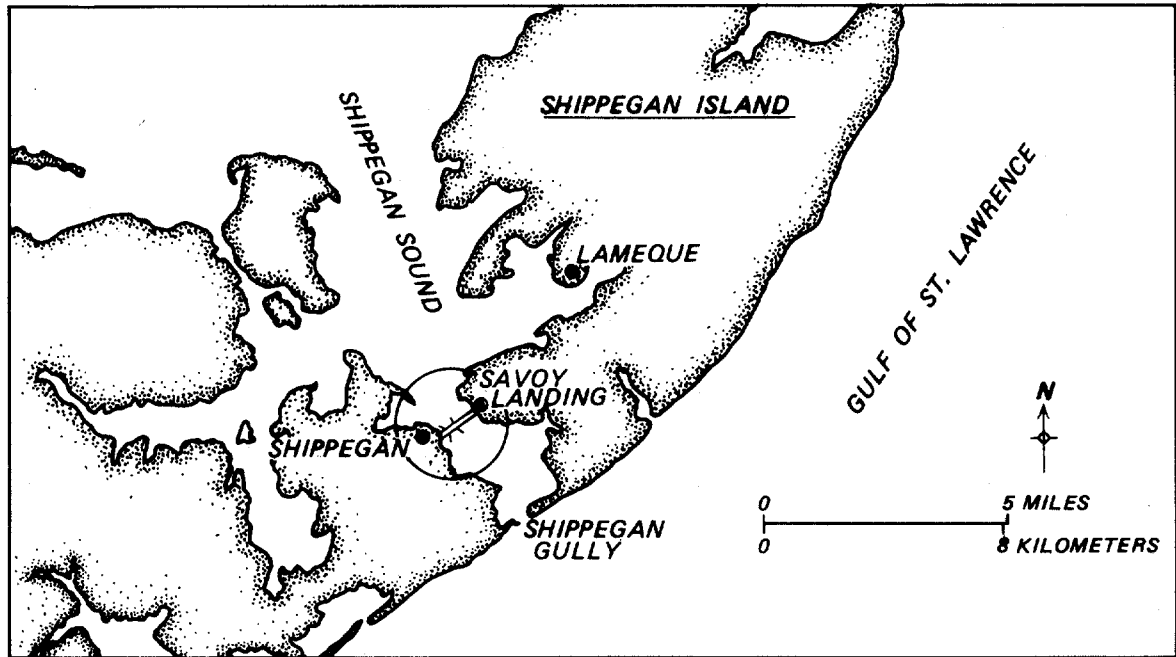
Figure 117. Sketch map showing location of Lameque-Shippegan bridge, New Brunswick, Canada.

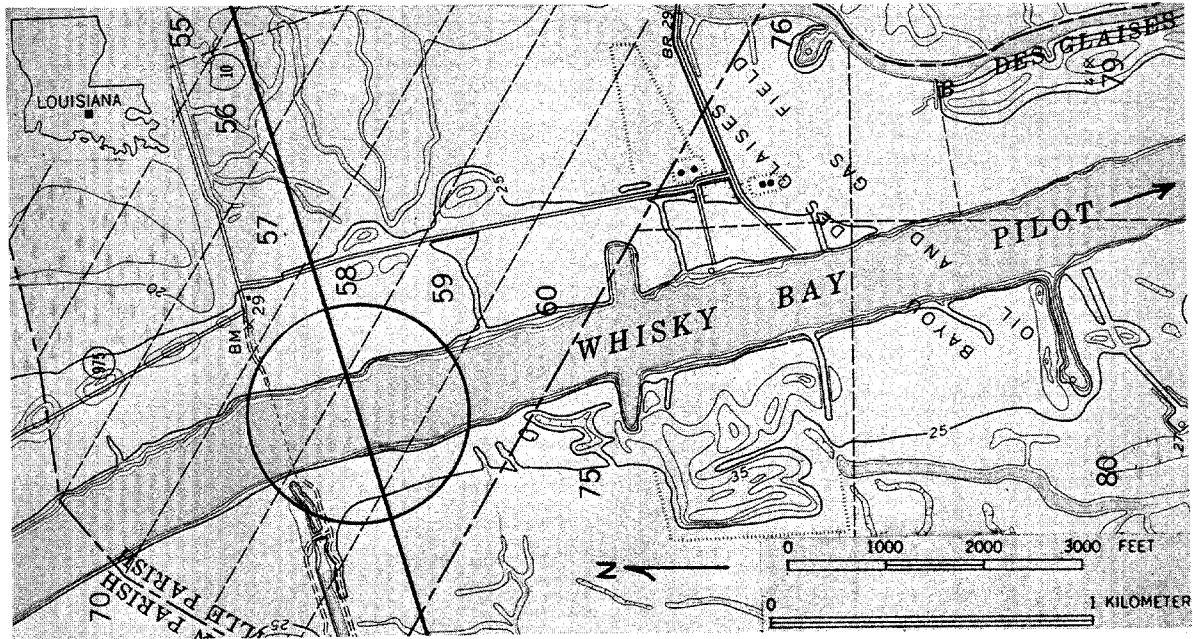
Figure 121. Map showing Whisky Pay pilot channel at I-10 crossing (circled). (Base from U.S. Geol. Survey Butte La Rose, La., 7.5' quadrangle, contour interval 5 feet, 1968.)

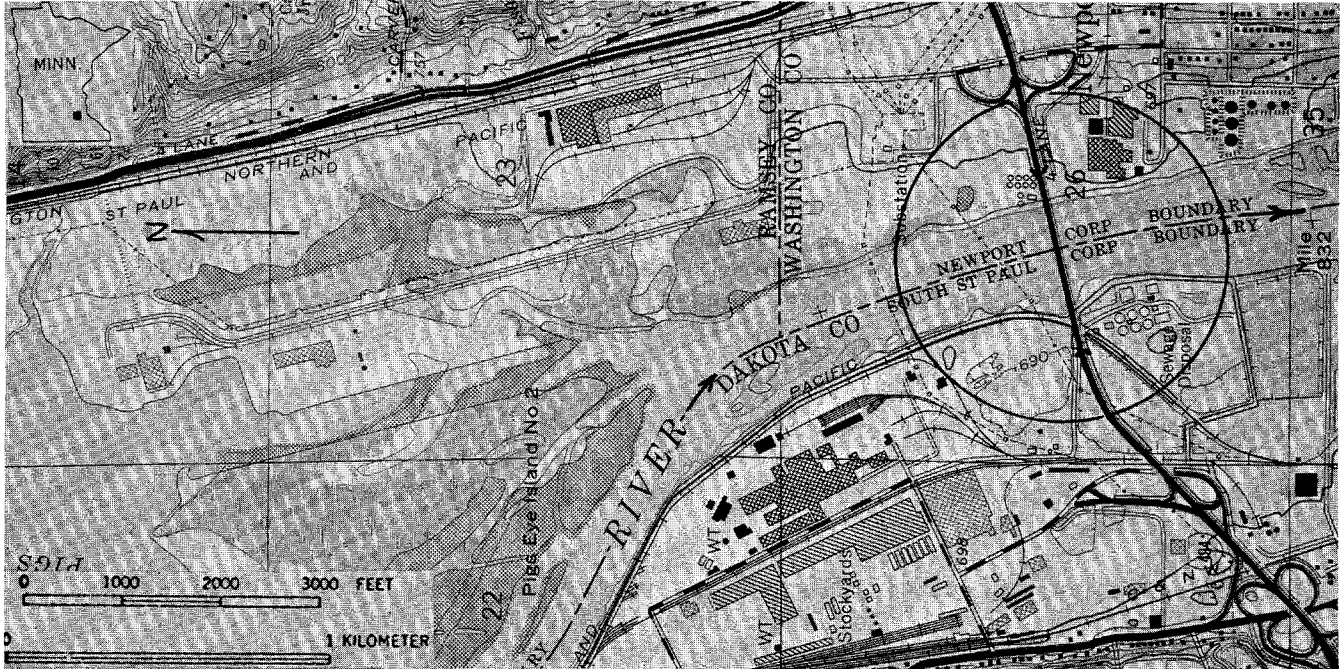
Figure 128. Map showing Mississippi River at I-494 crossing (circled). (Base from U.S. Geol. Survey St. Paul East, Minn., 7.5' quadrangle, contour interval 10 feet, 1967 photorevised 1972.)

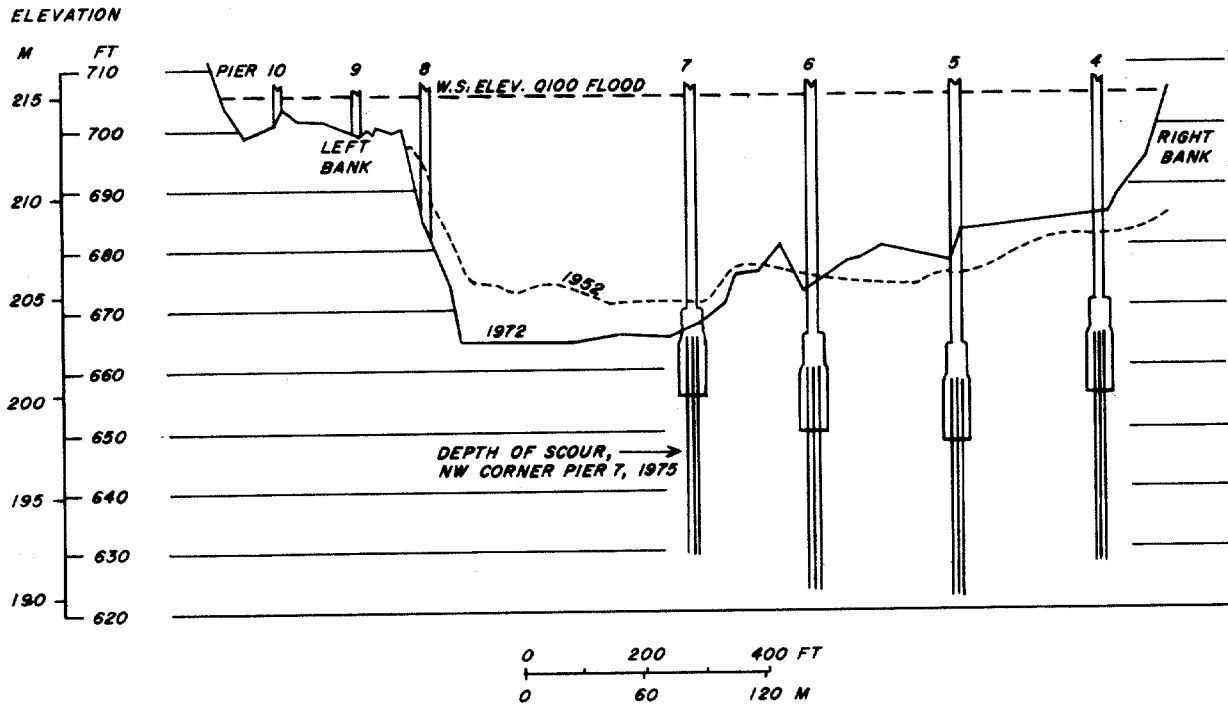
Figure 130. Channel cross section at I-494 bridge, showing channel degradation and depth of scour at pier 7.
