Report No. FHWA-RD-78-163

Hydraulics Branch  
Library

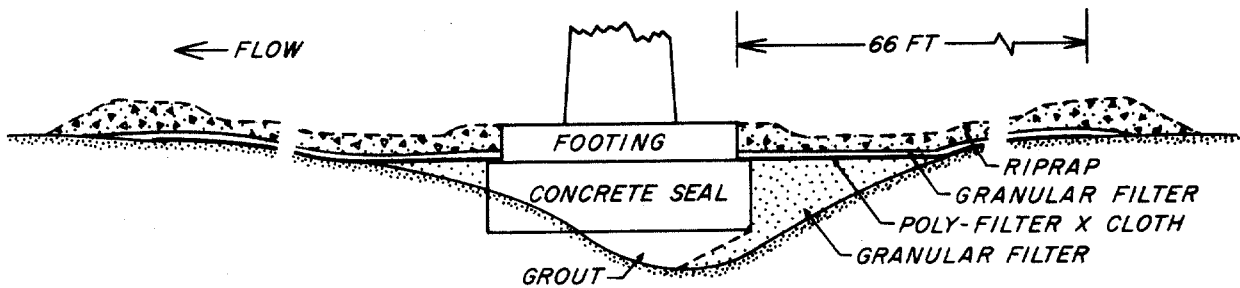
Figure 131. Cross section showing placement of revetment at pier 7.

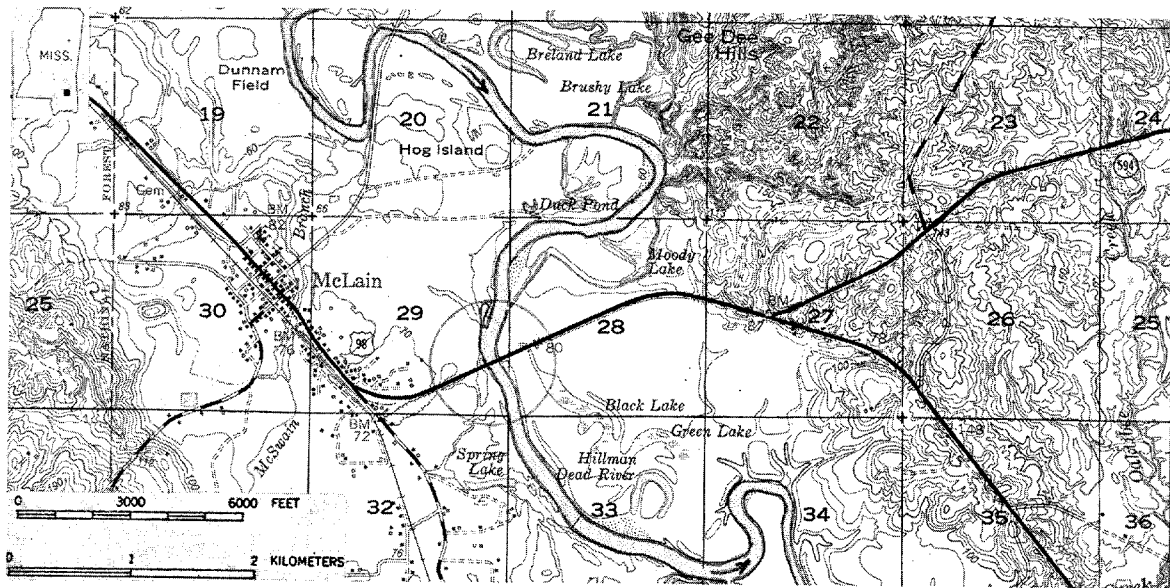
Figure 132. Map showing Leaf River at US-98 crossing (circled). (Base from U.S. Geol. Survey Beaumont, Miss., 15' quadrangle, contour interval 10 feet, 1943.)

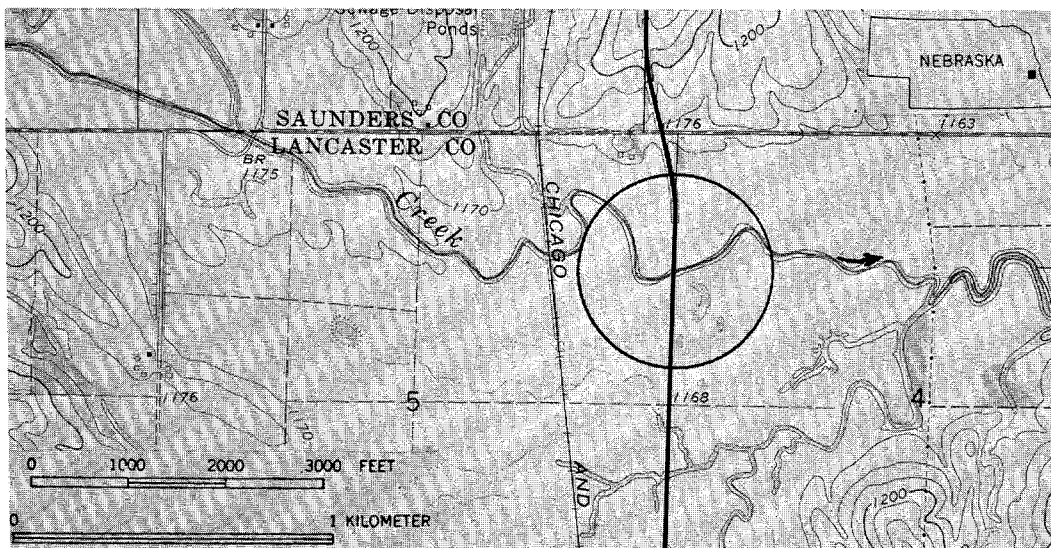
Figure 224. Map showing Rock Creek at US-77 crossing. (Base from U.S. Geol. Survey Ceresco, Nebr., 7.5' quadrangle, contour interval 10 feet, 1968.)

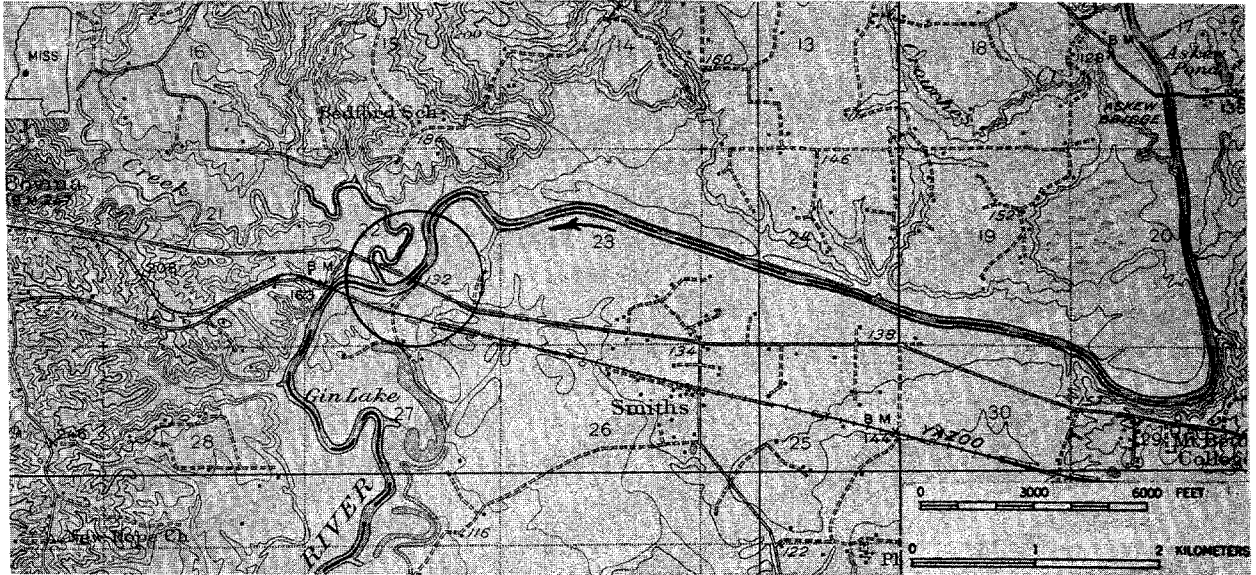
Figure 145. Map showing Big Black River at US-80 crossing (circled).  
 (Base from U.S. Geol. Survey Edwards, Miss., 15' quadrangle, contour interval 20 feet, surveyed 1934-1935.)

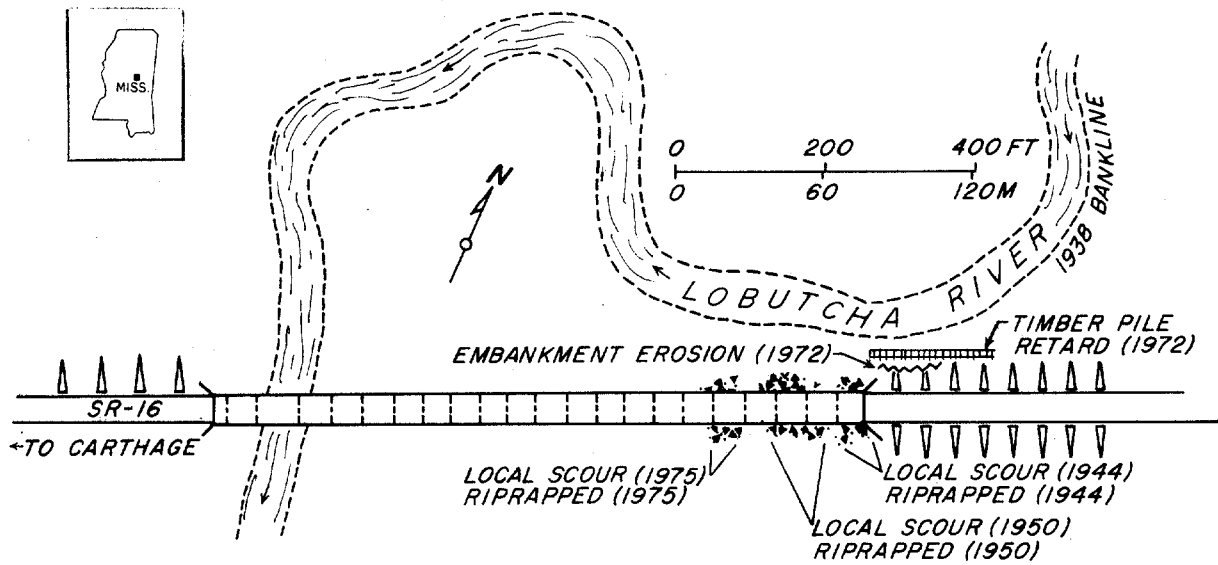
Figure 149. Plan sketch of Lobutchka Creek at SR-16.

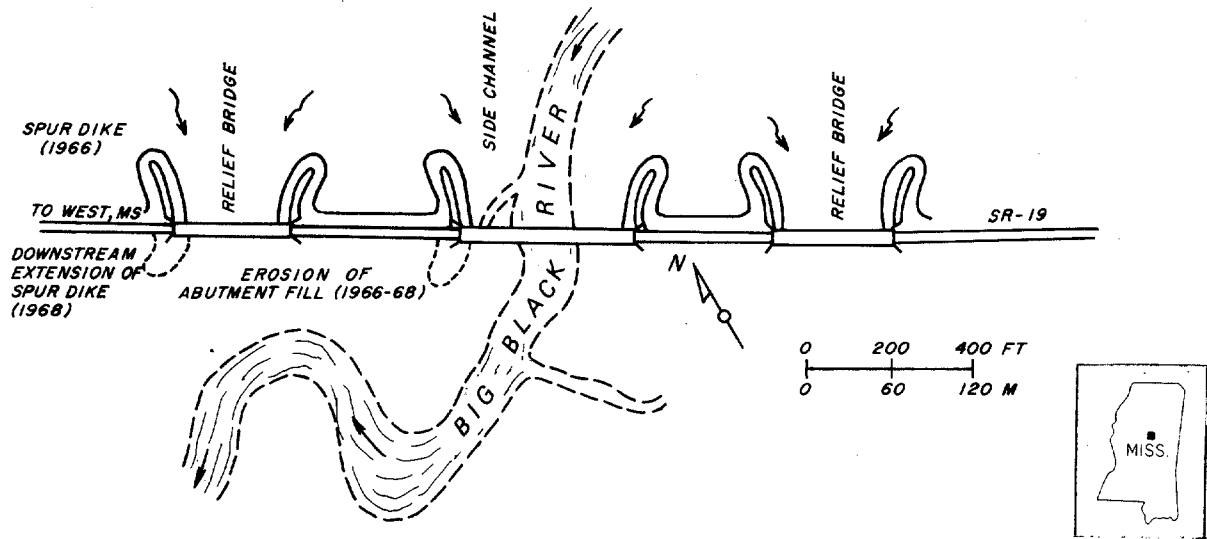
Figure 156. Plan sketch showing SR-19 crossing of Big Black River.

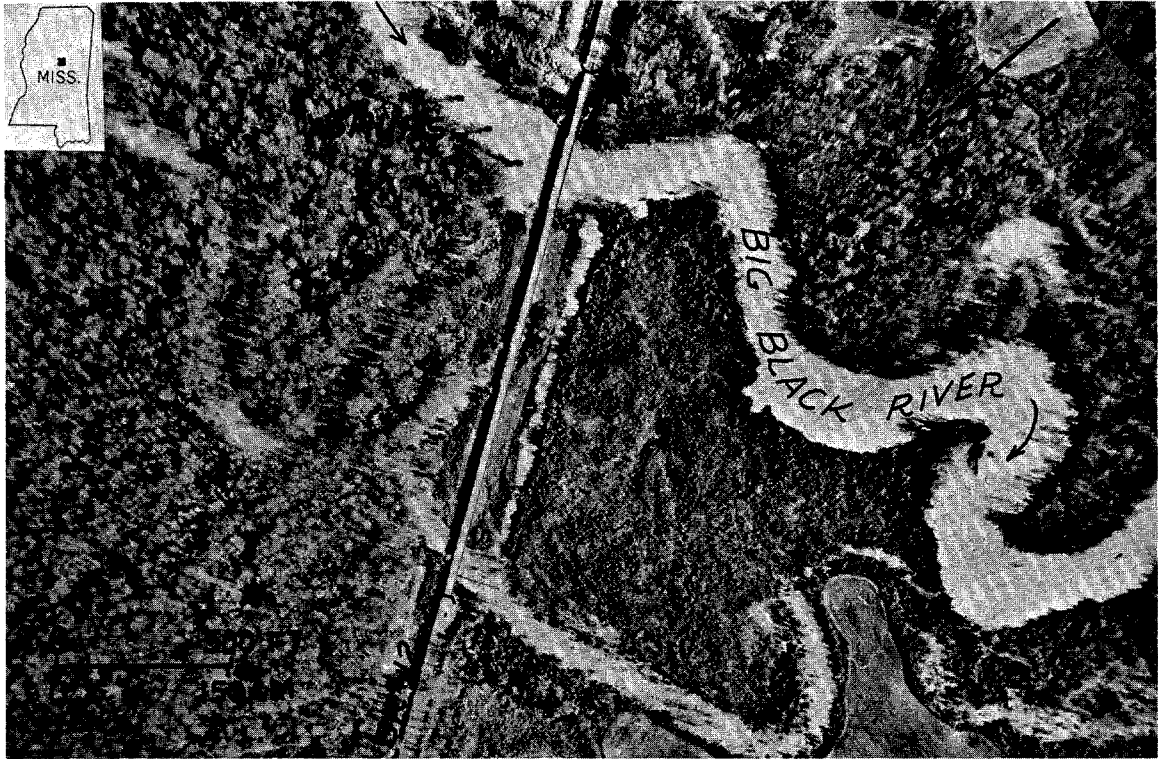
Figure 158. Aerial photograph of Big Black River at SR-12 crossing, on January 27, 1976. (From Mississippi Dept. of Highways.)

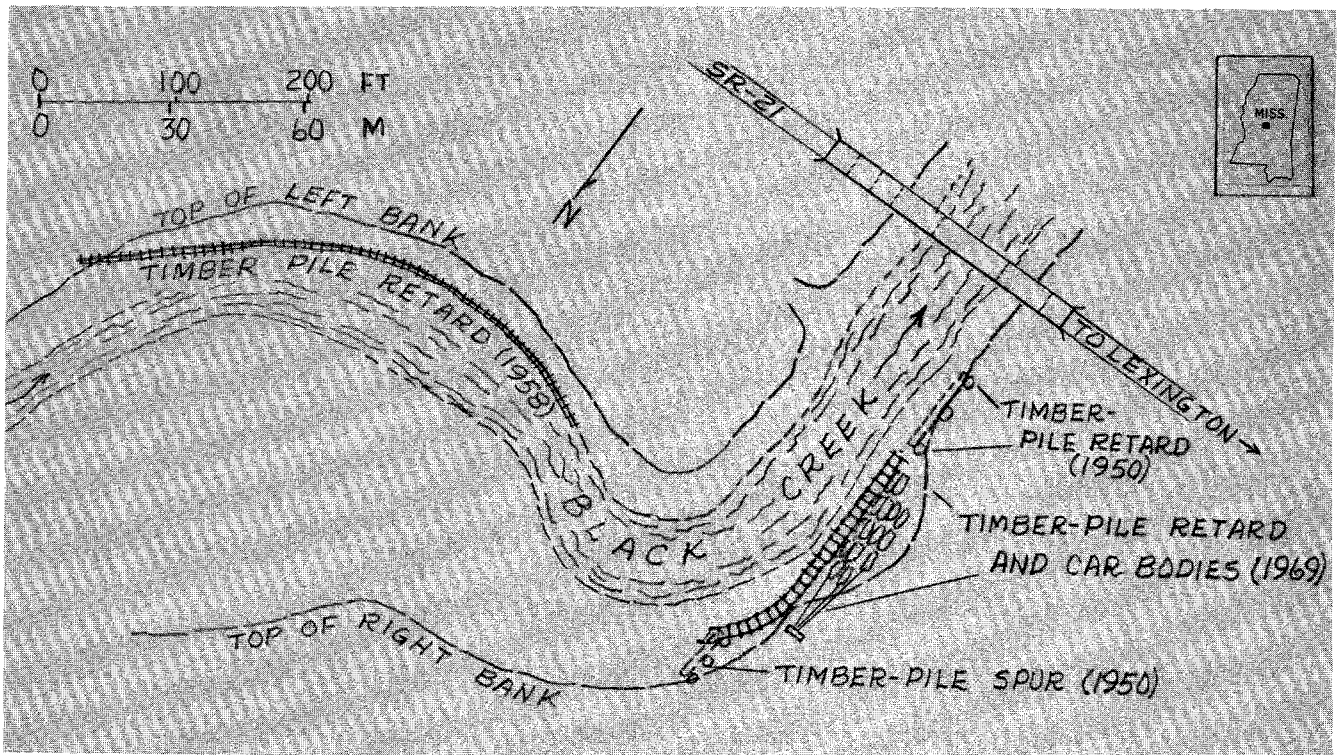
Figure 161. Plan sketch showing countermeasures at SR-12 crossing at Lexington, Miss.

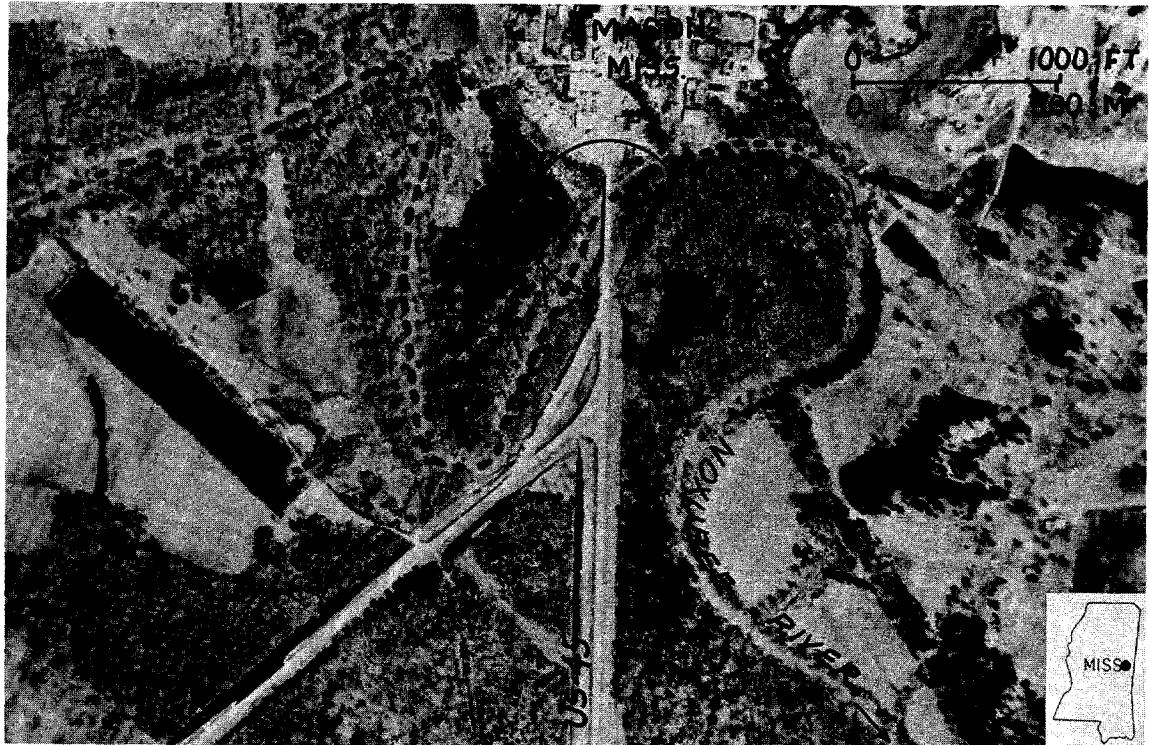
Figure 163. Aerial photograph of Noxubee River at US-45 crossing, on March 11, 1969. Note uniformity of channel downstream from bridge. (From U.S. Dept. of Agriculture.)

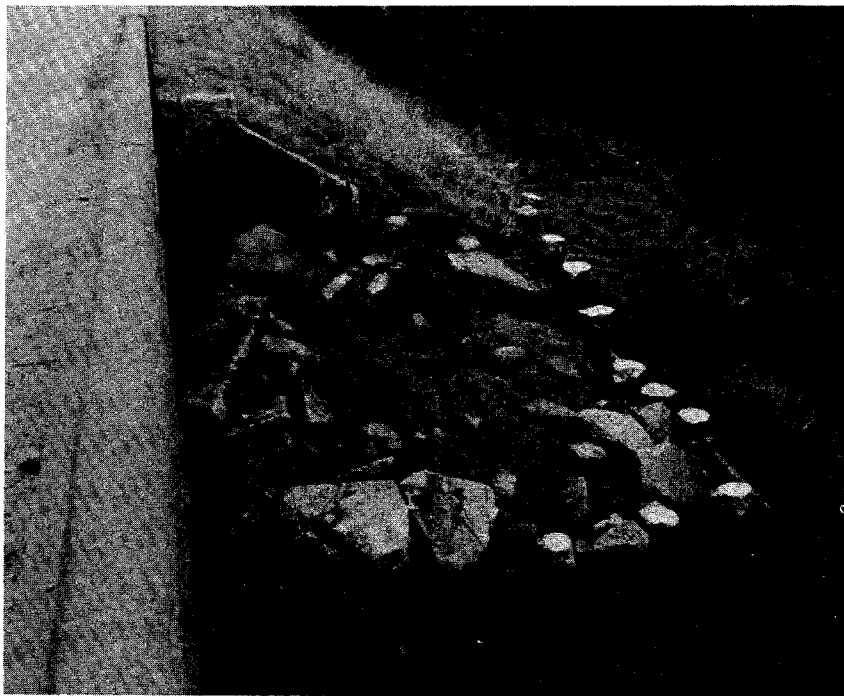
Figure 164. View along upstream side of right approach embankment, showing timber pile retaining wall and broken concrete riprap, on November 13, 1975.

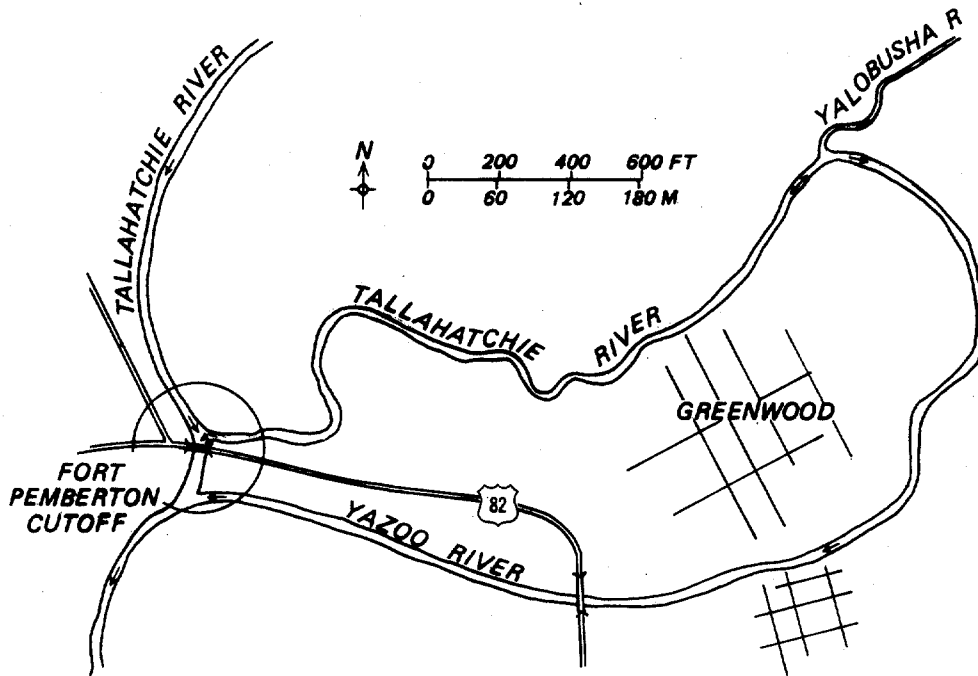
Figure 165. Plan sketch showing location of bridge at Fort Pemberton cutoff, with respect to the Tallahatchie, Yalobusha, and Yazoo Rivers.

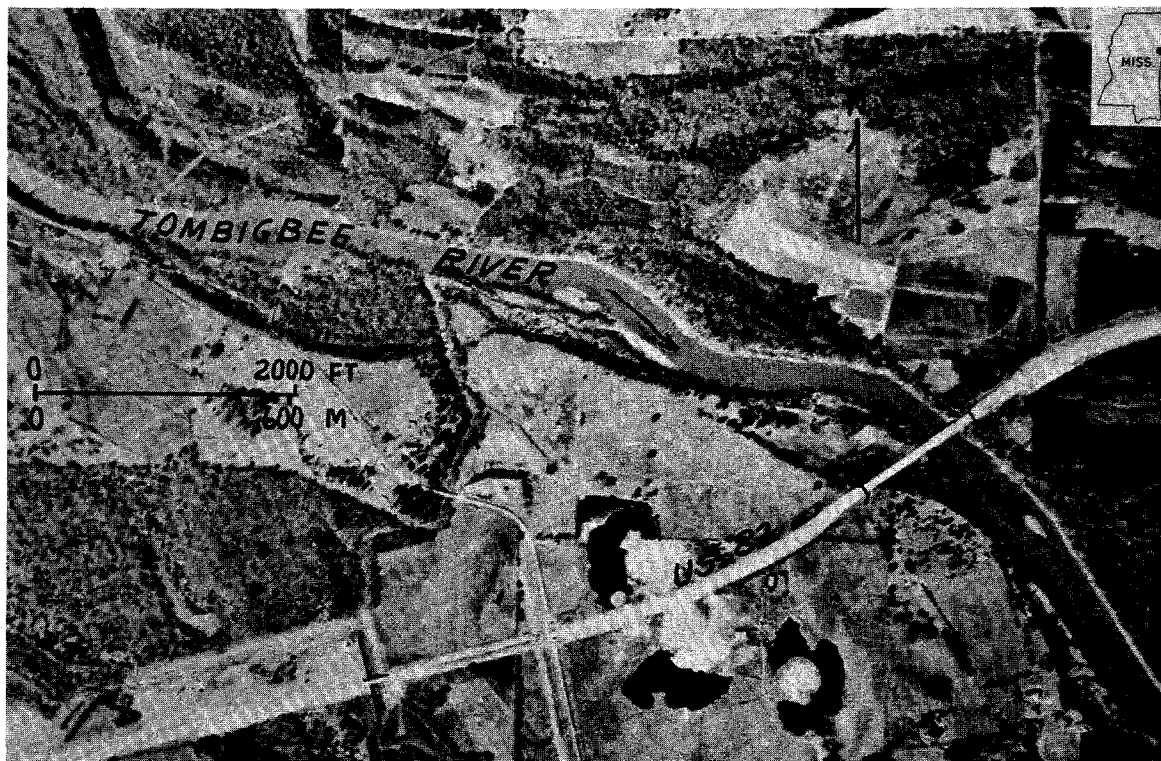
Figure 167. Aerial photograph of Tombigbee River at US-82 crossing, on March 13, 1969. (From U.S. Dept. of Agriculture.)

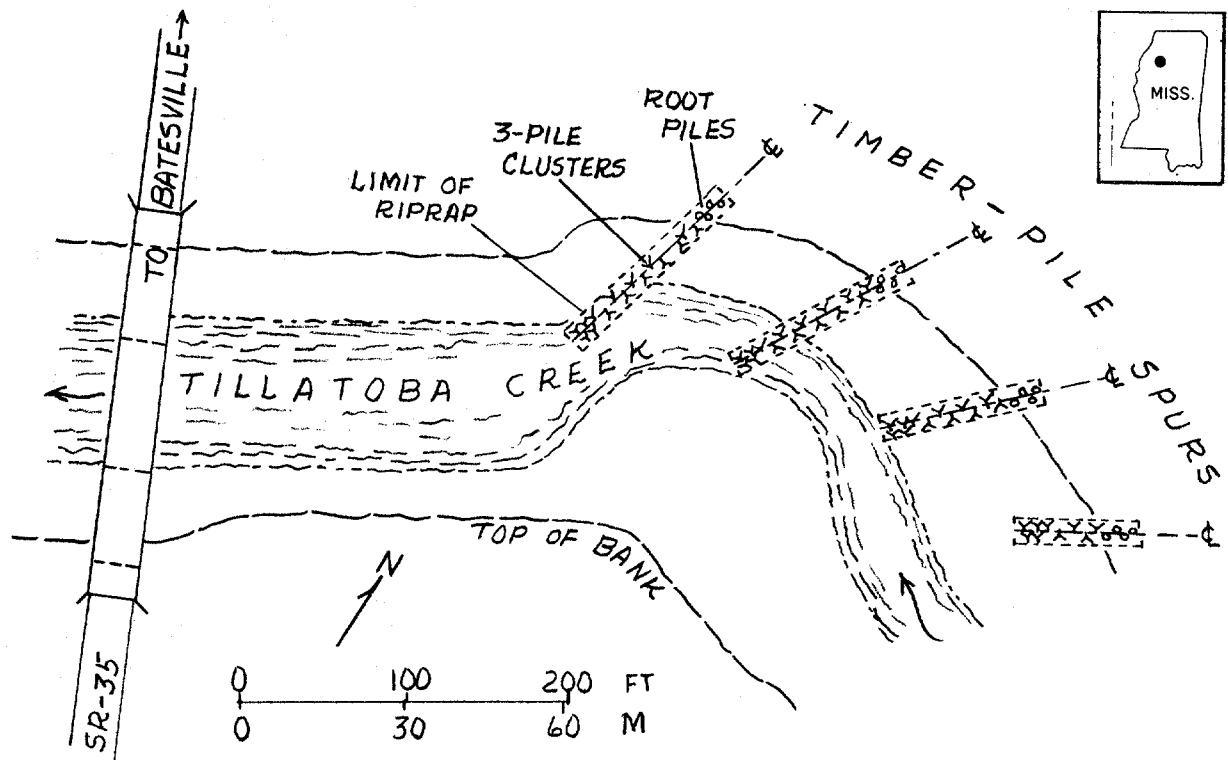
Figure 169. Plan sketch showing location of spurs at SR-35 crossing.

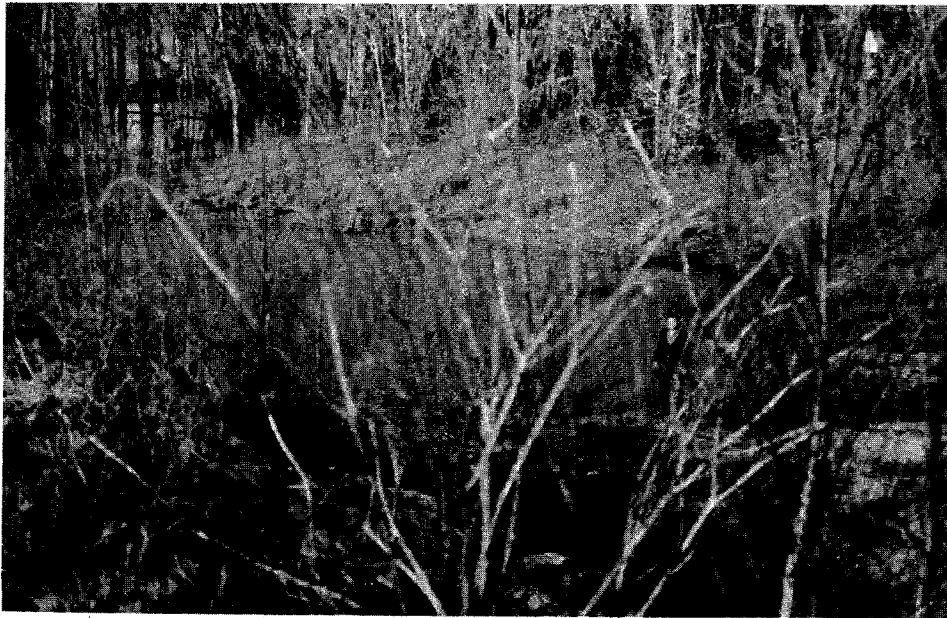
*Figure 171. View from end of spur dike (foreground) toward scour hole (background) in March, 1962.*

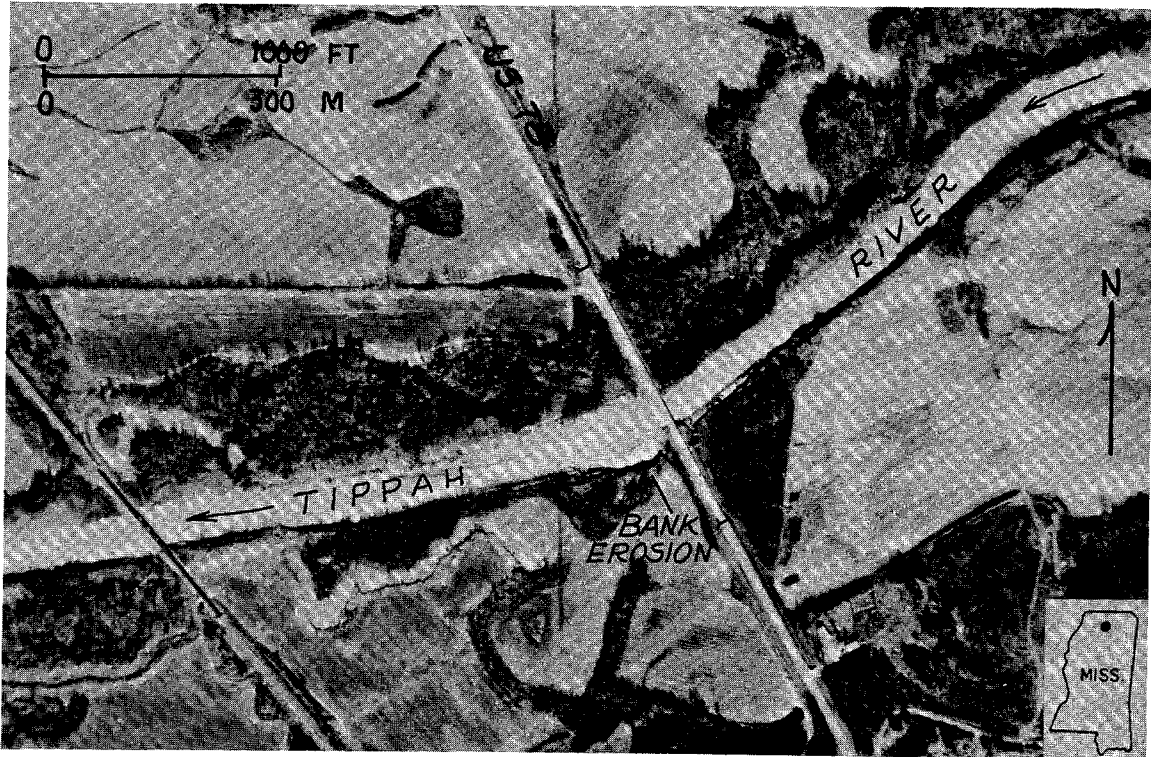
Figure 172. Aerial photograph of channelized Tippah River at US-78 crossing. (From U.S. Dept. of Agriculture.)

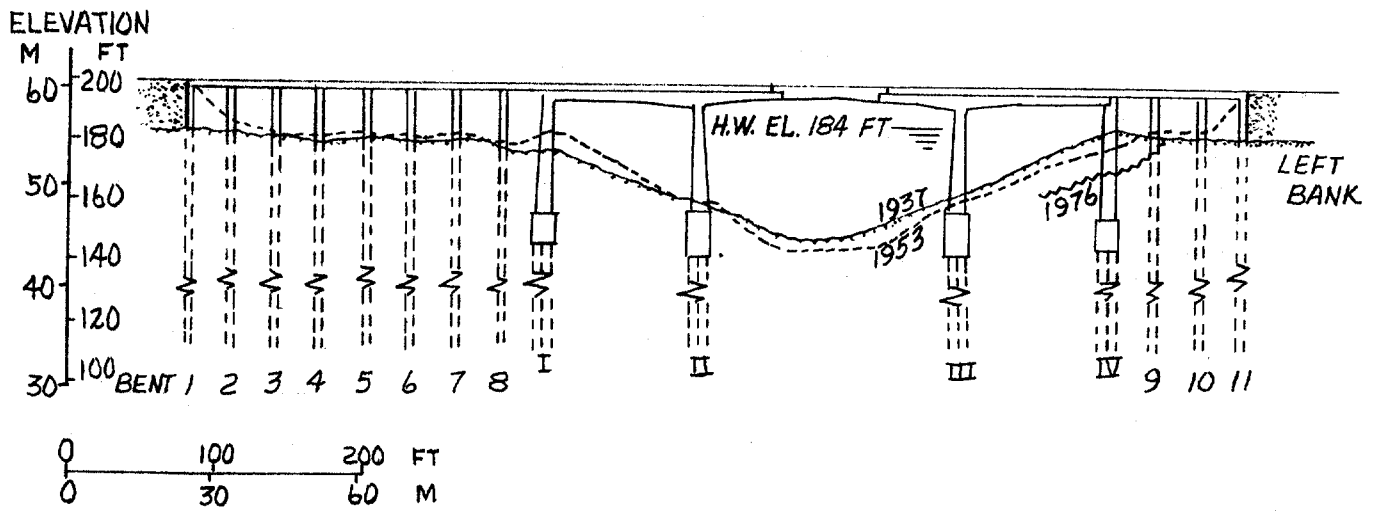
Figure 174. Cross section at US-84 bridge, Pearl River.

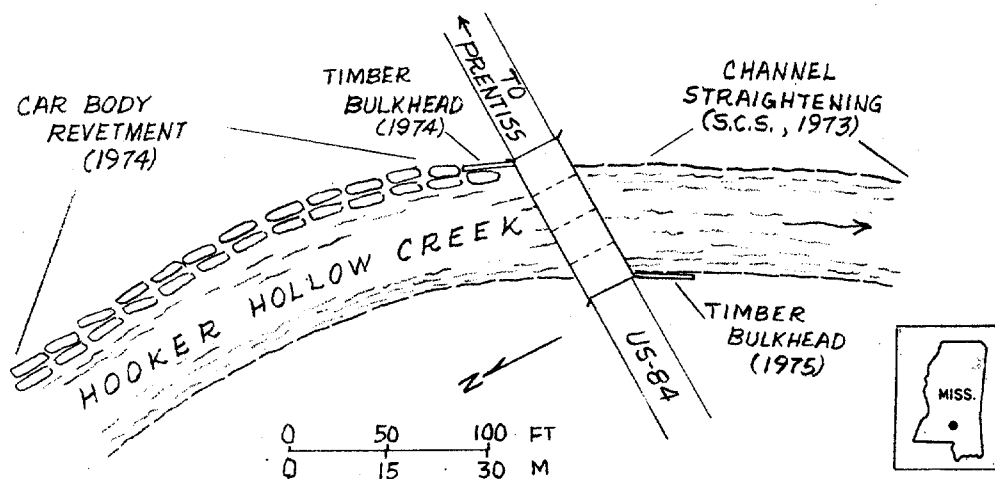
Figure 176. Plan sketch of Hooker Hollow Creek at US-84 crossing.

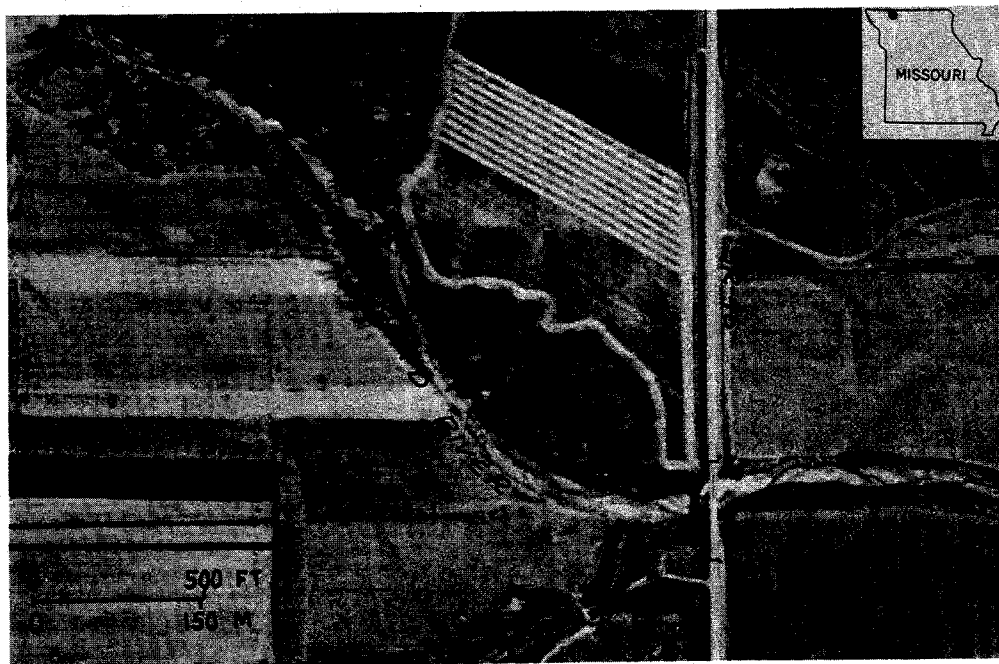
Figure 185. Vertical aerial photograph of Middle Fork Grand River at SR-46, November 19, 1967. (Missouri Highway Commission photograph.)

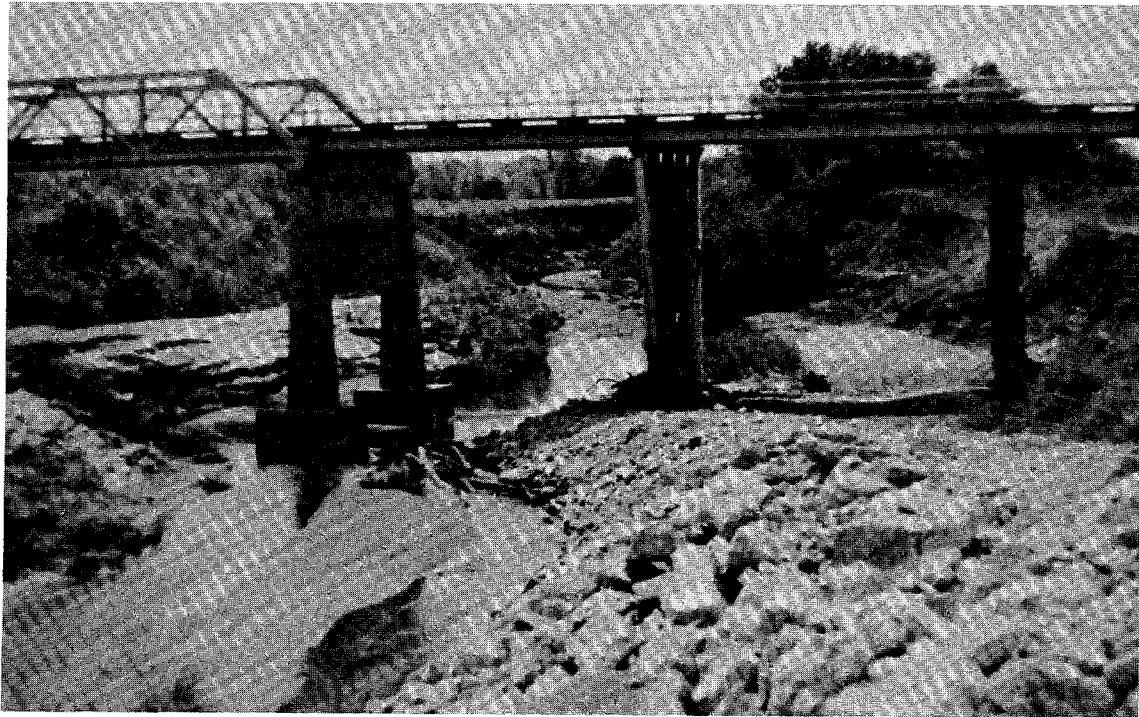
Figure 186. Downstream view of SR-46 bridge on May 26, 1976, showing rock retard (at right foreground), channel degradation at pier 6, and supplementary pile at bent 5. (Missouri Highway Commission photograph.)

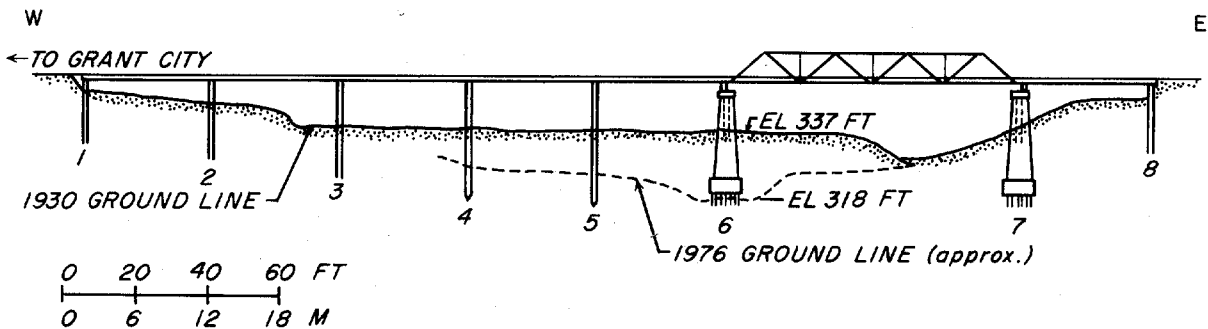
Figure 187. Elevation sketch of SR-46 bridge.

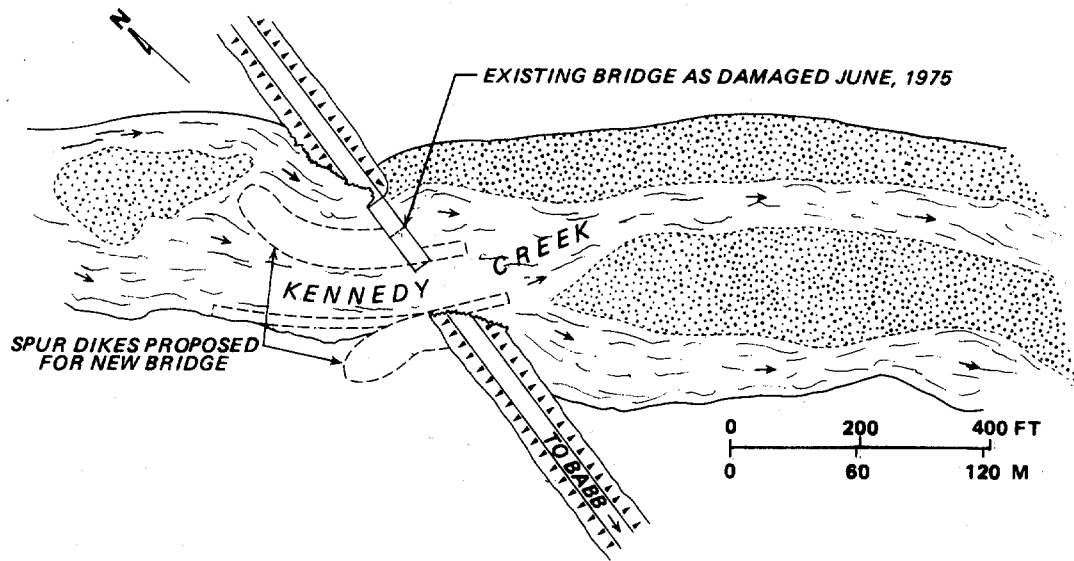
Figure 193. Plan sketch showing 1975 flood damage at US-89 crossing site. Also shown, in dashed lines, are spur dikes proposed for new bridge.

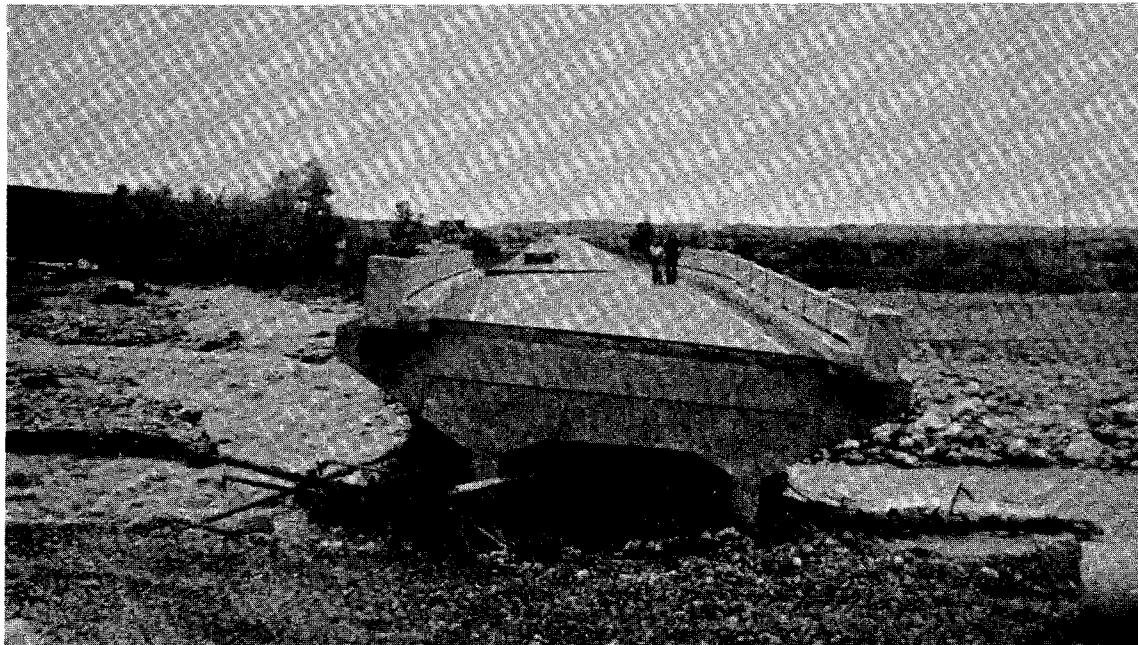
Figure 194. View, looking north, of 1975 flood damage at US-89 crossing site. (From Montana Dept. of Highways.)

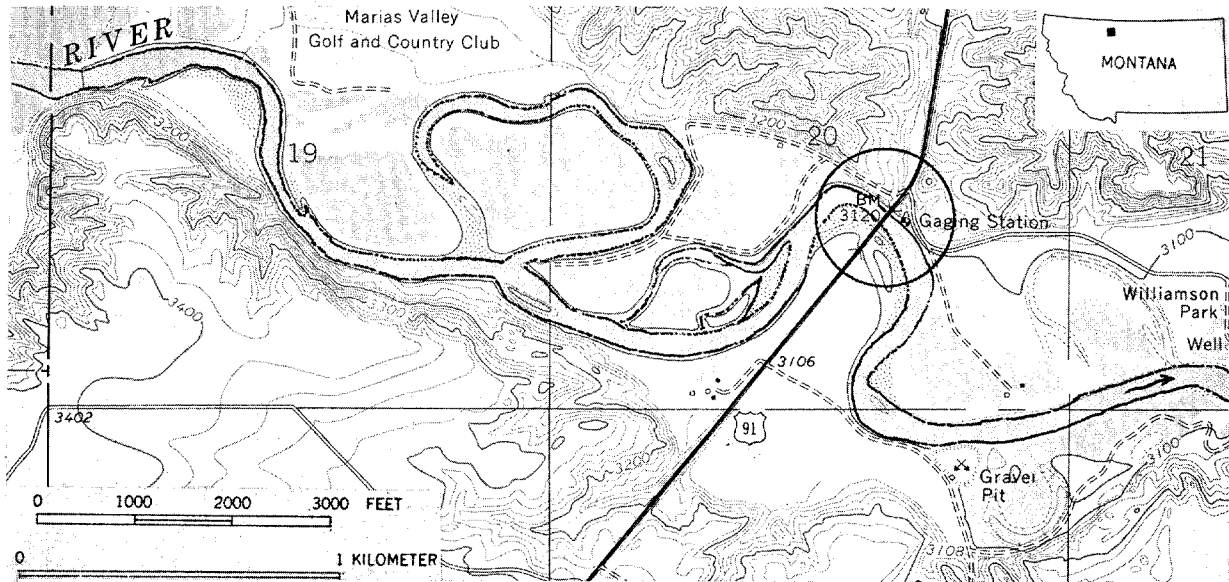
Figure 195. Map showing Marias River at US-91 crossing (circled). (Base from U.S. Geol. Survey Ledger NW, Mont., 7.5' quadrangle, contour interval 20 ft, 1966.)

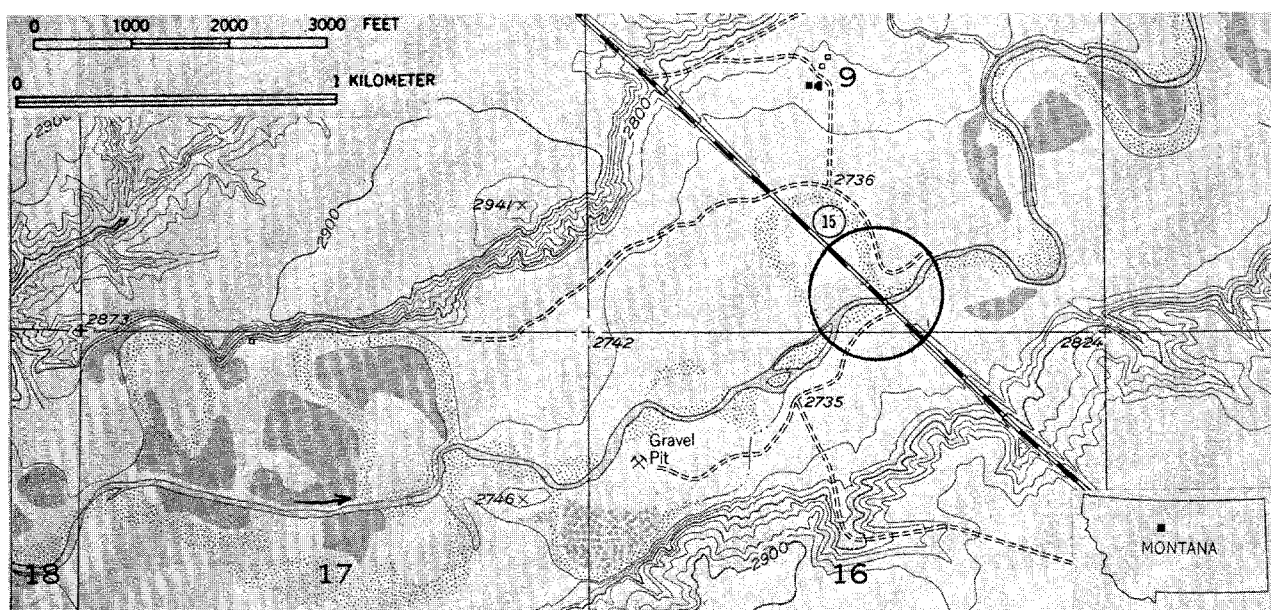
Figure 199. Map showing Teton River at SR-223 crossing (circled). (Base from U.S. Geol. Survey Fort Benton, Mont., 7.5' quadrangle, contour interval 20 feet, 1954.)

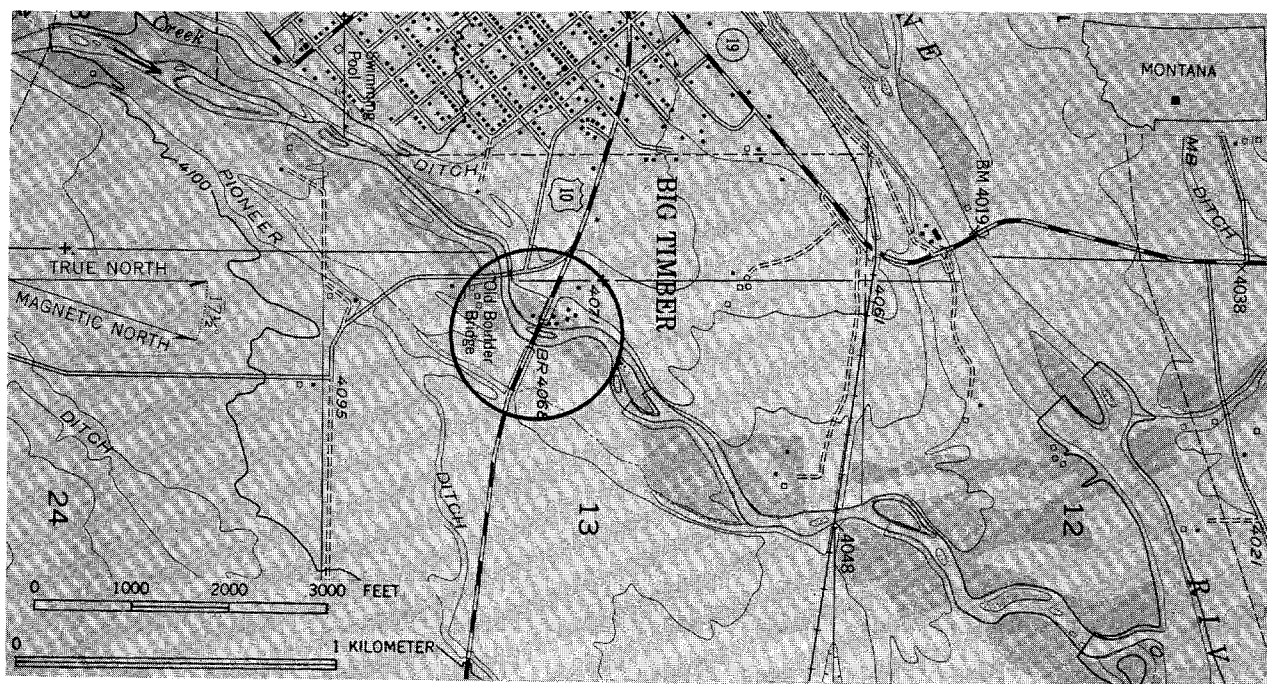
Figure 201. Map showing Boulder River at I-25 (US-10) crossing (circled). (Base from U.S. Geol. Survey Big Timber, Mont., 7.5' quadrangle, contour interval 20 ft, 1953.)

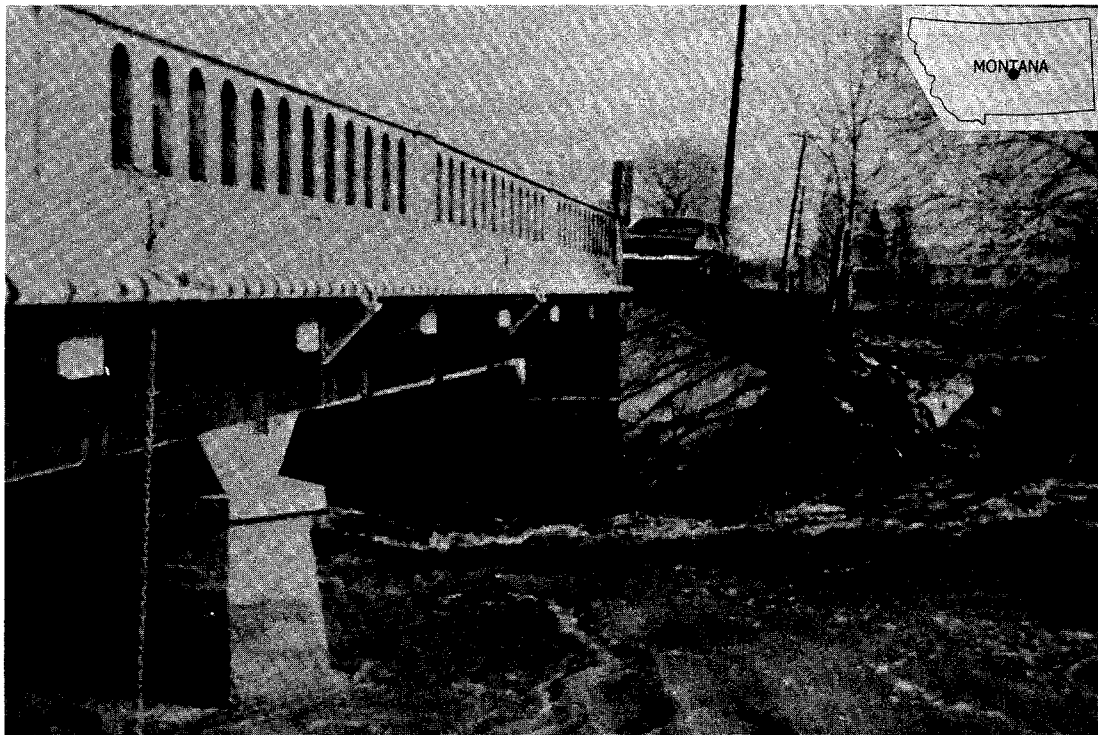
Figure 203. View of right abutment of US-191 bridge in May, 1975, after undermining and subsidence of abutment footing. (From Montana Dept. of Highways.)

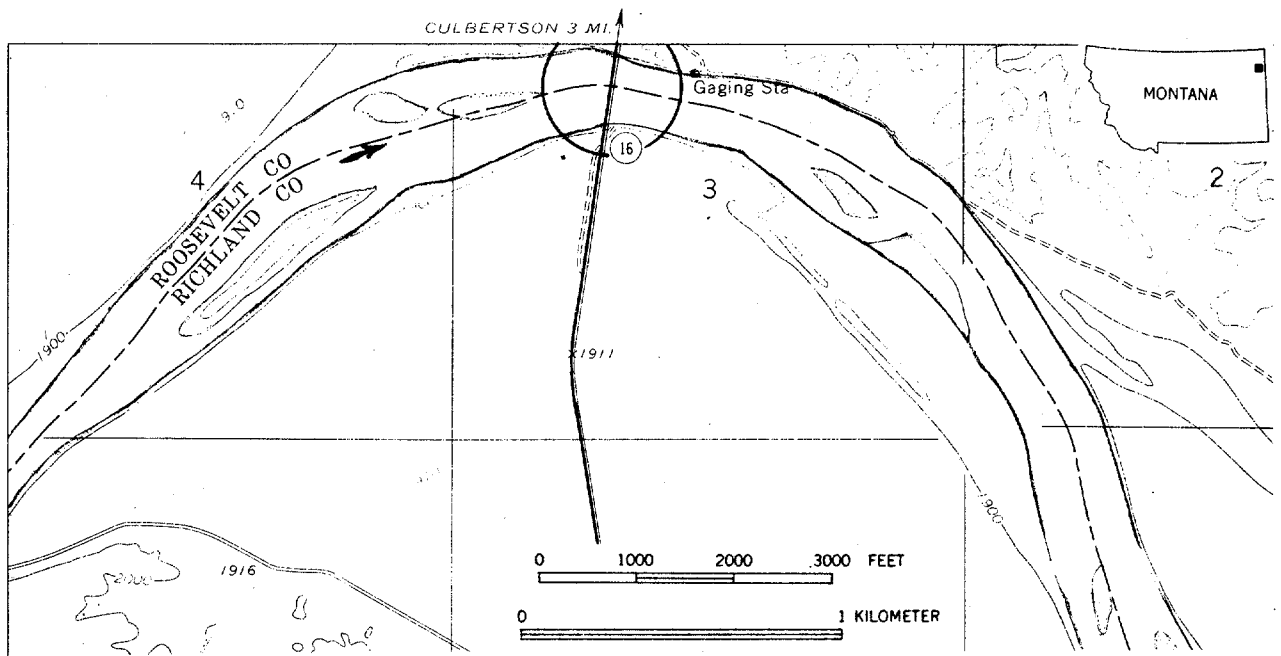
Figure 204. Missouri River at SR-16 crossing (circled). (Base from U.S. Geol. Survey Three Buttes, Mont., 7.5' quadrangle, contour interval 20 ft, 1969.)

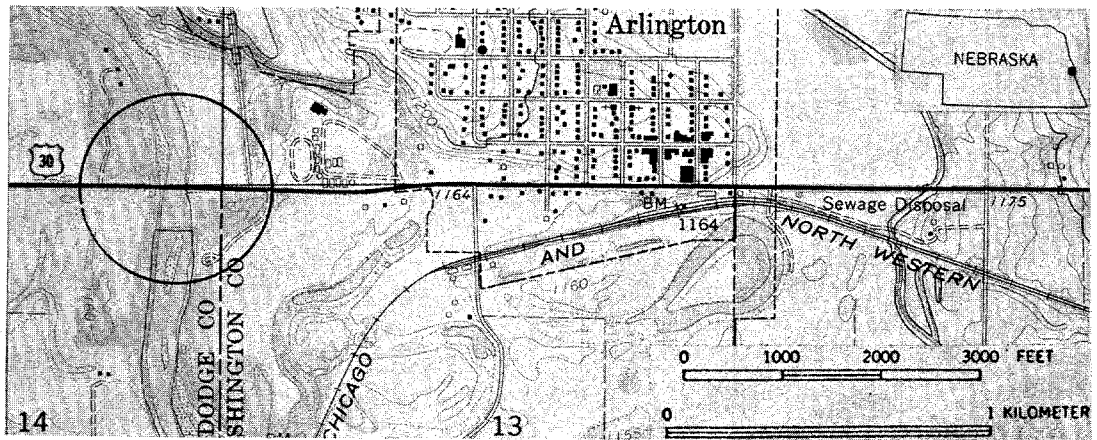
Figure 206. Map showing Elkhorn River at US-30 crossing (circled). (Base from U.S. Geol. Survey Arlington, Nebr., 7.5' quadrangle, contour interval 10 feet, 1968.)

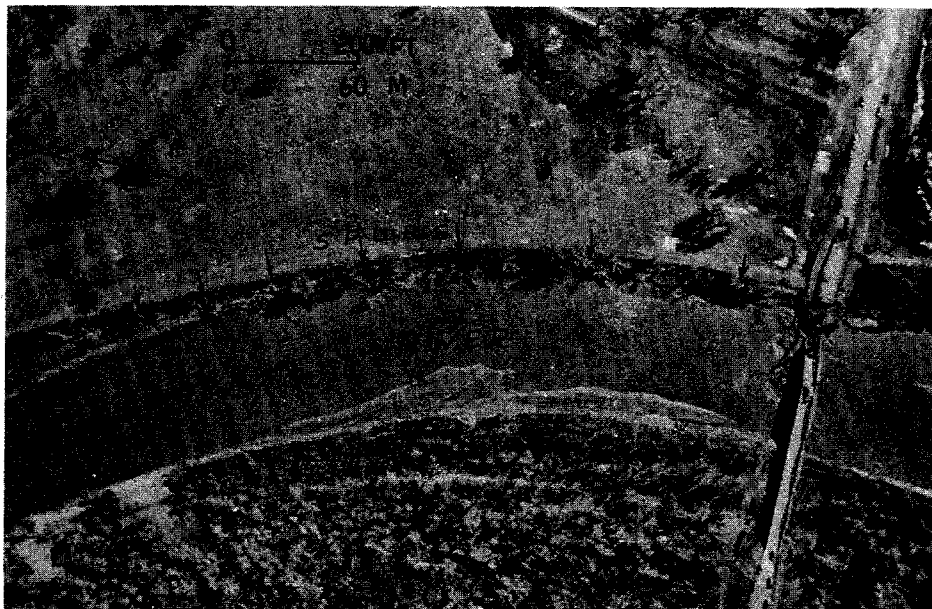
Figure 208. Aerial photograph, taken March 29, 1971, showing failure of bridge and location of spurs on left bank upstream from bridge. (Nebraska Dept. of Roads photograph.)

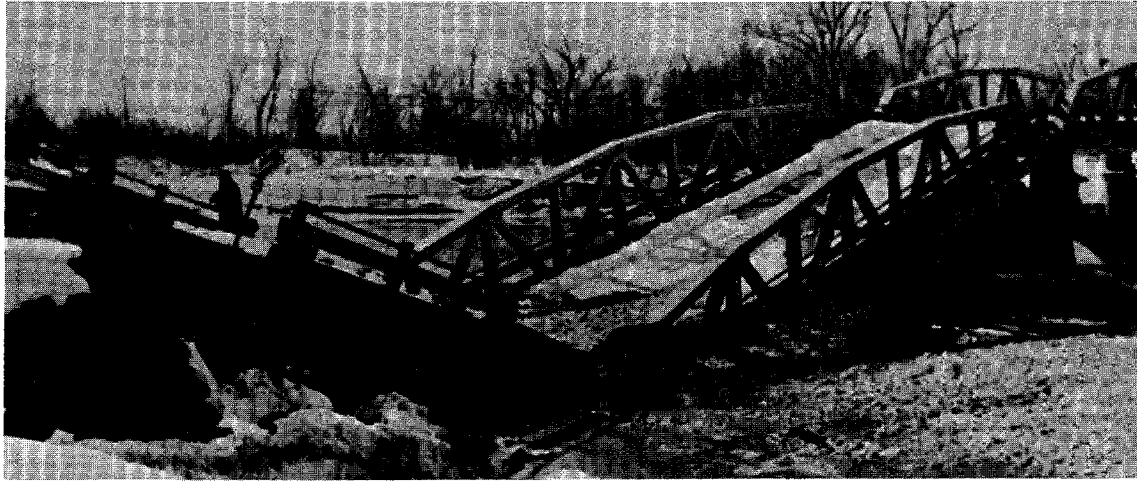
Figure 209. View of left end of failed bridge. (Nebraska Dept. of Roads photograph.)

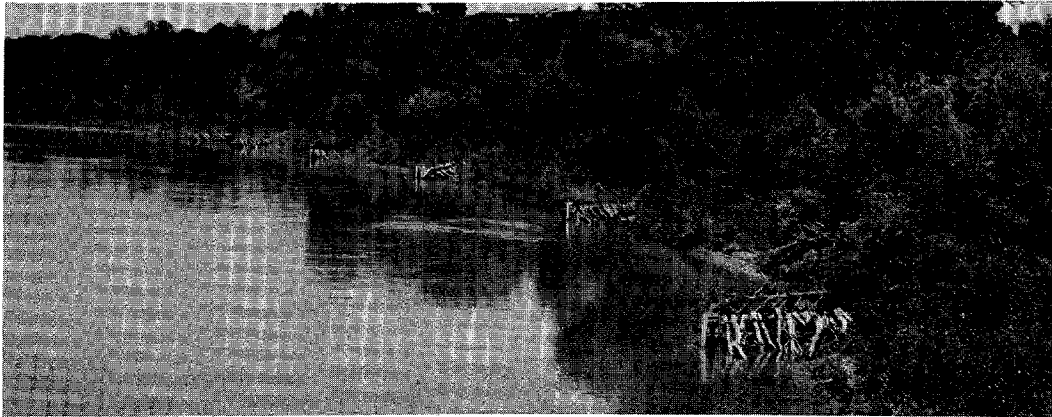
Figure 210. Upstream view, in 1977, of spurs at left bank upstream from bridge.

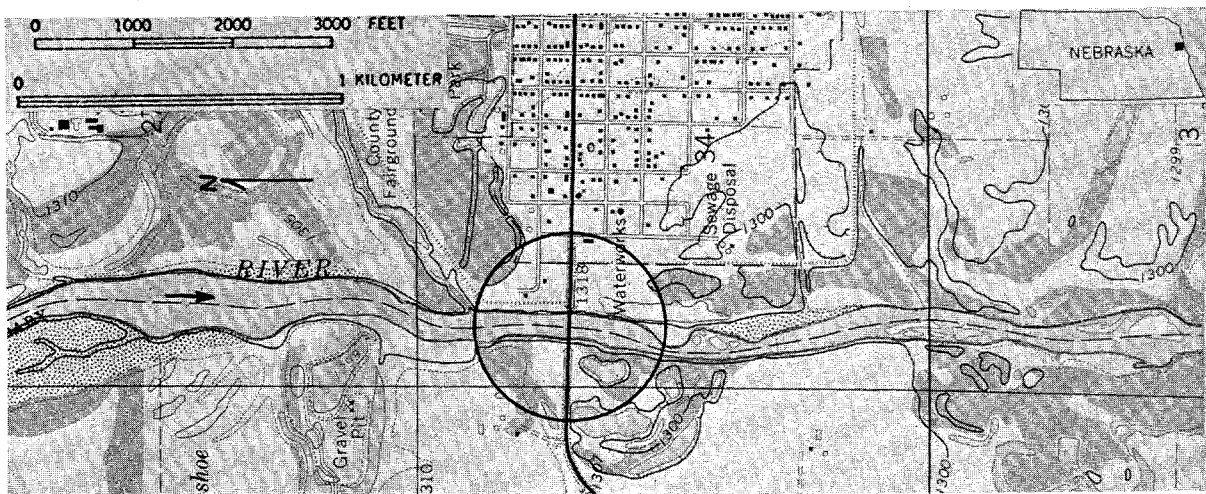
Figure 213. Map showing Elkhorn River at SR-32 crossing (circled). (Base from U.S. Geol. Survey West Point, Nebr., 7.5' quadrangle, contour interval 10 feet, 1966.)
