Report No. FHWA-RD-78-163

Hydraulics Branch  
Library

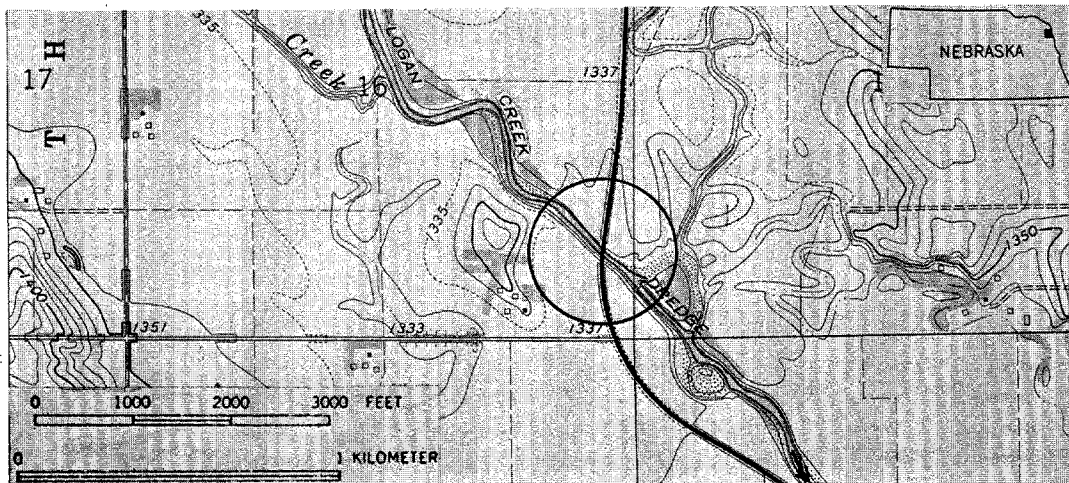
Figure 216. Map showing Logan Creek at SR-9 crossing (circled). (Base from U.S. Geol. Survey Thurston, Nebr., 7.5' quadrangle, contour interval 10 feet, 1966.)

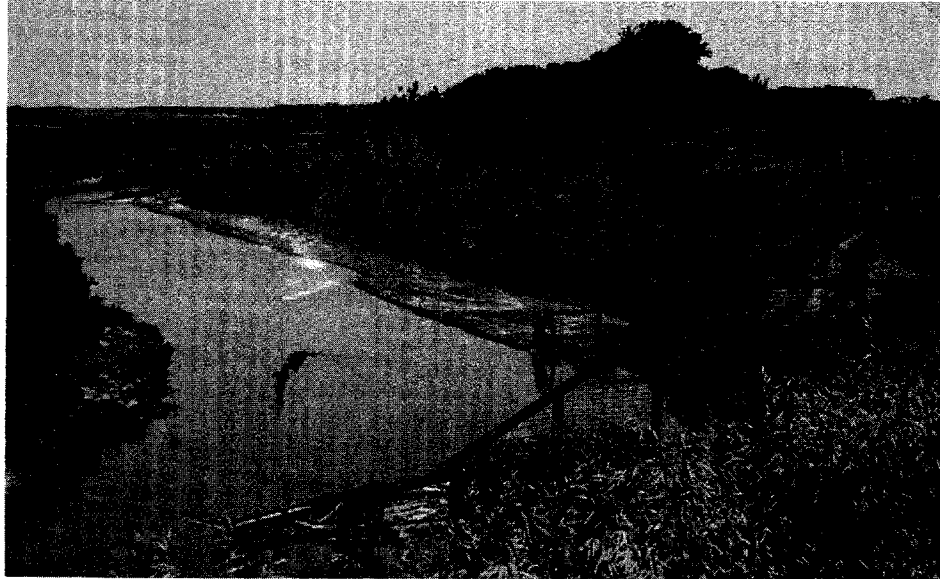
*Figure 217. View of steel-and-wire mesh spurs on left bank upstream from bridge, in 1977.*

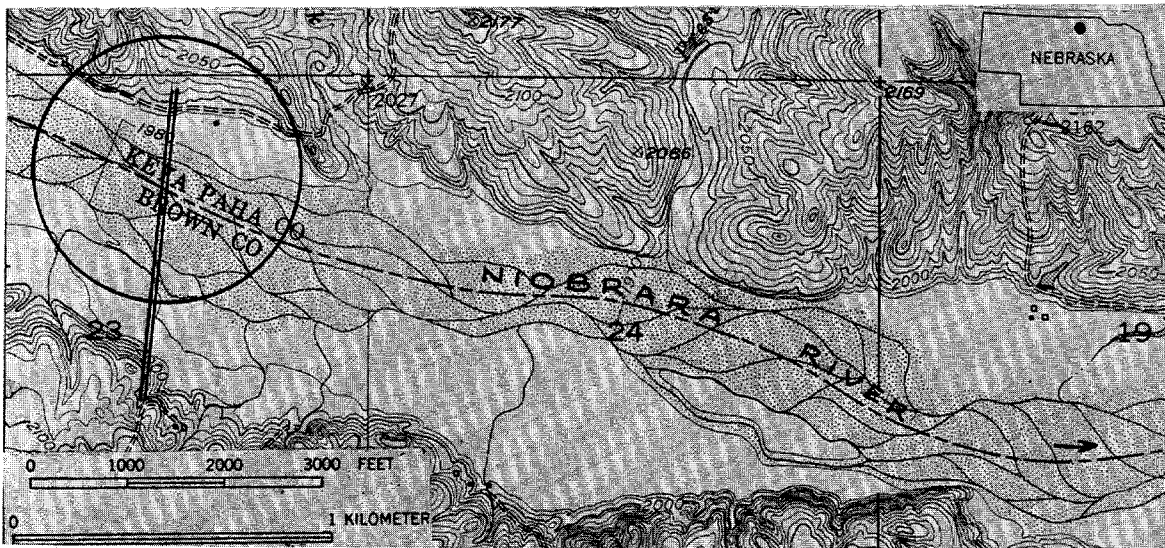
Figure 219. Map showing Niobrara River at US-183 crossing (circled). (Base from U.S. Geol. Survey Bassett NW, Nebr., 7.5' quadrangle, contour interval 10 feet, 1950.)

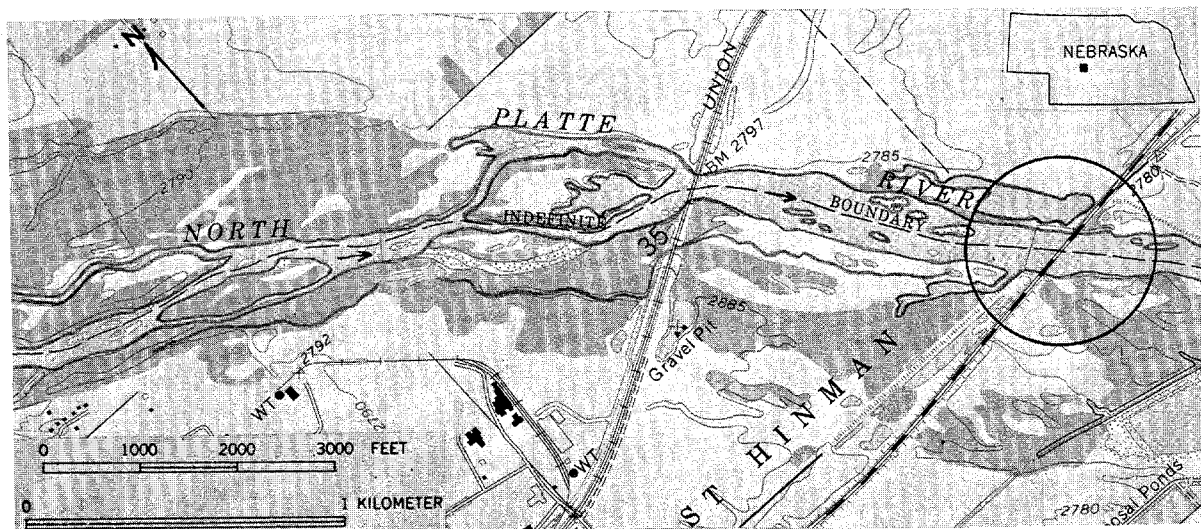
Figure 222. Map showing North Platte River at SR-11 crossing (circled). (Base from U.S. Geol. Survey North Platte east, Nebr., 7.5' quadrangle, contour interval 20 feet, 1970.)

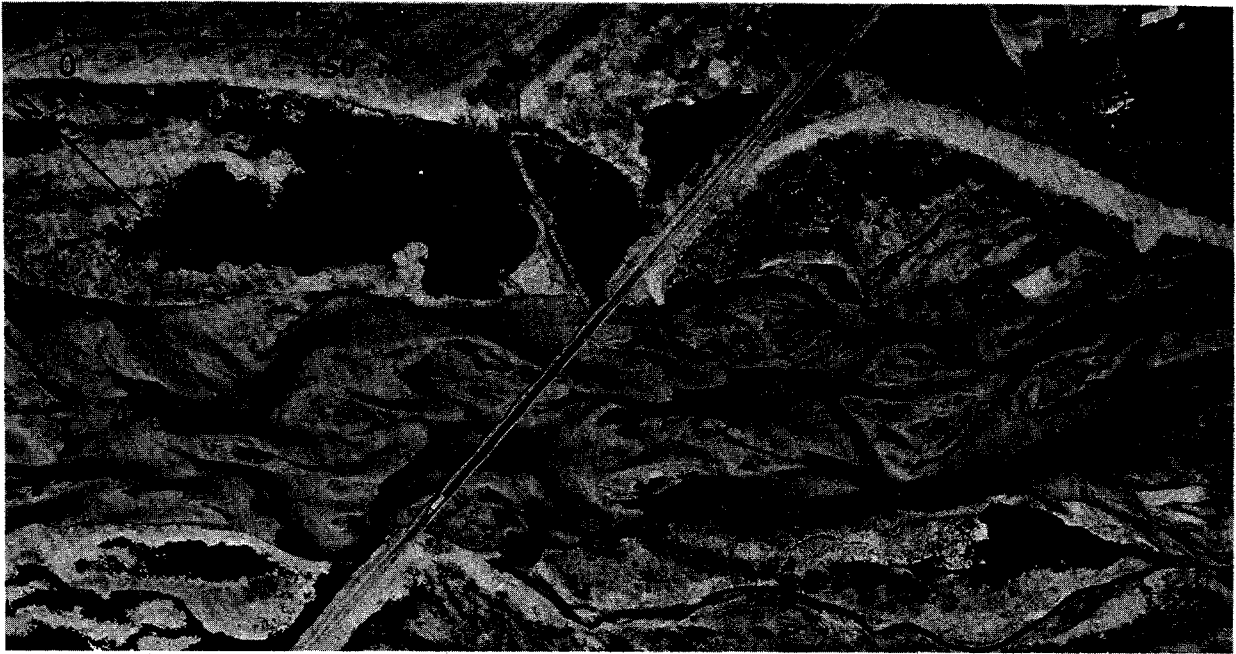
Figure 223. Aerial photograph of SR-11 crossing in 1959, showing bridge (replaced in 1960) and permeable spurs. (From Nebraska Dept. of Roads.)

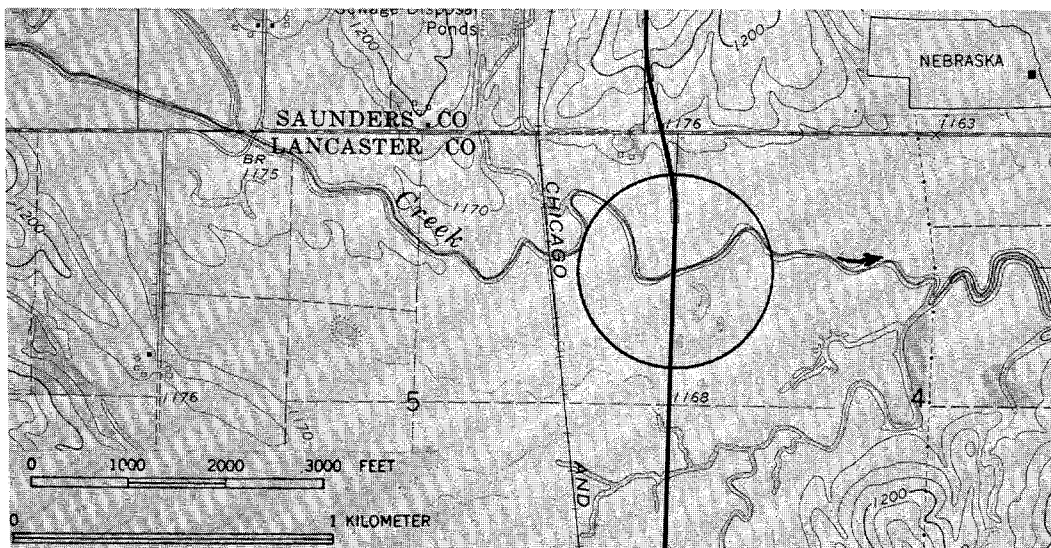
Figure 224. Map showing Rock Creek at US-77 crossing. (Base from U.S. Geol. Survey Ceresco, Nebr., 7.5' quadrangle, contour interval 10 feet, 1968.)

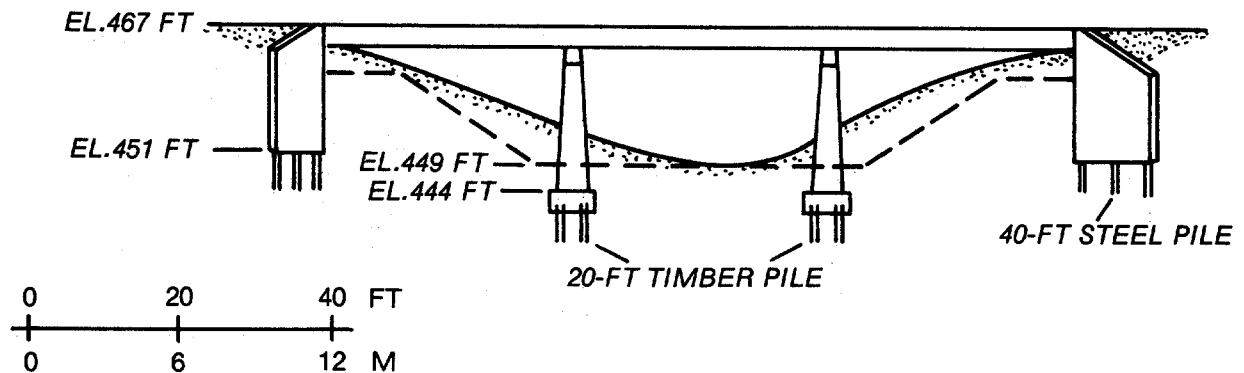
Figure 225. Elevation sketch of US-77 bridge at Rock Creek.

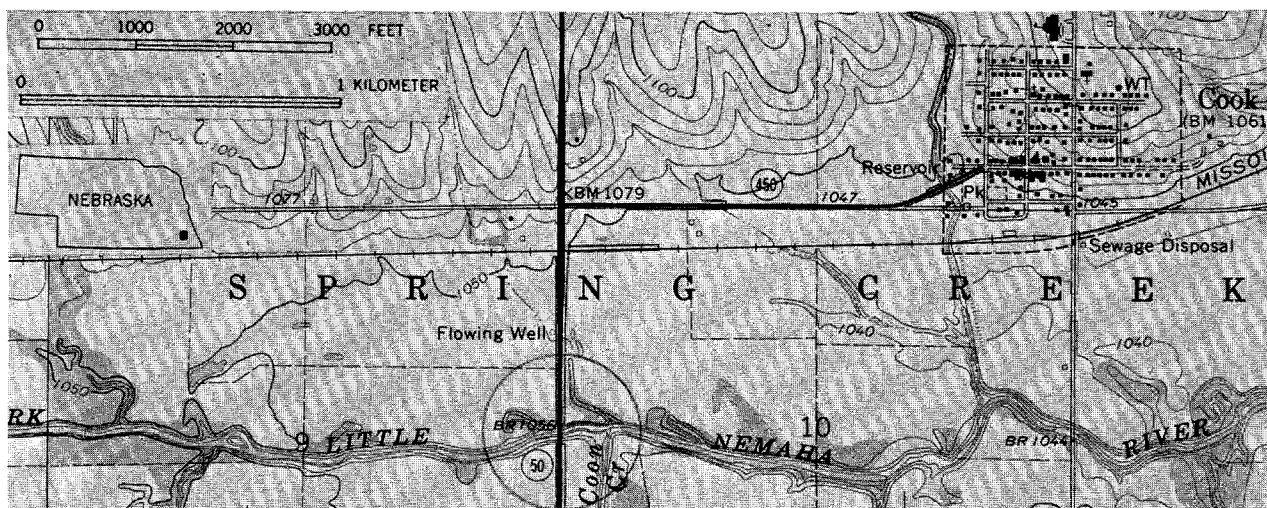
Figure 227. Map showing South Fork Little Nemaha River at US-50 crossing (circled). (Base from U.S. Geol. Survey Cook, Nebr., 7.5' quadrangle, contour interval 10 feet, 1966.)

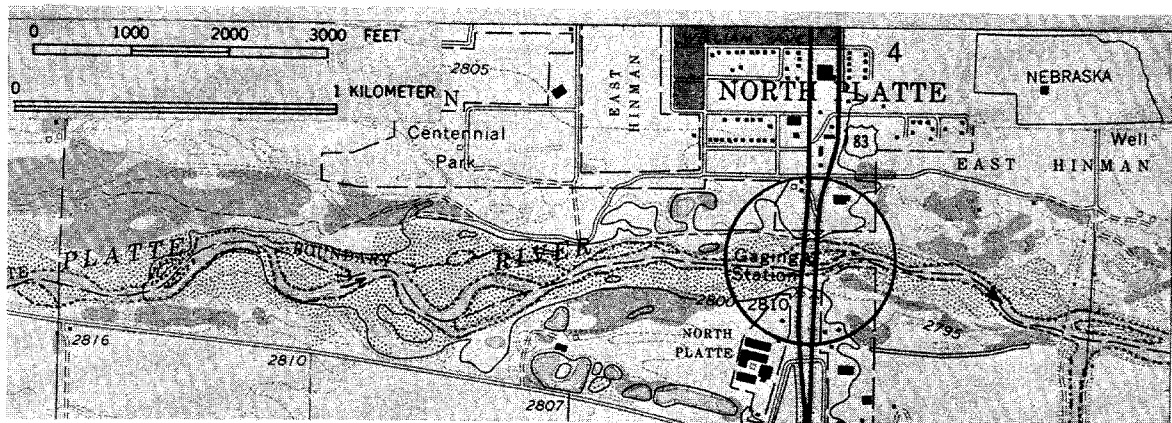
Figure 228. Map showing South Platte River at US-83 crossing. (Base from U.S. Geol. Survey Lake Maloney, Nebr., 7.5' quadrangle, contour interval 20 feet, 1969.)

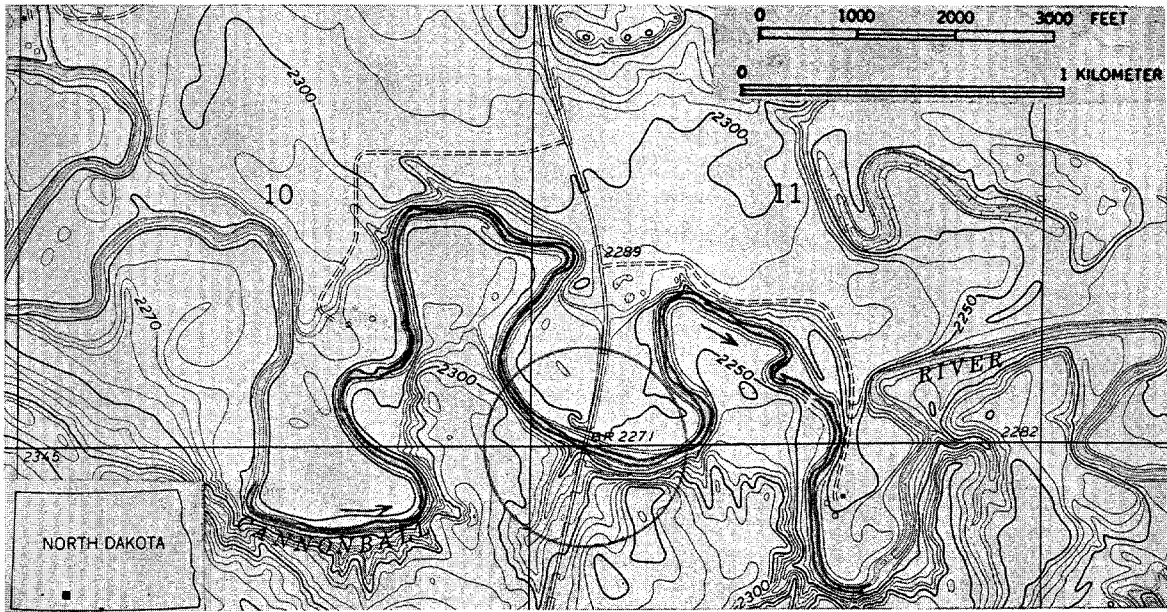
Figure 232. Map showing Cannonball River at SR-49 crossing (circled). (Base from U.S. Geol. Survey New Leipzig south, N. Dak., 7.5' quadrangle, 1972.)

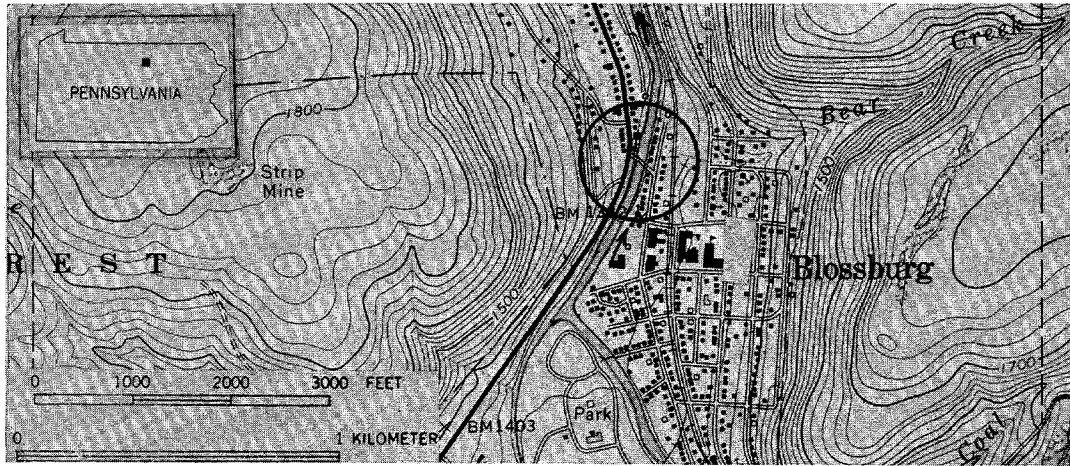
Figure 234. Map showing Tioga River at connecting road to US-15 (circled). (Base from U.S. Geol. Survey Blossburg, Pa., 7.5' quadrangle, contour interval 20 feet, 1970.)

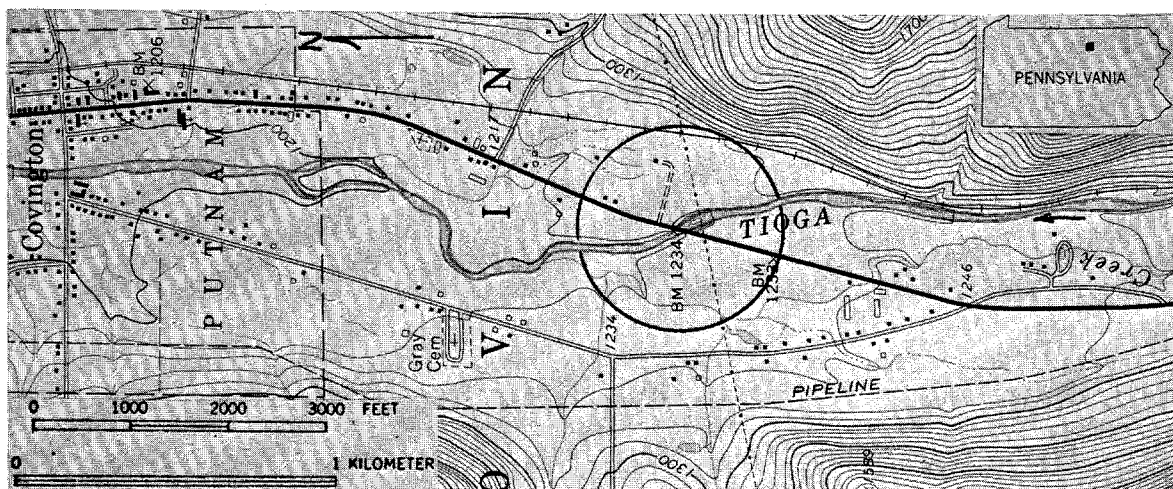
Figure 236. Map showing Tioga River at US-15 near Covington, PA. (Base from U.S. Geol. Survey Blossburg, PA., 7.5' quadrangle, contour interval 20 feet, 1970.)

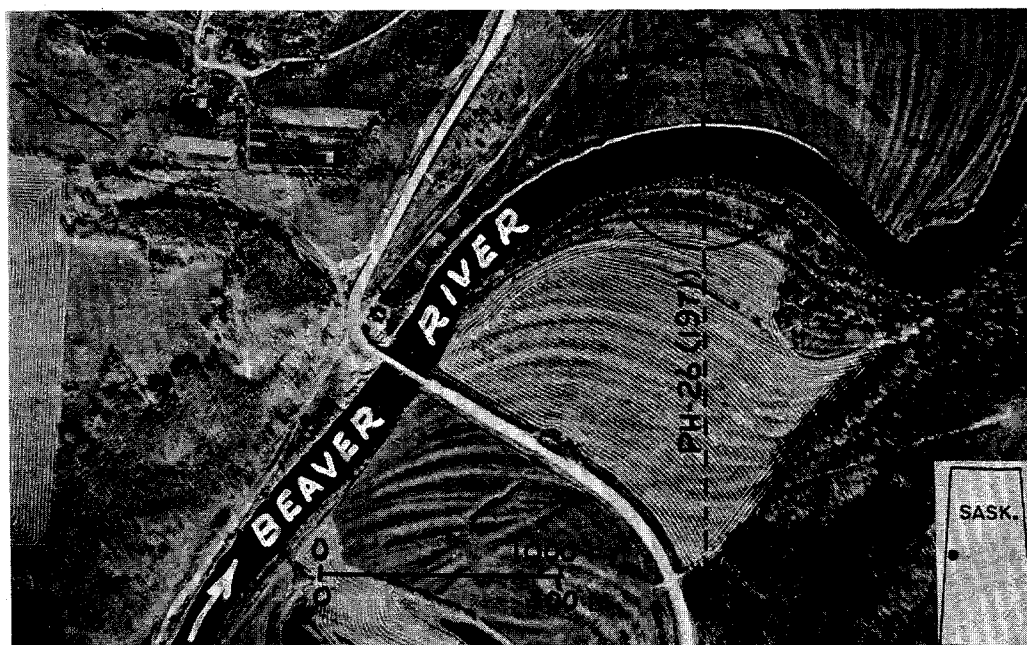
Figure 241. Aerial photograph of Beaver River at PH-26 crossing site, on May 10, 1968. Bridge shown was replaced by new bridge in 1971, at the location circled. (From Saskatchewan Dept. of Highways and Transportation.)

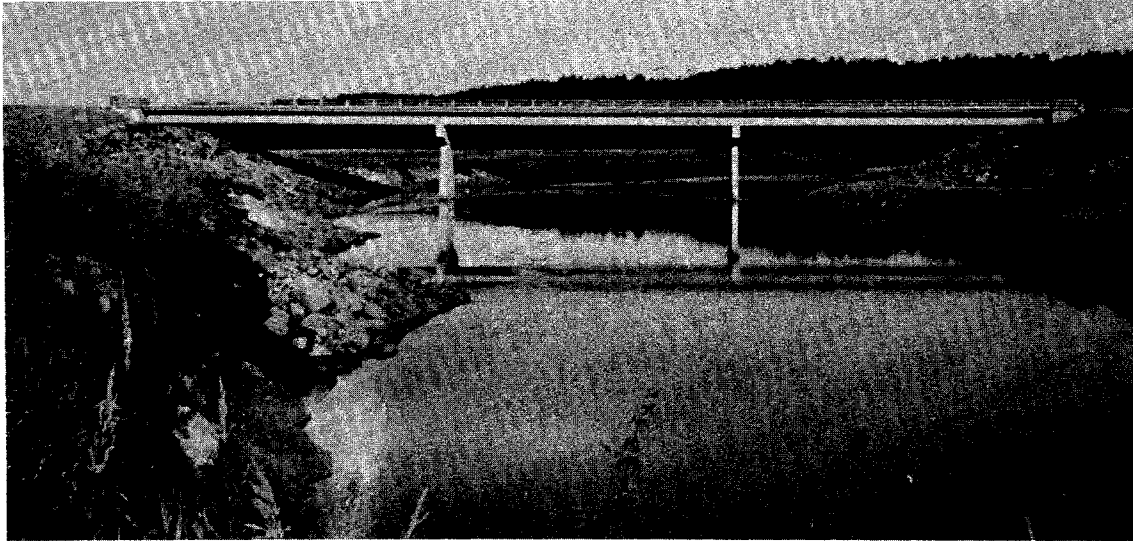
Figure 242. Downstream view of bridge built in 1971, showing spurs (at left) and part of guide bank (extreme right). (From Saskatchewan Dept. of Highways and Transportation.)

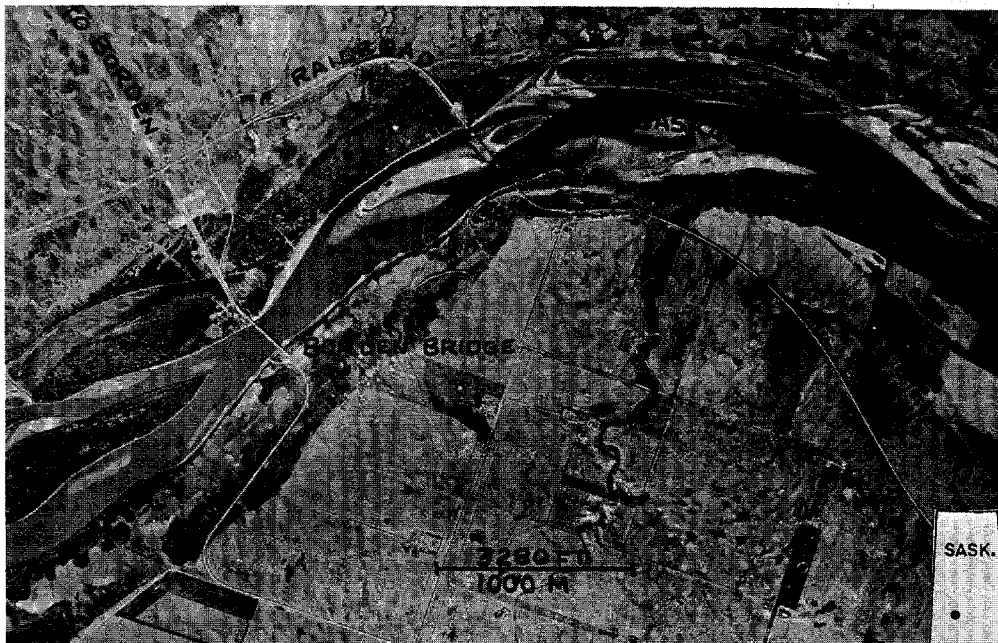
Figure 244. Aerial photograph of North Saskatchewan River at PH-5, in May, 1960. (From Saskatchewan Dept. of Highways and Transportation.)

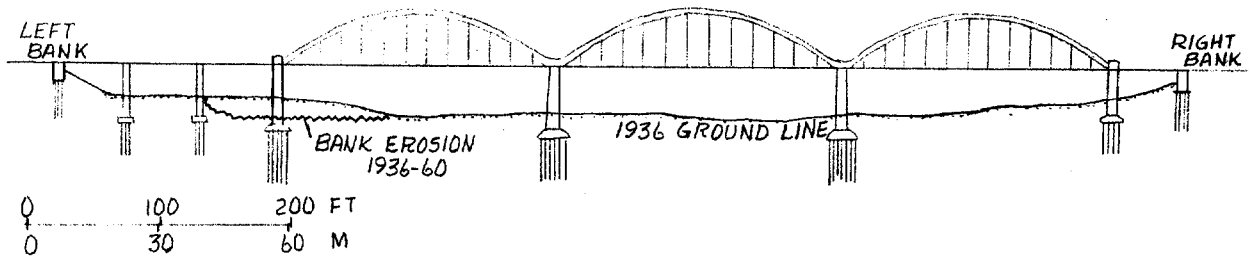
Figure 245. Elevation sketch of PH-5 bridge, North Saskatchewan River, showing bank erosion.

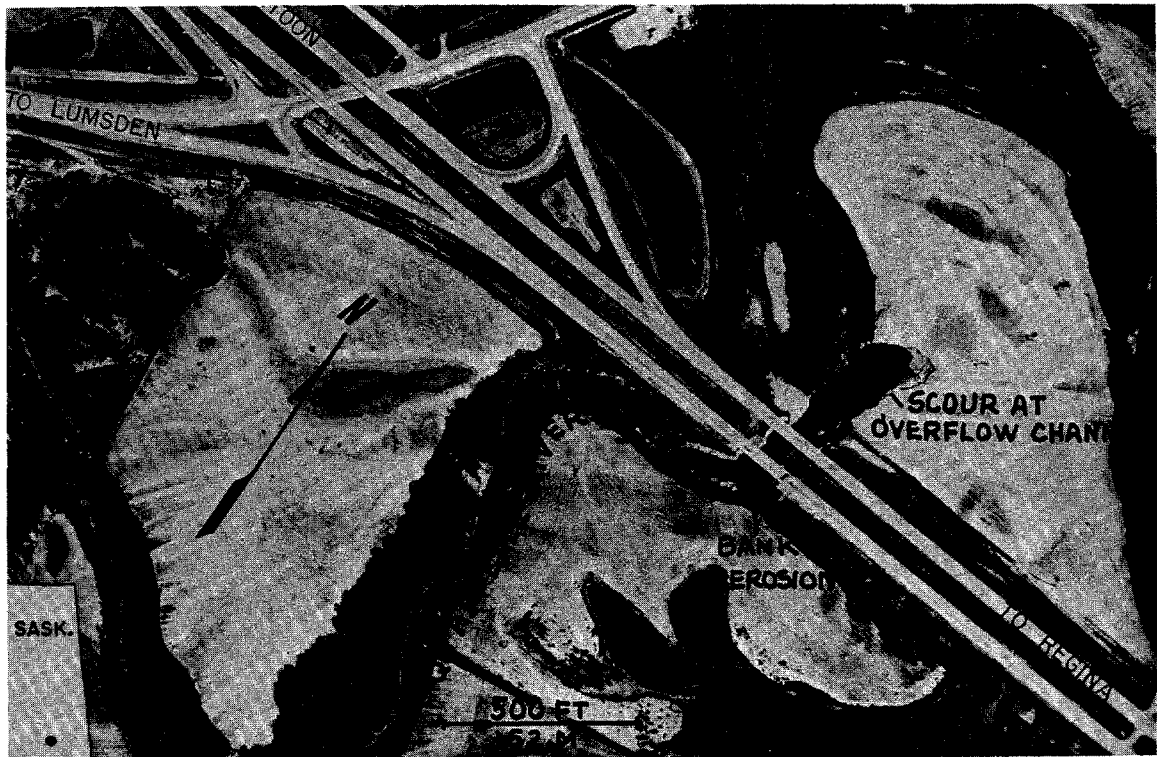
Figure 251. Aerial photograph of Qu'Appelle River after 1974 flood at PH-11 near Lumsden, Saskatchewan, Canada. (From Saskatchewan Dept. of Highways and Transportation.)

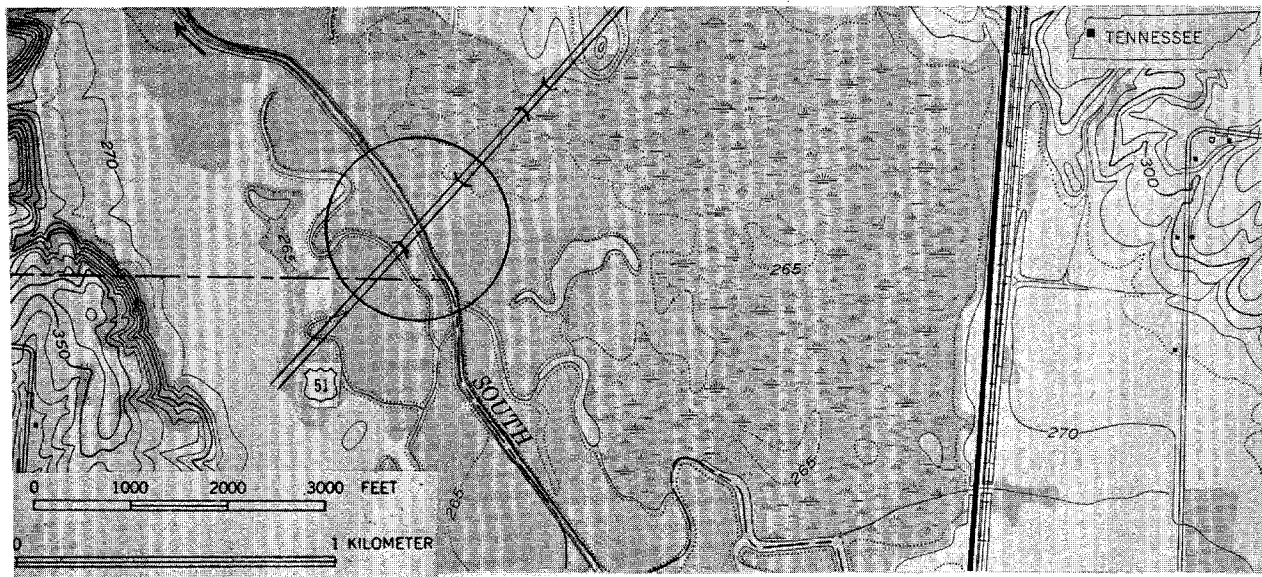
Figure 255. Map showing South Fork Forked Deer River at US-51 crossing (circled). (Base from U.S. Geol. Survey Fowlkes, Tenn., 7.5' quadrangle, contour interval 10 feet, 1952.)

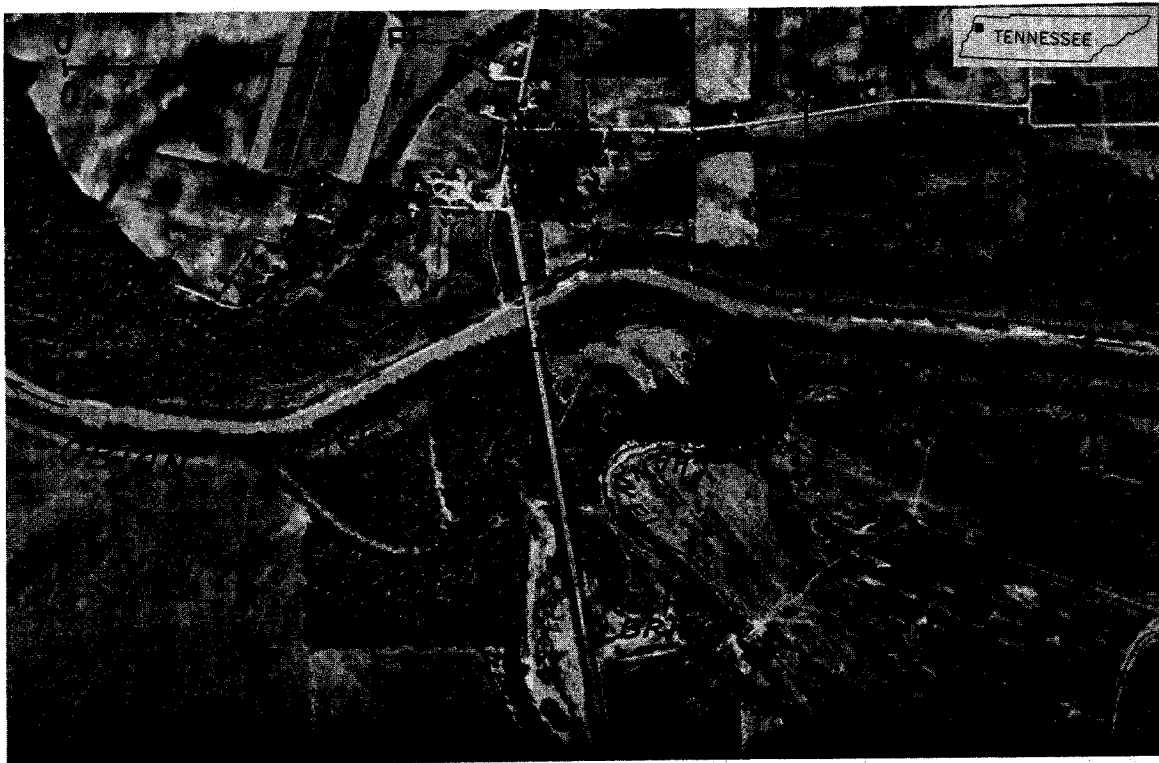
Figure 258. Vertical aerial photograph of Obion River at S-8005 bridge, on November 3, 1971, just prior to bridge failure. (From U.S. Dept. of Agriculture.)

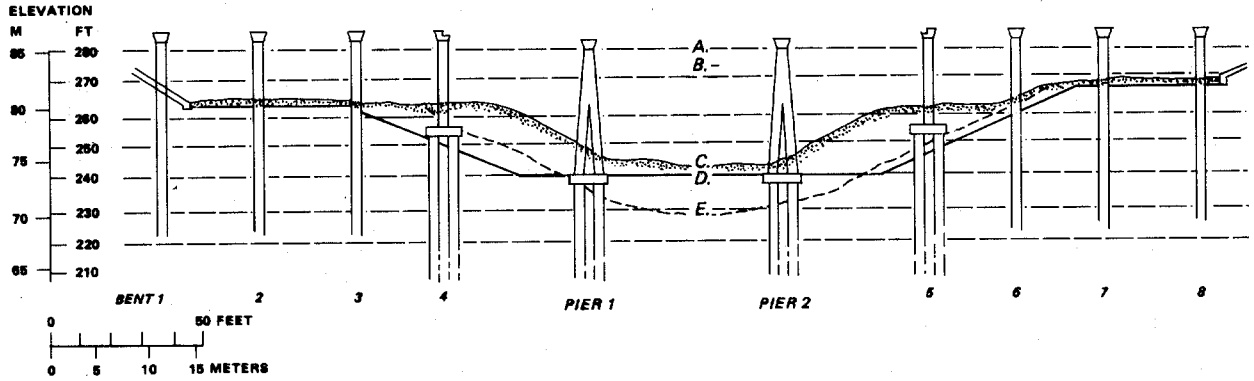
Figure 259. Channel cross section of Obion River at S-8005 bridge, showing bridge substructure, water levels, and channel bed at different dates. A, water surface elevation at bridge design flood, 50-yr R.I.; B, water surface at flood of 1-14-74; C, ground line from bridge plans, 1957; D, ground line from channel dredging plans, 1963; E, channel bed from soundings by Tennessee Dept. Transportation, after bridge failure.

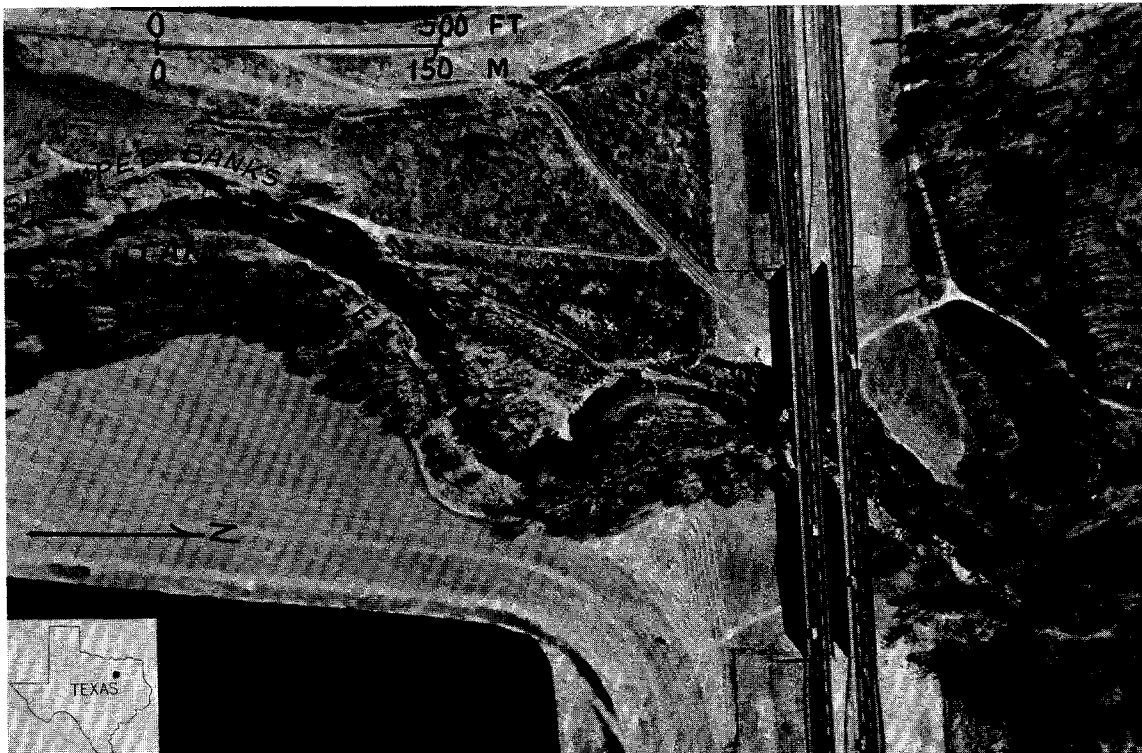
Figure 260. Aerial photograph of turnpike bridges at Mountain Creek, prior to installation of bank revetment, on December 12, 1975. (From Howard, Needles, Tammen, and Bergendoff, engineering consultants.)

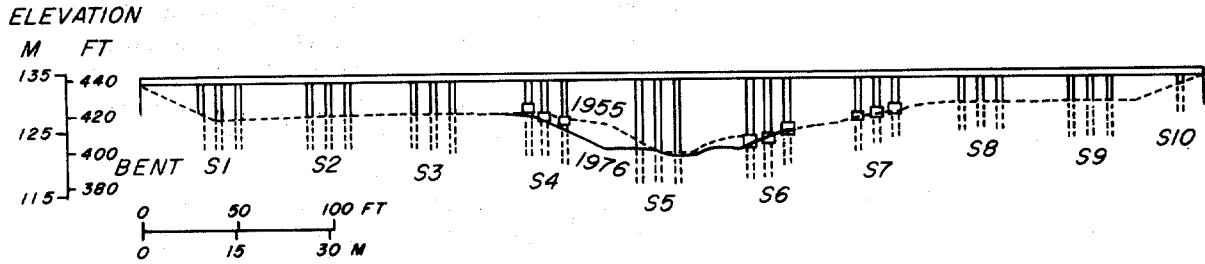
Figure 261. Elevation sketch of south bridge, as projected in a plane normal to flow direction of stream. Collars for strengthening of bent columns are shown.

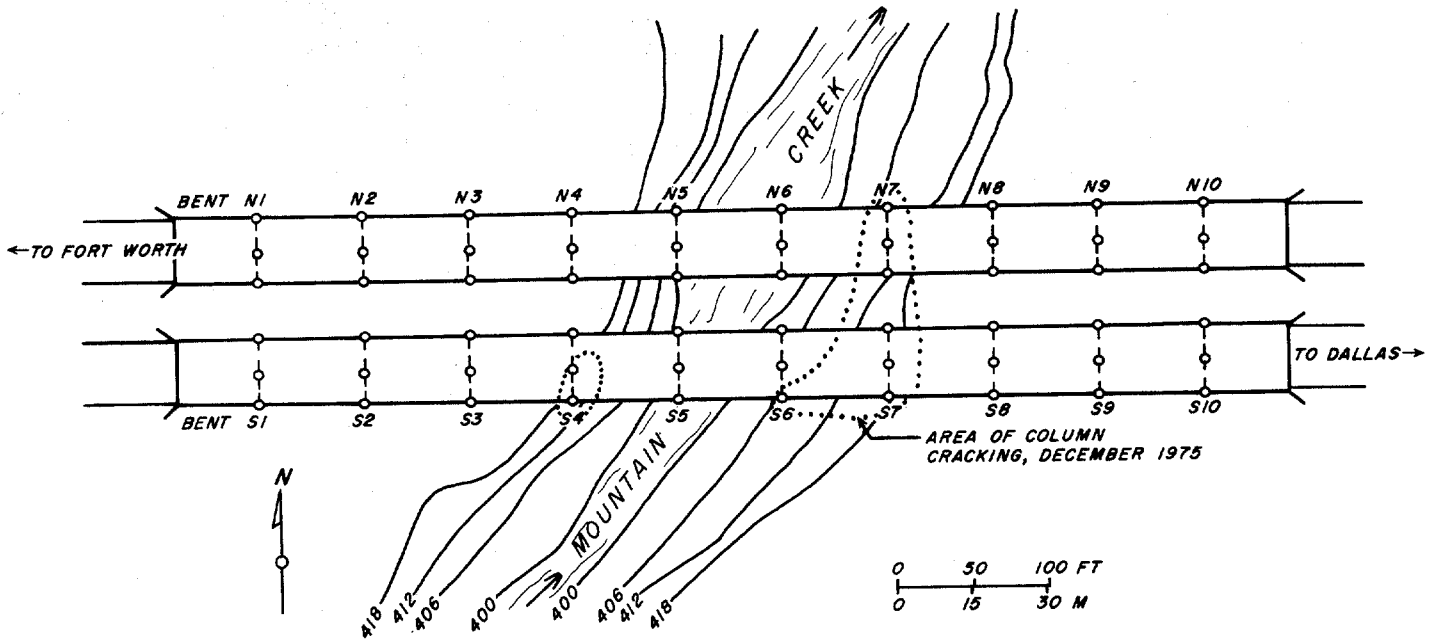
Figure 262. Plan sketch of turnpike bridges, showing contours of creek channel and location of cracked columns.

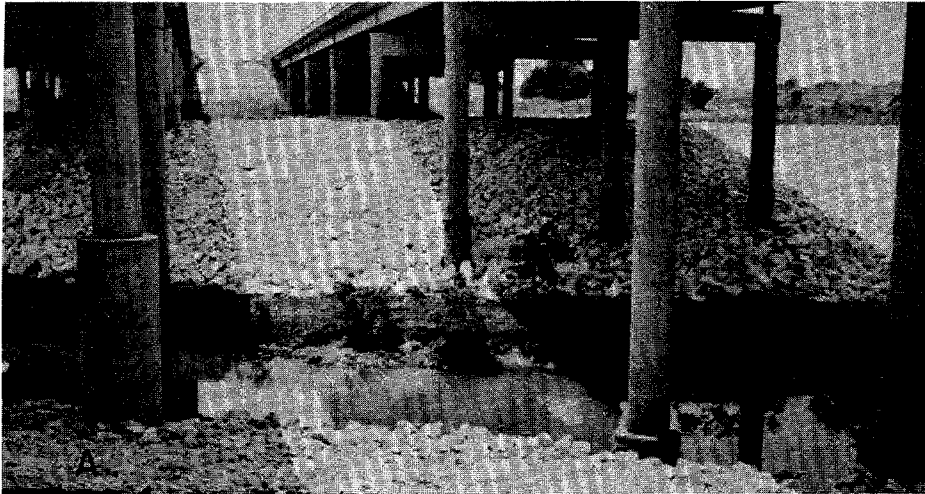
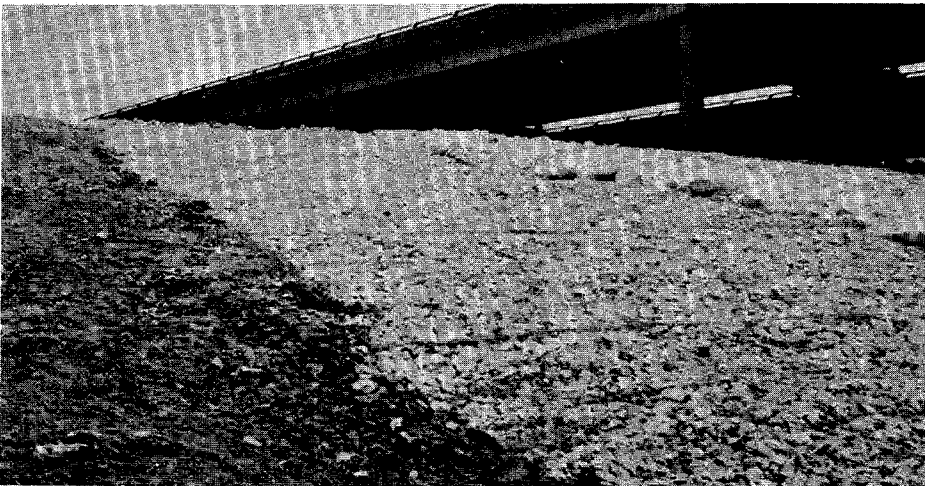
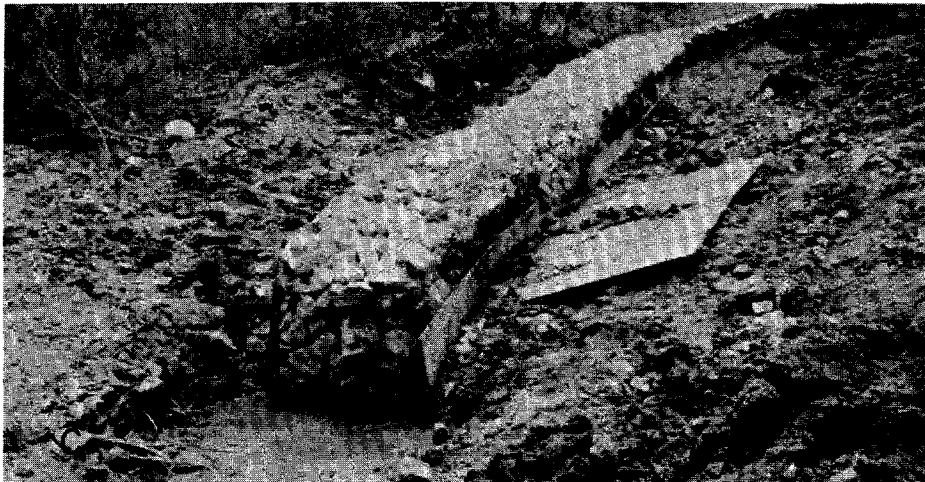
Figure 263. A, view of revetment installed on west bank and of collars on bent columns. B, view of installation of revetment on east bank, June 1, 1977. Rock-and-wire mattress, serving as a filter blanket, has been laid on graded slope at center and, at upper right, has been topped by rock riprap. C, view of gabion wall that will serve to anchor end of revetment on west bank, June 1, 1977.

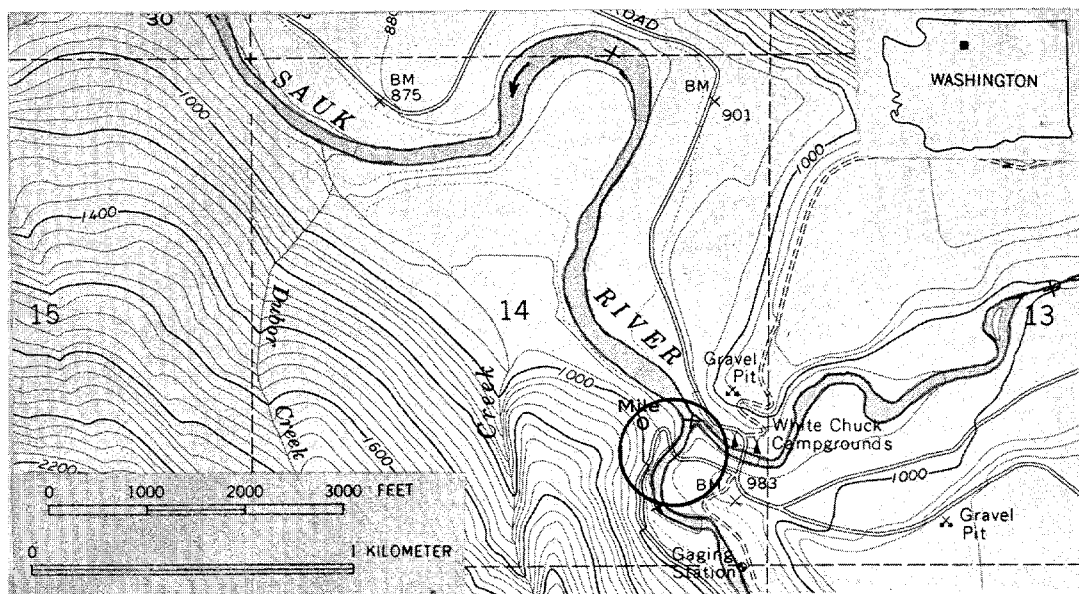
Figure 264. Map showing Sauk River at Forest Service bridge 3211-5.8, which is indicated by circle. (Base from U.S. Geol. Survey White Chuck Mtn., Wash., 7.5' quadrangle, contour interval 40 feet, topography from aerial photographs taken 1953).

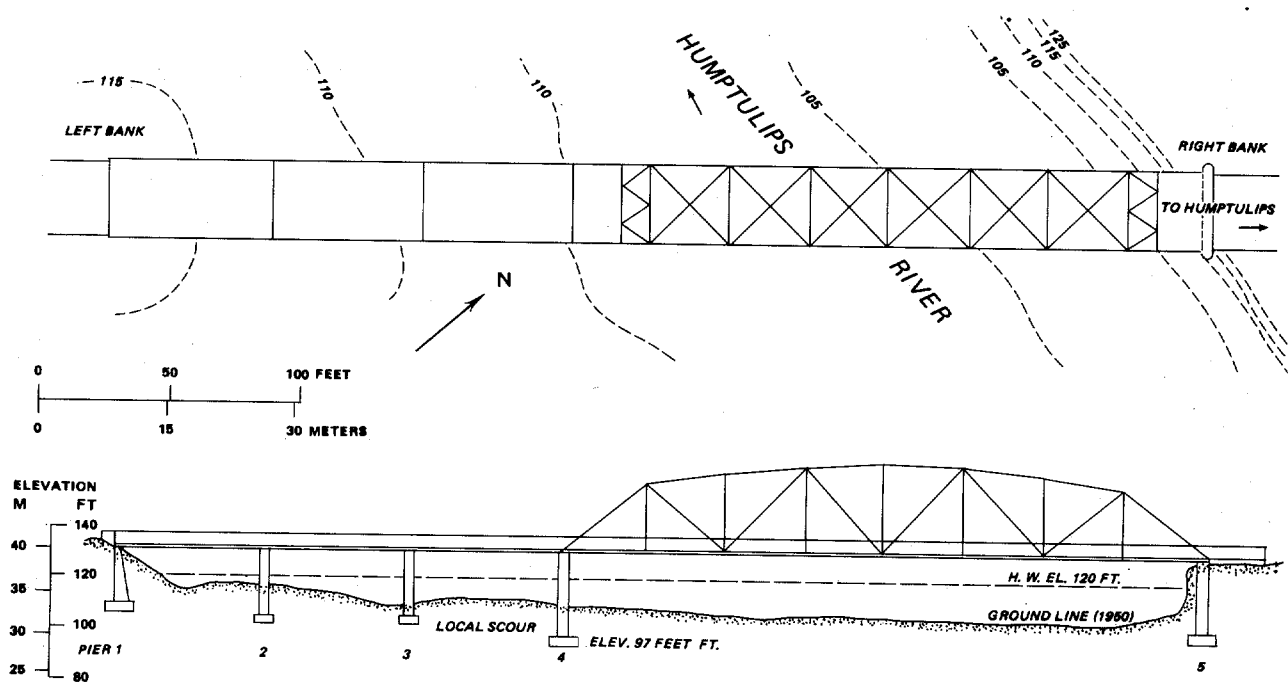
Figure 267. Plan, at top, and elevation, at bottom, of US-101 bridge at Humptulips River.

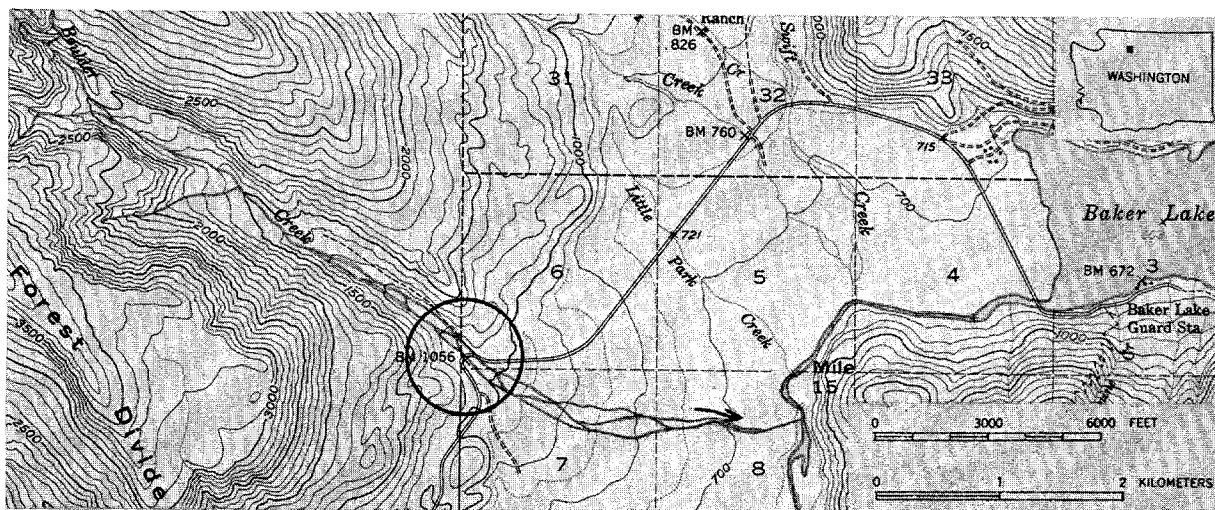
Figure 270. Map showing Boulder Creek at Forest Service bridge 394.2.4 (circled). (Base from U.S. Geol. Survey Lake Shannon Wash., 15' quadrangle, contour interval 100 feet, 1948.)

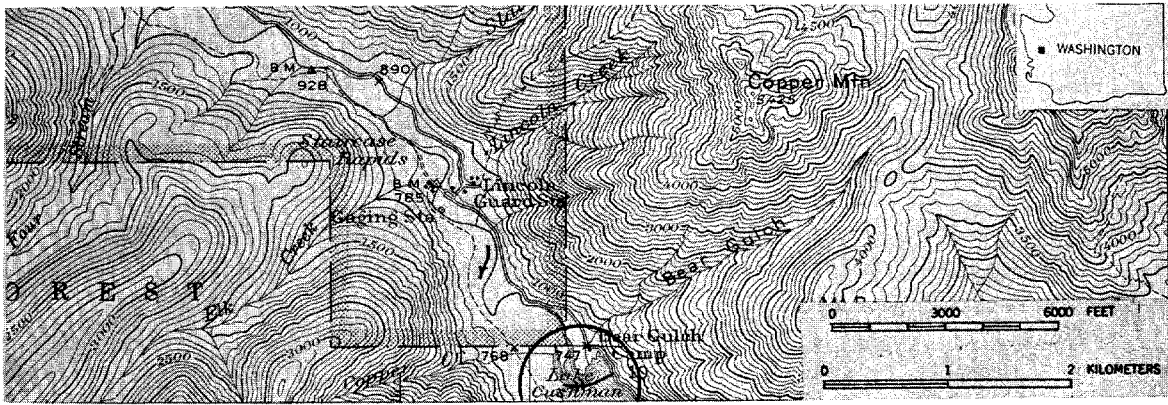
Figure 274. Map showing North Fork Skokomish River and Lake Cushman at Forest Service bridge 2357-0.1 (circled). (Base from U.S. Geol. Survey Mt. Steel, Wash., 15' quadrangle, contour interval 100 feet, 1948).

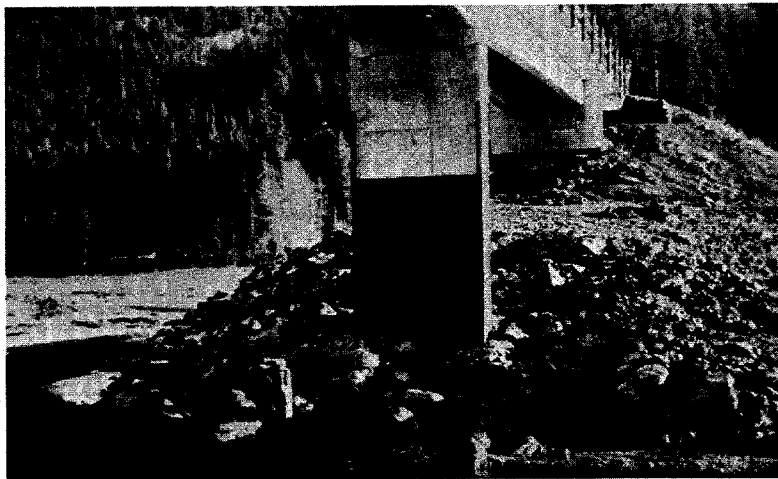
Figure 276. View of left (east) end of Lake Cushman bridge, on January 6, 1977. Footing and top seal of pier 3, center, are exposed and H-pile foundations of pier 2, background, also exposed. Note gabion wall at top of abutment fill-slope and approach alignment of stream, at left.

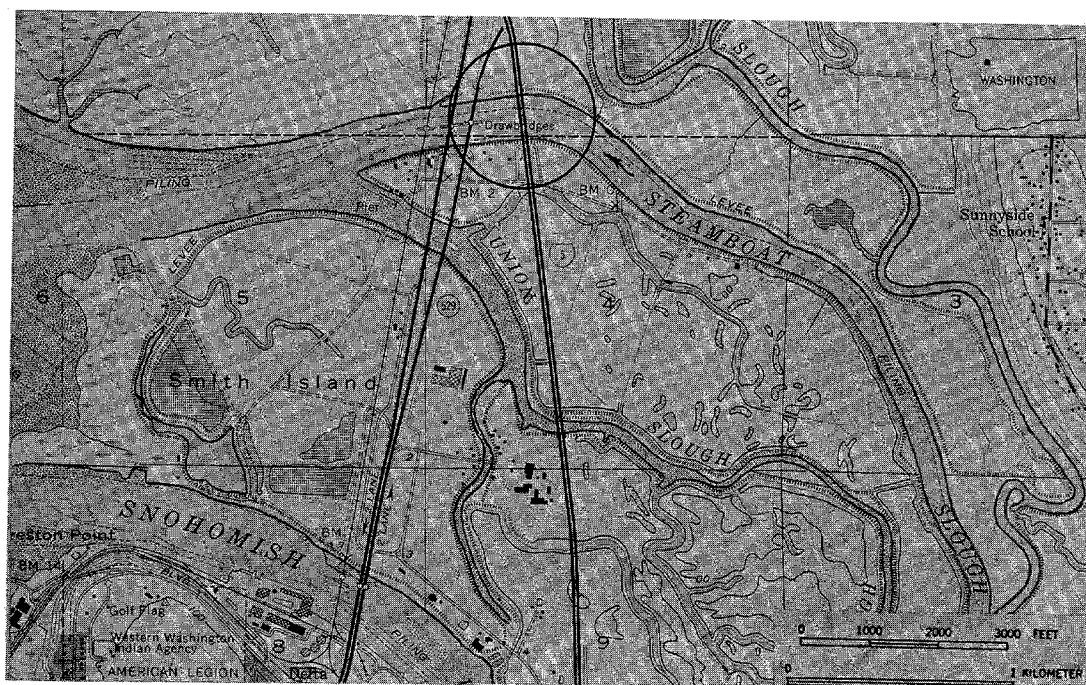
Figure 277. Map showing Steamboat Slough at I-5 crossing (circled). (Base from U.S. Geol. Survey Marysville, Wash., 7:5' quadrangle, contour interval 20 feet, photorevised 1973.)

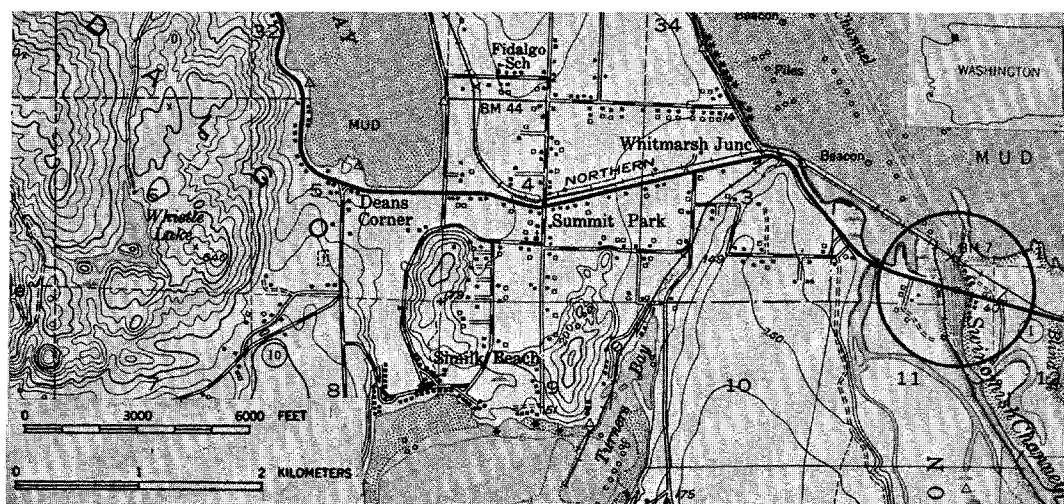
Figure 280. Map showing Swinomish Channel at SR-20 crossing (circled). (Base from U.S. Geol. Survey Deception Pass, Wash., 15; quadrangle, contour interval 50 feet, 1951.)

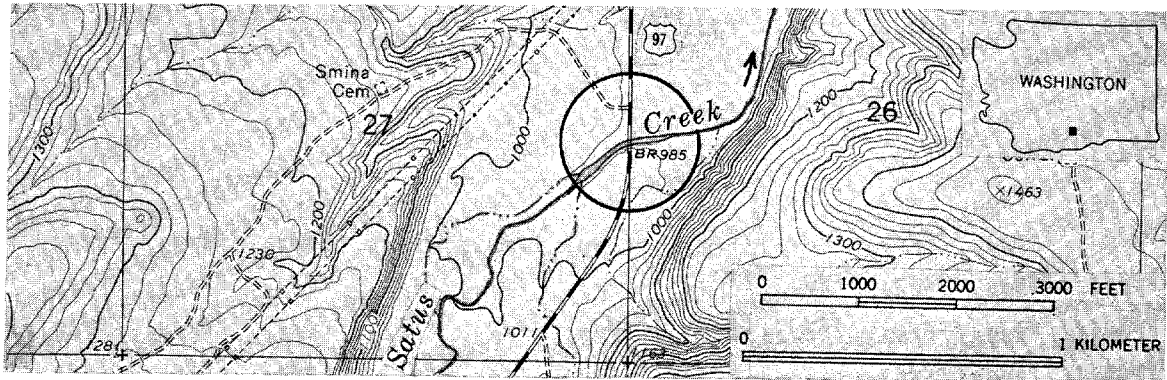
Figure 282. Map showing Satus Creek at first crossing of US-97 (circled). (Base from U.S. Geol. Survey Poisel Butte NW, Wash., 7.5' quadrangle, contour interval 20 feet, 1965.)

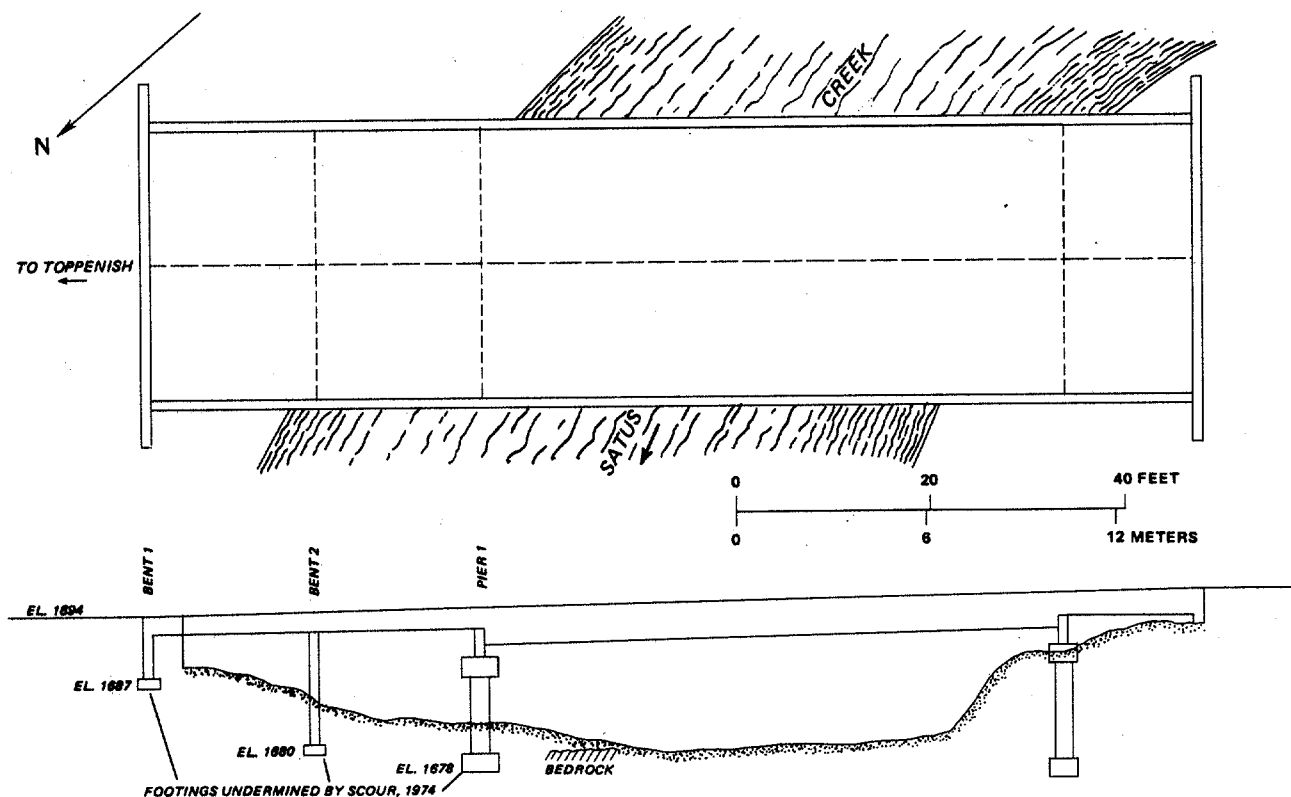
Figure 285. Sketch of plan (top) and elevation (bottom) for bridge at fourth crossing of Satus Creek.
