Report No. FHWA-RD-78-163

Hydraulics Branch  
Library

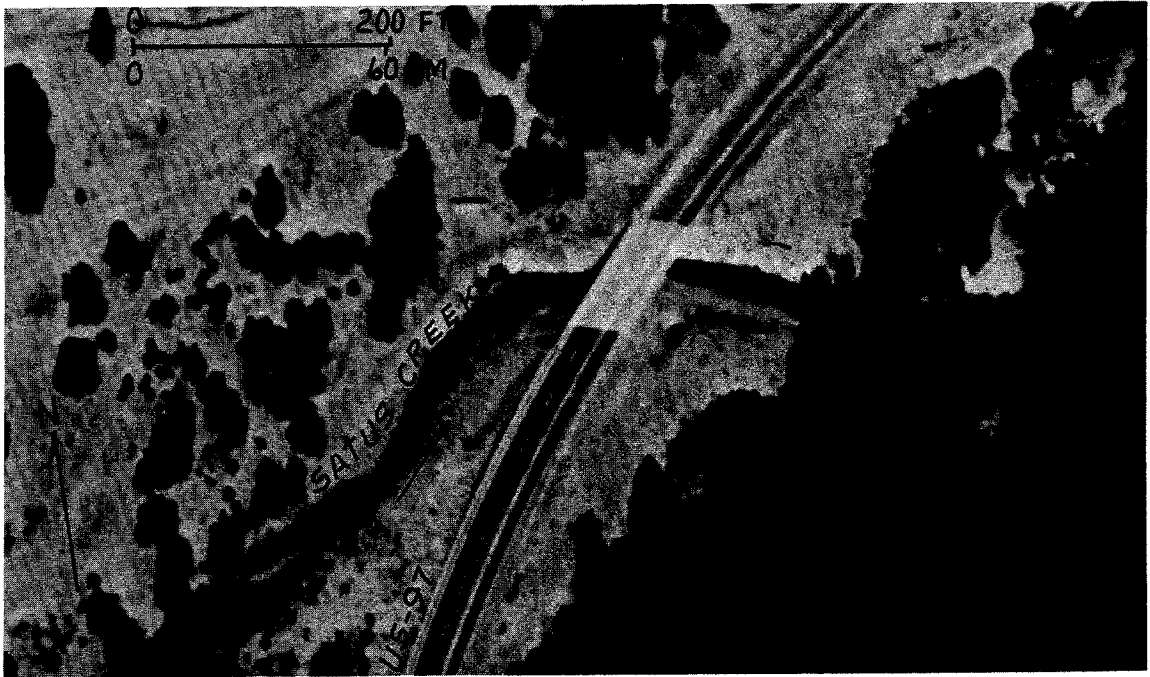
Figure 286. Aerial photograph of fifth crossing of Satus Creek, prior to flood damage. (From Washington Dept. of Highways, 1966.)

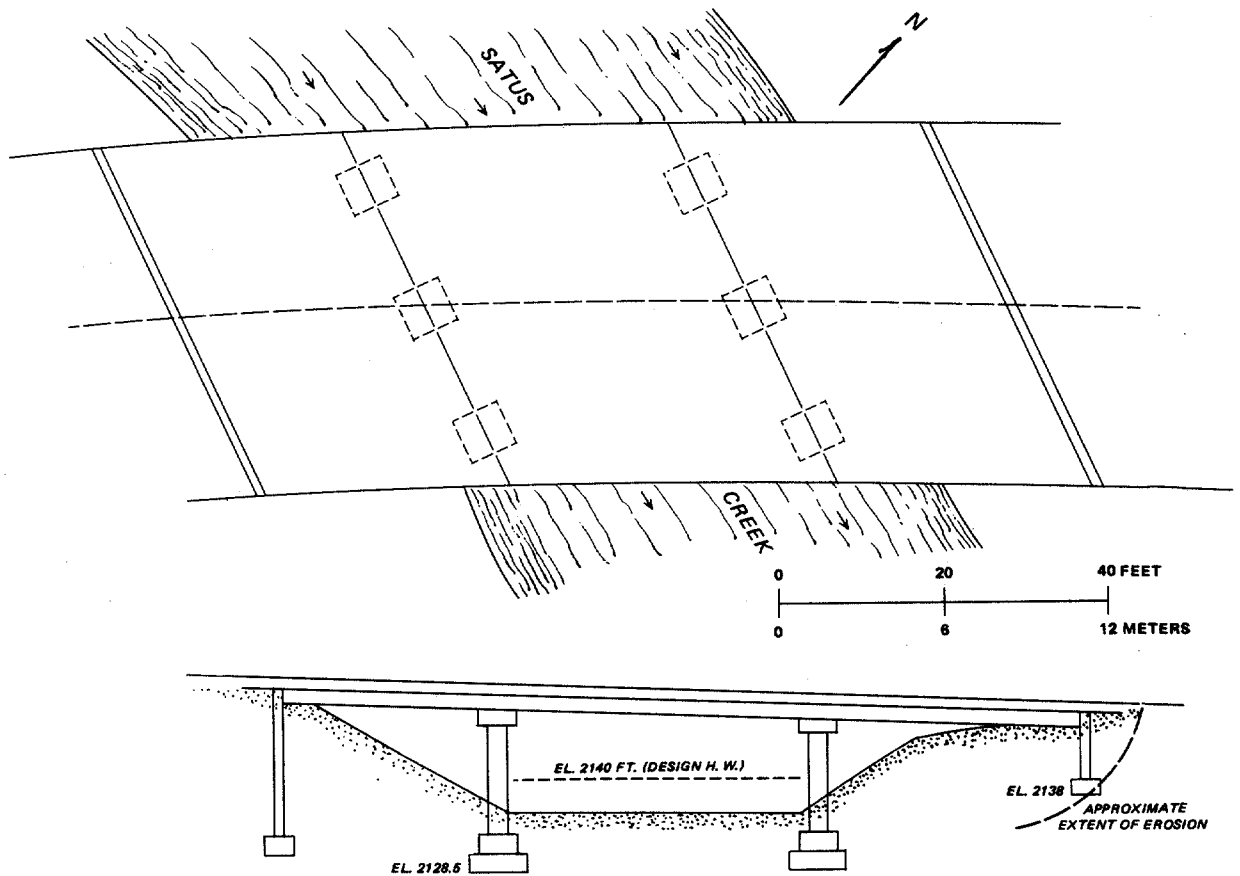
Figure 287. Sketch of plan (top) and elevation (bottom) for bridge at fifth crossing of Satus Creek.

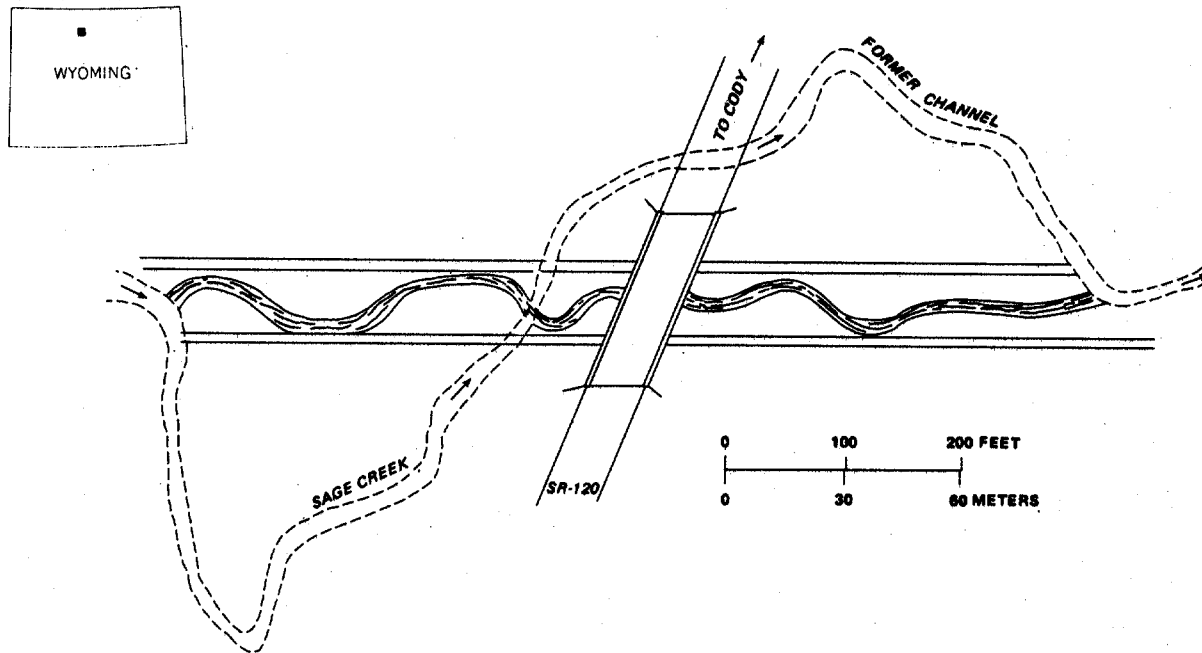
Figure 288. Plan sketch of channel alteration at Sage Creek.

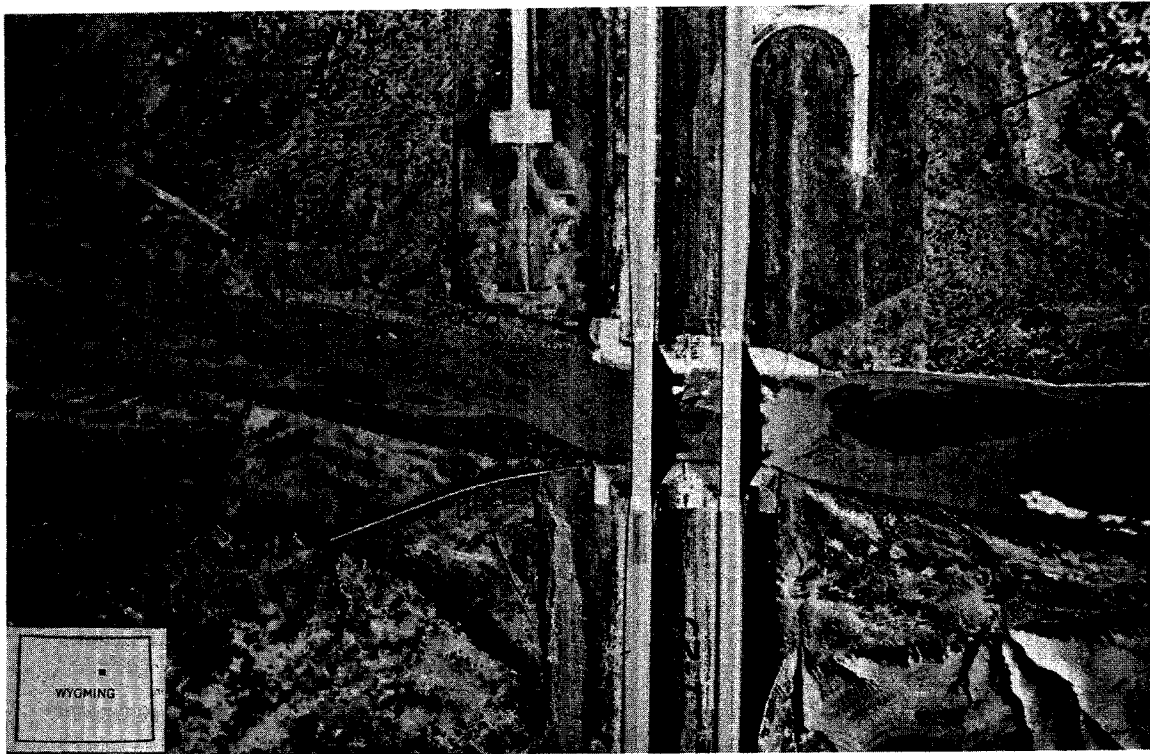
Figure 289. Aerial photograph of I-25 crossing, South Fork Powder River, March 1, 1968. (From Wyoming Dept. of Highways.)

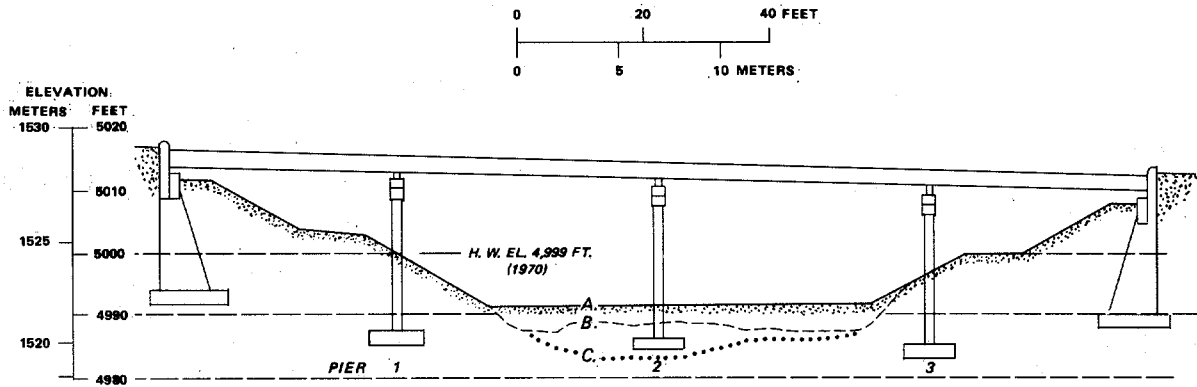
Figure 292. Elevation sketch of I-25 bridge at Box Elder Creek. A, channel bed as excavated at time of bridge construction; B, bed after flood, as surveyed in 1970; C, top of unscoured gravel, as determined by Wyoming State Highway Department.

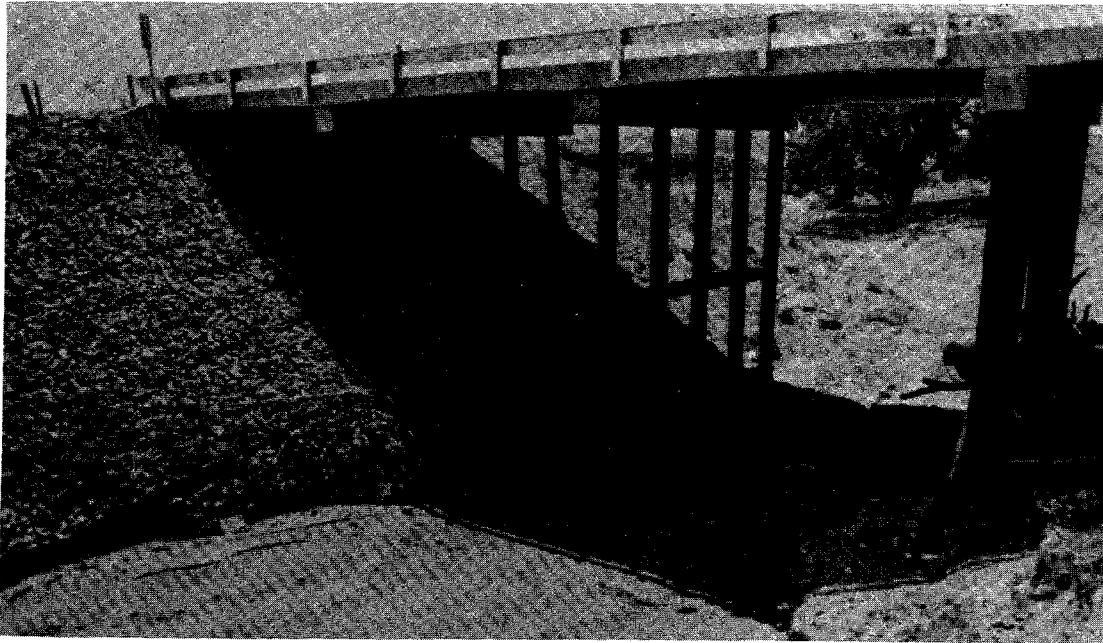
Figure 294. Upstream view of SR-192 bridge at Carpenters Draw in May, 1977, showing rock-and-wire mattress on abutment fill-slope, left, which extends to center of channel. Mattress on opposite slope also extends to center of channel. At lower left, wire is failing to hold riprap.

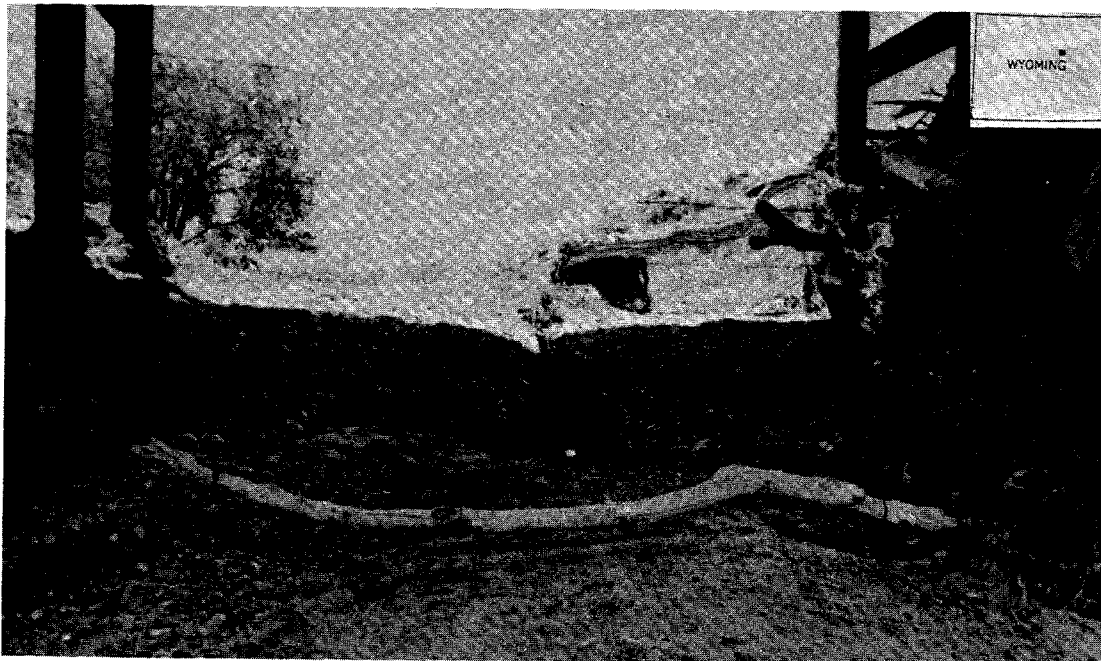
Figure 295. Upstream view beneath SR-192 bridge at Carpenters Draw in May, 1977. In foreground, mattresses have subsided and been covered with sediment; in background, narrow space between opposite mattresses is visible, at scarp of headcut. At right, wire is failing to hold riprap.

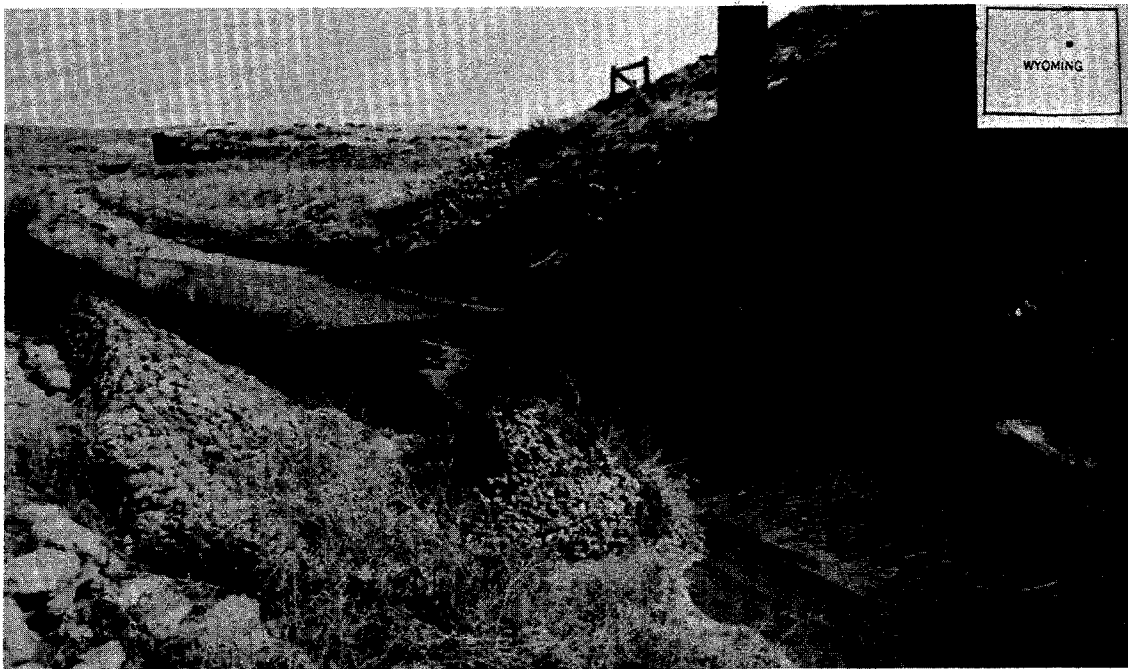
*Figure 296. Downstream view beneath bridge of northbound lane in April 1977, I-25 at Murphy Creek. At left, hand-placed riprap has been eroded from area above rock-and-wire mattress. At center, wire has been displaced from mattress. At right hand-placed riprap has been eroded from fill-slope at piers.*

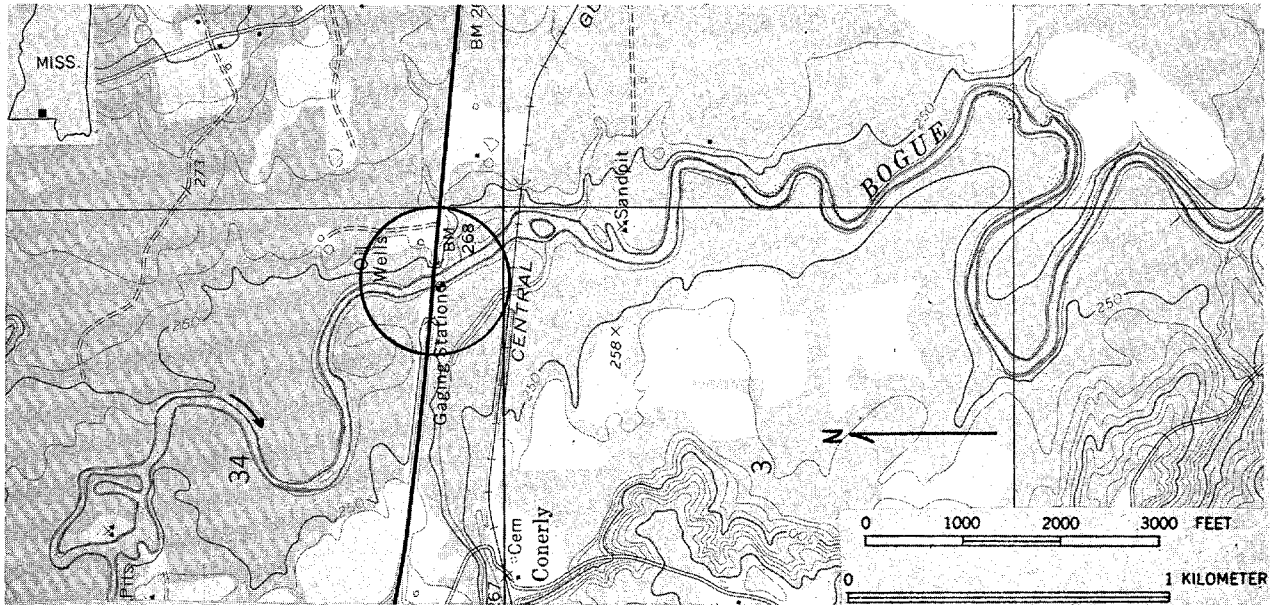
Figure 299. Map showing Bogue Chitto at US-98 crossing (circled) near Tylertown, Miss. (Base from U.S. Geol. Survey Holmesville, Miss., 7.5' quadrangle, contour interval 10 feet, 1971.)

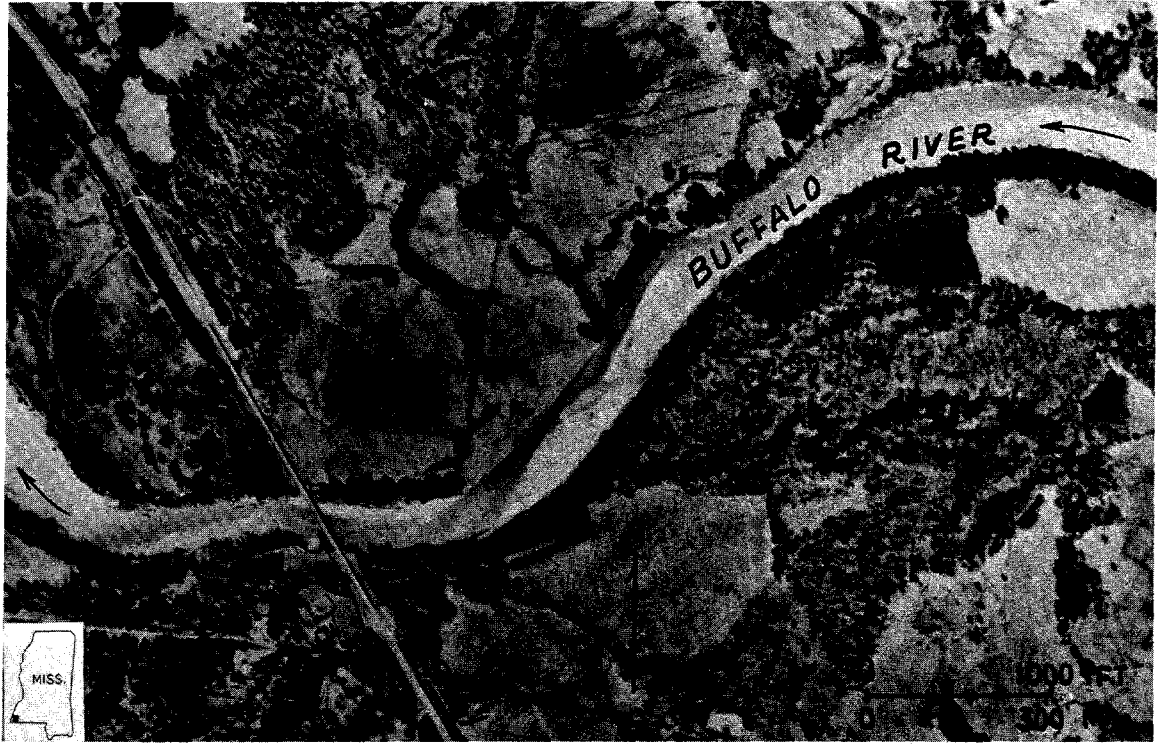
Figure 301. Aerial photograph of Buffalo River on February 10, 1973, at US-61 crossing. (Mississippi Highway Dept. photograph.)

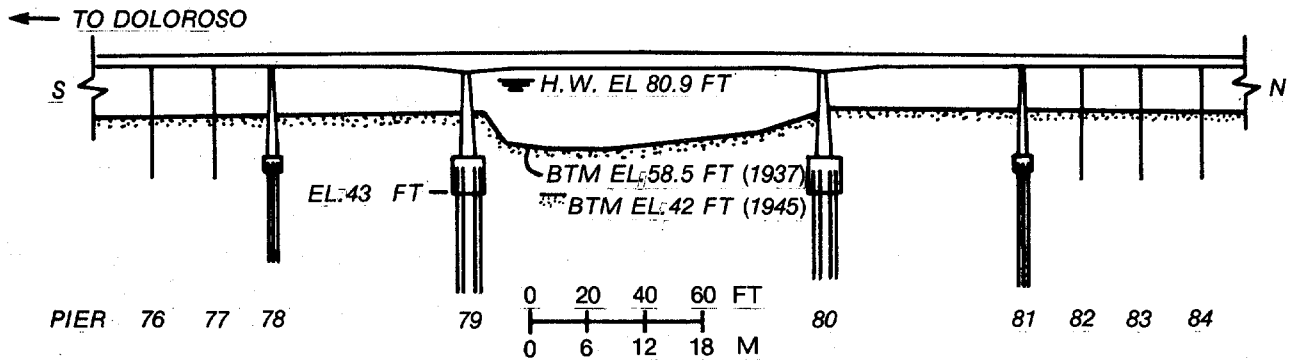
Figure 305. Elevation sketch of main-channel spans of US-61 bridge, which failed in 1955, from plans dated 1937.

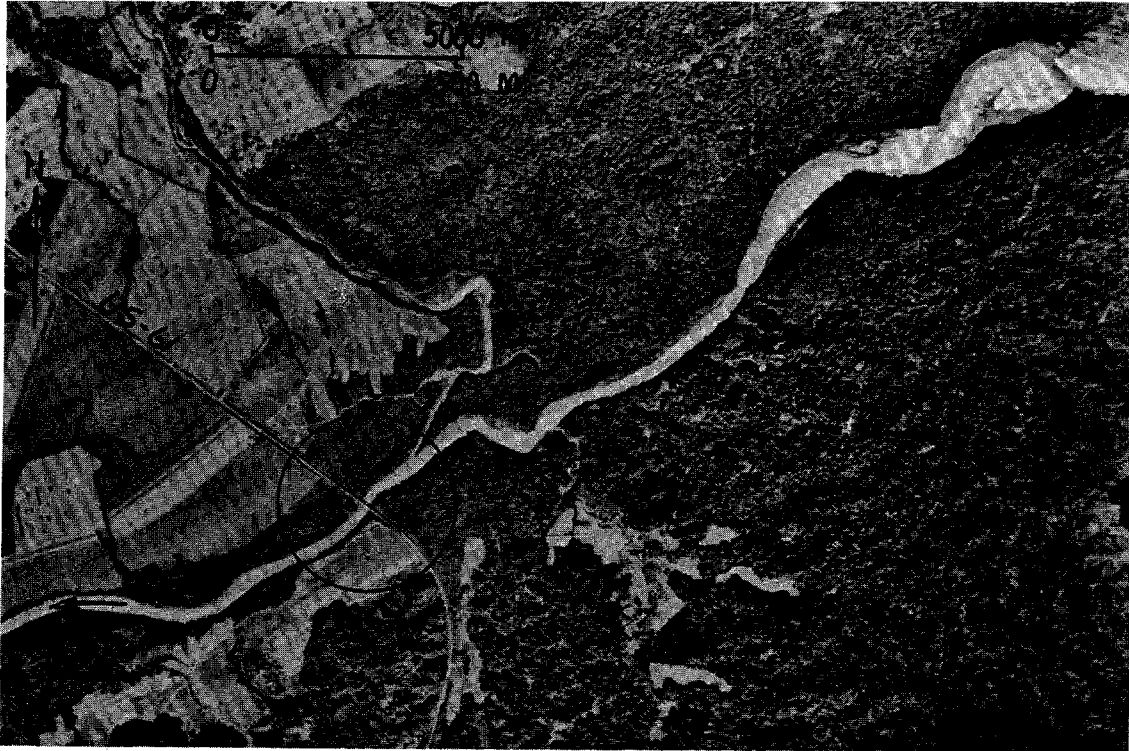
*Figure 306. Aerial photograph of Homochitto River in 1971 at US-61 crossing. Note distinct increase in channel width, an indication of lateral instability, that begins upstream from crossing. (From U.S. Dept. of Agriculture.)*

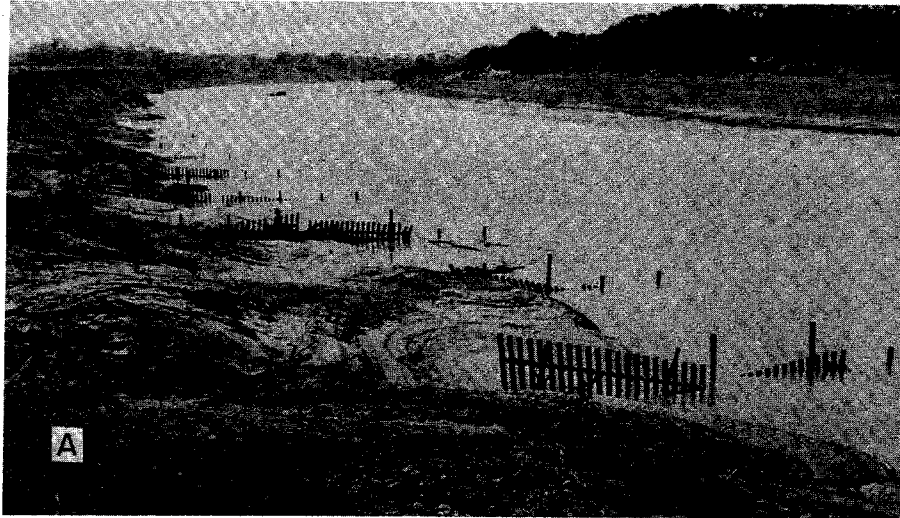
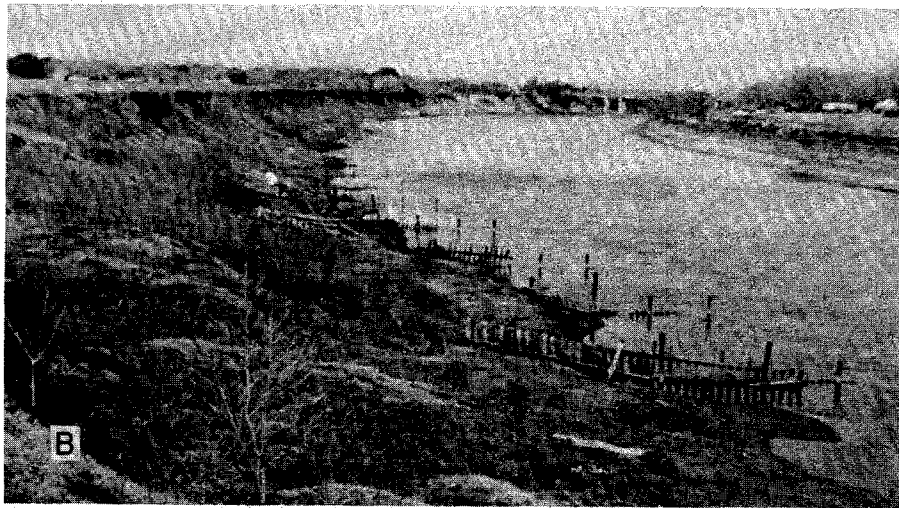
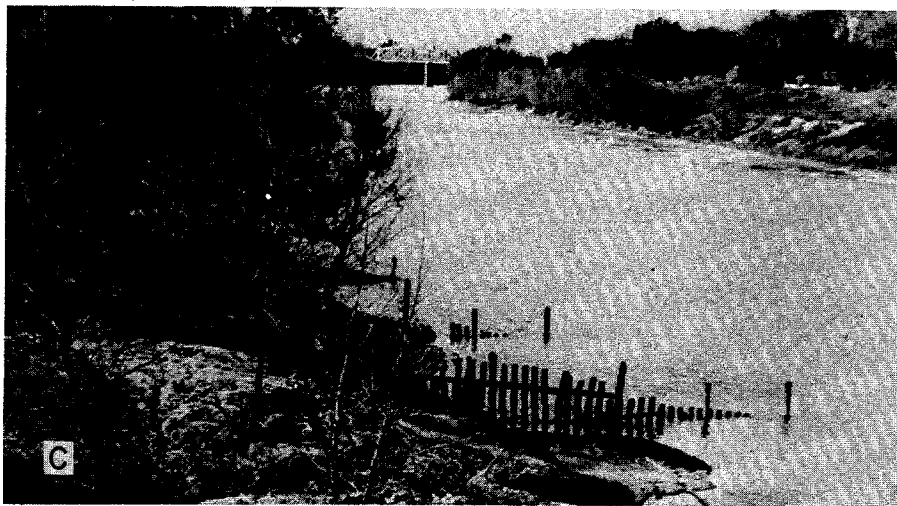
Figure 307. Sequential photographs of "spur jetties" at right bank of Brazos River, looking upstream, US-90A crossing in background. A, bank in 1966, after a flood; B, bank in 1969; C, bank in 1975.
