PERFORMANCE OF FLEXIBLE DITCH LININGS

FHWA/RD-86/114

Final Report

September 1985

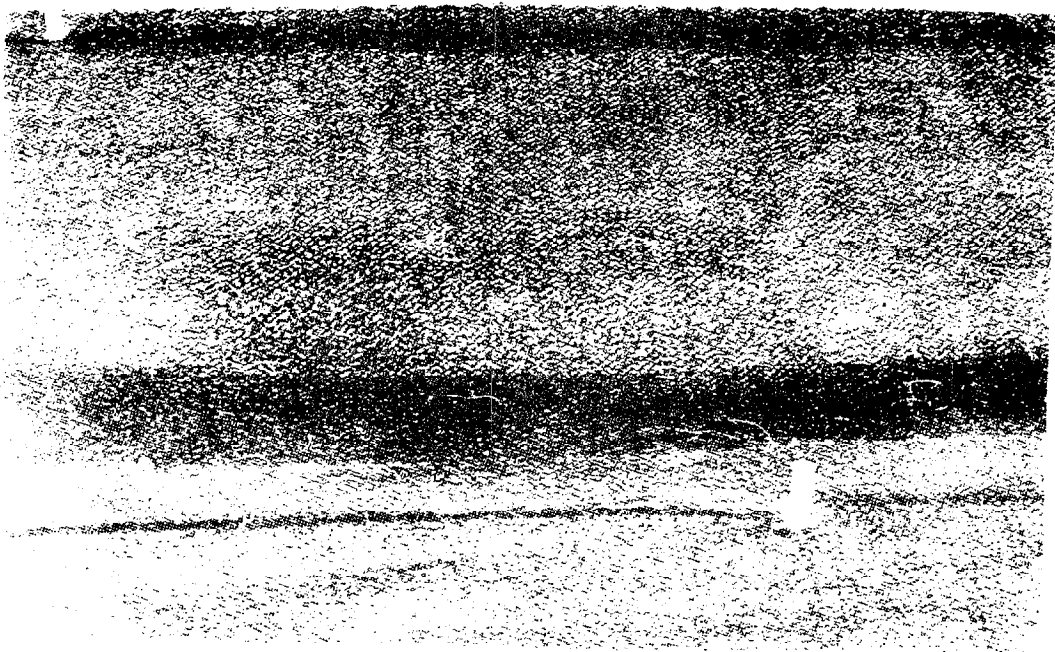
- 1) Erosion appears to occur at a steady rate throughout the entire 30 minute test.
- 2) Erosion damage was minimal in all tests.
- 3) Most erosion occurred on the side slopes of the ditch around the wood survey stakes (figure 52).
- 4) The liner was observed stretching at high slopes with high water flows.

Figure 52.--Liner Enkamat after testing: Note the washout near the stake.

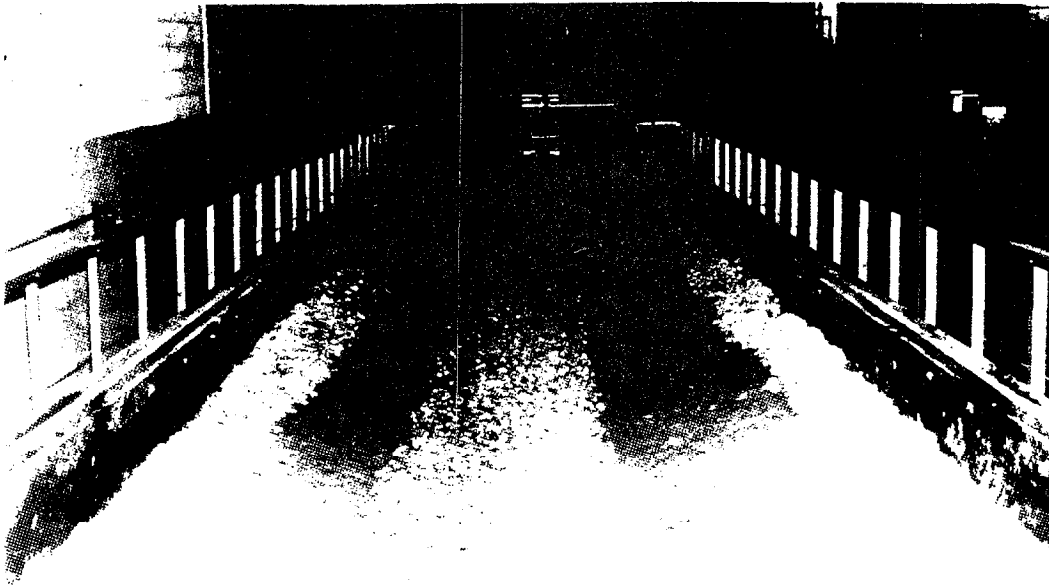
- 1) All failures were due to liner failures, not erosion failure.
- 2) The gravel appears to move down the ditch at a steady rate throughout the entire 30 minute test.
- 3) The failure at 1 percent slope had a moderate rate of failure with the gravel on the side slope of the ditch being deposited on the bottom of the ditch (figure 55).
- 4) The failure at 2 percent slope had a moderate rate of failure with the gravel at the upstream portions of the test ditch moving to the downstream portions of the ditch.
- 5) The liner failure at 3 percent slope was a rapid failure.
- 6) Erosion damage was minimal in all tests.

Figure 55.--Loose gravel after failure of liner showing the gravel on the side slopes washed out.

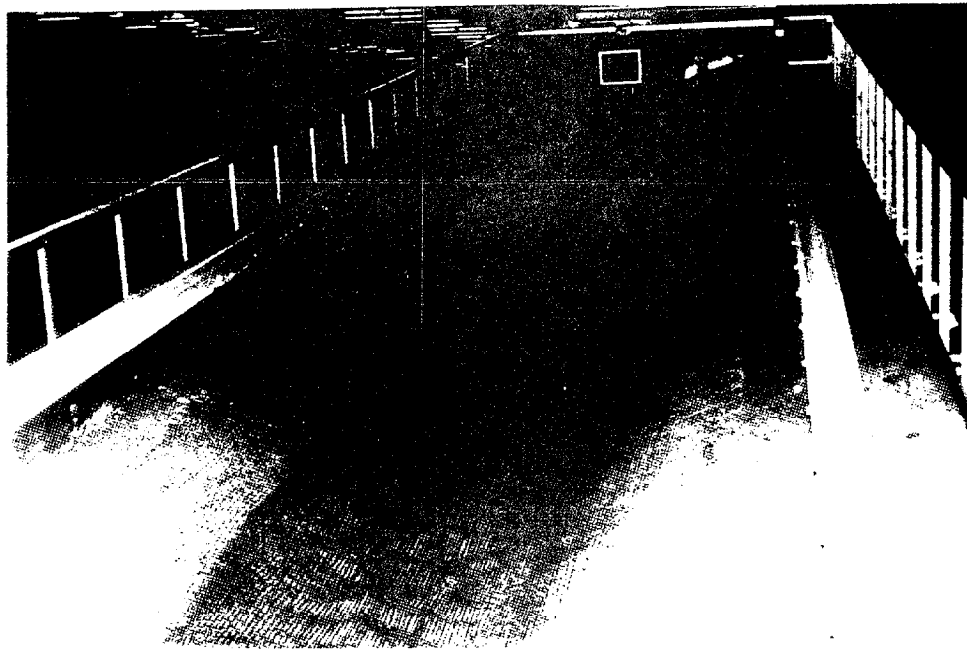
- 1) Erosion appeared to occur at a steady rate throughout the entire 30 minute test.
- 2) Erosion damage was minimal in all tests.
- 3) High water flows at high slopes appeared to unravel the jute netting between staples (figure 61).
- 4) The longitudinal jute strands appear to offer adequate protection in the areas where the liner was unraveled.

Figure 61.--Jute netting liner after testing showing the netting unraveling.

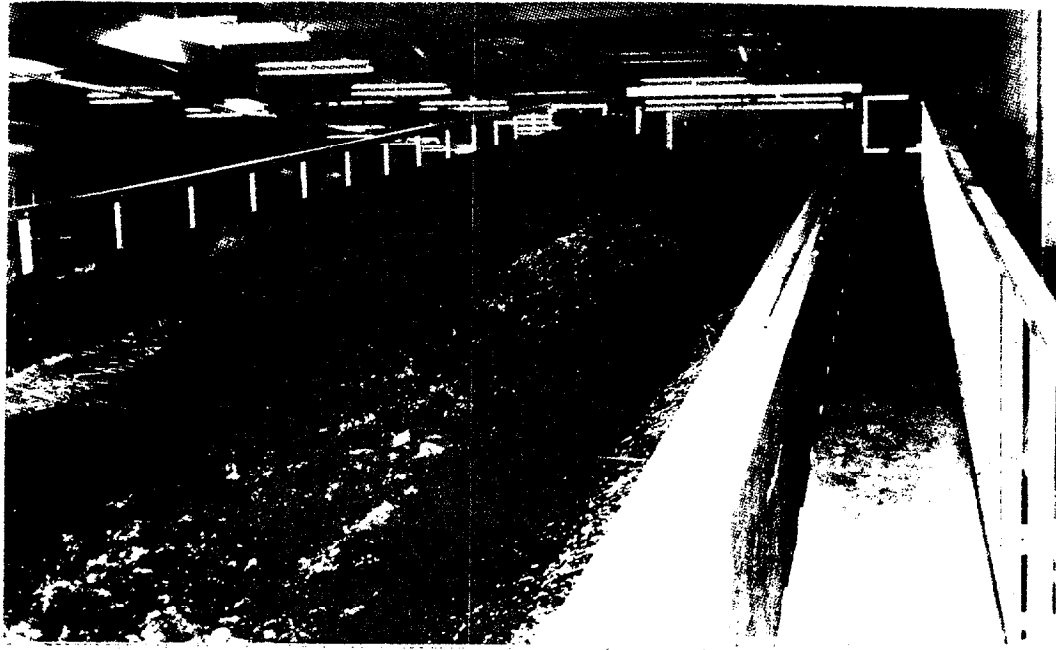
- 1) The liner had a tendency to float during all tests (figures 63 and 64).
- 2) All failures during the first set of testing were due to erosion failure.

Figure 64.--Jute netting over straw sprayed with asphalt liner during testing at high water flows also shows signs of floating along the water's edge.

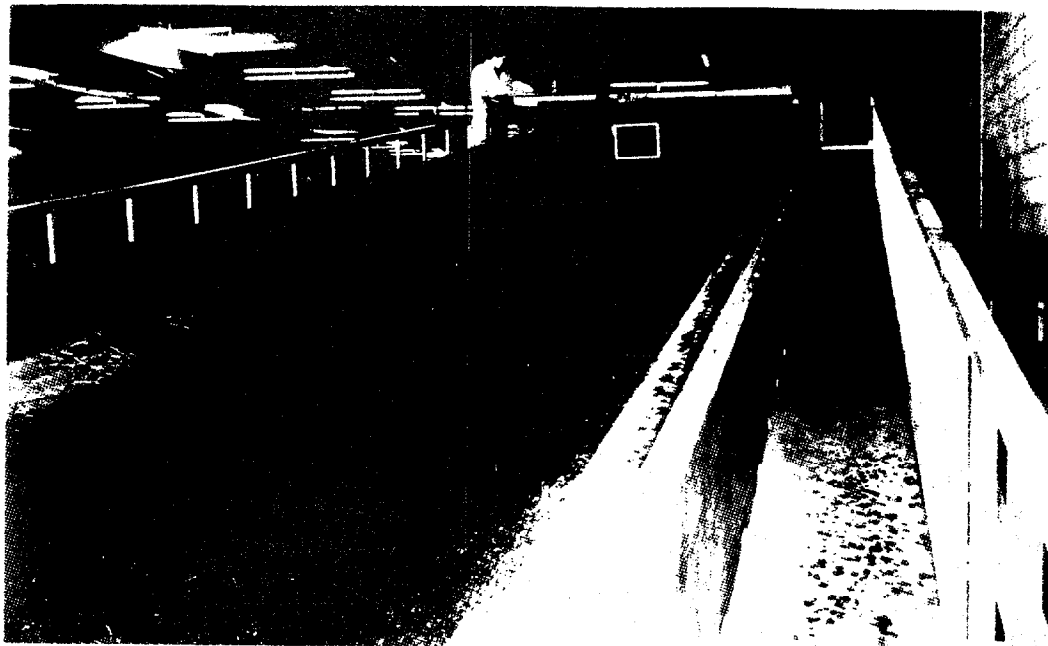
- 6) At low slopes and low flows the jute netting falls down to the ditch protecting against excessive erosion as the straw washes out from under it.
- 7) During the first set of testing, failure at 9% slope occurred at a moderate rate and at a fast rate at 11.5% slope.

Figure 65.--Jute netting over straw sprayed with asphalt liner after testing shows areas where straw has washed out from under netting (lower left).

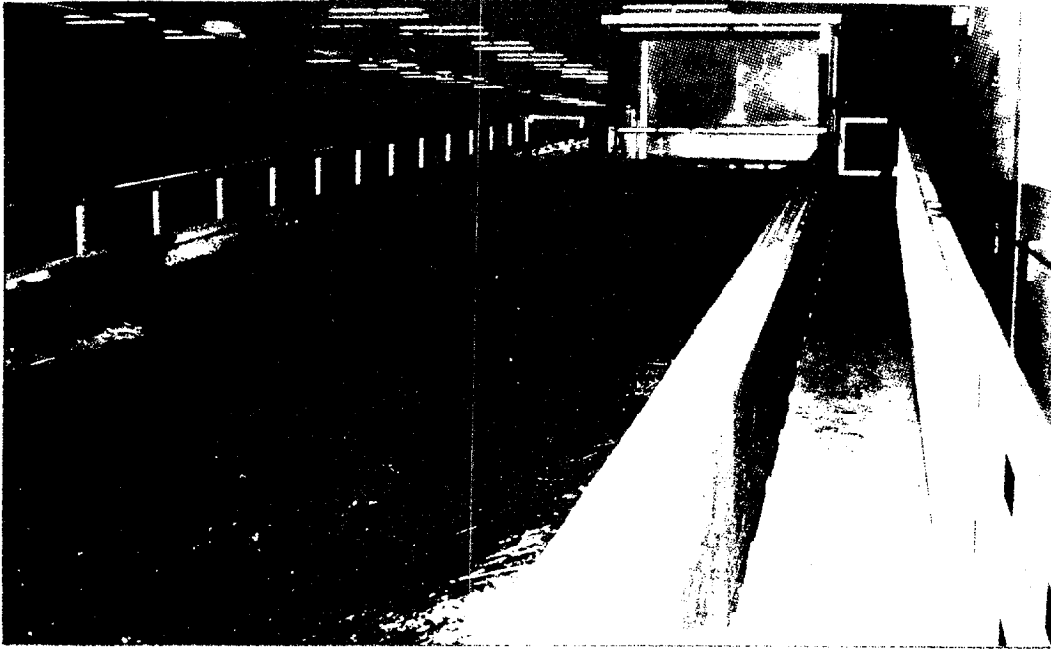
- 1) During the first set of testing, the netting was difficult to get to lie down over the straw. The netting tended to lift along the lower portions of the side slopes.
- 2) All failures were due to liner failure.
- 3) The straw floated, lifting the netting in all tests (figure 67).
- 4) The straw always moved downstream under the netting in all tests, creating bare spots between the staples in the bottom of the ditch while creating small checkdams upstream of the staples (figure 68).
- 5) Erosion damage was minimal in all tests.
- 6) Liner damage occurs at a steady rate throughout the entire duration of the test (30 minutes).
- 7) The test run at 9% slope and 0.3 foot depth (run 3/6/85) had partial liner failure (9% degradation of the liner).

Figure 67.--Amxco netting over straw sprayed with asphalt liner during testing showing liner floating along the water's edge.

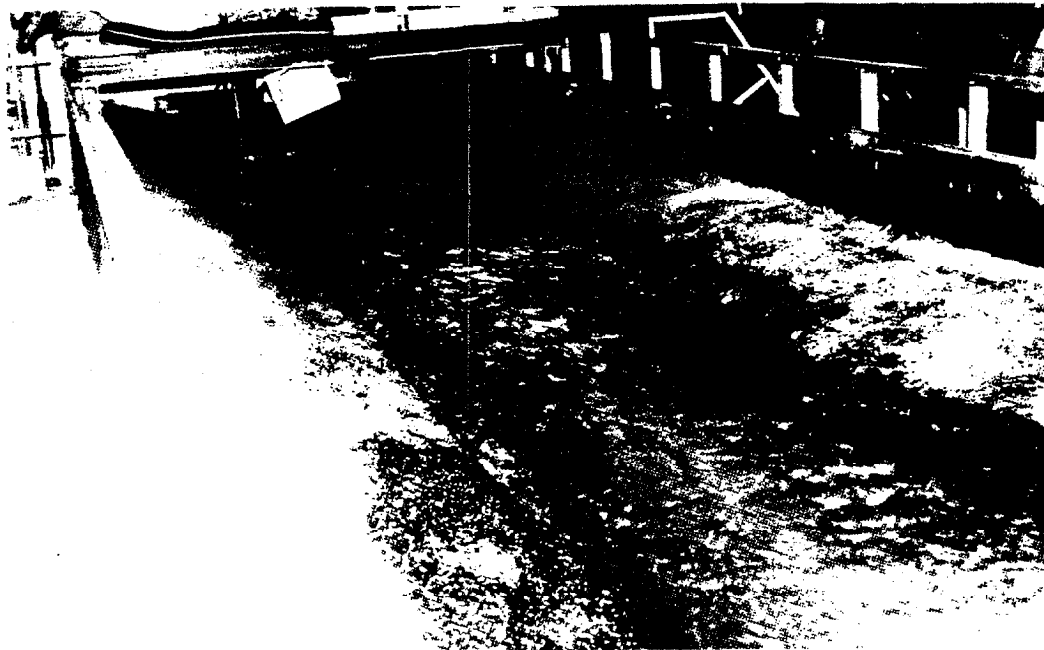
- 1) The asphalt used for the 11/84 test did not set and was easily washed out with water. A new supplier for asphalt was obtained for all following tests.
- 2) The asphalt obtained from the new supplier also showed signs of being washed out by the water flow. However, the washing out was only slight.
- 3) All failures were due to liner failure, not erosion failure.
- 4) When liner failure began, the failure was rapid, less than two to three minutes.
- 5) When the liner failed, large sections of the liner would float up and move down the ditch together (figures 70,71, and 72).

Figure 70.--Fiberglass roving, single layer, during testing 30 seconds after the lower 1/2 of the liner washed out.

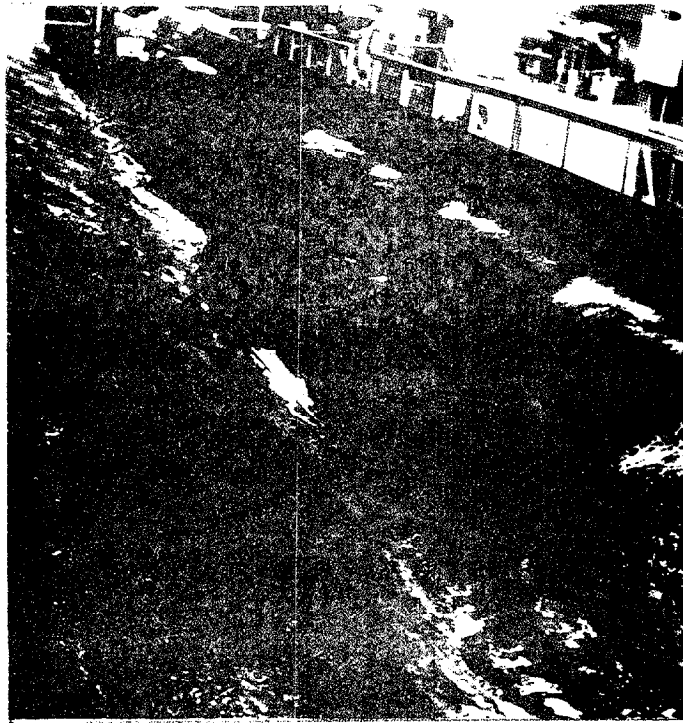
Figure 71. --Fiberglass roving, single layer, liner after testing showing lower 1/2 of test channel with the liner piled to the right of the channel after failure.

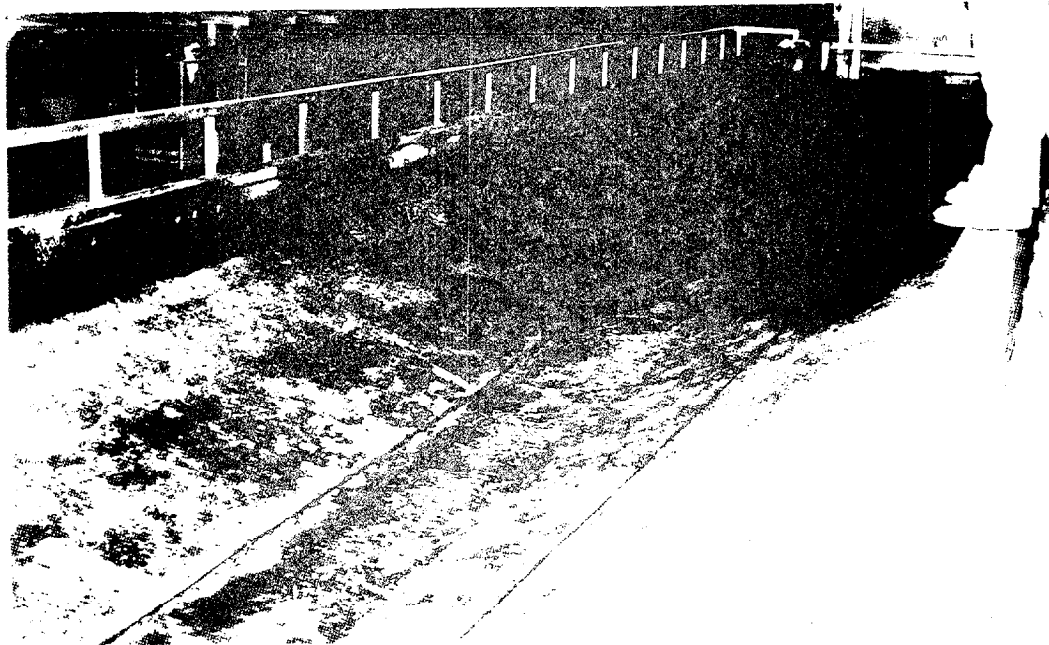
Figure 72.--Fiberglass roving, single layer, after testing showing upper 1/2 of test channel.

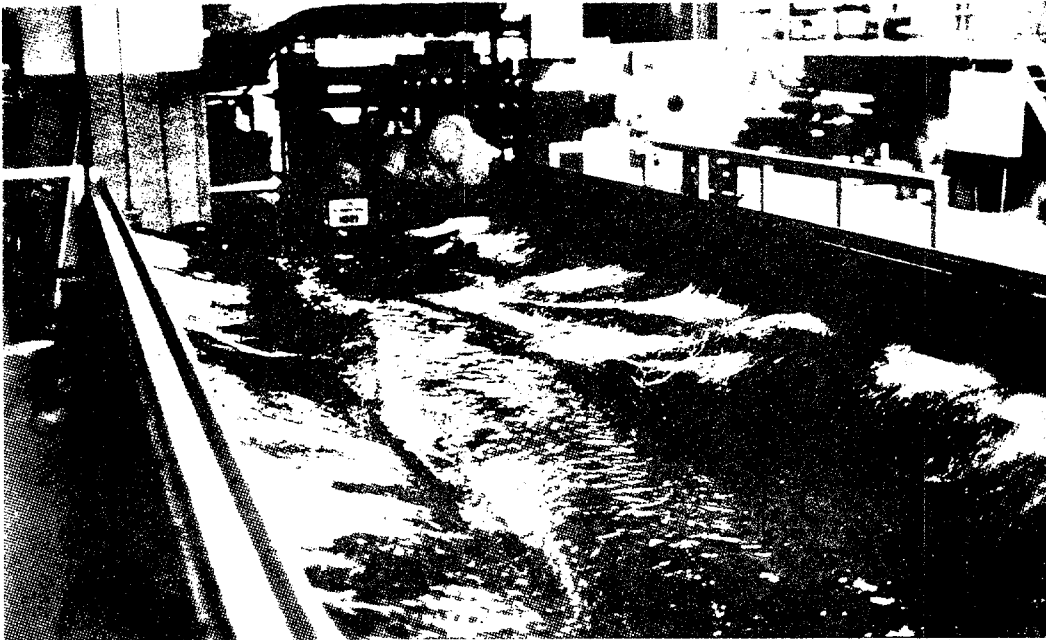
Figure 75.--Fiberglass roving, double layer, liner failing during test.
