# UNITED STATES COAST GUARD

## REPORT OF INVESTIGATION INTO THE ALLISION OF THE COSCO BUSAN WITH THE DELTA TOWER OF THE SAN FRANCISCO-OAKLAND BAY BRIDGE IN SAN FRANCISCO BAY ON NOVEMBER 7, 2007

MISLE ACTIVITY NUMBER: 3095030

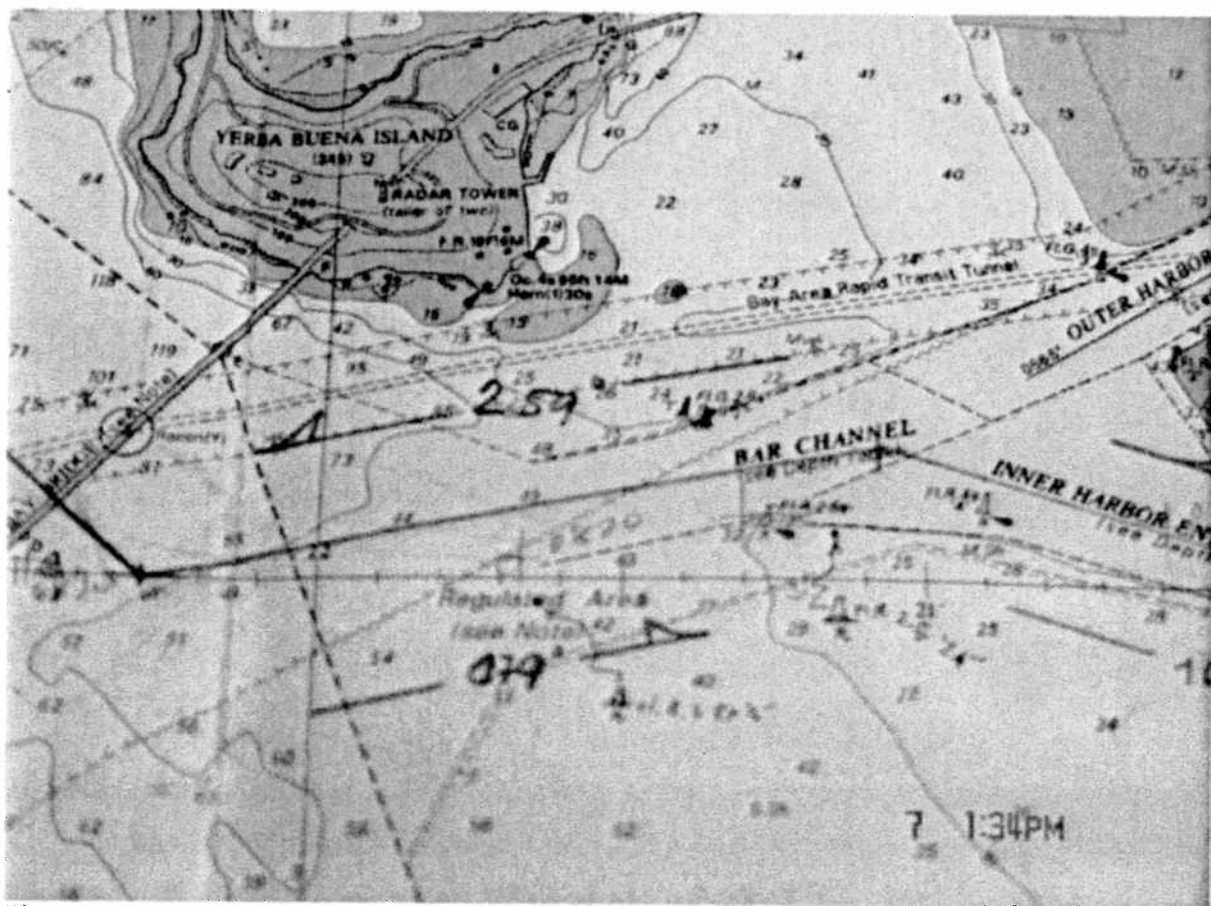
Figure 1. Coast Guard photo of the navigation chart from the M/V COSCO BUSAN. Note the "X" and "0820" (near the center of the photo) and "0830" notations, which are GPS positions plotted by the Third Officer while underway. This photo was taken before the Third Officer erased these positions after the casualty.

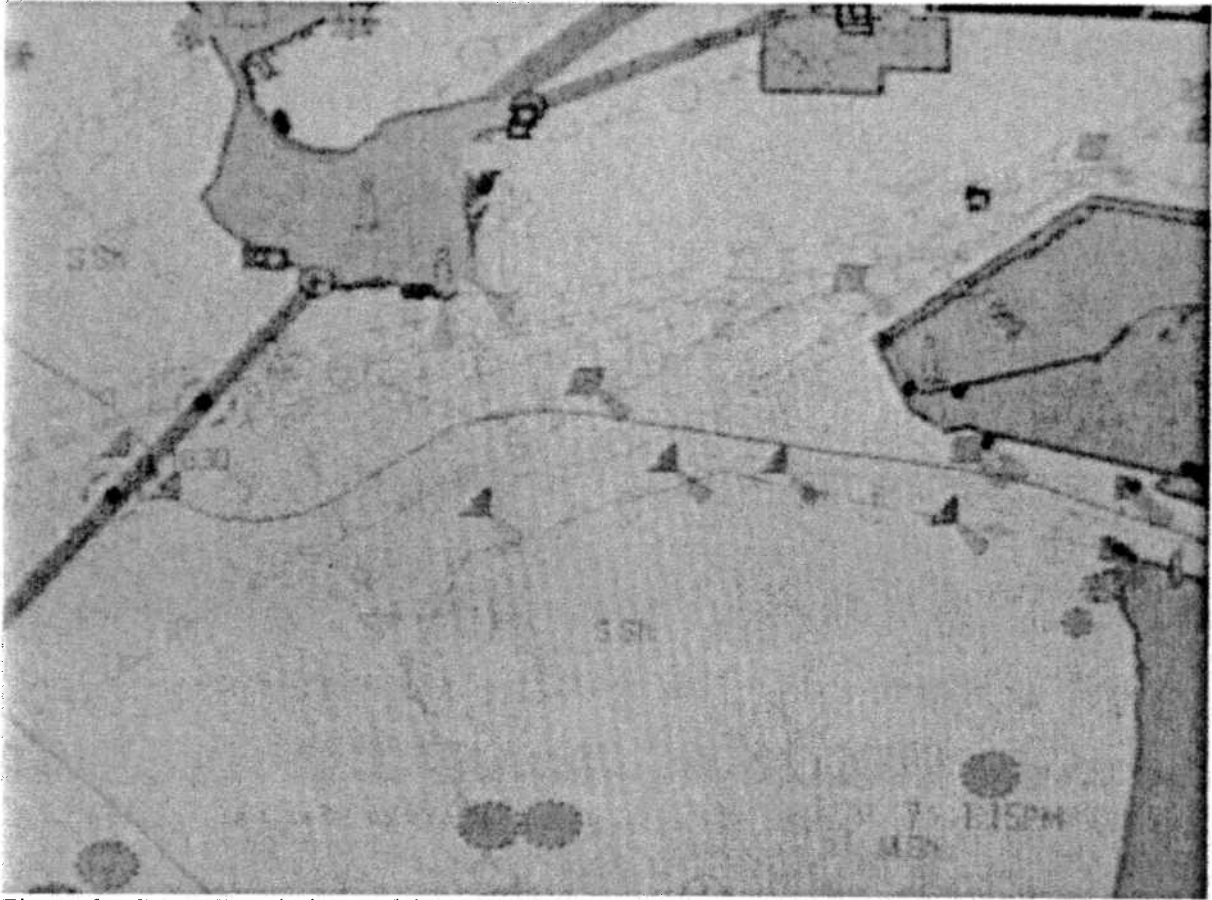
Figure 2. Coast Guard photo of the ECDIS display of the M/V COSCO BUSAN. Note the red triangle symbols with teardrops indicating lighted aids to navigation, and two red triangle symbols on either side of the Delta Tower Island, representing the buoys marking the Tower Island. The racon symbols (dark circles with magenta broken halo) on the bridge are also clearly visible. The blue trackline is the vessel's AIS course.

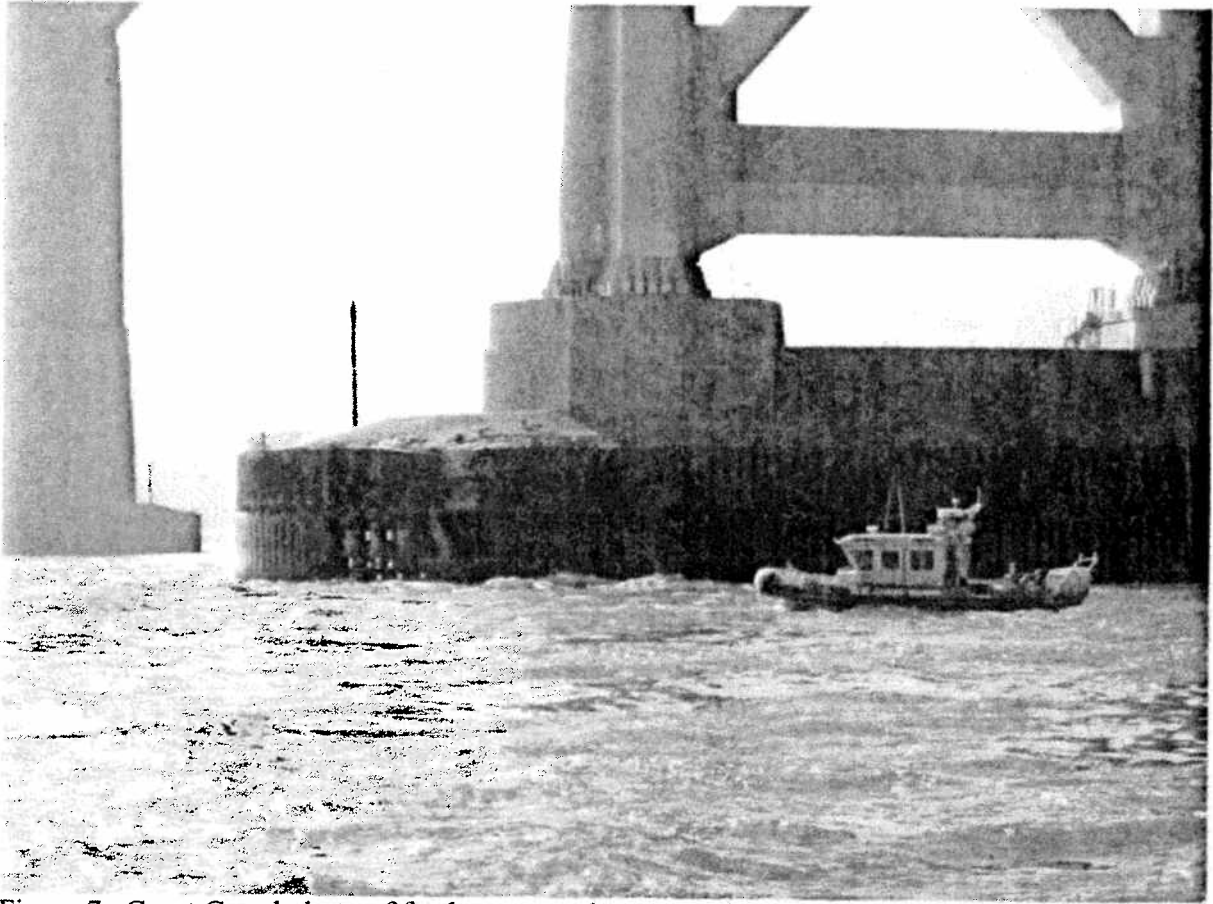
The Bay Bridge sustained damage to the wood and plastic fender system and concrete tower support (ECN 3095030 #044 [REDACTED]). Some fender material that fell into the water was recovered by the Army Corps of Engineers (ACOE), and some washed up on beaches in the days following the casualty. The bridge was inspected by the California Department of Transportation (CALTRANS) and found structurally sound. The estimate for repairs to the fender system was \$1.5 to \$2 million (See Figure 7, with additional photos located in ECN 3095030 #022 [REDACTED]).

Figure 7. Coast Guard photo of fender system damage to the Bay Bridge

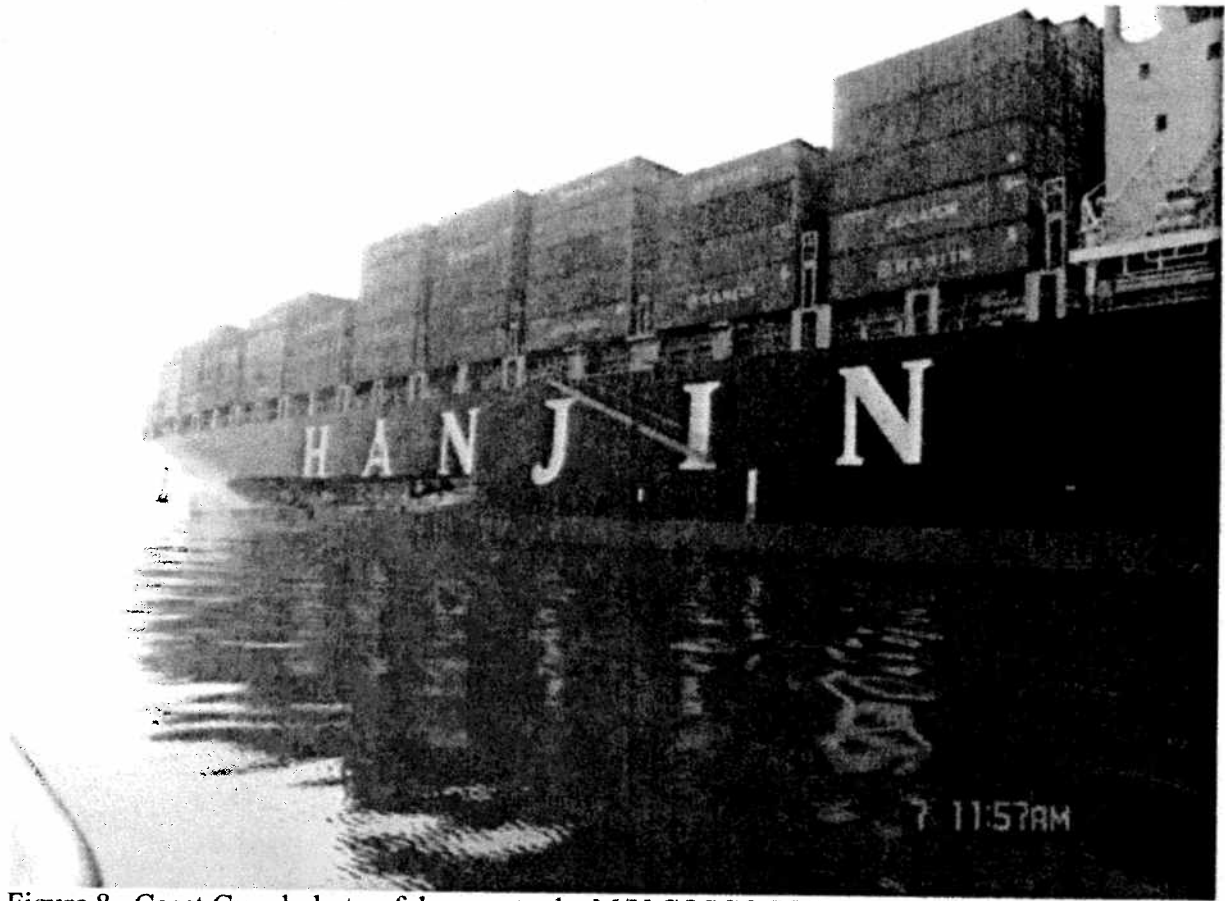
The COSCO BUSAN sustained significant structural damage to the port side shell above the waterline between frames 128 and 150. The hull was breached to a height of three meters, and inboard to the longitudinal bulkhead, which was buckled and punctured in way of cargo hold #2. All associated internals were completely destroyed (ECN 3095030 #001 [REDACTED] and ECN 3095030 #013 [REDACTED]). Temporary repairs were completed in San Francisco at an estimated cost of \$1 million (ECN 3095030 #038 [REDACTED]). Permanent repairs were completed outside the U.S., at an estimated cost of \$1.5 million (See Figure 8, with additional photos located in ECN 3095030 #023 [REDACTED]).

The side shell of the COSCO BUSAN was damaged in way of the #2 water ballast tank, #3 wing

fuel oil tank and #4 wing fuel oil tank. The fuel oil level in the #3 tank was below the lower edge of the damage, and thus it is unlikely that there was a substantial flow of oil, if any, from the #3 fuel oil tank. The #4 fuel oil tank discharged an estimated 53,653 gallons of Intermediate Fuel Oil (IFO 380) (ECN 3095030 #009 [REDACTED]). Based on calculations by the Coast Guard Marine Safety Center (MSC), the majority of the discharge occurred in a period estimated at less than 10 seconds (ECN 3095030 #009 [REDACTED]). One witness reported that a "substantial flow of oil" was pouring out of the after part of the damaged area as late as 0852 (ECN 3095030 #055 [REDACTED]).

Figure 8. Coast Guard photo of damage to the M/V COSCO BUSAN
