Electrical Safety Case Study #1

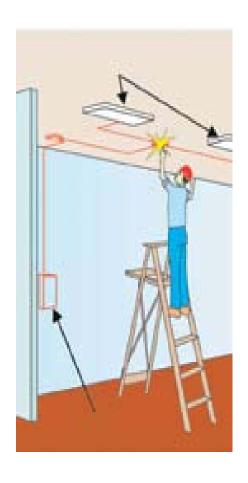
worker was attempting to correct an electrical problem involving two non-operational lamps. He examined the circuit in the area where he thought the problem was located. He had not shut off the power at the circuit breaker panel and did not test the wires to see if they were live. He was electrocuted when he grabbed the two live wires with his left hand. He collapsed to the floor and was found dead.

prevent this accident?
Describe the steps in the procedures
