**RTI Group, LLC**  
910 Bestgate Road, Suite E  
Annapolis, MD 21401  
ofc: +1 410 571 0712 | fax: +1 410 571 0713  
www.rtiForensics.com

**DOT Requested Analysis**  
**of**  
**Failed SCUBA Cylinder/Valve Assembly**

**Report Date**  
**August 29, 2012**

**RTI Matter**  
**No. 50151.ME002**

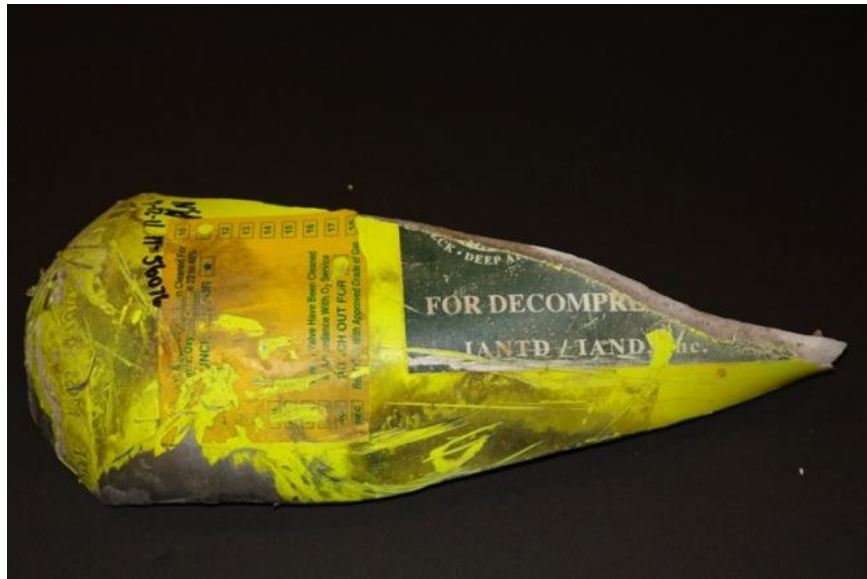
The smaller fragment from the cylinder measured approximately 30 cm by 15 cm, and is seen in **Figure 1**. This fragment contained a portion of the upper part of the cylinder proximate to the threaded opening. The fragment was clearly fractured by a catastrophic overload failure. In the portion near the cylinder opening, the fracture transitioned into a melted/eroded area where the material appeared to have eroded or “flowed” from the interior surface of the cylinder. The erosion was most extensive at the fracture where the cylinder wall was very thin, almost terminating into a sharp edge, with increasing thickness towards the non-eroded area. The flow patterns suggest that the eroded material flowed out of the crack formed in the cylinder wall, as well as out of the valve opening. The remaining cylinder interior surface was otherwise unremarkable. The curvature of the fragment was measured using a spherometer, and resulted in a reading of up to 200 mm near a portion of the interior fracture surface, compared to the original radius of curvature of 57 mm.

Figure 1. Smaller portion of high pressure gas cylinder

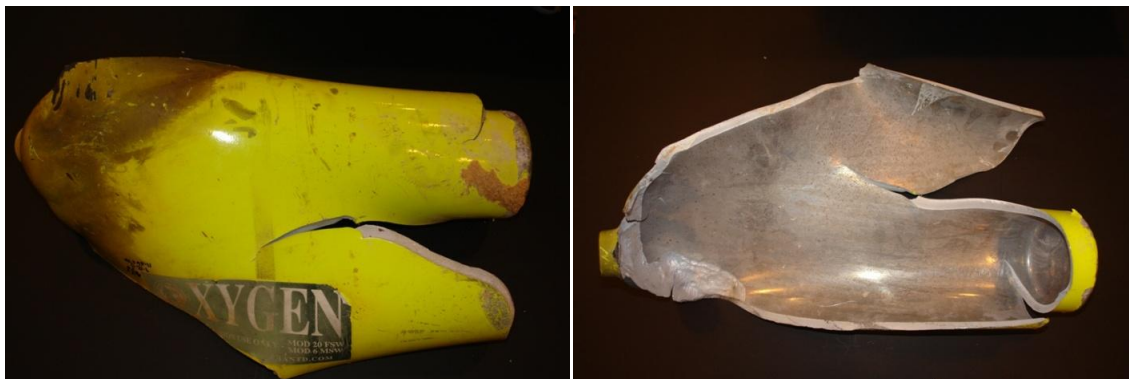
The larger fragment of the high pressure gas cylinder, seen in **Figure 4**, contained the bottom, neck, and valve opening portions.

Figure 4. Larger portion of high pressure gas cylinder

A similar erosion pattern to that found on the smaller fragment was seen near the opening at the top. Facing the interior surface with the opening up, the inside surface to the left of the opening had significant erosion extending about 20 cm below the top before transitioning to a fracture. The threads in the opening were clearly stripped with only part of the thread root visible. The pattern of erosion within the opening was uneven in depth and texture, and was different around the opening compared to along the cylinder side towards the fractures. The opening had a stippled texture whereas the areas away from the opening had distinct flow lines with perpendicular waves.

The exterior surface exhibited evidence of heat effects and darkened coloration near the cylinder top. The normally yellow paint is discolored to brown, with black material (soot) found on some of the fracture surface.

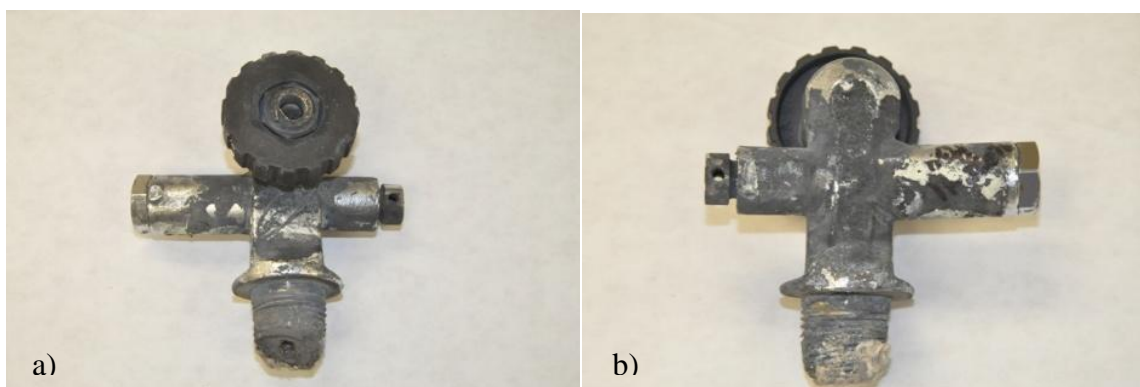
A label stamped into the body indicated the incident cylinder valve was manufactured by Genesis and contained a 32.6 MPa (5000 psi, 30 lb/hr) CG-1 type rupture disk. A pressure regulator adaptor was present in the opening containing a fractured outlet. A metal particle filter was evident in the opening. The rubber hand valve closure knob was present, but separated from the valve, as seen in **Figure 5**.

Figure 5. View of cylinder valve, a) front, b) back

As shown in **Figure 5**, the incident valve was received with several parts missing from the valve including the locking nut; the rubber valve handle (present but damaged and no longer attached); the threaded and square segment of the valve stem to which the handle attaches (this appeared to have separated from the main body of the valve stem leaving a square fracture surface); the dip tube; and a significant portion of the cylinder neck opening threads. The entire exterior of the incident valve and its installed components appeared charred and roughened compared to the exemplar valve.

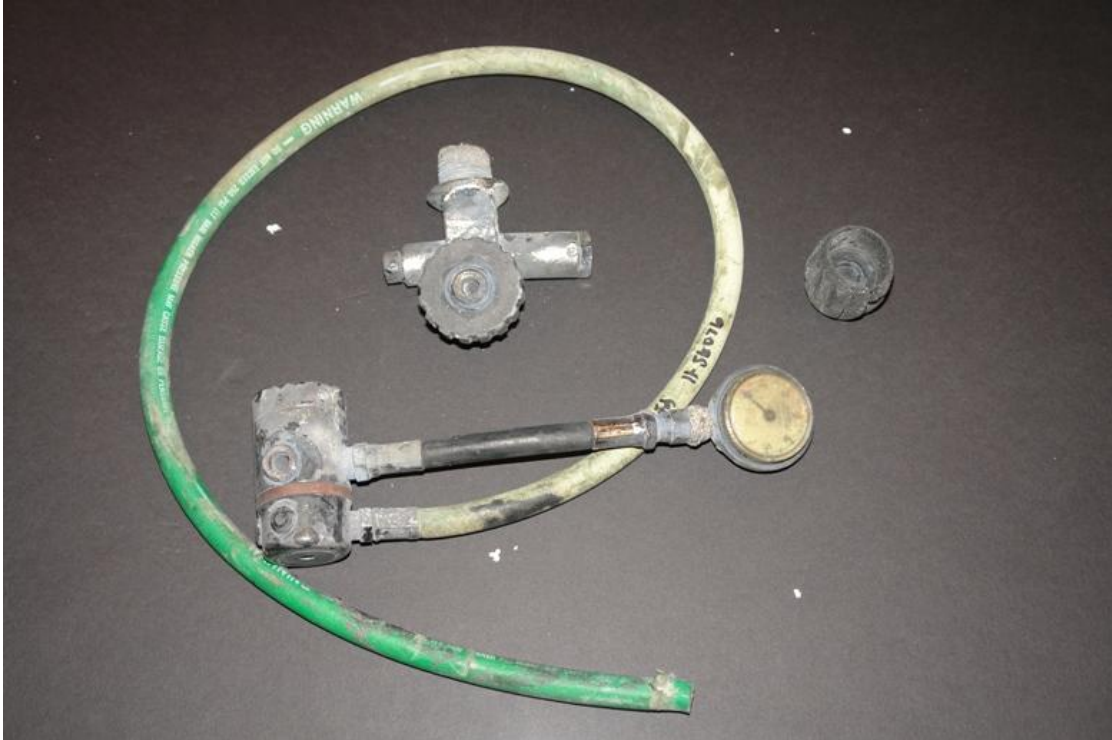
The incident pressure regulator was manufactured by Dive Rite, serial number 12008135. The high pressure inlet opening was occupied by the fractured end of the pressure regulator adaptor, see **Figure 6**. Attached to the regulator were:

Figure 6. Cylinder valve, cylinder valve adapter, regulator and regulator assembly.

The green line was discolored (lightened to yellow white) proximate to the regulator, indicating possible exposure to high heat. There were no indications of melting or combustion. The distal portion of the outlet line was bright green and terminated without the anticipated second stage regulator.

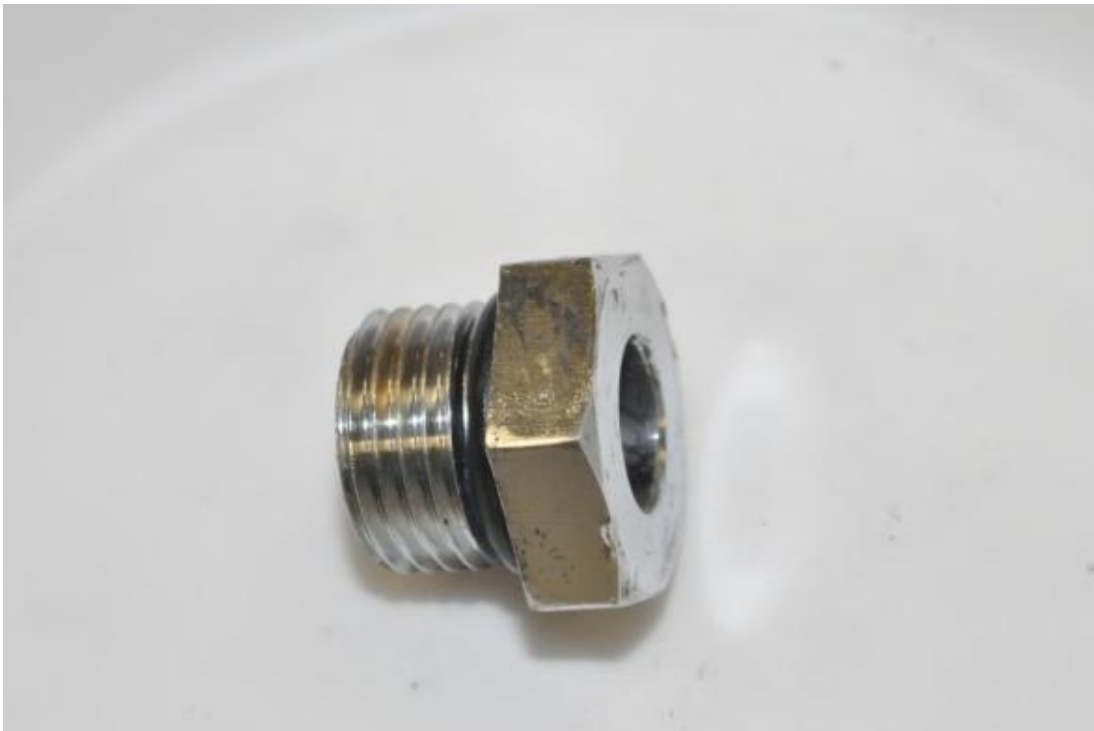
RTI began the disassembly process of the incident valve by removing the gland nut, shown in **Figure 15**, with a torque wrench fitted with an appropriately sized socket in order to measure the installation torque. The gland nut was found to be threaded into the valve body approximately finger tight as measurements showed zero installation torque. The nut made four and one sixth turns before clearing the valve body. An intact O-ring similar to that found in the exemplar remained in its intended position on the gland nut.

Figure 15. View of the incident cylinder valve gland nut showing the presence of the intact O-ring.

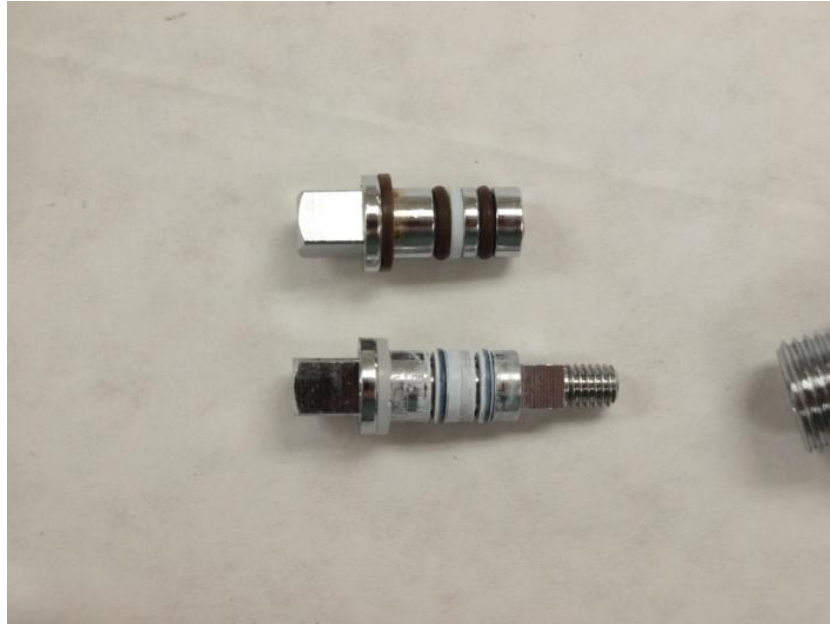
Removal of the gland nut allowed access to the valve stem and the valve seat body. As shown in **Figure 16**, the incident valve stem was very similar in appearance to the exemplar although one of the bushings was different in color. Compared to the exemplar valve seat body in **Figure 17**, the incident valve seat body displayed a different color coating. The incident valve seat was also coated with some material, but with a green color. All portions of the incident gland nut, the

stem, the valve seat body, the plastic valve seat, and the interior of the valve stem portion of the valve body were further notable in that they were free of any apparent damage, heat effects, or discoloration as might be expected to result from fire or explosion.

Figure 16. View of the incident valve stem (top) as compared to the exemplar valve stem.

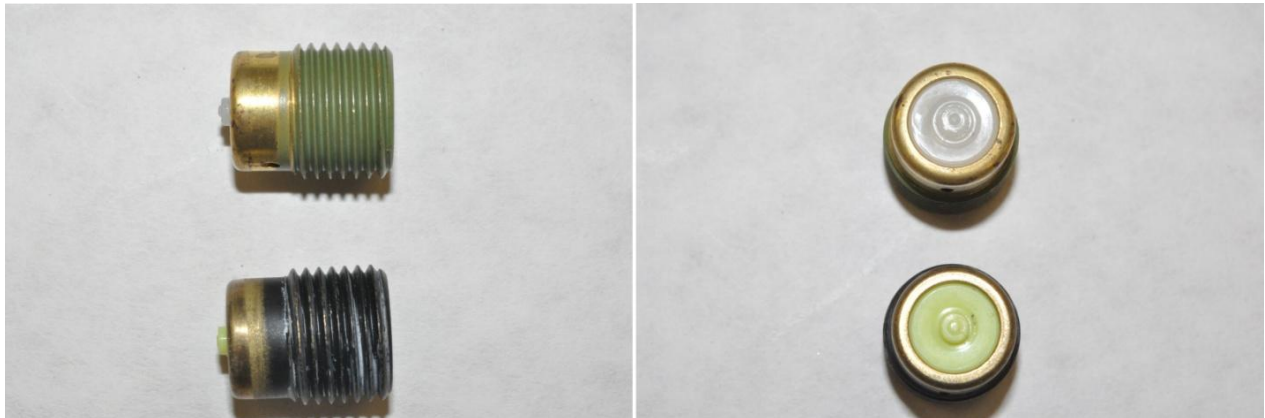
Figure 17. View of the incident valve seat body (green with white valve seat, upper) as compared to the exemplar valve seat body (black with yellow valve seat, lower).

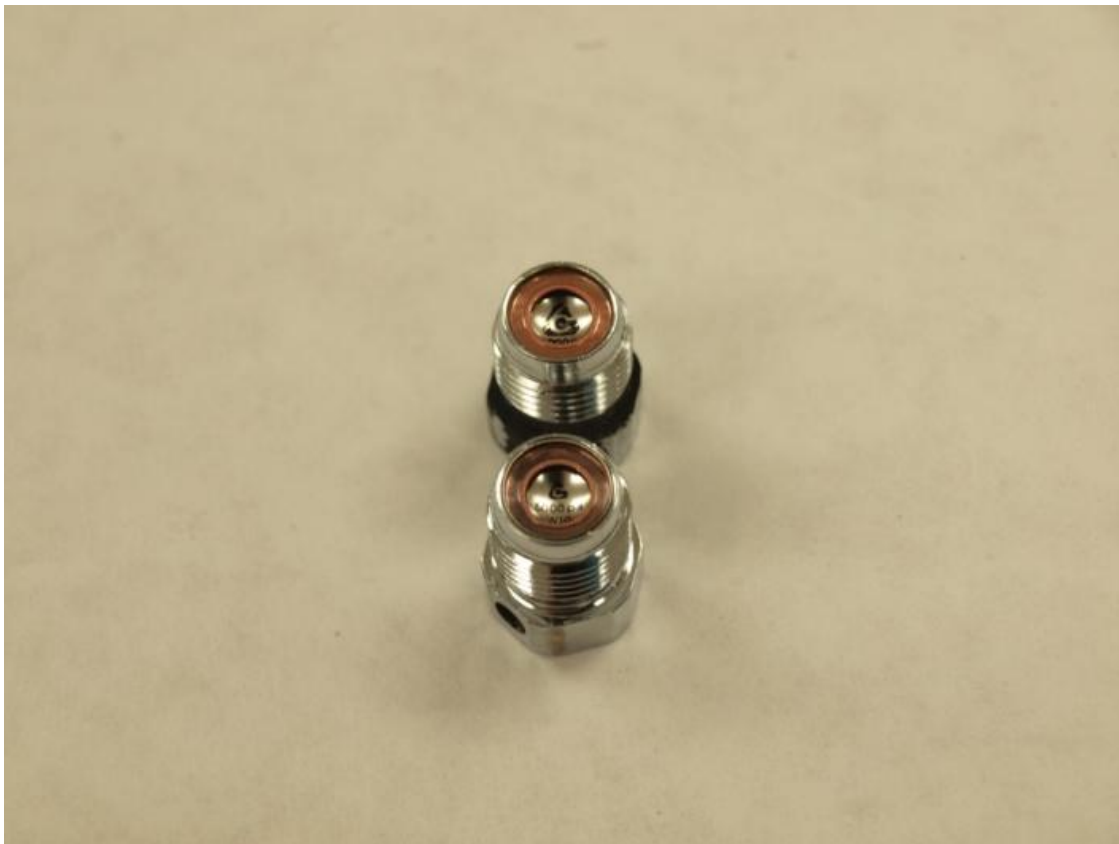
RTI next removed the burst disk assembly of the incident valve. Compared to the gland nut, the burst disk assembly appeared tightly fit into the valve body. The installation torque was measured to be 10.17 N-m (90 in-lb). It took 5  $\frac{3}{4}$  turns to remove the assembly. While the exterior exposed surfaces of the plug had the same charred and damaged appearance as the rest of the incident valve, the interior surfaces were clean and bright and the burst disk was intact, see **Figure 18**. Correspondingly, the interior surfaces of the valve body in the area of the burst disk also proved to be clean and bright.

Figure 18. View of the incident burst disk assembly (upper) as compared to the exemplar burst disk assembly (lower).

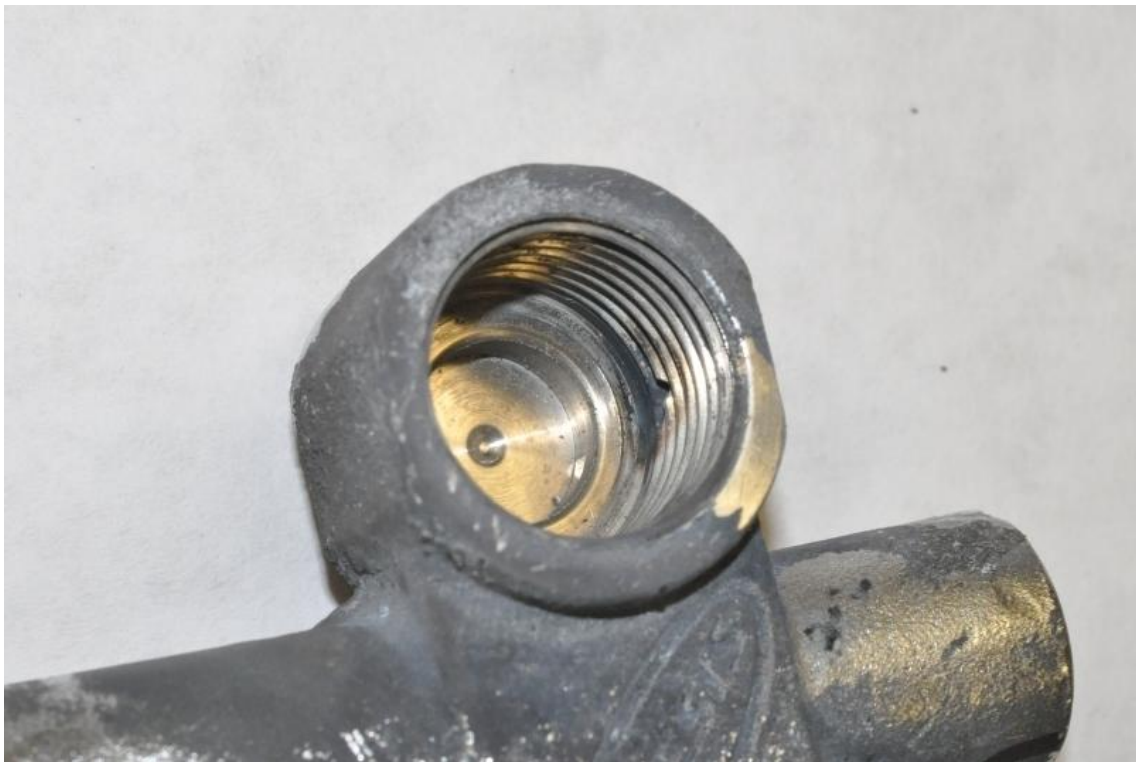
the valve regulator port. This adapter included a plastic handle used for tightening into the regulator port, which remained intact. As seen in **Figure 5**, the adapter broke such that the handle remained attached to the valve but the portion that threads into the regulator remained with the regulator. Simply turning the handle allowed the adapter fragment to be removed from the valve. Some soot was observed on the interior surfaces of the regulator port and the adapter fragment. Inside the regulator port, charring was seen extensively around the vent and along the bottom thread. Soot-like discoloration was observed extending into the port from the charring near the center. Otherwise, the interior of the regulator port was clean and bright, see **Figure 19**.

Figure 19. View of the incident valve high pressure regulator port showing discoloration sooting around the vent.

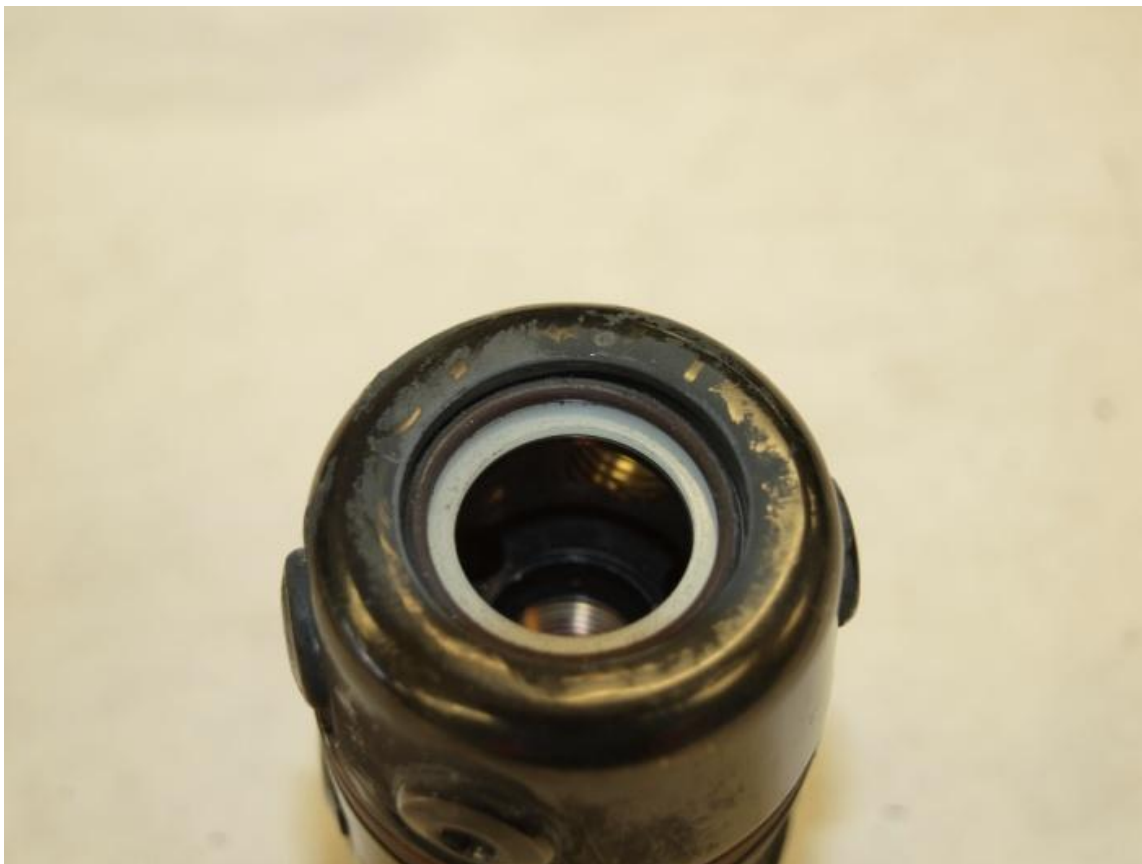
Figure 22. View into the low pressure portion of the incident regulator showing the O-ring and washer.

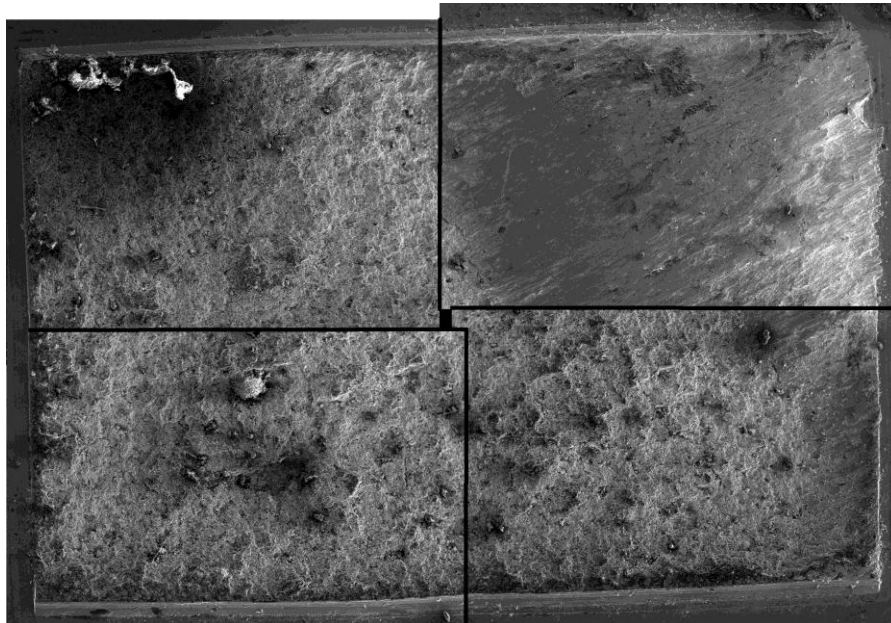
**Figure 23** is a composite view of the four corners of the fracture surface on the incident valve stem. It is notable that the majority of the fracture surface from the left edge proceeding to the right has the appearance of a ductile tensile fracture. A small remaining area along the right edge, conversely, has the appearance of a shear failure. Otherwise there is nothing remarkable about the fracture surface. EDS of the fracture surface measured high levels of copper and zinc, indicating that the valve stem was manufactured from a brass alloy.

Figure 23. Composite SEM micrograph of incident valve stem fracture surface.

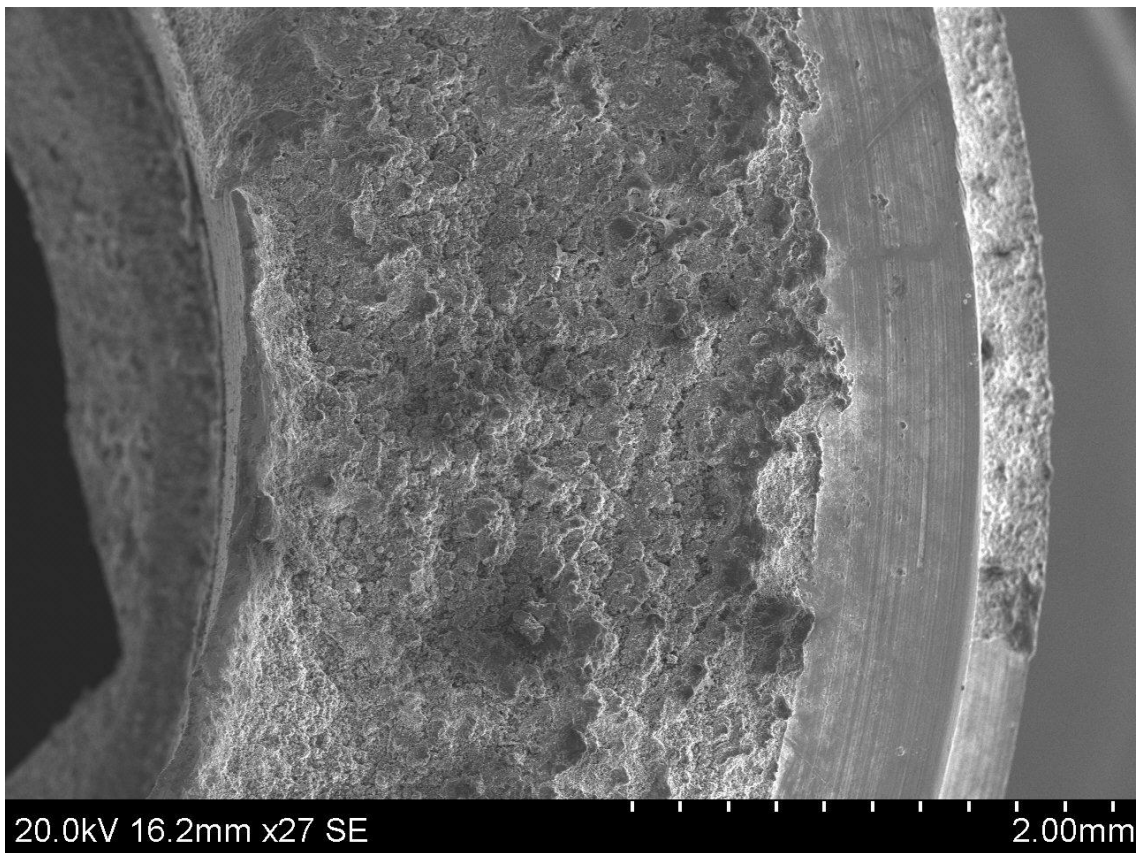
**Figure 24** shows the fracture surface present on the pressure regulator adapter. As the exposed surfaces of the adapter, including the fracture surface, were covered in soot, the exact fracture morphology is not immediately apparent. Further compounding the characterization are areas that have the appearance of being mashed, or damaged, post fracture. These areas are also heavily sooted. Although there was a layer of soot on the adapter, EDS was able to measure high levels of copper and zinc which indicated that it was manufactured from a brass alloy.

Figure 24. SEM micrograph of pressure regulator adapter fracture surface.

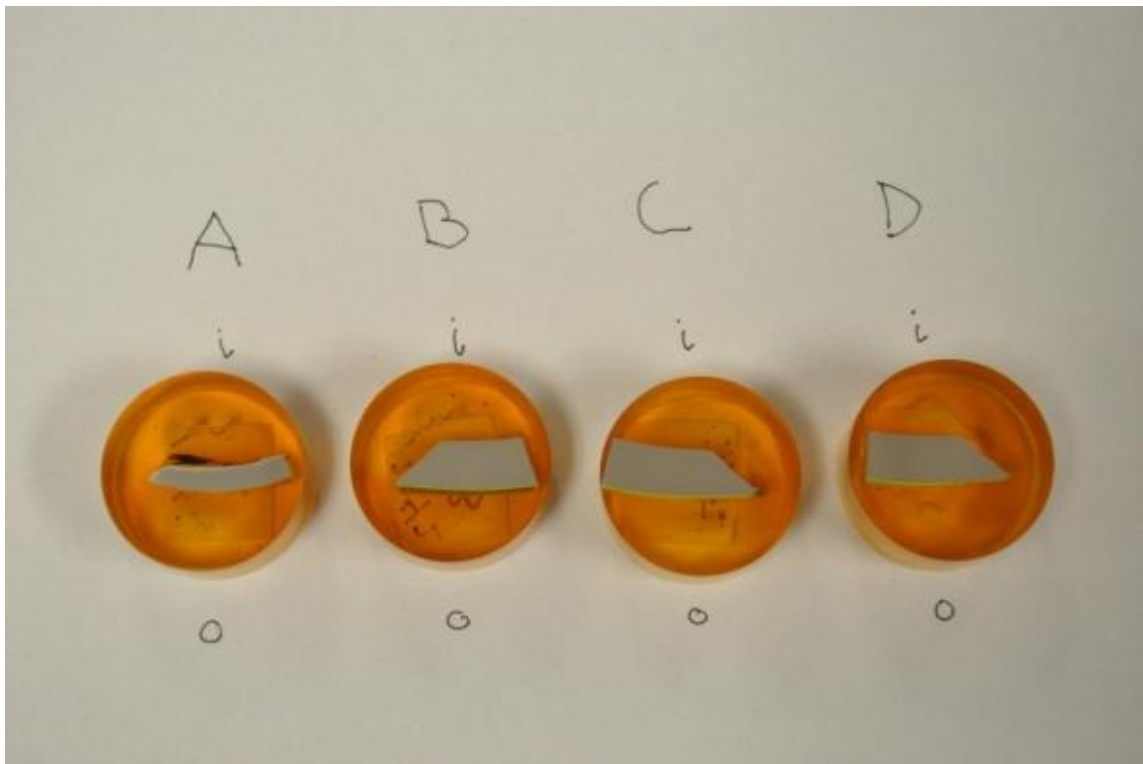
Samples A through D, as seen in **Figure 31**, were mounted and polished for metallographic examination. A weak hydrofluoric solution was used as an etchant to reveal the grain structure. The specimens were examined optically using a metallograph and images captured from various regions of all four samples. **Figure 32** and **Figure 33** show representative micrographs of samples A and D. Micrographs from all the samples were compared to a representative micrograph of 6061-T6 published in “Introduction to Aluminum Alloys and Tempers”.<sup>7</sup> The microstructures compare favorably, confirming that the incident cylinder was manufactured from 6061-T6.

Figure 31. View of the four metallography/microhardness specimens prior to hardness testing. The “i” and “o” notations indicate the inner and outer surfaces, respectively.

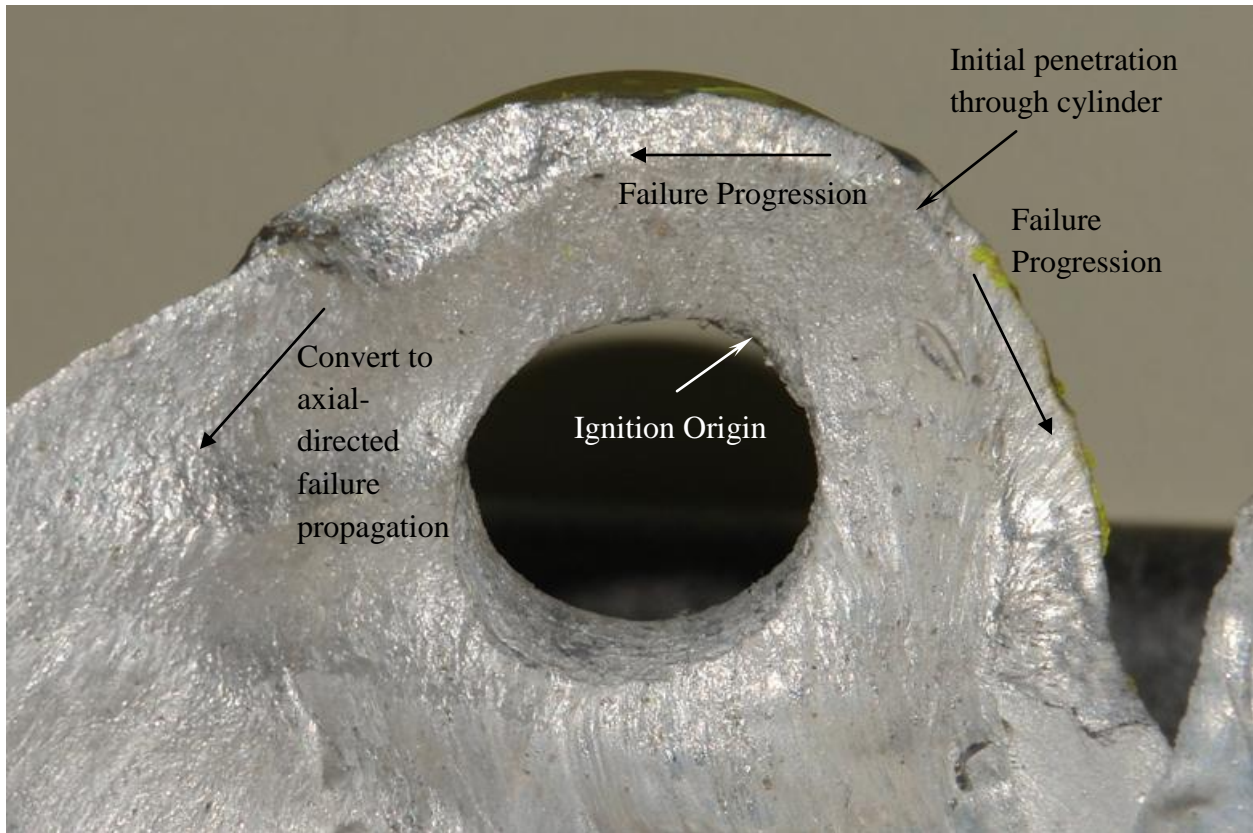
The explosion has been determined to have been caused by the ignition of aluminum cylinder material and originated between the threads of the cylinder valve and the cylinder neck opening. Analysis of the cylinder dimensions and materials revealed that the cylinder was made from a material consistent with aluminum 6061-T6, and the wall thickness was appropriate. Laboratory testing failed to reveal the presence of contaminants or oxygen incompatible materials that may have auto-ignited. The resulting ignition promoted the growth and spread of further combustion of cylinder wall material. The combustion of aluminum occurred and was restricted to the inside surface of the cylinder. The heat generated was sufficient to locally soften the cylinder wall, as demonstrated by the over-aged condition of metallographic specimen “A”. The combustion also reduced the wall thickness. Additionally, the heat of combustion was released into the compressed gas, causing the gas pressure to rise. The combination of weakening the cylinder wall from heat of combustion, thinning due to the combustion of the cylinder material, and the increase in gas pressure from the release of heat from combustion, caused the cylinder to rupture and explosively release its contents.

The magnitude of aluminum material eroded from the event is greatest in the threaded neck opening region, indicative of the region of most intense and/or the longest burning. The initial fracture of the cylinder occurred along the base of the threaded opening, or “neck,” proximate to the ignition origin and began to grow along the perimeter of the opening base, until realigning along the cylinder axis and growing down towards the cylinder base, as indicated in **Figure 34**. Some of the fracture surfaces were either melted or covered by melted aluminum that re-solidified, but this could also be the result of the cylinder striking a hard surface which caused the cylinder to break up.

Figure 34. View showing the threaded neck opening region of the incident cylinder from the interior.

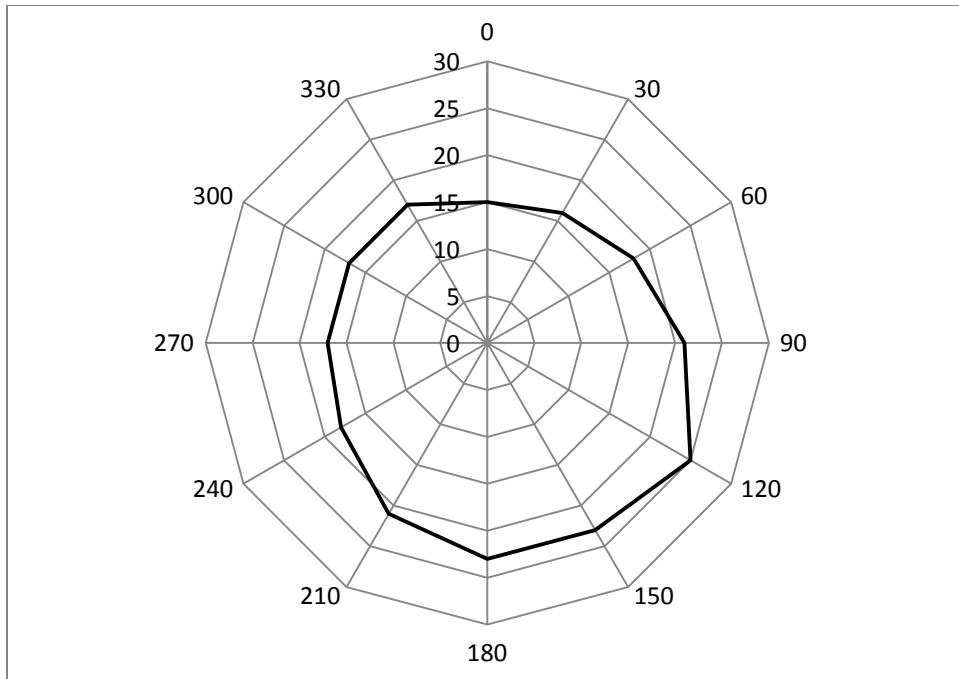
To evaluate the pattern of erosion about the cylinder opening, the depth of the threaded neck opening was measured at 30° intervals from the flat exterior top to the point where erosion seemed to stop along the threaded wall. The resulting measurements are shown in **Figure 35** in the radial diagram. The deepest erosion was set as the 0° point. The least erosion appears to have occurred at the 120°. The 120° region happened to be the area where the combustion deviated away from the opening and began to travel down the side of the cylinder interior, also being the direction where the hoop stress dominates the pattern of crack growth.

Figure 35. Depth measurements of the threaded neck cylinder opening, in mm.

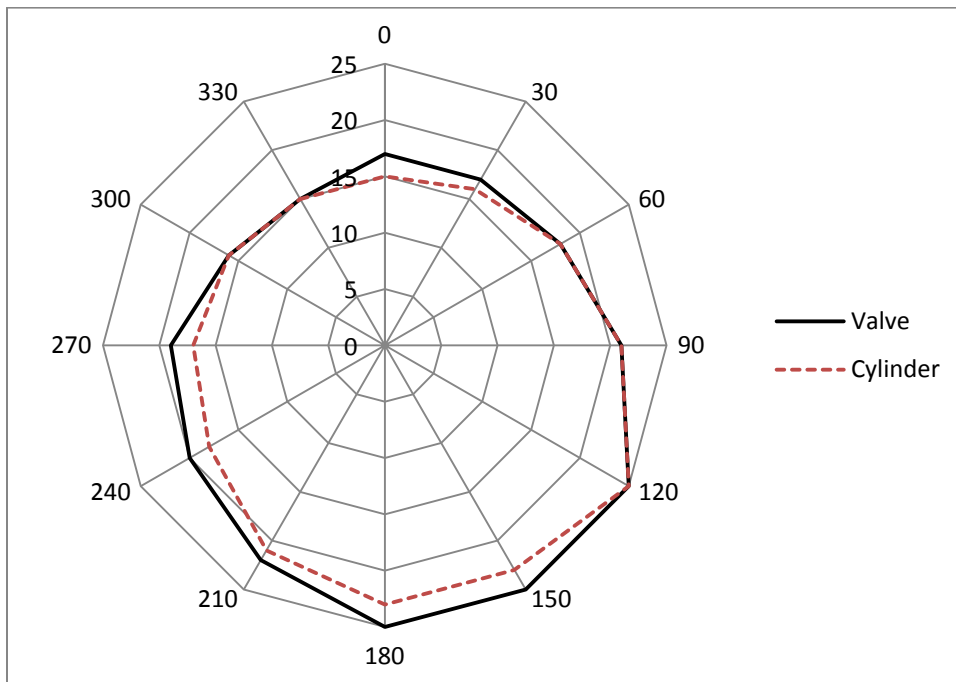
The cylinder valve base also exhibits a matching pattern of erosion consistent with combustion from ignited aluminum, and alloying<sup>8</sup> from flowing molten aluminum, all originating from the threaded region within the threaded neck cylinder opening, as seen in **Figure 36**. There is a region along the perimeter that exhibits fracture as well as melting and reaction. The gross erosion was angled to the axial normal, indicating that once ignited, the products of combustion were expelled downward into the cylinder. The damage pattern suggests the initial ignition and resultant kindling to promoted ignition occurred within the threads closest to the edge of where the threaded neck cylinder opening bottom and cylinder valve threads meet.

Figure 38. Comparison of measured depths, in mm. Valve depth is rotated  $-60^\circ$  to match.

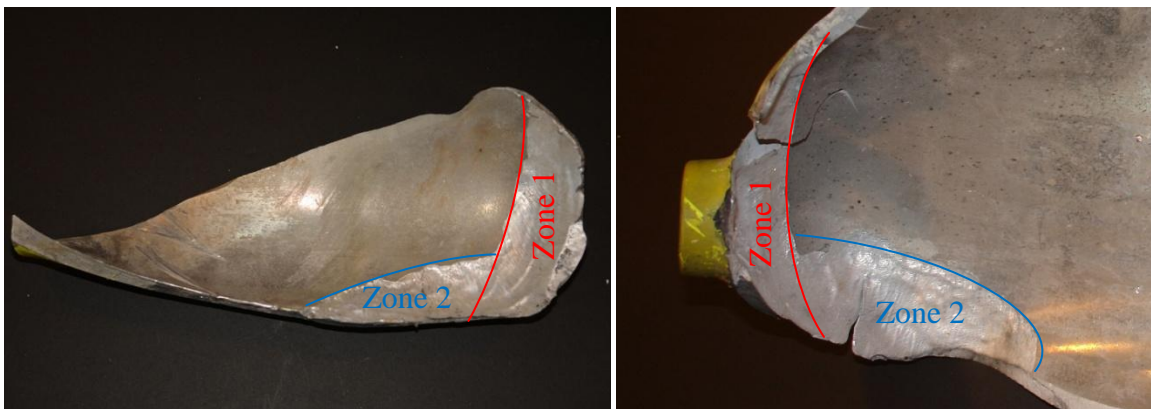
The burn pattern within the cylinder had two distinct burn zones as seen in **Figure 39**. Zone 1 matched the hemispherical geometry of the domed cylinder top with a demarcation line of between 4 cm and 5 cm from the opening center. Zone 2 extended vertically down the cylinder wall about 20 cm from the opening, and having a width of about 11 cm. A fracture divided the second burn zone, indicating this region was the area from which the crack propagated after initiating at the base of the “neck.” The area in Zone 1 was due to a circumferential combustion progressing from the origin point. The burn pattern in Zone 2 is a directional effect due to gravity as the cylinder may have been on its side. Despite the fracture starting at the base of the “neck,” the weakened area of Zone 2 influenced the crack to propagate in that direction as the hoop stress from internal pressure was greater in this area.

Figure 39. View of interior surface showing the two distinct burn zones.

As the aluminum was consumed, the local wall thickness was reduced; the heat weakened the aluminum; and the internal gas pressure increased from the heat energy produced by the combustion. The reaction was likely to have been more of a burning rather than explosive process. Due to this combustion process the cylinder failed at a pressure less than 38 MPa (5,500 psi)<sup>9</sup> as the pressure relieving burst disk in the cylinder valve was still intact after the explosion.

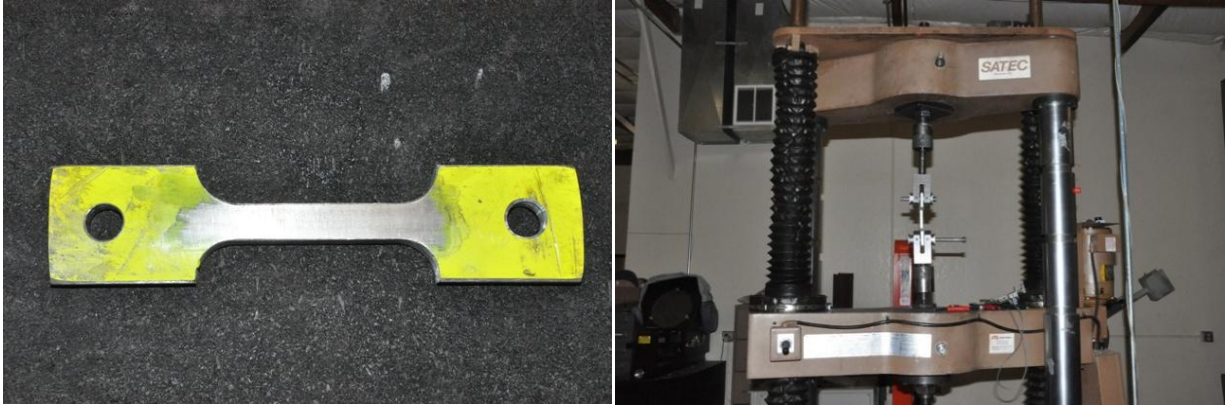
The requirements for a 3AL cylinder are found in Title 49 of the Code of Federal Regulations, part 178.46. The regulation dictates the cylinder material is to be similar to aluminum alloy 6061 with a T6 heat treatment with the mechanical properties having a minimum yield strength of 241 MPa (35,000 psi), a minimum tensile strength of 262 MPa (38,000 psi), and a minimum elongation of 14%. A sample of the cylinder was removed for tensile testing and compression testing. The sample was machined from the wall section having as much of the original curvature as possible to minimize the effects of work hardening from the accident. The specimen, seen in **Figure 40**, measured 12.93 mm (0.509 in) wide by 9.68 mm (0.381 in) thick by 131.75 mm (5.187 in) long. The testing performed in this investigation revealed that the cylinder material had a yield strength of 318 MPa (46,100 psi), a tensile strength of 354 MPa (51,400 psi), and an elongation of 15% – exceeding the minimum requirements of the regulation.

Figure 40. Tensile test specimen and tensile test.
