**National Transportation Safety Board**  
Washington, D.C. 20594

**Aircraft Accident Brief**

**Accident Number:** LAX01MA272  
**Aircraft and Registration:** Eurocopter AS350-B2, N169PA  
**Location:** Meadview, Arizona  
**Date:** August 10, 2001  
**Adopted On:** June 3, 2004

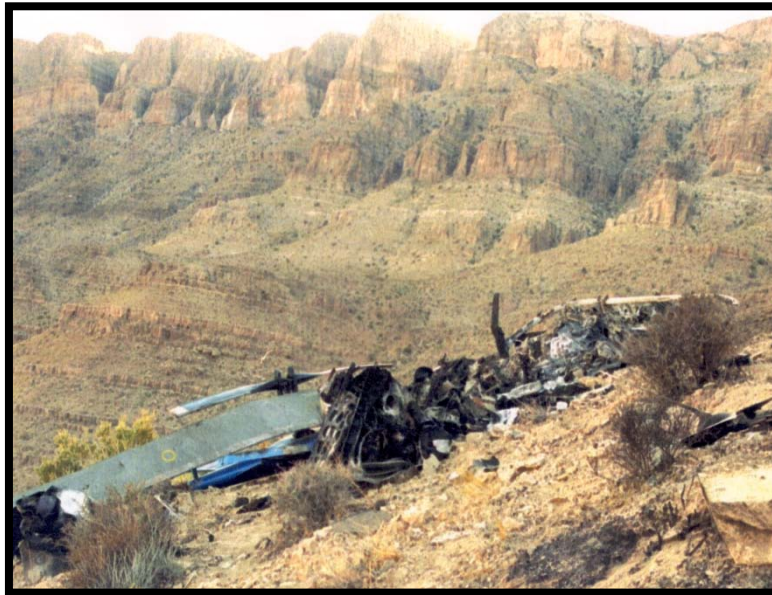
**Figure 3.** Profile view of the accident site. Note downsloping terrain.

The accident site was located at an elevation of 4,041 feet msl. The average elevation of the top of the mesa formed by Grand Wash Cliffs is about 5,500 feet msl. The accident site was just outside the SFAR 50-2 (Green Route 4) area of the Grand Canyon National Park.

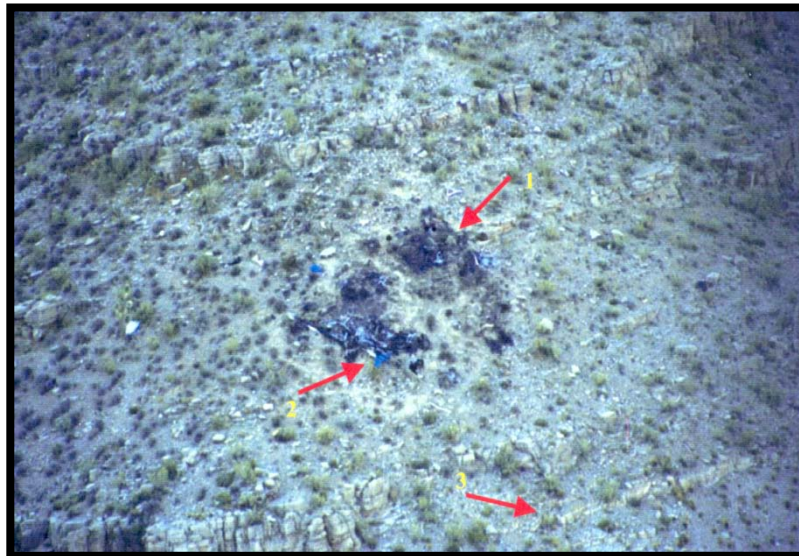
The main wreckage area distribution, including helicopter debris, tree strikes, and ground impressions, were contained in an area approximately 40 feet in diameter. See figure 4 for an aerial view of the crash site.

**Figure 4.** Aerial view of the crash site. Top arrow denotes first identified point of contact (IPI). Middle arrow denotes resting point of main wreckage. Lower arrow denotes right door. Note that the crash site is compact.

The first identified point of impact (IPI) contained an outcropping of boulders. Various portions of the center fuselage belly panel, canopy glass, and all of the landing gear with the exception of the aft cross tube were found on and immediately around the boulder outcropping.

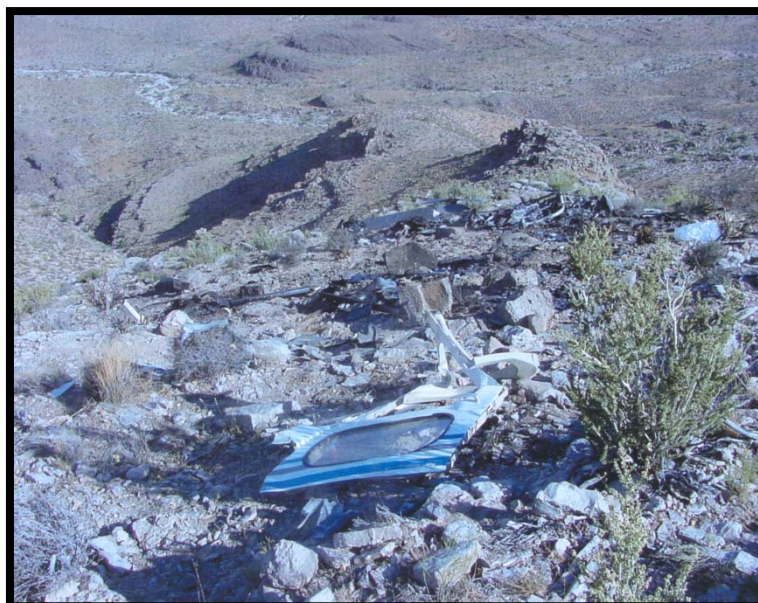
The left front door was found up slope from the IPI. (See figure 5.) It had separated from the fuselage with a portion of the forward fuselage doorpost attached to the upper and lower hinges. The doorpost section was torn from the fuselage structure. The lower hinge was bent and distorted, whereas the upper hinge was intact and undamaged. The hinge pins were fully seated in their corresponding gudgeons and also remained attached to the door jettison arm and rod mechanism, with the internal cockpit-side jettison handle in a near normal position. The door-operating handle was found in the closed and latched position.

**Figure 5.** View of crash site showing left door (in foreground) found upslope from IPI.

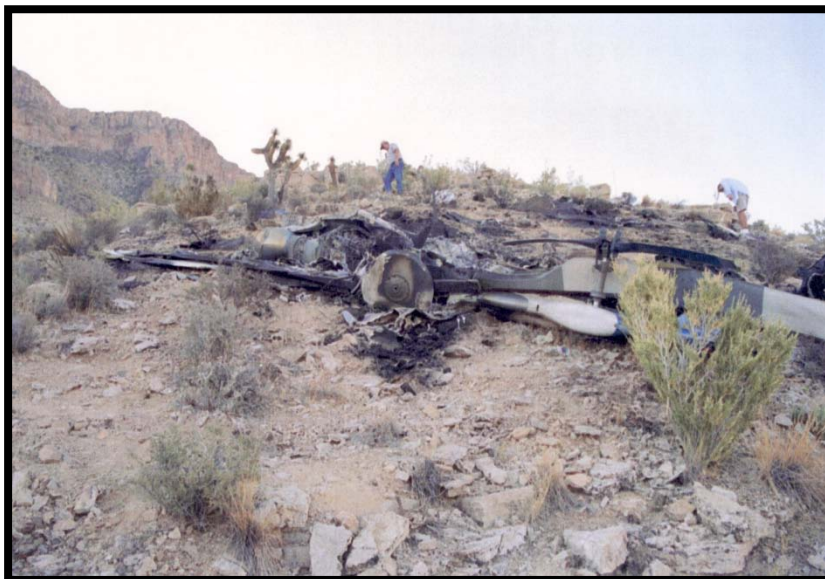
Examination of the fuselage wreckage disclosed that the floor of the cockpit was inverted in the main wreckage area. A portion of the aluminum tail boom aft of the horizontal stabilizer was separated, with the fracture features uneven and jagged in nature. The separated portion of the tail boom and the nose of the helicopter came to rest adjacent to each other. The yellow main rotor blade<sup>12</sup> was lying on top of the tail boom. The blue and red main rotor blades were oriented 180° from the tail boom, laying on top of each other (the blue blade was on top of the red blade) and adjacent to the engine. (See figure 6.) The engine came to rest behind the main gearbox debris in its normal relationship to the fuselage.

**Figure 6.** View looking upslope from IPI. The tail rotor blade is shown in right half of photograph.

The tail rotor blades were bowed and had minor leading edge damage. One strike tab was bent aft and exhibited chordwise scratching. The other strike tab was bent inboard and also exhibited chordwise scratching.
