Inflight Cargo Fire
United Parcel Service Company Flight 1307
McDonnell Douglas DC-8-71F, N748UP,
Philadelphia, Pennsylvania
February 7, 2006

NTSB/AAR-07/07

Aircraft Accident Report

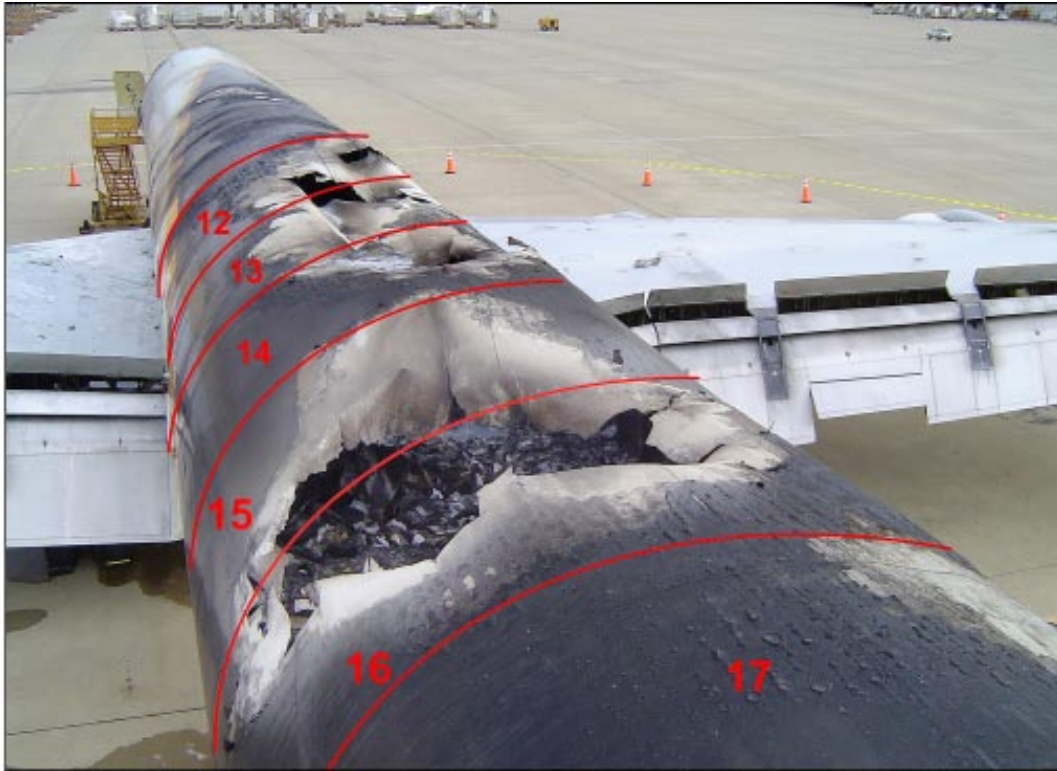
Figure 3. Damage to the fuselage crown.

The fuselage had two complete burnthrough holes in the crown (located over cargo containers 12, 13, and 14 and 15 and 16) and two areas of partial burnthrough (located at cargo containers 12 and 17)³⁰ on the right side of the airplane aft of the wing. (See figure 3 for a photograph showing the fire damage to the fuselage.) Except for the areas around the two complete burnthrough holes, the exterior paint was mostly present. The area around the forward entrance door, the four overwing hatches, and the right aft service door was sooted. The paint around the main outflow valve was heavily sooted and lightly bubbled. No other significant exterior damage to the airplane was noted.

Fuselage structure above cargo containers 12 to 14 exhibited severe thermal damage. Fire had consumed the upper portions of the fuselage frames above the forward section of container 12, and the skin was sagging in these areas. Severe thermal damage to the right fuselage adjacent to container 12 extended down to the floor and included a small burnthrough of the skin located near the bottom of the window. Most of the upper frame structure and a portion of the fuselage crown above containers 12 and 13 had been destroyed by fire. The fuselage crown had been burned through, and several of the upper frames had been destroyed in the areas above container 13 and the forward portion of container 14.

A large area of the fuselage crown over the aft portion of container 15 and the forward portion of container 16 had been consumed by fire, and the fuselage skin was sagging around the perimeter of the burned area. The area of the burnthrough extended down to just above the windows on the left side of the fuselage. Thermal damage to the fuselage extended from the crown to the windows on the right side of the fuselage, adjacent to container 17, and included a small burnthrough of the fuselage skin.
