Midair Collision Over Hudson River
Piper PA-32R-300, N71MC
and Eurocopter AS350BA, N401LH
Near Hoboken, New Jersey
August 8, 2009

Aircraft Accident Summary Report

NTSB/AAR-10/05
PB2010-910405

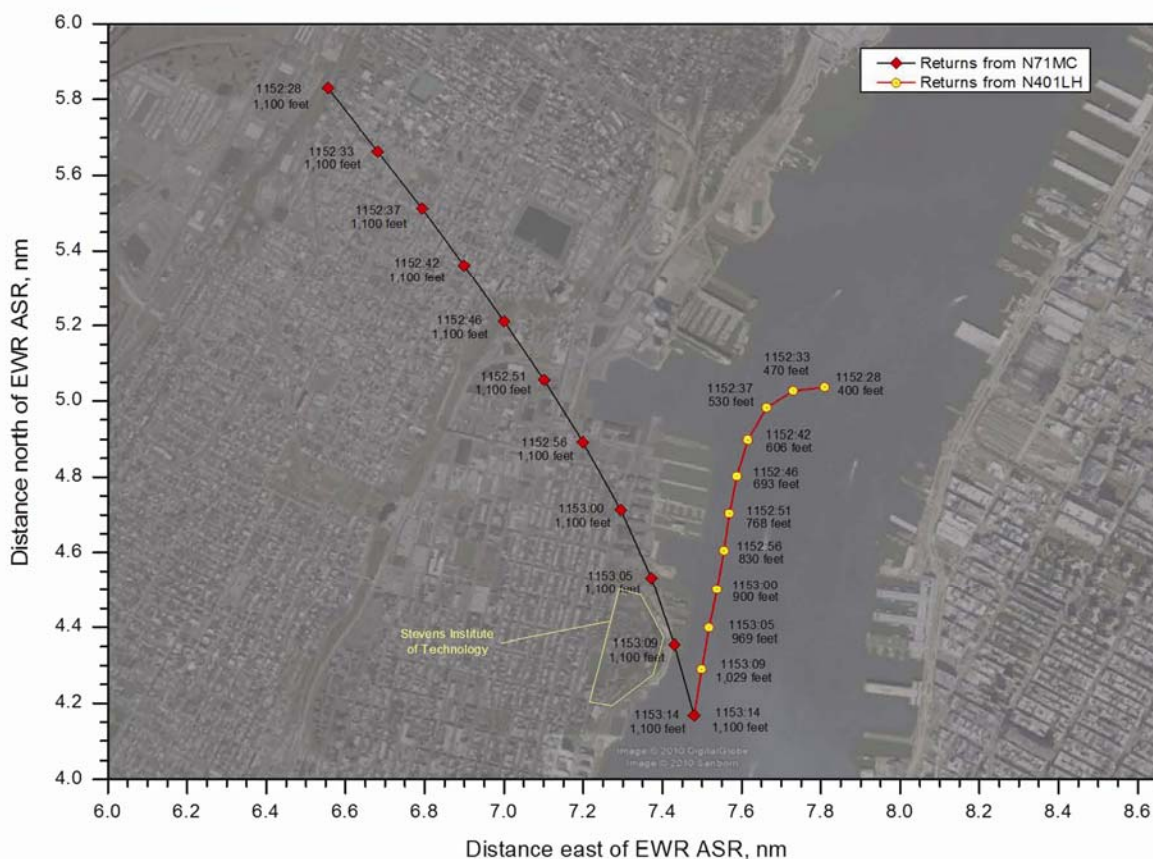
Figure 1. Accident aircraft ground tracks.

calculate the position and orientation of each aircraft in the minutes preceding the accident.²² Figure 1 shows the ground tracks of the accident aircraft and the collision location over a Google Earth™ image of the Hudson River Class B exclusion area along with each aircraft's mode C-reported altitudes at each data point. This information was used to estimate the approximate location of each aircraft during the same time as viewed from the other aircraft's windscreen and the traffic information that could have been presented on the navigation display in each aircraft, as discussed in section 2.2. Figure 2 shows the Class B exclusion area in relation to the surrounding Class B airspace. The accident aircraft ground tracks just before the collision are also depicted.

The aircraft performance radar study found that, shortly before the collision, (1) the airplane was flying level on a true heading of about 165° at 1,100 feet (± 50 feet) while in a shallow right turn to follow the Hudson River to the southeast and (2) the helicopter was in, or had just completed, a climb at an average rate of 900 feet per minute to an altitude of 1,100 feet (± 50 feet) on a true heading of about 190°. ³⁵ According to Liberty Helicopters procedures and its FAA-approved air tour safety plan, the altitude at which its helicopters normally operate when proceeding southbound on the west side of the Hudson River was 1,000 feet. The NTSB could not determine why the helicopter was operating above 1,000 feet during this part of the flight. Possible reasons include that the pilot overshot his planned level-off altitude, the pilot exceeded 1,000 feet intentionally, or the altimeter was in error. ³⁶ Regardless of the reason for the altitude deviation, the NTSB notes that, if the helicopter had been operating at an altitude of 1,000 feet, the vertical separation between the aircraft would likely have been greater, thus reducing the probability of a collision. The NTSB concludes that the helicopter's climb above 1,000 feet was not consistent with company procedures and decreased the vertical separation between the aircraft. Further, no federal regulations mandated that air tour helicopters or other local traffic operate at a lower altitude than that for transiting aircraft.

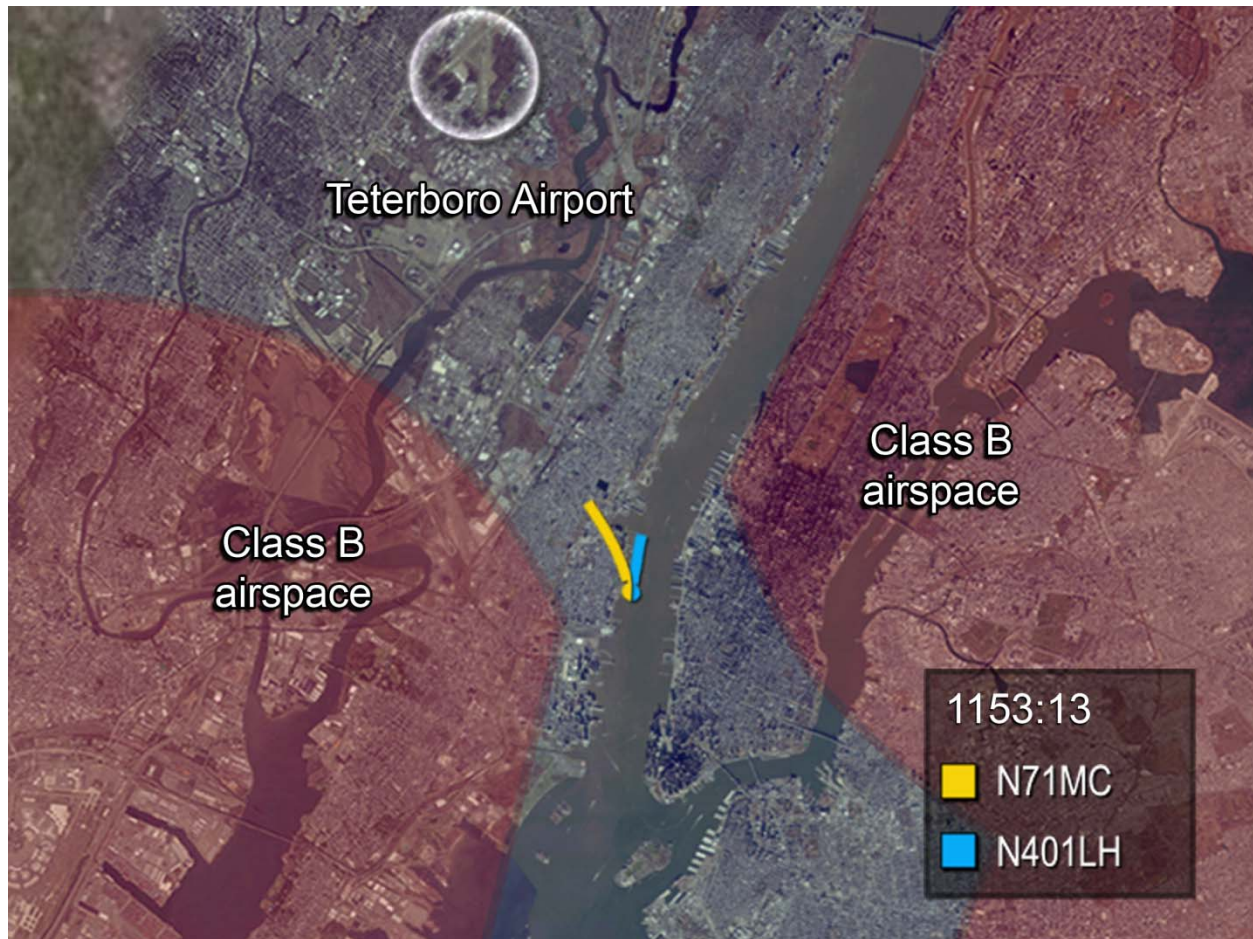
Figure 2. Hudson River Class B exclusion area.

Note: The Class B airspace over EWR, shown on the left, extends from 500 to 7,000 feet. The Class B airspace over LaGuardia Airport, shown on the right, extends from the surface to 7,000 feet.

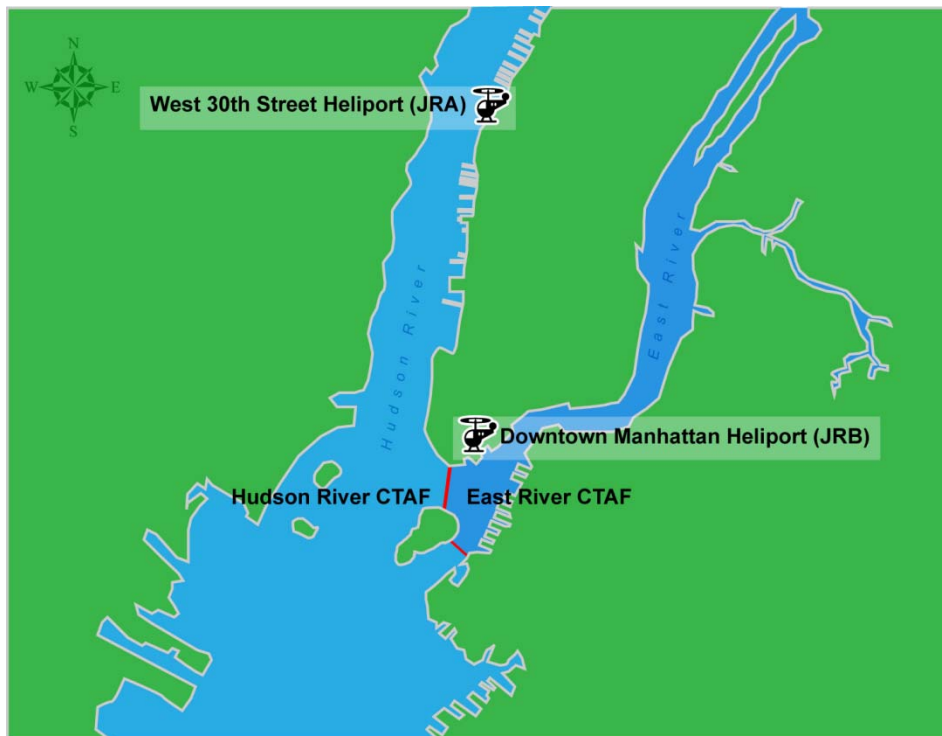
Figure 6. Location of West 30th Street and Downtown Manhattan Heliports and Boundary Between Hudson River and East River common traffic advisory frequencies.

Most of the traffic at JRB will be air tour helicopters operating in the Hudson River Class B exclusion area. However, as indicated on the VFR charts for the area, these air tour helicopters are now required to use the CTAF for the East River exclusion area (123.075) rather than the CTAF for the Hudson River exclusion area (123.05). As a result, pilots of these air tour helicopters will not be monitoring and communicating position reports with other aircraft operating in the Hudson River Class B exclusion area while transmitting on the East River CTAF. Figure 6 shows the location of JRA and JRB and the boundary between the Hudson River and East River CTAFs.

The NTSB concludes that pilots operating air tour helicopters to and from JRB may not be fully aware of other aircraft operating over the Hudson River because the CTAF used for such flights is for the adjacent East River area. Therefore, the NTSB recommends that the FAA redefine the boundaries of the East River CTAF so that JRB will be located in the area that uses the Hudson River CTAF.
