Subject: FORT CALHOON STATION – NRC SPECIAL INSPECTION REPORT  
05000285/2011014; FINDING OF PRELIMINARY HIGH SAFETY  
SIGNIFICANCE

IR 05000285/2011014; 09/12/2011 – 02/29/2012; Fort Calhoun Station; Special Inspection; Violations of 10 CFR Part 50, Appendix B, Criterion III and Criterion XVI, and License Condition 3.D were identified.

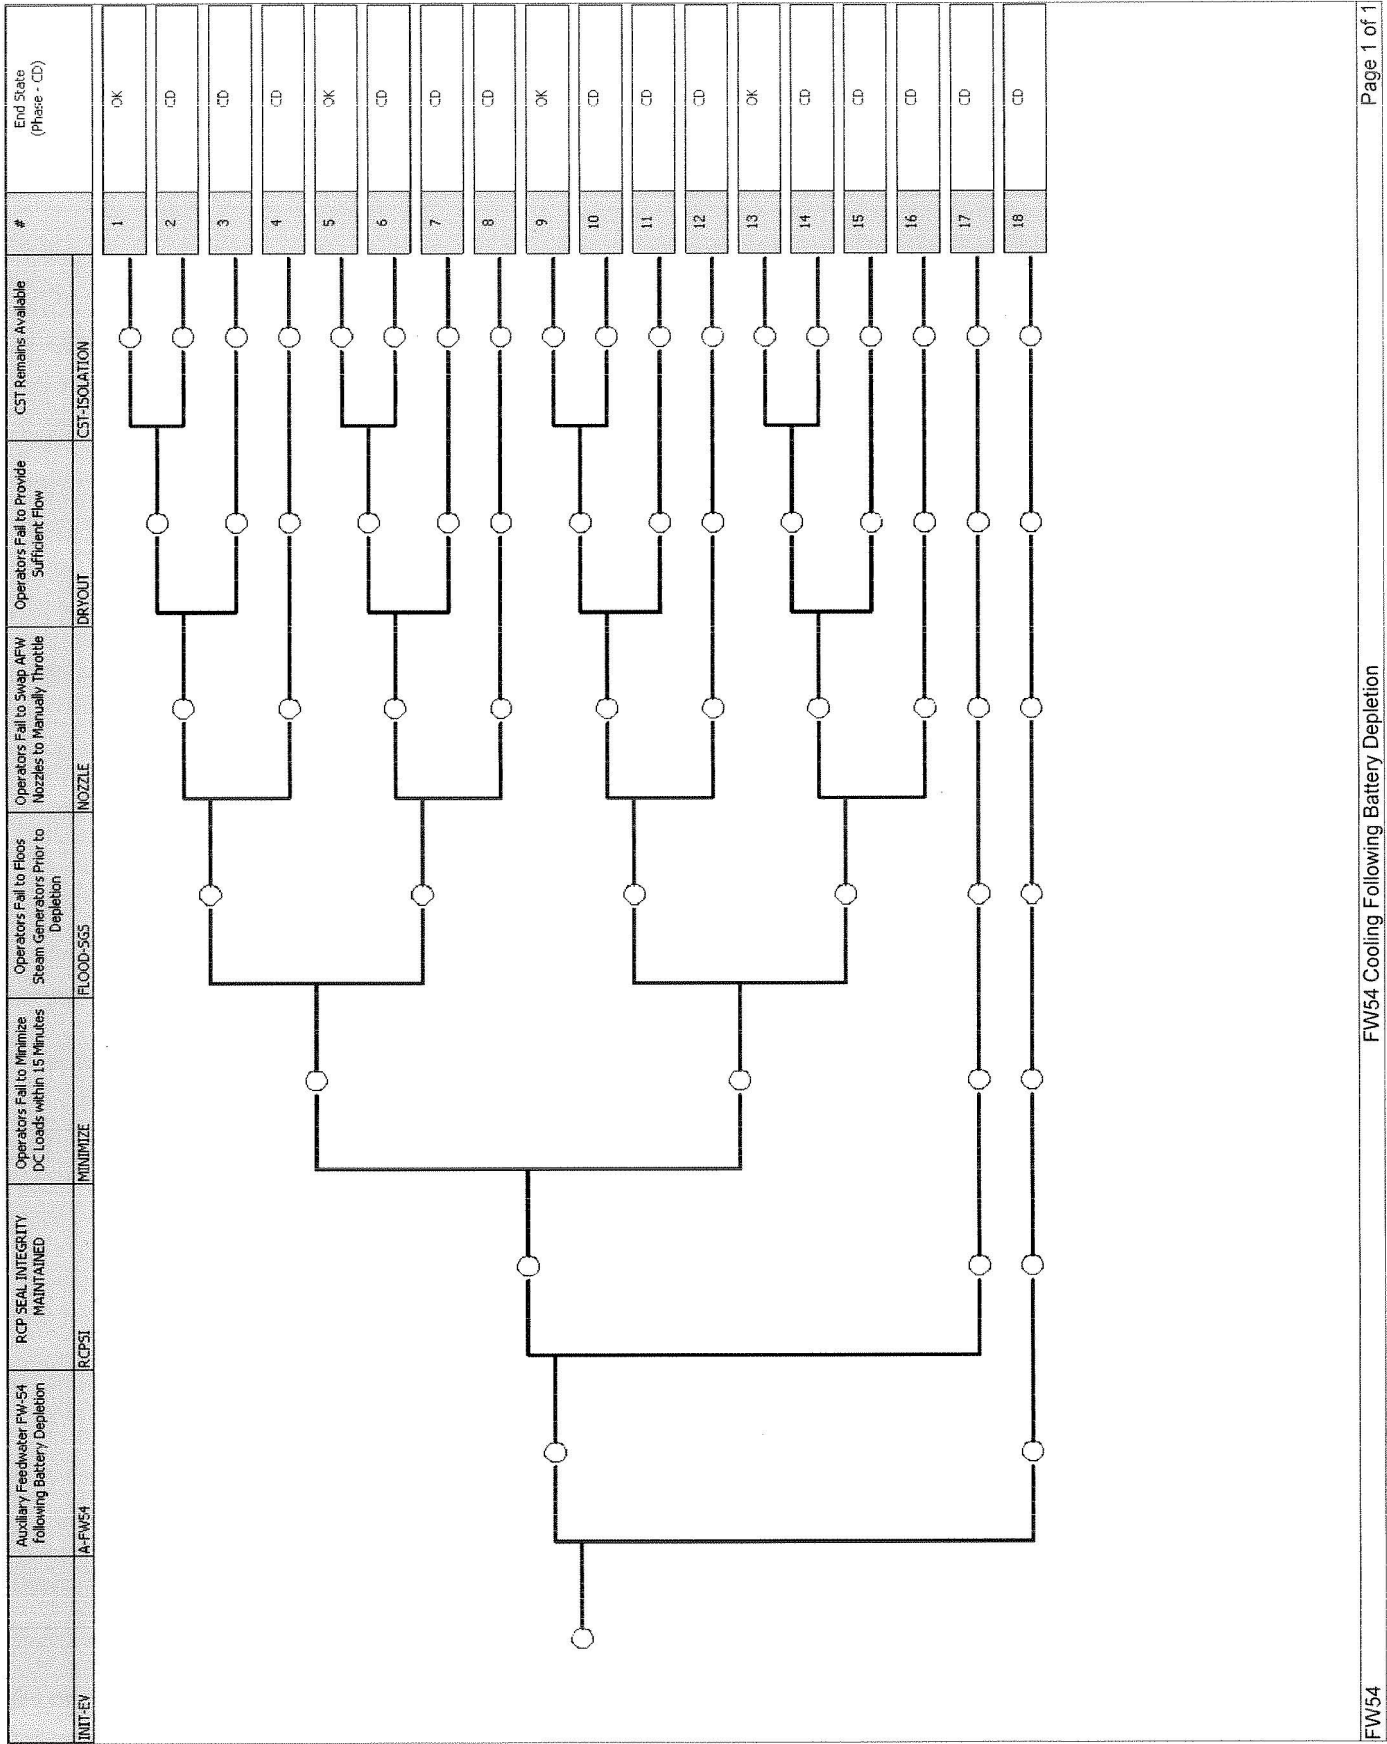
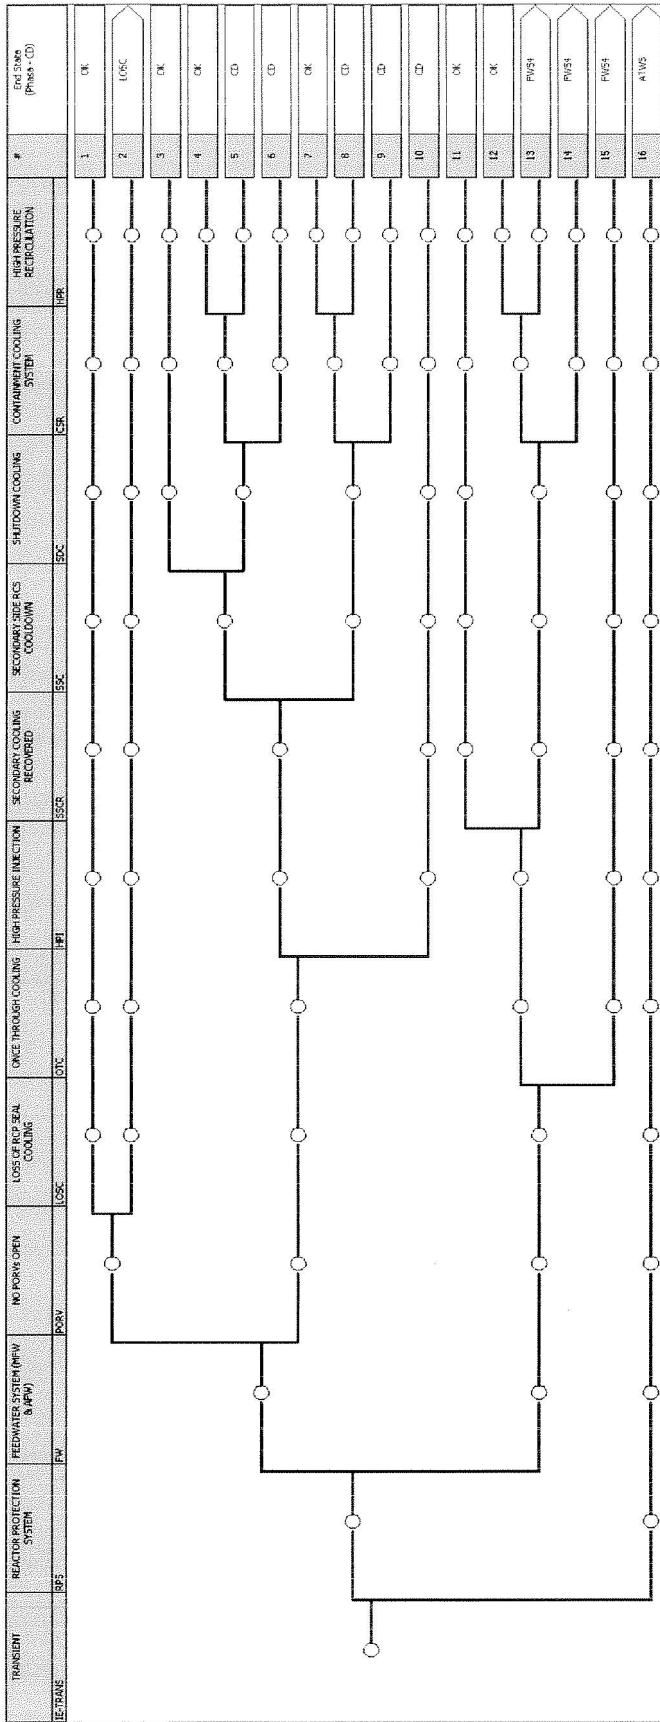
The analyst modified the SPAR model to include the attached Event Tree, "FW54 Cooling Following Battery Depletion." The analyst created a transfer to this tree from Event Tree, "Fort Calhoun PWR G Transient," for Sequences 13, 14, and 15.

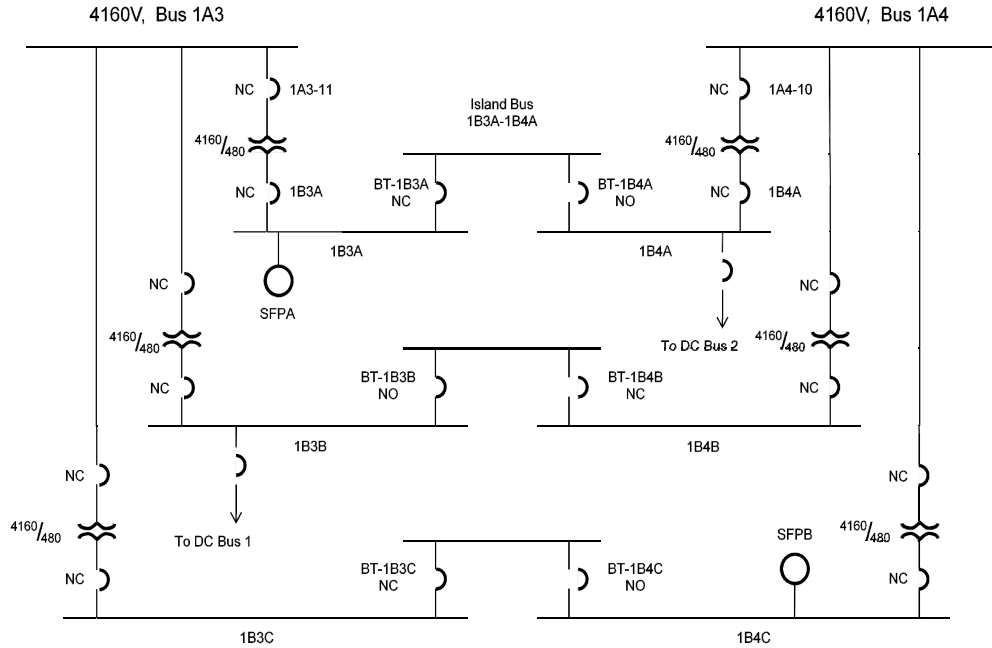
**Figure 1: Simplified 480 Vac Distribution Diagram**

The team reviewed modification EC 33464, "Replace AK-50 480 V Main and Bus-Tie Breakers With Molded Case Type or Equivalent," Revision 0, which replaced 12 General Electric AK-50 low voltage power circuit breakers with Nuclear Logistics Incorporated/Square-D Masterpact circuit breaker/cradle assemblies and digital trip devices in November 2009. The modification replaced six feeder circuit breakers and six bus-tie breakers. These breakers and their relation to the Fort Calhoun Station electrical distribution system are shown in Figure 1 of Attachment 4.

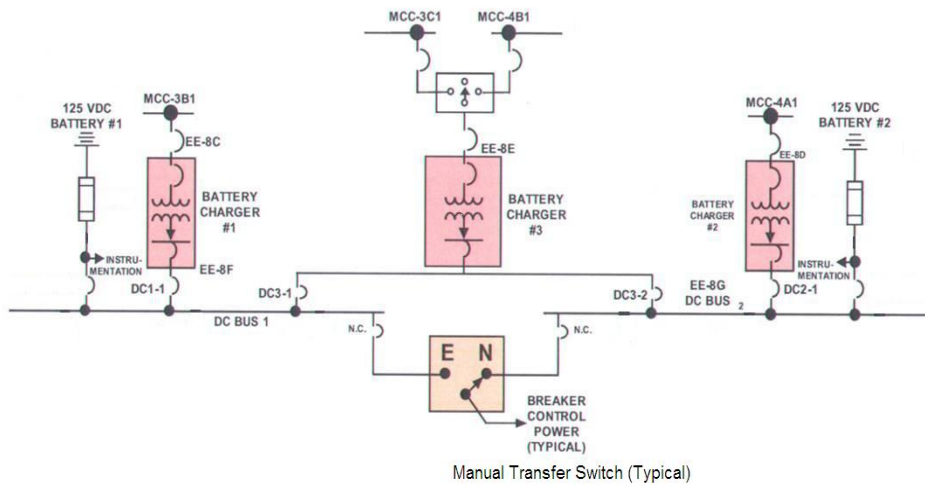
**Figure 2: Simplified 125 Vdc Distribution Diagram**

During the event, both trains of safety-related 125 Vdc power were affected by grounds caused by the effects of the fire in load center 1B4A.
