SUBJECT: DRESDEN NUCLEAR POWER STATION, UNITS 2 AND 3  
NRC SAFETY SYSTEM DESIGN AND PERFORMANCE CAPABILITY  
INSPECTION REPORT 05000237/2005009(DRS); 05000249/2005009(DRS)

Report No: 05000237/2005009(DRS); 05000249/2005009(DRS)

Facility: Dresden Nuclear Power Station, Units 2 and 3

IR 05000237/2005009(DRS); 05000249/2005009(DRS); 07/25/2005 - 08/12/2005; Dresden Nuclear Power Station, Units 2 and 3; Safety System Design and Performance Capability.

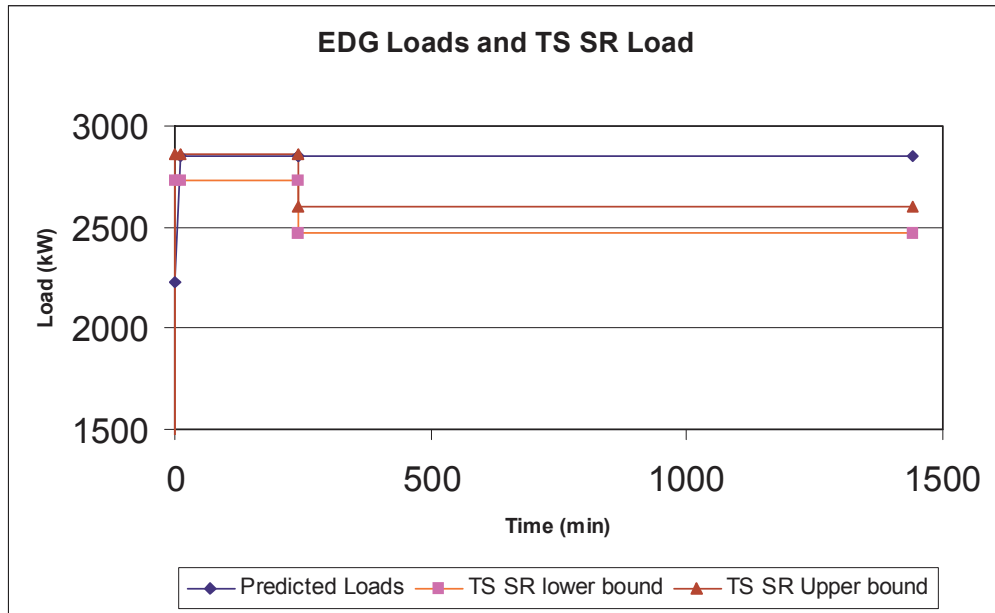
Predicted Loads Exceeding Surveillance Requirements

During a previous inspection, the inspectors identified that calculated design basis loads for a LOCA/LOOP event exceeded the continuous rating of the EDGs. The inspectors noted that TS SR 3.8.1.3, SR 3.8.1.11, and SR 3.8.1.15 used a load band of 2340 to 2600 kilowatts (kW) based on 90 to 100 percent of the EDGs' continuous rating of 2600 kW as basis for acceptability. However, the inspectors questioned whether the TS surveillance requirements should have been revised to reflect the design basis loads, which exceeded the EDG continuous ratings. The inspectors opened a URI to track the issue.

The original concern of the URI regarding the lack of a surveillance requirement which enveloped the design basis loads remains open. The table above and chart below depict where the Dresden EDGs would operate within the 10 percent overload rating beginning at 10 minutes after a design basis event and for an extended period of time after manual loads were added onto the EDG. However, the current TS surveillance requirements, and licensee testing practices, only demonstrated the ability of the EDG to carry a load near this level for 2 hours.
