SUBJECT: QUAD CITIES NUCLEAR POWER STATION  
NRC SPECIAL INSPECTION REPORT 50-254/02-03(DRS)

Report No: 50-254/02-03

Facility: Quad Cities Nuclear Power Station, Units 1 and 2

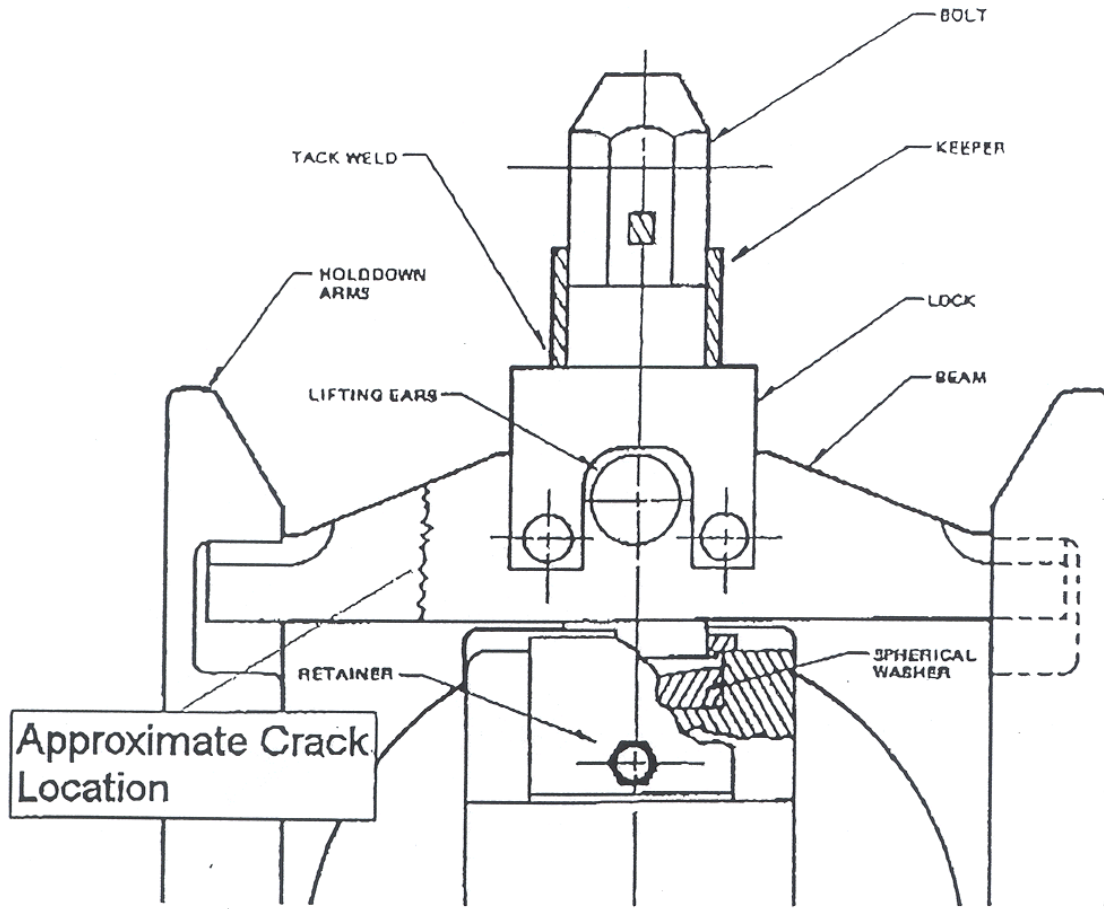
**JET PUMP BEAM No. 20**

On Saturday, January 12, 2002, failure of the #20 JPHB was discovered following disassembly and inspection of the reactor vessel (Attachment 2). The jet pump inlet mixer sub-assembly had lifted from the diffuser at the slip fit connection, disassembling the pump. It was found wedged against the swing-gate restrainer bracket assembly after lifting and tilting approximately 20 degrees off vertical. The restrainer gate in the reactor physically limits the displacement of the sub-assembly, which limits consequential failures. Portions of the beam were found on the shroud support plate and in the 1B reactor recirculation pump line. The hold-down spherical washer was not located. The licensee retrieved the two beam pieces and performed a lose part analysis (Quad Cities Unit 1 Lost Parts Evaluation for JPHB Insert, January 18, 2002) for the unrecovered spherical washer. The portion of the beam found in the 1B recirculation line caused severe damage to one of the six pump impeller vanes and significant damage to two other vanes.

Jet pump hold down beam #20 fractured approx. 2-1/2" from the end of the beam in the transition area on the reactor side. The cracks propagated over 90% of the beam cross section. The remaining 10% of the beam cross section failed from overload. Laboratory analysis confirmed the fracture to have initiated from IGSCC. There were no material defects or imperfections found associated with the IGSCC initiation sites. These observations were consistent with prior failures at Grand Gulf and Dresden Unit 3. Jet pump hold-down beam #4 and JPHB #15 both had two liquid penetrant Indications each on the transition region which were determined to be IGSCC. The results confirmed that cracking in the transition region was not isolated to JPHB-20.

The licensee performed an extent of condition examination of the remaining 15 old style (BWR-3) beams. The inspection involved ultrasonic examination of the beam ears and center bolt hole region, and visual examination of the transition region. Following the examinations the licensee decided to replace the original design beams (BWR-3) with redesigned beams (BWR-4) which are less susceptible to intergranular stress corrosion cracking. The BWR-4 style beams have improved design with a thicker cross sectional area in the bolt hole region and an age hardened full anneal heat treatment. Jet pump 6 (one of the four new type beams in Unit 1) was not one of the beams to be replaced, however, it was inadvertently de-tensioned and it was subsequently replaced. The licensee also developed operability determinations to justify the continued operation of the jet pumps at Quad Cities Unit 2, and Dresden Units 2 and 3. The damaged 1B recirculation pump impeller was replaced.
