NATIONAL TRANSPORTATION SAFETY BOARD

SAFETY STUDY

Emergency Evacuation
of Commercial Airplanes

**NTSB/SS-00/01
PB2000-917002
Notation 7266
Adopted June 27, 2000**

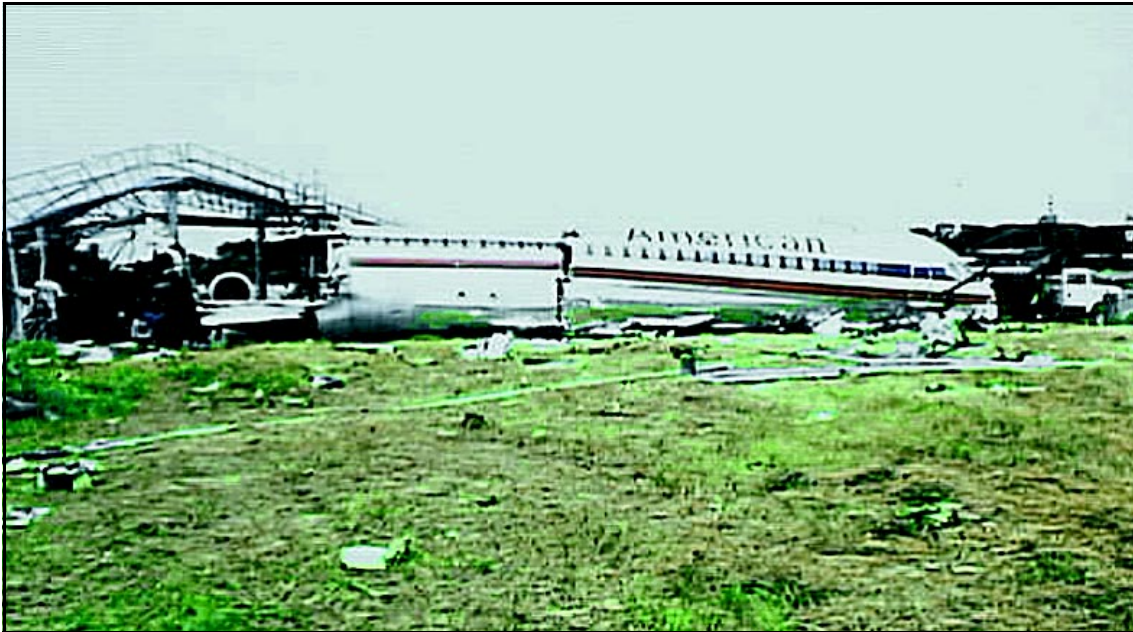
In the MD-82 accident in Little Rock, Arkansas (case 45), the crash forces caused seats to break free from their seat tracks and block aisles. In the forward portion of the cabin, passengers had to navigate around fallen overhead bins and across a severely deformed floor. Fortunately, the crash caused several gaps in the fuselage that passengers were able to use for egress. As seen in figure 5–3, the crash forces split the cabin in two separate sections divided at the wing.

Figure 5–3. View of the McDonnell Douglas MD-82 accident scene that involved evacuation on June 1, 1999, Little Rock, Arkansas (case 45).

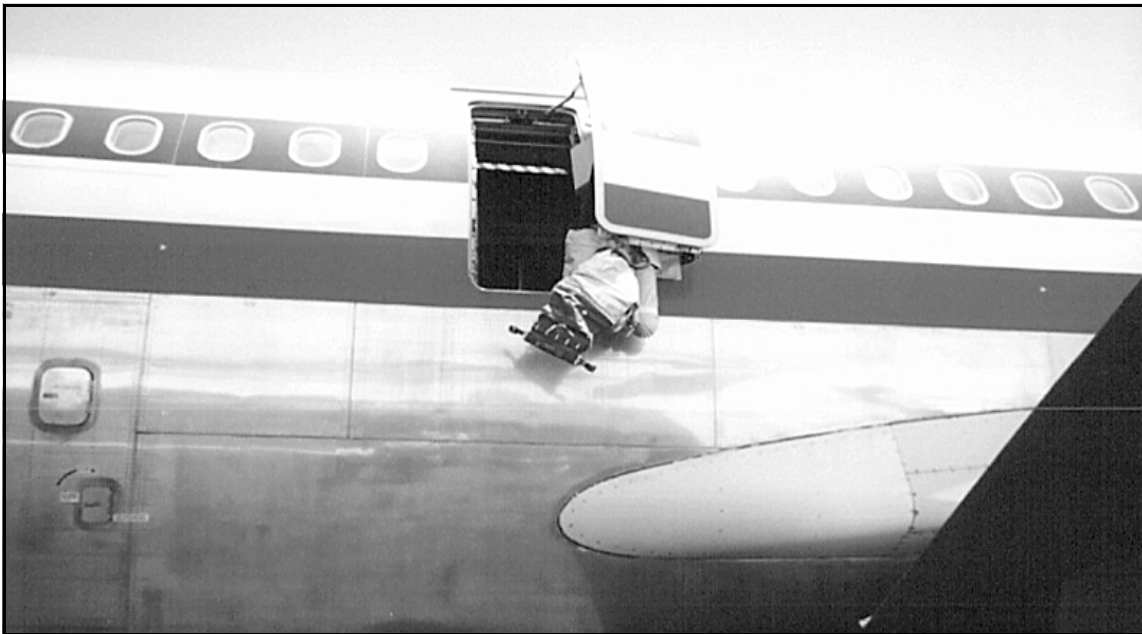
Seven passengers reported that they had difficulty attempting to open an airplane floor level exit door during their evacuation: five were involved in the evacuation of the MD-82 in Little Rock, Arkansas (case 45); one was involved in the evacuation of an A300 in San Juan, Puerto Rico (case 24); and the last was in the evacuation of a 727 in Chicago, Illinois (case 16). Three Little Rock passengers attempted to open a floor level exit door leading to the tailcone; the door exit could not be opened because of a deformation in the floor of the airplane. The two other Little Rock passengers attempted to open inoperable forward floor level exit doors. The 727 passenger reported opening the L2 door 10 inches before it “jammed.” Finally, the A300 passenger attempted to open the R3 door that had not opened as intended after a flight attendant first tried to open the door (figure 5-5).

Figure 5-5. View of the R3 door that failed to operate as intended following the Airbus 300 accident on July 9, 1998, in San Juan, Puerto Rico (case 24).

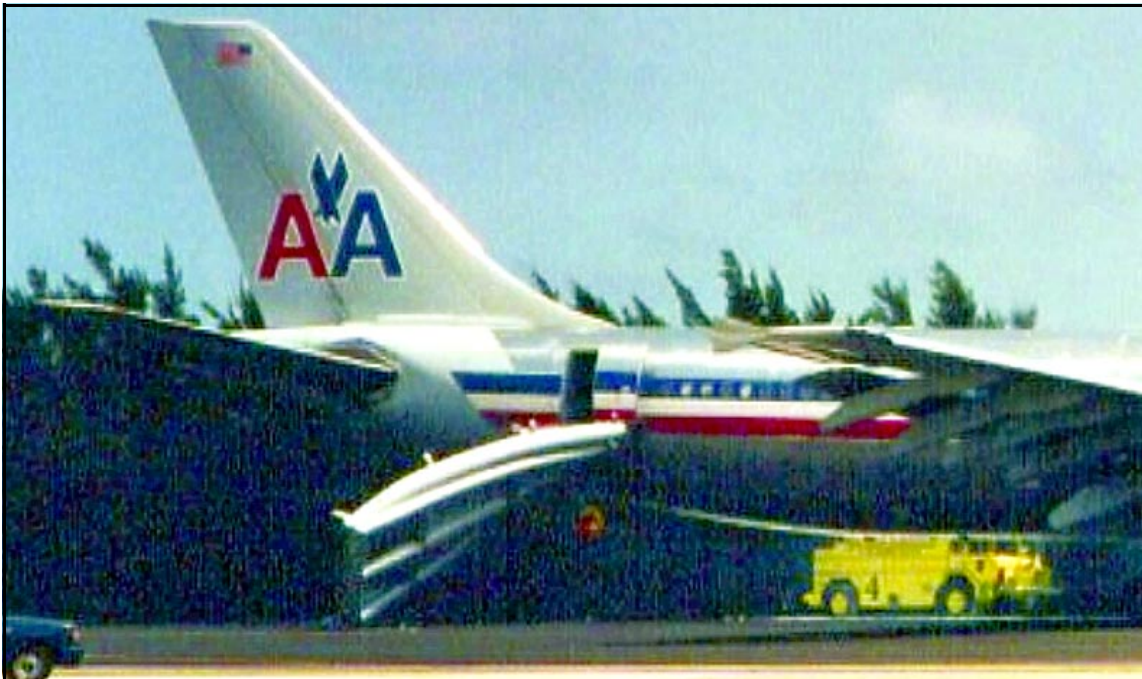
deploy the slides at R1, R2, and R4. However, there was a delay in deploying the R1 slide because of a failure of the power assist in the door. Also, the R3 door partially opened before jamming. The flight attendant tried repeatedly to open the door, but reported that he “knew [the slide] was caught up” in the pack. Postincident testing conducted by the Safety Board indicated that the malfunction might have been caused by a Velcro® fastener that became hooked on a clip on the inside of the decorative cover. In addition, the slide deployed at R4 was unusable for a period of time because winds were blowing the slide against the airplane (figure 5–9). During this time, the 234 passengers were exiting from only two of the eight exits on the A300.

Figure 5–9. View of the wind's effect (25-knot gusts) on the evacuation slide used following the Airbus 300 accident on July 9, 1998, in San Juan, Puerto Rico (case 24). Passengers were able to use this exit after a person on the ground held the slide in place.
