Loss of Control While Maneuvering
Pilatus PC-12/45, N128CM
Butte, Montana
March 22, 2009

NTSB/AAR-11/05
PB2011-910405

**LOSS OF CONTROL WHILE MANEUVERING
PILATUS PC-12/45, N128CM
BUTTE, MONTANA
MARCH 22, 2009**

NTSB/AAR-11/05
PB2011-910405
Notation 8102A
Adopted July 12, 2011

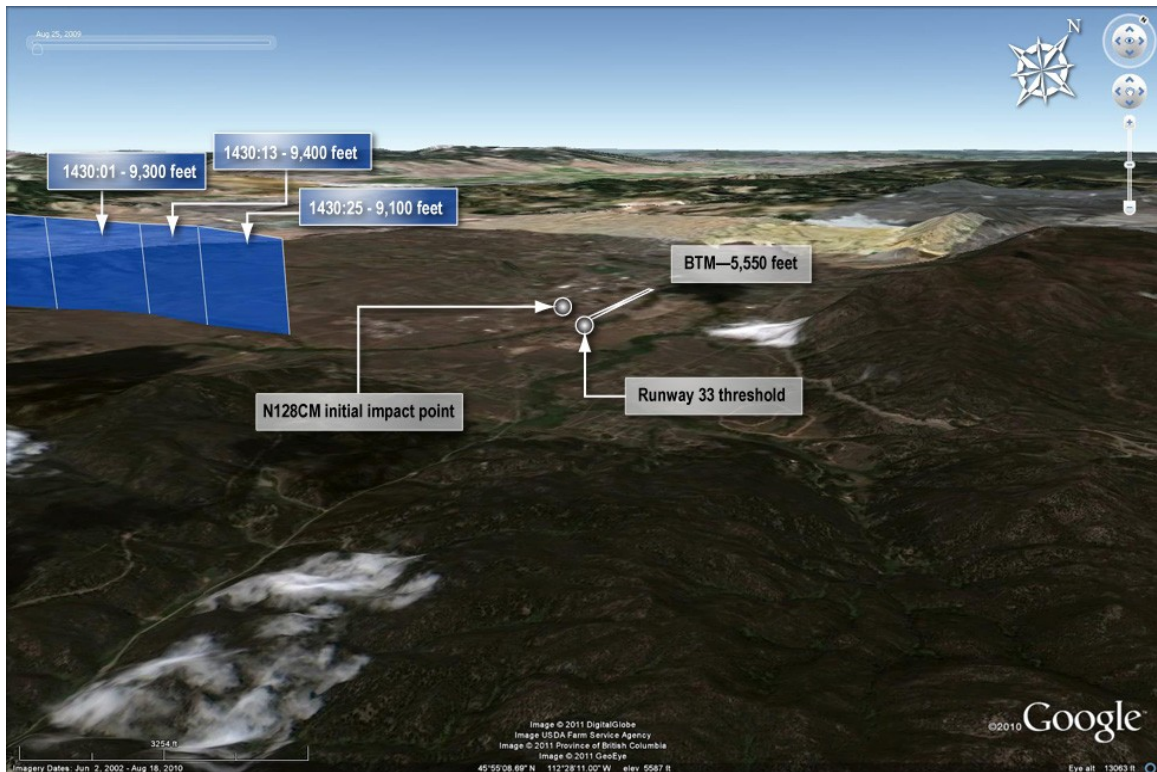
¹⁷ The airplane’s calculated groundspeed between the final two radar targets (1430:13 and 1430:25) was about 189 knots.

Figure 2. Final radar targets and terrain surrounding Butte, Montana (looking northwest).
