Collision of Tankship *Eagle Otome* with Cargo Vessel *Gull Arrow*
and Subsequent Collision with the *Dixie Vengeance* Tow
Sabine-Neches Canal, Port Arthur, Texas
January 23, 2010

NTSB/MAR-11/04
PB2011-916404

Marine Accident Report

The National Transportation Safety Board (NTSB) determines that the probable cause of the collision of tankship *Eagle Otome* with cargo vessel *Gull Arrow* and the subsequent collision with the *Dixie Vengeance* tow was the failure of the first pilot, who had navigational control of the *Eagle Otome*, to correct the sheering motions that began as a result of the late initiation of a turn at a mild bend in the waterway. Contributing to the accident was the first pilot's fatigue, caused by his untreated obstructive sleep apnea and his work schedule, which did not permit adequate sleep; his distraction from conducting a radio call, which the second pilot should have conducted in accordance with guidelines; and the lack of effective bridge resource management by both pilots. Also contributing was the lack of oversight by the Jefferson and Orange County Board of Pilot Commissioners.

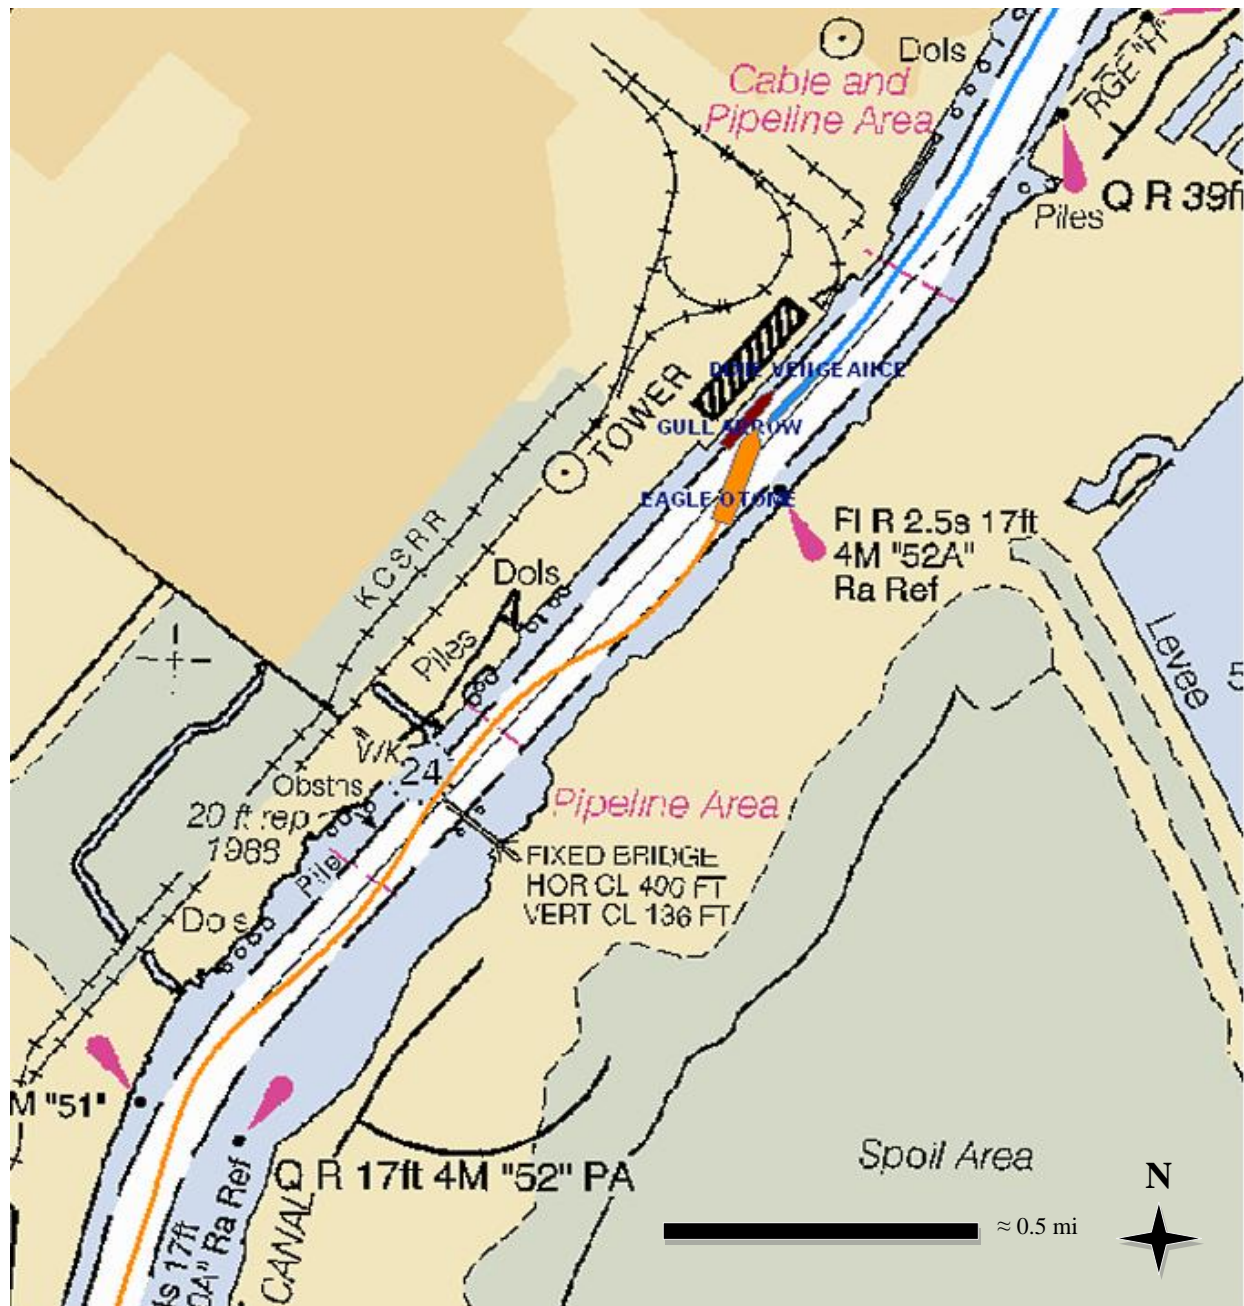
When the *Eagle Otome*’s starboard bow came close to the east bank, the tankship began sheering to port, despite the hard to starboard rudder command (figure 7). At 0933:14, the first pilot asked the second pilot, “Will you talk to this next tow?” The second pilot answered, “What do you want me to tell them? Just one whistle or look out here we come?” The first pilot replied, “One, yeah, look out, the one there is *Vengeance*.” However, neither the S-VDR nor the VHF radio recordings indicated that the second pilot contacted the towboat as the first pilot instructed him to do.

Figure 7. Trackline of the *Eagle Otome*, obtained from the tankship's S-VDR, overlaid as an orange line on NOAA chart 11342, and trackline of the *Dixie Vengeance*, obtained from automatic identification system (AIS)²¹ data, overlaid as a blue line.

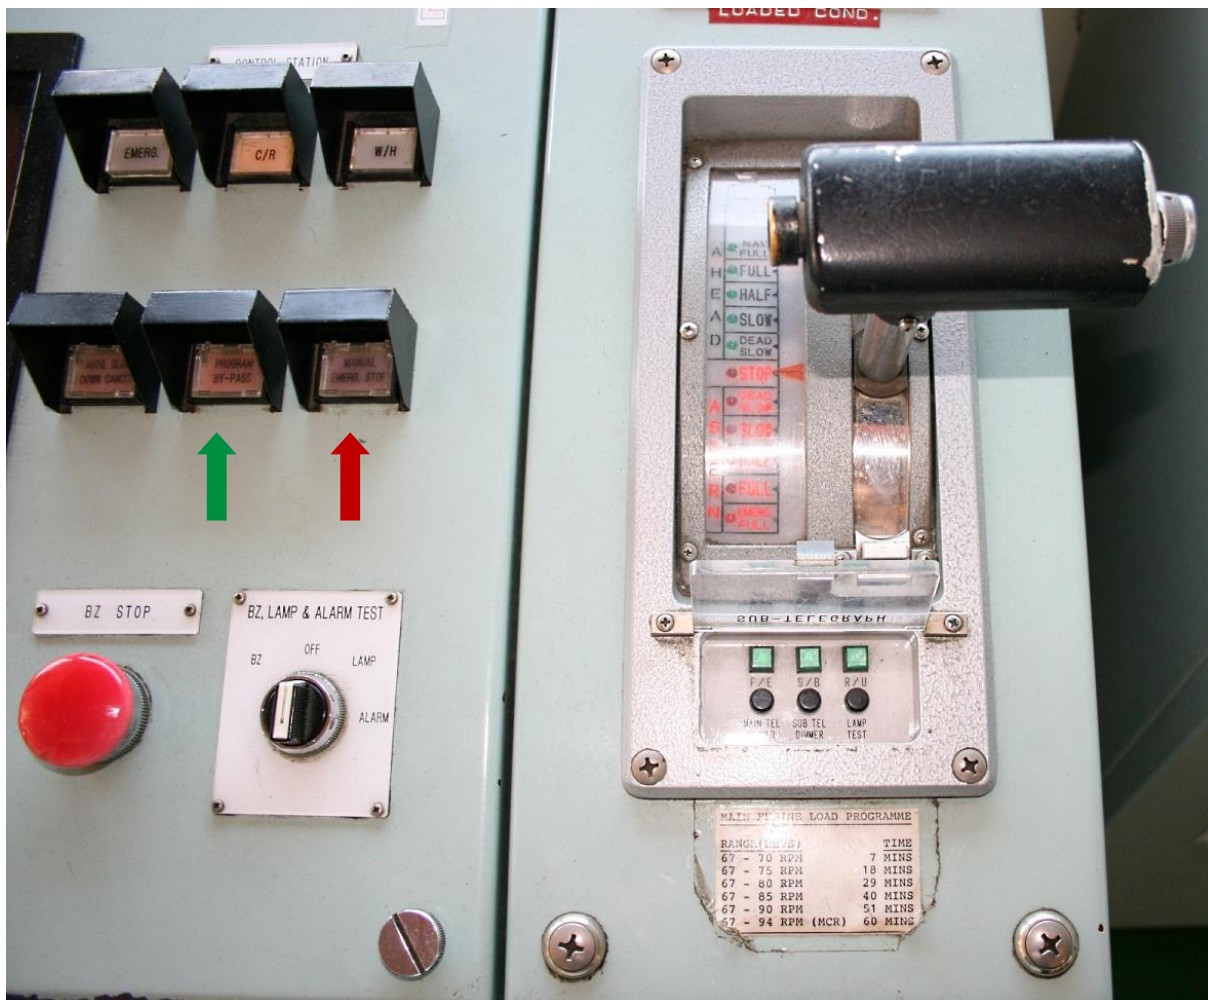
effectiveness. The *Eagle Otome* master told investigators that, to speed implementation of the full ahead order, he then used the engine order telegraph, which was set to bridge control, to increase the tankship's speed from full ahead to "navigational full ahead." This would gradually increase the tankship's propeller revolutions from about 65 rpm to 90 rpm.²² To complete the navigational full ahead, a specific button labeled "program by-pass" on the engine control console must be pushed.²³ In his attempt to activate the navigational full ahead, however, the master inadvertently pushed a button marked "manual emergency stop," which was identically shaped and located immediately adjacent to the "program by-pass" button (figure 8).

Figure 8. Section of the engine control console on the *Eagle Otome*. Activating the navigational full ahead required pushing the button marked with a green arrow. However, the master inadvertently pushed the "manual emergency stop" button, marked with a red arrow. (The arrows were added to this image; they are not featured on the actual engine control console.)

²³ On large marine propulsion diesel engines, the engine control system restricts the rate of loading above the normal maneuvering range to prevent damage to the engine from uneven heating. The ship's crew can manually override or bypass the engine loading program in case of emergency, and on the *Eagle Otome* this override required pushing the "program by-pass" button.

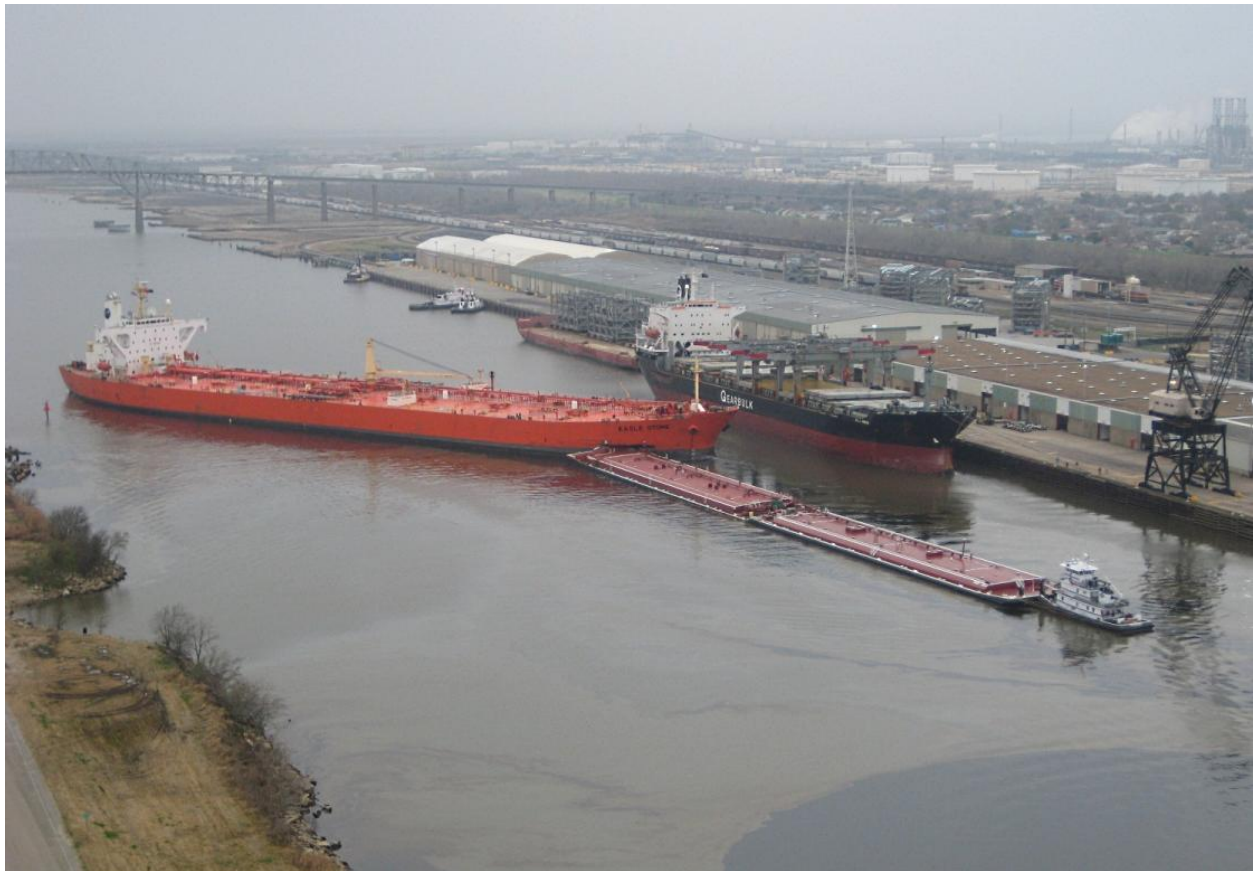
As a result of the breach, an estimated 462,000 gallons of crude oil spilled into the water. The vessels remained together in the center of the canal while pollution response procedures were initiated (figure 9). (For more information, see section “1.9 Oil Spill and Recovery Efforts.”)

Figure 9. The three vessels after the accident. Overflight photo by the Coast Guard, looking west-southwest.

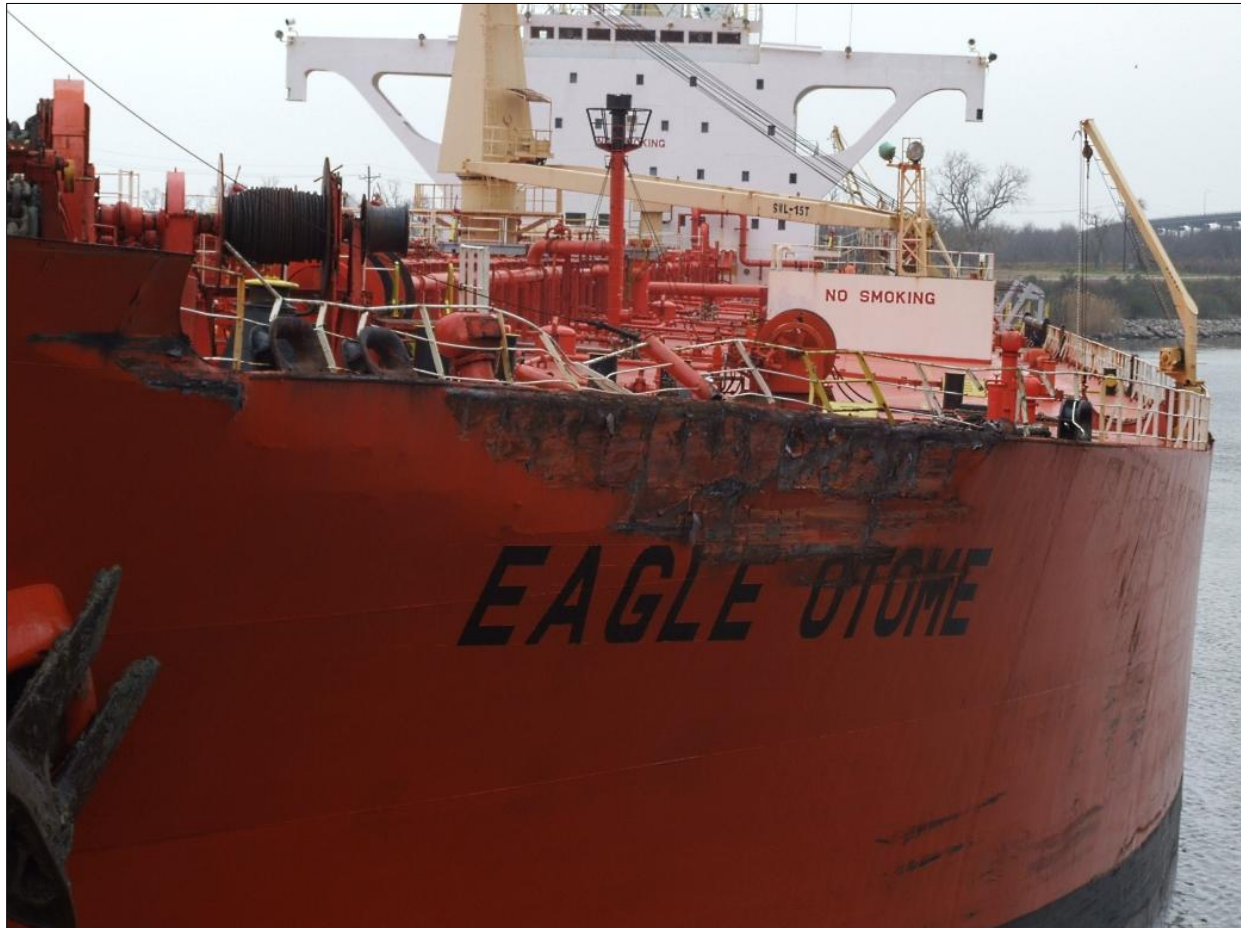
side. The damage to the portside shell plating and internal structure extended horizontally about 55 feet and down about 12 feet from the main deck. The damaged compartments in this area were the No. 1 port ballast tank, the forward cofferdam,³⁰ and the bosun store room, and involved buckling, detachment, and fracturing of the internal structure, which was inset about 3 feet as a result of the impact. The main deck plating, deck railings, and port bulwark were also damaged in this area (figure 10).

Figure 10. Portside damage to the *Eagle Otome*.

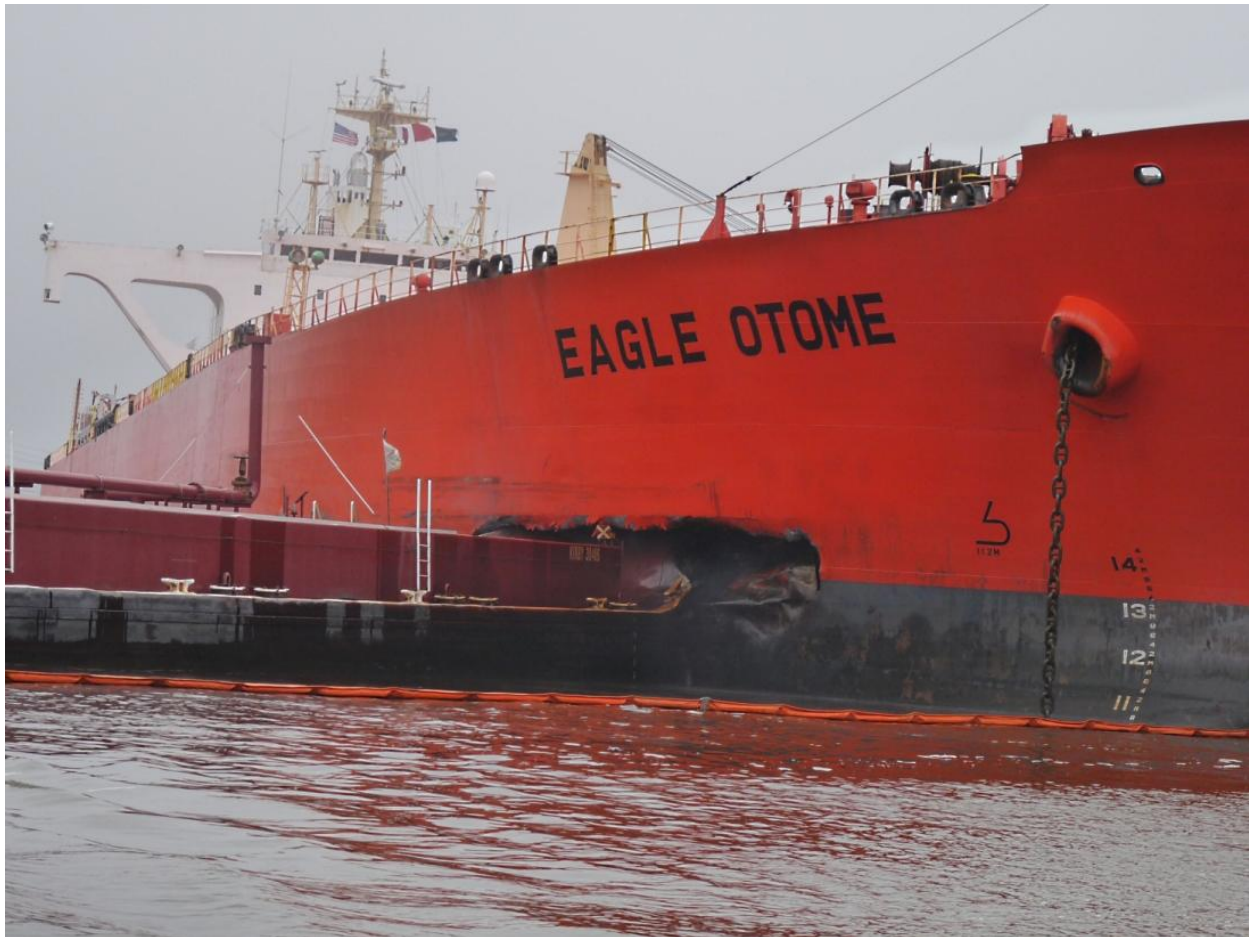
The subsequent collision with the *Kirby 30406* created a hole in the *Eagle Otome*'s starboard hull about 30 feet aft of the tankship's bow, above the waterline (figure 11). The side shell plating was punctured and inset across an area about 43 feet long and 10 feet high, extending from the No. 1 starboard ballast tank to the forward cofferdam. Frames and stringers in this area were buckled, fractured, and completely detached in several locations. The damage to the *Eagle Otome* was estimated at \$1.5 million.

Figure 11. Starboard side of the *Eagle Otome*, with the *Kirby 30406* lodged in it.

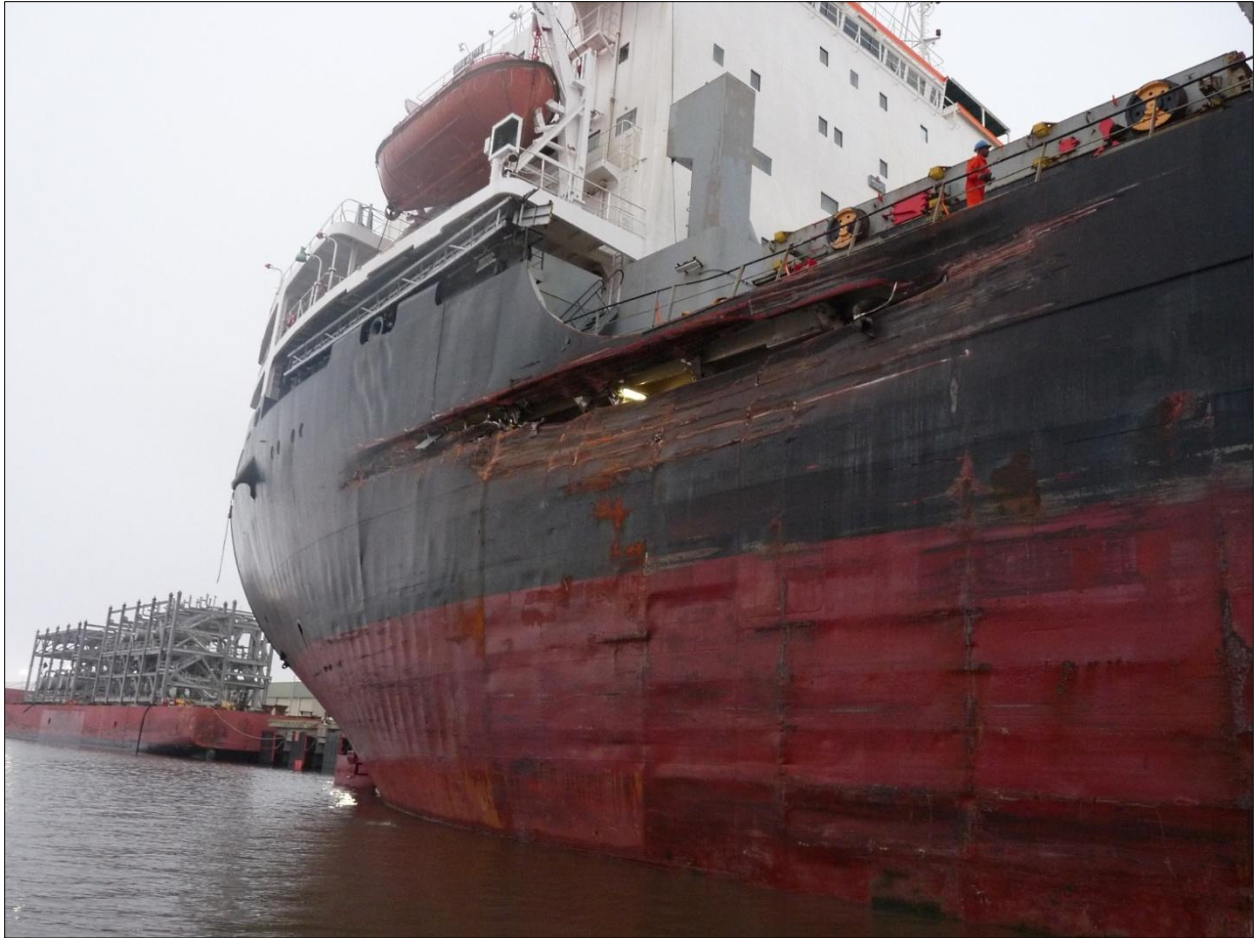
The *Gull Arrow* sustained a gash about 100 feet long and 3 feet high just below its starboard-side gunwale.³¹ According to a surveyor's report, the structural frames in this area were buckled, with six frames broken and distorted. The shell plating below the gash was inset between 1 and 3 feet. On the main deck, 16 sections of handrails, stanchions, and brackets were bent over to an angle of about 45 degrees (figure 12). In the interior spaces of the damaged area, including the engine machine shop and maintenance tunnel, damage was sustained to electrical conduits and to various piping systems, such as sewage and steam. The *Gull Arrow* also sustained damage to its portside hull when the impact pushed the ship into the concrete wharf. On the portside, a 10-foot-high by 115-foot-long section of shell plating, between frames 42 and 79, was inset about 3 inches.

No fuel tank was breached and no fuel was released from the *Gull Arrow*. The damage to the *Gull Arrow* was estimated at \$381,000.

Figure 12. Damage to the *Gull Arrow*.

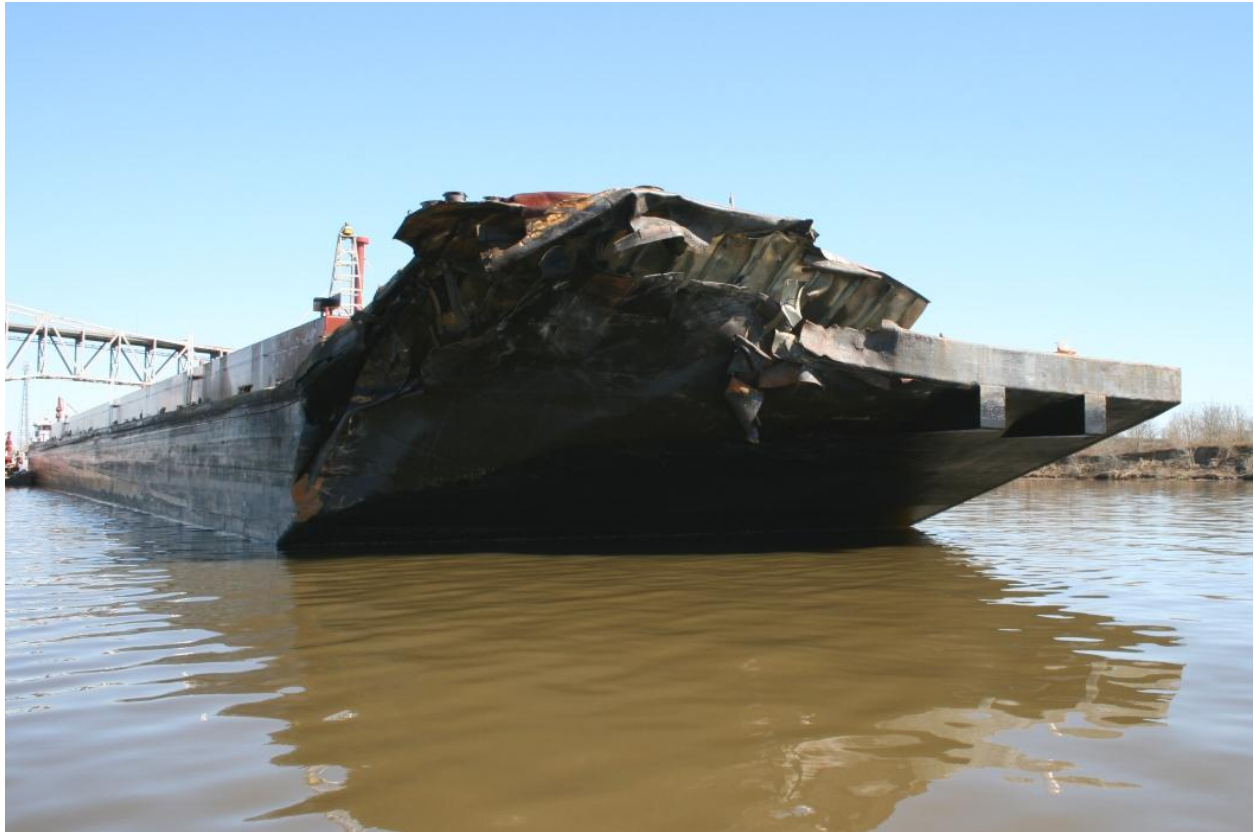
The bow (or rake) of the barge *Kirby 30406* was peeled back in the collision with the *Eagle Otome* (figure 13). The barge's void space on its starboard-side rake was crushed, and about 5 feet of the rake had curled up under the hull plating of the *Eagle Otome*. The cargo tanks remained intact, and no aromatic concentrate product was released.

The damage to the *Kirby 30406* was estimated at \$35,000.

Figure 13. Damage to *Kirby 30406*.
