Miami International Airport, Automated People Mover  
Train Collision with Passenger Terminal Wall  
Miami, Florida  
November 28, 2008

NTSB/RAR-11/01  
PB2011-916301

# Railroad Accident Report

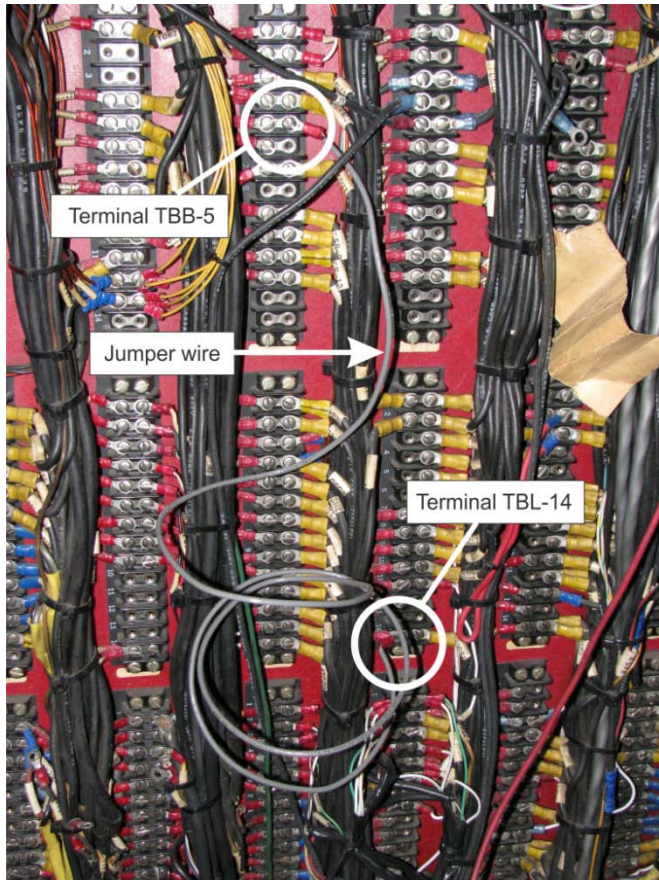
**Figure 7.** Train control terminal board as found after the accident with a jumper wire in place.

NTSB investigators inspected the system control compartment of the lead car (A-car) of the south train after the accident. A jumper wire was found to be in place on the terminal board between terminal locations TBB-5 and TBL-14. (See figure 7.) Because of damage to the south train, investigators were unable to test the train control system with the jumper wire in place. A review of the electric circuit schematics revealed that the jumper wire was bypassing the circuit that controlled electrical energy to the coil of the vital overspeed/overshoot relay. In case of a

failure of the program stop module, the circuit was designed to cut electrical power to the overspeed/overshoot relay coil, causing it to command an emergency stop. The jumper wire provided direct voltage to the coil, which kept the vital relay energized and prevented it from commanding a stop when the program stop module failed.

The investigation revealed, however, that JCI maintenance technicians, while troubleshooting ongoing problems with the ATC system and in order to keep the trains in service, had installed a jumper wire in the train control compartment of the south train. The NTSB reviewed the system schematics and determined that this jumper wire bypassed the overspeed/overshoot system relay. Bypassing the relay took the fail-safe component of the system “out of the loop” and placed sole responsibility for safely stopping the train on the nonvital program stop system—with no backup system in place if that system failed. Postaccident examination of train control and train braking system components revealed no evidence to suggest that the overspeed/overshoot system would not have worked as designed on the day of the accident. The NTSB concludes that, had it not been bypassed by placement of a jumper wire as part of a troubleshooting process, the overspeed/overshoot relay on board the south train would have functioned as designed when the program stop module failed and the overspeed/overshoot system would have intervened to safely stop the train and prevent the accident.
