Thirteenth Coast Guard District Waterways Analysis and Management System

Umpqua River 18584

Pacific Ocean to Reedsport

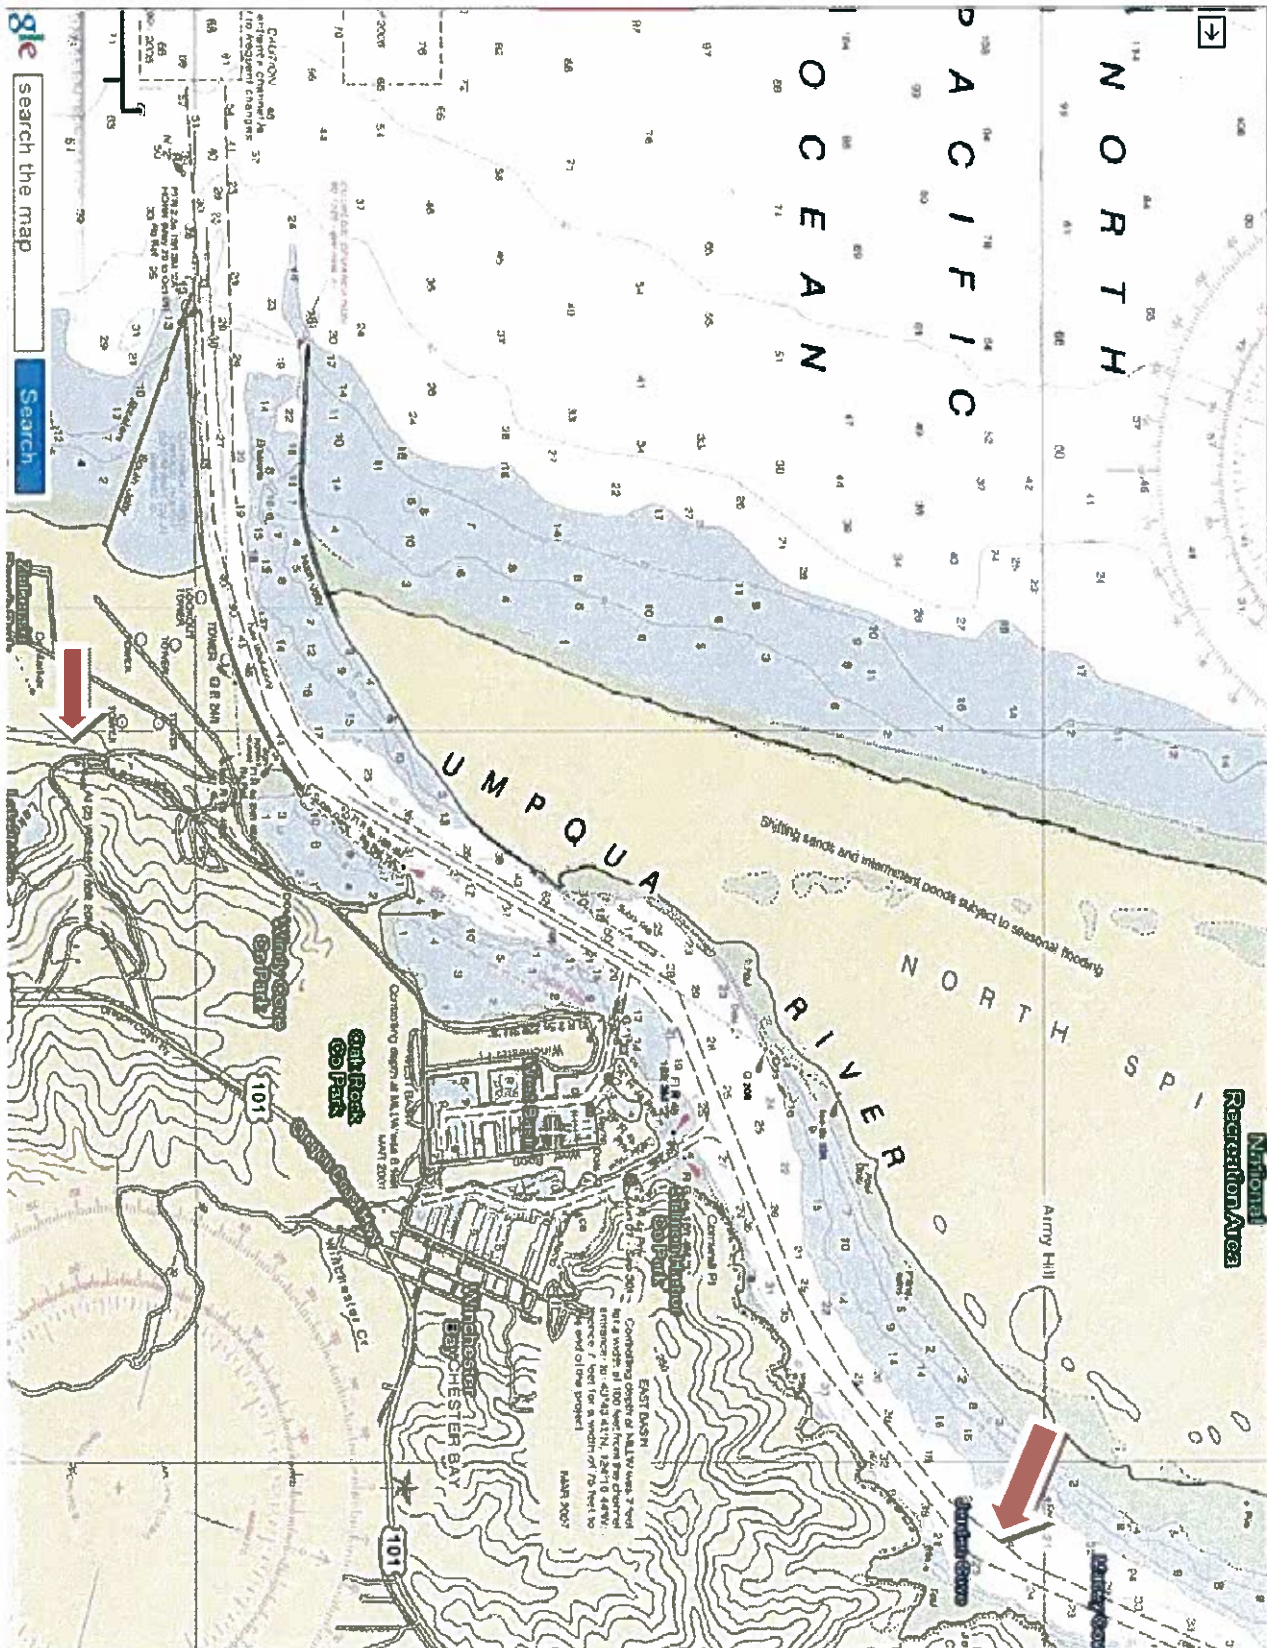
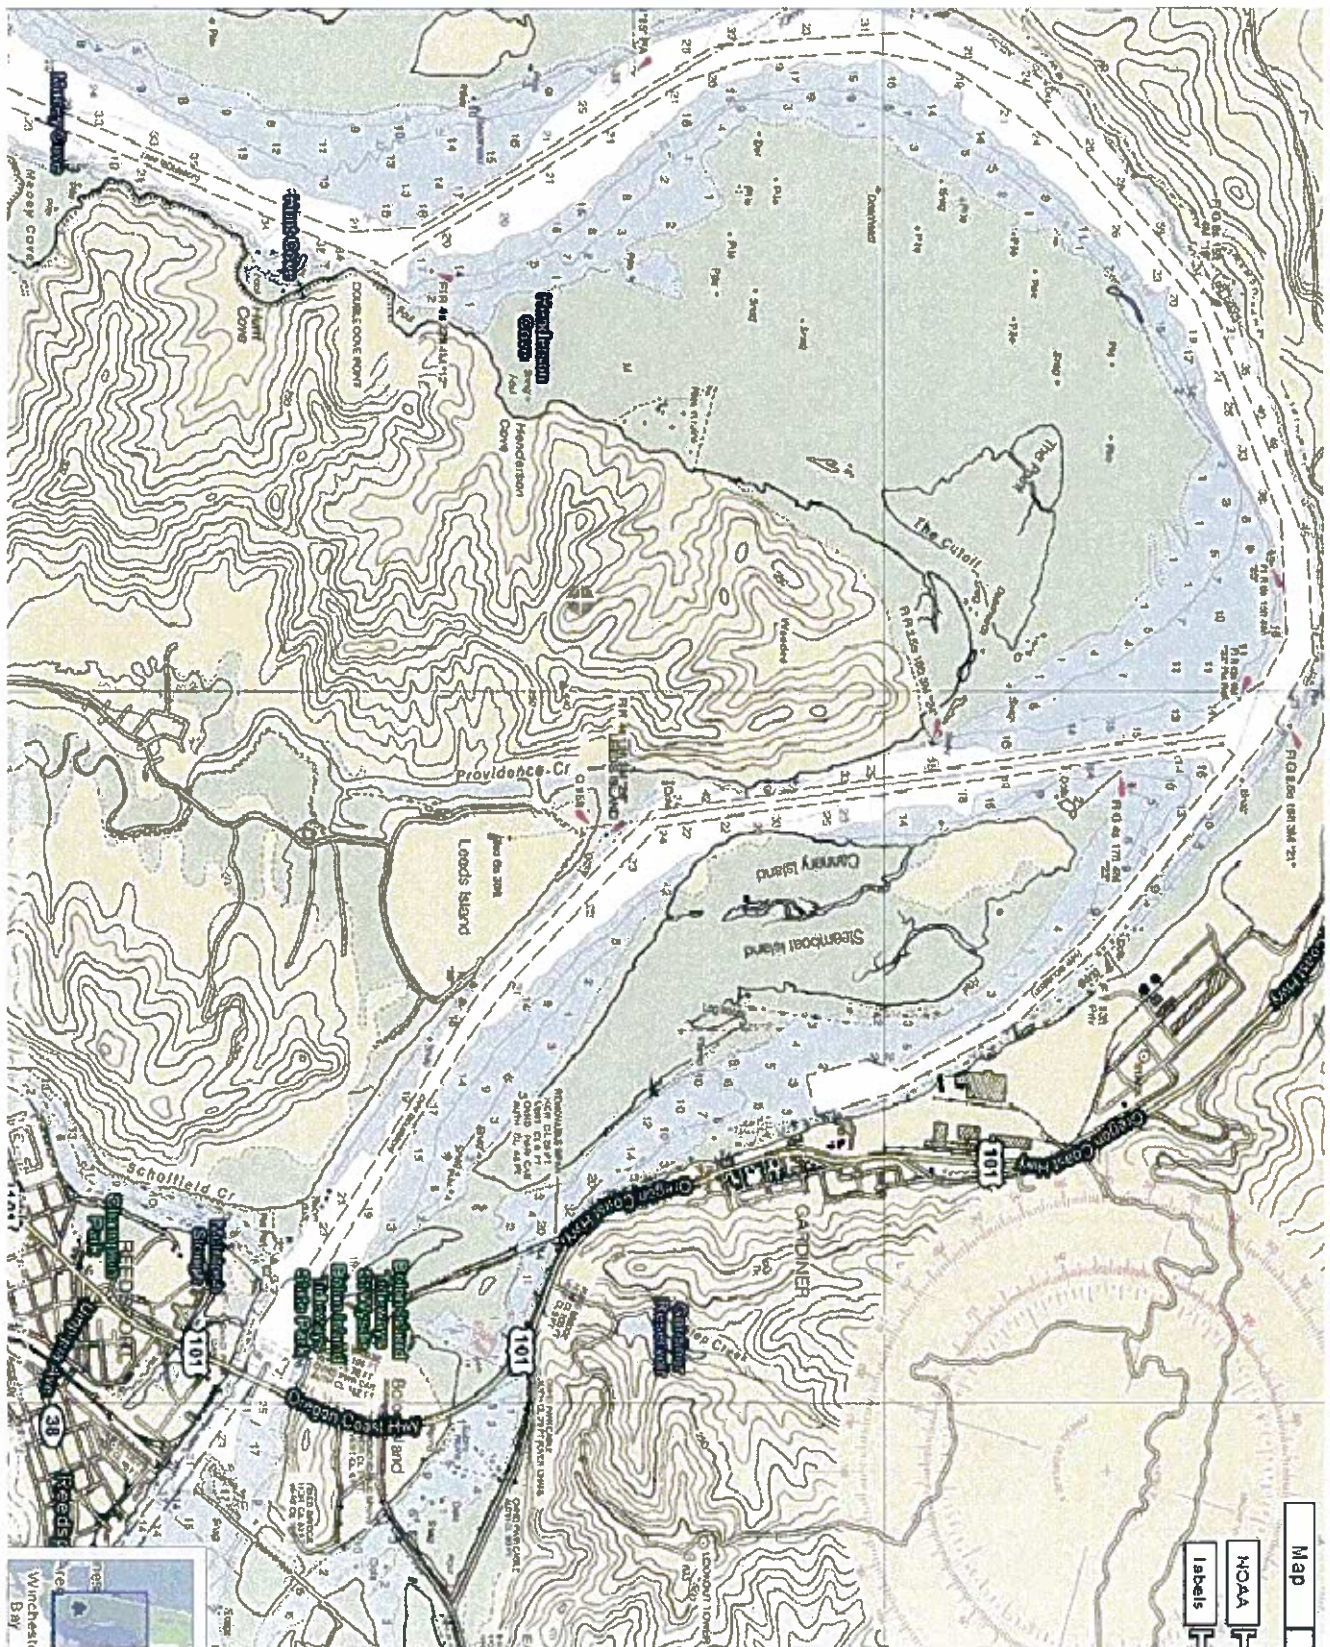
III. CHARTLET: Umpqua River

Based upon a review of all the available information regarding the Umpqua River Waterway, it is determined that the majority of the aids to navigation in the waterway are well intact and are suitable for safe navigation. However, there are two recommendations for ATON changes based upon all the information gathered and considered. Locations of these two are indicated by the red arrows on the chartlet on page 3.

The small boat transit of the waterway allowed CG reps to verify survey comments regarding the lack of markings between the East Basin and light #12. The two present aids are over two miles apart and a turn in the waterway blocks visual sighting of one aid when abeam the other. During nighttime transits, the current aid setup creates a visual gap which would be greatly improved with a lighted aid, presumably #10, marking a turn at approximate position 43-42' N and 124-09.6' W. The Commanding Officer of Station Umpqua River agreed with this recommendation.
