Long-Term Performance of Corrosion Inhibitors Used in Repair of Reinforced Concrete Bridge Components

Publication No. FHWA-RD-01-097

U.S. Department of Transportation
Federal Highway Administration
Research and Development
6300 Georgetown Pike
McLean, VA 22101-2296

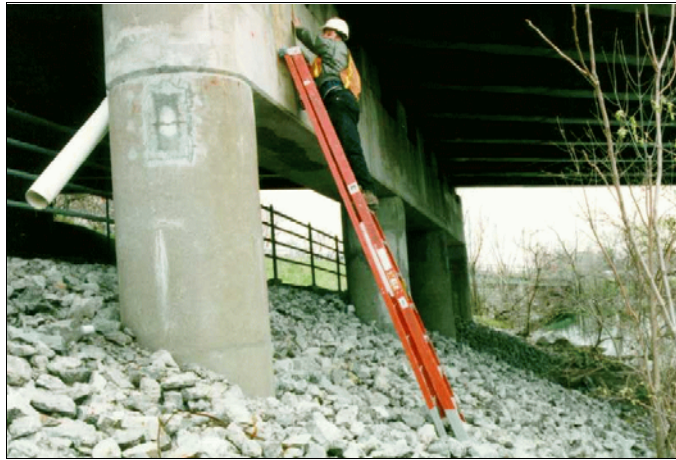
Visual surveys were conducted during all three visits. In October 1994, approximately 2 years after the repair of the piers, the west section of the south face of all three pier caps appeared sound and no spalls were observed. The patched areas, particularly those with inhibitor treatments, were severely cracked. The observed cracking pattern was mud-flat cracking, typical of drying shrinkage cracks. During the second and third visits (May 1997, and June 1998, respectively), the drying shrinkage cracks appeared to be about the same. However, minor spalling was observed in the three piers.

Figure 2-2. Views of test sections on: (a) south pier (control), (b) middle pier (Cortec 2000), and (c) north pier (DCI).

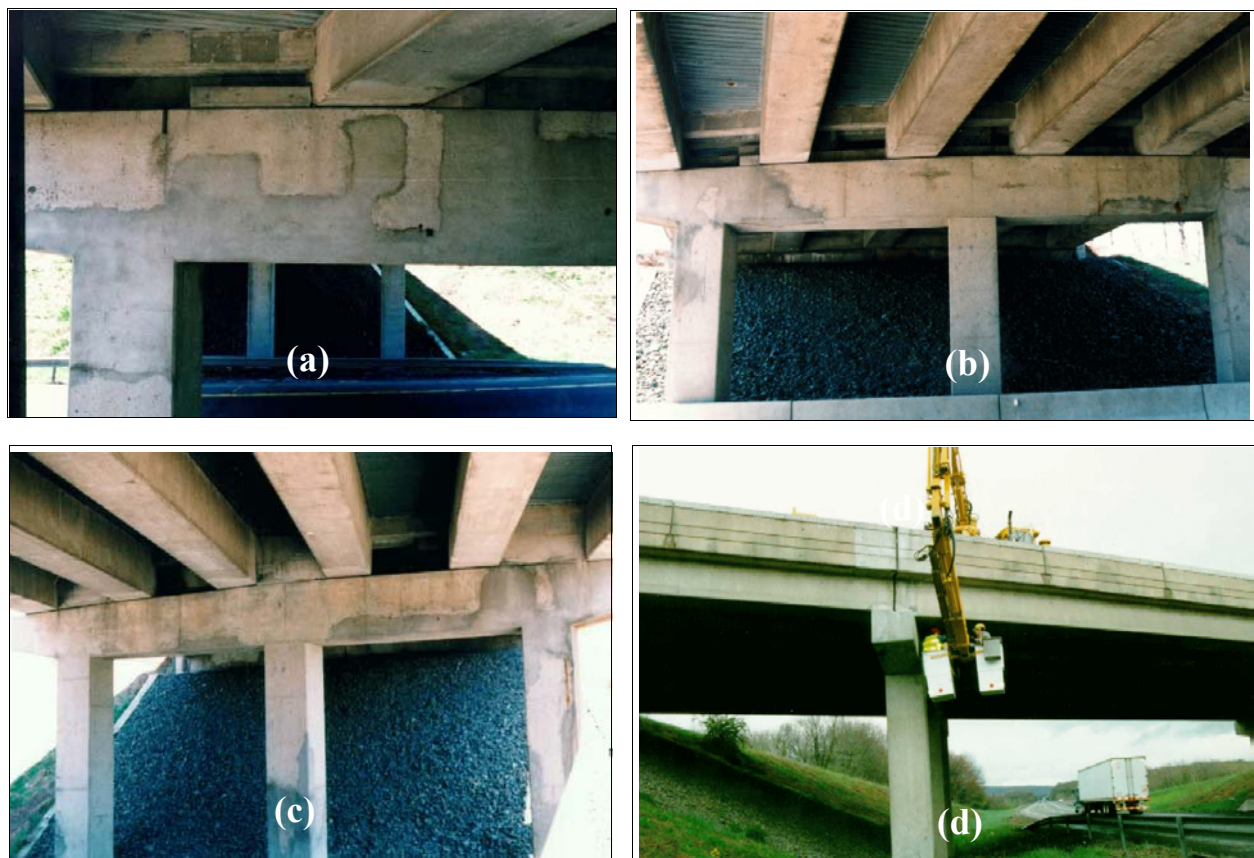
Figure 3-2. General views of piers:
(a) pier 1, (b) pier 2, (c) pier 3, and (d) field evaluation in progress.

During the first visit, the concrete surface of the three pier caps did not have spalls. All patched areas on the three pier caps were cracked. Detailed mapping of the cracks was not performed. Cracks generally occurred along patch perimeters and the crack pattern within patched areas was typical of drying shrinkage cracking. Cracking was not observed in the original concrete areas. Visual observations of the three piers during the second visit did not show much change compared to the first evaluation. During the third visit, approximately 2.5 m of new cracks were documented in the patch areas of pier 3 (treated with Cortec 2000). These cracks did not appear to be caused by drying shrinkage. Outside the survey area of pier 3, corrosion products were visible in the original concrete. The shrinkage cracks on the other two piers remained the same. Spalls were not visible on any of the three pier caps.

All patches on the control pier and the treated piers were experiencing shrinkage cracking. By the third evaluation, additional cracks had developed in the patches treated with Cortec inhibitor. Rust staining that originated in a crack at the patch concrete interface of a patch treated with the Cortec inhibitor was noted in the third evaluation. Hollow-sounding areas were observed on the patch of the pier treated with DCI inhibitor and they increased with time.
