**US Army Corps  
of Engineers**

USACERL Technical Report 99/28  
February 1999

# Engineering Life-Cycle Cost Comparison Study of Barrier Fencing Systems

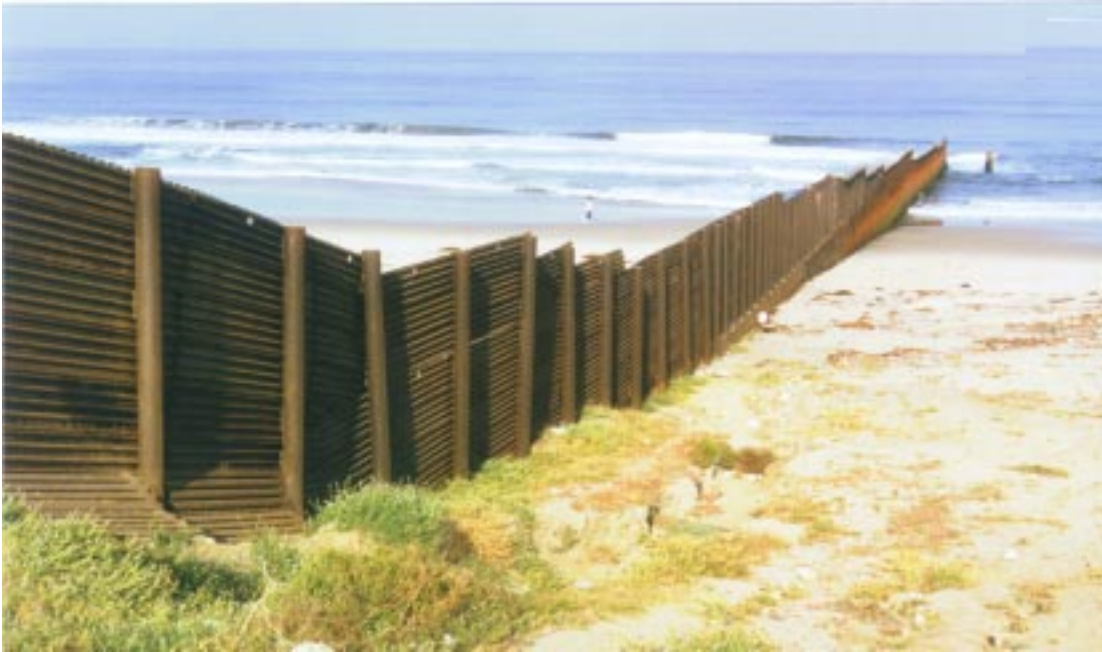
Figure 1. Landing mat design barrier.

The landing mat fence (shown in Figure 1) is one of the few designs where significant long-term experience has been gained for its application. Although its installation was an impressive effort in response to the mission needs of the Border Patrol, the benefit of functional experience offers some lessons learned. An initial lack of detailed design, construction procedures, and performance requirements has resulted in problems. These problems include:

- inadequate footings for the terrain, loads, and soil conditions involved
- lack of provision for thermal expansion
- inadequate corrosion protection
- lack of dig-under prevention
- inadequate resistance to mechanical attack
- inadequate barrier to quick re-entry into Mexico to avoid apprehension (a Border Patrol operational requirement).

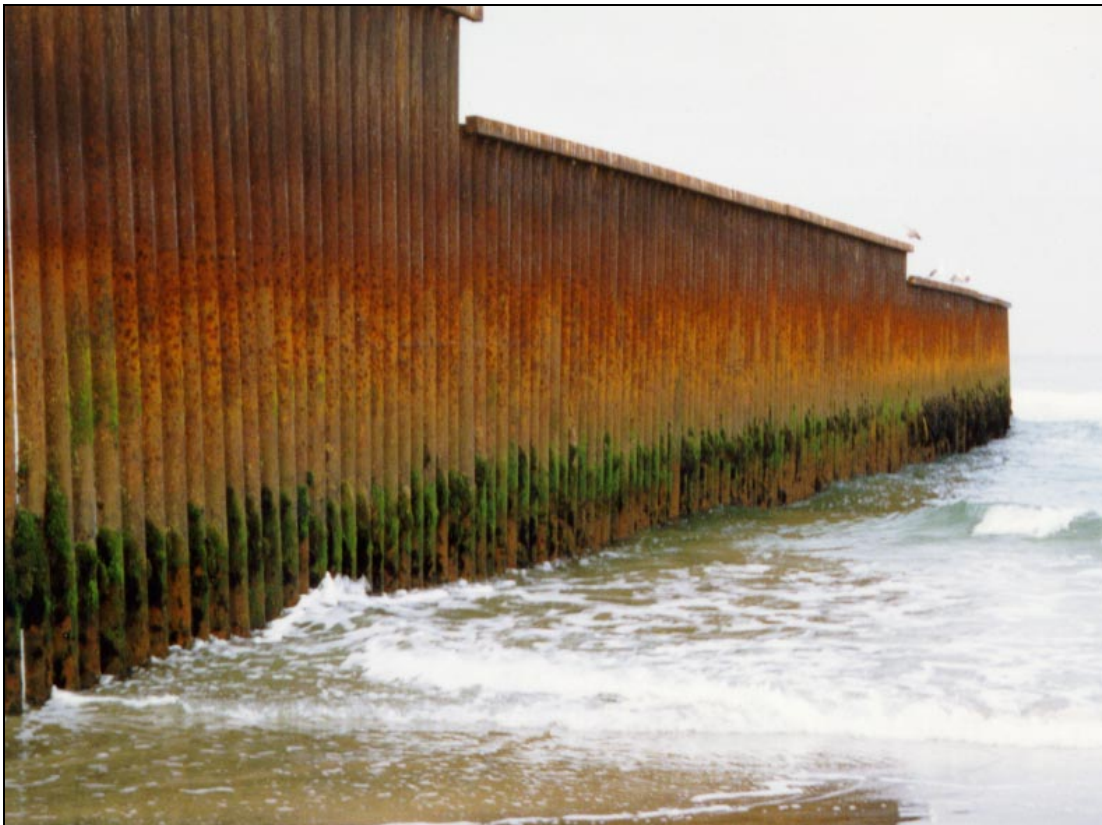
The first section of primary barrier is the ocean fence shown in Figure B.1. This section has severe corrosion from saltwater exposure. Figure B.2 shows the first subsection, which is usually in contact with sea water except at low tide. Subsection 1 is constructed of hollow vertical steel poles 6 in. in diameter, inserted 5 to 6 in. apart in the sand. The poles are Schedule 80 or 120 and are welded together at the top with 4x6-in. steel bars and buried 12 to 15 ft in the sand. Some poles are not equipped with endcaps. Therefore, some poles are exposed to salt and sand both internally and externally. The fence is approximately 12-ft tall on the beach. Blistering on the poles is evident along with algae and barnacle deposits. The metal has an orange color on surfaces that regularly contact the sea water during high tide.

Figure B.1. Sea water corrosion on border fence.

have been reinforced with concrete to prevent dig-under breaches. The subsection of the fence in contact with saltwater will need to be replaced in 3 to 5 years because of severe corrosion. The other subsections near to the water will require replacement within several years. Cathodic protection should be used with the replacement fence components where applicable. The replacement fence on the embankment and beach will need to be built on a concrete foundation.

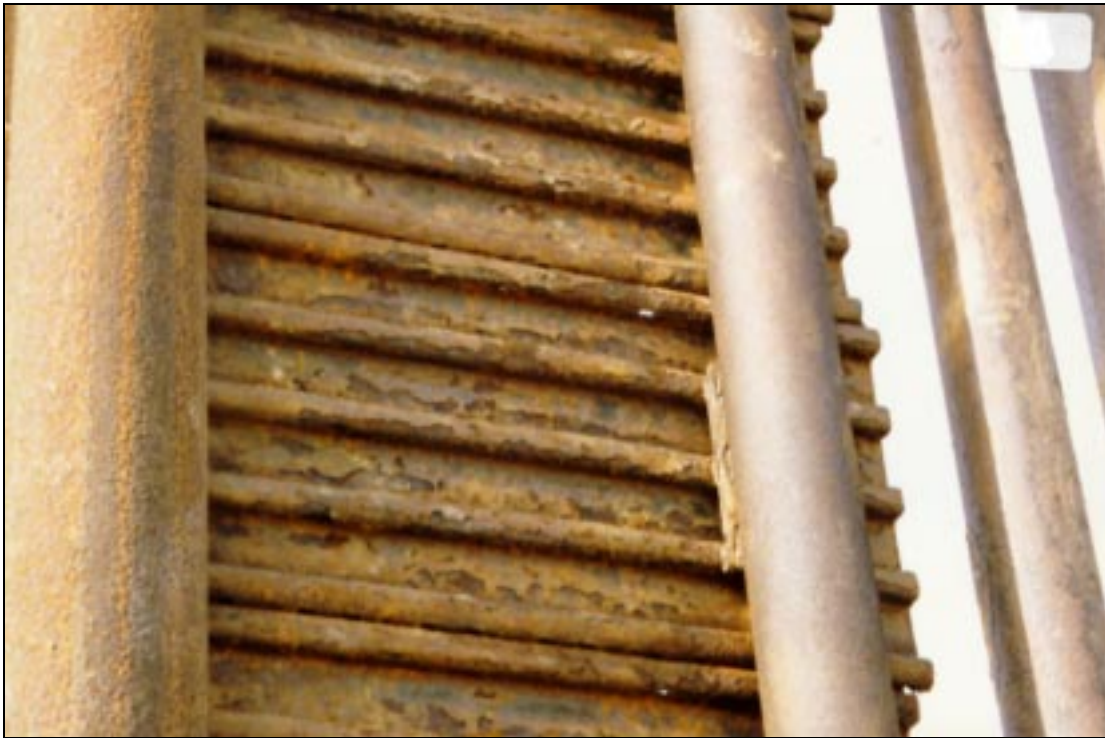
The landing mats and square pipes are heavily corroded with flaking on the surfaces as shown in Figure B.2, which also shows welds that are broken from the thermal stresses on the landing mats. No paint remains on the landing mats. Figure B.3 shows the landing mat section going up the embankment to a chain link fence. This subsection is heavily corroded from the salty ocean air. Erosion and digging under the fence are major problems for the loose sandy soil on the steep embankment. Figure B.4 shows an area where the bottoms of the fence

Figure B.2. Welds on landing mats are broken from thermal stresses.

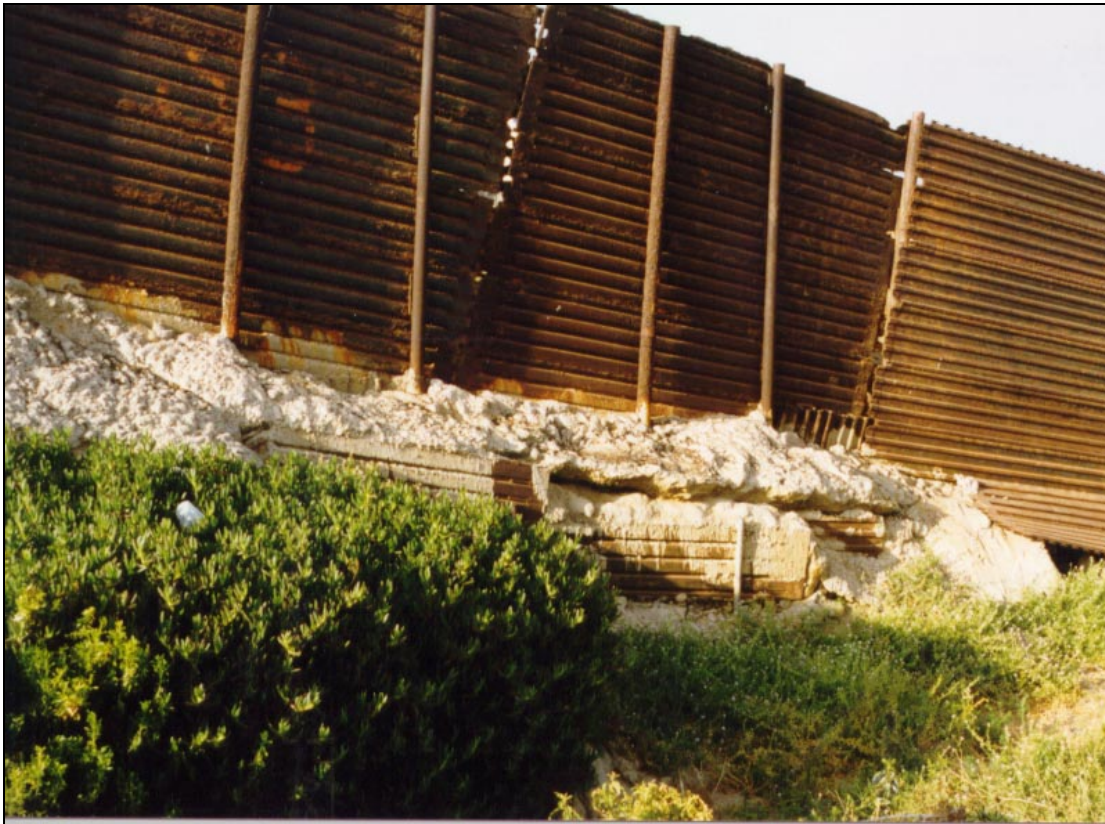
Figure B.4. Concrete poured into holes under the fence as a result of dig-under breaches and erosion of the loose beach sand.

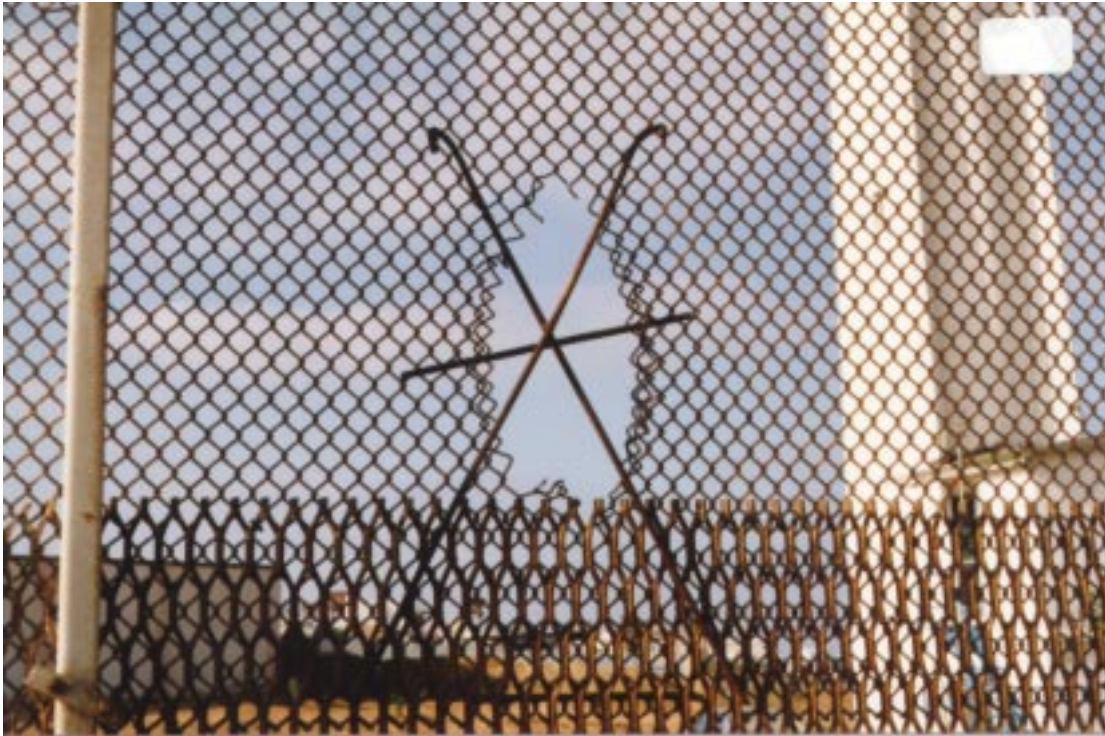
Figure B.6. Ad-hoc repairs to the chain link fence.

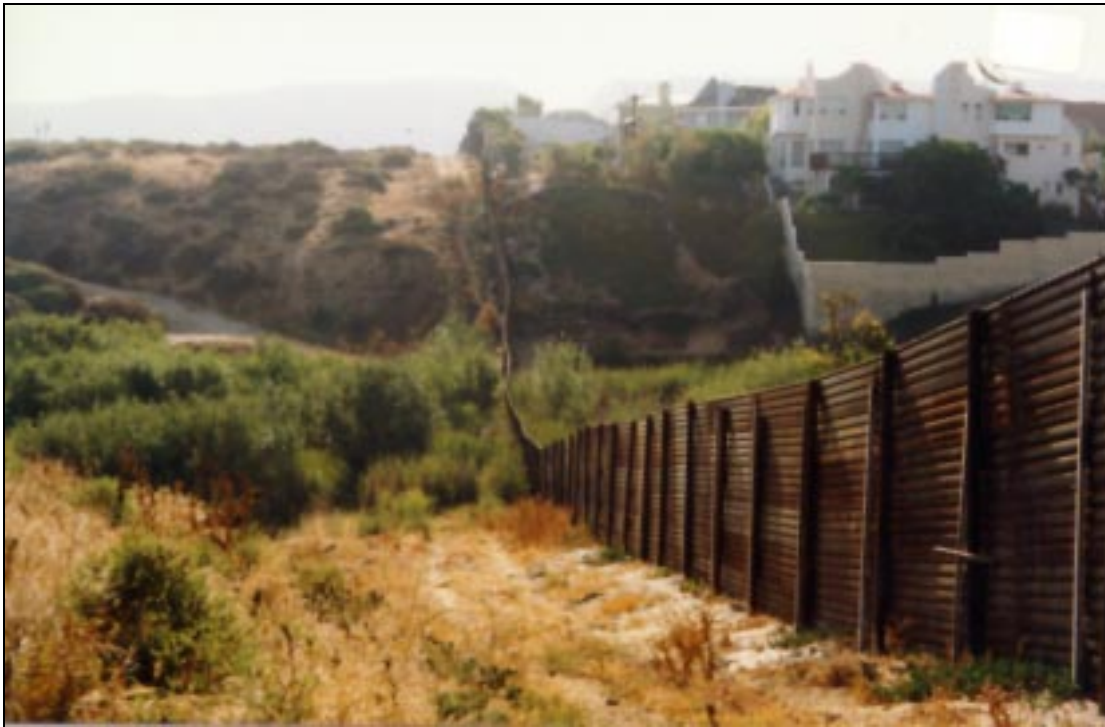
Figure B.5 shows the chain link fence that connects to the beginning of the landing mat fence about 500-ft inland. Figure B.7 shows where the fence extends over the hill to a salt marsh that is 1,000 ft inland. Sections are horizontally installed with six panels per section for a height of 10 ft. The original fence used channel bar every 6 ft to support the landing mat sections but was later reinforced with 4.5-in. well casings between the bars as shown in Figure B.8. Close inspection of the landing mat in Figure B.8 shows the mats connected to the support poles by welds and connected to each other by pins welded on both sides. Welding of both sides of the connecting pin restricts thermal expansion of mats and results in the welds to the poles being broken and the fence bending to relieve thermal stress as seen in Figure B.7. One method of relieving the thermal stress is to weld just one side of the connecting pin. The effects of saltwater corrosion lessen significantly just several hundred feet inland. Figure B.8 shows paint on the landing mats with reduced corrosion from the ocean fence sections. The loose sandy soil causes considerable problems from dig-unders and erosion. Figure B.9 was taken 1,000 ft inland in the salt marsh and shows a repair for a dig-under and a cut pole. The poles have been reinforced in concrete so they can hold steady in the loose sandy soil.

Figure B.7. Fence is bowed from thermal expansion as it extends inland.

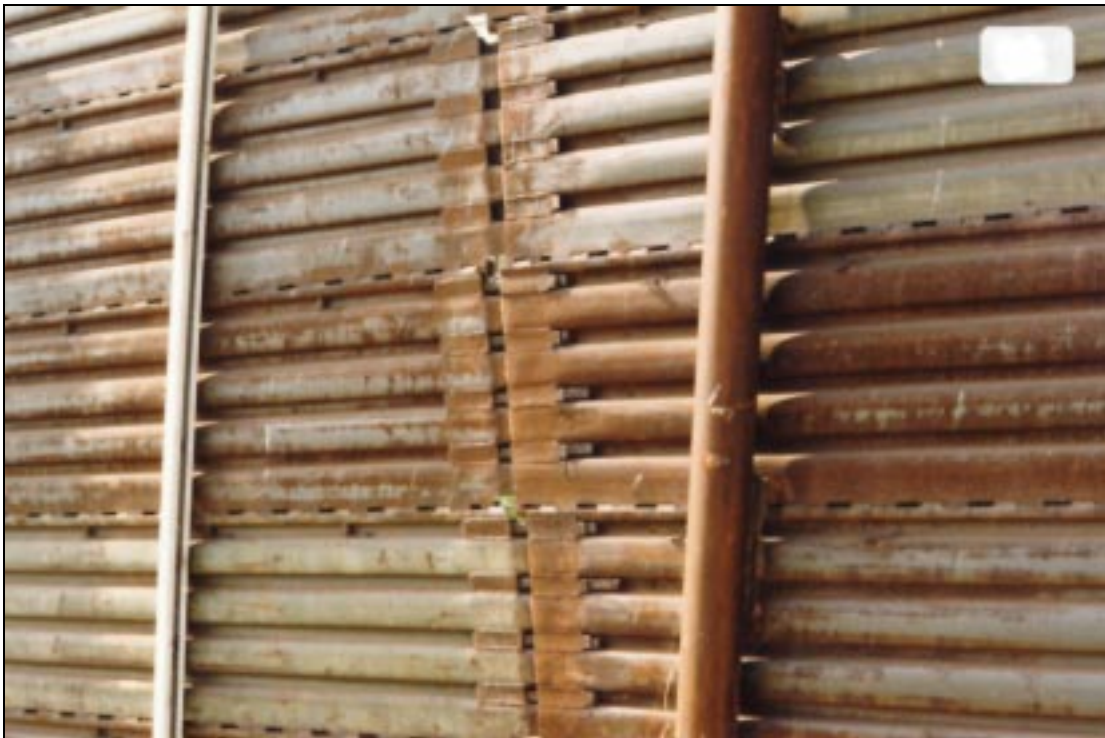
Figure B.8. Mats still have paint only 700 ft inland, and sections are connected by square pins and welded to vertical pipes.

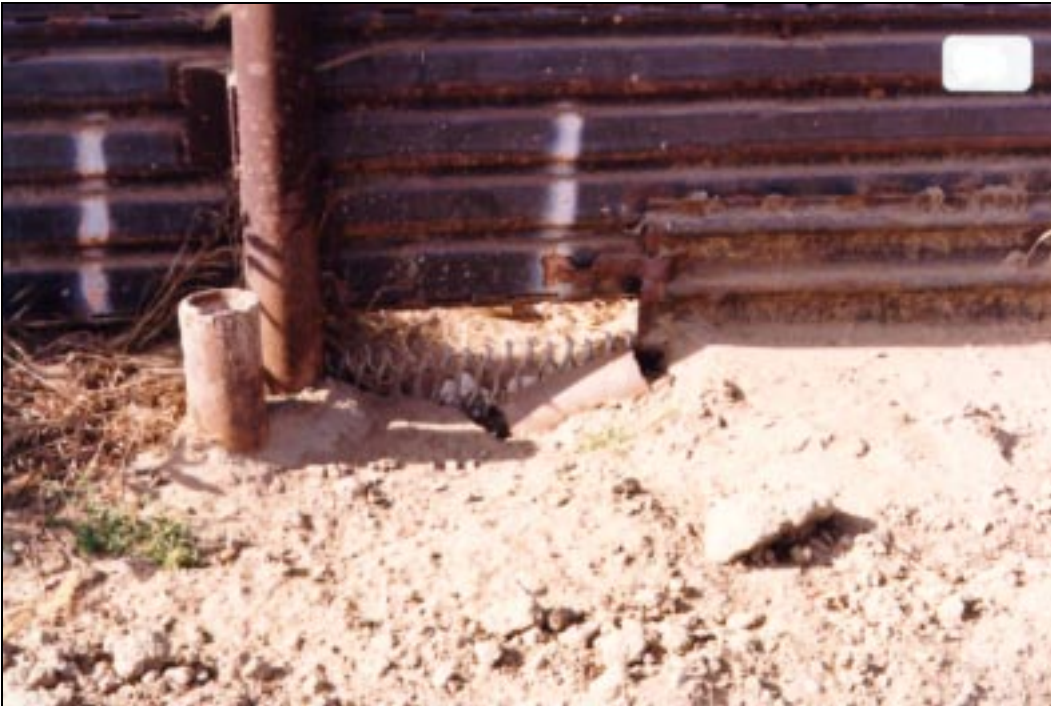
Figure B.9. Dig-under and cut pipe repairs 1,000 ft inland.

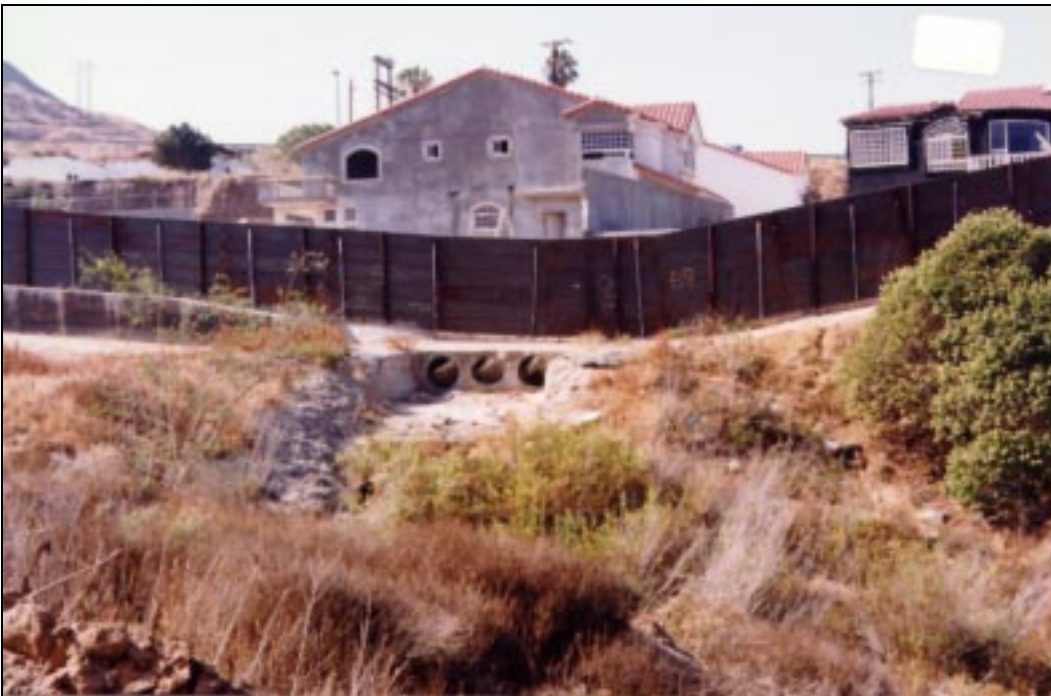
Figure B.10 shows drainage tubes under the fence at the bottom of the second hill. These tubes are a high traffic area for crossing. Drainage from rain and sewage flows through the tubes and would clog if gates were installed. The trash could then pile up against the primary barrier. This pile up not only would put an added load on the fence but also could act as a ramp if compacted.

Figure B.10. The high traffic through the drainage tubes under the fence has buffed the metal interior to a shine.

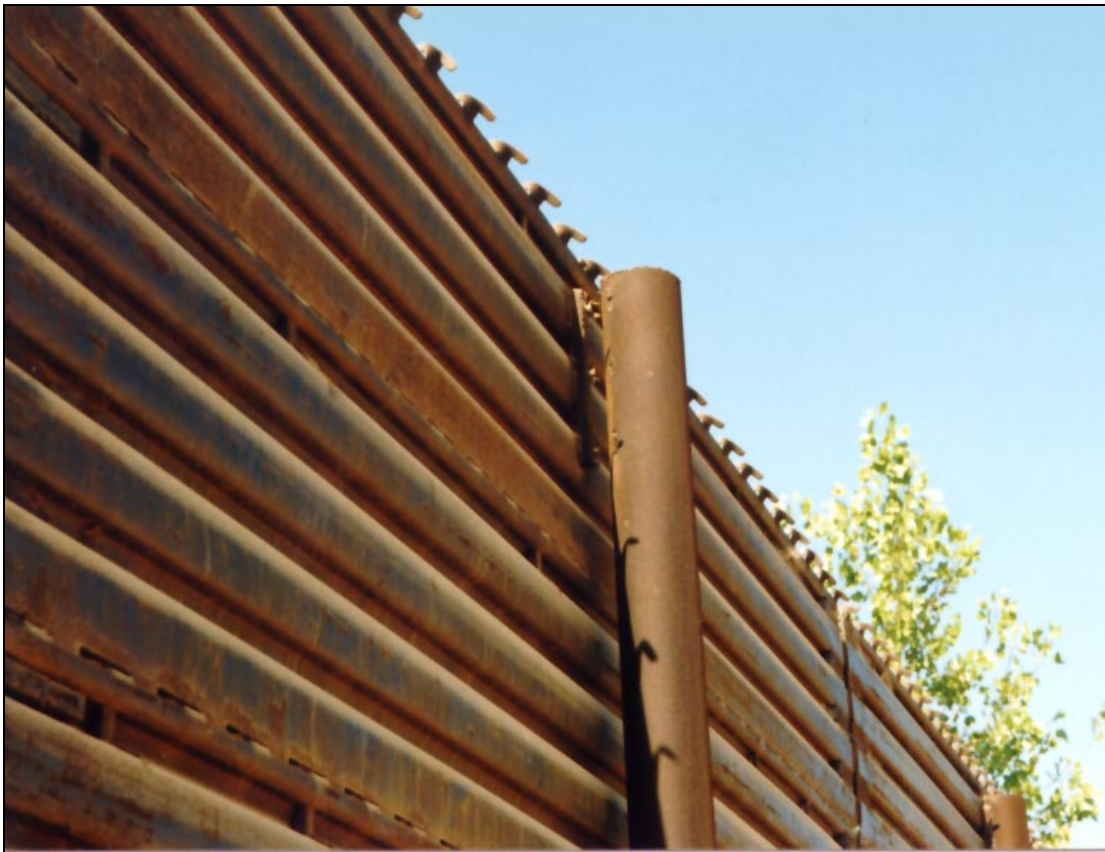
Figure B.12. Welds between the mat and poles are broken from thermal stresses.

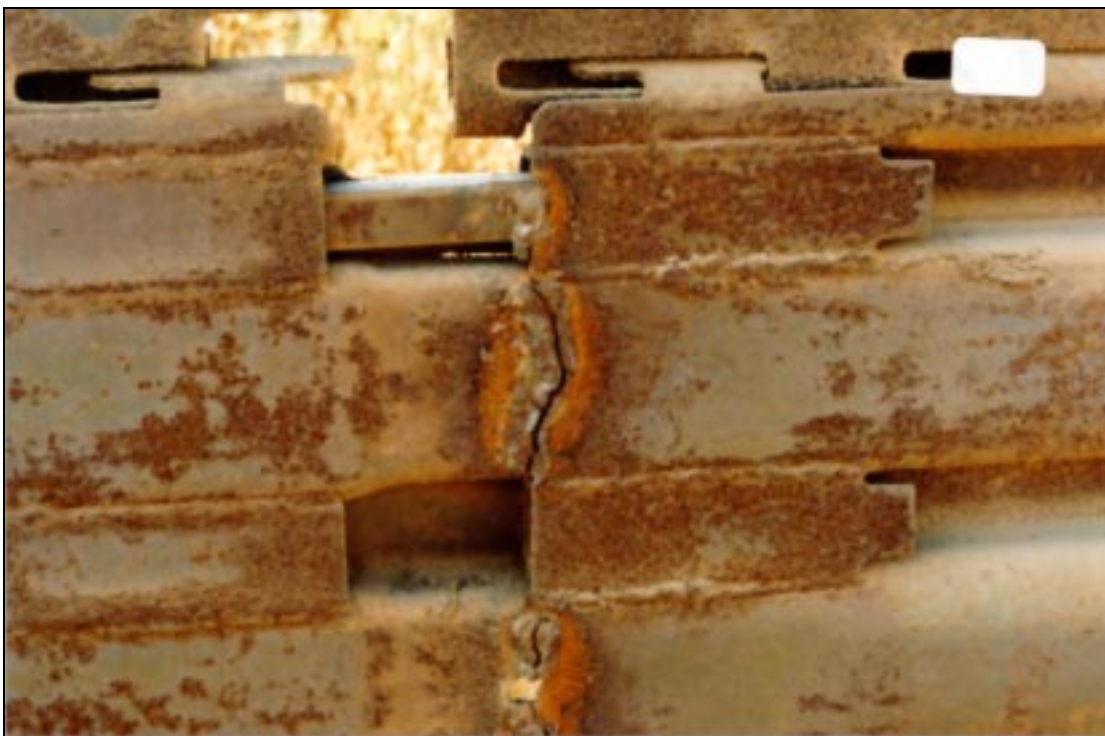
Figure B.13. Broken welds between mats and a repair made by welding one side of the square attachment pin.

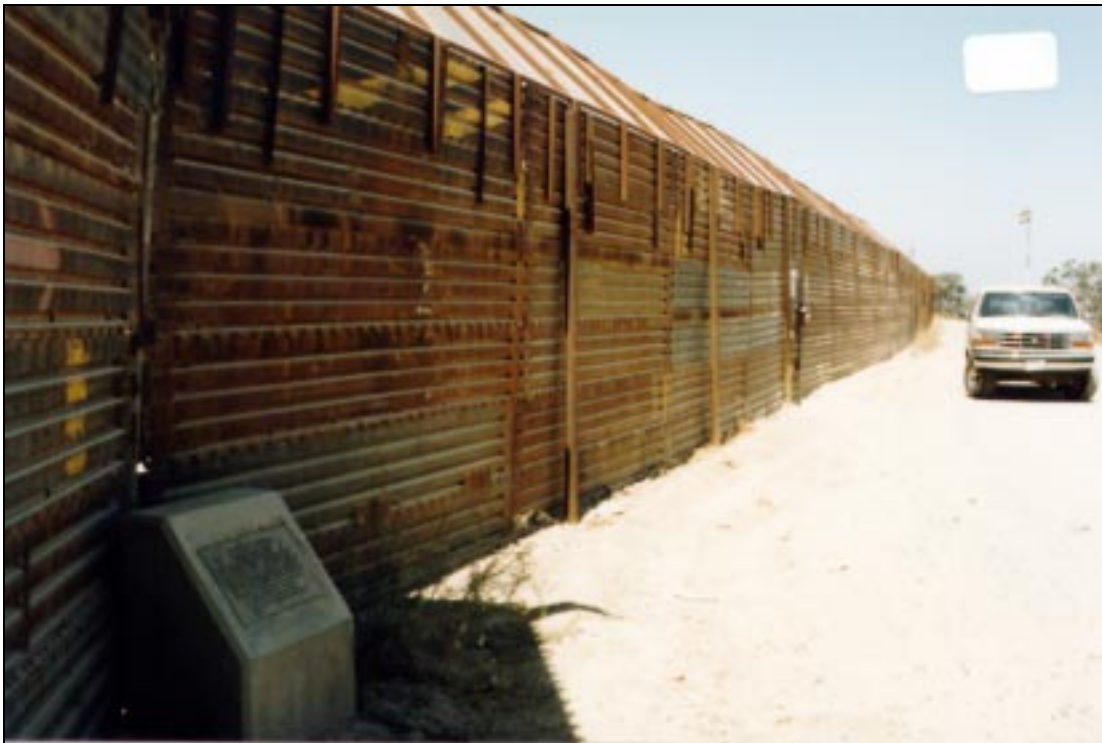
The Tijuana levee is east of the sewage plant. The fence borders the levee and extends past the old truck entry point to the San Ysidro border entry point. The area shown in Figure B.16 is another high traffic area where the BP has rein-

forced the fence. Angled extensions have been added to the top of the fence making it well over 10-ft tall. The support poles for the fence are 3.5-in. diameter pipes (not the well casings) that are welded to the mats only at the end of the pipe. The poles are positioned nearly 12-ft apart on center, which is not sufficient to properly support the weight of the landing mat sections. The pole behind the monument is only 2.5 in. in diameter, which is inadequate to support the weight of the fence. The sections are seven panels high, weighing approximately 1,260 lb. The ground along the levee is firm, so poles have a stable footing. The fence extends from the levee monument down a small hill to the old U.S.-Mexico truck entry point shown in Figure B.17. The secondary landing mat fence starts behind the BP vehicle parked in the shade west of the old gate. The fence runs parallel to the primary barrier. Figure B.18 shows the additional deterrents added to the secondary fence, which is six panels high with two panels in the overhang. Two-ft wide sheet metal is attached to the fence about 5-ft above the ground. In addition, the overhang is capped with 6- to 7-in. diameter PVC pipe, which does not allow anyone climbing the fence to grip the top. The secondary fence appears rusted but not damaged.

Figure B.16. Fence along the Tijuana levee.

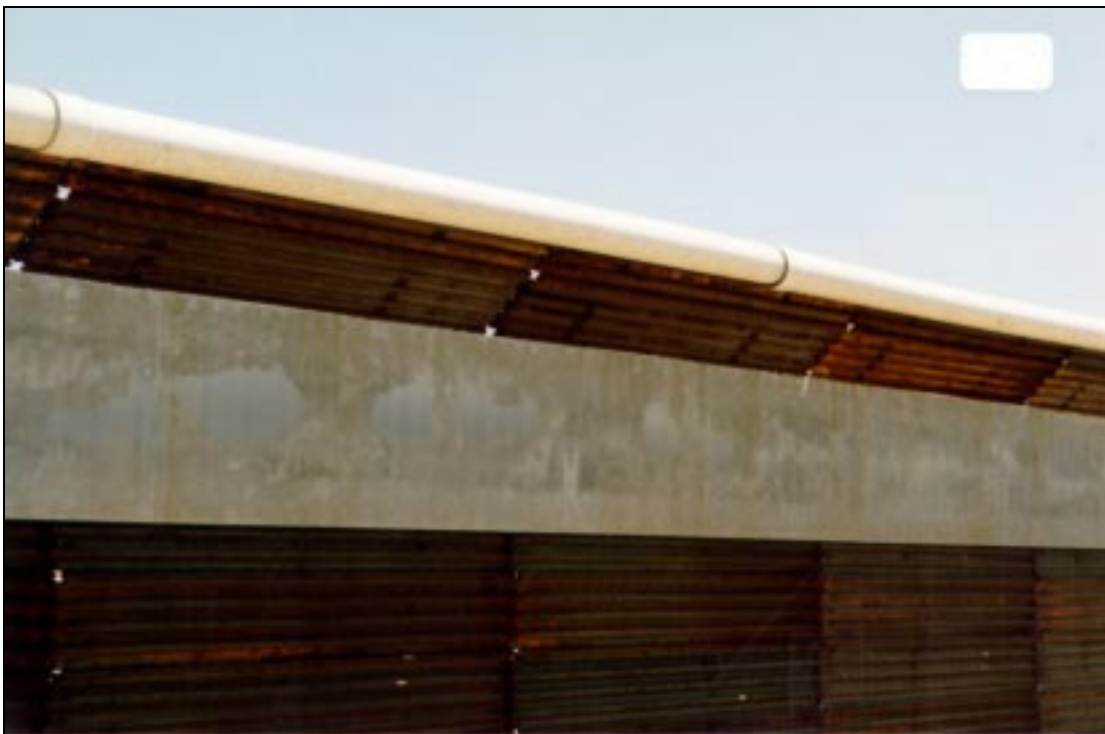
Figure B.18. Secondary fence in the section west of the San Ysidro border entry.

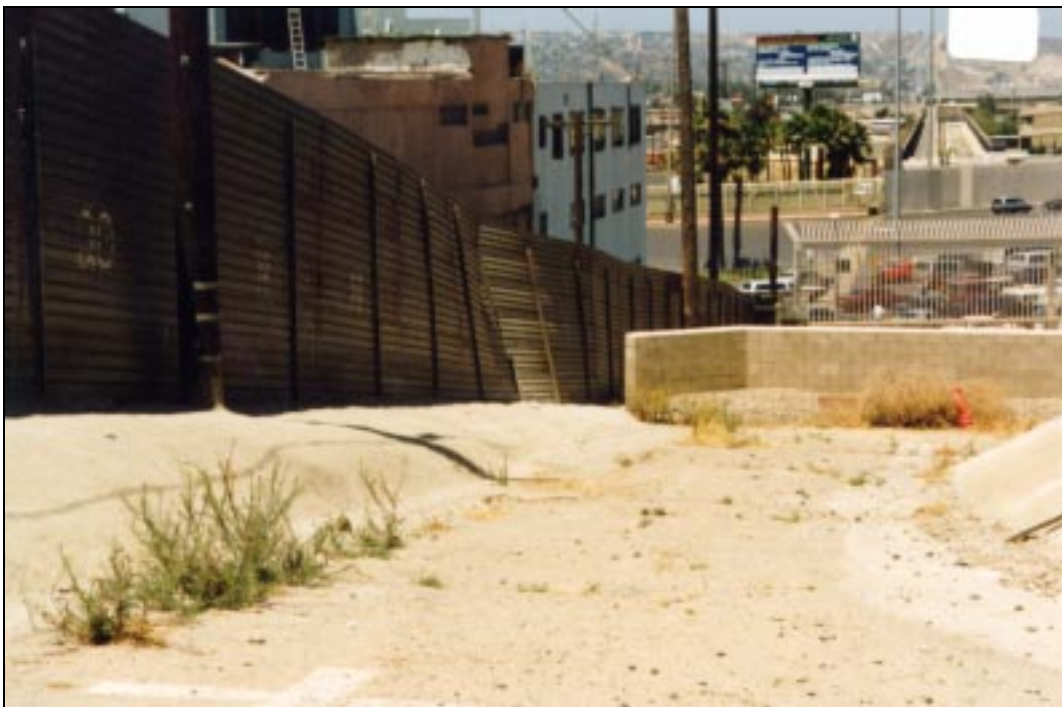
The fence shown in Figure B.19 begins east of the San Ysidro border entry point. The other side of the brown vertical bar fence is Mexican territory. The fence is supported with 2-by-2-in. I-beams embedded in concrete. The concrete reinforcement of the fence bottom with wire mesh inserted into the ground. The I-beams are approximately 10 ft on center and about 8.5-ft aboveground. The deformation in the fence shown in Figure B.19 has resulted from pulling on the fence. The sheared I-beam at the bend indicates that the I-beams are insufficient to support the fence. The panel surfaces have small amounts of corrosion with some of the original paint still intact. The fence extends from the border entry point east to the hilly terrain shown in Figure B.20. Note how close the dwellings on the Mexican side of the fence are to the primary barrier. The hills precede a large stretch of fairly flat ground that is a high traffic area for illegal crossings. The flatness of the ground is shown in Figure B.21. A large highway south of the fence leads to the Tijuana Airport. Figure B.21 shows repairs made to the fence after an accident with a semi-truck on the Mexican highway. The truck bent a section of fence, but the BP was able to bend the damaged pole back to support the panels and maintain the integrity of the fence.

**Figure B.19. Fence east of the San Ysidro border entry point.**

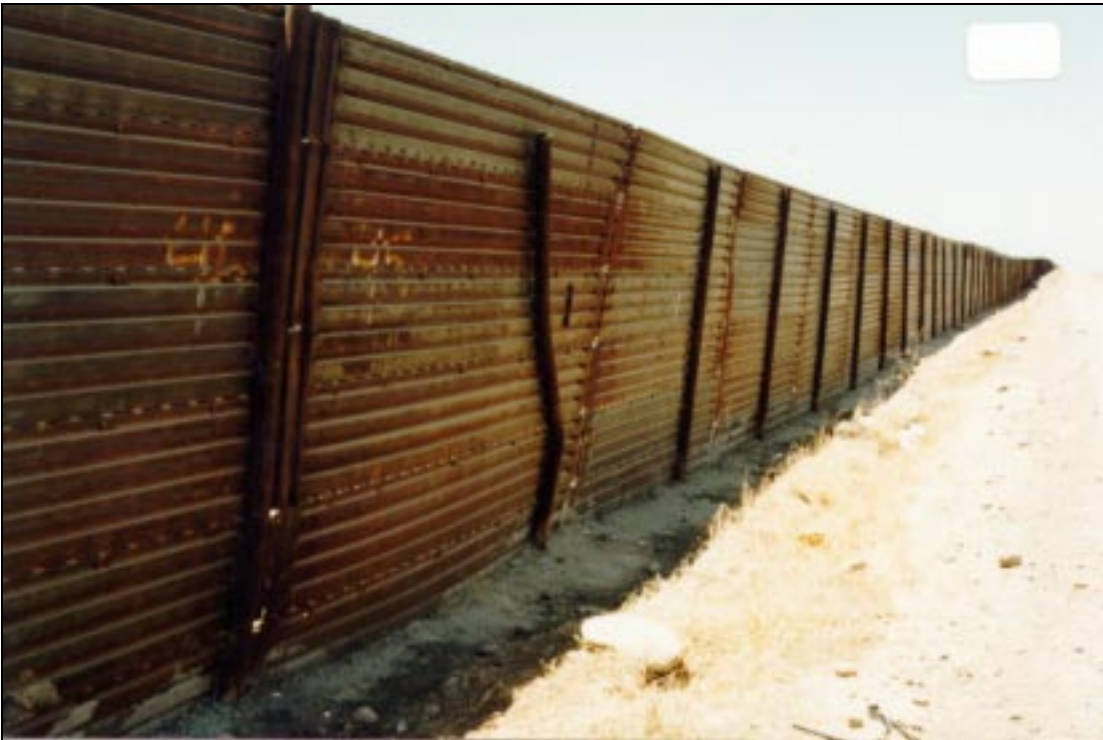
Figure B.21. Fence running between the hills and the Tijuana Airport is repaired from a truck collision on the Mexican side.

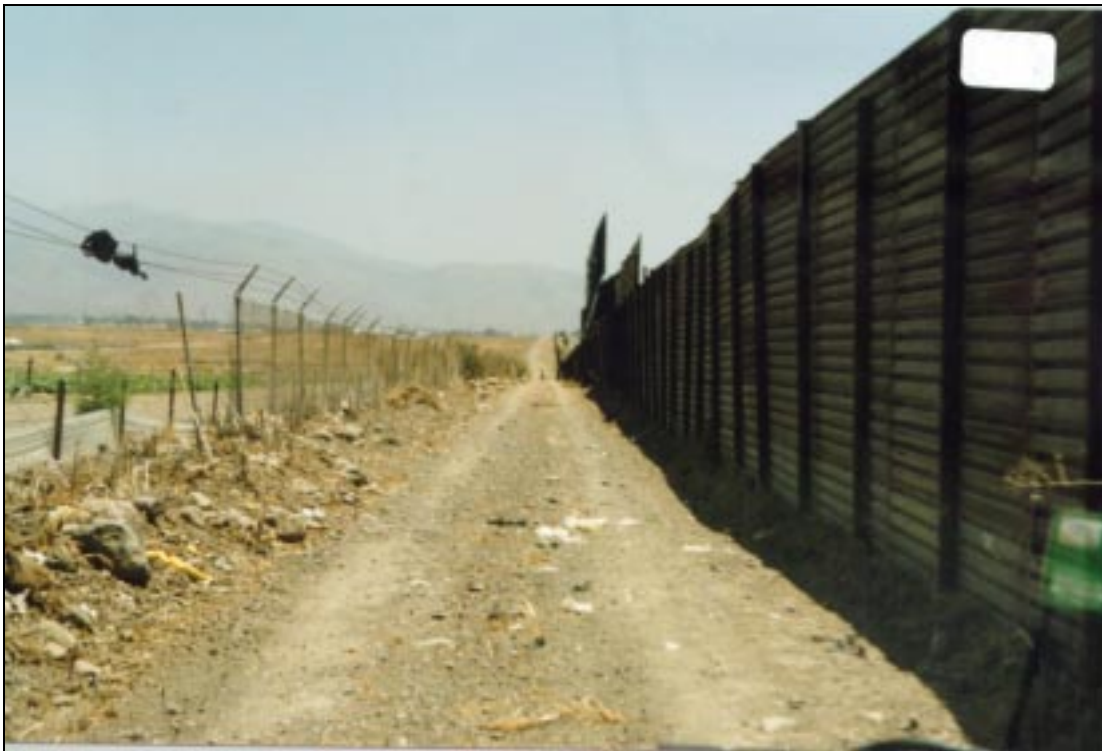
Figure B.22 looks east over the flat landscape preceding the Otay hills in the distance. The soil composition is still loose and sandy, making digging under the fence easy. The 8.5-ft height of the fence makes climbing over the fence easy also. An illegal alien is surveying the ground in the distance. If the BP were to approach him, the alien would just hop back over the fence. The billboards rising above the fence are next to the Tijuana Airport. The chain link fence just 10 to 12 ft north of the primary fence borders private property. The fence has been damaged by heavy traffic, and sections of it are completely gone. Trash from Mexico is also visible. About 1 mile east of the Tijuana Airport and 1 mile west of the Otay truck border entry point is the installation site for the secondary Sandia fence. The Sandia fence is roughly 120 ft north of and parallel to the primary fence.

**Figure B.22.** Looking east along the fence toward the Otay hills.

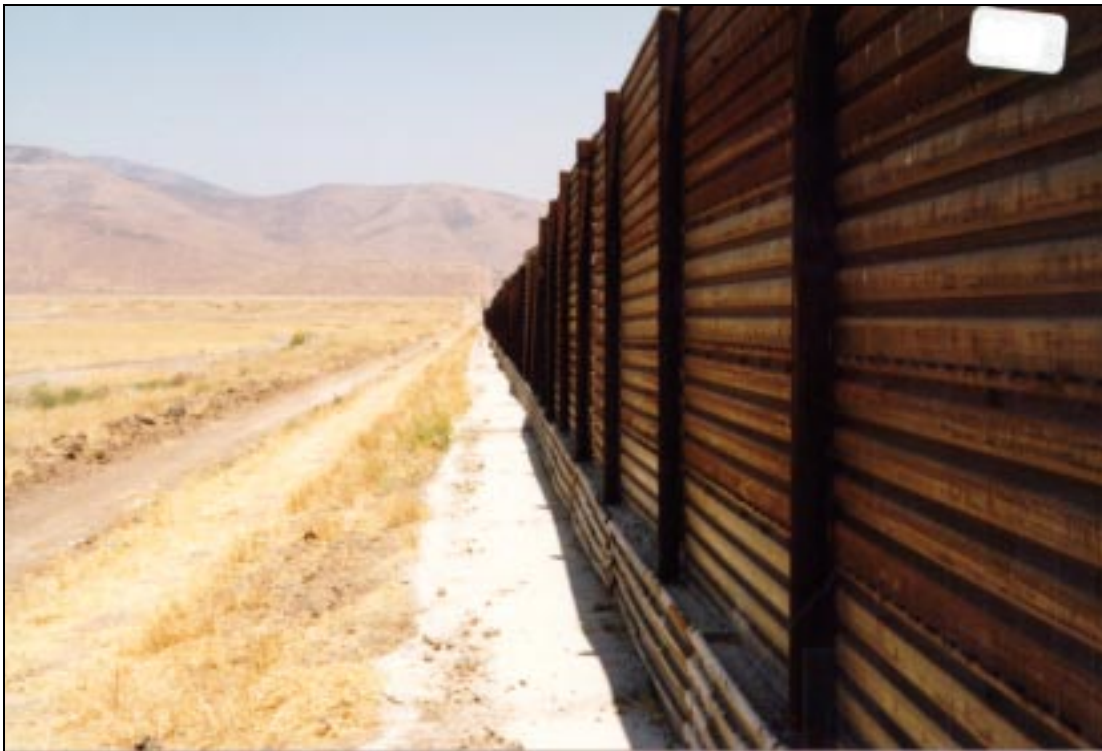
Figure B.23 shows the fence on the level terrain east of the Otay truck border entry. This area of primary fence has been reinforced at the base with additional landing mat inserted into the ground and concrete. This reinforcement method appears to work very well in preventing dig-under breaches and solidifying the pole supports in the loose soil. There are no major bows in the fence alignment and much of the original paint still exists on the mats. Damage to the fence has been more aggressive in this area of the border. Figure B.24 shows damage to the fence made by cutting and/or disconnecting the panels. Repairs were made by welding a horizontal pipe between vertical supports. The far east part of the fence has not been reinforced with concrete. Figure B.25 shows the result of attacks on this part of the fence by car ramming. The panels toward the top of the fence were separated by the ramming, but the fence did not collapse from the impact. Note that the connections between landing mat sections are welded rods between sections and an additional panel behind the poles without concrete. The sturdiness of the well casings as support poles and the landing mat panel as a primary wall was verified in this incident.

**Figure B.23. Flat region of fence east of Otay truck entry point.**

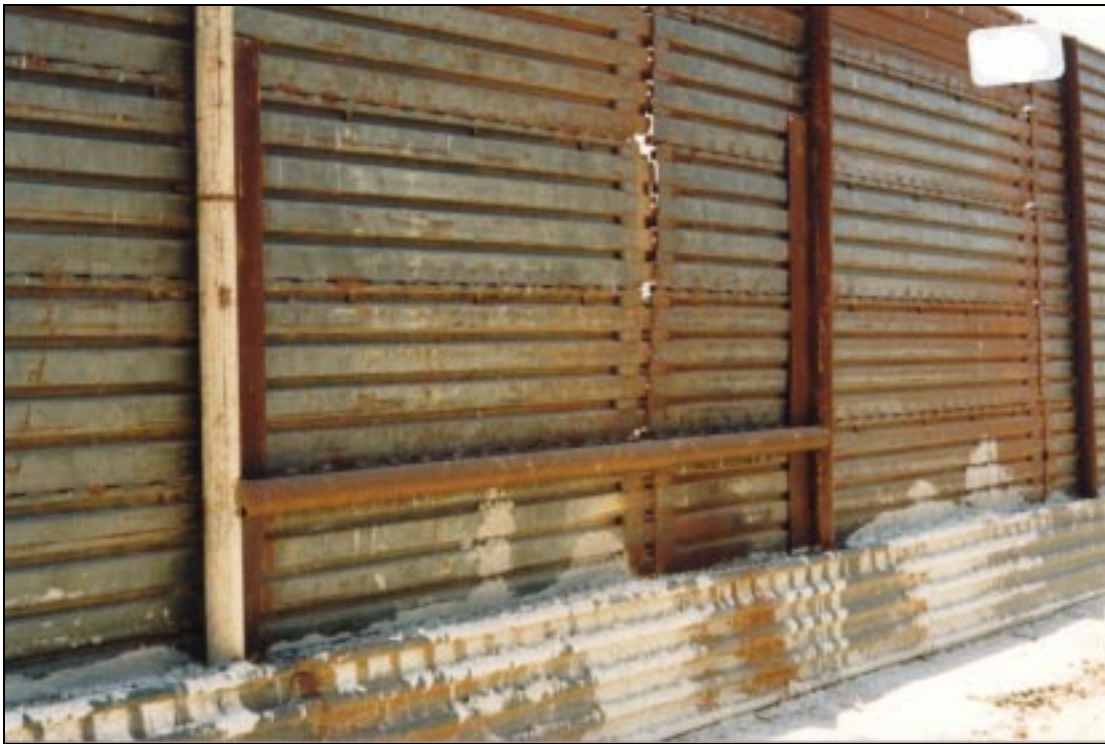
Figure B.24. Repairs to fence damaged by cutting and disassembly.

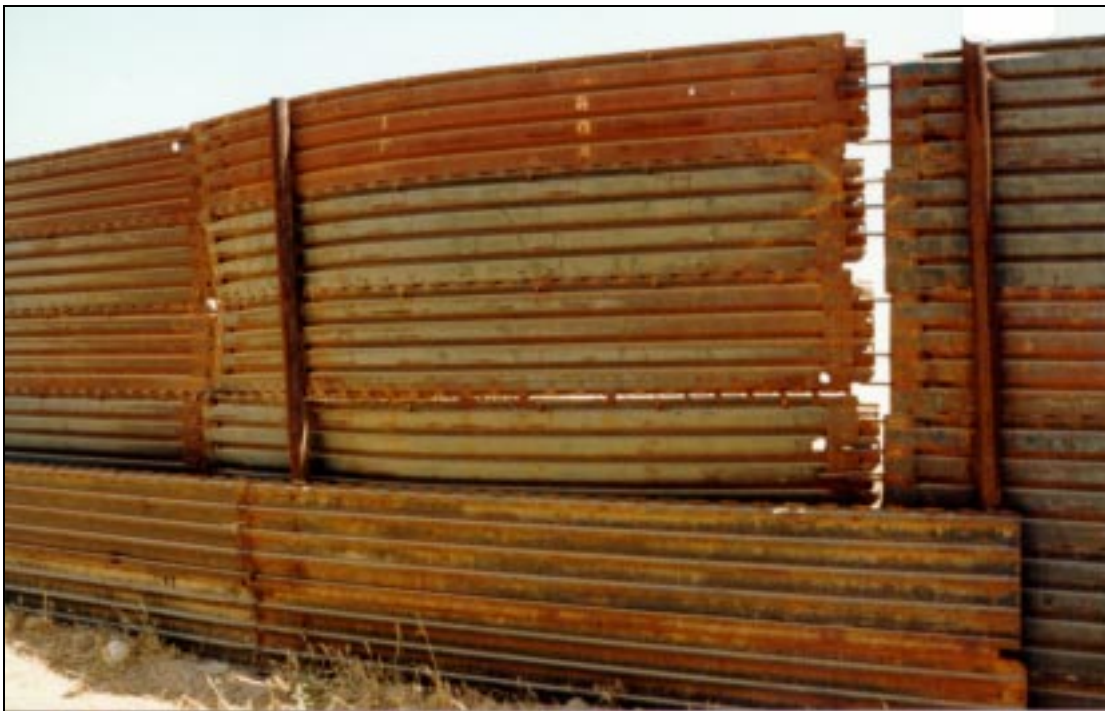
Figure B.25. This fence is still intact after being damaged by car ramming.

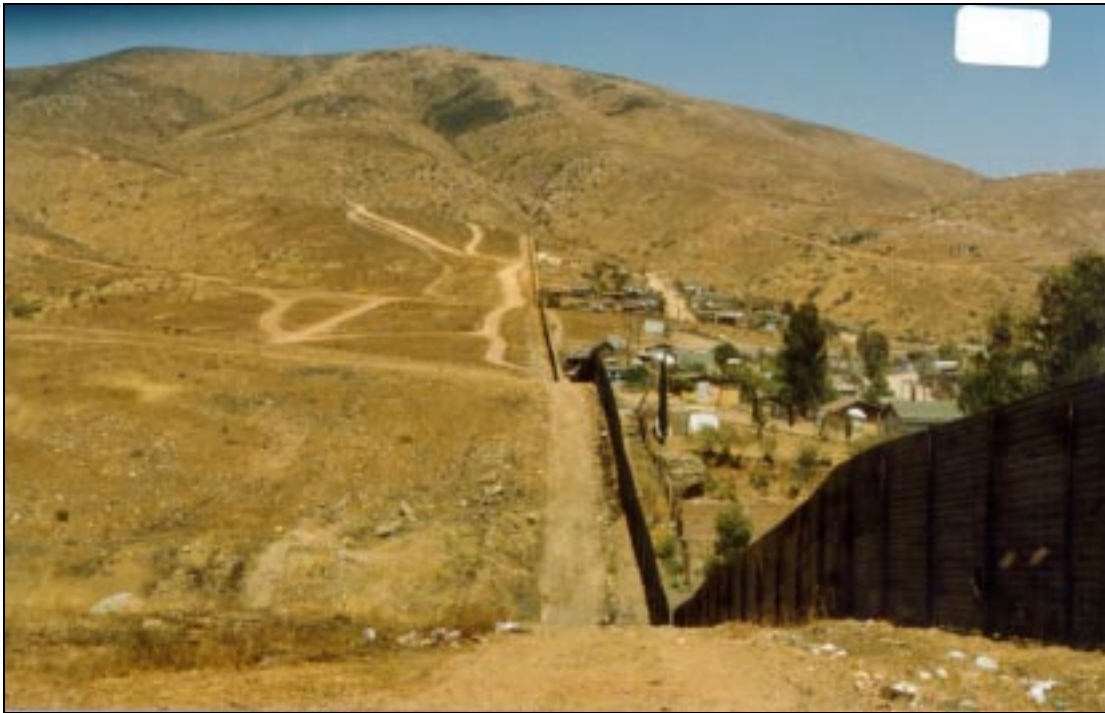
The final mile of fence running to the Otay hills is shown in Figure B.26. The hilly terrain makes fence construction difficult. Gaps at the base of the fence (seen in Figure B.27) show the ease with which fence penetration can occur by burrowing under. The loose soil erodes easily from the fence footings. A break between sections is also seen at the bottom of the hill. Figure B.28 shows the end of the fence looking into Mexico. Pathways worn by walking and driving around the fence (at the left of the picture) are visible to onsite inspectors. The inland expansion of Tijuana is shown in the distance.

**Figure B.26. The last mile of fence in the Otay hills.**

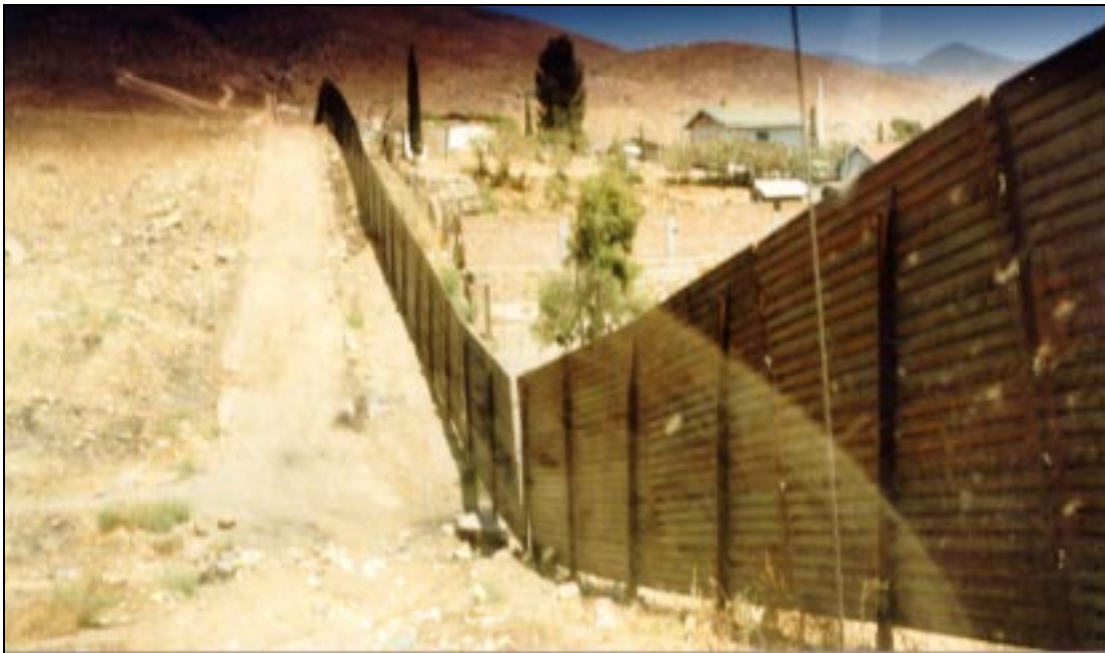
Figure B.27. Gaps exist under the fence, and a break in the section is seen at the bottom of the hill.
