BIENNIAL REPORT 111th CONGRESS

AMERICANS WITH DISABILITIES ACT INSPECTIONS RELATING TO PUBLIC SERVICES AND ACCOMODATIONS

**Office of Compliance
August 2012**

Accessibility in the Legislative Branch – Report on Americans with Disabilities Act Inspections Relating to Public Services and Accommodations during the 111th Congress

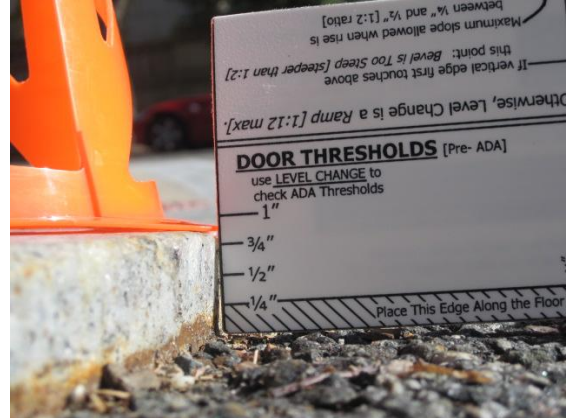
Transition Too High (Curb Ramp 27)

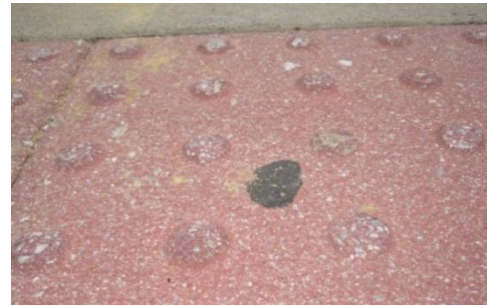
The OOC found 8 curb ramps with detectable warnings that had deteriorated. While these are only rated as “C” severities, these deteriorated warnings do make it more difficult for the ramp to be detected by people who use canes because of visual impairments.

Deteriorated Detectable Warning (Curb Ramp 39)

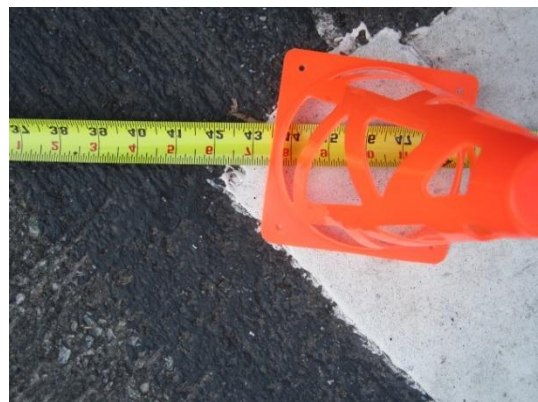
The OOC found 4 curb ramps where not enough of the ramp was within the marked crosswalk. These all involved diagonal (or corner) type curb ramps where one curb ramp is serving two marked cross walks. The standards require at least 48 inches of the bottom landing to be within the marked crosswalks.

Ramp Outside of Marked Crosswalk (Curb Ramp 16)

Close-up of Tape Measure in Previous Photo (Curb Ramp 16)

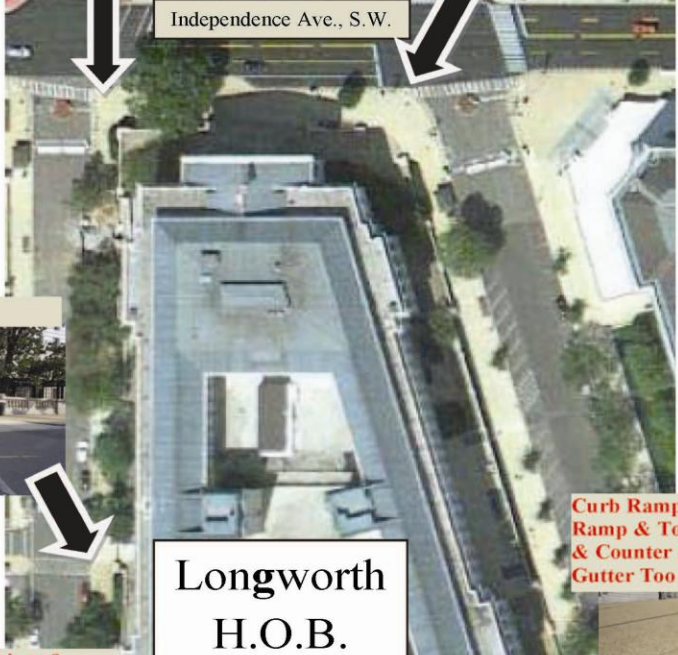
No Curb Ramp (B)
