Collision into Mountainous Terrain
GCI Communication Corp.
de Havilland DHC-3T, N455A
Aleknagik, Alaska
August 9, 2010

NTSB/AAR-11/03
PB2011-910403

Aircraft Accident Report

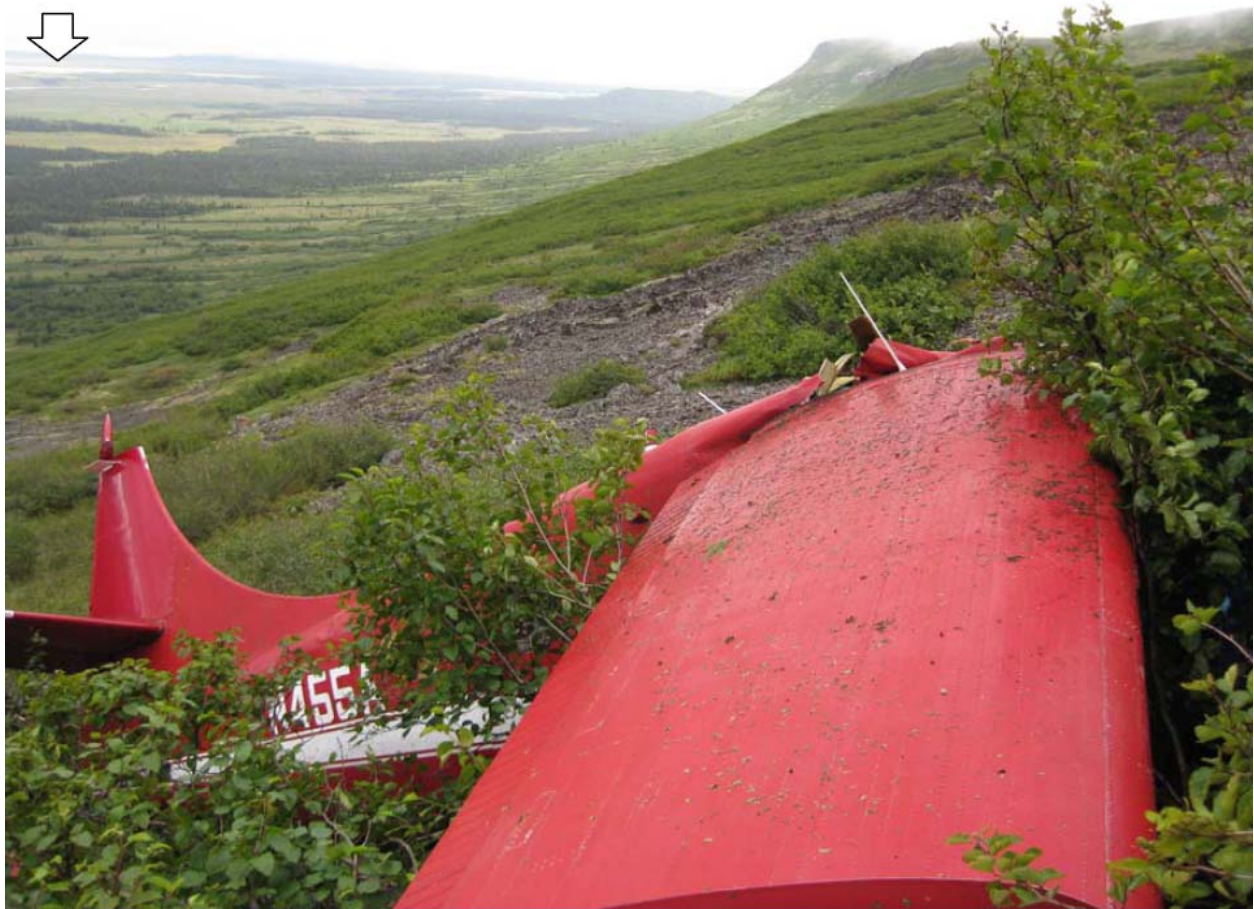
Figure 1. Accident site (view looking north-northwest).

Note: The east end of Lake Nerka (from which the airplane departed) is visible in the upper left corner of the photograph (indicated by the arrow).

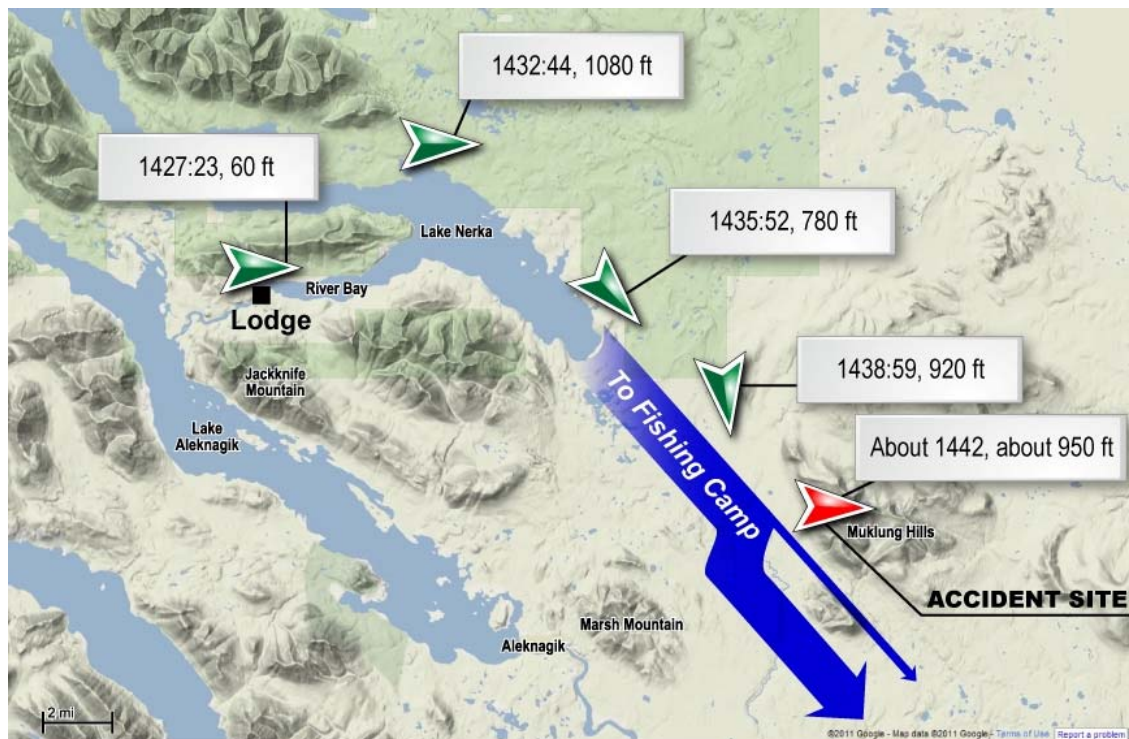
Figure 9. Illustration showing select Sky Connect data for the accident flight and the accident site.

Note: The orientation of each green arrow indicates the airplane's recorded ground track angle; the orientation of the red arrow indicates the approximate heading of the airplane at the accident site.

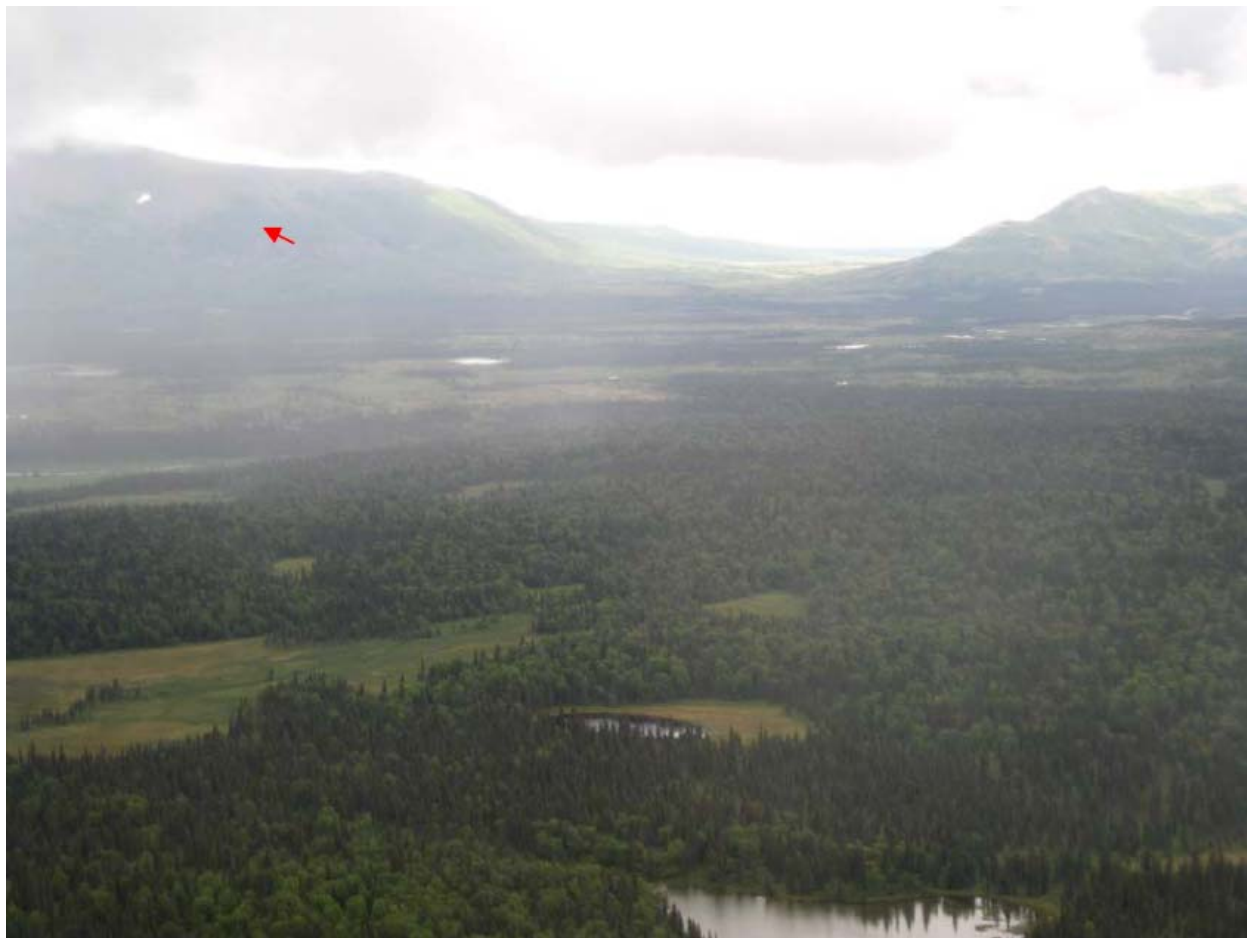
Figure 10. View from about 5 nautical miles south-southeast of Lake Nerka showing the narrow pass near Muklung Hills (view is facing east-southeast).

Note: The red arrow points to the accident site.

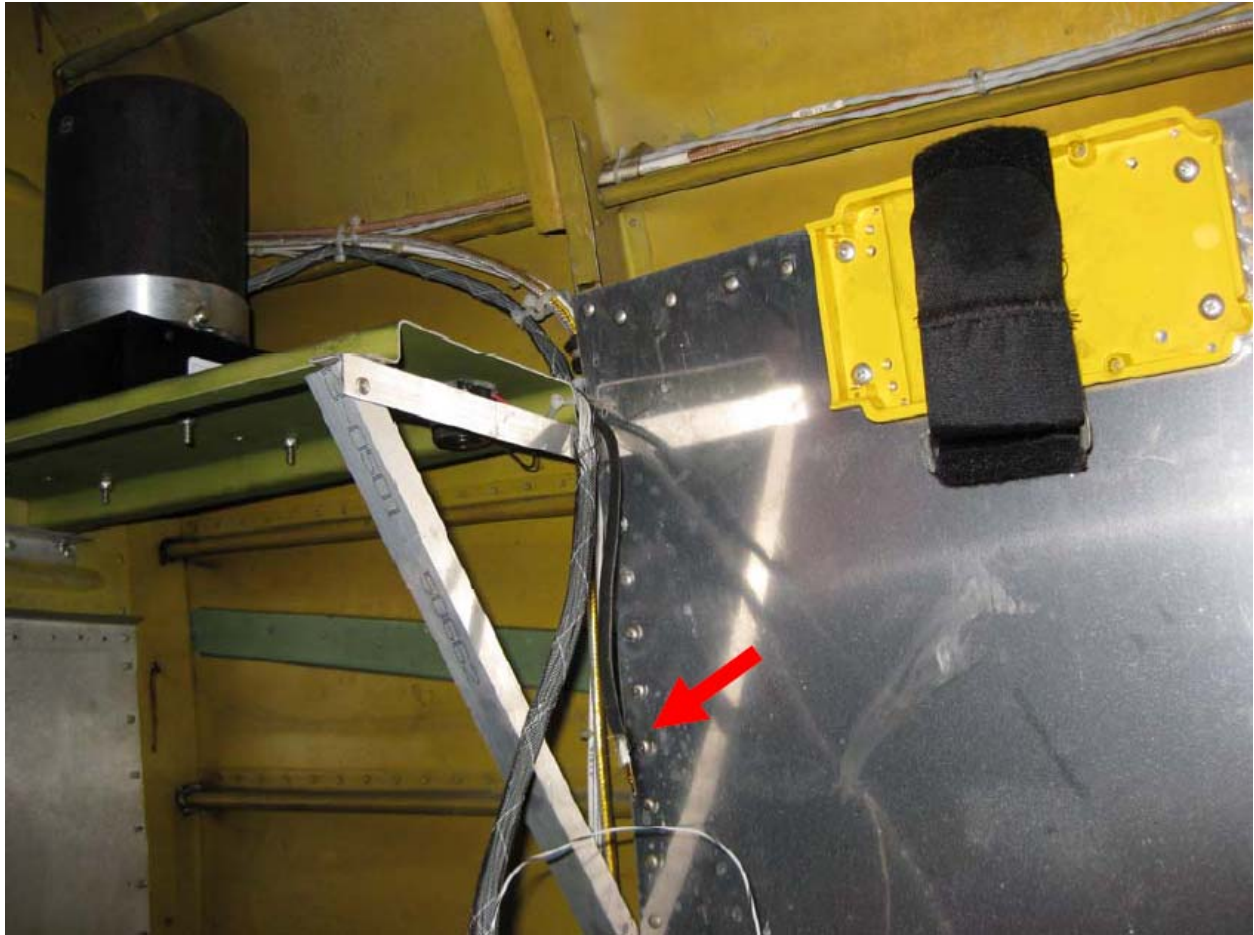
accident airplane's ELT mounting tray was attached securely to the airplane sidewall structure and that the retention strap, which had a hook-and-loop (Velcro®) fastener, was fastened closed, consistent with having been used to secure the ELT unit to the tray. Also, the ELT unit was separated from its remote switch wiring and coaxial antenna cable, which were broken near their connectors. An interior part of the airplane that had been located forward of the mounting tray showed marks consistent with having been impacted by the ELT unit when it dislodged from the tray and the retention strap, which was found secured. Figure 12 shows the accident airplane's ELT mounting tray and retention strap.

Figure 12. Accident airplane's emergency locator transmitter mounting tray and retention strap.

Note: Arrow shows damaged and separated coaxial antenna cable. (Forward is to the left.)

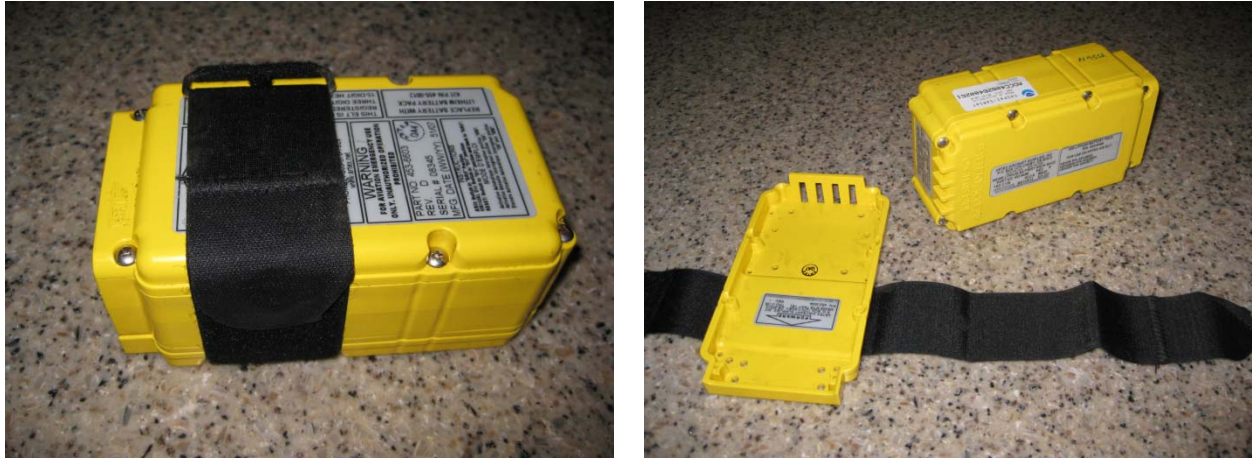
The ELT's retention system is designed so that the ELT unit nests in the mounting tray affixed to the airplane and is secured to the tray with the retention strap. This retention system meets the performance standards prescribed by FAA Technical Standard Orders (TSOs) C91a and C126, which include a safety test standard intended to ensure that an ELT will not break loose from its mounts under impact conditions. Figure 13 shows the ELT's retention system.

Figure 13. Two views of the accident airplane's emergency locator transmitter's (ELT) retention system.

Note: The left image shows the ELT unit nested in the mounting tray with the retention strap secured. The right image shows the ELT unit outside the tray with the retention strap unfastened.
