Pacific Gas and Electric Company  
Natural Gas Transmission Pipeline Rupture and Fire  
San Bruno, California  
September 9, 2010

NTSB/PAR-11/01  
PB2011-916501

NTSB/PAR-11/01  
PB2011-916501  
Notation 8275C  
Adopted August 30, 2011

# Pipeline Accident Report

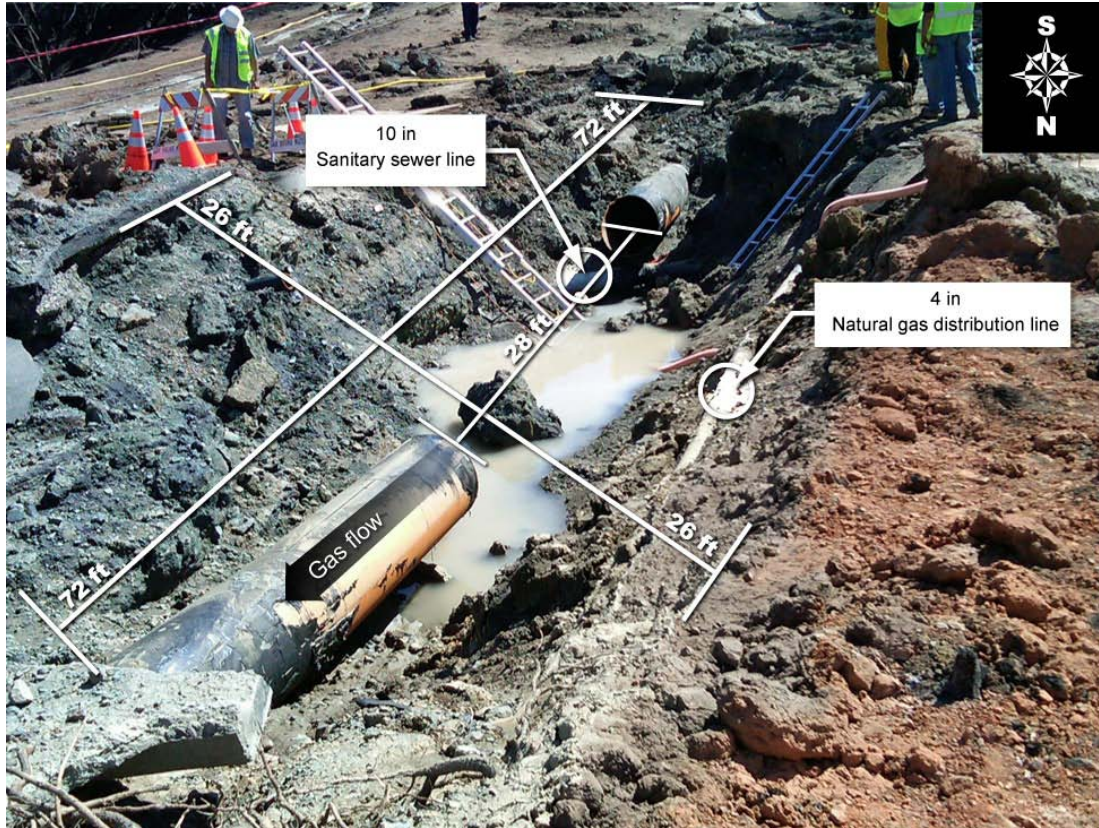
Figure 1. Picture of crater and ruptured pipeline.

The rupture of Line 132 released an estimated 47.6 million standard cubic feet of natural gas, created a 72-foot-long by 26-foot-wide crater, and ejected a 28-foot piece of pipe weighing 3,000 pounds, which came to rest about 100 feet away. The gas ignited and caused an explosion. As previously noted in section 1.2, “Emergency Response,” the fire was declared about 75 percent contained at 4:24 a.m. on September 10, 2010, about 10 hours and 13 minutes after the accident occurred.

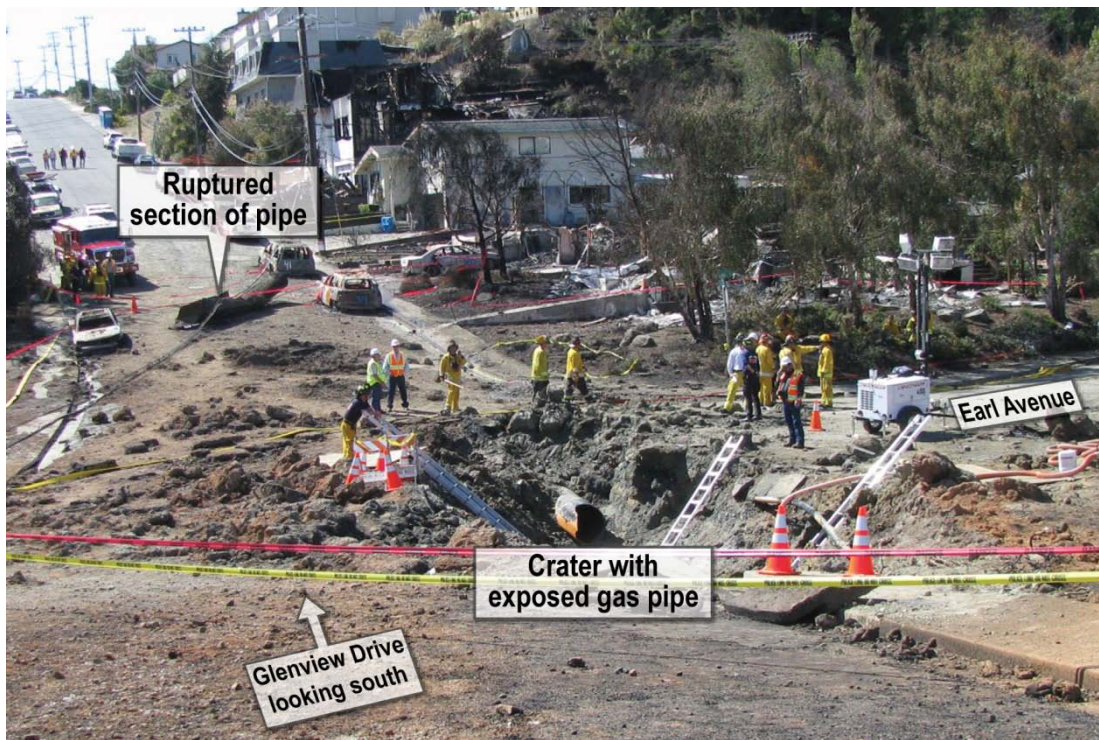
Figure 2. Picture of ejected pipe section.

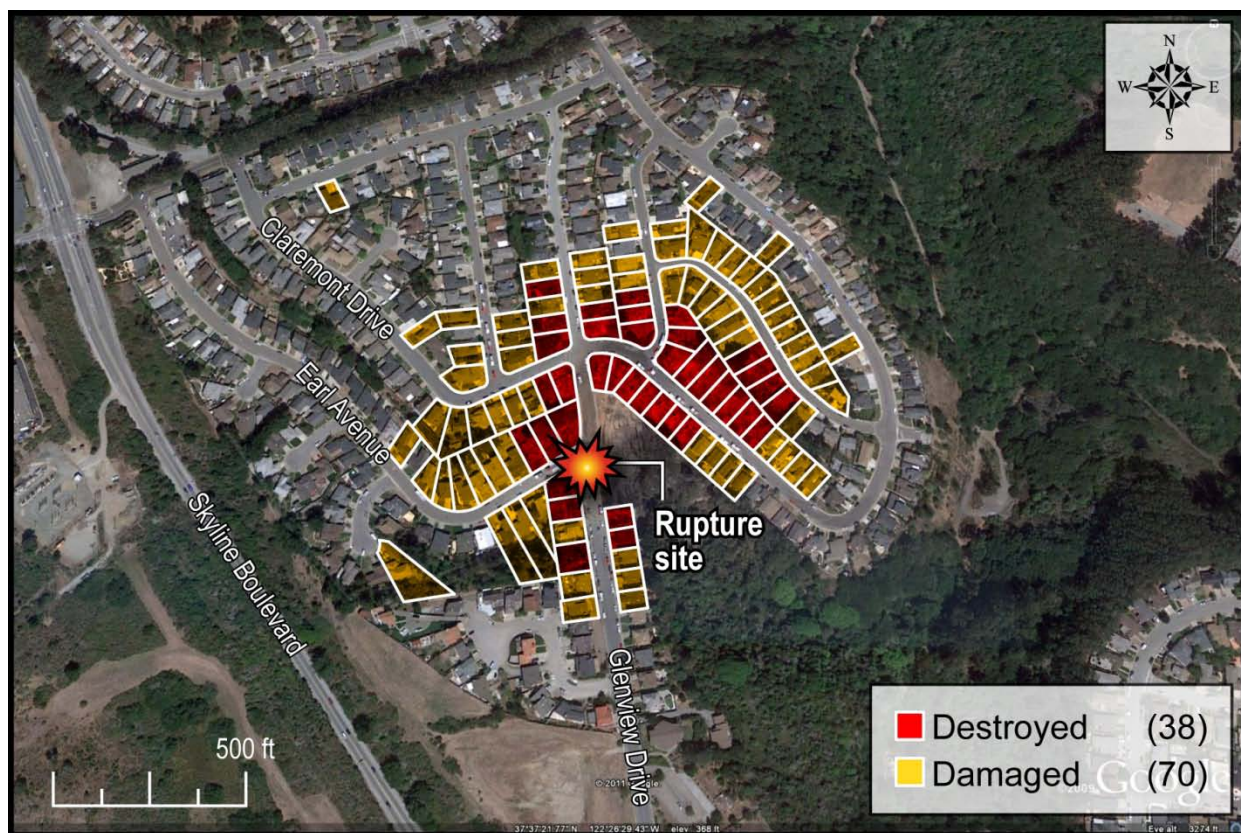
The fire damage extended to a radius of about 600 feet from the pipeline blast center, mostly spreading in a northeast direction. (See figure 11.) The fire affected 108 houses—38 of which were destroyed, 17 of which received severe-to-moderate damage, and 53 of which received minor damage.<sup>33</sup> (See figure 12.) In addition, 74 vehicles were damaged or destroyed. (See figure 13.) The burned area also included a park with woodlands and a playground. According to PG&E, the cost to repair the pipeline was about \$13,500,000,<sup>34</sup> and the loss of natural gas accounted for \$263,000.

**Figure 11.** Picture showing area of damage from blast and fire.

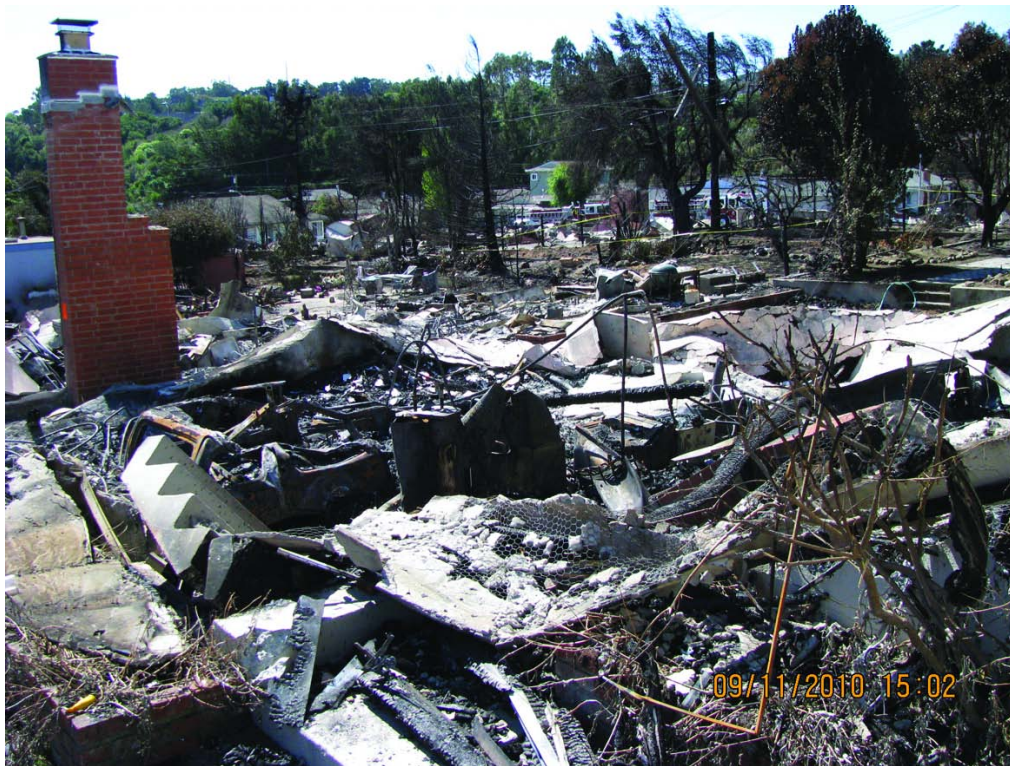
**Figure 12.** Picture of destroyed houses.

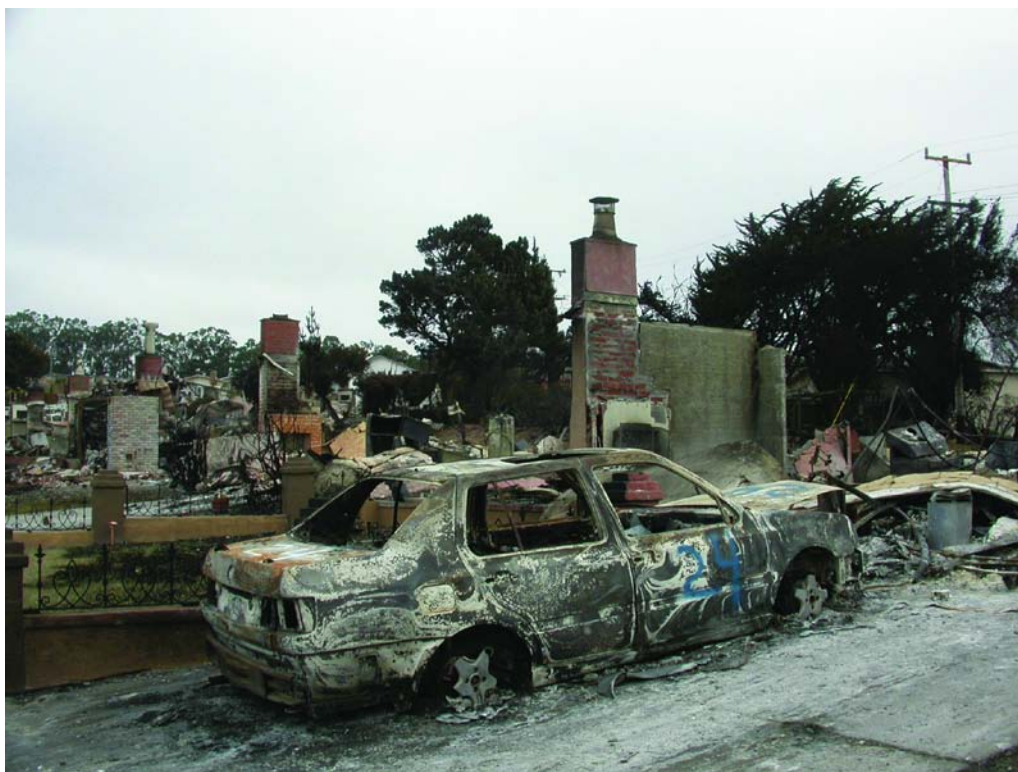
**Figure 13.** Picture of a burned car in front of several destroyed houses.

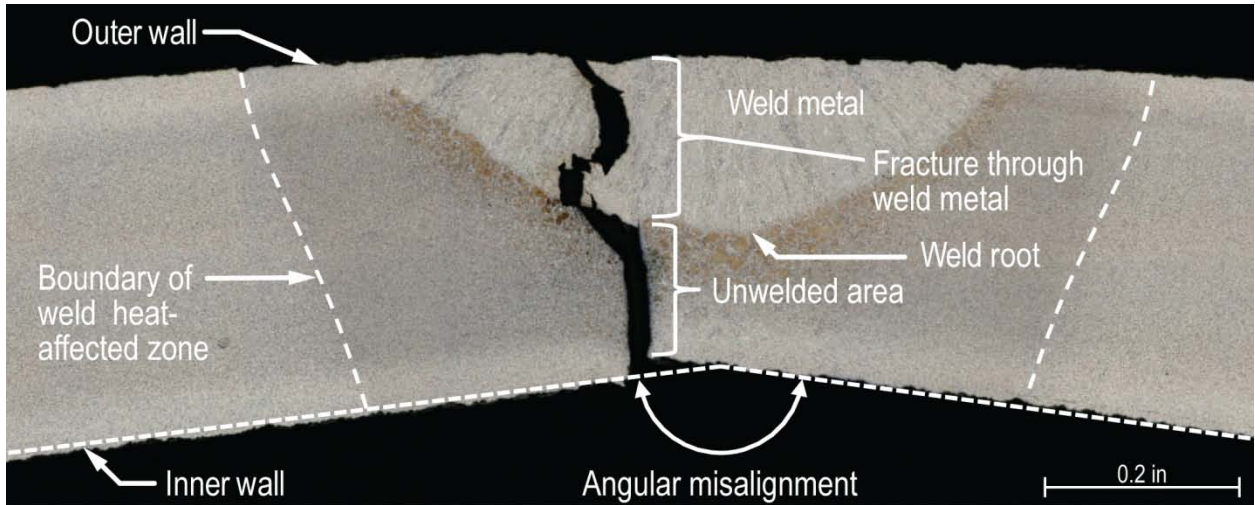
**Figure 19a.** Picture showing cross section of longitudinal seam in pup 1.

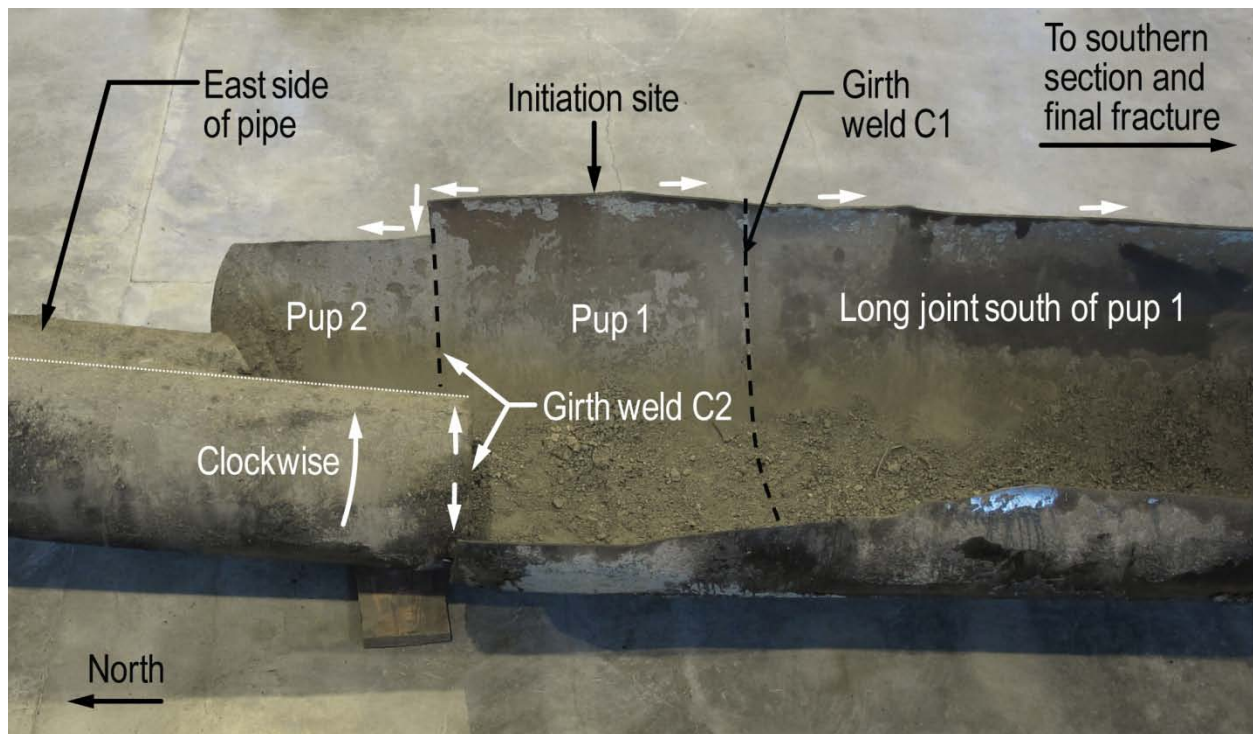
cracks that initiated from the root of the weld but did not exhibit fatigue at the ductile fracture boundary.

**Figure 20.** Picture of pipe section with white arrows showing direction of crack propagation.

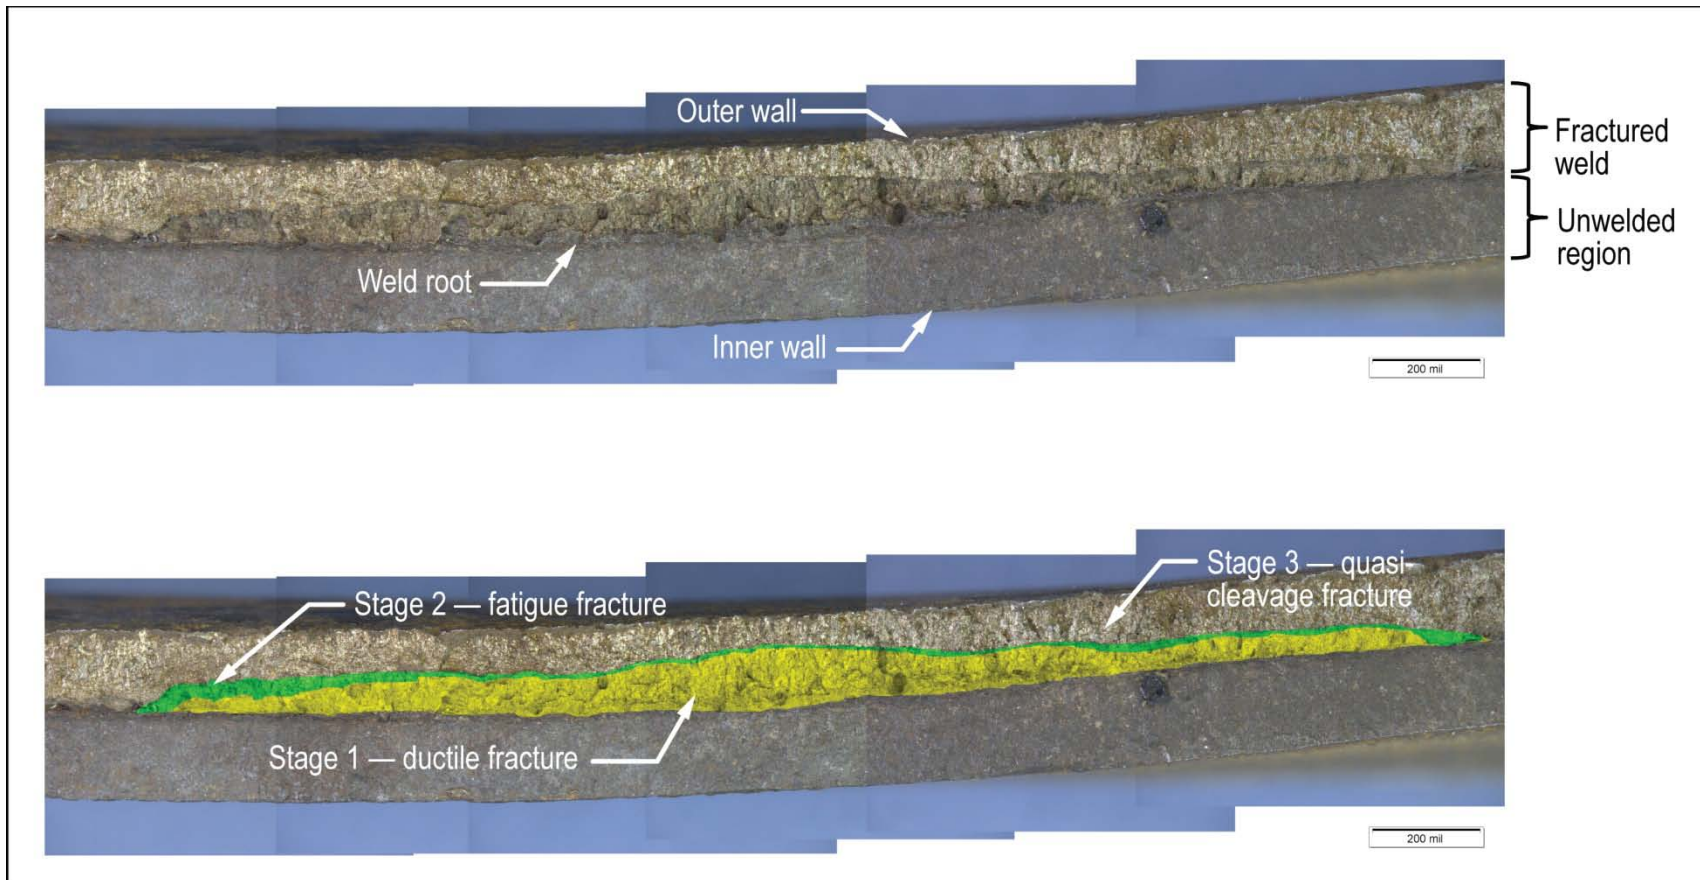
The National Transportation Safety Board's investigation found that the rupture of Line 132 was caused by a fracture that originated in the partially welded longitudinal seam of one of six short pipe sections, which are known in the industry as "pups." The fabrication of five of the pups in 1956 would not have met generally accepted industry quality control and welding standards then in effect, indicating that those standards were either overlooked or ignored. The weld defect in the failed pup would have been visible when it was installed. The investigation also determined that a sewer line installation in 2008 near the rupture did not damage the defective pipe.

**Figure 21.** Pictures highlighting rupture initiation site in pup 1 longitudinal seam.

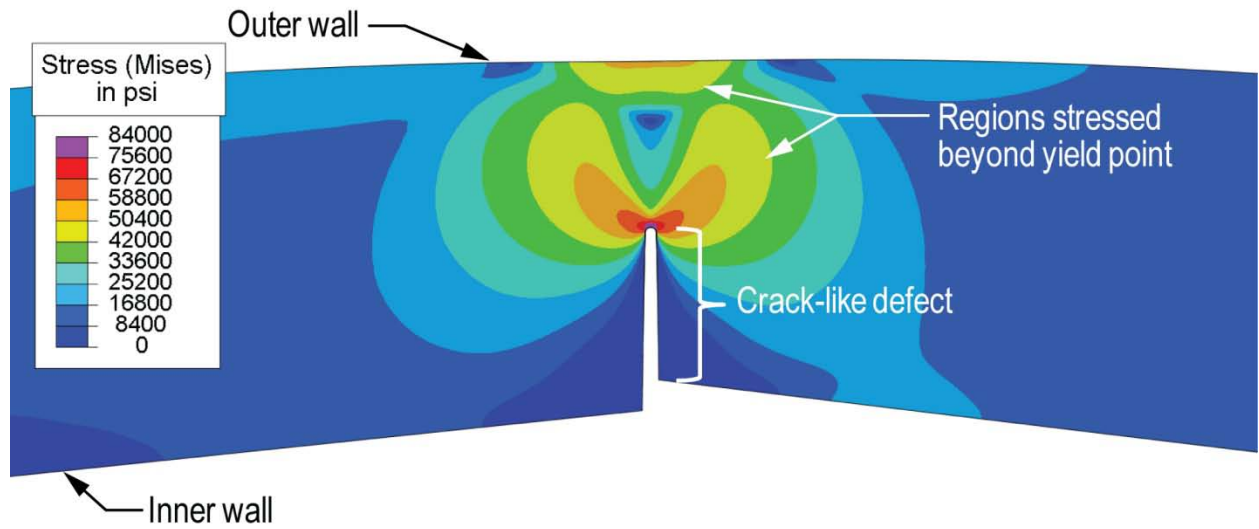
**Figure 22a.** Stress contours at an internal pressure of 375 psig for the finite element model of the weld geometry similar to pup 1. Contour values are the same as in figure 22b.
