National Transportation Safety Board

Railroad Accident Brief

Accident No.: DCA-09-FR-001
Location: Rialto, California
Date: November 20, 2008
Time: 11:25 a.m., Pacific standard time¹
Railroad: Metrolink
Property Damage: \$25,000
Injuries: 4 Minor
Type of Accident: Collision

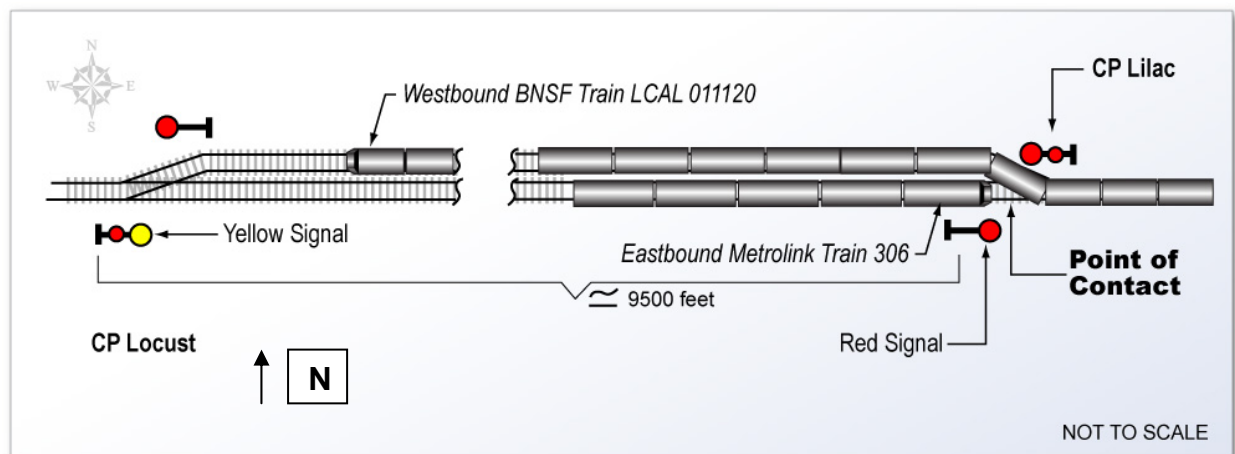
The Metrolink train slid past the red signal, and the left front corner of the Metrolink locomotive came into contact with the moving freight train. Because of the length of the freight train, its locomotive was almost a mile away from the collision at the rear of the train, and the BNSF engineer was unaware that the Metrolink train had passed the red signal. (See figure 2.) The freight train continued moving into the siding and the sides of the rear eight cars and two remotely controlled locomotives at the rear of the train scraped against the Metrolink locomotive. (See figure 3.) The physical contact with the Metrolink equipment caused the freight train to uncouple, and this automatically activated an emergency application of the brakes and stopped the freight train. Neither train derailed.

Figure 2. Diagram of accident showing BNSF freight train entering siding and Metrolink train beyond red signal making contact with freight train.

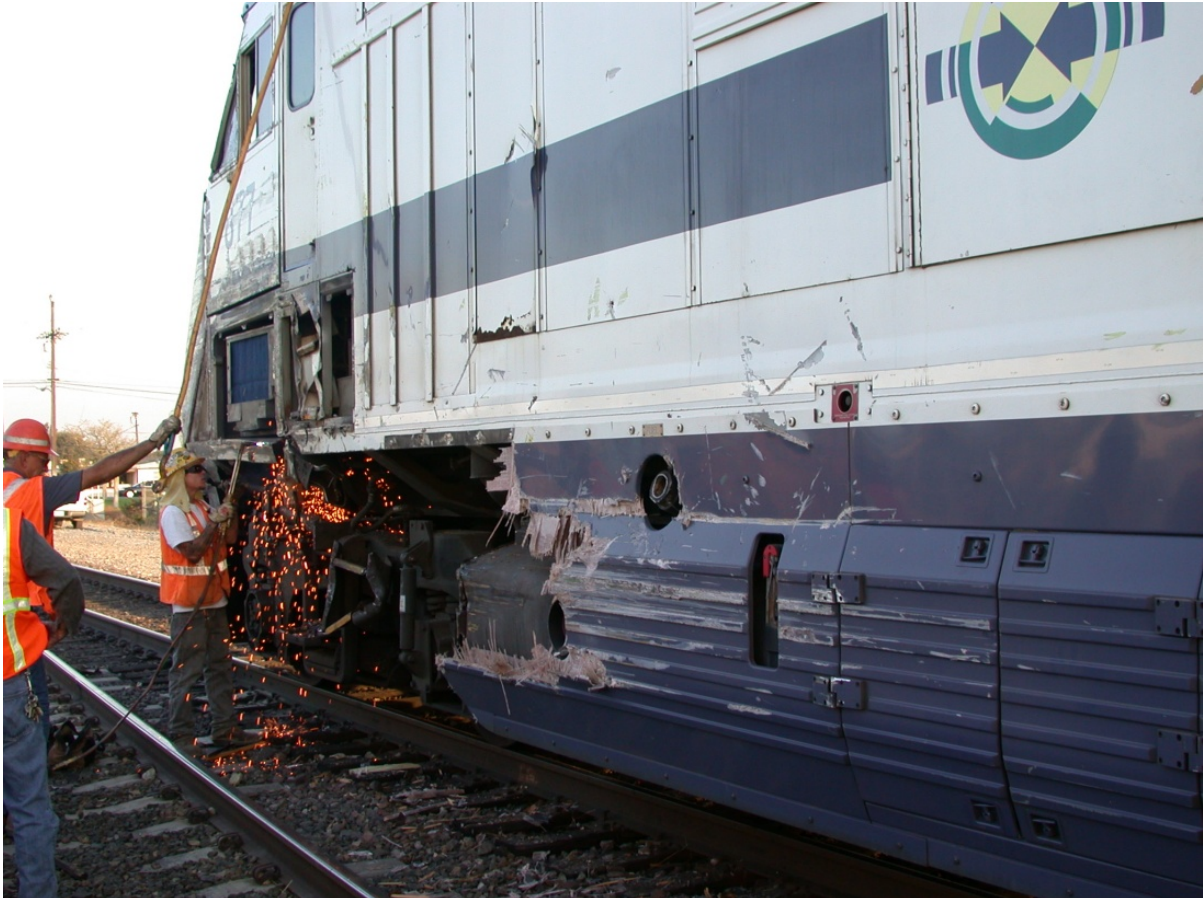
The Metrolink train, which had one locomotive and four passenger cars, was about 400 feet long. The BNSF train, which consisted of 6 locomotives (4 at the front of the train and 2 at the rear) and 102 cars (96 loaded and 6 empty), was 6,926 feet long and weighed 12,201 tons. The left front corner of the locomotive of the Metrolink train was damaged when it scraped the BNSF train. The last eight cars and the 2 rear locomotives of the BNSF train were scraped by the Metrolink locomotive. The total damage was estimated to be \$25,000.

Figure 3. Metrolink employees making minor repairs to damaged side of Metrolink locomotive.

Three days after the accident, the Metrolink train was returned to service after minor repairs were made and investigators conducted stopping tests at the accident site. Three tests were performed, and during all three tests the train was accelerated from a station stop at Fontana, the same as the accident train.² The event recorder data storage devices were removed from the locomotive and cab car of Metrolink train 306 after the stop tests were performed. The event recorders contained the data from the accident day and the data from the stopping tests.
