Pilot/Race 177, *The Galloping Ghost*  
North American P-51D, N79111  
Reno, Nevada  
September 16, 2011

NTSB/AAB-12/01  
PB2012-102899

# Aircraft Accident Brief

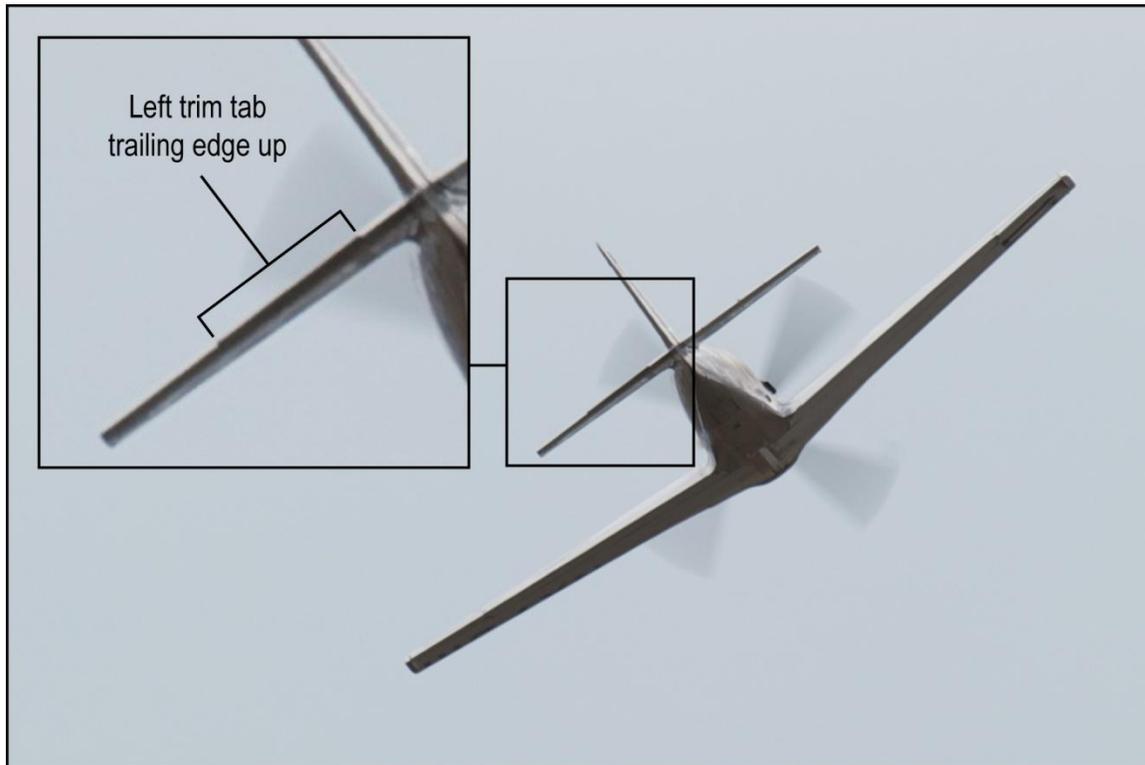
edge down when the right aileron was faired with the wing. Photographs of the airplane during flights on the race course 3 days before the accident showed that the airplane's left elevator trim tab was deflected trailing edge up; image study calculations determined that, in one photograph, the deflection was 5° trailing edge up, and in another photograph, it was 8° trailing edge up. Available telemetry data showed that, at the time that the photograph showing 8° trailing edge up was taken, the airplane was in a section of the race course between pylons 6 and 7 and had a ground speed of about 360 to 380 knots (see figure 4).

**Figure 4.** Left trim tab deflection of 8° trailing edge up during a previous flight.

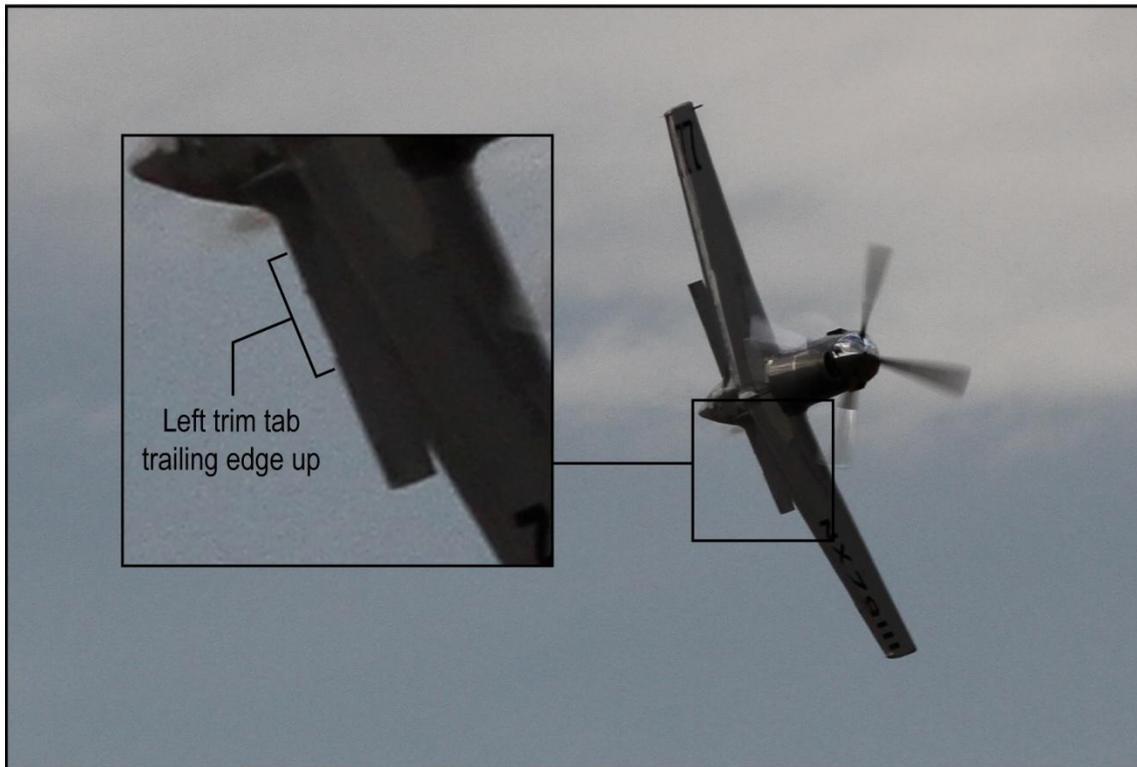
Trailing-edge-up left elevator trim tab deflection was also evident in photographs of the airplane during the accident race. One photograph showed that, as the airplane began to round pylon 8 at 1624:28.65<sup>29</sup> during the accident lap, the left elevator trim tab was trailing edge up, consistent with the position observed during previous laps (see figure 5).

**Figure 5.** Airplane rounding pylon 8 during accident lap before the left roll upset at 1624:28.65.

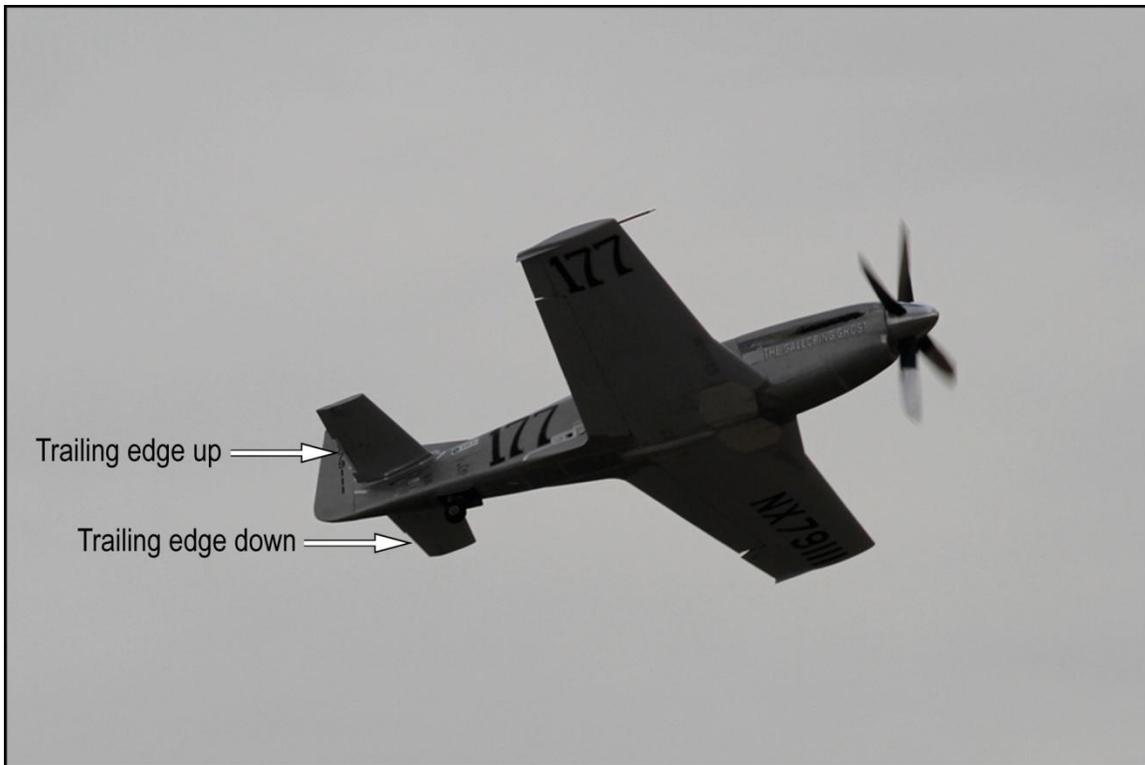
A photograph captured about 0.14 second later, at 1624:30.34, showed that the left elevator trim tab was trailing edge down, and the right elevator trim tab was trailing edge up. Nearly full right-wing-down aileron deflection (right aileron trailing edge up, left aileron trailing edge down) was also evident (see figure 8).

**Figure 8.** Airplane pitching up with left elevator trim tab trailing edge down at 1624:30.34, right elevator trim tab trailing edge up, and nearly full right-wing-down aileron deflection.

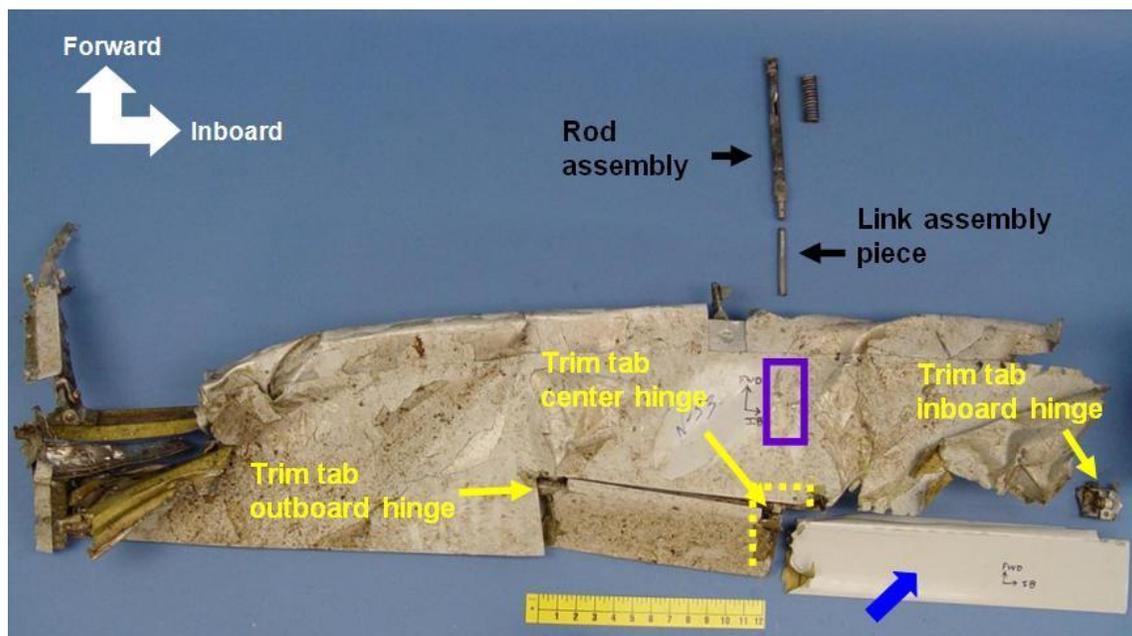
The outboard piece of the left elevator trim tab was still attached to the elevator at its outboard and center hinges; the left elevator trim tab rod assembly, link assembly pieces, and the inboard piece of the left trim tab (which separated in flight) were recovered (see figure 12).<sup>36</sup> The right elevator trim tab was found attached to the elevator.

**Figure 12.** Left elevator showing the relative installed locations of the recovered trim tab pieces, trim tab hinges, trim tab rod assembly, and trim tab link assembly piece.

The blue arrow points to the piece of the tab that separated in flight, and the purple box shows a long, upward bulge in the upper elevator skin.

The left elevator trim tab link assembly was buckled and fractured in bending overload in the threaded portion of the clevis with the bending process producing an upward bulge in the upper skin of the elevator (indicated by the purple box in figure 12). Evidence of subsequent oscillations of the free trim tab was indicated by scoring on the elevator's lower skin material, and on the fracture of the link assembly's tubing section, which showed notched fracture faces from repeated contact.

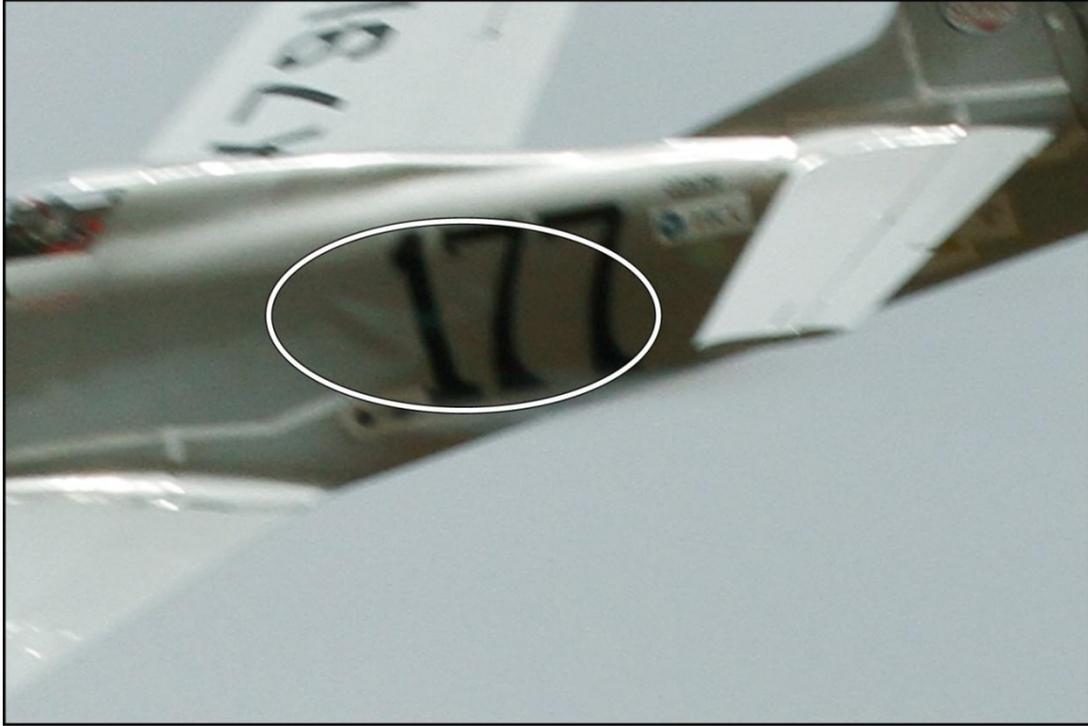
fuselage. Figure 16, which is a photograph that was taken as the airplane passed pylon 2 during the accident lap, shows that similar (although less pronounced) diagonal wrinkles were evident on the airplane's left side; photographs showed that this deformation was evident during all three laps of the accident race and during qualifying flights performed on September 13, 2011. Figure 17, which was taken during the first lap of the accident race, shows that deformation was evident along the canopy and windscreen, such that a gap was visible; this deformation was also evident in photographs taken during the third lap of the accident race but was not evident in prerace photographs of the airplane on the ground.

**Figure 16.** Diagonal wrinkles on left side during accident race.

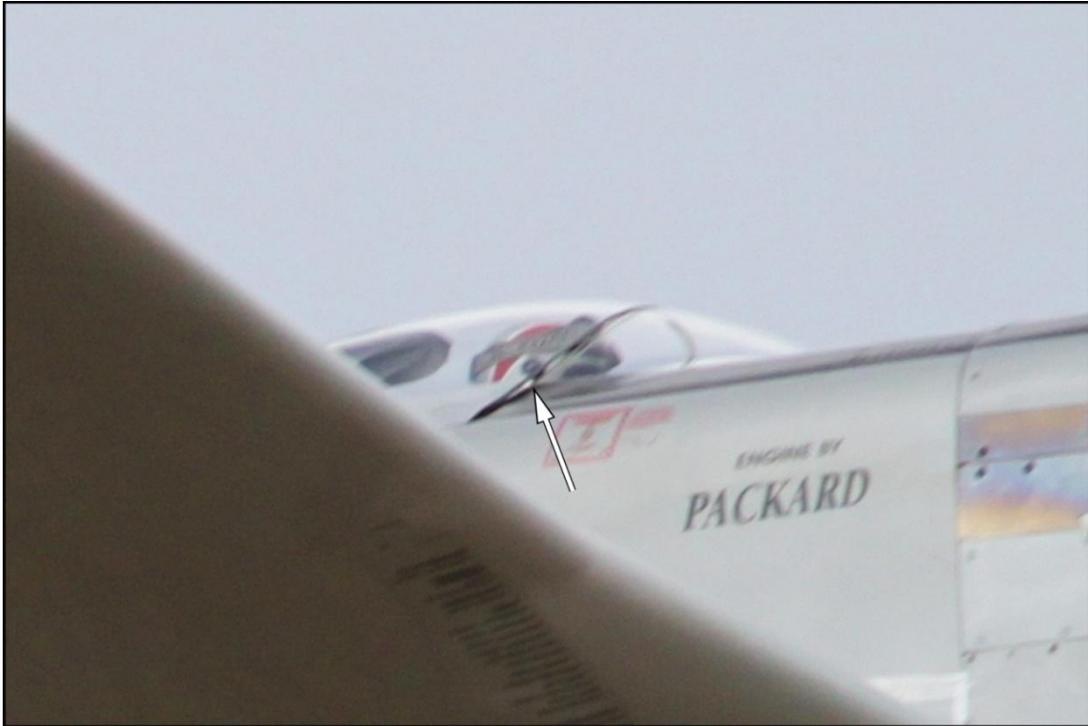
**Figure 17.** Gap between canopy and windscreen in flight.
