Collision of the Tankship *Elka Apollon*
With the Containership *MSC Nederland*
Houston Ship Channel, Upper Galveston Bay, Texas
October 29, 2011

NTSB/MAR-12/02
PB2012-916402

Marine Accident Report

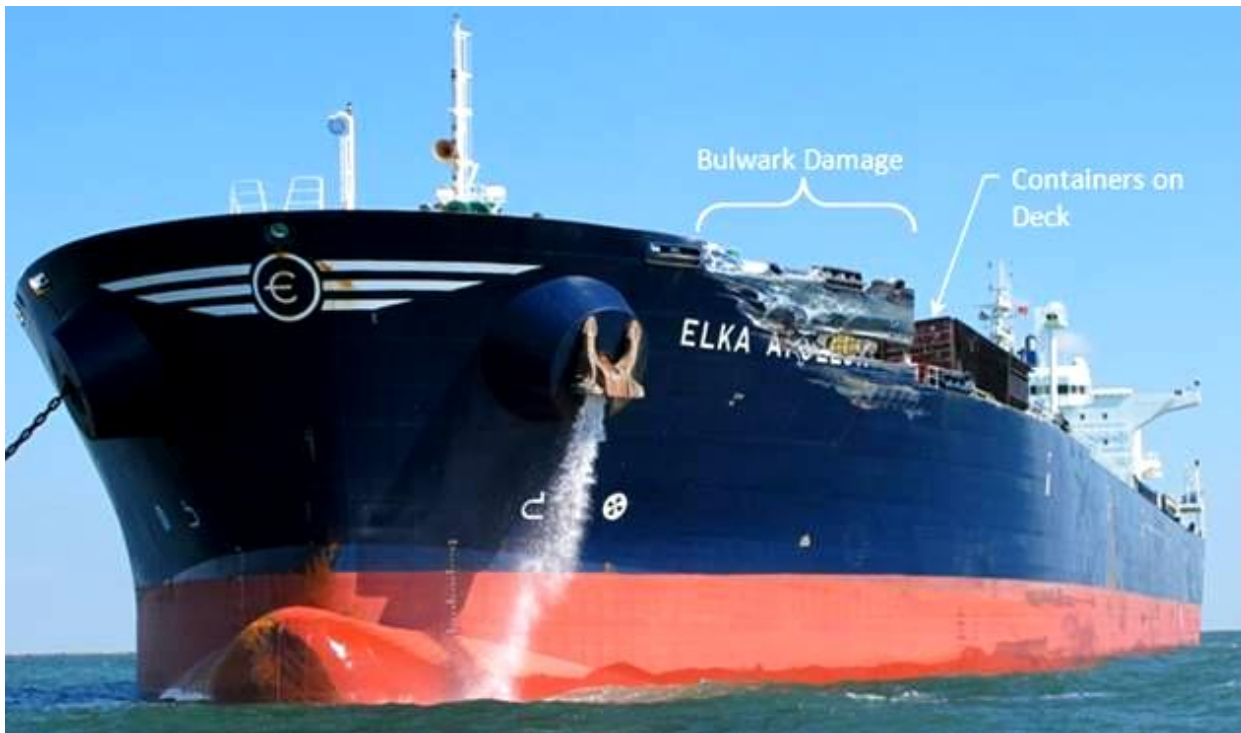
All damage to the *Elka Apollon* was above the vessel's waterline, primarily to the port hull side plating and bow bulwark⁶ from 5 feet below the main deck upward to the top of the bulwark (figure 5) and extending about 40 feet. The bulwark in this area was severely bent with

an open tear approximately 3 feet high and about 20 feet long. The structural support in the area of the tear was also distorted.

Figure 5. Damage to *Elka Apollon* port bow and partial view of containers that fell to its deck from the *MSC Nederland*.

Upon impact, three containers fell from the *MSC Nederland* onto the portside foredeck of the *Elka Apollon*. Two containers held three agricultural tractors each, and one contained stoves. None of the *Elka Apollon*'s cargo piping was damaged, but the fallen containers damaged the vessel's cargo tank fittings to the no. 1 port cargo tank on the main deck immediately above the cargo tank.

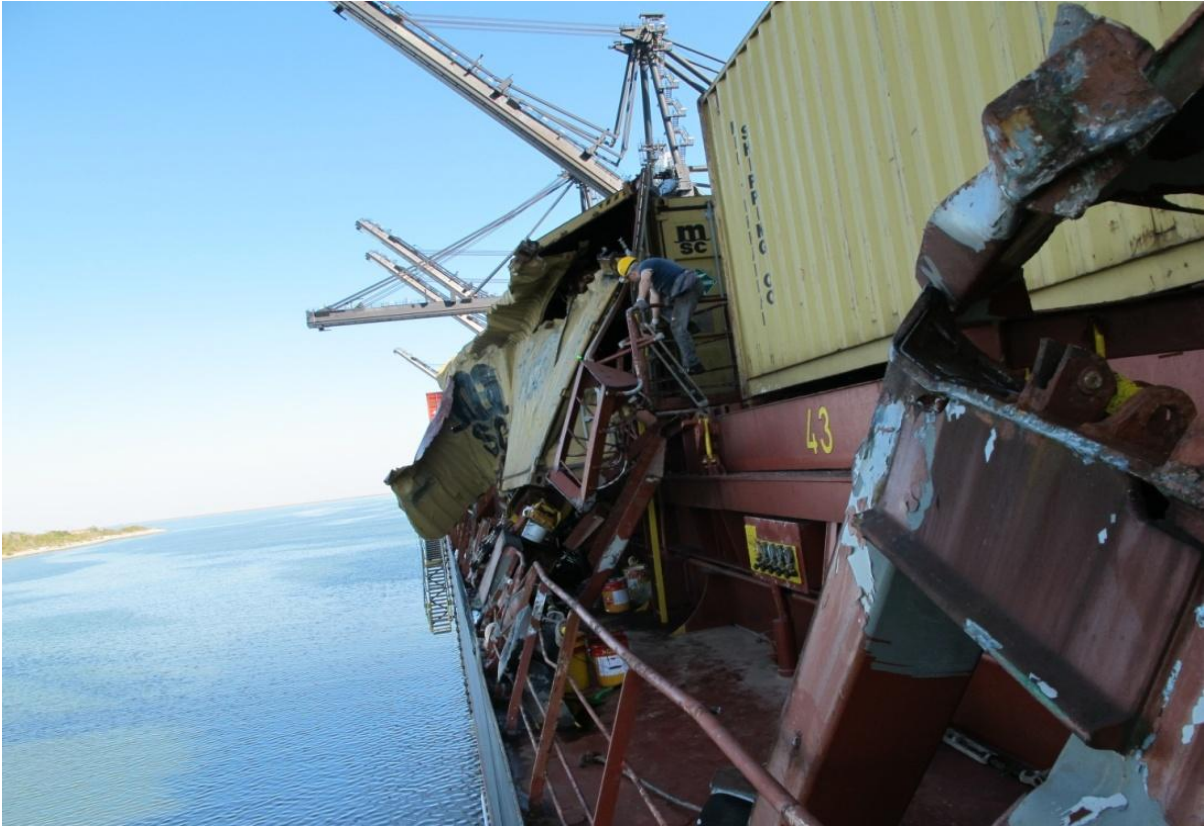
The *Elka Apollon*'s port bow struck the port side of the *MSC Nederland* about 98 feet forward of the vessel's superstructure and scraped along the side of the ship above its main deck for about 148 feet. (Partial damage to the port side is shown in figure 6.) The main deck was punctured in one location. The puncture was approximately 18 inches long and several inches high and led into the longitudinal passageway outboard on the deck below the main deck. Damage to the *MSC Nederland* extended vertically from the main deck about 12 feet up the port side.

Figure 6. *MSC Nederland* damage, looking forward from superstructure at main deck.

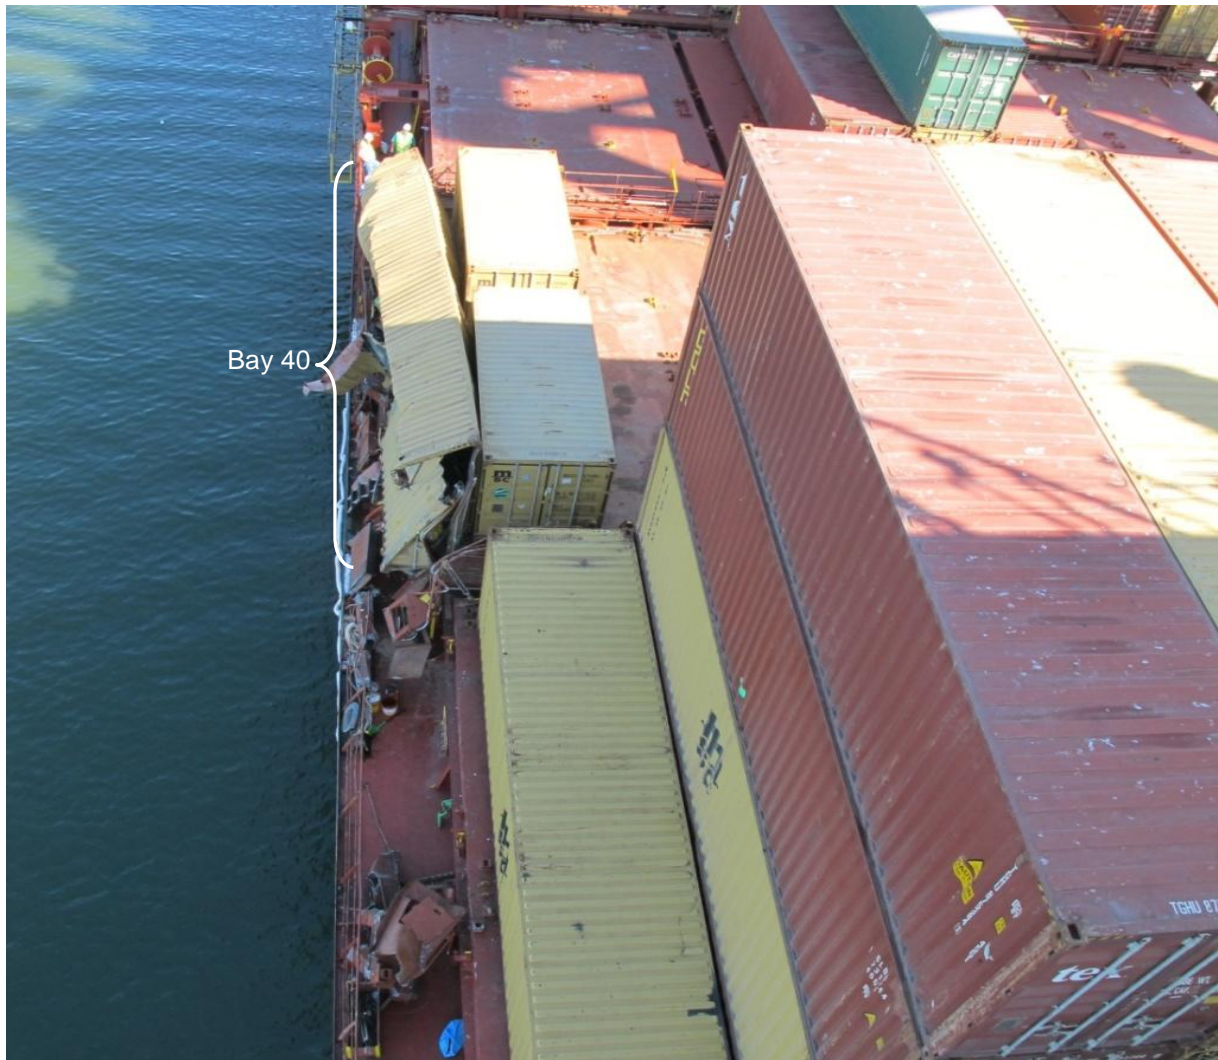
According to the Marine Field Survey Report,⁸ six containers stowed on the port side just forward of the superstructure also were damaged. The *Elka Apollon's* port bow crushed the outermost 40-foot container stowed just over the *MSC Nederland* main deck in bay 40 and tore three similar containers stacked on top of it from the vessel. These three containers fell to the foredeck of the *Elka Apollon*. (Damage to containers is shown in figure 7.)

Figure 7. Damaged containers on *MSC Nederland*, photographed forward from bridge wing.

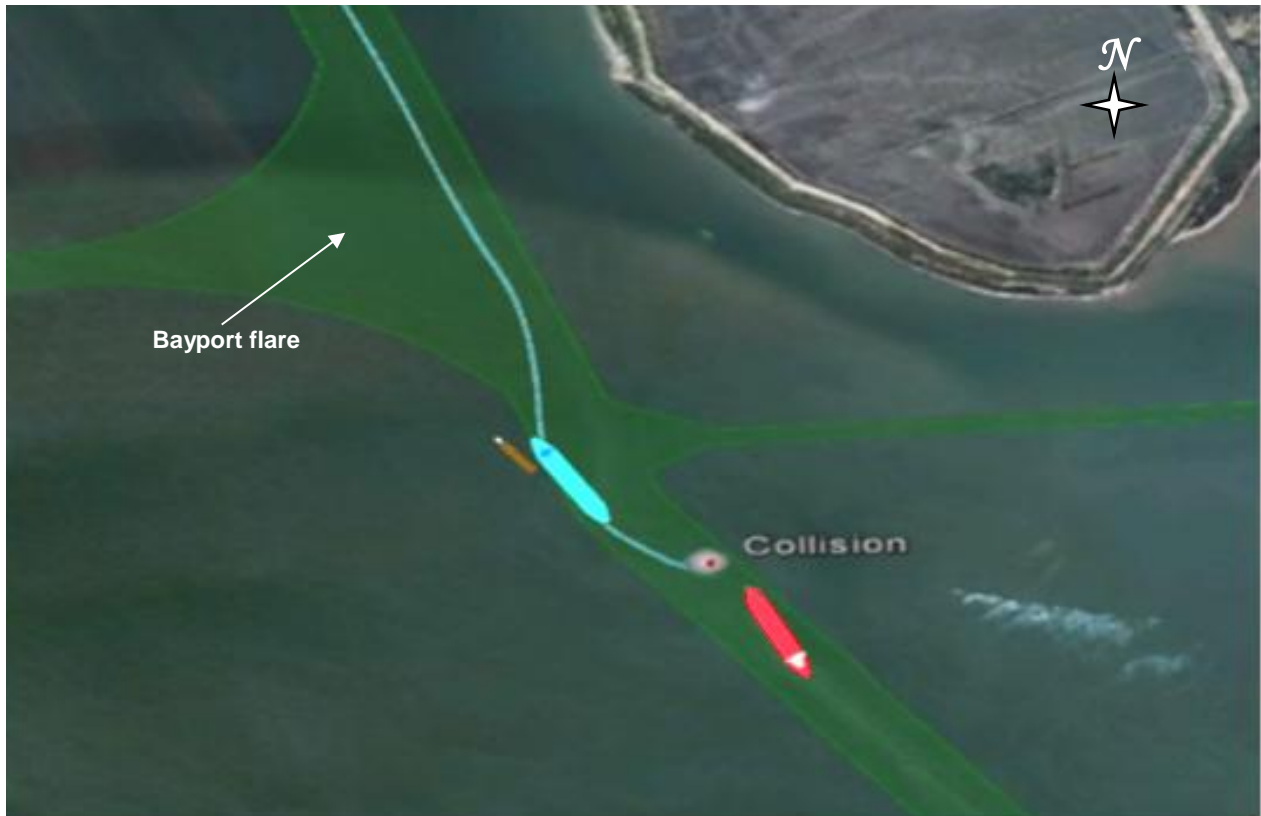
As described in the previous section, the pilot on the *Elka Apollon* ordered a series of rudder commands as the tanker transited the Bayport flare. As illustrated in figure 11, the ship responded by turning to starboard, toward the right bank of the Houston Ship Channel south of the flare, and then turning toward the left side of the channel and colliding with the *MSC Nederland*. To determine the cause of this motion and assess the role of channel hydrodynamic bank effects,³⁸ the NTSB conducted a study to examine the forces and moments³⁹ on the *Elka Apollon* extracted from the ship's recorded motion.⁴⁰

Figure 11. Trackline of the *Elka Apollon* (blue) and positions of the *MSC Nederland* (red) and the *Mr. Earl* (brown) at 0904:29, about 1 minute before the accident.

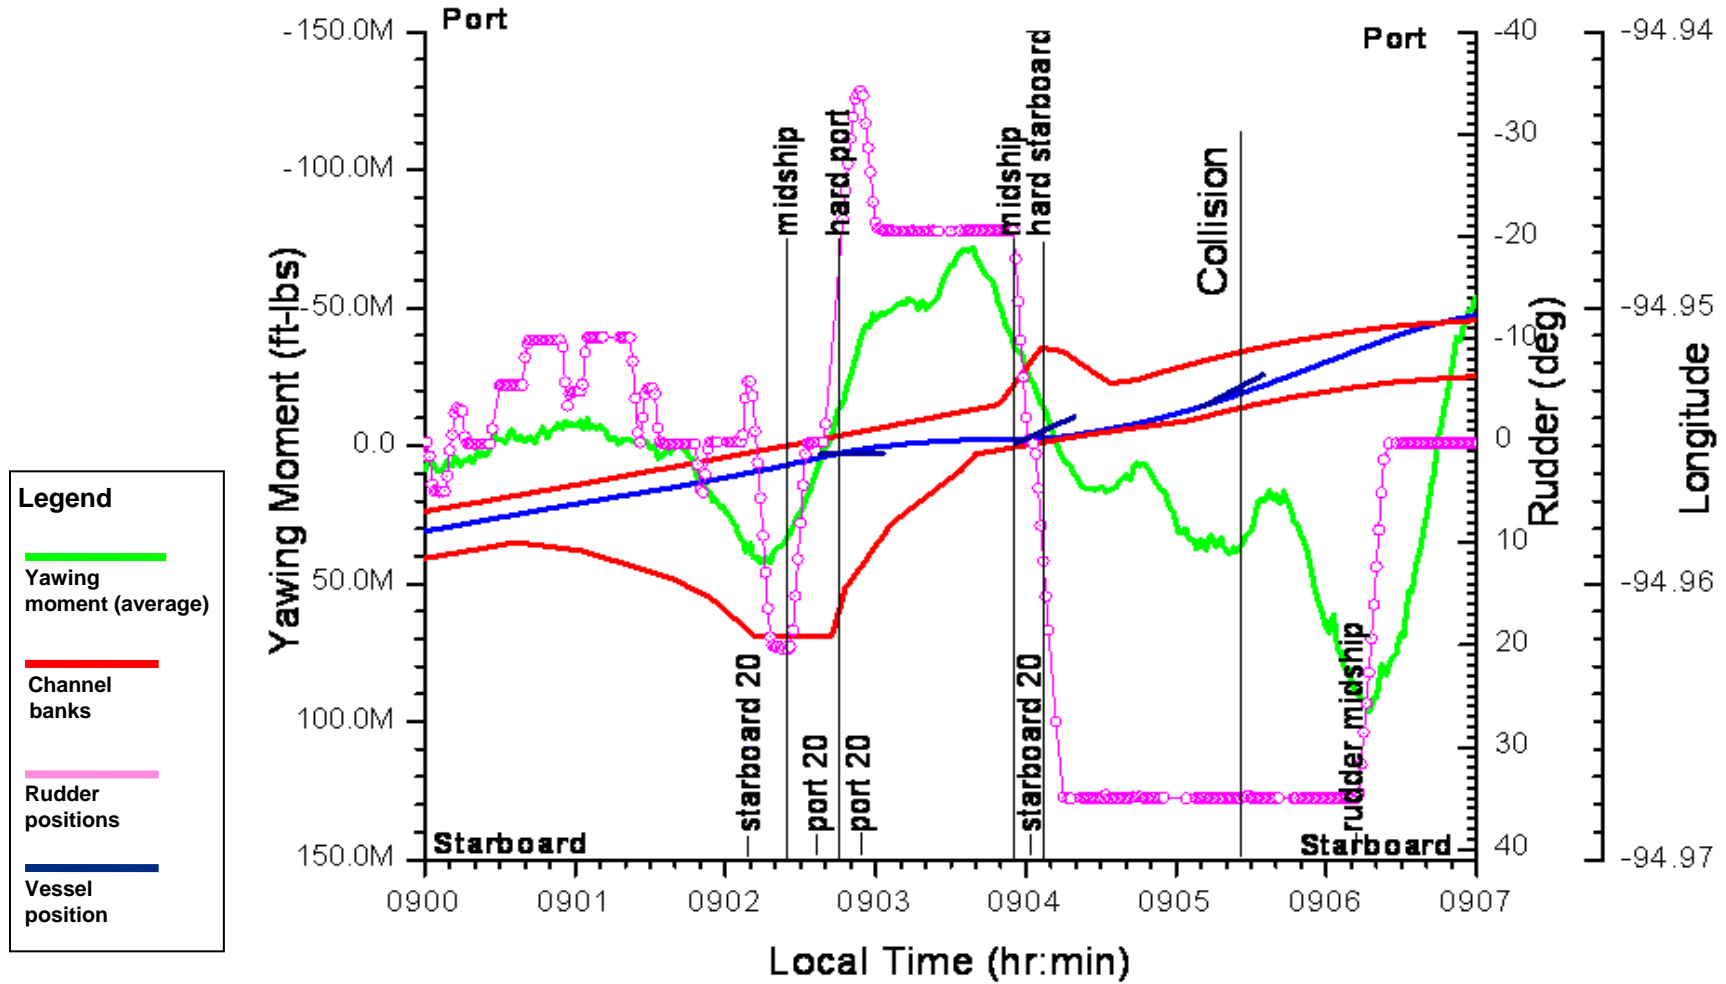
Figure 12. Rudder positions, average yawing moment, and position of the *Elka Apollon* over time as the vessel traveled south (from left to right on the plot) through the Bayport flare in the minutes prior to and just after the collision.
